**Flood Control Project Maintenance  
Levee Inspections**

## Maintenance Issue Types Only, Levee Inspection Report By Mile - Spring 2024

### Reclamation District No. 2075 McMullin

Waterway	Bank	Unit Miles	Inspection Start/End	Inspector
Unit No. 01 San Joaquin River	Right	7.45	04/02/2024 04/02/2024	Alberto De Leon

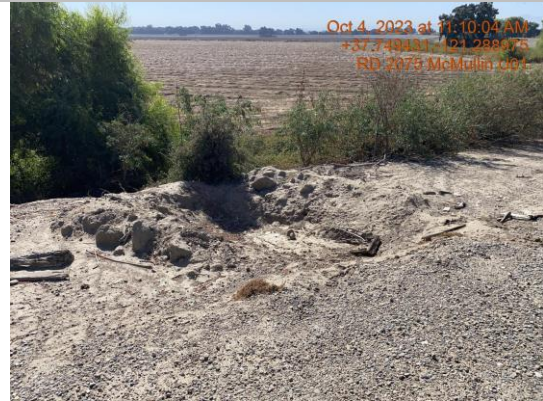
Photo 1 of 1 : SP\_2024\_RD2075\_315\_17\_20240214\_00010.jpg

LM Start	0.02	Rating **	M	Issue No.	17
LM End	0.02	Issue Type +	Ma	Location *	LS
Category	Earthen Levee			GPS Latitude/Longitude	
				Start	End
Item	Erosion / Bank Caving			37.749410°	37.749410°
				-121.288975°	-121.288975°
DWR ID	DWR_RD2075_01_f_2021_17				
Comment Code					
E2 : Schedule repair of erosion site prior to the next inspection.					
Inspector Comment					
There is caving within the overbuilt landside slope. The caving has not extended into the levee prism.

View of landside slope caving. Fall 2023

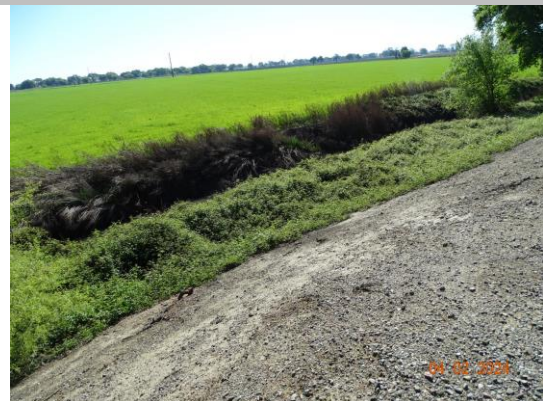
Photo 1 of 1 : SP\_2024\_RD2075\_315\_18\_20240402\_00029.jpg

LM Start	0.10	Rating **	U	Issue No.	18
LM End	0.23	Issue Type +	Ma	Location *	LS
Category	Earthen Levee			GPS Latitude/Longitude	
				Start	End
Item	Vegetation			37.748428°	37.746547°
				-121.289766°	-121.289465°
DWR ID	DWR_RD2075_01_f_2020_18				
Comment Code					
V2 : Remove the wild growth and woody vegetation other than native grasses from the levee slopes.					
Inspector Comment					
Berry bushes are obstructing visibility of the landside easement.

View of berry bushes along the landside easement. Spring 2024

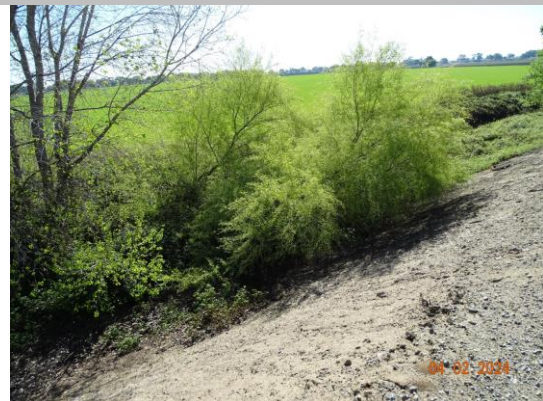
Photo 1 of 1 : SP\_2024\_RD2075\_315\_22\_20240402\_00027.jpg

LM Start	0.12	Rating **	U	Issue No.	22
LM End	0.12	Issue Type +	Ma	Location *	LS
Category	Earthen Levee			GPS Latitude/Longitude	
				Start	End
Item	Trim / Thin Trees			37.748139°	37.748139°
				-121.289666°	-121.289666°
DWR ID	DWR_RD2075_01_f_2022_22				
Comment Code					
T1 : Trim and thin trees to at least five feet above ground level to allow visibility of the ground and room to flood fight.					
Inspector Comment

View of untrimmed trees along the landside slope. Spring 2024

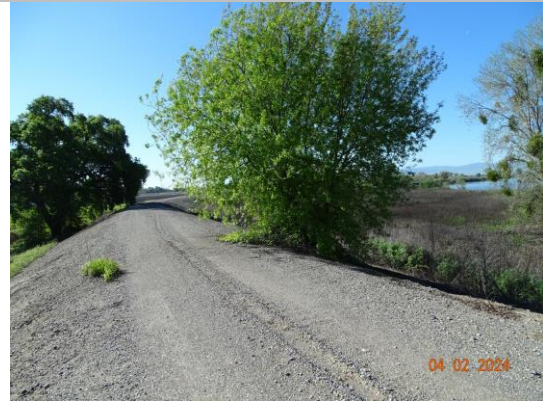
Photo 1 of 1 : SP\_2024\_RD2075\_315\_41\_20240402\_00028.jpg

LM Start	0.13	Rating **	U	Issue No.	41
LM End	0.13	Issue Type +	Ma	Location *	WS
Category	Earthen Levee			GPS Latitude/Longitude	
				Start	End
Item	Trim / Thin Trees			37.748072°	37.748072°
				-121.289657°	-121.289657°
DWR ID	DWR_RD2075_01_s_2021_41				
Comment Code					
T1 : Trim and thin trees to at least five feet above ground level to allow visibility of the ground and room to flood fight.					
Inspector Comment

View of untrimmed tree on the waterside slope. Spring 2024

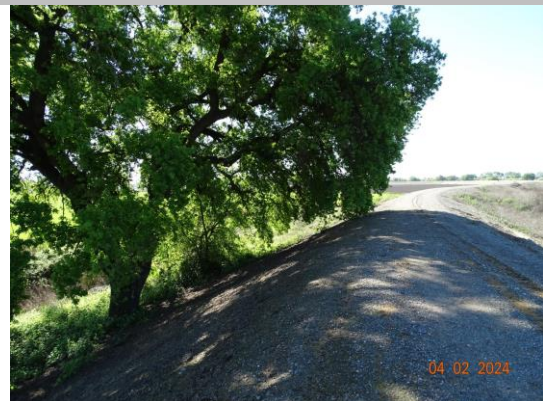
Photo 1 of 1 : SP\_2024\_RD2075\_315\_44\_20240402\_00030.jpg

LM Start	0.16	Rating **	M	Issue No.	44
LM End	0.16	Issue Type +	Ma	Location *	LS
Category	Earthen Levee			GPS Latitude/Longitude	
				Start	End
Item	Trim / Thin Trees			37.747633°	37.747633°
				-121.289462°	-121.289462°
DWR ID	DWR_RD2075_01_s_2021_44				
Comment Code					
T1 : Trim and thin trees to at least five feet above ground level to allow visibility of the ground and room to flood fight.					
Inspector Comment

View of untrimmed tree along the landside slope. Spring 2024

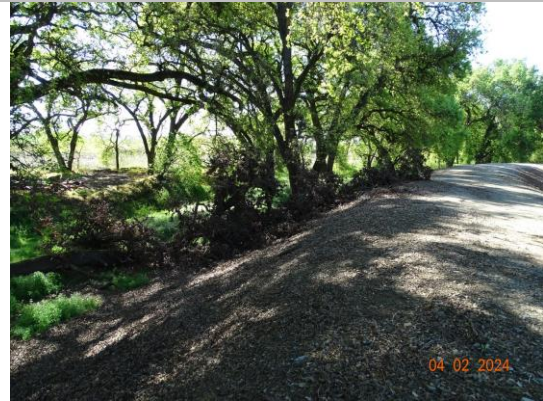
Photo 1 of 1 : SP\_2024\_RD2075\_315\_9\_20240402\_00031.jpg

LM Start	1.00	Rating **	U	Issue No.	9
LM End	1.00	Issue Type +	Ma	Location *	LS
Category	Earthen Levee			GPS Latitude/Longitude	
				Start	End
Item	Trim / Thin Trees			37.739827°	37.739827°
				-121.281219°	-121.281219°
DWR ID	DWR_RD2075_01_s_2024_9				
Comment Code					
T2 : Tree or limb.					
Inspector Comment

View of broken tree branch along the landside slope. Spring 2024

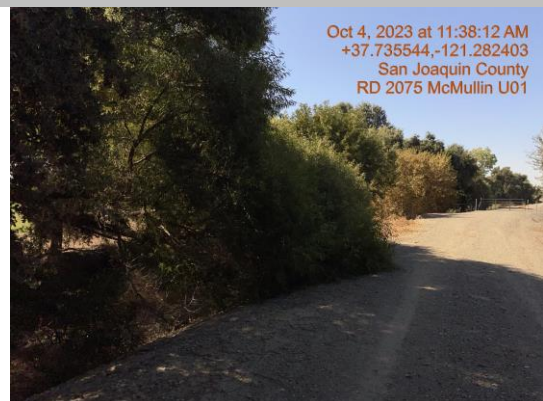
Photo 1 of 1 : SP\_2024\_RD2075\_315\_15\_20240214\_00008.jpg

LM Start	1.33	Rating **	U	Issue No.	15
LM End	1.33	Issue Type +	Ma	Location *	LS
Category	Earthen Levee			GPS Latitude/Longitude	
				Start	End
Item	Trim / Thin Trees			37.735539°	37.735539°
				-121.282403°	-121.282403°
DWR ID	DWR_RD2075_01_f_2023_15				
Comment Code					
T2 : Tree or limb.					
Inspector Comment

View of untrimmed trees along the landside slope. Fall 2023

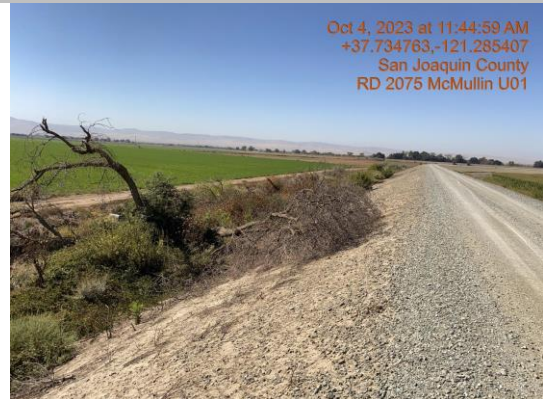
Photo 1 of 1 : SP\_2024\_RD2075\_315\_3\_20240214\_00001.jpg

LM Start	1.50	Rating **	U	Issue No.	3
LM End	1.50	Issue Type +	Ma	Location *	LS
Category	Earthen Levee			GPS Latitude/Longitude	
				Start	End
Item	Trim / Thin Trees			37.734737°	37.734737°
				-121.285422°	-121.285422°
DWR ID	DWR_RD2075_01_s_2023_3				
Comment Code					
T2 : Tree or limb.					
Inspector Comment

View of tree branches along the landside slope and easement. Fall 2023

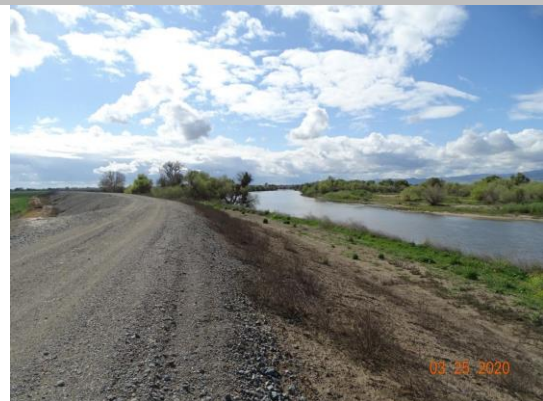
Photo 1 of 1 : SP\_2024\_RD2075\_315\_16\_20240214\_00009.jpg

LM Start	<b>2.74</b>	Rating **	A/W	Issue No.	<b>16</b>
LM End	<b>2.84</b>	Issue Type +	Ma	Location *	WS
Category	Earthen Levee			GPS Latitude/Longitude	
				Start	End
Item	Erosion / Bank Caving			37.725200°	37.724000°
				-121.294400°	-121.293200°
DWR ID	LMA-307

Channel bank has signs of erosion and is degrading in concave pocket sections. It is recommended the LMA continue to monitor and document the rate of erosion. Rock was placed on LS here during the 2017 storms. This was a 2017 Storm Damage site. Site ID No:480 & 81, Site Designation: LMA-307 & LMA-35

View of waterside slope looking upstream. Spring 2020

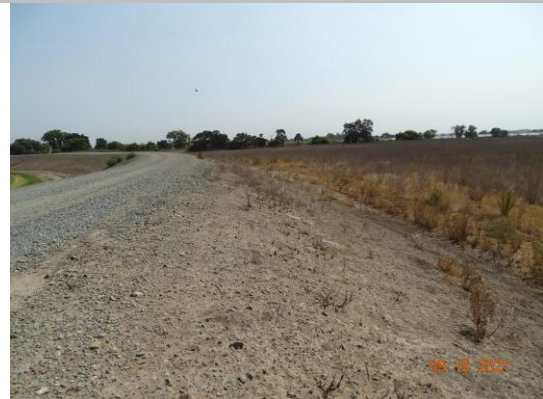
Photo 1 of 1 : SP\_2024\_RD2075\_315\_19\_20240214\_00012.jpg

LM Start	3.90	Rating **	A/W	Issue No.	19
LM End	4.04	Issue Type +	Ma	Location *	WS
Category	Earthen Levee			GPS Latitude/Longitude	
				Start	End
Item	Erosion / Bank Caving			37.713388°	37.714630°
				-121.280018°	-121.278263°
DWR ID	LMA-483				
Comment Code					
E1 : Note and monitor erosion site.					
Inspector Comment					
Channel banks has signs of erosion and is degrading in concave pocket sections. It is recommended the LMA continue to monitor and document the rate of erosion. Rock was placed on LS here during the 2017 storms. This was a 2017 Storm Damage site. Site ID No: 576 & 577, Site Designation: LMA-482 & LMA-483

View of waterside slope. Fall 2021

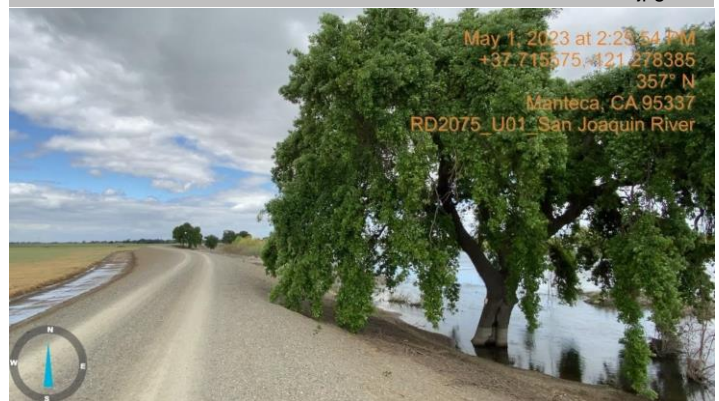
Photo 1 of 1 : SP\_2024\_RD2075\_315\_35\_20240214\_00017.jpg

LM Start	4.11	Rating **	M	Issue No.	35
LM End	4.11	Issue Type +	Ma	Location *	WS
Category	Earthen Levee			GPS Latitude/Longitude	
				Start	End
Item	Trim / Thin Trees			37.715603°	37.715603°
				-121.278441°	-121.278441°
DWR ID	DWR_RD2075_01_f_2020_35				
Comment Code					
T1 : Trim and thin trees to at least five feet above ground level to allow visibility of the ground and room to flood fight.					
Inspector Comment

View of an untrimmed tree on the waterside slope. Spring 2023

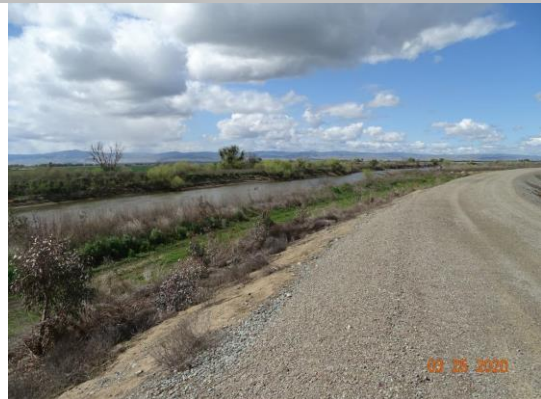
Photo 1 of 1 : SP\_2024\_RD2075\_315\_28\_20240214\_00015.jpg

LM Start	5.95	Rating **	A/W	Issue No.	28
LM End	6.33	Issue Type +	Ma	Location *	WS
Category	Earthen Levee			GPS Latitude/Longitude	
				Start	End
Item	Erosion / Bank Caving			37.721710°	37.720960°
				-121.267490°	-121.259830°
DWR ID	LMA-485				
Comment Code					
E1 : Note and monitor erosion site.					
Inspector Comment					
Channel bank has signs of erosion and is degrading in concave pocket sections. It is recommended the LMA continue to monitor and document the rate of erosion. Rock was placed on LS here during the 2017 storms. This was a 2017 Storm Damage site. Site ID No: 579 & 580. Site Designation: LMA-485 & LMA-486

View of waterside slope looking downstream. Spring 2020

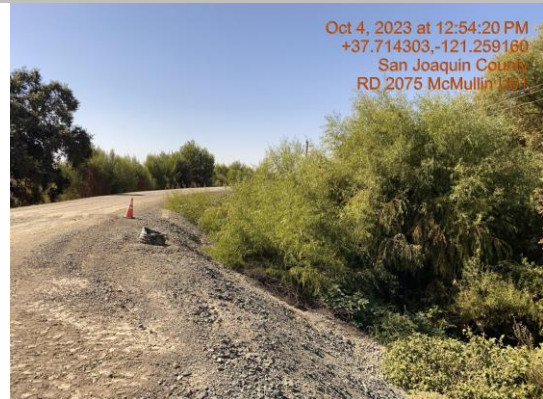
Photo 1 of 1 : SP\_2024\_RD2075\_315\_40\_20240214\_00018.jpg

LM Start	6.84	Rating **	U	Issue No.	40
LM End	6.84	Issue Type +	Ma	Location *	WS
Category	Earthen Levee			GPS Latitude/Longitude	
				Start	End
Item	Trim / Thin Trees			37.714123°	37.714123°
				-121.259279°	-121.259279°
DWR ID	DWR_RD2075_01_f_2020_40				
Comment Code					
T1 : Trim and thin trees to at least five feet above ground level to allow visibility of the ground and room to flood fight.					
Inspector Comment

View of trees on waterside slope obstructing visibility. Fall 2023

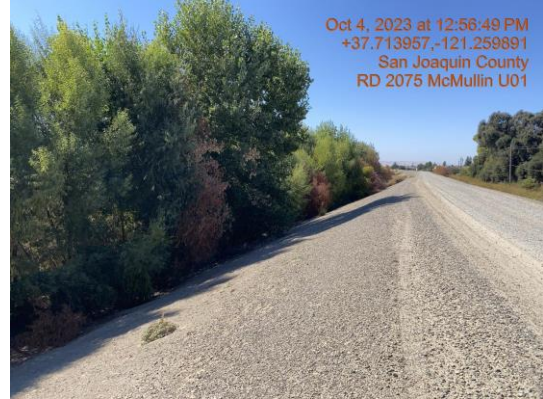
Photo 1 of 1 : SP\_2024\_RD2075\_315\_63\_20240214\_00023.jpg

LM Start	6.87	Rating **	U	Issue No.	63
LM End	6.94	Issue Type +	Ma	Location *	LS
Category	Earthen Levee			GPS Latitude/Longitude	
				Start	End
Item	Trim / Thin Trees			37.713961°	37.713765°
				-121.259676°	-121.260914°
DWR ID	DWR_RD2075_01_f_2022_63				
Comment Code					
T1 : Trim and thin trees to at least five feet above ground level to allow visibility of the ground and room to flood fight.					
Inspector Comment

View of untrimmed trees along the landside easement. Fall 2023
