**Flood Control Project Maintenance
Levee Inspections
LMA District Cover Sheet
Spring 2013 Levee Inspection Results**

Reclamation District No. 2075 McMullin

Levee Inspection Report By Mile - Spring 2013

Waterway		Bank	Unit Miles	Inspection Start/End	Inspector
Unit No. 01 San Joaquin River		Right	7.52	03/21/2013 03/21/2013	Herman Phillips

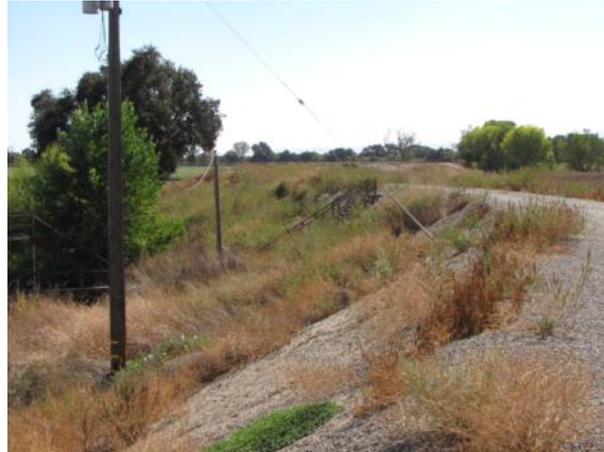
Levee Mile Report Line	4
Start Levee Mile	0.05
End Levee Mile	0.05
Location	Land Side
Category	
Item	Vegetation
RD 2075 at levee mile 0.00 looking downstream landside. Photo taken 10-09-2012.	
phillips_s_20130228_247.jpg

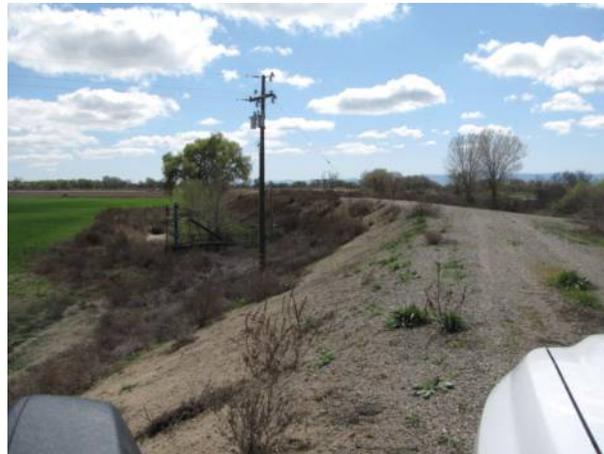
Levee Mile Report Line	4
Start Levee Mile	0.05
End Levee Mile	0.05
Location	Land Side
Category	
Item	Vegetation
RD 2075 Looking downstream of the landside slope levee mile 0.05. Photo taken 3-21-2013.	
phillips_s_20130513_424.JPG

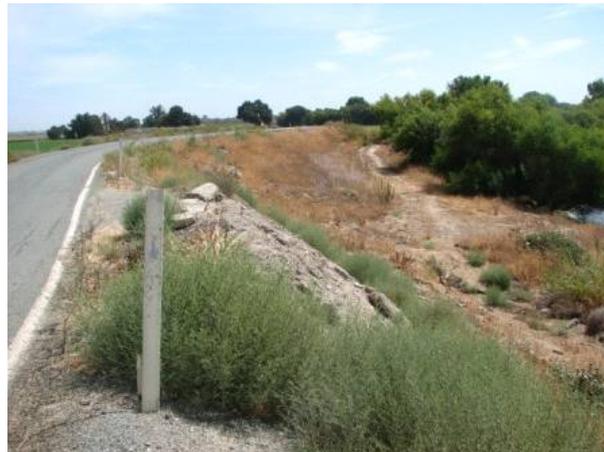
Levee Mile Report Line	22
Start Levee Mile	5.34
End Levee Mile	5.35
Location	Water Side
Category	Supplemental
Item	DWR Erosion Survey
Looking upstream of the site .	
phillips_s_20130228_243.jpg

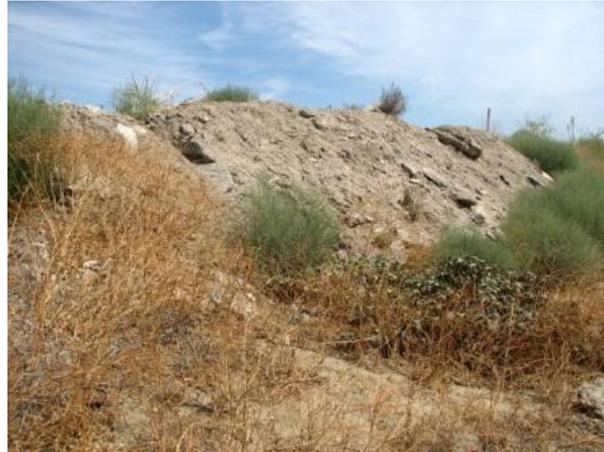
Levee Mile Report Line	22
Start Levee Mile	5.34
End Levee Mile	5.35
Location	Water Side
Category	Supplemental
Item	DWR Erosion Survey
Looking up to the levee crown at the added material.	
phillips_s_20130228_244.jpg

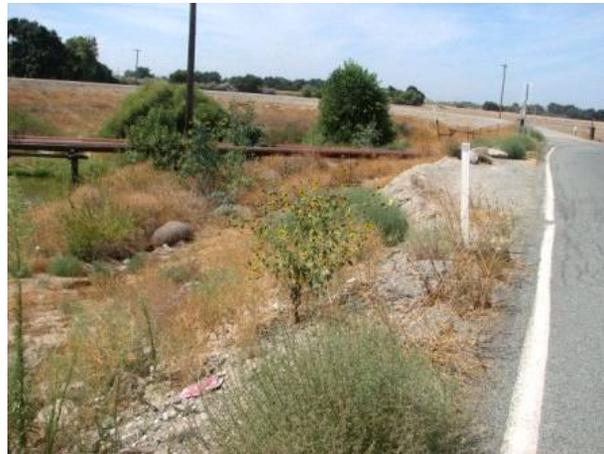
Levee Mile Report Line	22
Start Levee Mile	5.34
End Levee Mile	5.35
Location	Water Side
Category	Supplemental
Item	DWR Erosion Survey
Looking upstream of the erosion site	
phillips_s_20130228_245.jpg

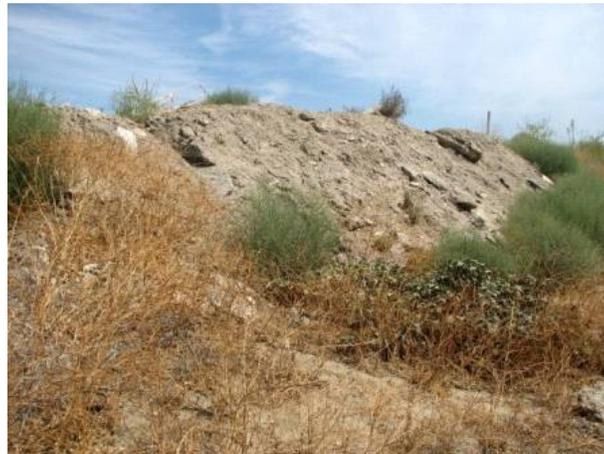
Levee Mile Report Line	22
Start Levee Mile	5.34
End Levee Mile	5.35
Location	Water Side
Category	Supplemental
Item	DWR Erosion Survey
Direct look at the levee slope.	
phillips_s_20130228_246.jpg
