**Flood Control Project Maintenance
Levee Inspections**

Fall 2008 Levee Maintenance Deficiency Summary Report

Reclamation District No. 2085

Levee Inspection Report By Mile - Fall 2008

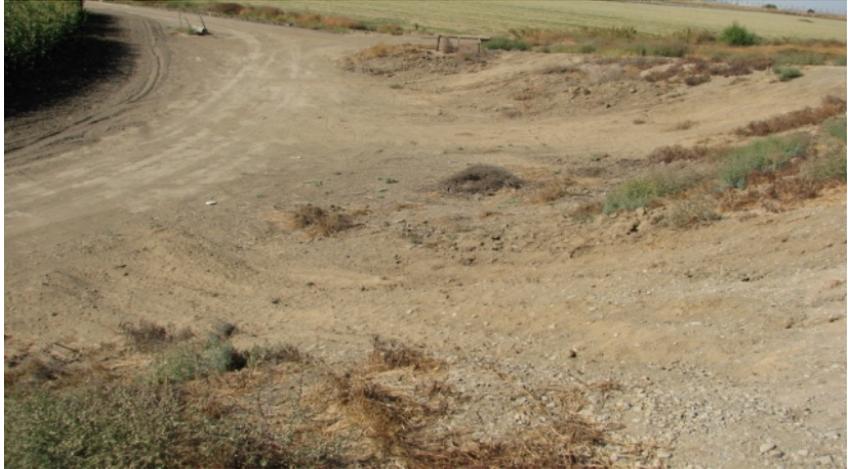
Levee Mile Report Line	1
Start Levee Mile	0.62
End Levee Mile	0.62
Location	
Category	Earthen Levee
Item	Erosion / Bank Caving
<p>RD 2085 Unit , LS. People are regularly driving across this levee where no access is present. Damage has occurred on both LS and WS, damage will only get worse if no action is taken to halt this driving pattern.</p>

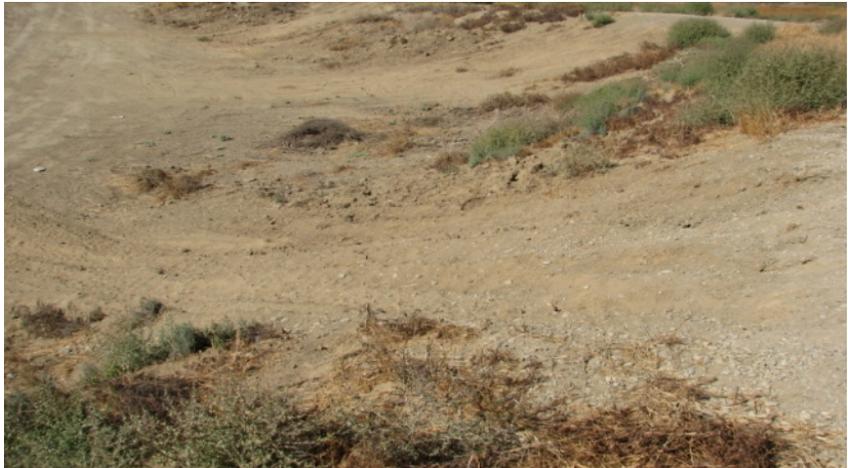
Levee Mile Report Line	1
Start Levee Mile	0.62
End Levee Mile	0.62
Location	
Category	Earthen Levee
Item	Erosion / Bank Caving
<p>Closer view of rutting occurring.</p>

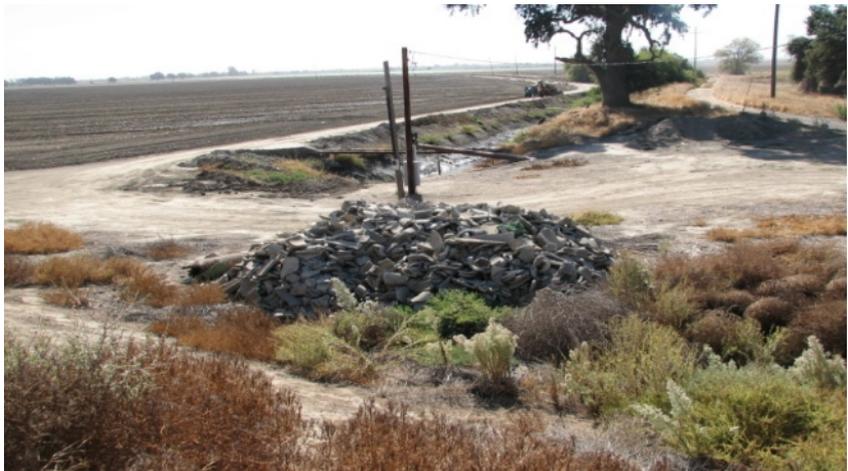
Levee Mile Report Line	4
Start Levee Mile	1.35
End Levee Mile	1.35
Location	
Category	Earthen Levee
Item	Encroachments
<p>RD 2085 unit1. This debris pile should be removed. This levee is known to have seepage problems and any attempt to fight a boil in this location would be hampered. Also, typically debris tends to attract more debris.</p>

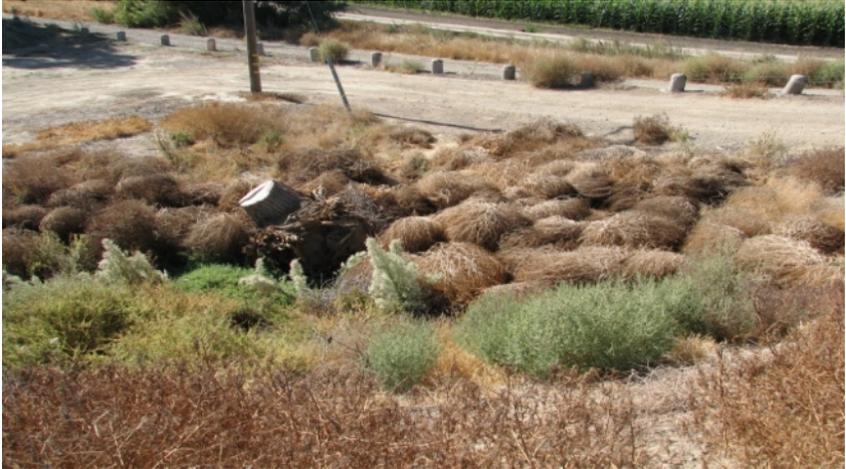
Levee Mile Report Line	4
Start Levee Mile	1.35
End Levee Mile	1.35
Location	
Category	Earthen Levee
Item	Encroachments
Same comments as prior photo.

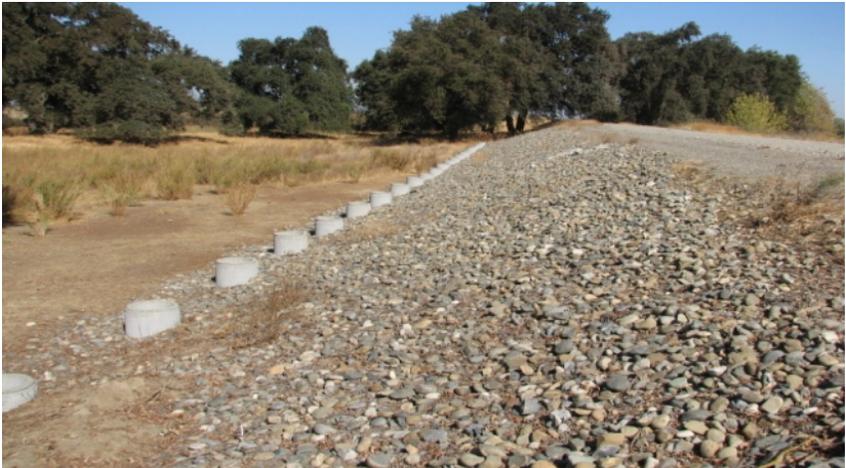
Levee Mile Report Line	6
Start Levee Mile	2.50
End Levee Mile	2.52
Location	
Category	Earthen Levee
Item	Underseepage Relief Wells
Each drain element is filled with sediment.

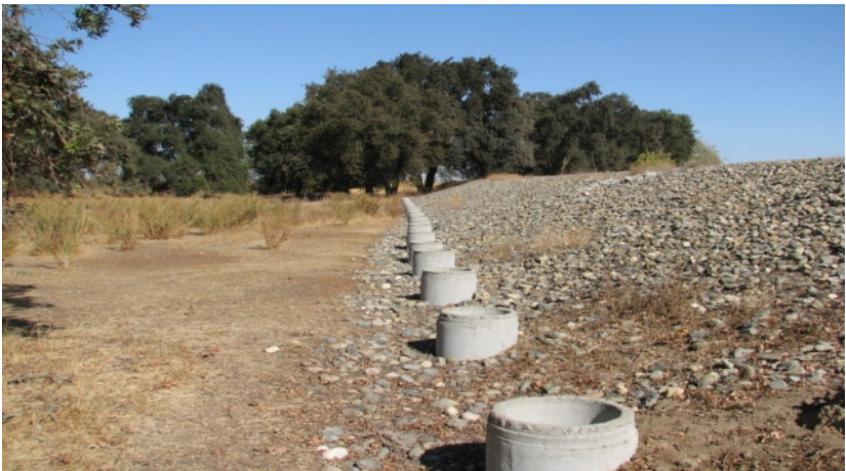
Levee Mile Report Line	6
Start Levee Mile	2.50
End Levee Mile	2.52
Location	
Category	Earthen Levee
Item	Underseepage Relief Wells
Another view of the toe drain feature.

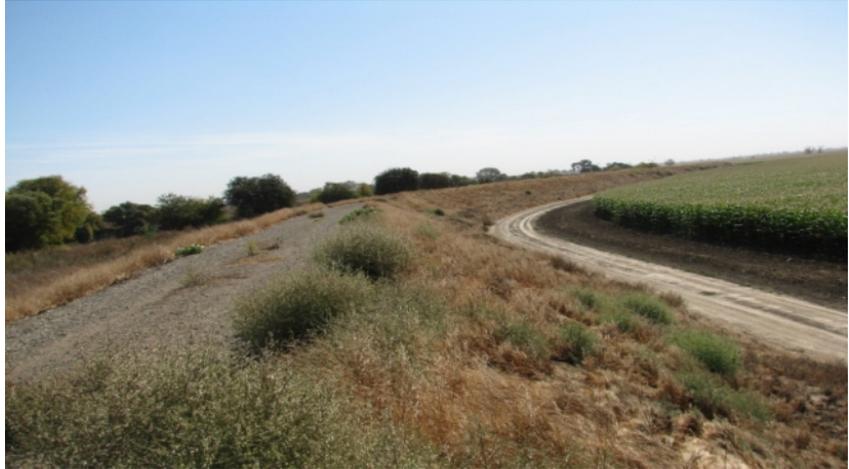
Levee Mile Report Line	9
Start Levee Mile	4.12
End Levee Mile	4.17
Location	
Category	Earthen Levee
Item	Crown Surface / Depressions / Rutting
RD 2085 unit 1.

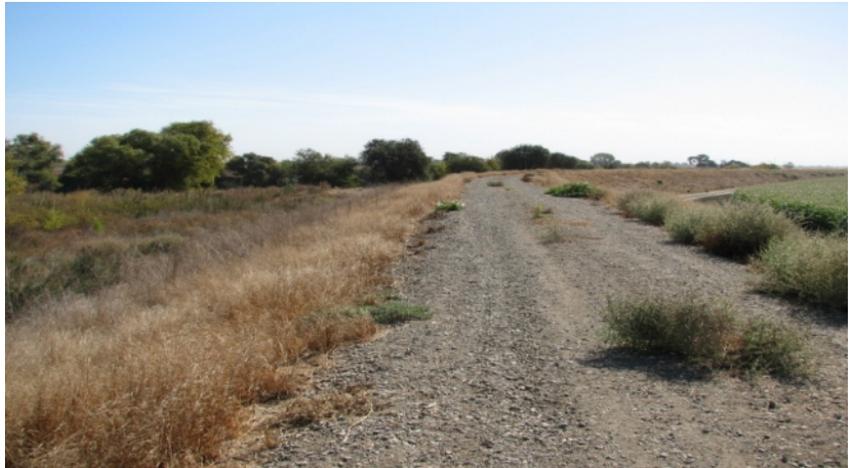
Levee Mile Report Line	9
Start Levee Mile	4.12
End Levee Mile	4.17
Location	
Category	Earthen Levee
Item	Crown Surface / Depressions / Rutting
RD2085 unit 1. Roadway is beginning to develop unwanted vegetation. Best to get control before growth becomes out of hand.
