**Flood Control Project Maintenance
Levee Inspections**

Fall 2009 Levee Maintenance Deficiency Summary Report

San Joaquin River Basin

Reclamation District No. 2085 Kasson

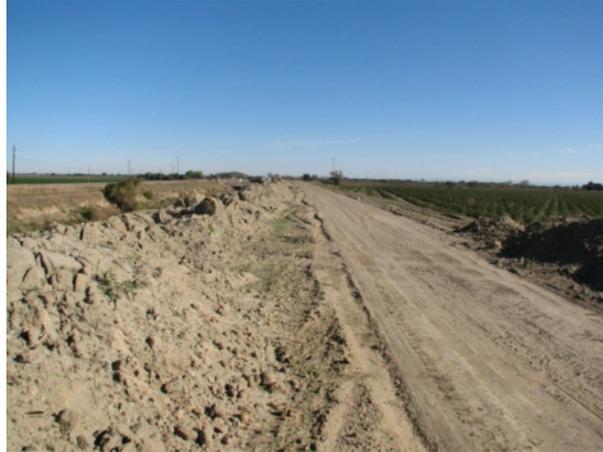
Levee Mile Report Line	1
Start Levee Mile	0.00
End Levee Mile	0.46
Location	Water Side
Category	Earthen Levee
Item	Encroachments

Photo of tailings along canal.

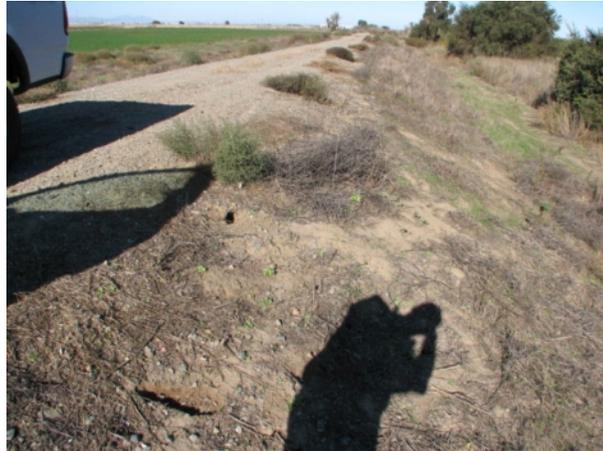
Levee Mile Report Line	3
Start Levee Mile	0.83
End Levee Mile	0.83
Location	Water Side
Category	Earthen Levee
Item	Animal Control

Photo of several animal burrows on water side slope.

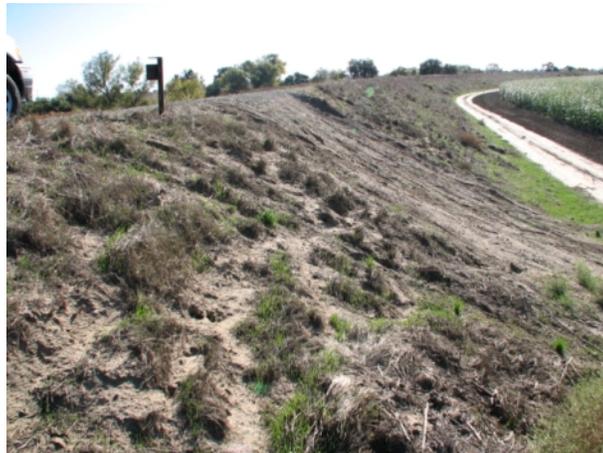
Levee Mile Report Line	4
Start Levee Mile	0.90
End Levee Mile	0.90
Location	Land Side
Category	Earthen Levee
Item	Slope Stability

Photo of vehicle traffic on landside slope of levee. Tracks continue onto water side.

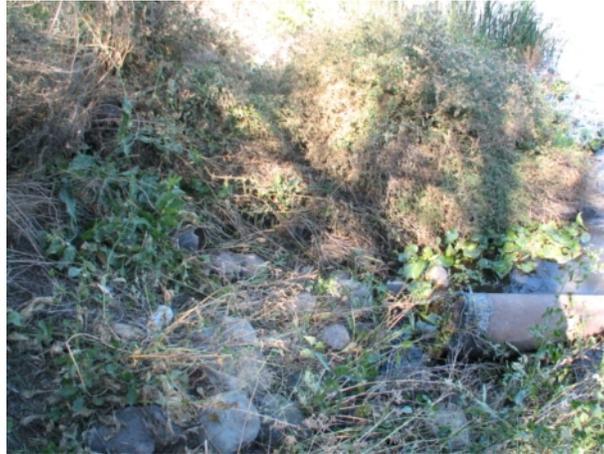
5	1.28	1.28	Interior Drainage & Piping Systems	Metal Pipes	WS	M	Inspector Comments: Drainage outlet pipe has completely deteriorated. District has a design and is accepting bids for the repair.	37.714462 ° -121.289608 °	37.714462 ° -121.289608 °	43 Y
6	1.59	1.59	Earthen Levee	Animal Control	WS	M	Exterminate rodents and backfill and compact or grout burrows.	37.712639 ° -121.284665 °	37.712639 ° -121.284665 °	26
7	2.45	2.45	Earthen Levee	Trim / Thin Trees	CR	M	Trim trees over roadway to at least 12 feet above ground level.	37.703743 ° -121.274552 °	37.703743 ° -121.274552 °	6
8	2.49	2.49	Earthen Levee	Trim / Thin Trees	LS	M	Trim trees over roadway to at least 12 feet above ground level.	37.703144 ° -121.274716 °	37.703144 ° -121.274716 °	27 Y
9	2.56	2.56	Earthen Levee	Trim / Thin Trees	WS	M	Trim trees to at least five feet above ground level.	37.702135 ° -121.275212 °	37.702135 ° -121.275212 °	7

Levee Mile Report Line	5
Start Levee Mile	1.28
End Levee Mile	1.28
Location	Water Side
Category	Interior Drainage & Piping Systems
Item	Metal Pipes
Photo of deteriorated drainage outlet at the bank of the San Joaquin River.	
jpaasch_20091102_133.jpg

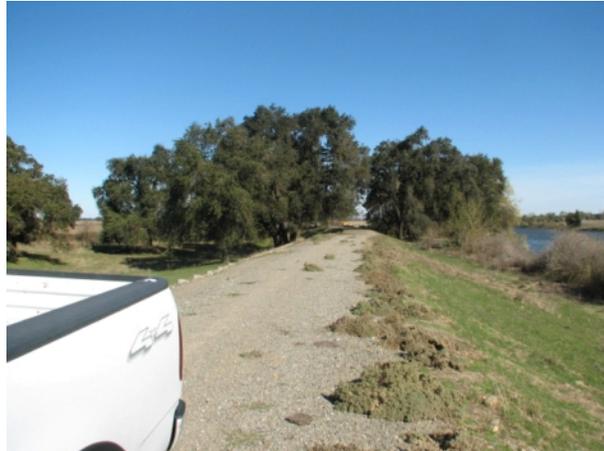
Levee Mile Report Line	8
Start Levee Mile	2.49
End Levee Mile	2.49
Location	Land Side
Category	Earthen Levee
Item	Trim / Thin Trees
Trim tree branches that are low at this location to allow for vehicular traffic.	
jpaasch_20091102_134.jpg

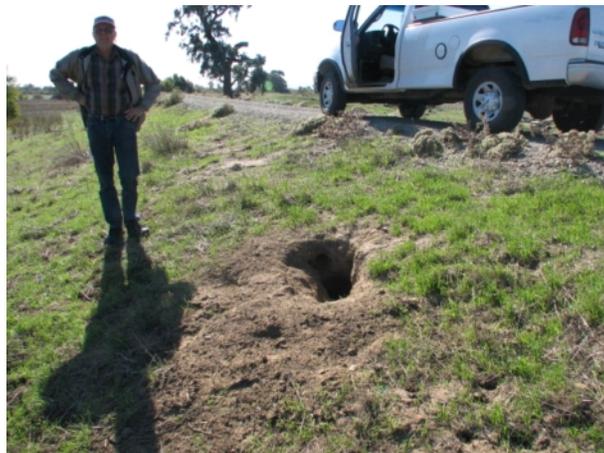
10	2.66	2.66	Earthen Levee	Animal Control	LS	M	No rodents visible, but rodent burrows visible; need to backfill and compact or grout borrows.	37.714462 ° -121.289608 °	37.714462 ° -121.289608 °	44
11	3.01	3.01	Earthen Levee	Animal Control	WS	U	Exterminate rodents and backfill and compact or grout burrows. Inspector Comments: Photo of uncovered den	37.696662 ° -121.277066 °	37.696662 ° -121.277066 °	45 Y
12	3.04	3.04	Earthen Levee	Encroachments	LS	C	Tree or limb	37.696289 ° -121.276870 °	37.696289 ° -121.276870 °	28
13	3.24	3.24	Earthen Levee	Encroachments	WS	M	Pipe Inspector Comments: Steel Pipe daylights on water side. Remnants of a turnout and collar on land side. Condition of abandoned pipe under levee is unknown.	37.693439 ° -121.277702 °	37.693439 ° -121.277702 °	46

Levee Mile Report Line	11
Start Levee Mile	3.01
End Levee Mile	3.01
Location	Water Side
Category	Earthen Levee
Item	Animal Control
Photo of small animal burrow uncovered by a predator creating a larger entrance.	
jpaasch_20091102_135.jpg

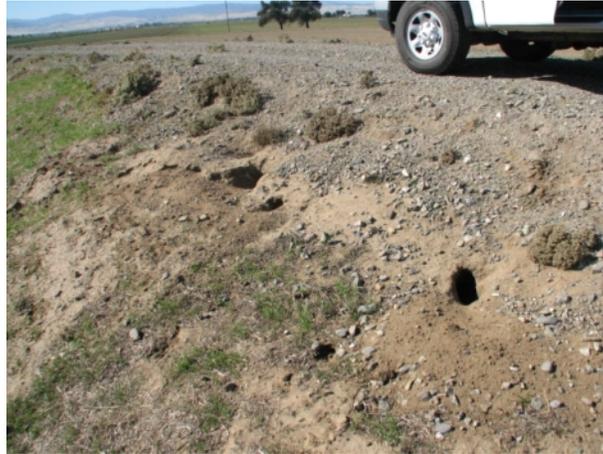
LMIR No	Levee Mile		Category	Item	Location	Rating	Action/Comment	GPS Latitude/Longitude		Issue No. Photo
	Start	End						Start	End	
14	3.24	3.33	Earthen Levee	Animal Control	WS	U	No rodents visible, but rodent burrows visible; need to backfill and compact or grout borrows. Inspector Comments: Numerous animal burrows through this segment of levee.	37.693439 ° -121.277702 °	37.692166 ° -121.278074 °	47 Y
15	3.76	3.76	Earthen Levee	Encroachments	LS	PO	Landscaping Inspector Comments: Iceplant	37.686358 ° -121.276752 °	37.686358 ° -121.276752 °	29
16	3.78	3.78	Earthen Levee	Trim / Thin Trees	WS	C	Trim trees to at least five feet above ground level.	37.686063 ° -121.276757 °	37.686063 ° -121.276757 °	10
17	3.84	3.84	Earthen Levee	Encroachments	LS	PO	Landscaping Inspector Comments: Iceplant	37.685251 ° -121.276522 °	37.685251 ° -121.276522 °	30
18	3.87	3.89	Earthen Levee	Trim / Thin Trees	WS	M	Thin trees to allow visibility of the ground and room to flood fight. Inspector Comments: Visibility and access are more limited as tree density increases.	37.684827 ° -121.276350 °	37.684531 ° -121.276267 °	31 Y

Levee Mile Report Line	14
Start Levee Mile	3.24
End Levee Mile	3.33
Location	Water Side
Category	Earthen Levee
Item	Animal Control
Several animal burrows on the water side slope.	
jpaasch_20091102_136.jpg

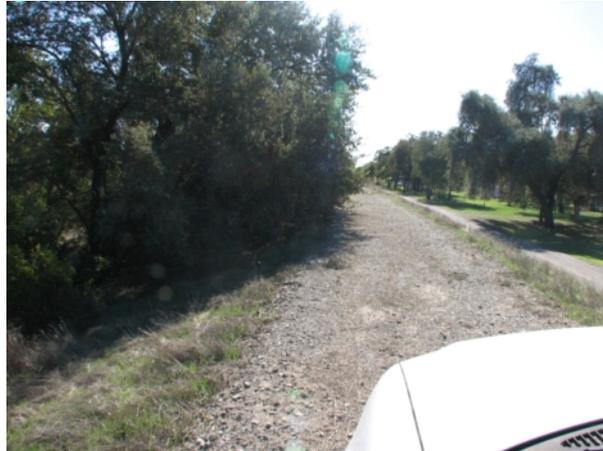
Levee Mile Report Line	18
Start Levee Mile	3.87
End Levee Mile	3.89
Location	Water Side
Category	Earthen Levee
Item	Trim / Thin Trees
Photo of untrimmed trees on water side slope of levee.	
jpaasch_20091102_137.jpg

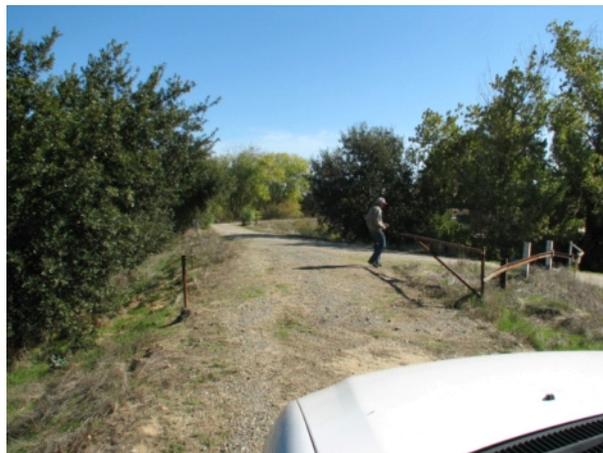
Levee Mile Report Line	21
Start Levee Mile	4.29
End Levee Mile	4.32
Location	Land Side
Category	Earthen Levee
Item	Trim / Thin Trees
Photo of trees requiring trimming on land side slope.	
jpaasch_20091102_138.jpg

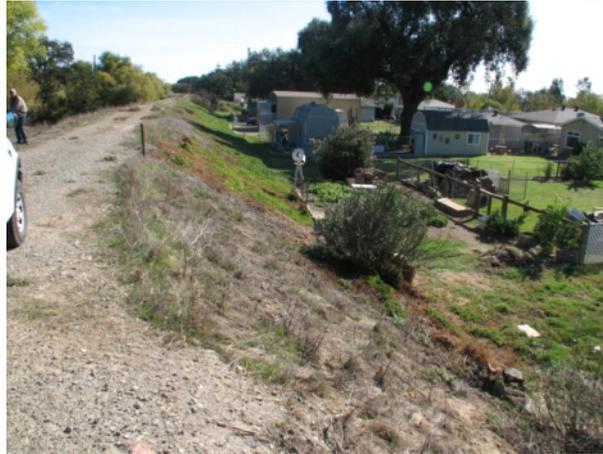
Levee Mile Report Line	22
Start Levee Mile	4.32
End Levee Mile	4.37
Location	Land Side
Category	Earthen Levee
Item	Encroachments

Photo of obstructive landscaping on land side slope and toe.

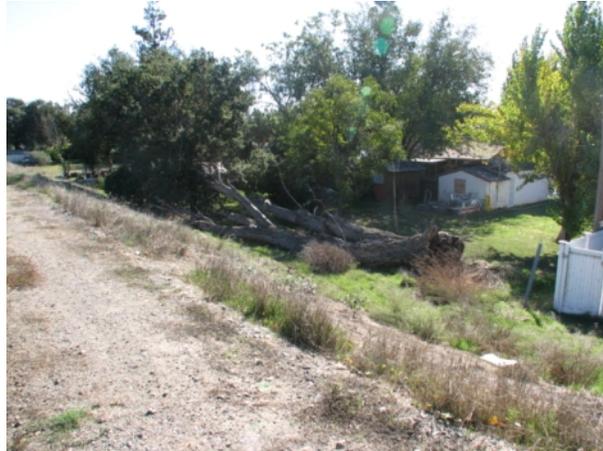
Levee Mile Report Line	24
Start Levee Mile	4.39
End Levee Mile	4.39
Location	Land Side
Category	Earthen Levee
Item	Encroachments

Photo of fallen tree near levee slope and toe. This tree was documented in the previous inspection.

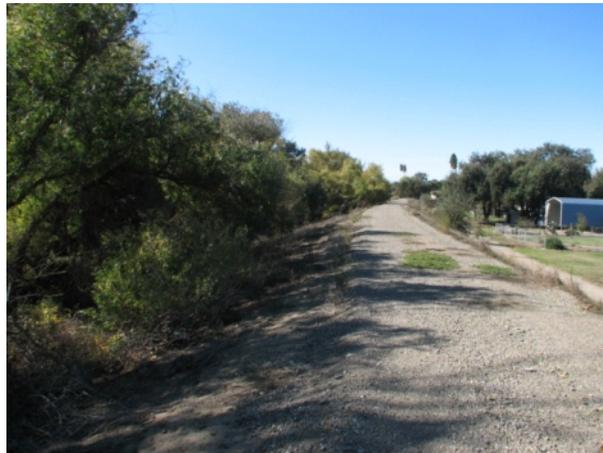
Levee Mile Report Line	31
Start Levee Mile	4.87
End Levee Mile	4.87
Location	Water Side
Category	Earthen Levee
Item	Trim / Thin Trees

Trees within 20-ft of levee crown need to be trimmed for access and visibility.

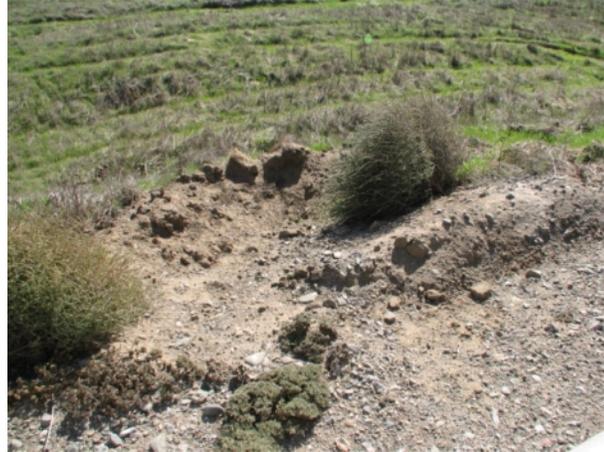
LMIR No	Levee Mile		Category	Item	Location *	Rating **	Action/Comment	GPS Latitude/Longitude		Issue No. Photo
	Start	End						Start	End	
1	0.21	0.21	Earthen Levee	Slope Stability	WS	M	Repair the levee slope damaged by vehicle traffic and prevent access where possible.	37.682796 ° -121.262034 °	37.682796 ° -121.262034 °	3 Y
2	0.28	0.28	Earthen Levee	Vegetation	WS	A	Remove the wild growth other than native grasses from the levee slopes. Inspector Comments: Condition of this unit serves as an example of acceptable vegetation.	37.683617 ° -121.261845 °	37.683617 ° -121.261845 °	2

Levee Mile Report Line	1
Start Levee Mile	0.21
End Levee Mile	0.21
Location	Water Side
Category	Earthen Levee
Item	Slope Stability
Photo of damaged slope due to vehicle traffic.	
jpaasch_20091102_142.jpg
