**Flood Control Project Maintenance
Levee Inspections**
LMA District Cover Sheet
Spring 2014 Levee Inspection Results

Reclamation District No. 2085 Kasson

Waterway	Bank	Unit Miles
Unit No. 01 San Joaquin River	Left	5.20

Levee Inspection Report By Mile - Spring 2014

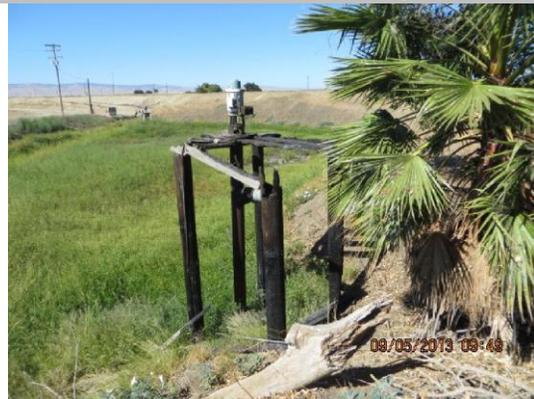
Photo 1 of 1 : UCIP_1813.jpg

LM Start	0.47	Rating **	M	Issue No.	5
LM End	0.47	Issue Type +	En	Location *	LS
Category	Supplemental		GPS Latitude/Longitude		
			Start	End	
Item	DWR UCIP Field Study		37.723415 °	37.723415 °	
			-121.298595 °	-121.298595 °	
DWR ID	DWR_RD2085_01_s_2014_5				
Action/Comments					
Inspector Comments: FS_ID:19383 EP_NO: N/A Repair Type: Crossing Status: UCIP Comments: Pipe abandoned. Erosion around pipe on WS slope. Pipe severely corroded. Pier badly damaged. FIELD_STRUCT_DESC: 14-inch steel stormdrain pipe through the levee 4.5 feet below crown. Pump on pile structure in ditch on the landward side. Siphon breaker in corrugated metal riser unit on the waterward shoulder. Originally included in the 1968 O&M manual. FS Date: 9/5/2013

Pump on delapidated pier with no connection.

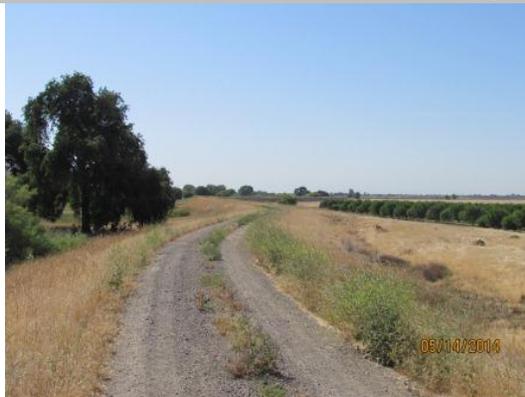
Photo 1 of 1 : mkhashch_s_20140519_01024.jpg

LM Start	0.70	Rating **	M	Issue No.	41
LM End	0.79	Issue Type +	Ma	Location *	CR
Category	Earthen Levee		GPS Latitude/Longitude		
			Start	End	
Item	Vegetation		37.721272 °	37.720408 °	
			-121.295376 °	-121.294339 °	
DWR ID	DWR_RD2085_01_f_2013_41				
Action/Comments					
Remove the wild growth other than native grasses from the levee

View of tall vegetation along levee crown obstructing visibility.

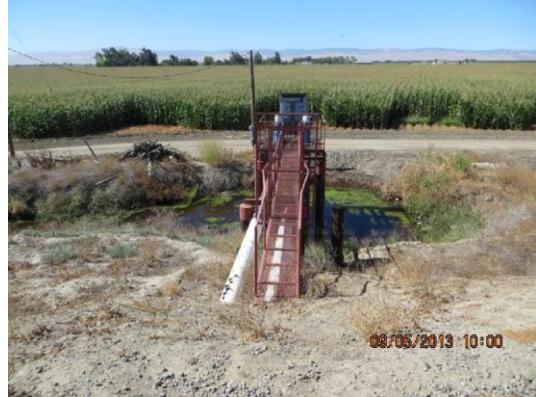
Photo 1 of 1 : UCIP_2935.jpg

LM Start	1.29	Rating **	M	Issue No.	11
LM End	1.29	Issue Type +	En	Location *	LS
Category	Supplemental			GPS Latitude/Longitude	
				Start	End
Item	DWR UCIP Field Study			37.714404 °	37.714404 °
				-121.289469 °	-121.289469 °
DWR ID	DWR_RD2085_01_s_2014_11				
Action/Comments					
Inspector Comments: FS_ID:22285 EP_NO: N/A Repair Type: Crossing Status: UCIP Comments: No permit identified for this modified crossing. FIELD_STRUCT_DESC: 12-inch steel pipe through the levee 3-feet below the crown. Pump mounted on pile structure in ditch on the landward side. Siphon breaker in 12-inch steel riser unit and a gatevalve on the waterward shoulder. FS Date: 9/10/2013

Pipe, pump, and walkway visible on LS toe.

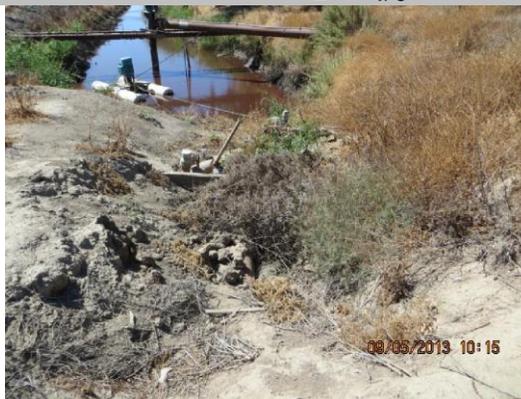
Photo 1 of 1 : UCIP_1816.jpg

LM Start	1.35	Rating **	M	Issue No.	13
LM End	1.35	Issue Type +	En	Location *	CR
Category	Supplemental			GPS Latitude/Longitude	
				Start	End
Item	DWR UCIP Field Study			37.714048 °	37.714048 °
				-121.288425 °	-121.288425 °
DWR ID	DWR_RD2085_01_s_2014_13				
Action/Comments					
Inspector Comments: FS_ID:19385 EP_NO: 3975 Repair Type: Crossing Status: UCIP Comments: Pipe abandoned and should be done so properly. Large hole in ground over pipe on WS berm. Pipe rusted through on WS at river bank. No connection to pump on LS toe. FIELD_STRUCT_DESC: 10-inch steel stormdrain pipe through the levee 4-feet below the crown. Steel plate over pipe end at pump station on LS toe. Siphon breaker in 24-inch corrugated metal riser unit on the waterward shoulder (Permit No. 3975, 1962). Originally included in the 1968 O&M manual. FS Date: 9/5/2013

Pipe visible at bottom of ditch on LS toe.

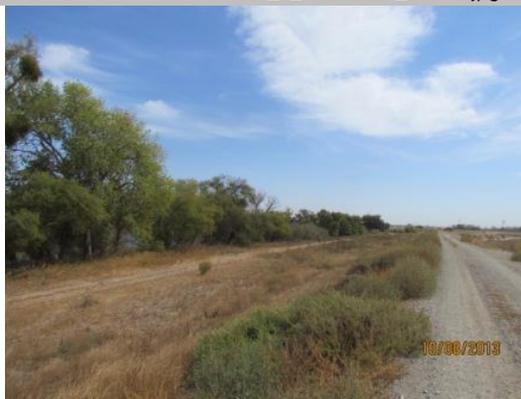
Photo 1 of 1 : mkhashch_s_20140428_00682.jpg

LM Start	1.68	Rating **	M	Issue No.	8
LM End	1.82	Issue Type +	Ma	Location *	WS
Category	Earthen Levee			GPS Latitude/Longitude	
				Start	End
Item	Vegetation			37.711917 °	37.710483 °
				-121.283089 °	-121.281030 °
DWR ID	DWR_RD2085_01_f_2013_8				
Action/Comments					
Control annual grass and weeds on the levee slopes and easements.

View of tall vegetation on waterside slope obstructing visibility.

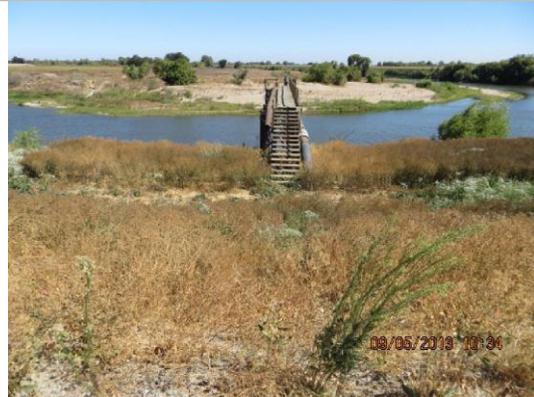
Photo 1 of 1 : UCIP_1824.jpg

LM Start	1.98	Rating **	M	Issue No.	16
LM End	1.98	Issue Type +	En	Location *	WS
Category	Supplemental		GPS Latitude/Longitude		
			Start	End	
Item	DWR UCIP Field Study		37.708826 °	37.708826 °	
			-121.279271 °	-121.279271 °	
DWR ID	DWR_RD2085_01_s_2014_16				
Action/Comments					
Inspector Comments: FS_ID:19423 EP_NO: N/A Repair Type: Crossing Status: UCIP Comments: This pipe is abandoned and should be done so properly. FIELD_STRUCT_DESC: 1 of 2: 10-inch pipe through the levee 2.0-feet below the crown. Pump mounted on pile structure in the river. Siphon breaker in 24-inch CMP riser on the LS slope. Power pole on LS toe. Wooden stairs and walkway from the berm to the pump structure. Originally included in the 1968 O&M manual. FS Date: 9/5/2013 8:22:24 AM

Pipe cut at wooden pier. No pump on end of pier for this pipe.

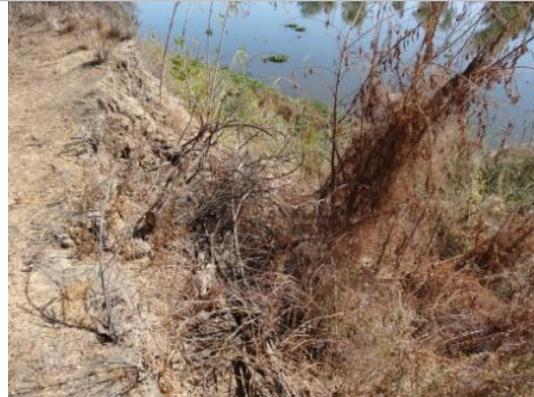
Photo 1 of 1 : mkhashch_s_20140428_00687.jpg

LM Start	2.24	Rating **	M	Issue No.	31
LM End	2.26	Issue Type +	Ma	Location *	WS
Category	Supplemental		GPS Latitude/Longitude		
			Start	End	
Item	DWR Erosion Survey		37.703094 °	37.703094 °

121.274894 °	121.274894 °	
DWR ID	DWR_RD2085_01_s_2014_31				
Action/Comments					
Inspector Comments: 09/20/2013: No significant change observed. 12/04/2012: The erosion has progressed remarkably toward levee, extended to the up-and downstream of the original pocket erosion. Trees and dense bush are present at the site. Animal burrow holes are visible, and possibly can cause seepage. 09/22/2010: No significant changes observed. There is little visibility due to seasonal grass on the berm and slope. 08/18/2009: Site is located on berm; pocket erosion has developed; the site is covered in dense vegetation; there are several relief wells on the landside of the levee; site is Not Rated because berm width is greater than 30 feet; site should be monitored to keep track of erosion progress. [2013 Site ID:RD2085U01RM66.5]

Close view of the erosion.

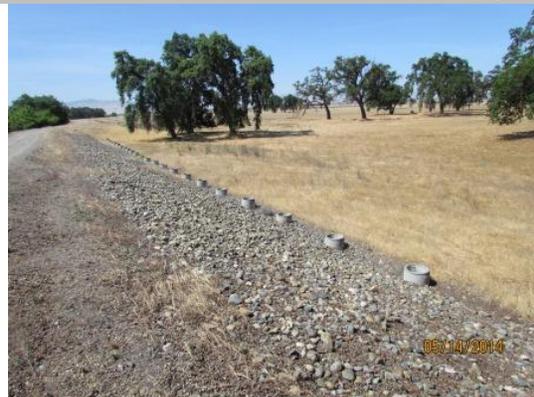
Photo 1 of 1 : mkhashch_s_20140519_01025.jpg

LM Start	2.51	Rating **	A/W	Issue No.	20
LM End	2.51	Issue Type +	Ob	Location *	LS
Category	Earthen Levee		GPS Latitude/Longitude		
			Start	End	
Item	Underseepage Relief Wells		37.702903 °	37.702903 °	
			-121.274860 °	-121.274860 °	
DWR ID	DWR_RD2085_01_s_2012_20				
Action/Comments

View of the underseepage relief wells at the landside levee toe.

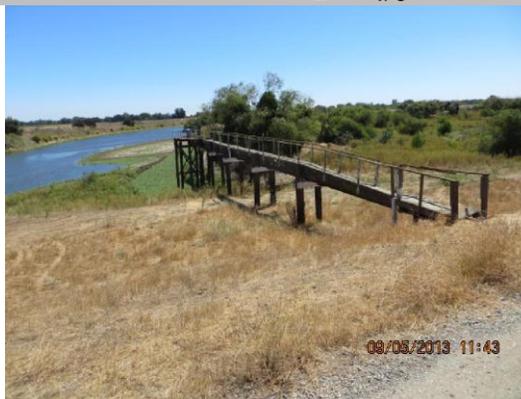
Photo 1 of 1 : UCIP_1828.jpg

LM Start	2.75	Rating **	M	Issue No.	19
LM End	2.75	Issue Type +	En	Location *	LS
Category	Supplemental		GPS Latitude/Longitude		
			Start	End	
Item	DWR UCIP Field Study		37.699697 °	37.699697 °	
			-121.276325 °	-121.276325 °	
DWR ID	DWR_RD2085_01_s_2014_19				
Action/Comments					
Inspector Comments: FS_ID:19431 EP_NO: 16970 Repair Type: Crossing Status: UCIP Comments: The wooden walkway on the WS slope is in disrepair. FIELD_STRUCT_DESC: 1 of 2: 14-inch steel irrigation pipe through the levee 2.0 feet below the crown. Pump on wooden pier at WS slope. Siphon breaker visible next to steel bollard on LS slope. Power pole on LS toe. FS Date: 9/5/2013

Pump on Wooden pier at WS slope.

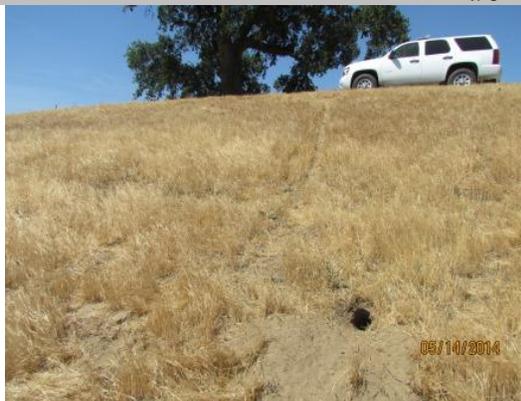
Photo 1 of 1 : mkhashch_s_20140519_01026.jpg

LM Start	3.04	Rating **	M	Issue No.	29
LM End	3.04	Issue Type +	Ma	Location *	WS
Category	Earthen Levee		GPS Latitude/Longitude		
			Start	End	
Item	Animal Control		37.696256 °	37.696256 °	
			-121.276877 °	-121.276877 °	
DWR ID	DWR_RD2085_01_s_2014_29				
Action/Comments					
Exterminate rodents and backfill and compact or grout burrows.

View of the rodent hole on the waterside levee slope.

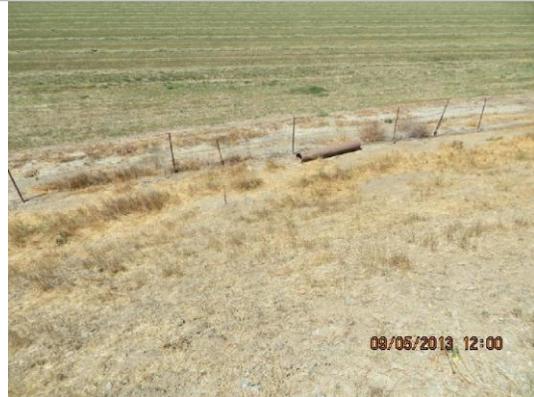
Photo 1 of 1 : UCIP_1832.jpg

LM Start	3.23	Rating **	M	Issue No.	25
LM End	3.23	Issue Type +	En	Location *	WS
Category	Supplemental		GPS Latitude/Longitude		
			Start	End	
Item	DWR UCIP Field Study		37.693618 °	37.693618 °	
			-121.277639 °	-121.277639 °	
DWR ID	DWR_RD2085_01_s_2014_25				
Action/Comments					
Inspector Comments: FS_ID:19433 EP_NO: N/A Repair Type: Crossing Status: UCIP Comments: Pipe appears abandoned and should be done so properly. FIELD_STRUCT_DESC: 10-inch steel stormdrain pipe through the levee 4.0-feet below the crown. T-post marks location of Pipe at LS toe. Steel plate welded over pipe on WS slope. Asbuilts available DWG 7-4-1685. Originally included in the 1968 O&M manual. FS Date: 9/5/2013

T-post marking pipe end on LS toe. 10-inch pipe debris on LS toe.

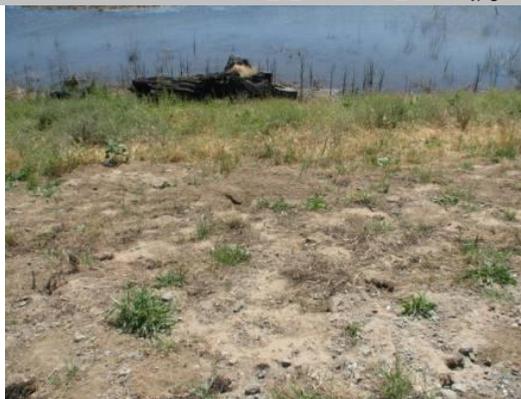
Photo 1 of 1 : mkhashch_s_20140428_00685.jpg

LM Start	3.28	Rating **	A/W	Issue No.	15
LM End	3.28	Issue Type +	Ma	Location *	WS
Category	Earthen Levee			GPS Latitude/Longitude	
				Start	End
Item	Animal Control			37.692916 °	37.692916 °
				-121.277929 °	-121.277929 °
DWR ID	DWR_RD2085_01_s_2012_15				
Action/Comments					
No rodents visible, but rodent burrows visible; need to backfill and compact or grout burrows.

04/28/2011 Fresh burrow in center of picture, "porch" extends to the grass line.

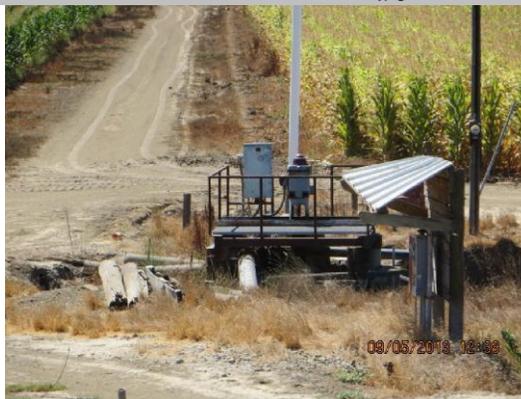
Photo 1 of 1 : UCIP_1834.jpg

LM Start	3.34	Rating **	M	Issue No.	26
LM End	3.34	Issue Type +	En	Location *	WS
Category	Supplemental			GPS Latitude/Longitude	
				Start	End
Item	DWR UCIP Field Study			37.691965 °	37.691965 °
				-121.278122 °	-121.278122 °
DWR ID	DWR_RD2085_01_s_2014_26				
Action/Comments					
Inspector Comments: FS_ID:19435 EP_NO: 16970 Repair Type: Crossing Status: UCIP Comments: Appears abandoned and if so should be done so properly. FIELD_STRUCT_DESC: 2 of 2: 10-inch steel stormdrain pipe through the levee 2-feet below the crown. Appears to connect to pump 150-feet off LS toe. Possible butterfly valve at LS toe. Vent on WS shoulder. Steel plate welded over pipe end on WS toe. FS Date: 9/5/2013

Possible connection at pump 150-feet off LS toe.

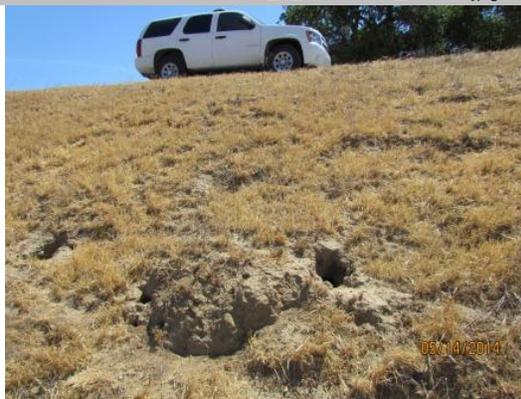
Photo 1 of 1 : mkhashch_s_20140519_01027.jpg

LM Start	3.52	Rating **	M	Issue No.	37
LM End	3.52	Issue Type +	Ma	Location *	LS
Category	Earthen Levee		GPS Latitude/Longitude		
			Start	End	
Item	Animal Control		37.6889610 °	37.6889610 °	
			-121.276257 °	-121.276257 °	
DWR ID	DWR_RD2085_01_s_2014_37				
Action/Comments					
No rodents visible, but rodent burrows visible; need to backfill and compact or grout burrows.

View of the rodent hole on the landside levee slope.

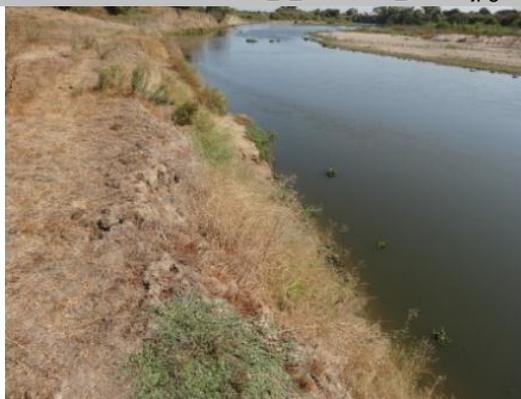
Photo 1 of 1 : mkhashch_s_20140428_00692.jpg

LM Start	3.58	Rating **	A/W	Issue No.	38
LM End	3.71	Issue Type +	Ma	Location *	WS
Category	Supplemental		GPS Latitude/Longitude		
			Start	End	
Item	DWR Erosion Survey		37.688545 °	37.688545 °	
			-121.276298 °	-121.276298 °	
DWR ID	DWR_RD2085_01_s_2014_38				
Action/Comments					
Inspector Comments: 09/10/2013: No significant change observed. 12/04/2012: This site has been documented before, and a cost estimate to repair has been prepared dated 05/09/2010. The fresh cut shows the erosion is developing. The berm width is at least 42 feet. Sticks were placed at three locations along the river bank, with 3 sticks 5 feet apart at each location. [2013 Site ID:RD2085U01RM67.7]

Close view of the erosion.

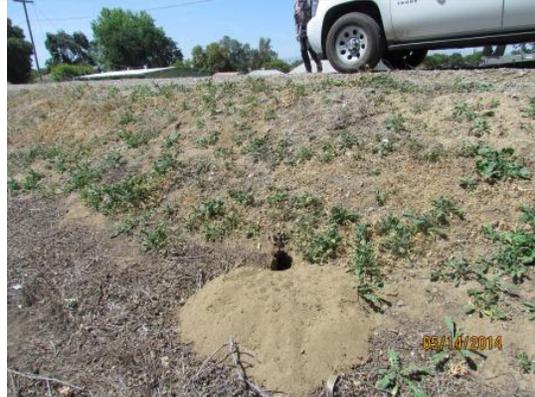
Photo 1 of 1 : mkhashch_s_20140521_038.jpg

View of the rodent hole on the waterside levee slope.

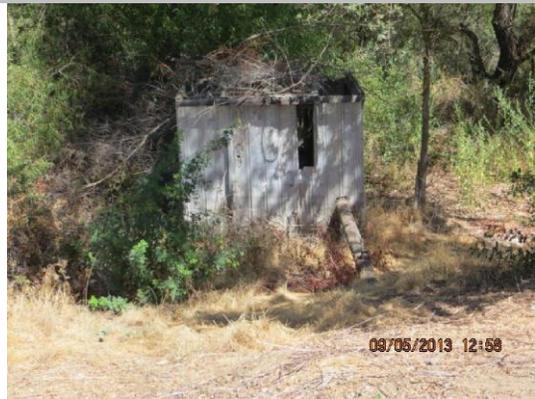
Photo 1 of 1 : UCIP_1839.jpg

LM Start	3.96	Rating **	M	Issue No.	27
LM End	3.96	Issue Type +	En	Location *	WS
Category	Supplemental			GPS Latitude/Longitude	
				Start	End
Item	DWR UCIP Field Study			37.683641 °	37.683641 °
				-121.275791 °	-121.275791 °
DWR ID	DWR_RD2085_01_s_2014_27				
Action/Comments					
Inspector Comments: FS_ID:19443 EP_NO: N/A Repair Type: Crossing Status: UCIP Comments: This pipe appears abandoned and should be done so properly. FIELD_STRUCT_DESC: 6-inch steel irrigation pipe through the levee 4.0-feet below the crown. Pump house on the waterward berm. Siphon breaker in 24-inch corrugated metal riser unit on the landside shoulder. Vent on WS toe. 2-inch galvanized iron electrical conduit at same location. Originally included in the 1968 O&M manual. FS Date: 9/5/2013

Pumphouse and pipe visible on WS toe.

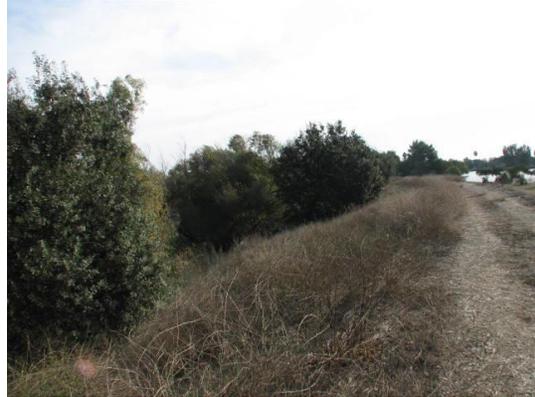
Photo 1 of 1 : mkhashch_s_20140428_00695.jpg

11/03/2011 Waterside vegetation needs to be maintained on the top 20' of the waterside slope.

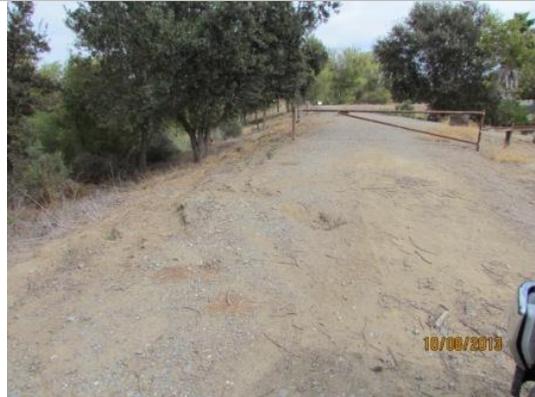
Photo 1 of 1 : mkhashch_s_20140428_00694.jpg

LM Start	4.28	Rating **	M	Issue No.	42
LM End	4.28	Issue Type +	Ma	Location *	CR
Category	Earthen Levee		GPS Latitude/Longitude		
			Start	End	
Item	Crown Surface / Depressions / Rutting		37.681752 °	37.681752 °	
			-121.270542 °	-121.270542 °	
DWR ID	DWR_RD2085_01_s_2013_42				
Action/Comments					
Repair depressions or ruts in the crown or slope.

View of rutting on waterside levee slope and crown.

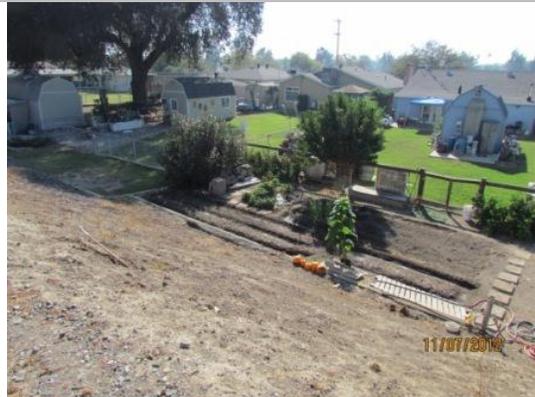
Photo 1 of 1 : mkhashch_s_20140428_00689.jpg

LM Start	4.32	Rating **	M	Issue No.	33
LM End	4.37	Issue Type +	En	Location *	LS
Category	Earthen Levee		GPS Latitude/Longitude		
			Start	End	
Item	Vegetation		37.681863 °	37.681640 °	
			-121.269856 °	-121.269046 °	
DWR ID	DWR_RD2085_01_s_2012_33				
Action/Comments					
Landscaping

Updated photo of encroachments on landside toe.

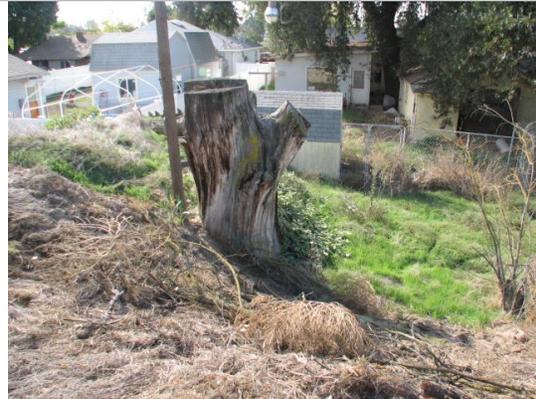
Photo 1 of 1 : mkhashch_s_20140428_00688.jpg

11/03/2011 Large stump on landside slope.

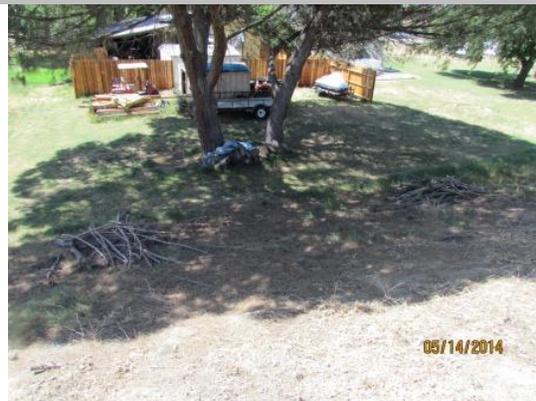
Photo 1 of 1 : mkhashch_s_20140521_039.jpg

LM Start	4.51	Rating **	M	Issue No.	17
LM End	4.51	Issue Type +	En	Location *	LS
Category	Earthen Levee		GPS Latitude/Longitude		
			Start	End	
Item	Encroachments		37.681158 °	37.681158 °	
			-121.266587 °	-121.266587 °	
DWR ID	DWR_RD2085_01_f_2013_17				
Action/Comments					
Firewood

View of the firewood stored at the landside levee toe.

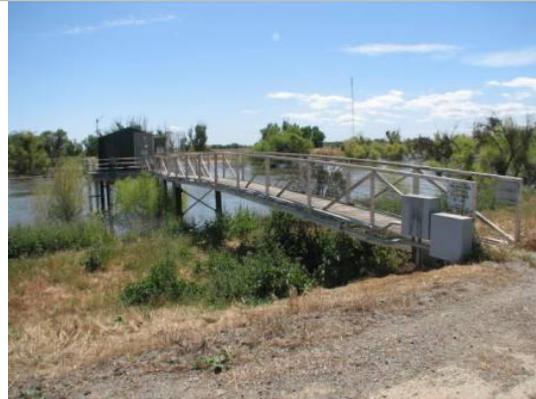
Photo 1 of 1 : mkhashch_s_20140428_00691.jpg

04/28/2011 Monitoring station.

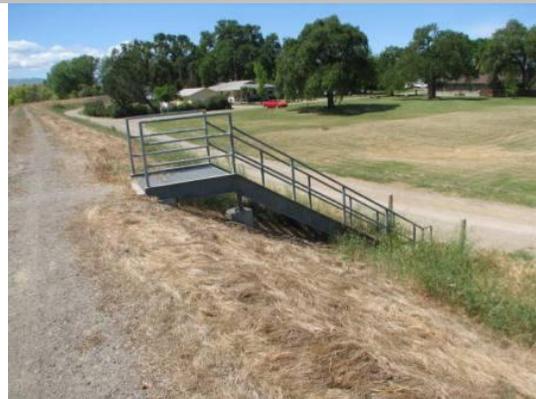
Photo 1 of 1 : mkhashch_s_20140428_00690.jpg

LM Start	4.70	Rating **	A/W	Issue No.	35
LM End	4.70	Issue Type +	En	Location *	LS
Category	Earthen Levee		GPS Latitude/Longitude		
			Start	End	
Item	Encroachments		37.679526 °	37.679526 °	
			-121.265367 °	-121.265367 °	
DWR ID	DWR_RD2085_01_s_2012_35				
Action/Comments					
Stairway Inspector Comments: Stairs for monitoring station on landside slope.

04/28/2011 Stairs on landside slope for monitoring station.

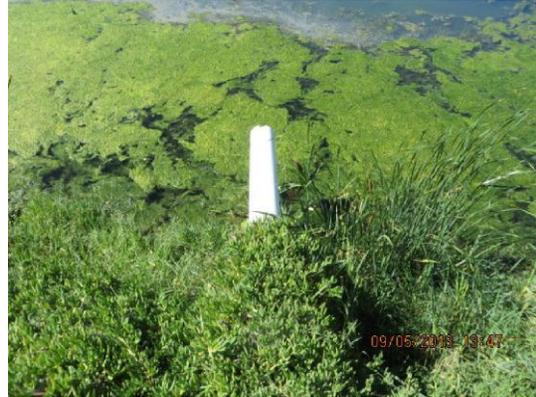
Photo 1 of 1 : UCIP_2937.jpg

LM Start	5.14	Rating **	M	Issue No.	28
LM End	5.14	Issue Type +	En	Location *	LS
Category	Supplemental			GPS Latitude/Longitude	
				Start	End
Item	DWR UCIP Field Study			37.675244 °	37.675244 °
				-121.269287 °	-121.269287 °
DWR ID	DWR_RD2085_01_s_2014_28				
Action/Comments					
Inspector Comments: FS_ID:22290 EP_NO: N/A Repair Type: Crossing Status: UCIP Comments: No permit identified for this crossing. FIELD_STRUCT_DESC: 10-inch steel irrigation pipe through the levee at unknown depth below the crown. Siphon breaker in 10-inch steel riser on LS shoulder. FS Date: 9/10/2013

Pipe visible at pond outlet off LS toe.

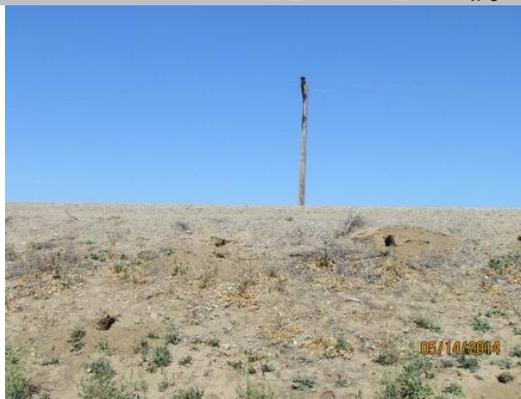
Photo 1 of 1 : mkhashch_s_20140519_01031.jpg

View of the rodent holes on the waterside levee slope.

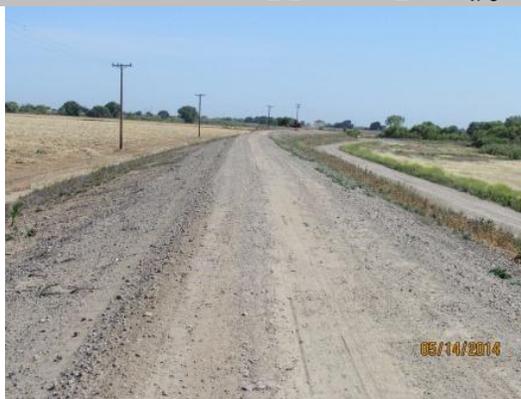
Photo 1 of 1 : mkhashch_s_20140519_01029.jpg

LM Start	0.37	Rating **	M	Issue No.	3
LM End	0.66	Issue Type +	Ma	Location *	CR
Category	Earthen Levee		GPS Latitude/Longitude		
			Start	End	
Item	Crown Surface / Depressions / Rutting		37.709893 °	37.713716 °	
			-121.272023 °	-121.269682 °	
DWR ID	DWR_RD2085_02_s_2014_3				
Action/Comments					
Add appropriate gravel or road base. Grade and compact.

View of the levee crown partially without all-weather surface.

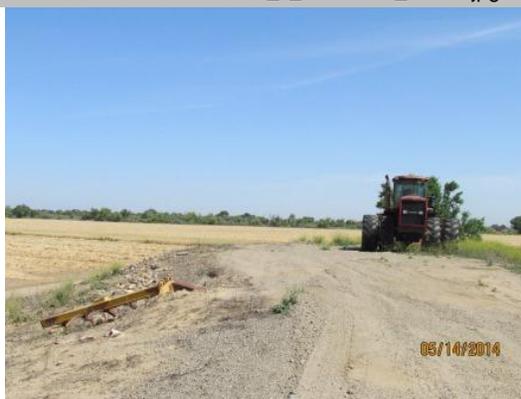
Photo 1 of 1 : mkhashch_s_20140519_01030.jpg

LM Start	0.67	Rating **	M	Issue No.	1
LM End	0.67	Issue Type +	En	Location *	CR
Category	Earthen Levee		GPS Latitude/Longitude		
			Start	End	
Item	Encroachments		37.713820 °	37.713820 °	
			-121.269685 °	-121.269685 °	
DWR ID	DWR_RD2085_02_s_2012_1				
Action/Comments					
Equipment Inspector Comments: Heavy equipment is being stored on the levee crown.

View of farming equipment being stored on the levee crown at the end of the spur levee.

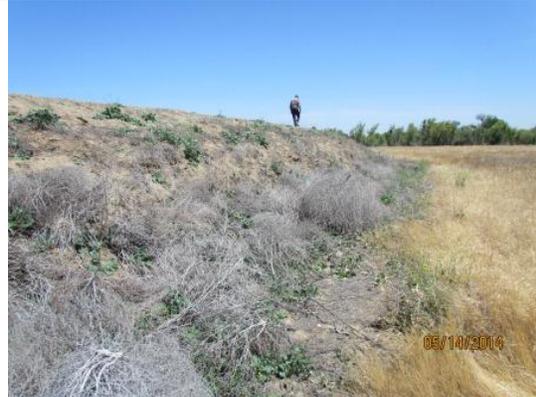
Photo 1 of 1 : mkhashch_s_20140519_01032.jpg

LM Start	0.21	Rating **	U	Issue No.	1
LM End	0.23	Issue Type +	Ma	Location *	WS
Category	Earthen Levee		GPS Latitude/Longitude		
			Start	End	
Item	Erosion / Bank Caving		37.682798 °	37.683052 °	
			-121.262059 °	-121.261851 °	
DWR ID	DWR_RD2085_03_s_2014_1				
Action/Comments					
Schedule repair of erosion site prior to the next inspection. Inspector Comments: Erosion of the waterside levee slope has been observed. The erosion is about 3 feet tall vertical from the slope to the base of projected levee toe.

View of the erosion at the waterside levee toe.
