**Flood Control Project Maintenance
Levee Inspections**
LMA District Cover Sheet
Spring 2016 Levee Inspection Results

Reclamation District No. 2085 Kasson

Waterway	Bank	Unit Miles
Unit No. 01 San Joaquin River	Left	5.29

Levee Inspection Report By Mile - Spring 2016

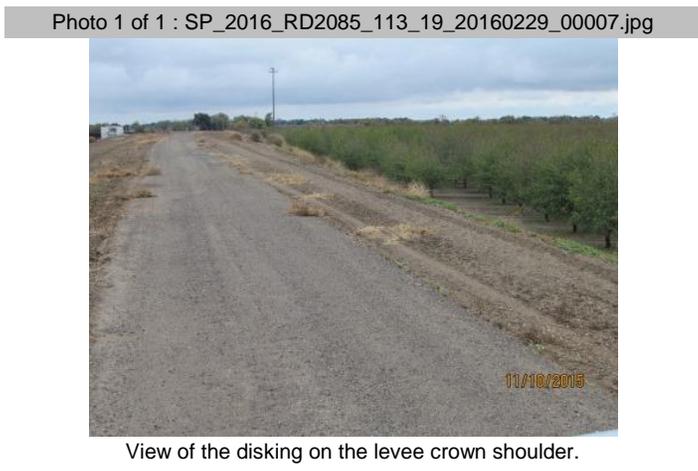
LM Start	0.12	Rating **	M	Issue No.	19
LM End	0.12	Issue Type +	Ma	Location *	CR
Category	Earthen Levee		GPS Latitude/Longitude		
			Start	End	
Item	Crown Surface / Depressions / Rutting		37.719052 °	37.719052 °	
			-121.302928 °	-121.302928 °	
DWR ID	DWR_RD2085_01_f_2015_19				
Comment Code					
C1 : Add appropriate material and re-grade the levee to bring the crown above the design elevation.					
Inspector Comment					
Disking on the levee shoulder. Make sure the water drains evenly to the slopes.

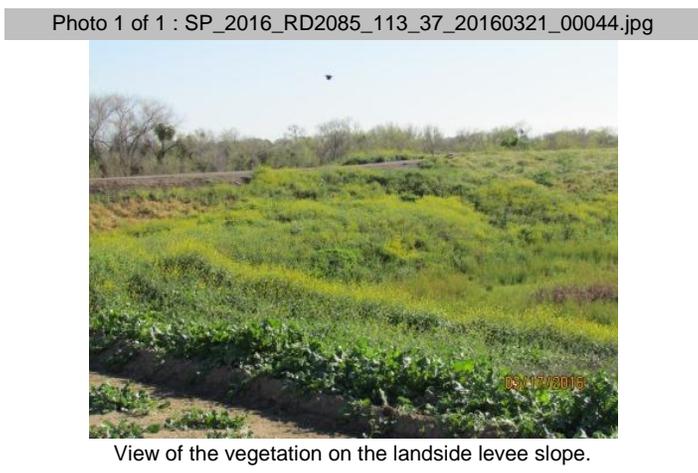
LM Start	0.49	Rating **	M	Issue No.	37
LM End	0.64	Issue Type +	Ma	Location *	LS
Category	Earthen Levee		GPS Latitude/Longitude		
			Start	End	
Item	Vegetation		37.723429 °	37.722477 °	
			-121.299313 °	-121.296956 °	
DWR ID	DWR_RD2085_01_s_2016_37				
Comment Code					
V1 : Control annual grass and weeds on the levee slopes and easements.					
Inspector Comment

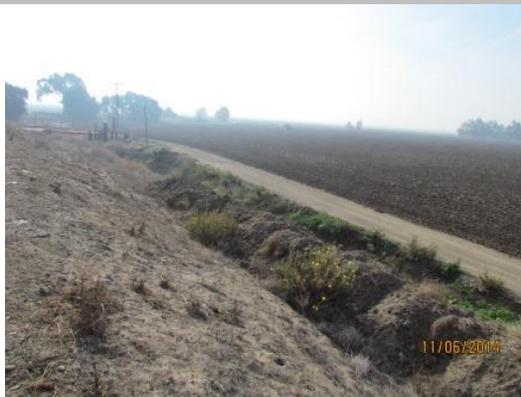
Photo 1 of 1 : SP_2016_RD2085_113_6_20160229_00005.jpg

LM Start	1.34	Rating **	M	Issue No.	6
LM End	1.38	Issue Type +	En	Location *	LS
Category	Earthen Levee		GPS Latitude/Longitude		
			Start	End	
Item	Encroachments		37.714265 °	37.714056 °	
			-121.289641 °	-121.289069 °	
DWR ID	DWR_RD2085_01_s_2012_6				
Comment Code					
DT : Ditch					
Inspector Comment					
Drainage ditch at levee toe.

View of the ditch at the landside levee toe.

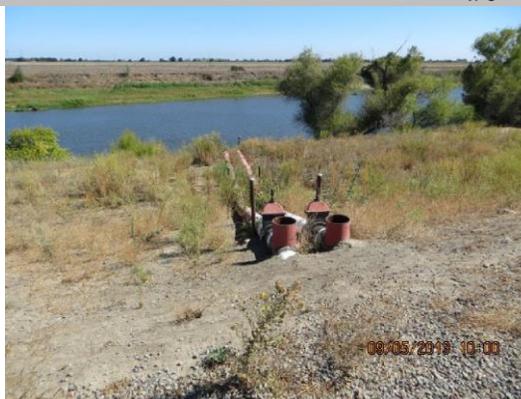
Photo 1 of 2 : UCIP_SP_2016_22285_38010.jpg

LM Start	1.35	Rating **	M	Issue No.	53
LM End	1.35	Issue Type +	En	Location *	LS
Category	Supplemental		GPS Latitude/Longitude		
			Start	End	
Item	DWR UCIP Field Study		37.714404 °	37.714404 °	
			-121.289469 °	-121.289469 °	
DWR ID					
Comment Code					
Inspector Comment					
FS_ID:22285 DS_ID:24055 EP_NO: N/A Repair Type: Non-Urgent Crossing Status: Found UCIP Comments: No permit identified for this modified crossing. FIELD_STRUCT_DESC: 12-inch steel pipe through the levee 3-feet below the crown. Pump mounted on pile structure in ditch on the landward side. Siphon breaker in 12-inch steel riser unit and a gatevalve on the waterward shoulder. (Permit No. 8189, 1972) FS Date: 9/10/2013

Pipe, gate valve, and siphon breaker visible on WS slope.

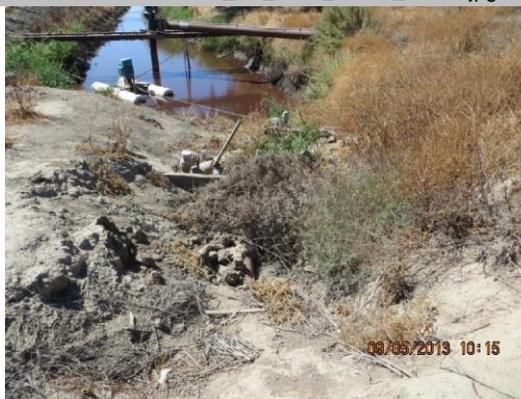
Photo 2 of 2 : UCIP_SP_2016_41351_62267.jpg

LM Start	1.41	Rating **	M	Issue No.	60 (cont)
LM End	1.41	Issue Type +	En	Location *	LS
Category	Supplemental			GPS Latitude/Longitude	
				Start	End
Item	DWR UCIP Field Study			37.714049 °	37.714049 °
				-121.288426 °	-121.288426 °
DWR ID					
Comment Code					
Inspector Comment					
FS_ID:41351 DS_ID:20679 EP_NO: 3975 Repair Type: Non-Urgent Crossing Status: Found UCIP Comments: Pipe abandoned and should be done so properly. Large hole in ground over pipe on WS berm. Pipe rusted through on WS at river bank. No connection to pump on LS toe. FIELD_STRUCT_DESC: 10-inch steel stormdrain pipe through the levee 4-feet below the crown. Steel plate over pipe end at pump station on LS toe. Siphon breaker in 24-inch corrugated metal riser unit on the waterward shoulder (Permit No. 3975, 1962). Originally included in the 1968 O&M manual. FS Date: 9/5/2013

Pipe visible at bottom of ditch on LS toe.

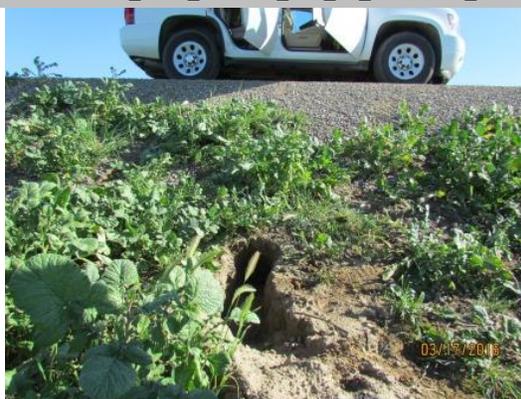
Photo 1 of 1 : SP_2016_RD2085_113_39_20160321_00045.jpg

LM Start	1.79	Rating **	M	Issue No.	39
LM End	1.79	Issue Type +	Ma	Location *	LS
Category	Earthen Levee			GPS Latitude/Longitude	
				Start	End
Item	Animal Control			37.711456 °	37.711456 °
				-121.282397 °	-121.282397 °
DWR ID	DWR_RD2085_01_s_2016_39				
Comment Code					
A3 : No rodents visible, but rodent burrows visible; need to backfill and compact or grout burrows.					
Inspector Comment

View of the rodent burrows on the landside levee slope.

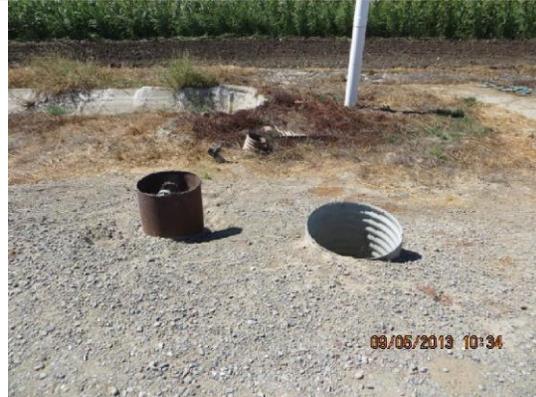
Photo 1 of 2 : UCIP_SP_2016_19423_32962.jpg

LM Start	2.04	Rating **	M	Issue No.	55
LM End	2.04	Issue Type +	En	Location *	LS
Category	Supplemental			GPS Latitude/Longitude	
				Start	End
Item	DWR UCIP Field Study			37.708826 °	37.708826 °
				-121.279271 °	-121.279271 °
DWR ID					
Comment Code					
Inspector Comment					
FS_ID:19423 DS_ID:20681 EP_NO: N/A Repair Type: Non-Urgent Crossing Status: Found UCIP Comments: This pipe is abandoned and should be done so properly. FIELD_STRUCT_DESC: 1 of 2: 10-inch pipe through the levee 2.0-feet below the crown. Pump mounted on pile structure in the river. Siphon breaker in 24-inch CMP riser on the LS slope. Power pole on LS toe. Wooden stairs and walkway from the berm to the pump structure. Originally included in the 1968 O&M manual. FS Date: 9/5/2013 8:22:24 AM

Siphon breaker in 24-inch CMP riser on LS slope. Possible gate valve at end of concrete channel on LS toe.

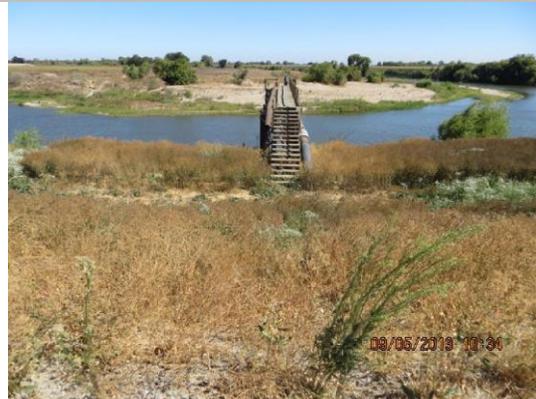
Photo 2 of 2 : UCIP_SP_2016_19423_32961.jpg

Pipe cut at wooden pier. No pump on end of pier for this pipe.

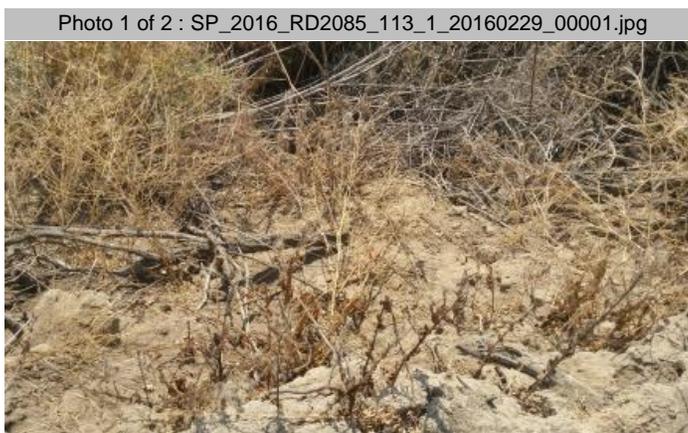
LM Start	2.56	Rating **	M	Issue No.	1
LM End	2.58	Issue Type +	Ma	Location *	WS
Category	Supplemental			GPS Latitude/Longitude	
				Start	End
Item	DWR Erosion Survey			37.703094 °	37.703094 °

121.274894 °	121.274894 °
DWR ID	DWR_RD2085_01_s_2016_1				
Comment Code					
Inspector Comment					
09/10/2015: No significant change observed. Signs of animal activity are present.					
09/10/2014: No significant change observed.					
09/20/2013: No significant change in erosion observed. More vegetation at the site.					
12/04/2012: The erosion has progressed remarkably toward levee, extended to the up-and downstream of the original pocket erosion. Trees and dense bush are present at the site. Animal burrow holes are visible, and possibly can cause seepage.					
09/22/2010: No significant change observed. There is little visibility due to seasonal grass on the berm and slope.					
08/18/2009: Site is located on berm; pocket erosion has developed; the site is covered in dense vegetation; there are several relief wells on the landside of the levee; site is Not Rated because berm width is greater than 30 feet; site should be monitored to keep track of erosion progress. [2015 Site ID:RD2085U01RM66.5]

Direct view of the erosion. Note dense vegetation at the site.

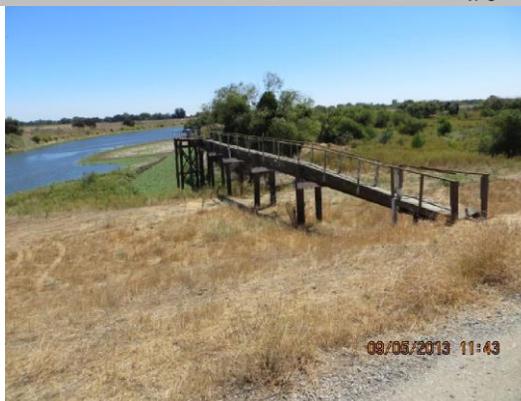
Photo 1 of 2 : UCIP_SP_2016_19431_32983.jpg

LM Start	2.82	Rating **	M	Issue No.	56
LM End	2.82	Issue Type +	En	Location *	LS
Category	Supplemental		GPS Latitude/Longitude		
			Start	End	
Item	DWR UCIP Field Study		37.699698 °	37.699698 °	
			-121.276325 °	-121.276325 °	
DWR ID					
Comment Code					
Inspector Comment					
FS_ID:19431 DS_ID:20688 EP_NO: 16970 Repair Type: Non-Urgent Crossing Status: Found UCIP Comments: The wooden walkway on the WS slope is in disrepair. FIELD_STRUCT_DESC: 1 of 2: 14-inch steel irrigation pipe through the levee 2.0 feet below the crown. Pump on wooden pier at WS slope. Siphon breaker visible next to steel bollard on LS slope. Power pole on LS toe. FS Date: 9/5/2013

Pump on Wooden pier at WS slope.

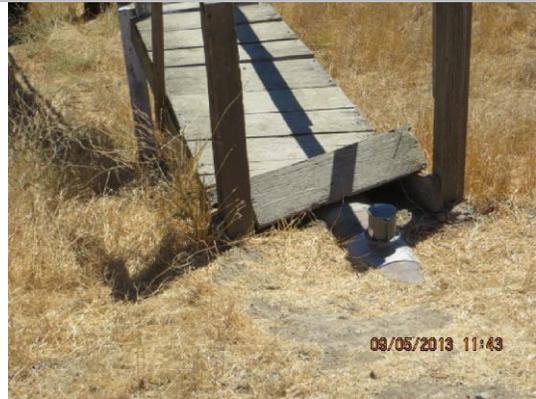
Photo 2 of 2 : UCIP_SP_2016_19431_32982.jpg

LM Start	2.82	Rating **	M	Issue No.	56 (cont)
LM End	2.82	Issue Type +	En	Location *	LS
Category	Supplemental			GPS Latitude/Longitude	
				Start	End
Item	DWR UCIP Field Study			37.699698 °	37.699698 °
				-121.276325 °	-121.276325 °
DWR ID					
Comment Code					
Inspector Comment					
FS_ID:19431 DS_ID:20688 EP_NO: 16970 Repair Type: Non-Urgent Crossing Status: Found UCIP Comments: The wooden walkway on the WS slope is in disrepair. FIELD_STRUCT_DESC: 1 of 2: 14-inch steel irrigation pipe through the levee 2.0 feet below the crown. Pump on wooden pier at WS slope. Siphon breaker visible next to steel bollard on LS slope. Power pole on LS toe. FS Date: 9/5/2013

Pipe visible under walkway on WS slope.

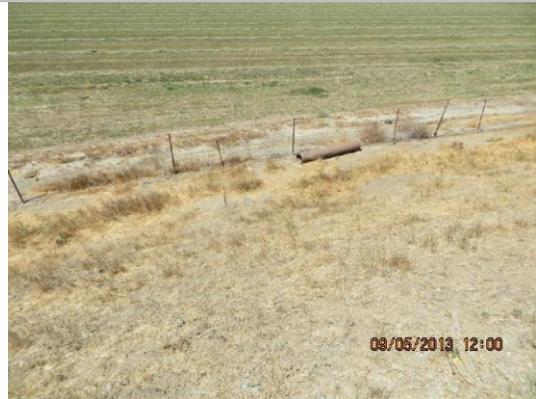
Photo 1 of 2 : UCIP_SP_2016_19433_32990.jpg

LM Start	3.30	Rating **	M	Issue No.	57
LM End	3.30	Issue Type +	En	Location *	WS
Category	Supplemental			GPS Latitude/Longitude	
				Start	End
Item	DWR UCIP Field Study			37.693618 °	37.693618 °
				-121.277639 °	-121.277639 °
DWR ID					
Comment Code					
Inspector Comment					
FS_ID:19433 DS_ID:20693 EP_NO: N/A Repair Type: Non-Urgent Crossing Status: Found UCIP Comments: Pipe appears abandoned and should be done so properly. FIELD_STRUCT_DESC: 10-inch steel stormdrain pipe through the levee 4.0-feet below the crown. T-post marks location of Pipe at LS toe. Steel plate welded over pipe on WS slope. Asbuilts available DWG 7-4-1685. Originally included in the 1968 O&M manual. FS Date: 9/5/2013

T-post marking pipe end on LS toe. 10-inch pipe debris on LS toe.

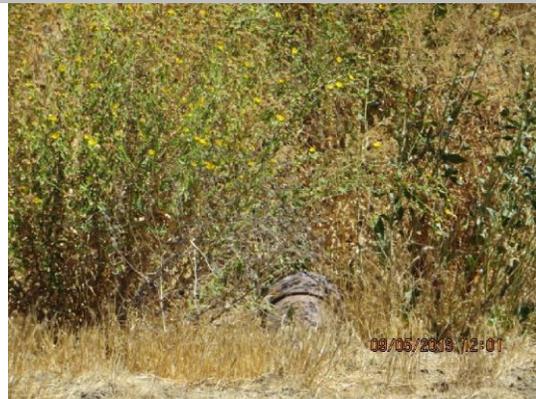
Photo 2 of 2 : UCIP_SP_2016_19433_32989.jpg

Pipe visible on WS slope.

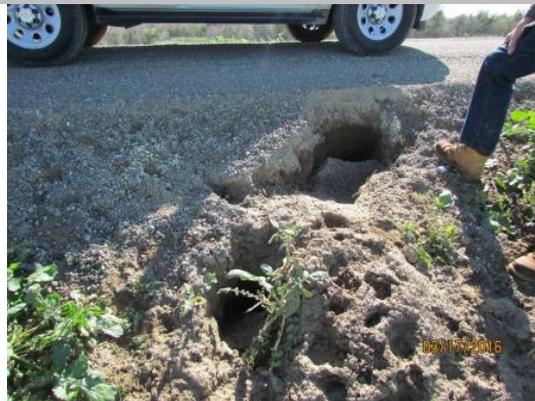
Photo 1 of 1 : SP_2016_RD2085_113_43_20160321_00046.jpg

View of the rodent burrows on the landside levee slope.

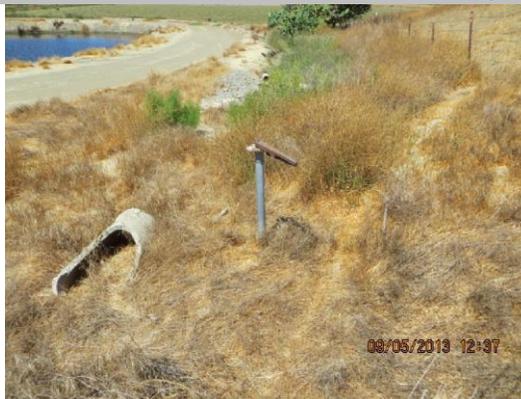
Photo 1 of 2 : UCIP_SP_2016_19435_32993.jpg

LM Start	3.42	Rating **	M	Issue No.	58
LM End	3.42	Issue Type +	En	Location *	LS
Category	Supplemental			GPS Latitude/Longitude	
				Start	End
Item	DWR UCIP Field Study			37.691966 °	37.691966 °
				-121.278122 °	-121.278122 °
DWR ID					
Comment Code					
Inspector Comment					
FS_ID:19435 DS_ID:20687 EP_NO: 16970 Repair Type: Non-Urgent Crossing Status: Found UCIP Comments: Appears abandoned and if so should be done so properly. FIELD_STRUCT_DESC: 2 of 2: 10-inch steel stormdrain pipe through the levee 2-feet below the crown. Appears to connect to pump 150-feet off LS toe. Possible butterfly valve at LS toe. Vent on WS shoulder. Steel plate welded over pipe end on WS toe. FS Date: 9/5/2013

Possible Butterfly valve at LS toe.

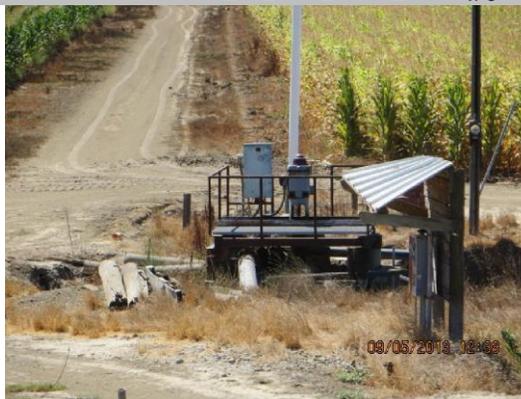
Photo 2 of 2 : UCIP_SP_2016_19435_32992.jpg

Possible connection at pump 150-feet off LS toe.

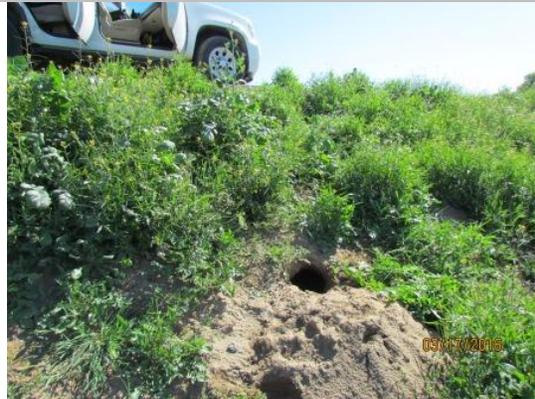
Photo 1 of 1 : SP_2016_RD2085_113_45_20160321_00047.jpg

View of the rodent burrows on the landside levee slope.

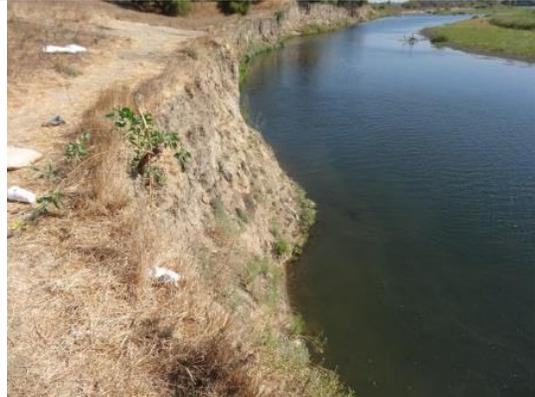
Photo 1 of 2 : SP_2016_RD2085_113_2_20160229_00003.jpg

LM Start	3.62	Rating **	A/W	Issue No.	2
LM End	3.75	Issue Type +	Ma	Location *	WS
Category	Supplemental			GPS Latitude/Longitude	
				Start	End
Item	DWR Erosion Survey			37.688545 °	37.688545 °
				-121.276298 °	-121.276298 °
DWR ID	DWR_RD2085_01_s_2016_2				
Comment Code					
Inspector Comment					
08/19/2015: No significant change observed. 7/17/2014: No significant change observed. 09/10/2013: No significant change observed. 12/04/2012: This site has been documented before, and a cost estimate to repair has been prepared dated 05/09/2010. The fresh cut shows the erosion is developing. The berm width is at least 42 feet. Sticks were placed at three locations along the river bank, with 3 sticks 5 feet apart at each location. [2015 Site ID:RD2085U01RM67.7]

Close view of the erosion.

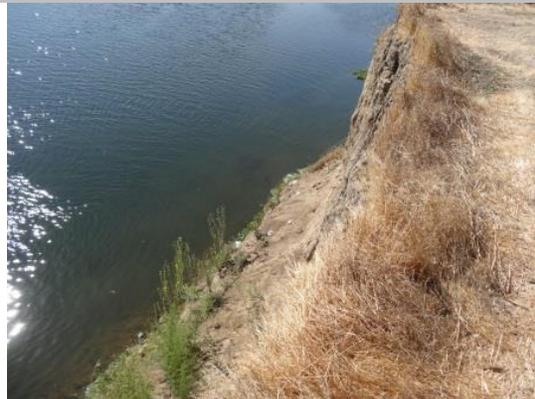
Photo 2 of 2 : SP_2016_RD2085_113_2_20160229_00004.jpg

Direct view of the erosion.

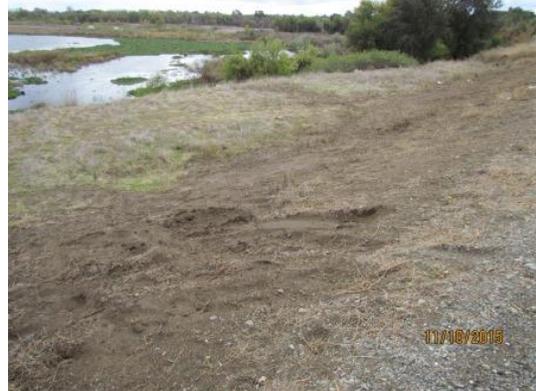
Photo 1 of 1 : SP_2016_RD2085_113_25_20160229_00009.jpg

LM Start	3.71	Rating **	M	Issue No.	25
LM End	3.71	Issue Type +	Ma	Location *	WS
Category	Earthen Levee		GPS Latitude/Longitude		
			Start	End	
Item	Slope Stability		37.688216 °	37.688216 °	
			-121.276603 °	-121.276603 °	
DWR ID	DWR_RD2085_01_f_2015_25				
Comment Code					
S3 : Repair the levee slope damaged by vehicle traffic and prevent access where possible.					
Inspector Comment

View of the waterside levee slope damaged by vehicle.

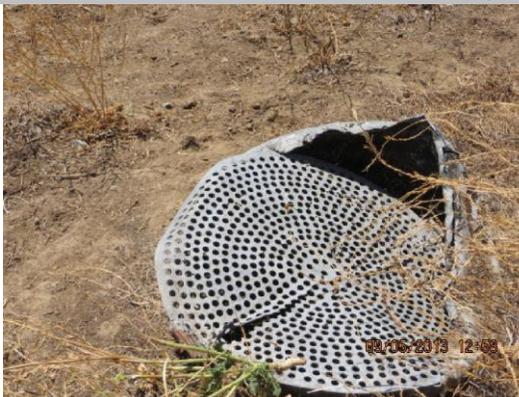
Photo 2 of 2 : UCIP_SP_2016_19443_33001.jpg

LM Start	4.03	Rating **	M	Issue No.	59 (cont)
LM End	4.03	Issue Type +	En	Location *	LS
Category	Supplemental			GPS Latitude/Longitude	
				Start	End
Item	DWR UCIP Field Study			37.683642 °	37.683642 °
				-121.275792 °	-121.275792 °
DWR ID					
Comment Code					
Inspector Comment					
FS_ID:19443 DS_ID:20684 EP_NO: N/A Repair Type: Non-Urgent Crossing Status: Found UCIP Comments: This pipe appears abandoned and should be done so properly. FIELD_STRUCT_DESC: 6-inch steel irrigation pipe through the levee 4.0-feet below the crown. Pump house on the waterward berm. Siphon breaker in 24-inch corrugated metal riser unit on the landside shoulder. Vent on WS toe. 2-inch galvanized iron electrical conduit at same location. Originally included in the 1968 O&M manual. FS Date: 9/5/2013

Siphon breaker on vent in 24-inch CMP riser on LS shoulder.

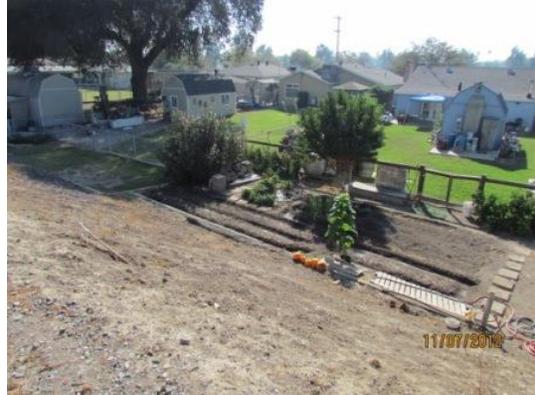
Photo 1 of 2 : SP_2016_RD2085_113_33_20160229_00013.jpg

Updated photo of encroachments on landside toe.

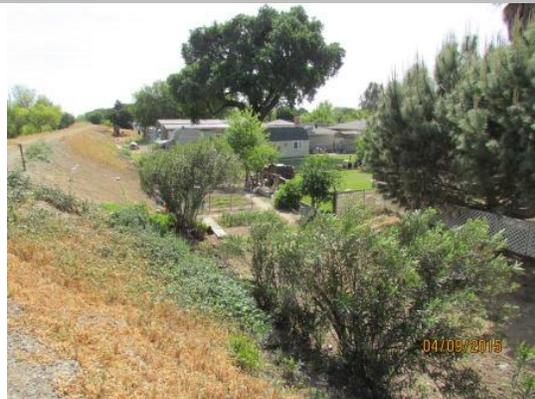
Photo 2 of 2 : SP_2016_RD2085_113_33_20160229_00014.jpg

View of the landscaping at the landside levee slope.

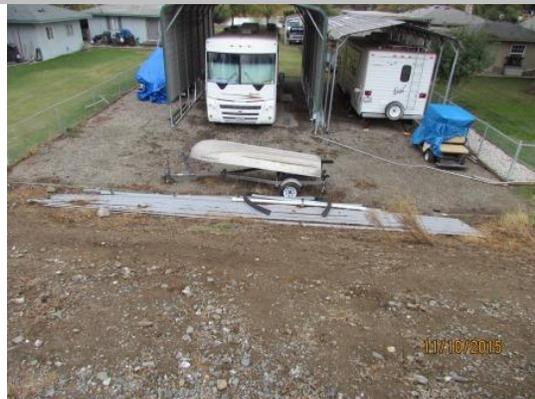
Photo 1 of 1 : SP_2016_RD2085_113_27_20160229_00010.jpg

LM Start	4.43	Rating **	M	Issue No.	27
LM End	4.43	Issue Type +	En	Location *	LS
Category	Earthen Levee		GPS Latitude/Longitude		
			Start	End	
Item	Encroachments		37.681710 °	37.681710 °	
			-121.269290 °	-121.269290 °	
DWR ID	DWR_RD2085_01_f_2015_27				
Comment Code					
MA : Material					
Inspector Comment

View of the material stored at the landside levee toe.

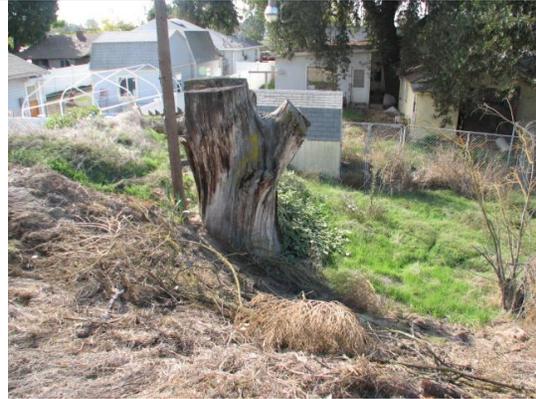
Photo 1 of 1 : SP_2016_RD2085_113_32_20160229_00012.jpg

11/03/2011 Large stump on landside slope.

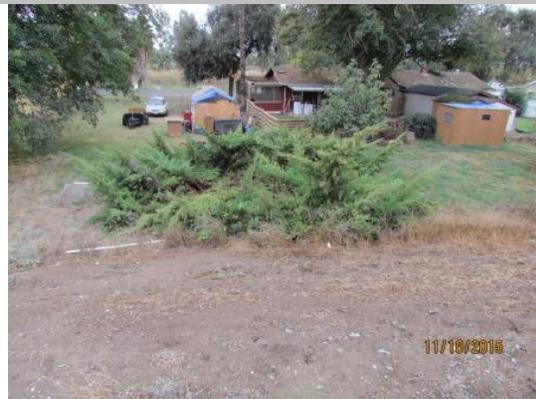
Photo 1 of 1 : SP_2016_RD2085_113_28_20160229_00011.jpg

LM Start	4.49	Rating **	U	Issue No.	28
LM End	4.49	Issue Type +	En	Location *	LS
Category	Earthen Levee		GPS Latitude/Longitude		
			Start	End	
Item	Vegetation		37.681453 °	37.681453 °	
			-121.268327 °	-121.268327 °	
DWR ID	DWR_RD2085_01_f_2015_28				
Comment Code					
V6 : Landscaping					
Inspector Comment

View of the unmaintained vegetation at the landside levee toe.

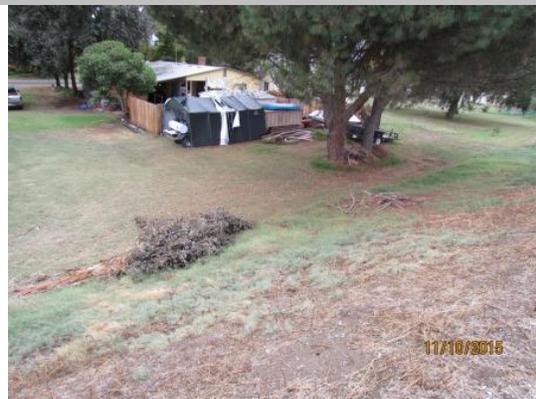
Photo 1 of 1 : SP_2016_RD2085_113_17_20160229_00006.jpg

LM Start	4.59	Rating **	M	Issue No.	17
LM End	4.59	Issue Type +	En	Location *	LS
Category	Earthen Levee		GPS Latitude/Longitude		
			Start	End	
Item	Encroachments		37.681158 °	37.681158 °	
			-121.266587 °	-121.266587 °	
DWR ID	DWR_RD2085_01_f_2013_17				
Comment Code					
FW : Firewood					
Inspector Comment

View of the firewood stored at the landside levee toe.

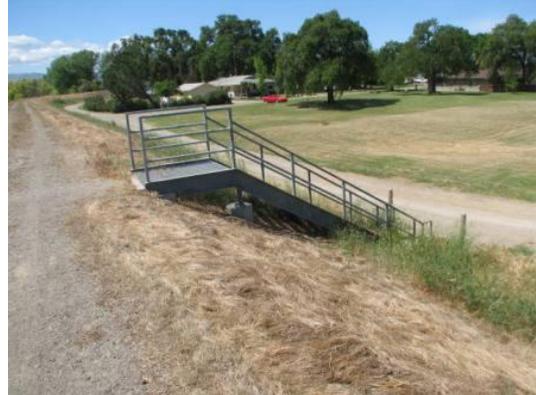
Photo 1 of 1 : SP_2016_RD2085_113_35_20160229_00015.jpg

04/28/2011 Stairs on landside slope for monitoring station.

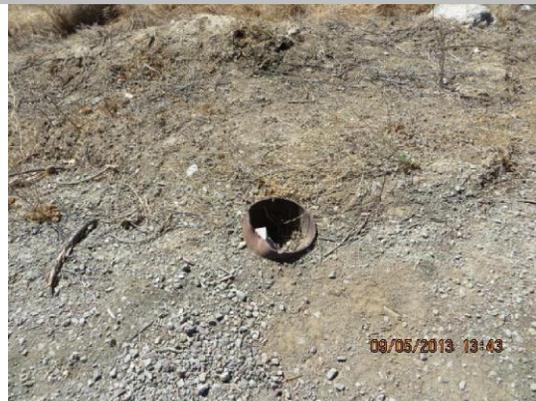
Photo 1 of 2 : UCIP_SP_2016_22290_38020.jpg

LM Start	5.23	Rating **	M	Issue No.	54
LM End	5.23	Issue Type +	En	Location *	LS
Category	Supplemental		GPS Latitude/Longitude		
			Start	End	
Item	DWR UCIP Field Study		37.675244 °	37.675244 °	
			-121.269287 °	-121.269287 °	
DWR ID					
Comment Code					
Inspector Comment					
FS_ID:22290 DS_ID:24058 EP_NO: N/A Repair Type: Non-Urgent Crossing Status: Found UCIP Comments: No permit identified for this crossing. FIELD_STRUCT_DESC: 10-inch steel irrigation pipe THROUGH the levee at unknown depth below the crown. Siphon breaker in 10-inch steel riser on LS shoulder. FS Date: 9/10/2013

Siphon breaker in 10-inch steel riser on LS shoulder.

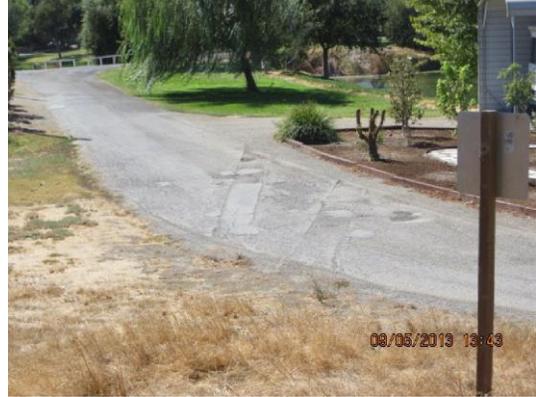
Photo 2 of 2 : UCIP_SP_2016_22290_38019.jpg

LM Start	5.23	Rating **	M	Issue No.	54 (cont)
LM End	5.23	Issue Type +	En	Location *	LS
Category	Supplemental			GPS Latitude/Longitude	
				Start	End
Item	DWR UCIP Field Study			37.675244 °	37.675244 °
				-121.269287 °	-121.269287 °
DWR ID					
Comment Code					
Inspector Comment					
FS_ID:22290 DS_ID:24058 EP_NO: N/A Repair Type: Non-Urgent Crossing Status: Found UCIP Comments: No permit identified for this crossing. FIELD_STRUCT_DESC: 10-inch steel irrigation pipe through the levee at unknown depth below the crown. Siphon breaker in 10-inch steel riser on LS shoulder. FS Date: 9/10/2013

Cuts in pavement may indicate alignment of pipe at LS toe.

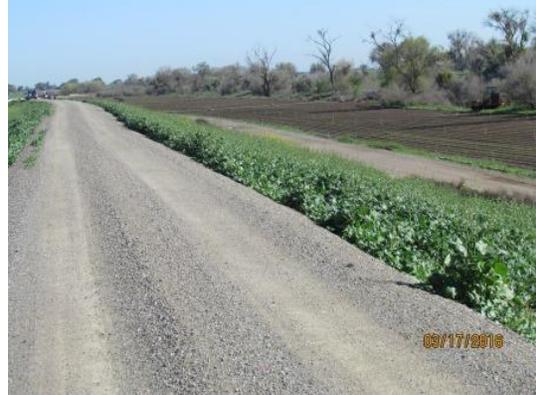
Photo 1 of 1 : SP_2016_RD2085_114_1_20160321_00001.jpg

View of the vegetation on the waterside levee slope.

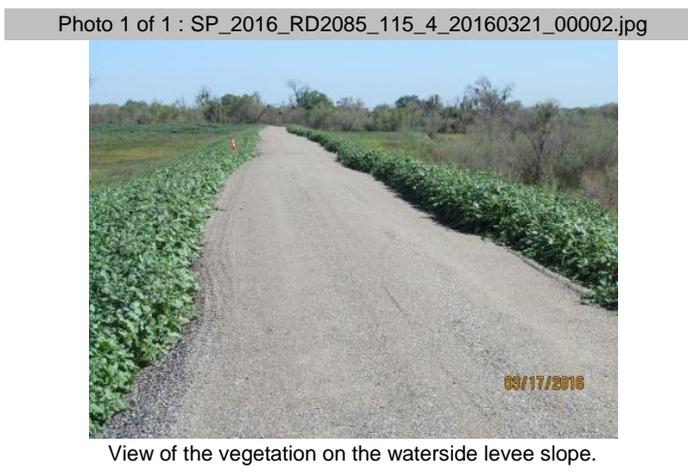
LM Start	0.01	Rating **	M	Issue No.	4
LM End	0.01	Issue Type +	Ma	Location *	WS
Category	Earthen Levee		GPS Latitude/Longitude		
			Start	End	
Item	Vegetation		37.680613 °	37.680613 °	
			-121.264533 °	-121.264533 °	
DWR ID	DWR_RD2085_03_s_2016_4				
Comment Code					
V1 : Control annual grass and weeds on the levee slopes and easements.					
Inspector Comment

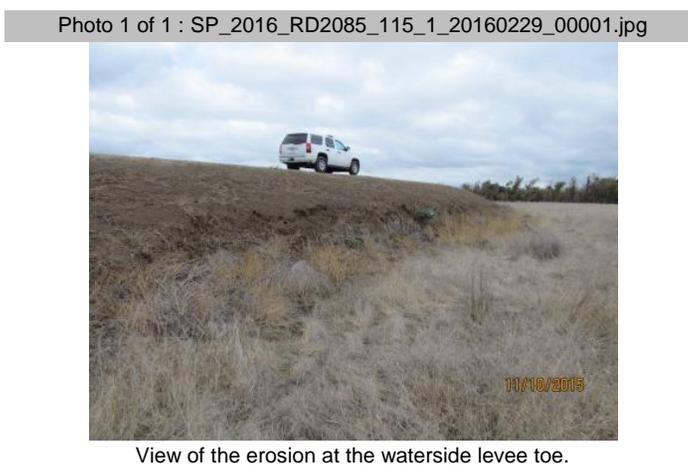
LM Start	0.21	Rating **	U	Issue No.	1
LM End	0.23	Issue Type +	Ma	Location *	WS
Category	Earthen Levee		GPS Latitude/Longitude		
			Start	End	
Item	Erosion / Bank Caving		37.682798 °	37.683052 °	
			-121.262059 °	-121.261851 °	
DWR ID	DWR_RD2085_03_s_2014_1				
Comment Code					
E2 : Schedule repair of erosion site prior to the next inspection.					
Inspector Comment					
Erosion of the waterside levee slope has been observed. The erosion is about 3 feet tall vertical from the slope to the base of projected levee toe.
