**Flood Control Project Maintenance  
Levee Inspections**  
**LMA District Cover Sheet**  
**Spring 2009 Levee Inspection Results**

**Reclamation District No. 2085**

**Levee Inspection Report By Mile - Spring 2009**

Waterway	Bank	Unit Miles	Inspection Start/End	Inspector
Unit No. 01 San Joaquin River	Left	5.20	05/14/2009 05/14/2009	David Pesavento

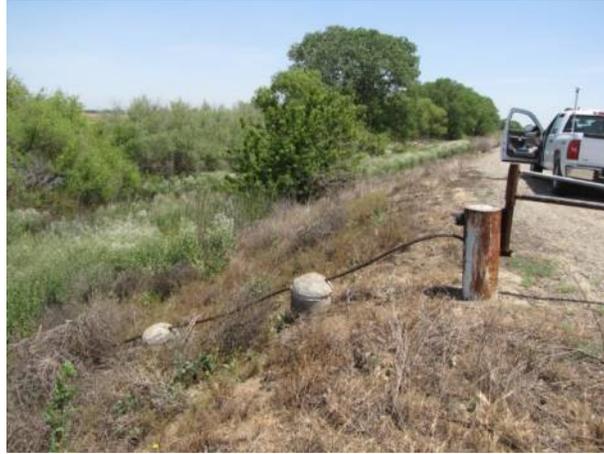
Levee Mile Report Line	4
Start Levee Mile	1.34
End Levee Mile	1.34
Location	Water Side
Category	Earthen Levee
Item	Vegetation
Remove/mow grass and vegetation within 20 feet of waterward shoulder of the crown.

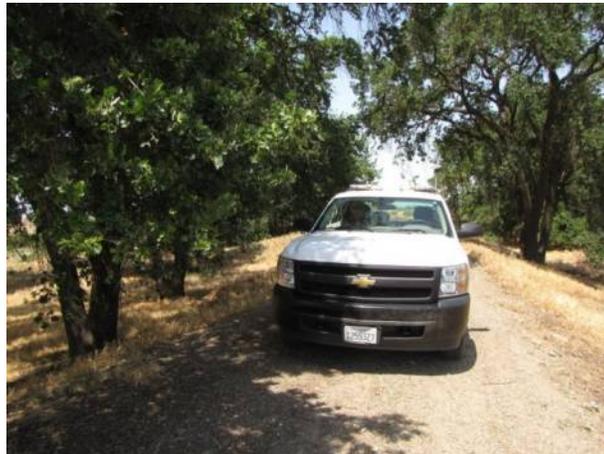
Levee Mile Report Line	8
Start Levee Mile	2.49
End Levee Mile	2.49
Location	Land Side
Category	Earthen Levee
Item	Trim / Thin Trees
Trim tree branches that are low at this location so allow for vehicular traffic.

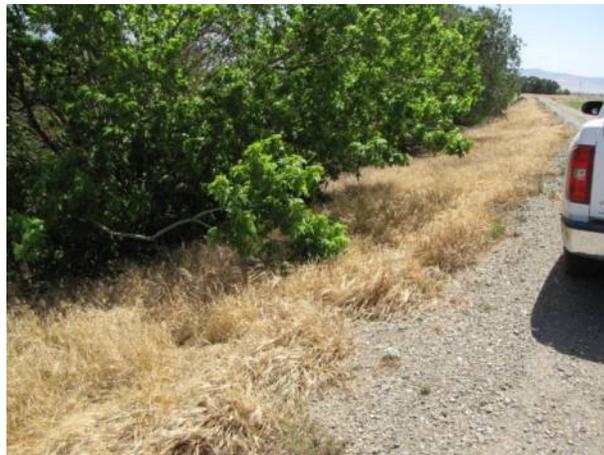
Levee Mile Report Line	10
Start Levee Mile	2.56
End Levee Mile	2.56
Location	Water Side
Category	Earthen Levee
Item	Trim / Thin Trees
Example photo of the maintenance of the trees along this unit. All trees should be trimmed and thinned to allow for visibility and access within 20 feet of waterward shoulder to 10 feet beyond the landward toe of the levee.

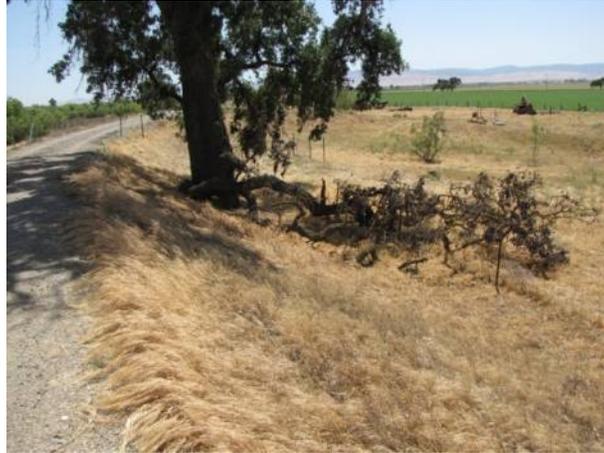
Levee Mile Report Line	11
Start Levee Mile	3.04
End Levee Mile	3.04
Location	Land Side
Category	Earthen Levee
Item	Encroachments
Remove tree limb from within 10 feet of the toe of the levee to maintain access and to remove rodent attraction.

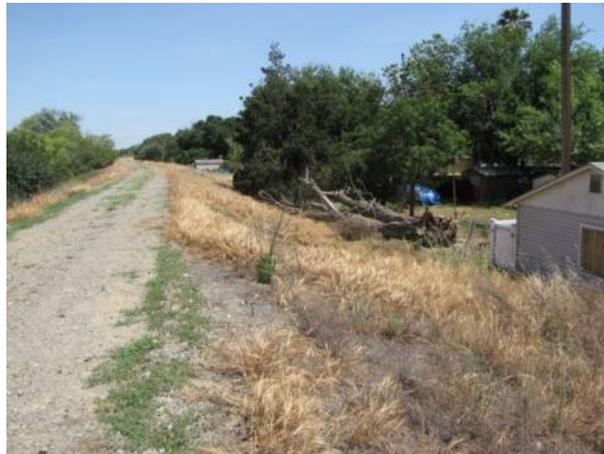
Levee Mile Report Line	21
Start Levee Mile	4.39
End Levee Mile	4.39
Location	Land Side
Category	Earthen Levee
Item	Encroachments
Remove fallen tree from within 10 feet of the landward toe of the levee.

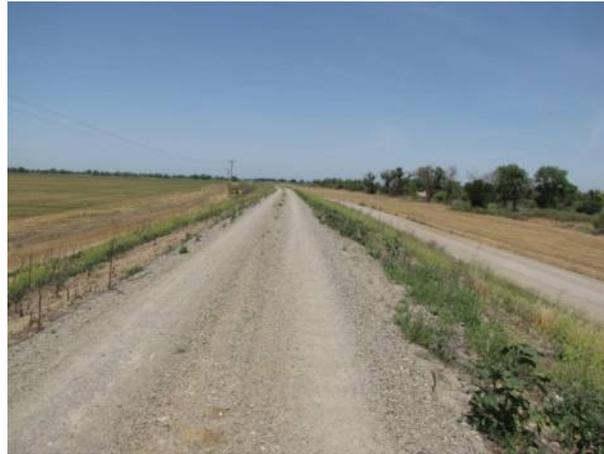
Levee Mile Report Line	1
Start Levee Mile	0.15
End Levee Mile	0.15
Location	
Category	Earthen Levee
Item	Vegetation
Example of good maintenance along this unit.

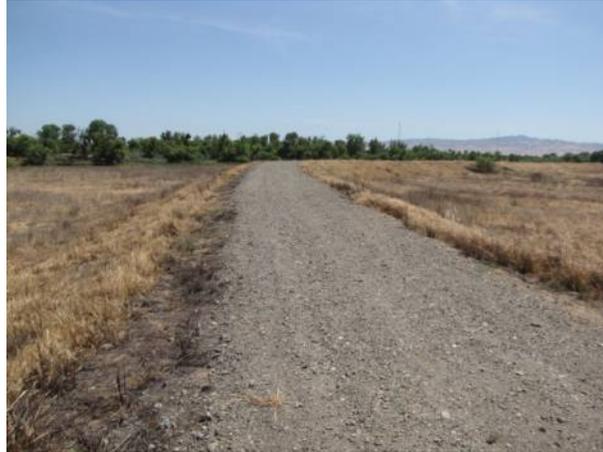
Levee Mile Report Line	2
Start Levee Mile	0.28
End Levee Mile	0.28
Location	Water Side
Category	Earthen Levee
Item	Vegetation

Example of good maintenance along this unit. While vegetation is present, it is low and thin enough that it does not obstruct visibility or prevent access to the levee for flood fighting.
