**Flood Control Project Maintenance
Levee Inspections**
LMA District Cover Sheet
Spring 2010 Levee Inspection Results

Reclamation District No. 2085 Kasson

Levee Inspection Report By Mile - Spring 2010

Waterway	Bank	Unit Miles	Inspection Start/End	Inspector
Unit No. 01 San Joaquin River	Left	5.20	04/19/2010 04/19/2010	John Paasch

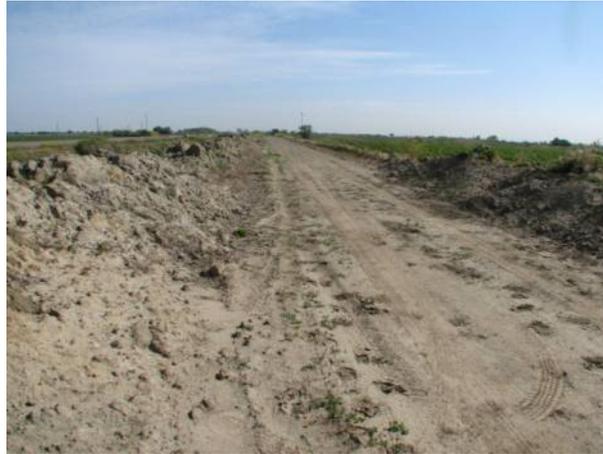
Levee Mile Report Line	1
Start Levee Mile	0.00
End Levee Mile	0.46
Location	Water Side
Category	Earthen Levee
Item	Encroachments
Dredge tailings from Banta Carbona intake remain on levee crown and slope.	
jpaasch_s_20100420_293.jpg

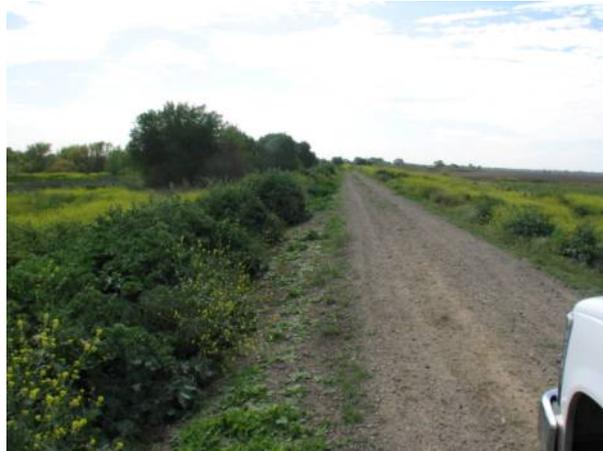
Levee Mile Report Line	3
Start Levee Mile	0.47
End Levee Mile	1.33
Location	Water Side
Category	Earthen Levee
Item	Vegetation
Annual grasses and weeds on levee slopes.	
jpaasch_s_20100420_294.jpg

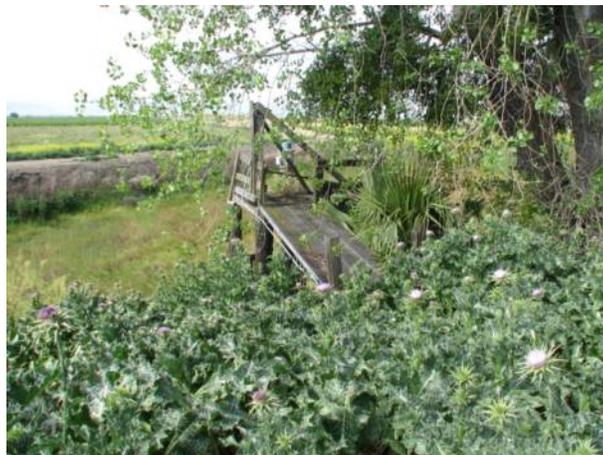
Levee Mile Report Line	4
Start Levee Mile	0.47
End Levee Mile	0.47
Location	Water Side
Category	Earthen Levee
Item	Encroachments
Drainage intake penetrates levee and discharges into San Joaquin River.	
jpaasch_s_20100420_295.jpg

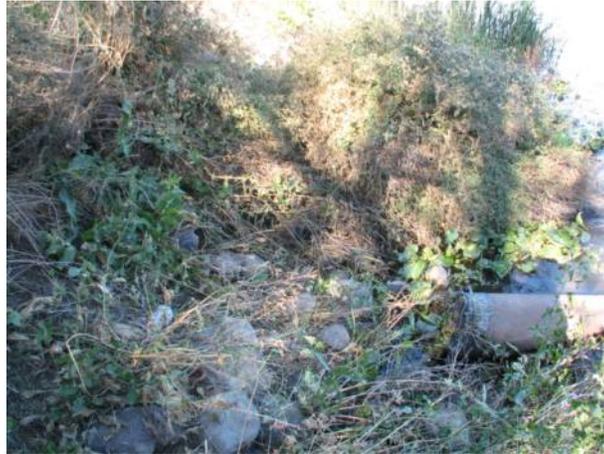
Levee Mile Report Line	9
Start Levee Mile	1.28
End Levee Mile	1.28
Location	Water Side
Category	Interior Drainage & Piping Systems
Item	Metal Pipes
Fall 2009 photo of deteriorated drainage outlet at the bank of the San Joaquin River.	
jpaasch_s_20100330_128.jpg

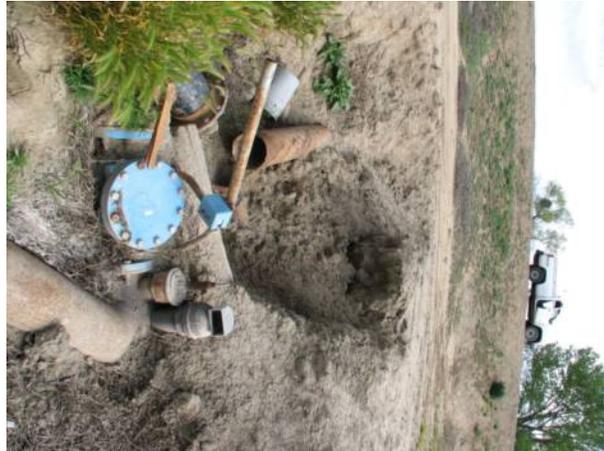
Levee Mile Report Line	10
Start Levee Mile	1.35
End Levee Mile	1.35
Location	Water Side
Category	Interior Drainage & Piping Systems
Item	Metal Pipes
Pipe opening beyond landside toe. Pipe penetrates levee. No closure devices.	
jpaasch_s_20100420_296.jpg

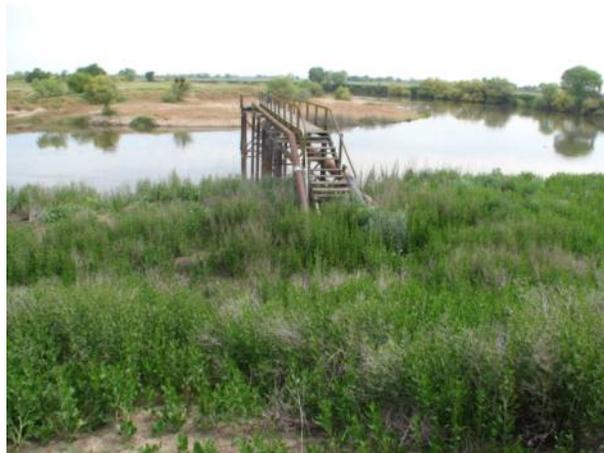
Levee Mile Report Line	14
Start Levee Mile	1.98
End Levee Mile	1.98
Location	Water Side
Category	Earthen Levee
Item	Encroachments
Irrigation intake on waterside berm. Pipe penetrates levee.	
jpaasch_s_20100420_297.jpg

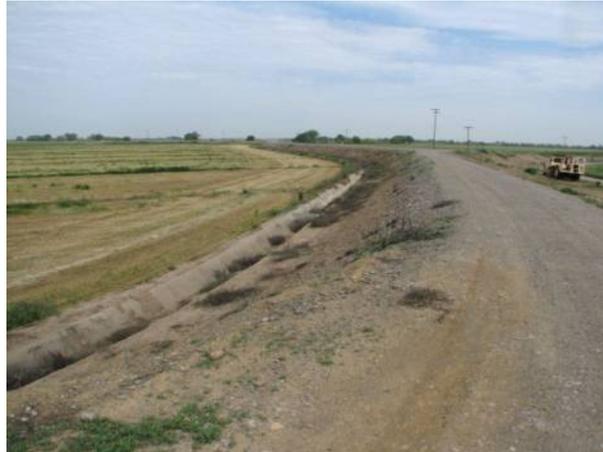
Levee Mile Report Line	15
Start Levee Mile	1.98
End Levee Mile	2.44
Location	Land Side
Category	Earthen Levee
Item	Encroachments
Concrete- lined agricultural ditch within 10' of levee toe.	
jpaasch_s_20100420_298.jpg

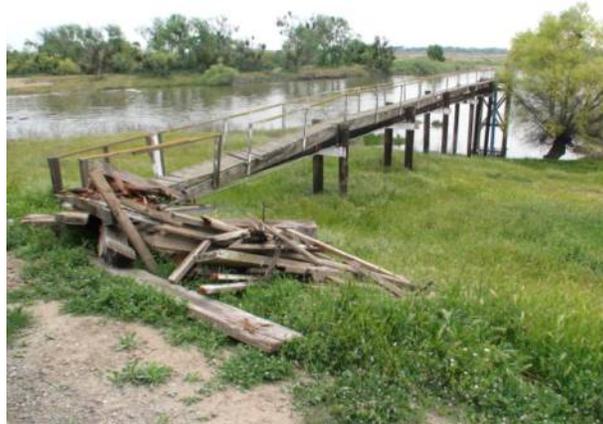
Levee Mile Report Line	22
Start Levee Mile	2.75
End Levee Mile	2.75
Location	Water Side
Category	Earthen Levee
Item	Encroachments
Irrigation intake pipe penetrates levee. Debris on waterside hinge point.	
jpaasch_s_20100420_300.jpg

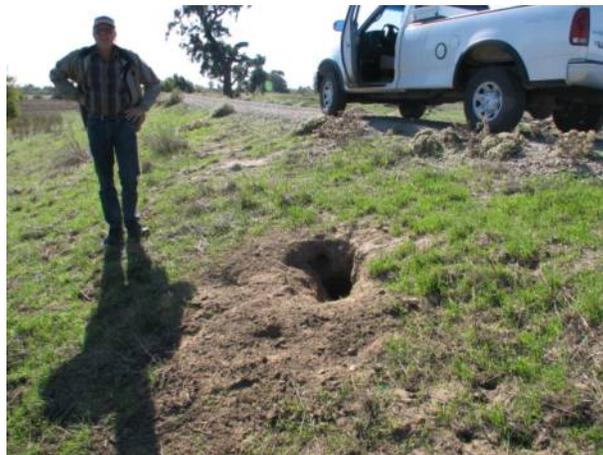
Levee Mile Report Line	23
Start Levee Mile	3.01
End Levee Mile	3.01
Location	Water Side
Category	Earthen Levee
Item	Animal Control
Fall 2009 photo of small animal burrow uncovered by a predator creating a larger entrance.	
jpaasch_s_20100330_129.jpg

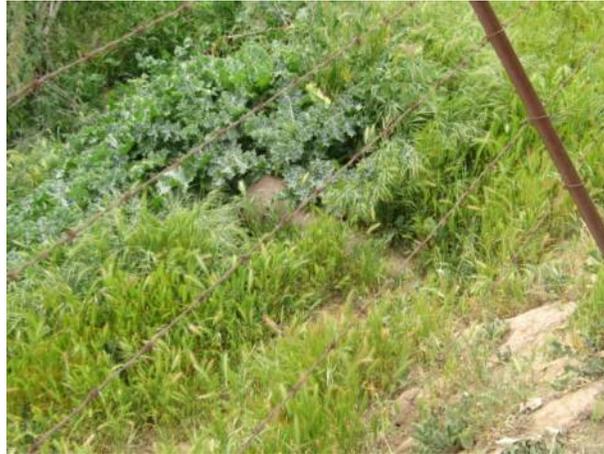
Levee Mile Report Line	24
Start Levee Mile	3.24
End Levee Mile	3.24
Location	Water Side
Category	Earthen Levee
Item	Encroachments
Steel pipe penetrates levee. There are no closure devices or gates at either end. Pipe opening on waterside slope below fence line.	
jpaasch_s_20100420_299.jpg

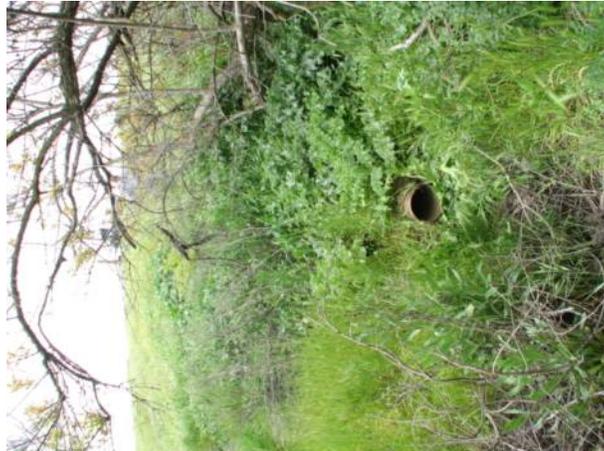
Levee Mile Report Line	26
Start Levee Mile	3.33
End Levee Mile	3.33
Location	Water Side
Category	Earthen Levee
Item	Encroachments
Steel pipe penetrates levee. Stand pipe on waterside hinge point. Valve on landside toe. Opening beyond waterside toe.	
jpaasch_s_20100420_301.jpg

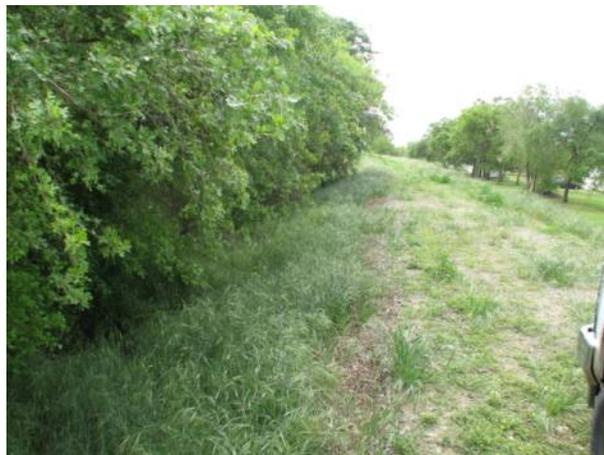
Levee Mile Report Line	30
Start Levee Mile	3.87
End Levee Mile	3.89
Location	Water Side
Category	Earthen Levee
Item	Trim / Thin Trees
Photo of untrimmed trees within 20' of levee crown on waterside slope.	
jpaasch_s_20100420_302.jpg

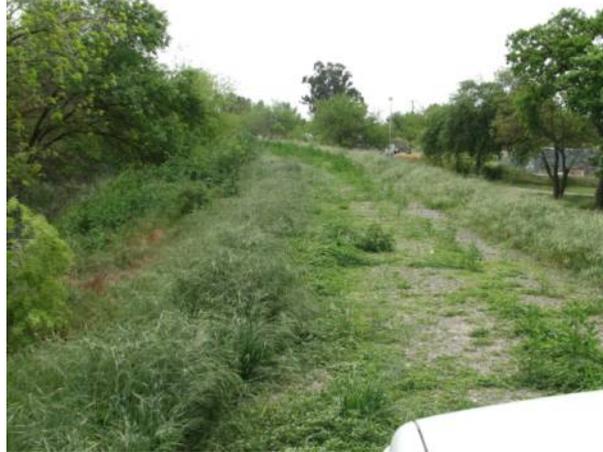
Levee Mile Report Line	32
Start Levee Mile	3.92
End Levee Mile	5.18
Location	Water Side
Category	Earthen Levee
Item	Vegetation
Annual grasses and weeds on levee slopes and crown.	
jpaasch_s_20100420_303.jpg

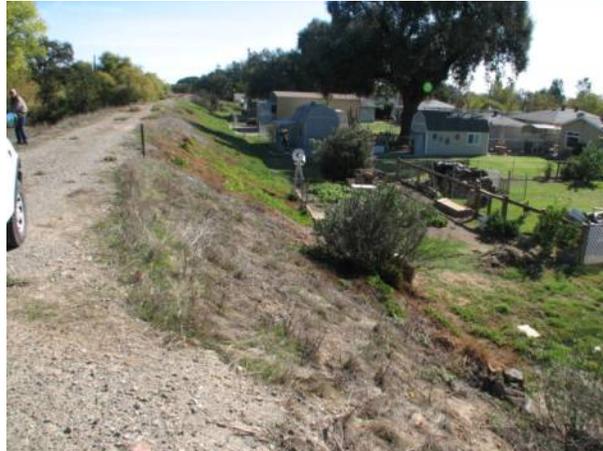
Levee Mile Report Line	35
Start Levee Mile	4.32
End Levee Mile	4.37
Location	Land Side
Category	Earthen Levee
Item	Encroachments
Fall 2009 photo of obstructive landscaping on land side slope and toe.	
jpaasch_s_20100330_123.jpg

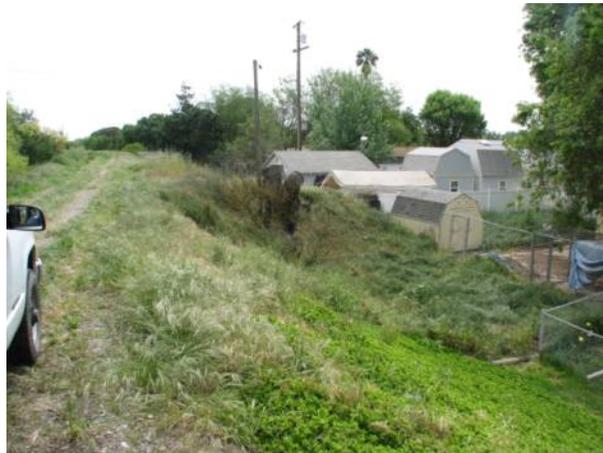
Levee Mile Report Line	37
Start Levee Mile	4.38
End Levee Mile	4.38
Location	Land Side
Category	Earthen Levee
Item	Trim / Thin Trees
Tree trunk and stump on landside levee slope.	
jpaasch_s_20100420_304.jpg

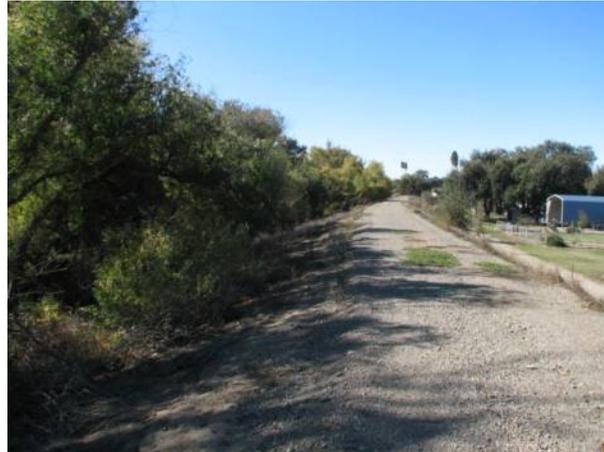
Levee Mile Report Line	46
Start Levee Mile	4.87
End Levee Mile	4.87
Location	Water Side
Category	Earthen Levee
Item	Trim / Thin Trees
<p>Fall 2009 photo: Trees within 20-ft of levee crown need to be trimmed for access and visibility.</p>	
<p>jpaasch_s_20100330_124.jpg</p>

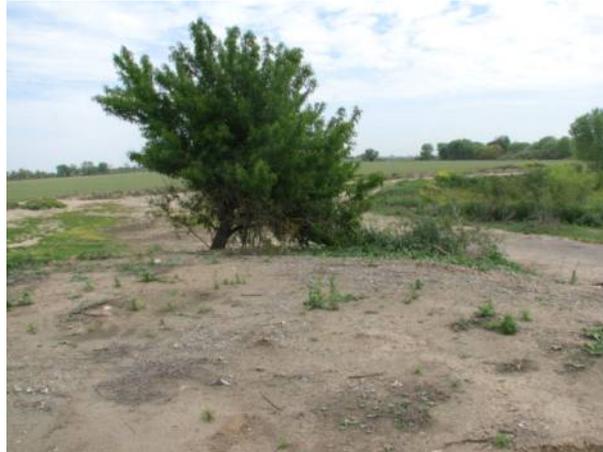
Levee Mile Report Line	1
Start Levee Mile	0.69
End Levee Mile	0.69
Location	Water Side
Category	Earthen Levee
Item	Vegetation
Vegetation on hinge point and slope at end of wing levee.	
jpaasch_s_20100420_291.jpg

LMIR No	Levee Mile		Category	Item	Location *	Rating **	Action/Comment	GPS Latitude/Longitude		Issue No. Photo
	Start	End						Start	End	
1	0.69	0.69	Earthen Levee	Vegetation	WS	M	Remove the wild growth other than native grasses from the levee slopes.	37.714039 ° -121.269665 °	37.714039 ° -121.269665 °	1 Y

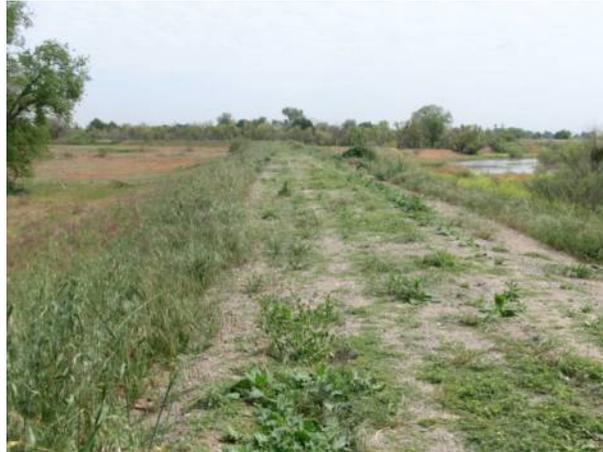
Levee Mile Report Line	1
Start Levee Mile	0.05
End Levee Mile	0.26
Location	Water Side
Category	Earthen Levee
Item	Vegetation
Annual grasses and weeds on slopes of wing levee.	
jpaasch_s_20100420_292.jpg
