**Flood Control Project Maintenance
Levee Inspections**
LMA District Cover Sheet
Spring 2011 Levee Inspection Results

Reclamation District No. 2085 Kasson

Waterway		Bank	Unit Miles
Unit No. 01 San Joaquin River		Left	5.20

Levee Inspection Report By Mile - Spring 2011

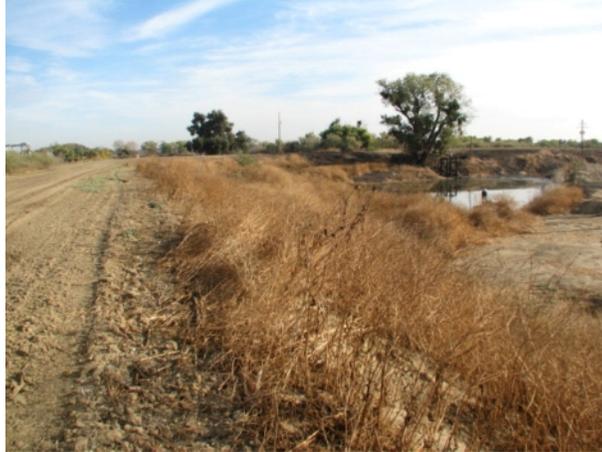
Levee Mile Report Line	1
Start Levee Mile	0.41
End Levee Mile	0.64
Location	Land Side
Category	Earthen Levee
Item	Vegetation
Tall weeds remain on the landside levee slope.	
jeto_s_20110301_199.jpg

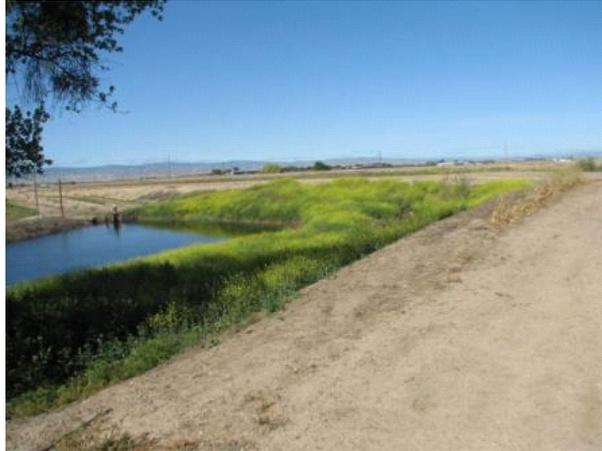
Levee Mile Report Line	1
Start Levee Mile	0.41
End Levee Mile	0.64
Location	Land Side
Category	Earthen Levee
Item	Vegetation
04/28/2011 Weeds taller than 12" inhibit visibility of landside slope and tow.	
jeto_s_20110428_455.jpg

Waterway				Bank	Unit Miles	Inspection Start/End	Inspector			
Unit No. 01 San Joaquin River				Left	5.20	04/28/2011 04/28/2011	Jim Eto			
LMR No.	Levee Mile		Category	Item	Location	Rating	Action/Comment	GPS Latitude/Longitude		Issue No. Photo
	Start	End						Start	End	
1	0.41	0.64	Earthen Levee	Vegetation	LS	M	Remove the wild growth other than native grasses from the levee slopes.	37.723140 ° -121.299541 °	37.721889 ° -121.296096 °	1 Y
2	0.47	0.47	Earthen Levee	Encroachments	WS	U	Pipe Inspector Comments: Pipe from abandoned drainage pump penetrates levee with no closure devices.	37.723396 ° -121.298572 °	37.723396 ° -121.298572 °	2 Y
3	0.64	0.69	Earthen Levee	Trim / Thin Trees	WS	C	Trim and thin trees to allow visibility of the ground and room to flood fight. Inspector Comments: Improvements made with chainsaw and mower. Additional work to be done to improve visibility to 20' down slope length.	37.722037 ° -121.296227 °	37.721460 ° -121.295535 °	3

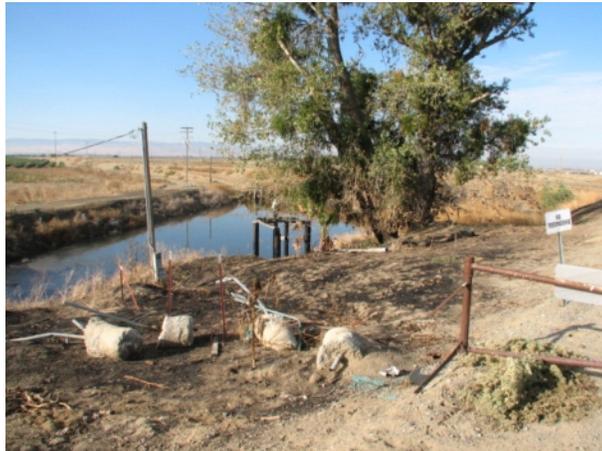
Levee Mile Report Line	2
Start Levee Mile	0.47
End Levee Mile	0.47
Location	Water Side
Category	Earthen Levee
Item	Encroachments
Drainage discharge pipe penetrates levee with no closure device.	
jeto_s_20110301_200.jpg

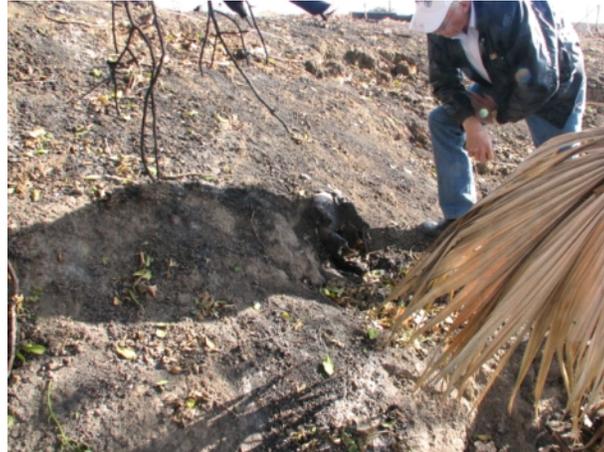
Levee Mile Report Line	2
Start Levee Mile	0.47
End Levee Mile	0.47
Location	Water Side
Category	Earthen Levee
Item	Encroachments
<p>Opening on landside appears to consist of melted poly pipe halfway up levee slope. Opening on waterside is heavily corroded steel pipe.</p>	
<p>jeto_s_20110301_201.jpg</p>

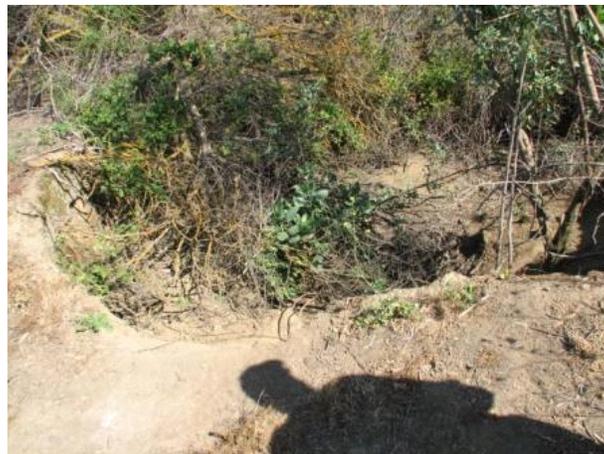
Levee Mile Report Line	2
Start Levee Mile	0.47
End Levee Mile	0.47
Location	Water Side
Category	Earthen Levee
Item	Encroachments
<p>04/28/2011 Area around discharge pipe appears to be in an area of erosion. Area was found after weeds were cleared.</p>	
<p>jeto_s_20110428_456.jpg</p>

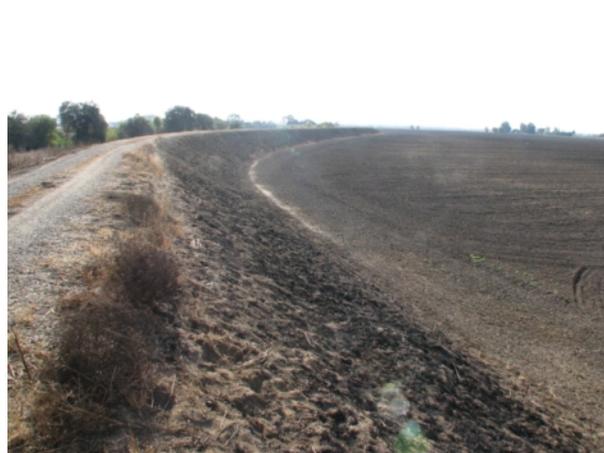
Levee Mile Report Line	6
Start Levee Mile	0.89
End Levee Mile	1.18
Location	Land Side
Category	Earthen Levee
Item	Encroachments
<p>Tilling of soil on the levee toe will destabilize the slope over time.</p>	
<p>jeto_s_20110301_202.jpg</p>

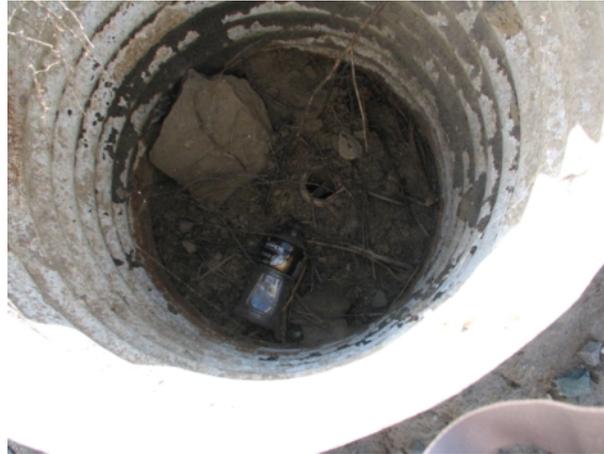
Levee Mile Report Line	11
Start Levee Mile	1.35
End Levee Mile	1.35
Location	Crown
Category	Earthen Levee
Item	Encroachments

Photo of anti siphon at waterside shoulder.

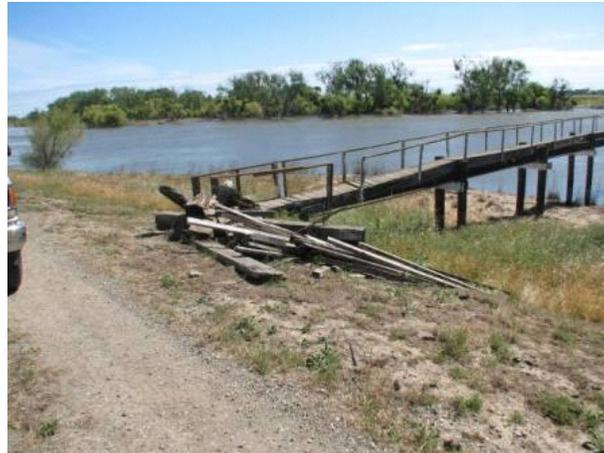
Levee Mile Report Line	16
Start Levee Mile	2.75
End Levee Mile	2.75
Location	Water Side
Category	Earthen Levee
Item	Encroachments

04/28/2011 Trash still present, item was noted in Fall 2010 inspection.

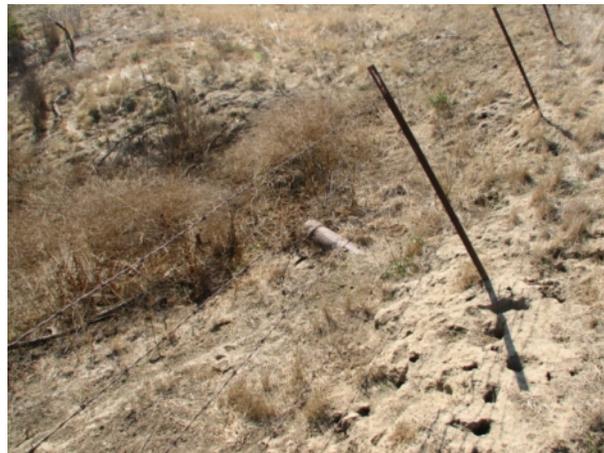
Levee Mile Report Line	20
Start Levee Mile	3.24
End Levee Mile	3.24
Location	Water Side
Category	Earthen Levee
Item	Encroachments

Photo of pipe penetration discharge off landside slope.

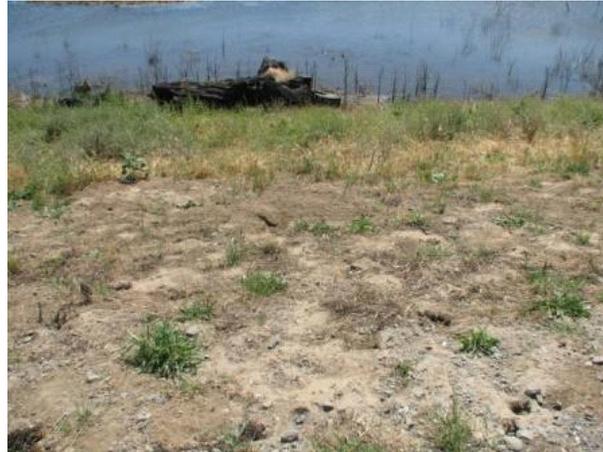
Levee Mile Report Line	21
Start Levee Mile	3.28
End Levee Mile	3.28
Location	Water Side
Category	Earthen Levee
Item	Animal Control
04/28/2011 Fresh burrow in center of picture, "porch" extends to the grass line.	
jeto_s_20110428_459.jpg

21	3.28	3.28	Earthen Levee	Animal Control	WS	W	No rodents visible, but rodent burrows visible; need to backfill and compact or grout burrows.	37.692916 ° -121.277929 °	37.692916 ° -121.277929 °	15 Y
22	3.33	3.33	Earthen Levee	Encroachments	WS	M	Pipe Inspector Comments: Pipe missing flap gate and positive closure device on waterside hinge point.	37.691969 ° -121.278093 °	37.691969 ° -121.278093 °	22
23	3.37	3.37	Earthen Levee	Animal Control	LS	M	No rodents visible, but rodent burrows visible; need to backfill and compact or grout burrows.	37.691680 ° -121.277925 °	37.691680 ° -121.277925 °	47 Y
24	3.46	3.46	Earthen Levee	Animal Control	LS	M	No rodents visible, but rodent burrows visible; need to backfill and compact or grout burrows.	37.690532 ° -121.276993 °	37.690532 ° -121.276993 °	16
25	3.46	3.46	Earthen Levee	Animal Control	WS	M	No rodents visible, but rodent burrows visible; need to backfill and compact or grout burrows.	37.690532 ° -121.276993 °	37.690532 ° -121.276993 °	19

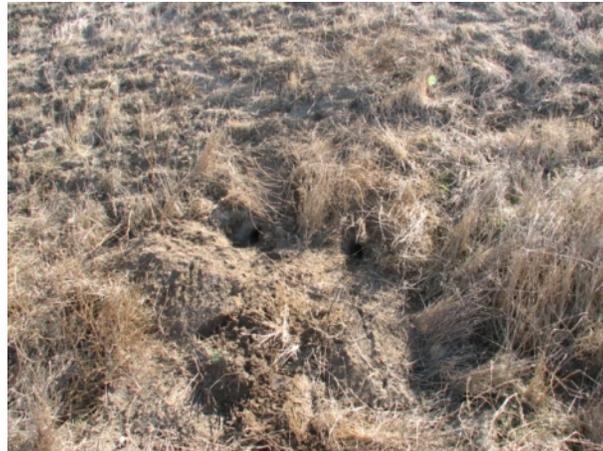
Levee Mile Report Line	23
Start Levee Mile	3.37
End Levee Mile	3.37
Location	Land Side
Category	Earthen Levee
Item	Animal Control
Rodent holes have been flagged for repair.	
jeto_s_20110301_207.jpg

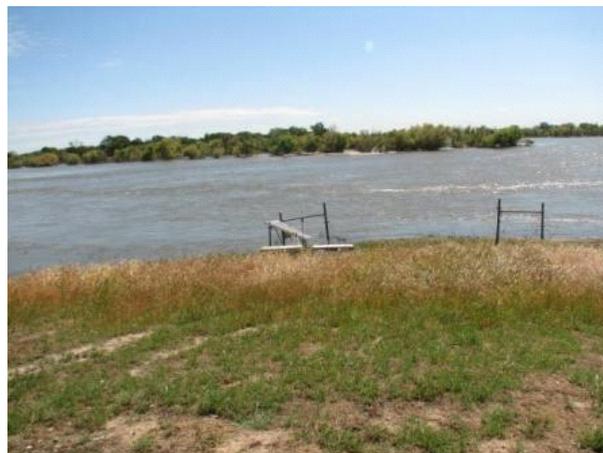
Levee Mile Report Line	26
Start Levee Mile	3.60
End Levee Mile	3.60
Location	Water Side
Category	Earthen Levee
Item	Encroachments
04/28/2011 Fish and Game fish monitoring station.	
jeto_s_20110428_460.jpg

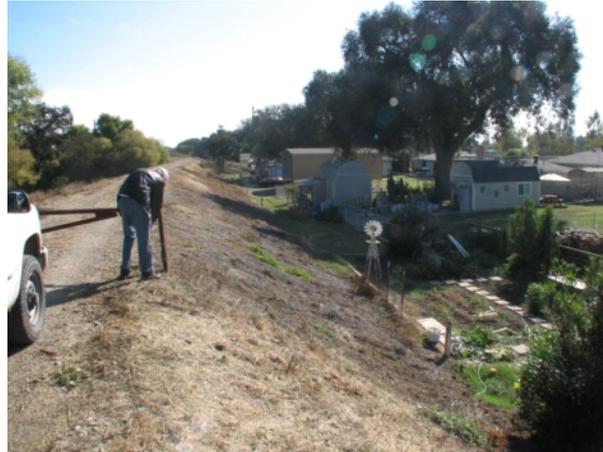
Levee Mile Report Line	35
Start Levee Mile	4.32
End Levee Mile	4.37
Location	Land Side
Category	Earthen Levee
Item	Encroachments
Updated photo of encroachments on landside toe.	
jeto_s_20110301_204.jpg

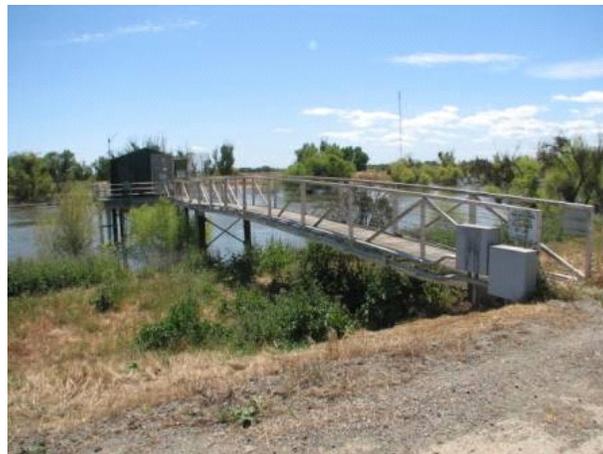
Levee Mile Report Line	41
Start Levee Mile	4.71
End Levee Mile	4.71
Location	Water Side
Category	Earthen Levee
Item	Encroachments
04/28/2011 Monitoring station.	
jeto_s_20110428_463.jpg

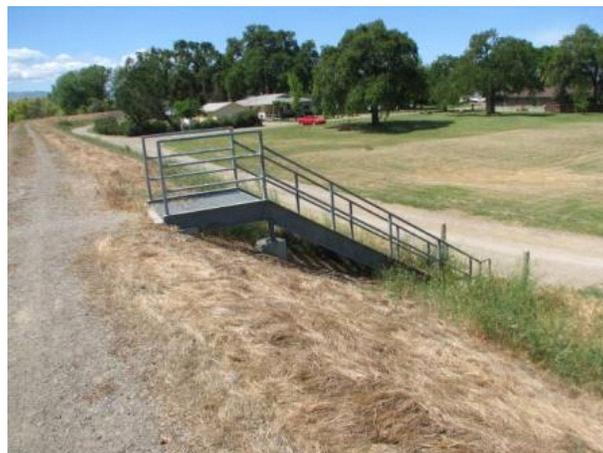
Levee Mile Report Line	42
Start Levee Mile	4.71
End Levee Mile	4.71
Location	Land Side
Category	Earthen Levee
Item	Encroachments
04/28/2011 Stairs on landside slope for monitoring station.	
jeto_s_20110428_462.jpg

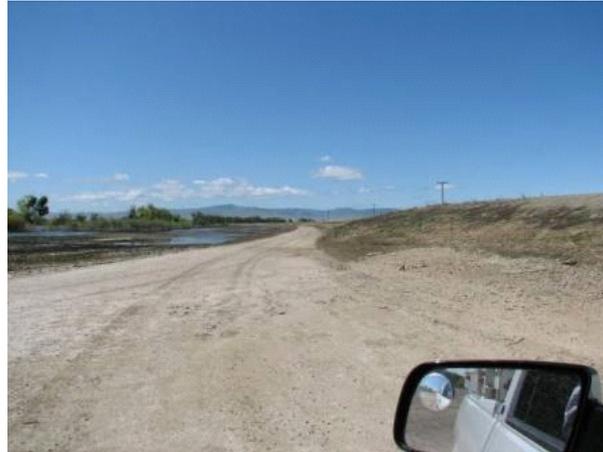
Levee Mile Report Line	2
Start Levee Mile	0.01
End Levee Mile	0.69
Location	Water Side
Category	Earthen Levee
Item	Vegetation

04/28/2011 Photo taken from bottom of levee waterside slope is shown on the right.

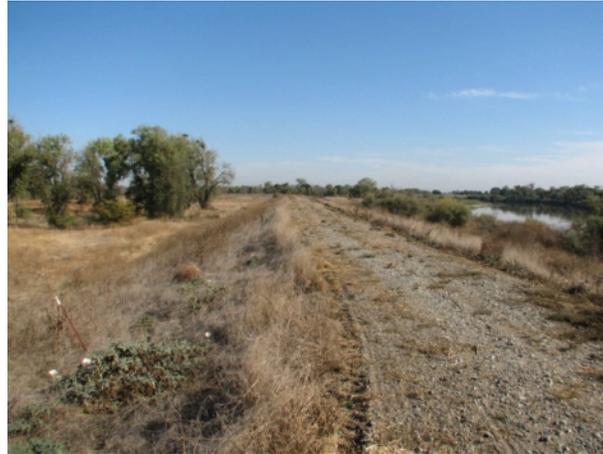
Levee Mile Report Line	1
Start Levee Mile	0.01
End Levee Mile	0.29
Location	Water Side
Category	Earthen Levee
Item	Vegetation
Unwanted weed growth on levee slopes.	
jeto_s_20110301_209.jpg

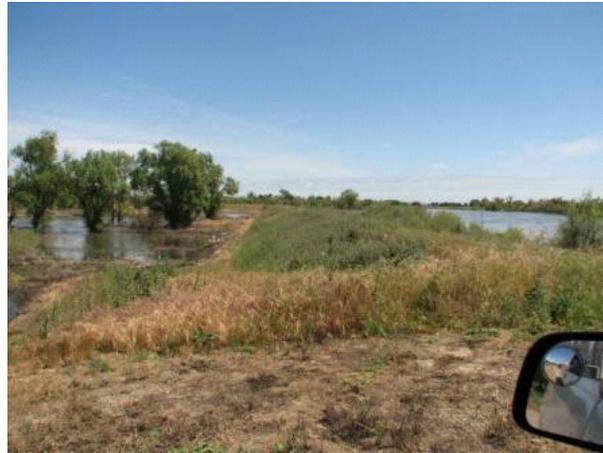
Levee Mile Report Line	2
Start Levee Mile	0.02
End Levee Mile	0.29
Location	Water Side
Category	Earthen Levee
Item	Vegetation
04/28/2011 Weeds taller than 12" are on both waterside slopes for the full length of the unit. Weeds prevent visibility of the slope and crown.	
jeto_s_20110428_461.jpg
