**Flood Control Project Maintenance
Levee Inspections**

**Fall 2010 Levee Maintenance Deficiency Summary Report
Overall LMA & Unit Ratings, including DWR Erosion Survey**

San Joaquin River Basin

Reclamation District No. 2089 Stark

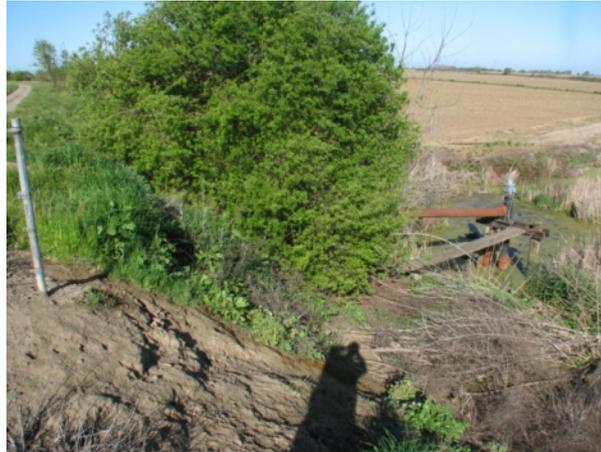
Levee Mile Report Line	2
Start Levee Mile	0.01
End Levee Mile	0.01
Location	Land Side
Category	Earthen Levee
Item	Trim / Thin Trees
Trees on landside slope limit access and visibility.	
jpaasch_f_20100923_321.jpg

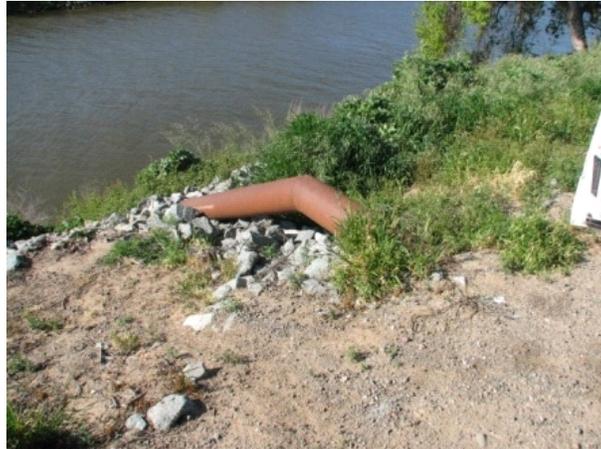
Levee Mile Report Line	3
Start Levee Mile	0.03
End Levee Mile	0.03
Location	Land Side
Category	Earthen Levee
Item	Encroachments
Waterside of drainage discharge to Old River.	
jpaasch_f_20100923_334.jpg

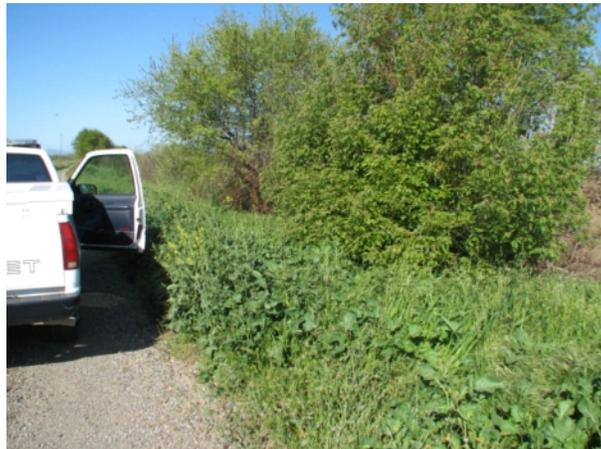
Levee Mile Report Line	4
Start Levee Mile	0.04
End Levee Mile	0.23
Location	Land Side
Category	Earthen Levee
Item	Vegetation
Brush and weeds on landside slope limit visibility and access.	
jpaasch_f_20100923_342.jpg

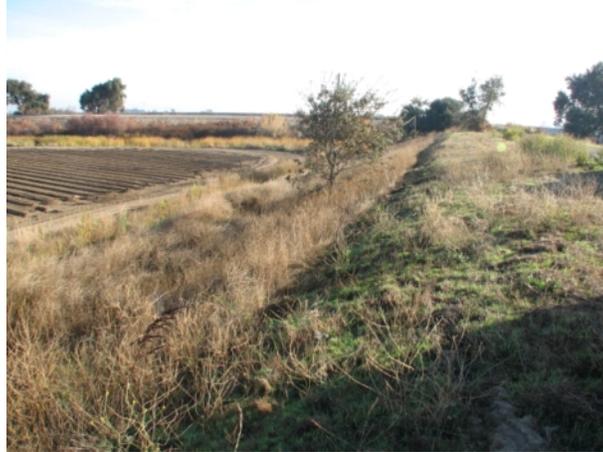
Levee Mile Report Line	4
Start Levee Mile	0.04
End Levee Mile	0.23
Location	Land Side
Category	Earthen Levee
Item	Vegetation
Vegetation on lower levee slope and within 10' of levee to obstruct access and visibility.	
jpaasch_f_20101105_536.jpg

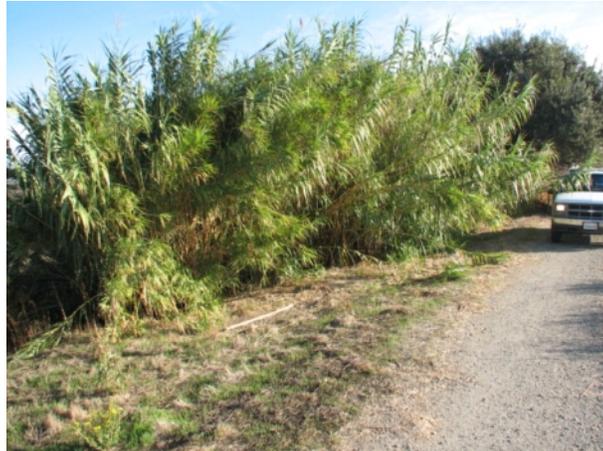
Levee Mile Report Line	12
Start Levee Mile	0.24
End Levee Mile	0.24
Location	Land Side
Category	Earthen Levee
Item	Vegetation
Bamboo on levee slope and crown obstruct access and visibility.	
jpaasch_f_20101105_534.jpg

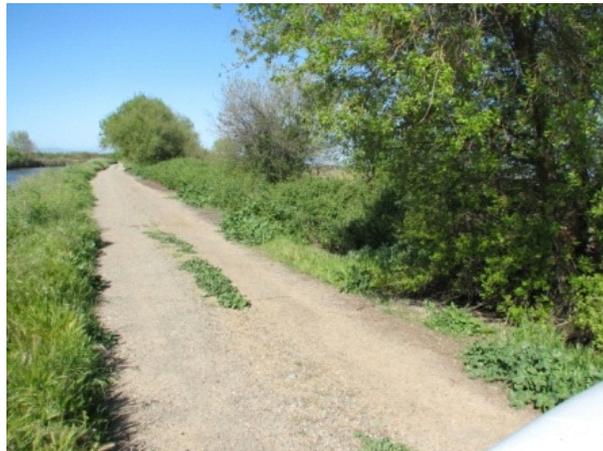
Levee Mile Report Line	16
Start Levee Mile	0.29
End Levee Mile	0.34
Location	Land Side
Category	Earthen Levee
Item	Vegetation
Thick brush and trees on levee crown and slope.	
jpaasch_f_20100923_346.jpg

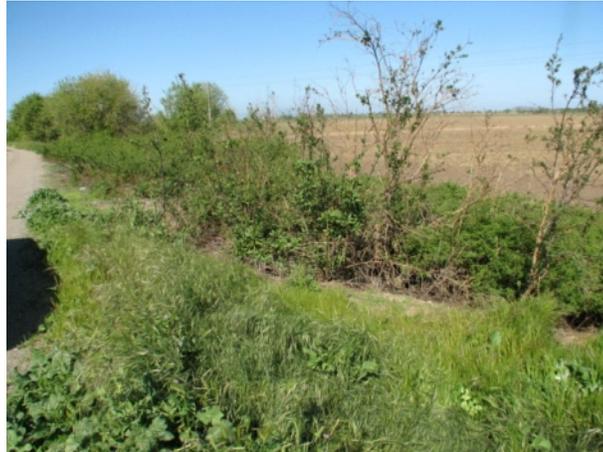
18	0.36	0.44	Earthen Levee	Vegetation	LS	U	Remove the wild growth other than native grasses from the levee slopes. Inspector Comments: Tobacco plant, not Elderberry. Wild rose on lower slope limits access and visibility.	37.809963 ° -121.390925 °	37.809524 ° -121.392266 °	945 Y
19	0.38	0.38	Earthen Levee	Trim / Thin Trees	LS	U	Trim trees to at least five feet above ground level.	37.809865 ° -121.391303 °	37.809865 ° -121.391303 °	946 Y
20	0.39	0.39	Earthen Levee	Animal Control	CR	C	No rodents visible, but rodent burrows visible; need to backfill and compact or grout borrows. Inspector Comments: Burrow holes on both sides of levee road.	37.809870 ° -121.391465 °	37.809870 ° -121.391465 °	947
21	0.41	0.47	Earthen Levee	Trim / Thin Trees	LS	U	Trim trees to at least five feet above ground level. Inspector Comments: Trees and wild rose obstruct access and visibility.	37.809793 ° -121.391717 °	37.809592 ° -121.392822 °	948 Y

Levee Mile Report Line	18
Start Levee Mile	0.36
End Levee Mile	0.44
Location	Land Side
Category	Earthen Levee
Item	Vegetation
Indian Tobacco plant and wild rose on levee slope obstruct access and visibility.	
jpaasch_f_20100923_347.jpg

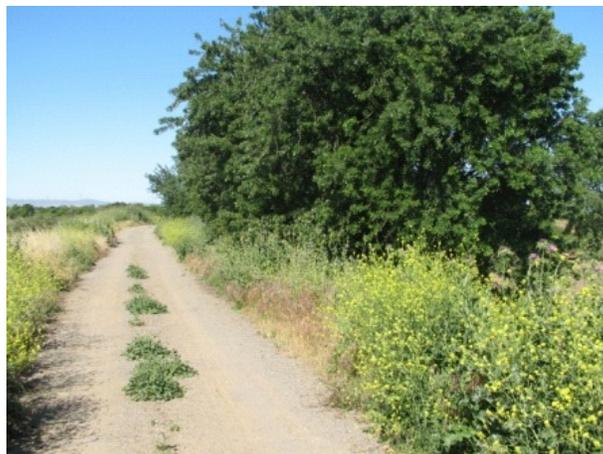
Levee Mile Report Line	19
Start Levee Mile	0.38
End Levee Mile	0.38
Location	Land Side
Category	Earthen Levee
Item	Trim / Thin Trees
Trees on levee slope obstruct access and visibility.	
jpaasch_f_20100923_348.jpg

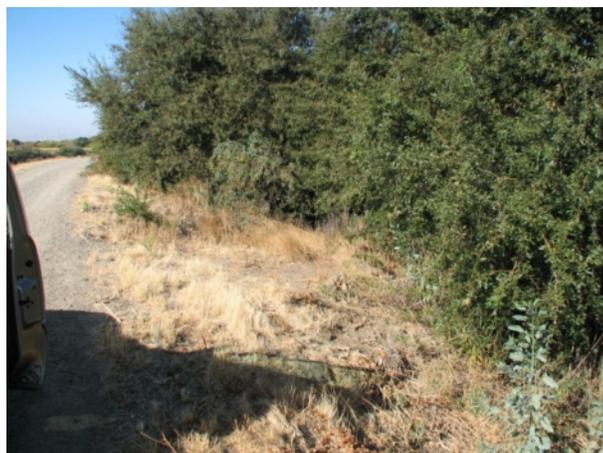
Levee Mile Report Line	21
Start Levee Mile	0.41
End Levee Mile	0.47
Location	Land Side
Category	Earthen Levee
Item	Trim / Thin Trees
Fall 2009 photo of completely obstructive vegetation on levee slope.	
jpaasch_f_20100923_349.jpg

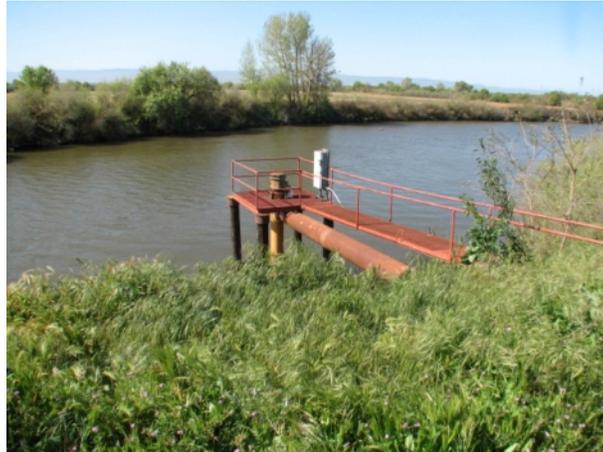
Levee Mile Report Line	23
Start Levee Mile	0.47
End Levee Mile	0.47
Location	Water Side
Category	Earthen Levee
Item	Encroachments
Irrigation intake pump and pipe at LM 0.46.	
jpaasch_f_20100923_335.jpg

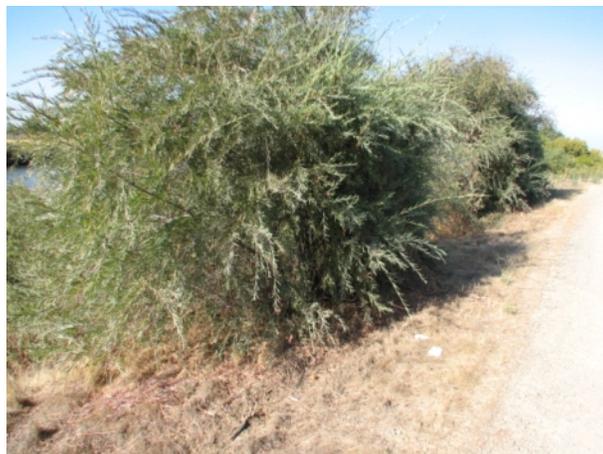
Levee Mile Report Line	24
Start Levee Mile	0.49
End Levee Mile	0.49
Location	Water Side
Category	Earthen Levee
Item	Trim / Thin Trees
Fall 2009 photo: trees within 20-ft of levee crown on the waterside slope obstruct visibility and access.	
jpaasch_f_20100923_350.jpg

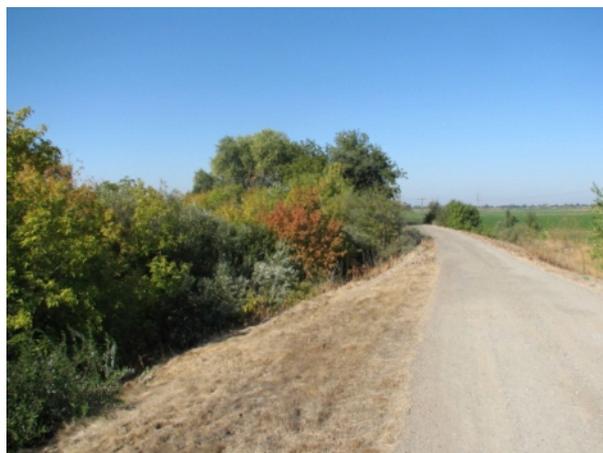
Levee Mile Report Line	25
Start Levee Mile	0.54
End Levee Mile	0.61
Location	Water Side
Category	Earthen Levee
Item	Trim / Thin Trees
Fall 2009 photo of trees within 20-ft of the levee crown on waterside slope. Access and visibility are obstructed.	
jpaasch_f_20100923_336.jpg

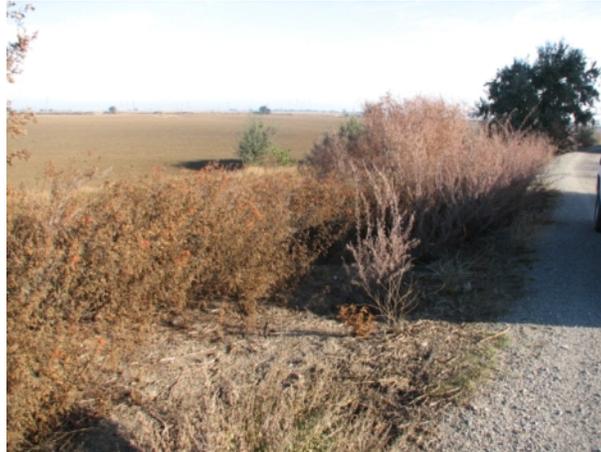
Levee Mile Report Line	27
Start Levee Mile	0.64
End Levee Mile	0.66
Location	Land Side
Category	Earthen Levee
Item	Vegetation
Sprayed brush block visibility and access.	
jpaasch_f_20101105_533.jpg

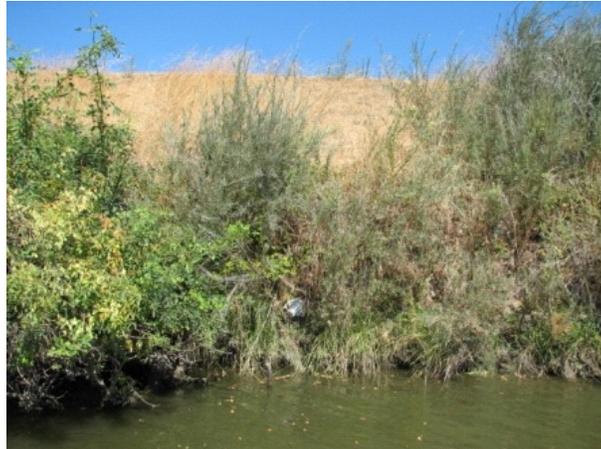
Levee Mile Report Line	29
Start Levee Mile	0.66
End Levee Mile	0.66
Location	Water Side
Category	Supplemental
Item	DWR Erosion Survey
Front view of site.	
SJR2010_RM29.61U1LM.66RBa.jpg

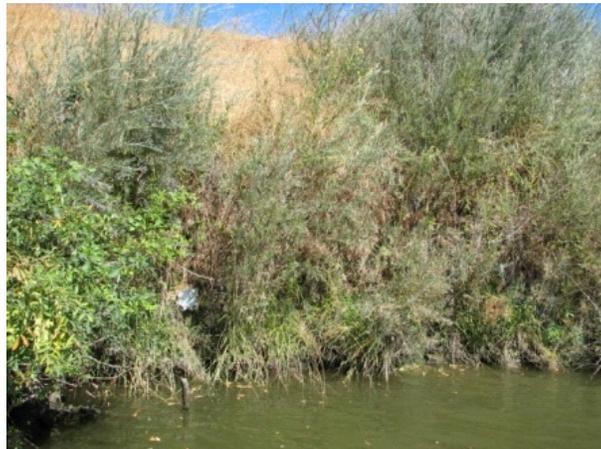
Levee Mile Report Line	29
Start Levee Mile	0.66
End Levee Mile	0.66
Location	Water Side
Category	Supplemental
Item	DWR Erosion Survey
Upstream view of site.	
SJR2010_RM29.61U1LM.66RBb.jpg

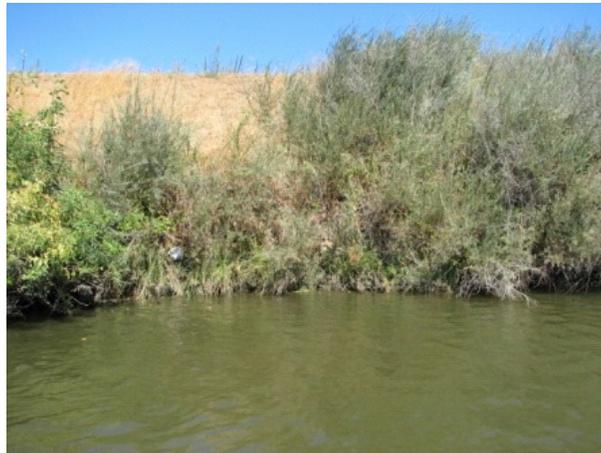
SJR2010_RM29.61U1LM.66RBd.jpg

Levee Mile Report Line	29
Start Levee Mile	0.66
End Levee Mile	0.66
Location	Water Side
Category	Supplemental
Item	DWR Erosion Survey

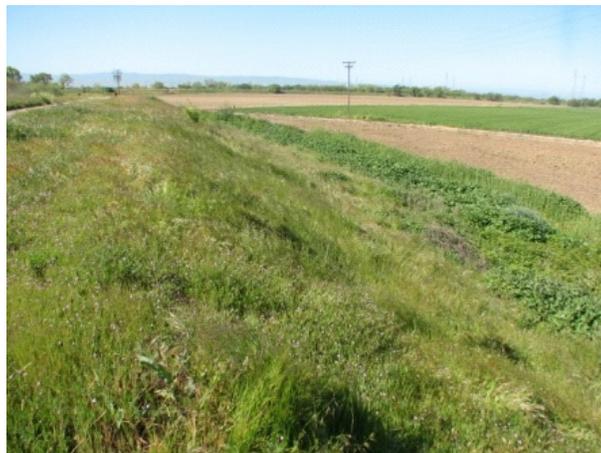
jpaasch_f_20100923_351.jpg

30	0.72	0.77	Earthen Levee	Vegetation	LS	M	Remove the wild growth other than native grasses from the levee slopes. Inspector Comments: Wild Rose on levee toe block access and visibility.	37.809508 ° -121.397062 °	37.808975 ° -121.397528 °	952 Y
31	0.78	0.78	Earthen Levee	Vegetation	WS	C	Remove the wild growth other than native grasses from the levee slopes. Inspector Comments: Tall brush on levee slope has been sprayed and mowed.	37.808857 ° -121.397412 °	37.808857 ° -121.397412 °	953
32	0.82	0.82	Earthen Levee	Encroachments	WS	W	Pipe Inspector Comments: Irrigation intake pump and pipe.	37.808427 ° -121.397827 °	37.808427 ° -121.397827 °	13 Y
33	0.84	0.84	Earthen Levee	Encroachments	LS	M	Agricultural tilling	37.808091 ° -121.397880 °	37.808091 ° -121.397880 °	14 Y
34	0.85	0.96	Earthen Levee	Vegetation	LS	M	Remove the wild growth other than native grasses from the levee slopes.	37.806115 ° -121.398676 °	37.806440 ° -121.397728 °	18 Y

Levee Mile Report Line	30
Start Levee Mile	0.72
End Levee Mile	0.77
Location	Land Side
Category	Earthen Levee
Item	Vegetation

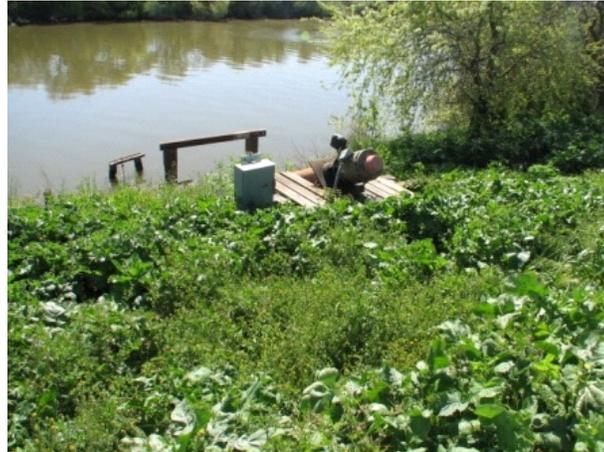
Levee Mile Report Line	32
Start Levee Mile	0.82
End Levee Mile	0.82
Location	Water Side
Category	Earthen Levee
Item	Encroachments
Irrigation intake pump and pipe on levee slope.	
jpaasch_f_20100923_337.jpg

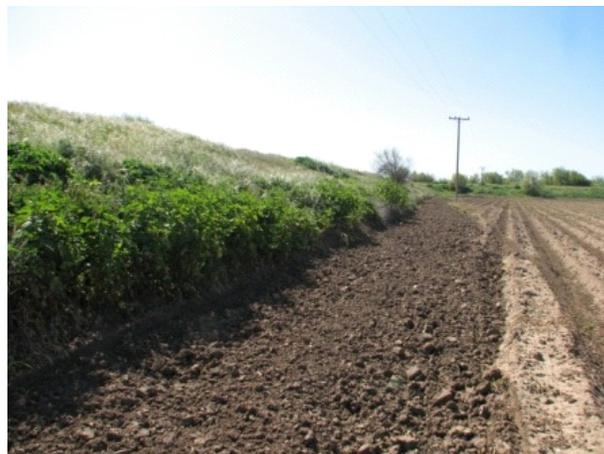
Levee Mile Report Line	33
Start Levee Mile	0.84
End Levee Mile	0.84
Location	Land Side
Category	Earthen Levee
Item	Encroachments
Agricultural tilling on landside has encroached on levee toe.	
jpaasch_f_20100923_338.jpg

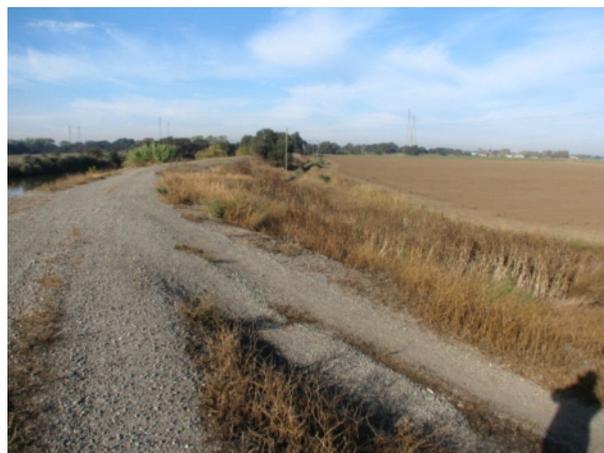
Levee Mile Report Line	34
Start Levee Mile	0.85
End Levee Mile	0.96
Location	Land Side
Category	Earthen Levee
Item	Vegetation
Vegetation on levee slope and toe obstruct access and visibility.	
jpaasch_f_20101105_535.jpg

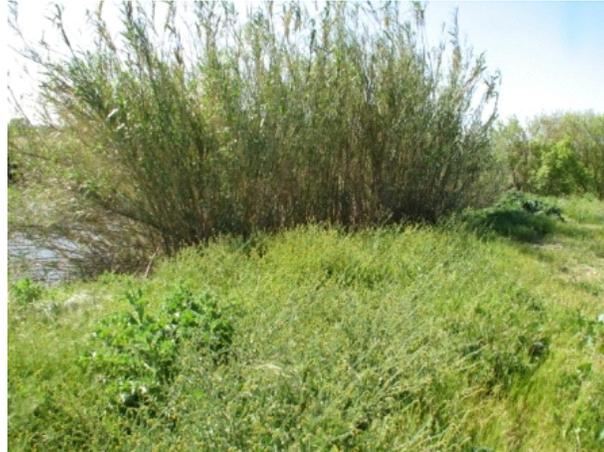
Levee Mile Report Line	36
Start Levee Mile	0.96
End Levee Mile	0.96
Location	Water Side
Category	Earthen Levee
Item	Vegetation
Tall vegetation on waterside hinge point and crown obstruct access and visibility.	
jpaasch_f_20100923_353.jpg

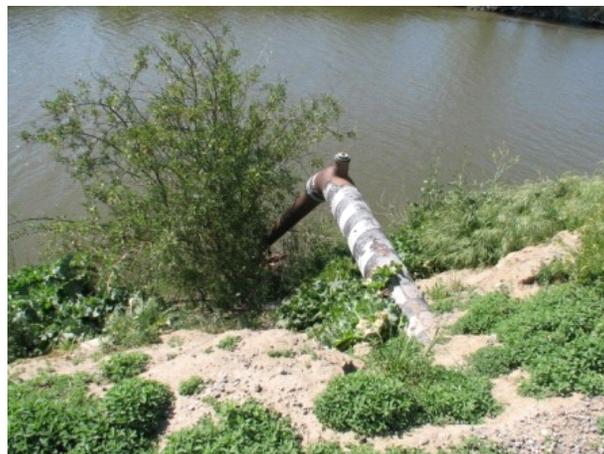
Levee Mile Report Line	42
Start Levee Mile	1.16
End Levee Mile	1.16
Location	Water Side
Category	Earthen Levee
Item	Encroachments
Drainage discharge into Old River.	
jpaasch_f_20100923_341.jpg

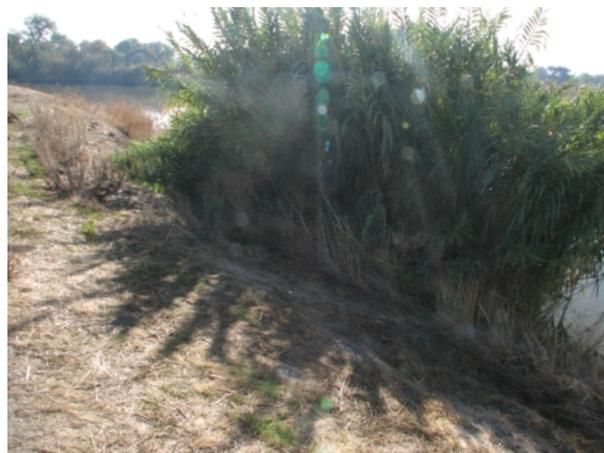
Levee Mile Report Line	44
Start Levee Mile	1.22
End Levee Mile	1.22
Location	Water Side
Category	Earthen Levee
Item	Vegetation
Bamboo on waterside levee slope obstructs access and visibility.	
jpaasch_f_20101105_531.jpg

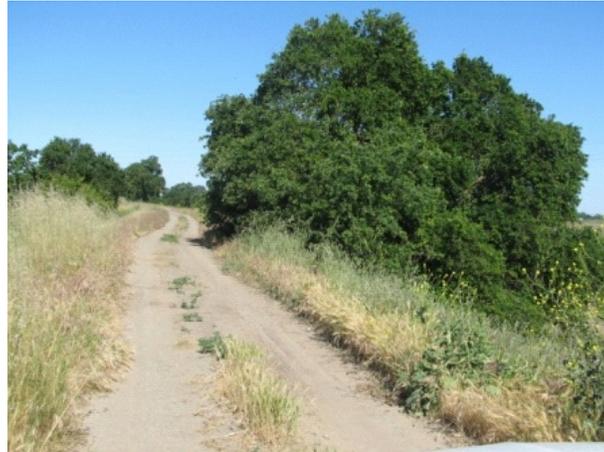
Levee Mile Report Line	45
Start Levee Mile	1.26
End Levee Mile	1.26
Location	Land Side
Category	Earthen Levee
Item	Trim / Thin Trees
Trees on levee slope obstruct access and visibility.	
jpaasch_f_20100923_339.jpg

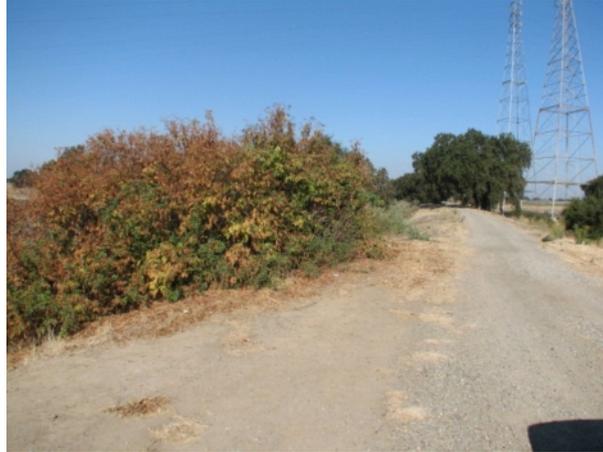
Levee Mile Report Line	3
Start Levee Mile	0.08
End Levee Mile	0.08
Location	Water Side
Category	Earthen Levee
Item	Vegetation
Fall 2009 photo of unacceptable vegetation on levee slope.	
jpaasch_f_20100923_355.jpg

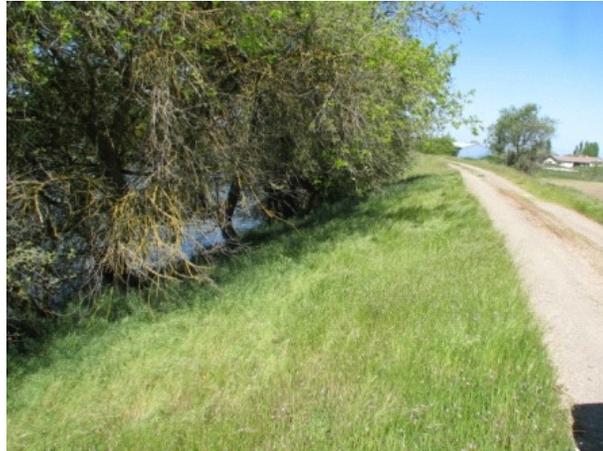
Levee Mile Report Line	5
Start Levee Mile	0.23
End Levee Mile	0.23
Location	Water Side
Category	Earthen Levee
Item	Trim / Thin Trees
Trees within 20' of crown on waterside slope should be trimmed to allow access and visibility.	
jpaasch_f_20100923_356.jpg

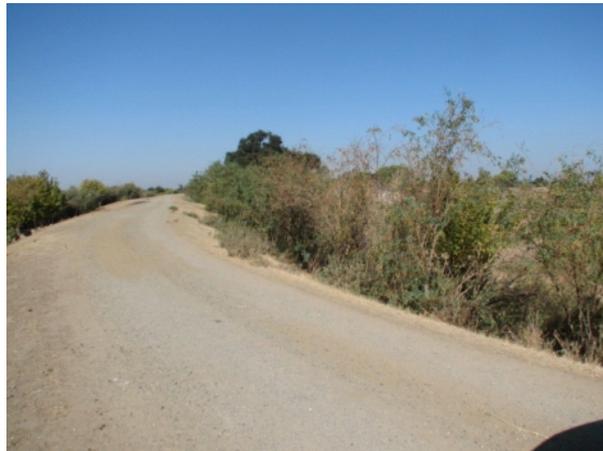
Levee Mile Report Line	9
Start Levee Mile	0.40
End Levee Mile	0.66
Location	Land Side
Category	Earthen Levee
Item	Vegetation
Fall 2009 photo: brush on landside toe limits visibility and accessibility.	
jpaasch_f_20100923_357.jpg

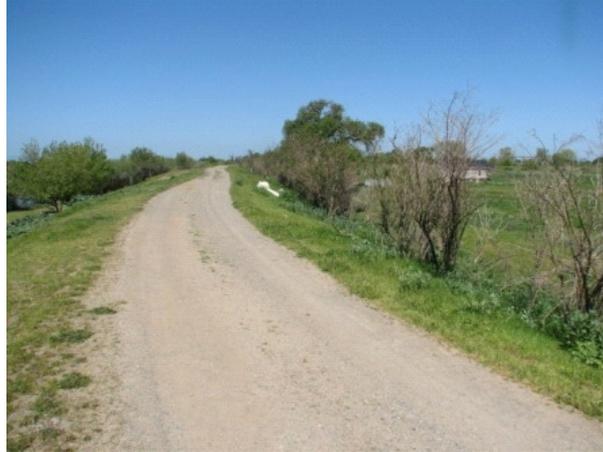
Levee Mile Report Line	9
Start Levee Mile	0.40
End Levee Mile	0.66
Location	Land Side
Category	Earthen Levee
Item	Vegetation
Brush on landside slope limits access.	
jpaasch_f_20100923_358.jpg

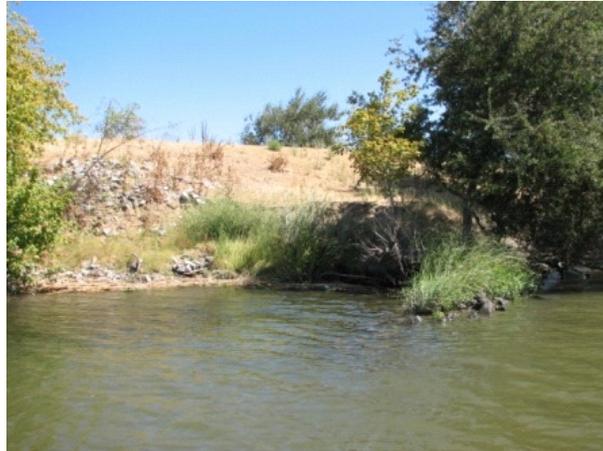
Levee Mile Report Line	10
Start Levee Mile	0.42
End Levee Mile	0.43
Location	Water Side
Category	Supplemental
Item	DWR Erosion Survey
Upstream view of site where jutting rip rap is located.	
SJR2010_RM28.35U2LM.42RBa.jpg

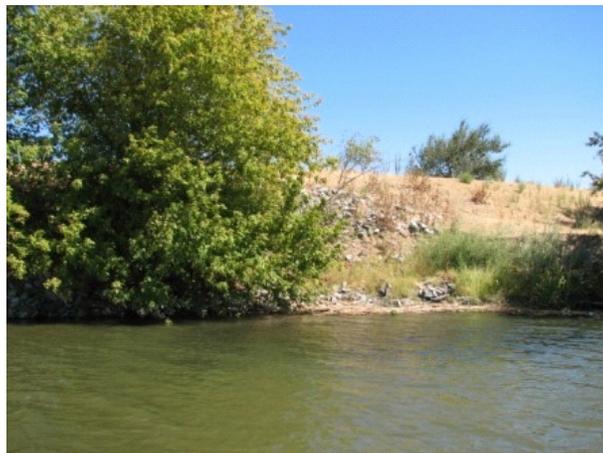
Levee Mile Report Line	10
Start Levee Mile	0.42
End Levee Mile	0.43
Location	Water Side
Category	Supplemental
Item	DWR Erosion Survey
Upstream view of site where rip rap has sloughed.	
SJR2010_RM28.35U2LM.42RBb.jpg

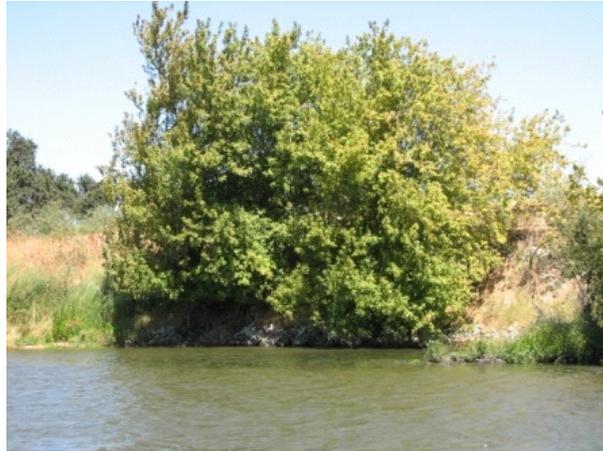
Levee Mile Report Line	10
Start Levee Mile	0.42
End Levee Mile	0.43
Location	Water Side
Category	Supplemental
Item	DWR Erosion Survey
<p>Downstream view of site. Note existing toe and lower slope revetment. Much of the revetment has sloughed.</p>	
<p>SJR2010_RM28.35U2LM.42RBd.jpg</p>

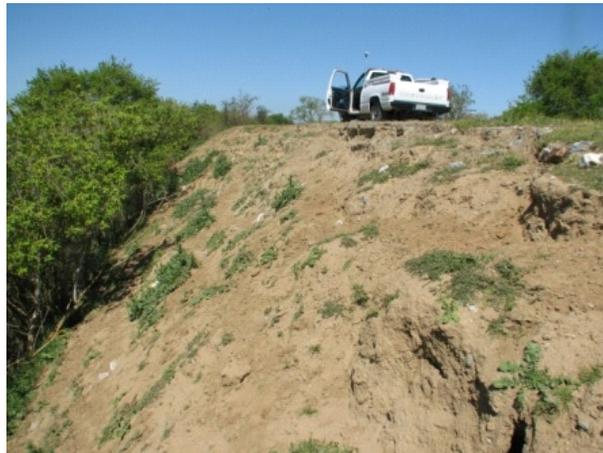
11	0.54	0.54	Earthen Levee	Animal Control	WS	U	Repair the levee slope damaged by livestock and prevent large animal access. Inspector Comments: Animal tracks on slope	37.811161 ° -121.414800 °	37.811161 ° -121.414800 °	11 Y
12	0.56	0.56	Earthen Levee	Encroachments	WS	W	Pipe Inspector Comments: Irrigation intake	37.811366 ° -121.415064 °	37.811366 ° -121.415064 °	12 Y

Levee Mile Report Line	11
Start Levee Mile	0.54
End Levee Mile	0.54
Location	Water Side
Category	Earthen Levee
Item	Animal Control
<p>Animal tracks on landside slope have created a slope stability issue.</p>	
<p>jpaasch_f_20100923_360.jpg</p>

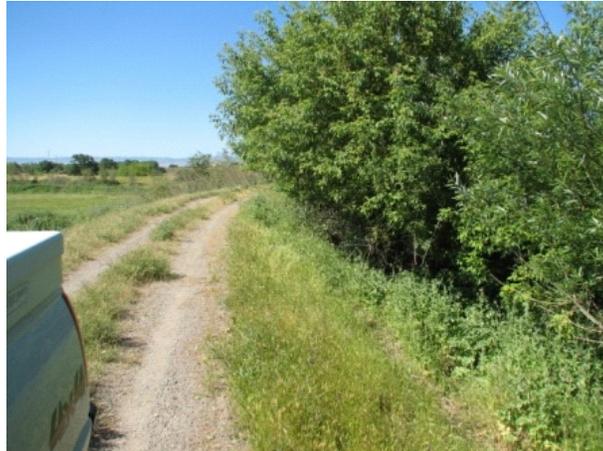
LMR No.	Levee Mile		Category	Item	* Location	** Rating	Action/Comment	GPS Latitude/Longitude		Issue No. Photo
	Start	End						Start	End	
13	0.69	0.85	Earthen Levee	Vegetation	WS	U	Remove the wild growth other than native grasses from the levee slopes. Inspector Comments: Vegetation has been sprayed but still remains.	37.812658 ° -121.415193 °	37.814843 ° -121.414732 °	10 Y
14	0.70	0.70	Earthen Levee	Crown Surface / Depressions / Rutting	CR	M	Add appropriate gravel or road base. Grade and compact. Inspector Comments: Animal tracks through gate degrading crown surface. Rock placement prevents additional damage.	37.812813 ° -121.415132 °	37.812813 ° -121.415132 °	15
15	0.75	0.75	Earthen Levee	Animal Control	CR	M	Repair the levee slope damaged by livestock and prevent large animal access. Inspector Comments: Animal traffic is degrading levee crown patrol road.	37.813643 ° -121.414461 °	37.813643 ° -121.414461 °	18

Levee Mile Report Line	13
Start Levee Mile	0.69
End Levee Mile	0.85
Location	Water Side
Category	Earthen Levee
Item	Vegetation
Trees and dense brush obstruct access and visibility.	
jpaasch_f_20100923_359.jpg

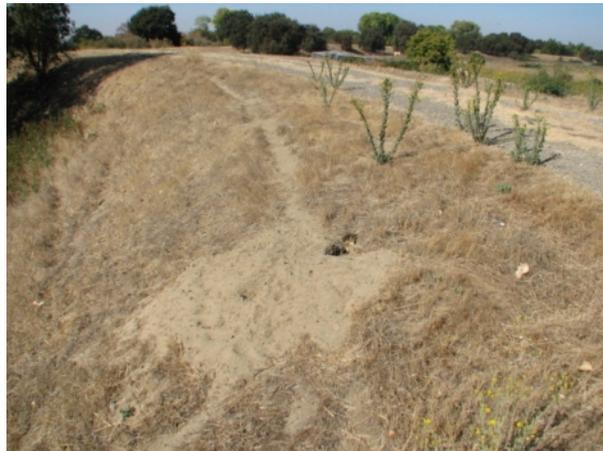
Levee Mile Report Line	21
Start Levee Mile	0.88
End Levee Mile	0.91
Location	Land Side
Category	Earthen Levee
Item	Animal Control
Fall 2009 photo of active rodent burrow on waterside slope.	
jpaasch_f_20100923_362.jpg

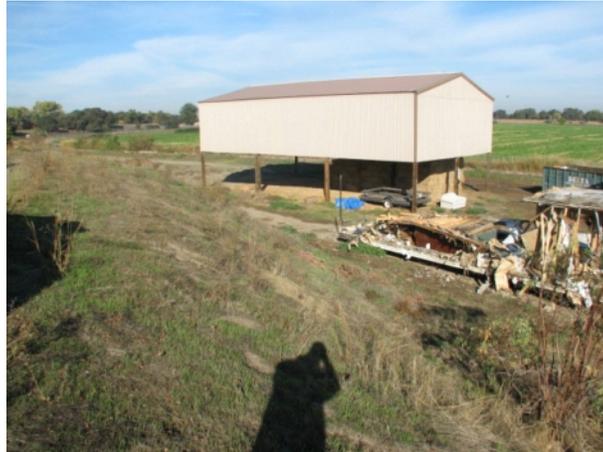
Levee Mile Report Line	22
Start Levee Mile	0.88
End Levee Mile	0.88
Location	Land Side
Category	Earthen Levee
Item	Encroachments
<p>Damaged trailer obstructs access and visibility.</p>	
<p>jpaasch_f_20101105_537.jpg</p>

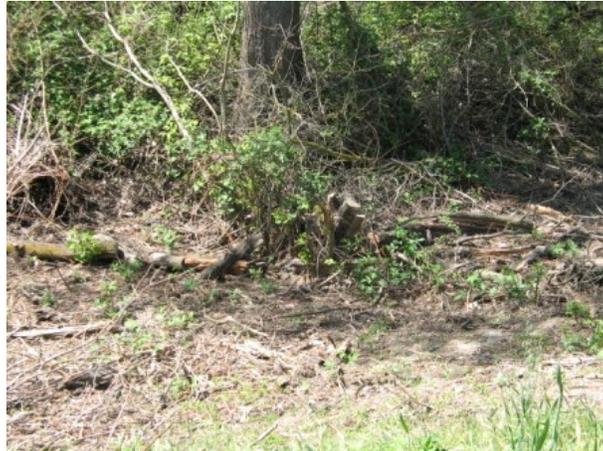
Levee Mile Report Line	24
Start Levee Mile	1.07
End Levee Mile	1.07
Location	Water Side
Category	Earthen Levee
Item	Trim / Thin Trees
<p>Tree stump >2" left after vegetation and tree removal.</p>	
<p>jpaasch_f_20100923_365.jpg</p>

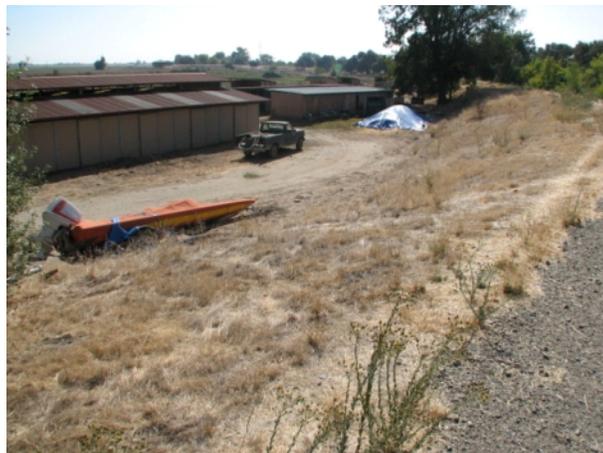
Levee Mile Report Line	29
Start Levee Mile	1.28
End Levee Mile	1.33
Location	Land Side
Category	Earthen Levee
Item	Encroachments
<p>Fall 2009 photo: boat and equipment stored within 10-ft of levee slope are an encroachment.</p>	
<p>jpaasch_f_20100923_363.jpg</p>
