**Flood Control Project Maintenance  
Levee Inspections**

**Fall 2014 Levee Maintenance Deficiency Summary Report**

**San Joaquin River Basin**

**Reclamation District No. 2089 Stark**

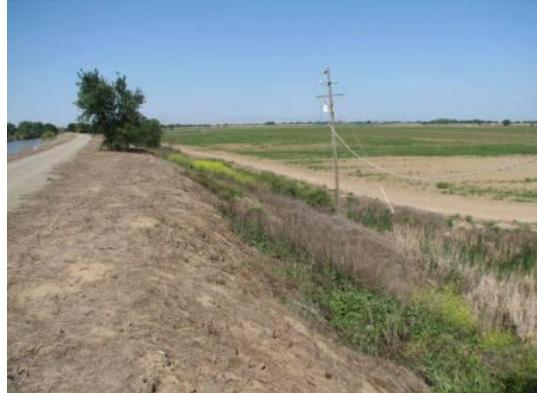
Photo 1 of 1 : FA\_2014\_RD2089\_316\_9\_20141001\_00006.jpg

05/24/2011 Ditch flows parallel with the utility line shown in the photo.

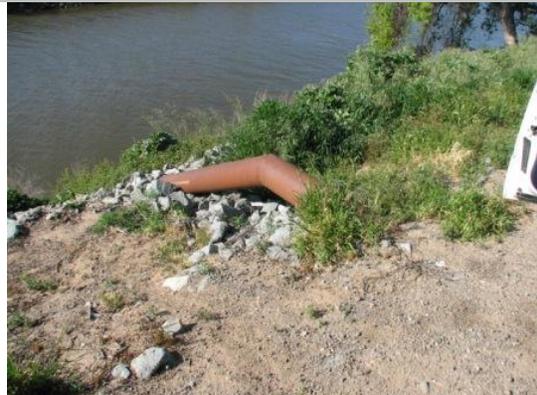
Photo 1 of 1 : FA\_2014\_RD2089\_316\_7\_20141001\_00005.jpg

LM Start	<b>0.04</b>	Rating **	A/W	Issue No.	<b>7</b>
LM End	<b>0.04</b>	Issue Type +	Ma	Location *	LS
Category	Earthen Levee		GPS Latitude/Longitude		
			Start	End	
Item	Encroachments		37.811467 °	37.811467 °	
			-121.385569 °	-121.385569 °	
DWR ID	DWR_RD2089_01_s_2012_7				
Action/Comments					
Pipe Inspector Comments: Drainage pump

Waterside of drainage discharge to Old River.

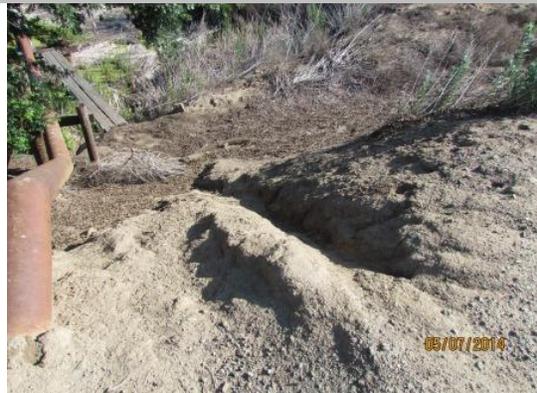
Photo 1 of 1 : FA\_2014\_RD2089\_316\_1\_20141001\_00001.jpg

LM Start	<b>0.04</b>	Rating **	M	Issue No.	<b>1</b>
LM End	<b>0.04</b>	Issue Type +	Ma	Location *	LS
Category	Earthen Levee		GPS Latitude/Longitude		
			Start	End	
Item	Encroachments		37.811474 °	37.811474 °	
			-121.385573 °	-121.385573 °	
DWR ID	DWR_RD2089_01_s_2012_1				
Action/Comments					
Stairway Inspector Comments: Steps have been cut into the levee slope, this could become an erosion point, please fill and compact.

View of the stairs eroding into the landside levee slope.

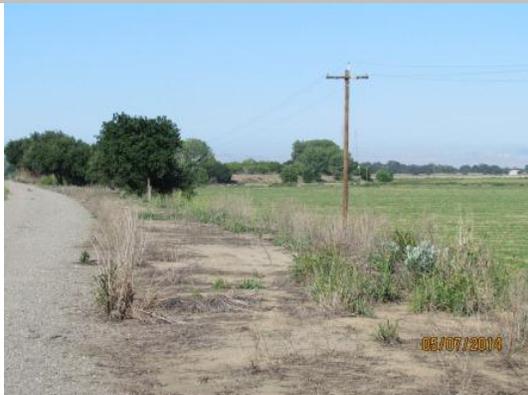
Photo 1 of 1 : FA\_2014\_RD2089\_316\_42\_20141001\_00020.jpg

View of the tall vegetation obstructing visibility of the landside levee slope.

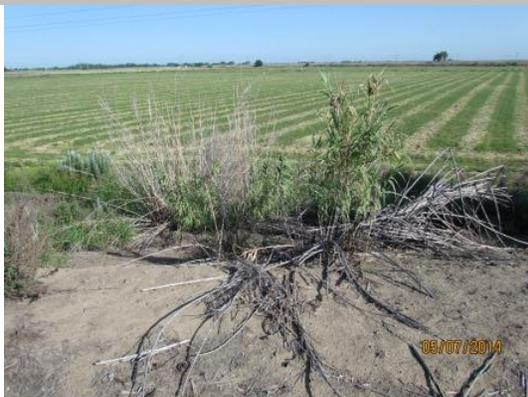
Photo 1 of 1 : FA\_2014\_RD2089\_316\_940\_20141001\_00028.jpg

LM Start	<b>0.25</b>	Rating **	M	Issue No.	<b>940</b>
LM End	<b>0.25</b>	Issue Type +	Ma	Location *	LS
Category	Earthen Levee		GPS Latitude/Longitude		
			Start	End	
Item	Vegetation		37.810412 °	37.810412 °	
			-121.389115 °	-121.389115 °	
DWR ID	DWR_RD2089_01_s_2012_940				
Action/Comments					
Remove the wild growth other than native grasses from the levee slopes. Inspector Comments: Arundo has been trimmed back from the crown but still remains as an obstruction to the slope and obstructs visibility, needs to be removed.

The LMA is actively trying to remove the vegetation on the landside levee slope and toe.

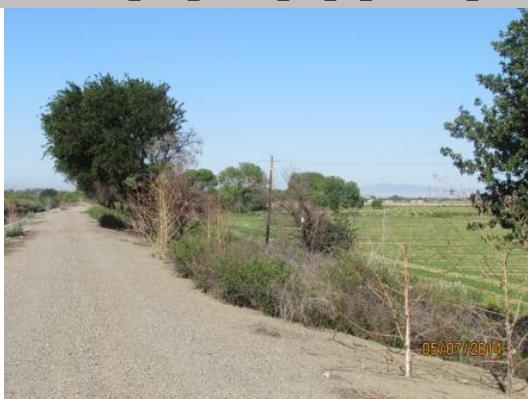
Photo 1 of 1 : FA\_2014\_RD2089\_316\_12\_20141001\_00007.jpg

LM Start	<b>0.27</b>	Rating **	U	Issue No.	<b>12</b>
LM End	<b>0.39</b>	Issue Type +	Ma	Location *	LS
Category	Earthen Levee		GPS Latitude/Longitude		
			Start	End	
Item	Vegetation		37.810319 °	37.809740 °	
			-121.389510 °	-121.391645 °	
DWR ID	DWR_RD2089_01_s_2012_12				
Action/Comments					
Remove the wild growth other than native grasses from the levee slopes. Inspector Comments: Access and visibility completely blocked. 11/10/2011 issue has not changed.

Thick brush and wild rose completely block access and visibility of landside slope and toe.

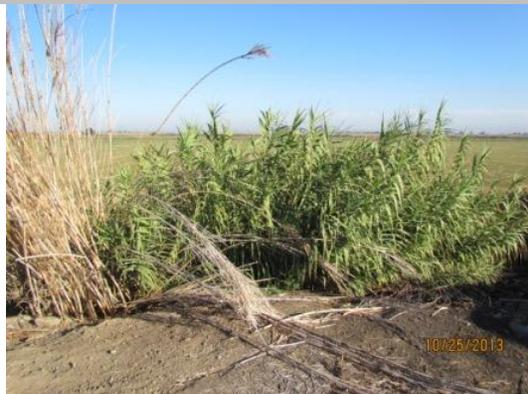
Photo 1 of 1 : FA\_2014\_RD2089\_316\_19\_20141001\_00010.jpg

LM Start	<b>0.34</b>	Rating **	M	Issue No.	<b>19</b>
LM End	<b>0.34</b>	Issue Type +	Ma	Location *	LS
Category	Earthen Levee			GPS Latitude/Longitude	
				Start	End
Item	Vegetation			37.809978 °	37.809978 °
				-121.390704 °	-121.390704 °
DWR ID	DWR_RD2089_01_s_2012_19				
Action/Comments					
Remove the wild growth other than native grasses from the levee slopes. Inspector Comments: Bamboo completely blocks access and visibility. 11/10/2011 Arundo has been trimmed back from the roadway, but still completely blocks access and visibility to the landside slope. This plant was improperly identified as bamboo in previous inspections.

Arundo has been trimmed back from the road, but needs to be removed to so that it does not obstruct visibility and access to the landside toe.

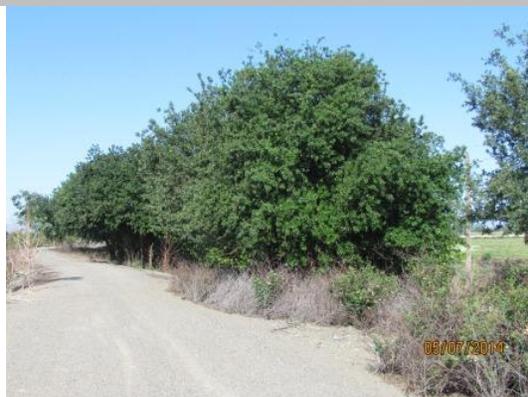
Photo 1 of 1 : FA\_2014\_RD2089\_316\_946\_20141001\_00029.jpg

LM Start	<b>0.38</b>	Rating **	U	Issue No.	<b>946</b>
LM End	<b>0.38</b>	Issue Type +	Ma	Location *	LS
Category	Earthen Levee			GPS Latitude/Longitude	
				Start	End
Item	Trim / Thin Trees			37.809865 °	37.809865 °
				-121.391303 °	-121.391303 °
DWR ID	DWR_RD2089_01_s_2012_946				
Action/Comments					
Trim trees to at least five feet above ground level.

Trees on levee slope obstruct access and visibility.

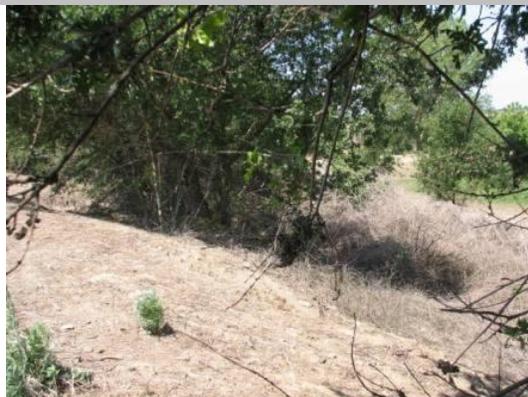
Photo 1 of 1 : FA\_2014\_RD2089\_316\_28\_20141001\_00014.jpg

LM Start	<b>0.42</b>	Rating **	U	Issue No.	<b>28</b>
LM End	<b>0.48</b>	Issue Type +	Ma	Location *	LS
Category	Earthen Levee			GPS Latitude/Longitude	
				Start	End
Item	Vegetation			37.809593 °	37.809507 °
				-121.391963 °	-121.392907 °
DWR ID	DWR_RD2089_01_s_2012_28				
Action/Comments					
Remove the wild growth other than native grasses from the levee slopes. Inspector Comments: Vegetation is too thick to allow access and visibility.

05/24/2011 Photo shows thick dead vegetation and continuation of trees in area that are preventing access and visibility of landside slope and toe.

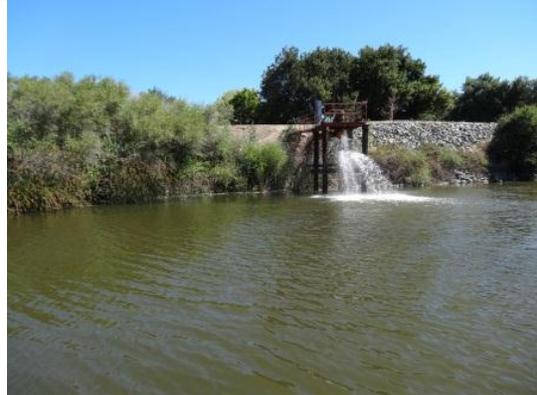
Photo 1 of 1 : SJR2014\_RD2089U01RM29.8\_1.jpg

LM Start	0.45	Rating **	M	Issue No.	5	
LM End	0.45	Issue Type +	Ma	Location *	WS	
Category	Supplemental			GPS Latitude/Longitude		
			Start	End		
Item	DWR Erosion Survey			37.809394 °	37.809394 °	
				-121.392791 °	-121.392791 °	
DWR ID						
Action/Comments						
Inspector Comments: 07/02/2014: No significant change observed. 08/13/2013: No significant change observed. 08/07/2012: The site has been visited by boat survey. No significant change observed 08/23/2011: The site shows loose material around the pipe crossing. The operation of the pipe might have caused an impact on the levee. [2014 Site ID:RD2089U01RM29.8]

Front view of the site.

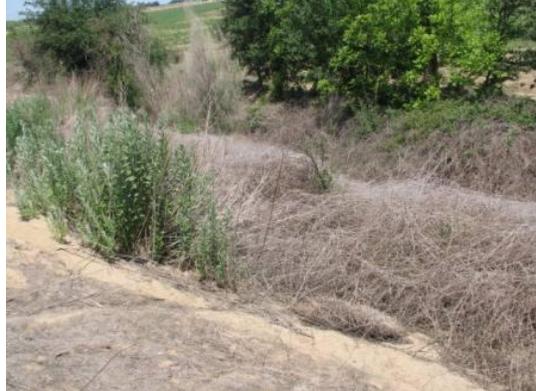
Photo 1 of 1 : FA\_2014\_RD2089\_316\_30\_20141001\_00015.jpg

05/24/2011 Dead brush is too thick to allow access and visibility of landside slope and toe.

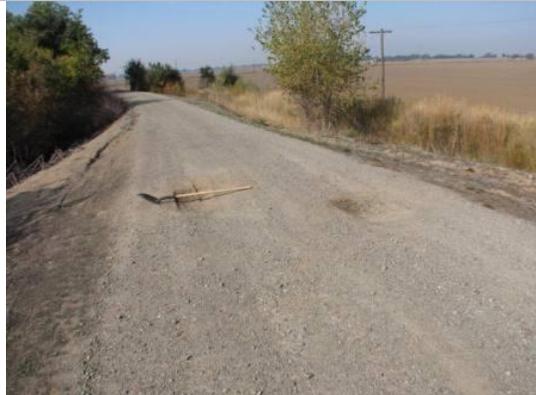
Photo 1 of 1 : FA\_2014\_RD2089\_316\_14\_20141001\_00008.jpg

LM Start	<b>0.56</b>	Rating **	M	Issue No.	<b>14</b>
LM End	<b>0.56</b>	Issue Type +	Ma	Location *	CR
Category	Earthen Levee		GPS Latitude/Longitude		
			Start	End	
Item	Crown Surface / Depressions / Rutting		37.810087 °	37.810087 °	
			-121.394200 °	-121.394200 °	
DWR ID	DWR_RD2089_01_s_2012_14				
Action/Comments					
Add appropriate gravel or road base. Grade and compact. Inspector Comments: 11/10/2011 Minor depressions will cause ponding.

11/10/2011 Depressions in crown.

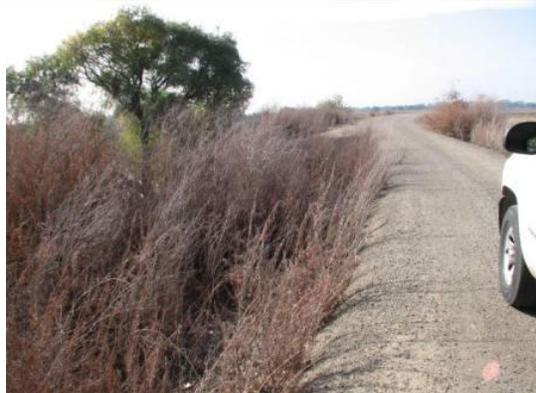
Photo 1 of 1 : FA\_2014\_RD2089\_316\_18\_20141001\_00009.jpg

11/10/2011 Vegetation needs to be cleared on the upper 20' of the waterside slope.

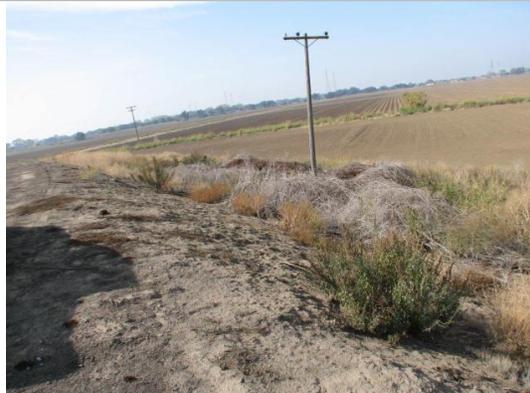
Photo 1 of 1 : FA\_2014\_RD2089\_316\_20\_20141001\_00011.jpg

11/10/2011 Vegetation obstructs visibility of slope and toe.

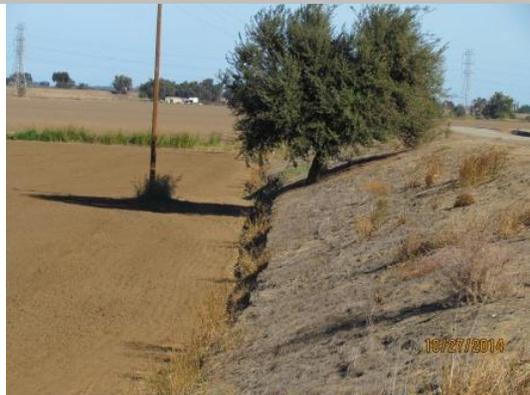
Photo 1 of 1 : FA\_2014\_RD2089\_316\_17\_20141027\_00035.jpg

LM Start	<b>0.83</b>	Rating **	M	Issue No.	<b>17</b>
LM End	<b>0.96</b>	Issue Type +	Ma	Location *	LS
Category	Earthen Levee			GPS Latitude/Longitude	
				Start	End
Item	Slope Stability			37.808319 °	37.806453 °
				-121.397881 °	-121.397755 °
DWR ID	DWR_RD2089_01_f_2014_17				
Action/Comments					
Repair slope instability. Inspector Comments: Landside levee toe cut due to farming.

View of the vertical cut along the landside levee toe.

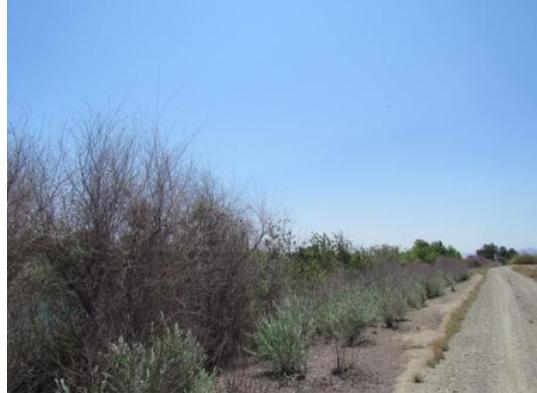
Photo 1 of 1 : FA\_2014\_RD2089\_316\_36\_20141001\_00019.jpg

View of tall weeds and brush obstructing visibility on waterside slope. 05/24/2012

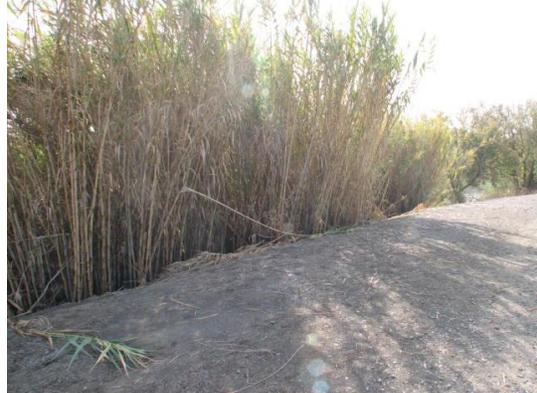
Photo 1 of 1 : FA\_2014\_RD2089\_316\_33\_20141001\_00017.jpg

11/10/2011 Arundo on upper 20' of waterside slope.

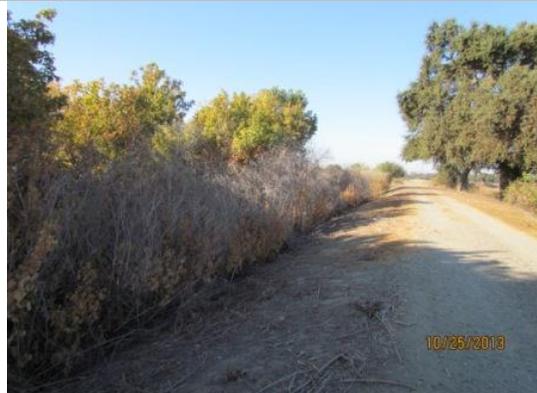
Photo 1 of 1 : FA\_2014\_RD2089\_316\_35\_20141001\_00018.jpg

Thick vegetation on upper 20' of waterside slope obstructing visibility and access.

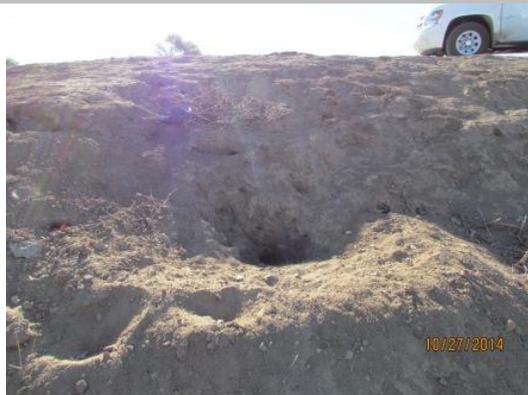
Photo 1 of 1 : FA\_2014\_RD2089\_316\_16\_20141027\_00034.jpg

View of the rodent burrow on the landside levee slope.

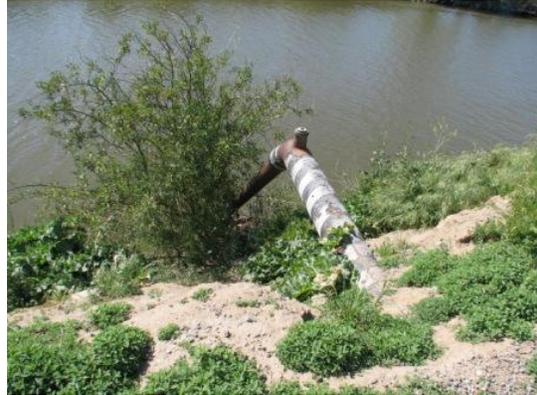
Photo 1 of 1 : FA\_2014\_RD2089\_316\_21\_20141001\_00012.jpg

Drainage discharge into Old River.

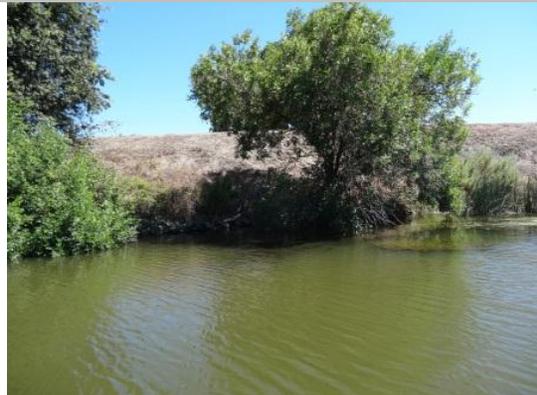
Photo 1 of 1 : SJR2014\_RD2089U01RM29.04\_1.jpg

LM Start	<b>1.22</b>	Rating **	M	Issue No.	<b>2</b>
LM End	<b>1.23</b>	Issue Type +	Ma	Location *	WS
Category	Supplemental		GPS Latitude/Longitude		
			Start	End	
Item	DWR Erosion Survey		37.805580 °	37.805580 °	
			-121.403010 °	-121.403010 °	
DWR ID					
Action/Comments					
Inspector Comments: 07/02/2014: No significant change observed. 08/13/2013: The erosion is around a tree at the levee toe. Dense vegetation is visible. [2014 Site ID:RD2089U01RM29.04]

Close view of the site. Note the tree and the vegetation.

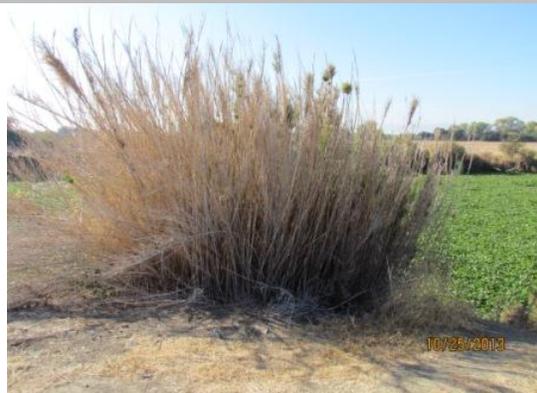
Photo 1 of 1 : FA\_2014\_RD2089\_316\_25\_20141001\_00013.jpg

View of the Arundo on the waterside slope obstructing visibility. LMA is actively trying to remove the wild growth.

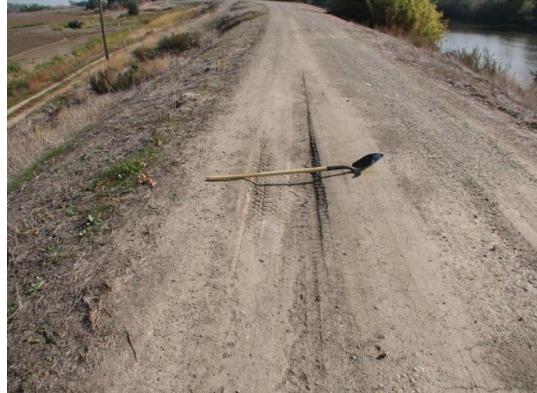
Photo 1 of 1 : FA\_2014\_RD2089\_316\_43\_20141001\_00021.jpg

11/10/2011 Depression in roadway.

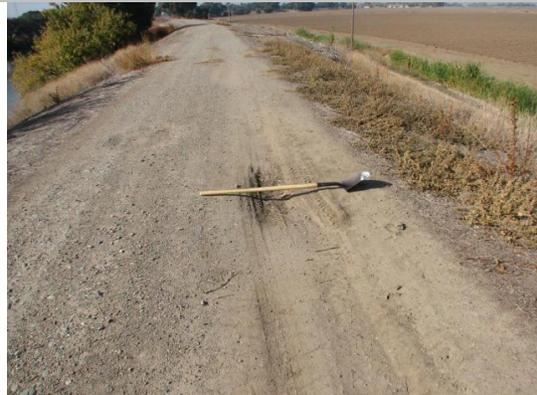
Photo 1 of 1 : FA\_2014\_RD2089\_316\_44\_20141001\_00022.jpg

11/10/2011 Roadway depression.

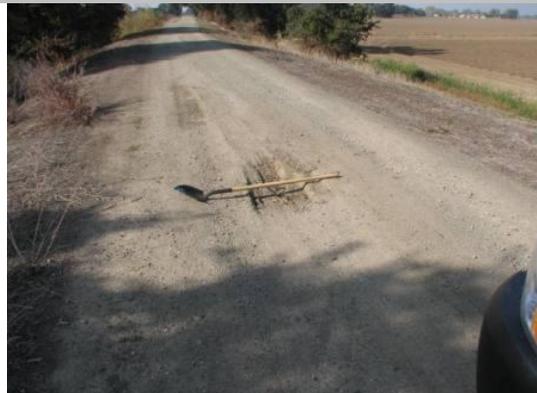
Photo 1 of 1 : FA\_2014\_RD2089\_316\_45\_20141001\_00023.jpg

11/10/2011 Roadway depression.

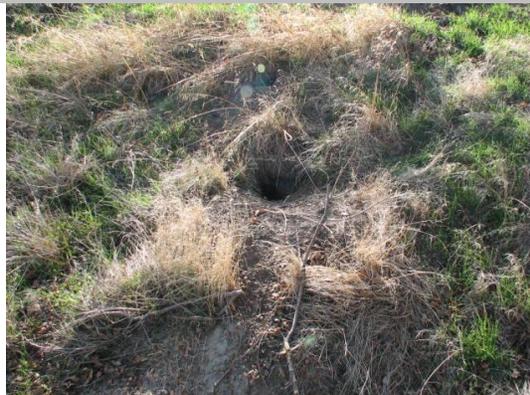
Photo 1 of 1 : FA\_2014\_RD2089\_316\_47\_20141001\_00025.jpg

11/10/2011 Active rodent burrow on landside slope.

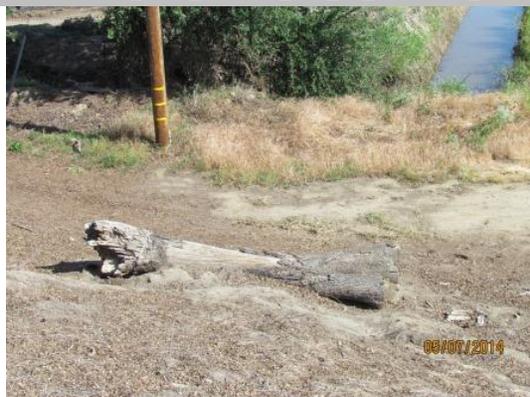
Photo 1 of 1 : FA\_2014\_RD2089\_316\_46\_20141001\_00024.jpg

Decaying tree at the landside levee toe is obstructing visibility and access.

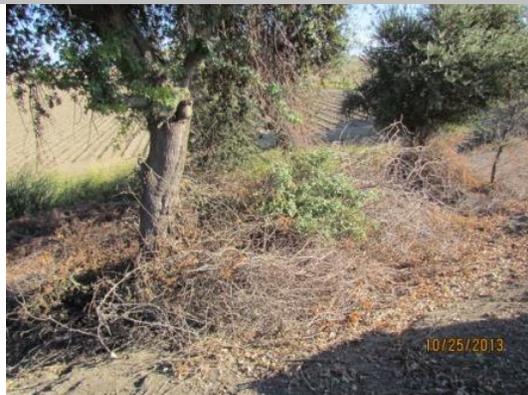
Photo 1 of 1 : FA\_2014\_RD2089\_316\_52\_20141001\_00027.jpg

View of the tree branches obstructing landside levee slope.

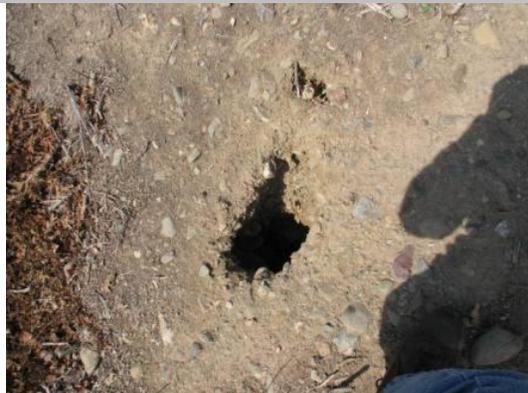
Photo 1 of 1 : FA\_2014\_RD2089\_316\_49\_20141001\_00026.jpg

11/10/2011 Deep burrow on waterside.

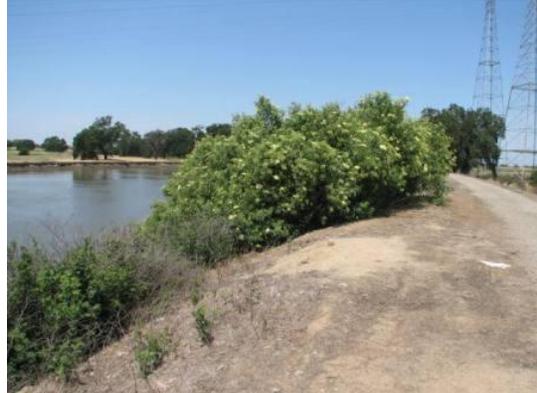
Photo 1 of 2 : FA\_2014\_RD2089\_317\_4\_20141001\_00003.jpg

05/24/2011 Updated photo of issue noted in Fall 2010 inspection.

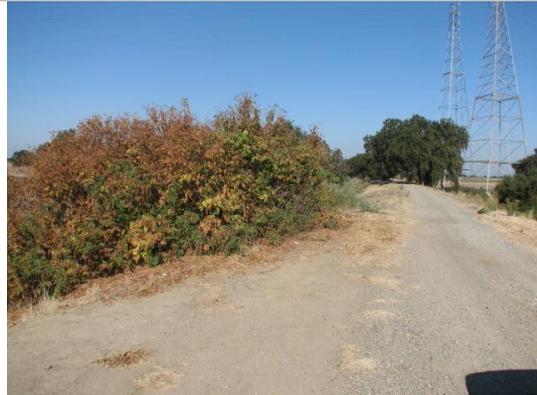
Photo 2 of 2 : FA\_2014\_RD2089\_317\_4\_20141001\_00004.jpg

LM Start	<b>0.08</b>	Rating **	U	Issue No.	<b>4 (cont)</b>
LM End	<b>0.08</b>	Issue Type +	Ma	Location *	WS

Fall 2009 photo of unacceptable vegetation on levee slope.

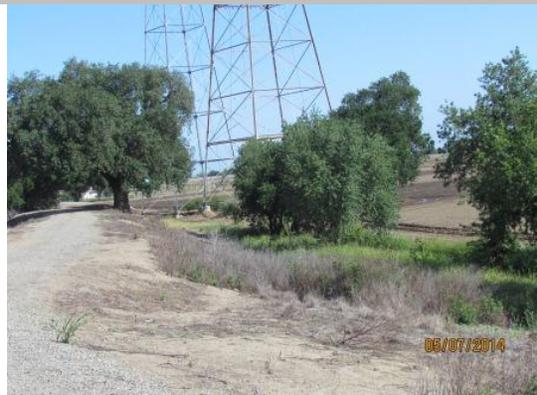
Photo 1 of 1 : FA\_2014\_RD2089\_317\_19\_20141001\_00015.jpg

View of the vegetation on the landside levee slope.

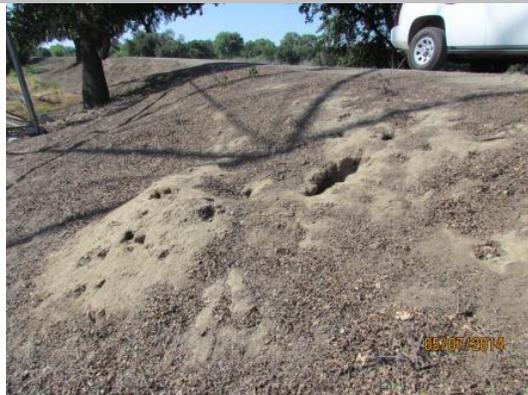
Photo 1 of 1 : FA\_2014\_RD2089\_317\_48\_20141001\_00025.jpg

View of the rodent burrow on the landside levee slope.

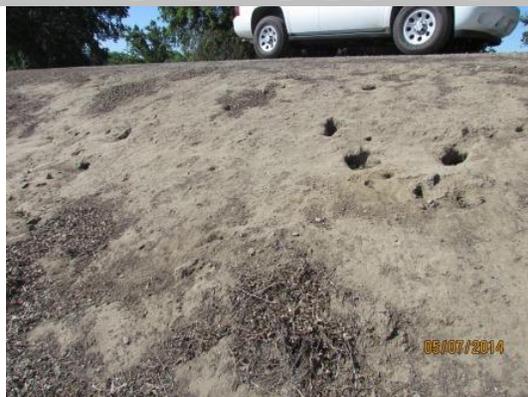
Photo 1 of 1 : FA\_2014\_RD2089\_317\_49\_20141001\_00026.jpg

View of the multiple rodent burrows on the landside levee hinge and slope.

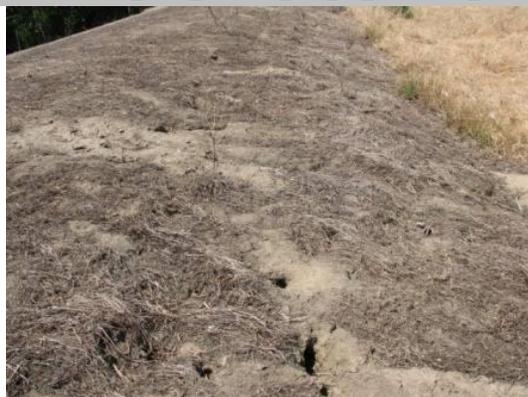
Photo 1 of 1 : FA\_2014\_RD2089\_317\_24\_20141001\_00017.jpg

05/24/2011 Active burrows, ground squirrel sighted in area.

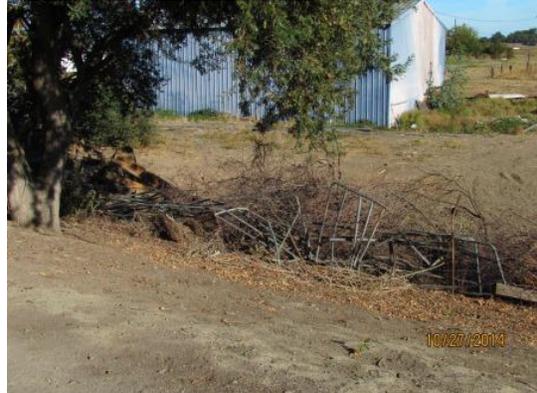
Photo 1 of 1 : FA\_2014\_RD2089\_317\_52\_20141027\_00040.jpg

View of the tree branches on the landside levee toe obstructing access.

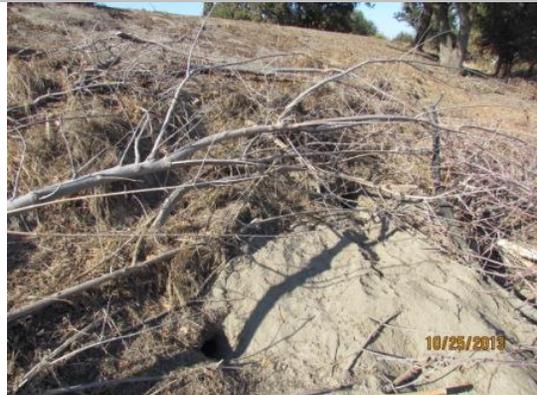
Photo 1 of 1 : FA\_2014\_RD2089\_317\_51\_20141001\_00027.jpg

View of the rodent burrow on the landside levee toe.

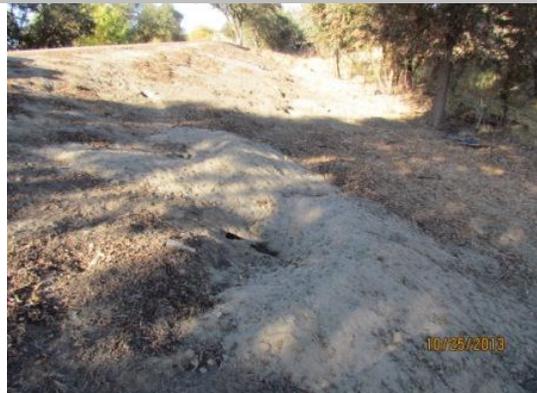
Photo 1 of 3 : FA\_2014\_RD2089\_317\_53\_20141001\_00029.jpg

LM Start	<b>0.32</b>	Rating **	U	Issue No.	<b>53</b>
LM End	<b>0.33</b>	Issue Type +	Ma	Location *	N/A
Category	Earthen Levee		GPS Latitude/Longitude		
			Start	End	
Item	Animal Control		37.809977 °	37.810022 °	
			-121.411189 °	-121.411387 °	
DWR ID	DWR_RD2089_02_f_2013_53				
Action/Comments					
Exterminate rodents and backfill and compact or grout burrows. Inspector Comments: Exterminating rodents and grouting the burrows recommended.

View of the multiple rodent burrows on the landside levee slope.

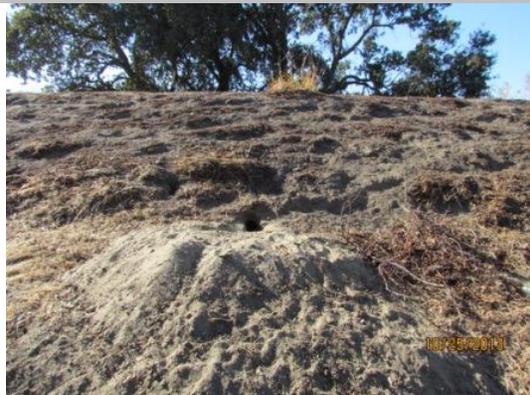
Photo 2 of 3 : FA\_2014\_RD2089\_317\_53\_20141001\_00030.jpg

LM Start	<b>0.32</b>	Rating **	U	Issue No.	<b>53 (cont)</b>
LM End	<b>0.33</b>	Issue Type +	Ma	Location *	N/A
Category	Earthen Levee		GPS Latitude/Longitude		
			Start	End	
Item	Animal Control		37.809977 °	37.810022 °	
			-121.411189 °	-121.411387 °	
DWR ID	DWR_RD2089_02_f_2013_53				
Action/Comments					
Exterminate rodents and backfill and compact or grout burrows. Inspector Comments: Exterminating rodents and grouting the burrows recommended.

View of the rodent burrow on the landside levee slope.

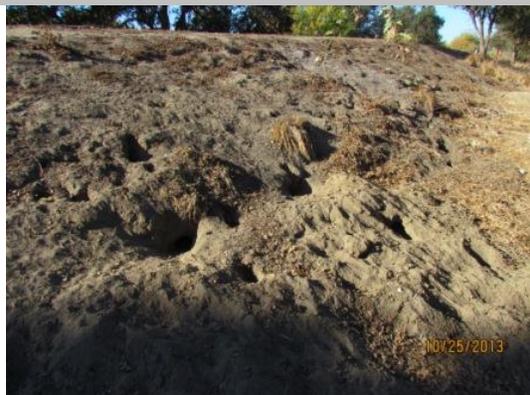
Photo 3 of 3 : FA\_2014\_RD2089\_317\_53\_20141001\_00031.jpg

Another view of the multiple rodent burrows on the landside levee slope.

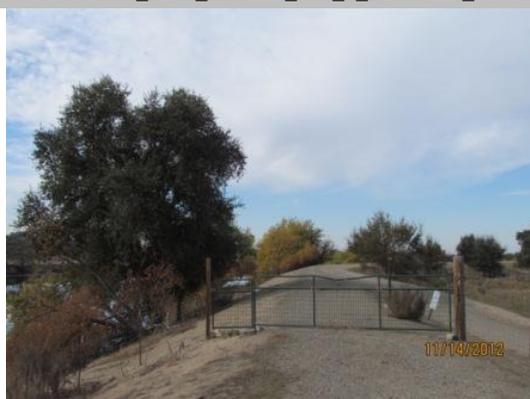
Photo 1 of 1 : FA\_2014\_RD2089\_317\_2\_20141001\_00002.jpg

View of gate across levee crown.

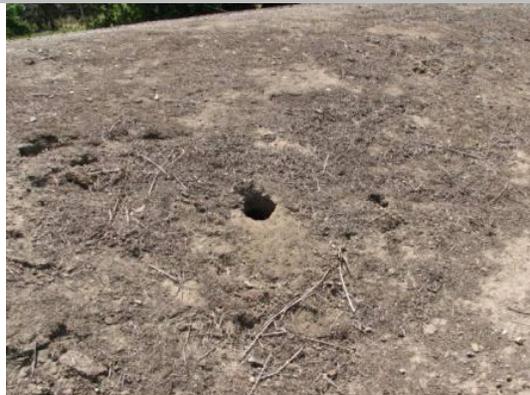
Photo 1 of 1 : FA\_2014\_RD2089\_317\_26\_20141001\_00018.jpg

LM Start	<b>0.38</b>	Rating **	M	Issue No.	<b>26</b>
LM End	<b>0.38</b>	Issue Type +	Ma	Location *	LS
Category	Earthen Levee		GPS Latitude/Longitude		
			Start	End	
Item	Animal Control		37.810125 °	37.810125 °	
			-121.412317 °	-121.412317 °	
DWR ID	DWR_RD2089_02_s_2012_26				
Action/Comments					
No rodents visible, but rodent burrows visible; need to backfill and compact or grout burrows. Inspector Comments: Active burrow needs to be repaired.

05/24/2011 Active rodent burrow.

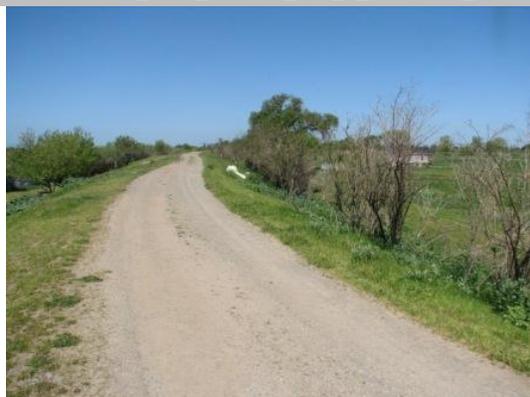
Photo 1 of 2 : FA\_2014\_RD2089\_317\_8\_20141001\_00008.jpg

Brush on landside slope limits access.

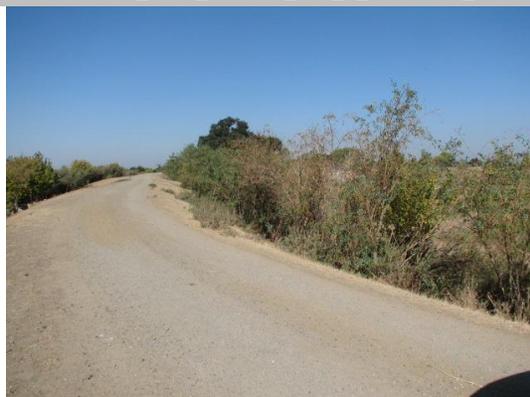
Photo 2 of 2 : FA\_2014\_RD2089\_317\_8\_20141001\_00009.jpg

Fall 2009 photo: Brush on landside toe limits visibility and accessibility.

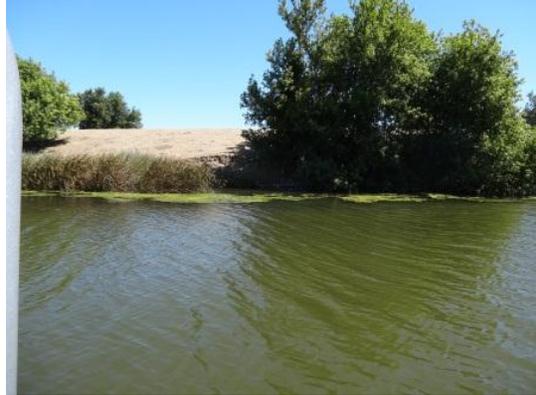
Photo 1 of 1 : SJR2014\_RD2089U02RM28.35\_1.jpg

View of the site from the survey boat.

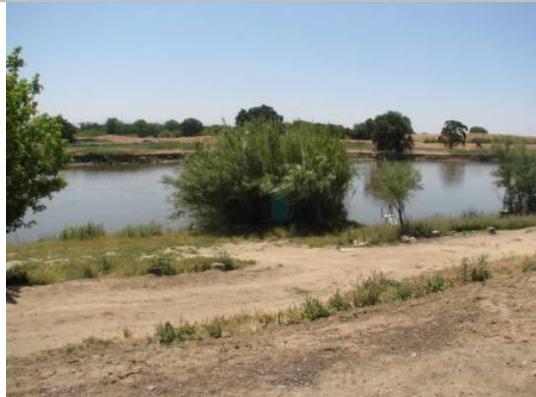
Photo 1 of 1 : FA\_2014\_RD2089\_317\_27\_20141001\_00019.jpg

05/24/2011 Portable toilet is in the shadows in the center of the photo at the water's edge.

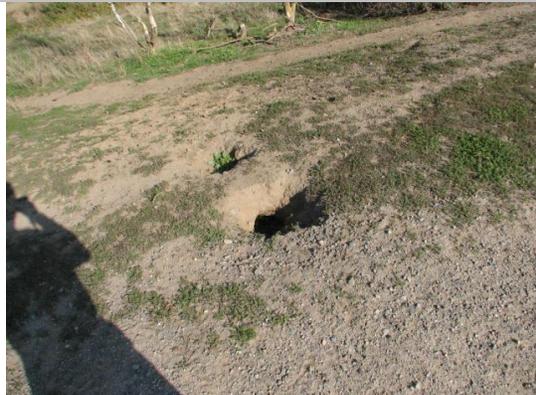
Photo 1 of 1 : FA\_2014\_RD2089\_317\_13\_20141001\_00012.jpg

11/10/2011 Two large burrows on crown, need to be filled.

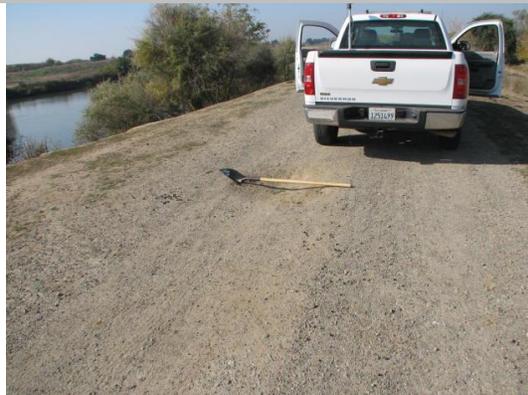
Photo 1 of 1 : FA\_2014\_RD2089\_317\_10\_20141001\_00011.jpg

11/10/2011 Depression in crown needs to be filled.

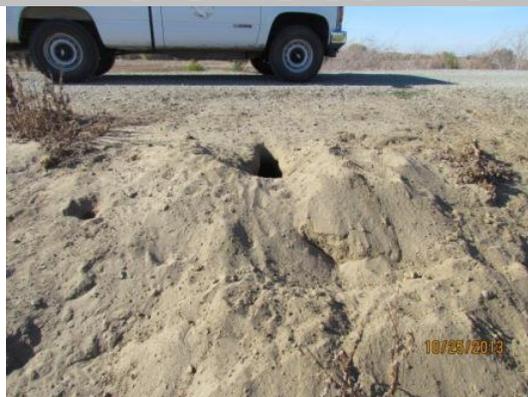
Photo 1 of 1 : FA\_2014\_RD2089\_317\_54\_20141001\_00032.jpg

View of the rodent burrow on the landside levee slope.

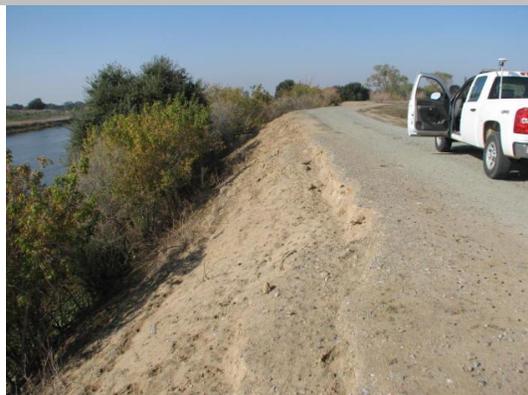
Photo 1 of 1 : FA\_2014\_RD2089\_317\_14\_20141001\_00013.jpg

11/10/2011 Approximately 1' scarp has been created by livestock travel.

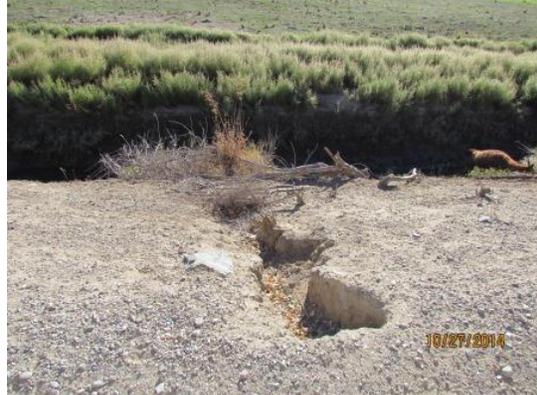
Photo 1 of 1 : FA\_2014\_RD2089\_317\_15\_20141027\_00039.jpg

View of the scour from surface runoff on the landside levee slope.

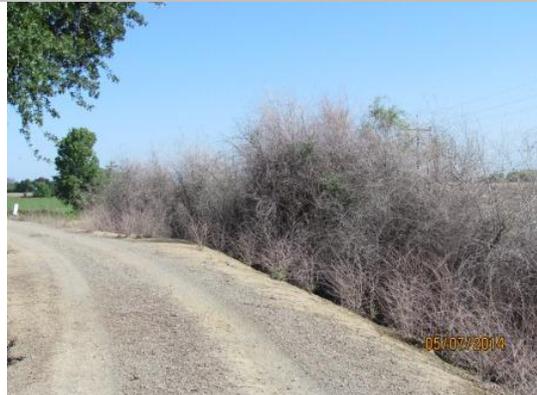
Photo 1 of 1 : FA\_2014\_RD2089\_317\_36\_20141001\_00021.jpg

Extremely thick dead brush prevents access and visibility.

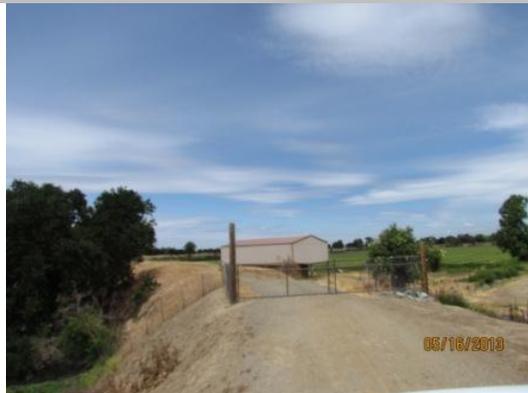
Photo 1 of 1 : FA\_2014\_RD2089\_317\_9\_20141001\_00010.jpg

View of the fence gate across levee crown.

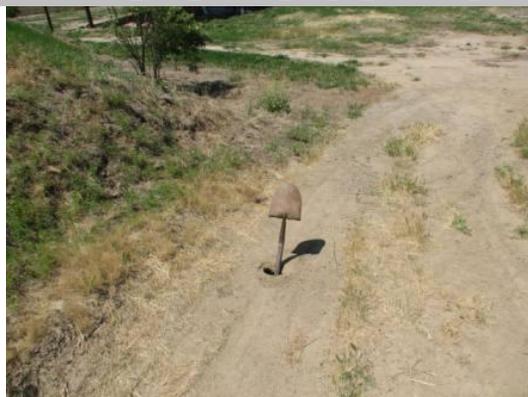
Photo 1 of 2 : FA\_2014\_RD2089\_317\_40\_20141001\_00022.jpg

05/24/2011 Deep vertical burrow in ramp on land side of levee.

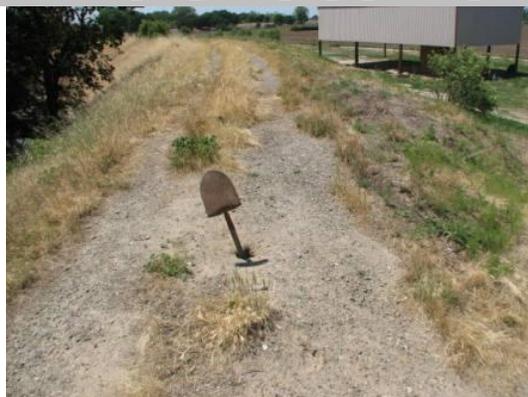
Photo 2 of 2 : FA\_2014\_RD2089\_317\_40\_20141001\_00023.jpg

05/24/2011 Deep vertical burrow in levee crown.

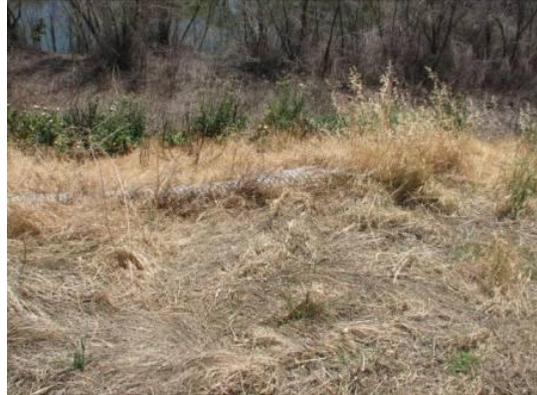
Photo 1 of 1 : FA\_2014\_RD2089\_317\_41\_20141001\_00024.jpg

05/24/2011 Old CMP left on waterside levee slope, needs to be removed.

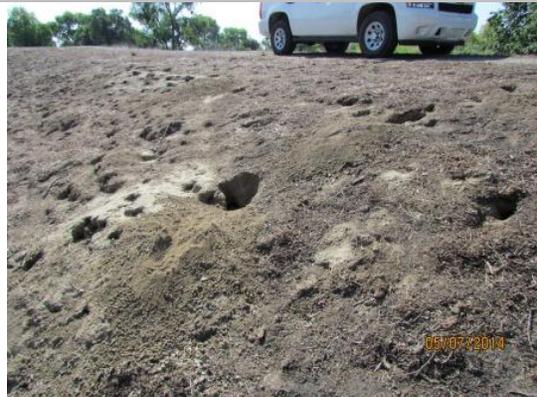
Photo 1 of 1 : FA\_2014\_RD2089\_317\_5\_20141001\_00005.jpg

View of the rodent holes on the landside levee slope.

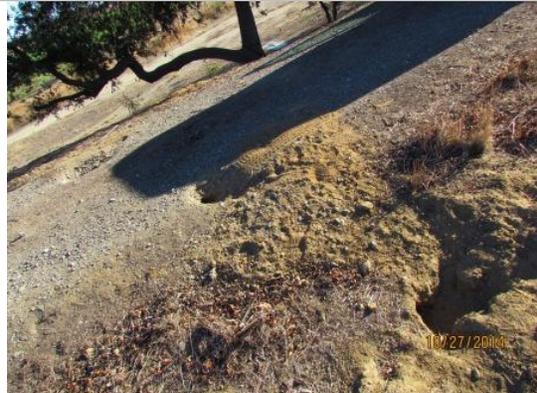
Photo 1 of 2 : FA\_2014\_RD2089\_317\_12\_20141027\_00037.jpg

View of several large rodent holes on the levee crown.

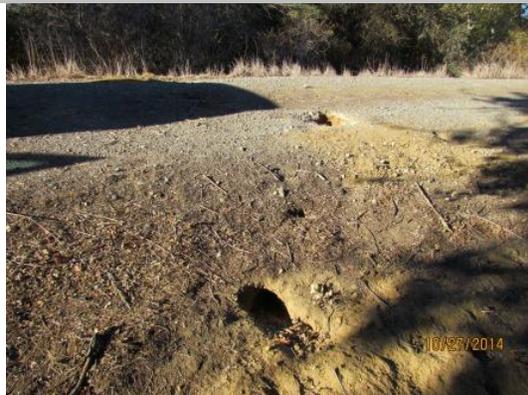
Photo 2 of 2 : FA\_2014\_RD2089\_317\_12\_20141027\_00038.jpg

View of several rodent burrows on landside levee hinge and crown.

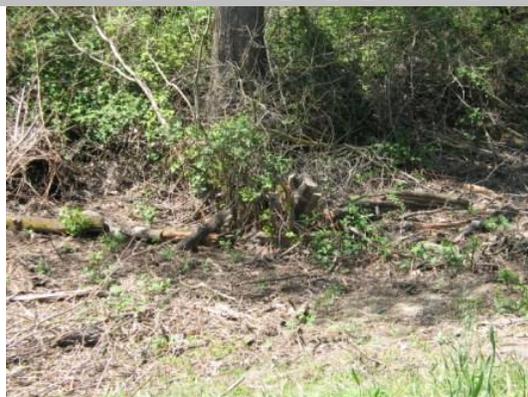
Photo 1 of 1 : FA\_2014\_RD2089\_317\_29\_20141001\_00020.jpg

Tree stump >2" left after vegetation and tree removal.

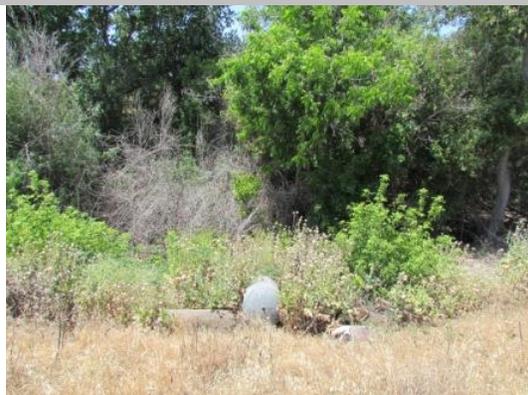
Photo 1 of 1 : FA\_2014\_RD2089\_317\_17\_20141001\_00014.jpg

View of water tanks disposed on waterside slope.

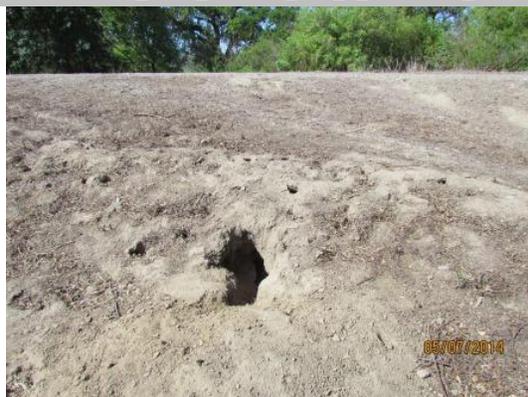
Photo 1 of 1 : FA\_2014\_RD2089\_317\_6\_20141001\_00006.jpg

View of the large rodent hole on the landside levee slope.

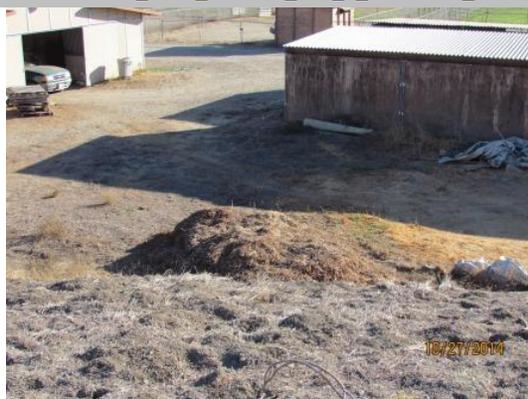
Photo 1 of 1 : FA\_2014\_RD2089\_317\_7\_20141027\_00036.jpg

View of the animal feed stockpiled at the landside levee toe.

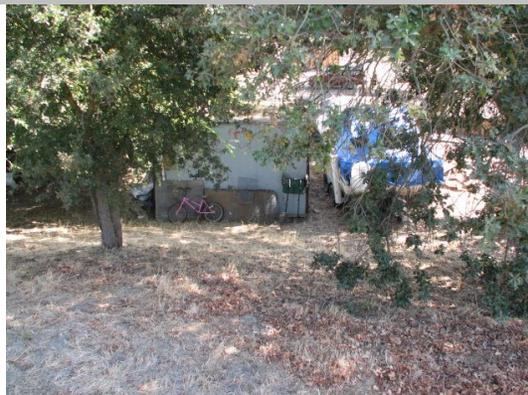
Photo 1 of 1 : FA\_2014\_RD2089\_317\_23\_20141001\_00016.jpg

Fall 2009 photo: Buildings and patio decks are built within 10-ft of the levee slope.

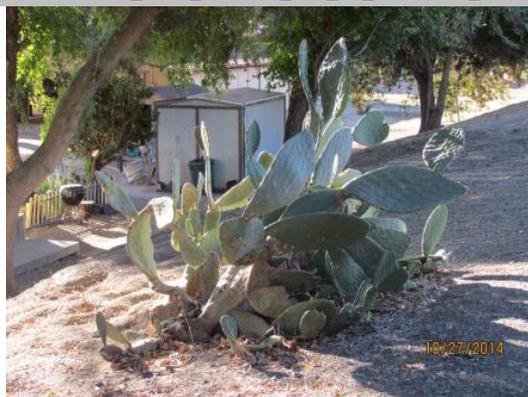
Photo 1 of 1 : FA\_2014\_RD2089\_317\_57\_20141027\_00035.jpg

View of the cactus on the landside levee shoulder.

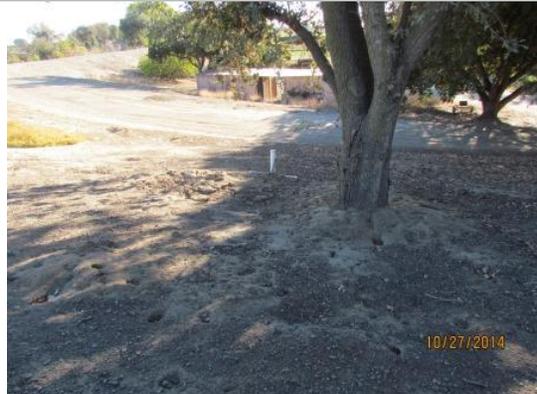
Photo 1 of 1 : FA\_2014\_RD2089\_317\_11\_20141027\_00034.jpg

View of the multiple rodent burrows on the landside levee slope.
