**Flood Control Project Maintenance
Levee Inspections**
LMA District Cover Sheet
Spring 2009 Levee Inspection Results

Reclamation District No. 2089

Levee Inspection Report By Mile - Spring 2009

Waterway				Bank	Unit Miles	Inspection Start/End	Inspector		
Unit No. 01 Old River				Right	1.50	05/14/2009 05/14/2009	Herman Phillips

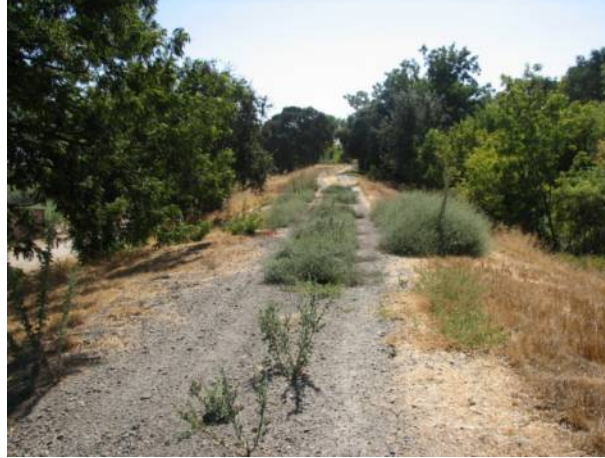
Levee Mile Report Line	20
Start Levee Mile	1.24
End Levee Mile	1.40
Location	Crown
Category	Earthen Levee
Item	Crown Surface / Depressions / Rutting

RD 2089: Crown roadway needs improvements.
