**Flood Control Project Maintenance
Levee Inspections**
LMA District Cover Sheet
Spring 2010 Levee Inspection Results

Reclamation District No. 2089 Stark

Levee Inspection Report By Mile - Spring 2010

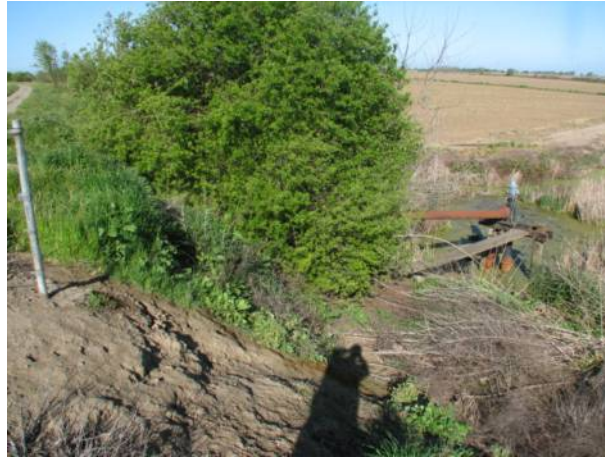
jpaasch_s_20100412_261.jpg

Levee Mile Report Line	1
Start Levee Mile	0.01
End Levee Mile	0.01
Location	Land Side
Category	Earthen Levee
Item	Trim / Thin Trees

Trees on landside slope limit access and visibility.

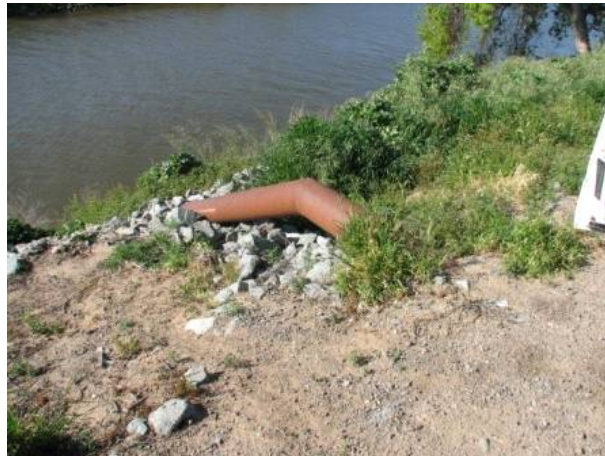
jpaasch_s_20100412_260.jpg

Levee Mile Report Line	2
Start Levee Mile	0.03
End Levee Mile	0.03
Location	Land Side
Category	Earthen Levee
Item	Encroachments

Waterside of drainage discharge to Old River.

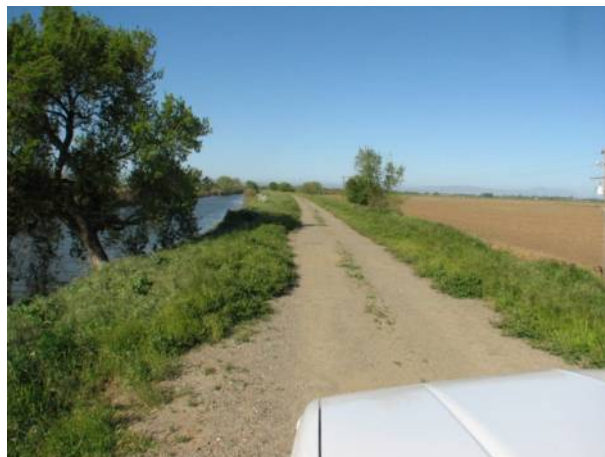
jpaasch_s_20100412_262.jpg

Levee Mile Report Line	4
Start Levee Mile	0.03
End Levee Mile	0.54
Location	Water Side
Category	Earthen Levee
Item	Vegetation

Annual grasses on levee crown and slopes.

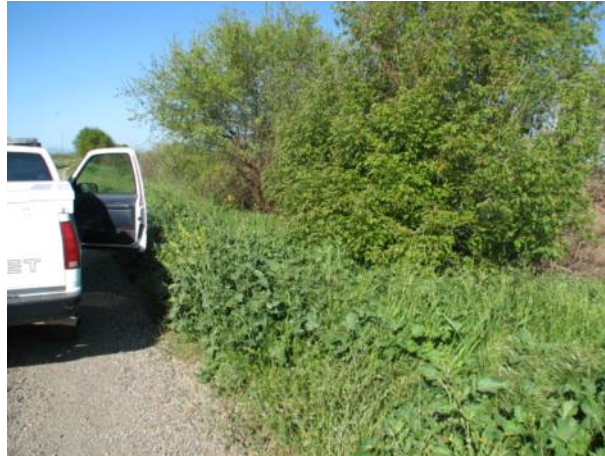
Levee Mile Report Line	5
Start Levee Mile	0.04
End Levee Mile	0.10
Location	Land Side
Category	Earthen Levee
Item	Vegetation
Brush and weeds on landside slope limit visibility and access.	
jpaasch_s_20100412_263.jpg

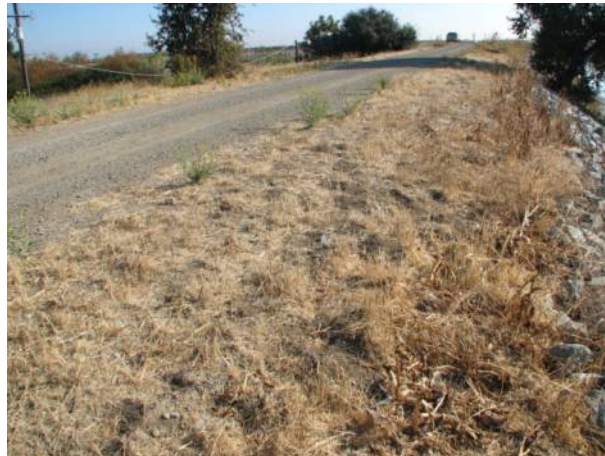
6	0.07	0.07	Earthen Levee	Animal Control	WS	M	No rodents visible, but rodent burrows visible; need to backfill and compact or grout borrows. Inspector Comments: No change, veg limits visibility.	37.811350 ° -121.386077 °	37.811350 ° -121.386077 °	934 Y	
7	0.10	0.10	Earthen Levee	Trim / Thin Trees	LS	M	Trim trees to at least five feet above ground level. Inspector Comments: Two scrub oaks obstruct access to levee slope.	37.811272 ° -121.386703 °	37.811272 ° -121.386703 °	935	
8	0.18	0.18	Earthen Levee	Animal Control	CR	M	No rodents visible, but rodent burrows visible; need to backfill and compact or grout borrows.	37.810833 ° -121.387897 °	37.810833 ° -121.387897 °	936 Y	
9	0.22	0.22	Supplemental	DWR Erosion Survey	WS	M	Inspector Comments: 2009: localized sloughing near the toe; rock protection has been added along the upper slope and along the toe; recommend annual assessment and monitoring of erosion site, per CLRO CES Evaluation 2008 Report; previously rated "M" [2009 SiteID:RD2089U1RM30.02]	37.810460 ° -121.388870 °	37.810460 ° -121.388870 °	1 Y

Levee Mile Report Line	6
Start Levee Mile	0.07
End Levee Mile	0.07
Location	Water Side
Category	Earthen Levee
Item	Animal Control
Fall 2009 photo of animal burrows on waterside slope near crown.	
jpaasch_s_20100330_107.jpg

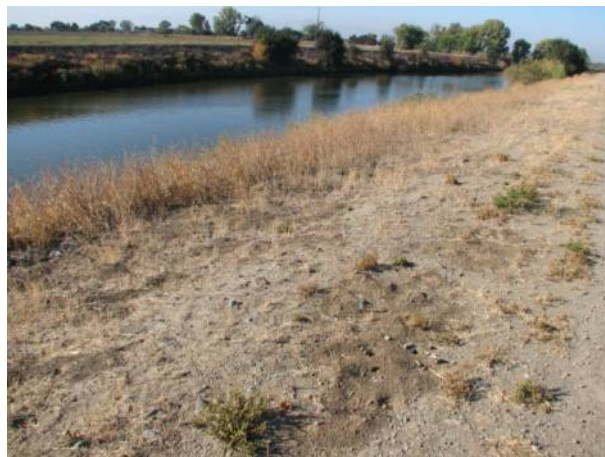
Levee Mile Report Line	8
Start Levee Mile	0.18
End Levee Mile	0.18
Location	Crown
Category	Earthen Levee
Item	Animal Control
Fall 2009 photo of burrows on levee crown. During spring 2010 inspection vegetation too dense to locate holes. District stated that repair of holes not completed since last inspection.	
jpaasch_s_20100330_108.jpg

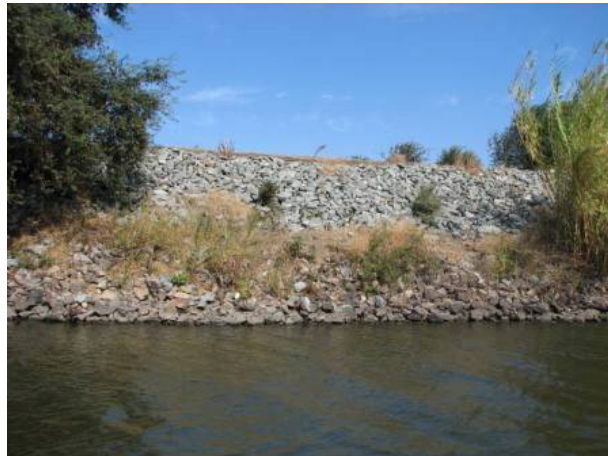
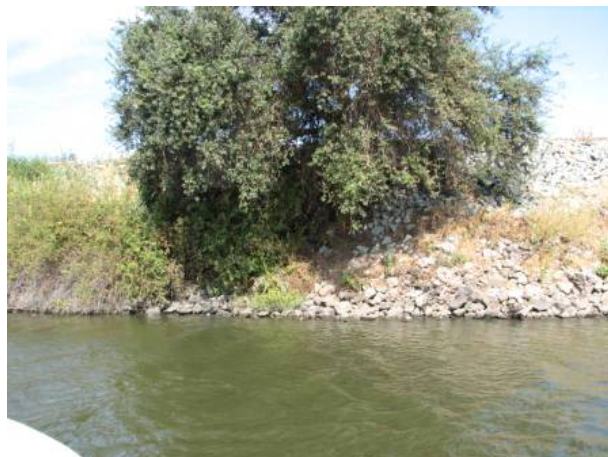
Levee Mile Report Line	9
Start Levee Mile	0.22
End Levee Mile	0.22
Location	Water Side
Category	Supplemental
Item	DWR Erosion Survey

2009: localized sloughing near the toe; rock protection has been added along the upper slope and along the toe; recommend annual assessment and monitoring of erosion site, per CLRO CES Evaluation 2008 Report; previously rated "M" [2009 SiteID:RD2089U1RM30.02]

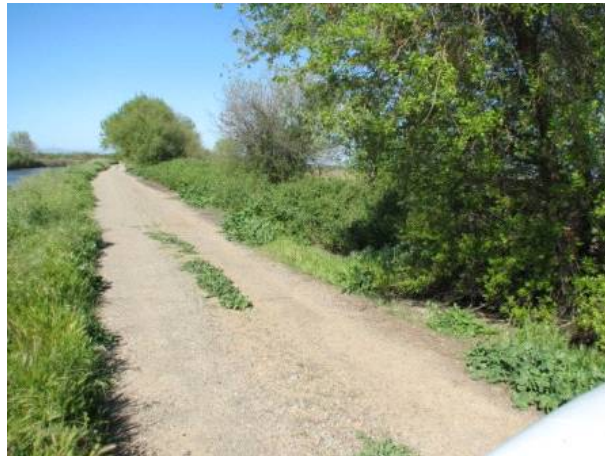
jpaasch_s_20100412_266.jpg

Levee Mile Report Line	17
Start Levee Mile	0.29
End Levee Mile	0.34
Location	Land Side
Category	Earthen Levee
Item	Vegetation

Thick brush and trees on levee crown and slope.

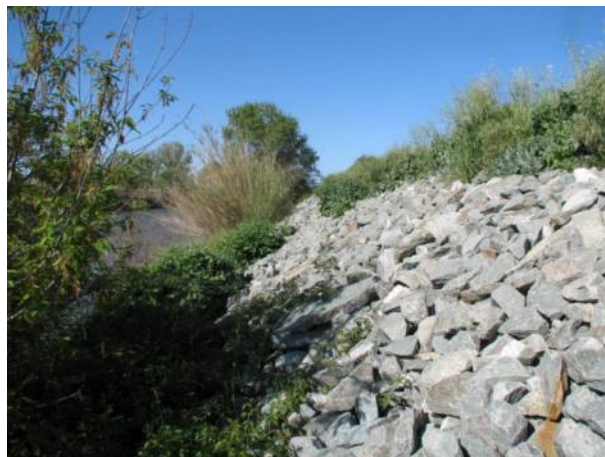
jpaasch_s_20100412_264.jpg

Levee Mile Report Line	18
Start Levee Mile	0.30
End Levee Mile	0.31
Location	Water Side
Category	Supplemental
Item	DWR Erosion Survey

Slope protection placed Fall 2008 from LM 0.00 to 0.46. Photo looking downstream on waterside slope.

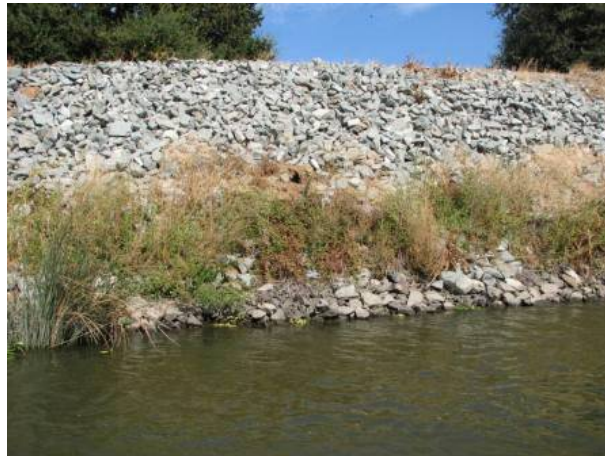
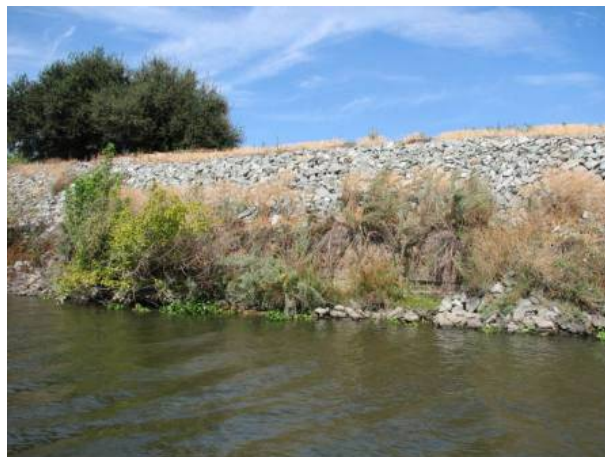
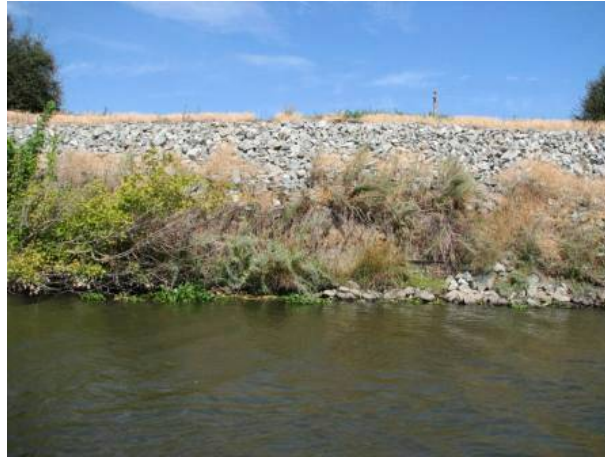
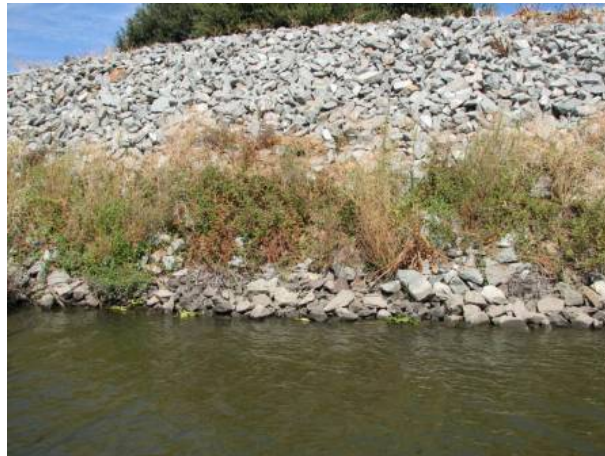
2009: Rock revetment placed on the upper slope; however, vertical scarp is still present; recommend annual assessment and monitoring of erosion site, per CLRO CES Evaluation 2008 Report; site same as RM29.95,LM0.22; previously rated "M" [2009 SiteID:RD2089U1RM29.95]

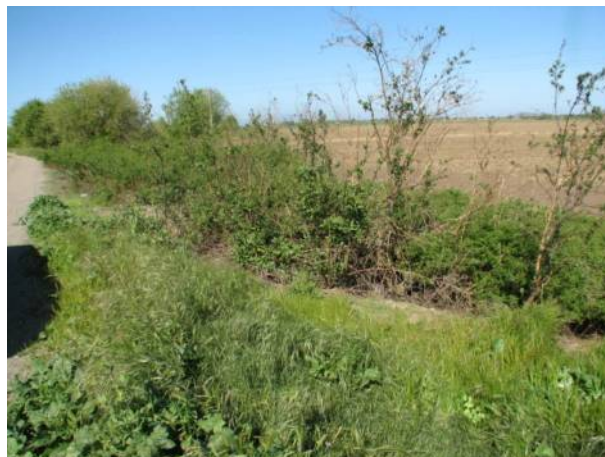
jpaasch_s_20100412_268.jpg

19	0.36	0.37	Earthen Levee	Vegetation	LS	U	Remove the wild growth other than native grasses from the levee slopes. Inspector Comments: Tobacco plant, not Elderberry. Wild rose on lower slope limits access and visibility.	37.809963 ° -121.390925 °	37.809920 ° -121.391105 °	945 Y
20	0.38	0.38	Earthen Levee	Trim / Thin Trees	LS	U	Thin trees to allow visibility of the ground and room to flood fight.	37.809865 ° -121.391303 °	37.809865 ° -121.391303 °	946 Y
21	0.39	0.39	Earthen Levee	Animal Control	CR	M	No rodents visible, but rodent burrows visible; need to backfill and compact or grout borrows. Inspector Comments: Burrow holes on both sides of levee road.	37.809870 ° -121.391465 °	37.809870 ° -121.391465 °	947
22	0.41	0.47	Earthen Levee	Trim / Thin Trees	LS	U	Thin trees to allow visibility of the ground and room to flood fight. Inspector Comments: Trees and wild rose obstruct access and visibility.	37.809793 ° -121.391717 °	37.809592 ° -121.392822 °	948 Y

Levee Mile Report Line	19
Start Levee Mile	0.36
End Levee Mile	0.37
Location	Land Side
Category	Earthen Levee
Item	Vegetation

Indian Tobacco plant and wild rose on levee slope obstruct access and visibility.

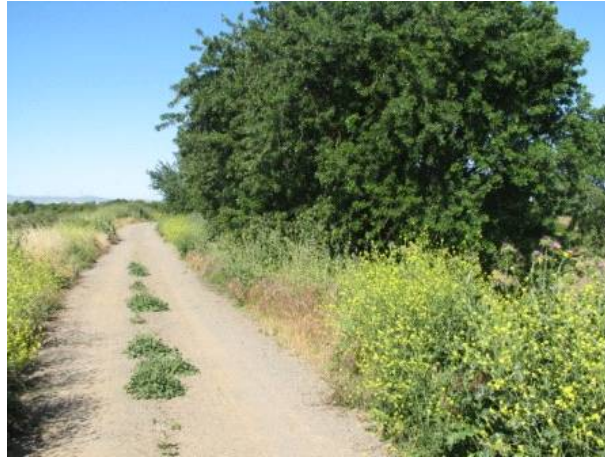
Levee Mile Report Line	20
Start Levee Mile	0.38
End Levee Mile	0.38
Location	Land Side
Category	Earthen Levee
Item	Trim / Thin Trees
Trees on levee slope obstruct access and visibility.	
jpaasch_s_20100510_365.jpg

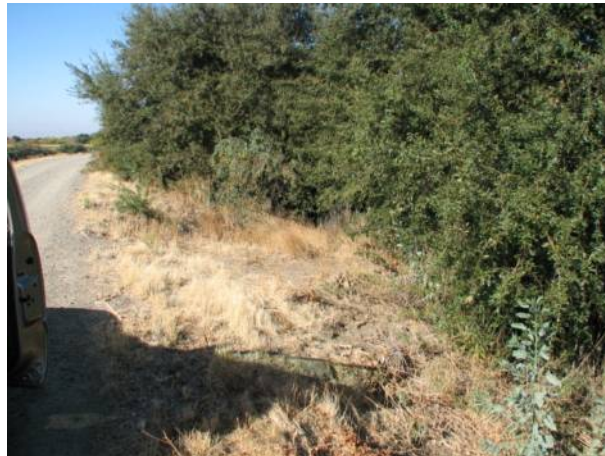
Levee Mile Report Line	22
Start Levee Mile	0.41
End Levee Mile	0.47
Location	Land Side
Category	Earthen Levee
Item	Trim / Thin Trees
Fall 2009 photo of completely obstructive vegetation on levee slope.	
jpaasch_s_20100330_112.jpg

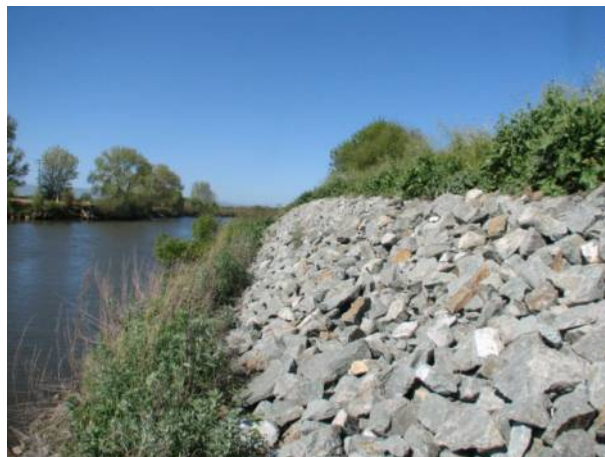
Levee Mile Report Line	23
Start Levee Mile	0.41
End Levee Mile	0.41
Location	Water Side
Category	Supplemental
Item	DWR Erosion Survey
Slope protection placed Fall 2008.	
jpaasch_s_20100412_267.jpg

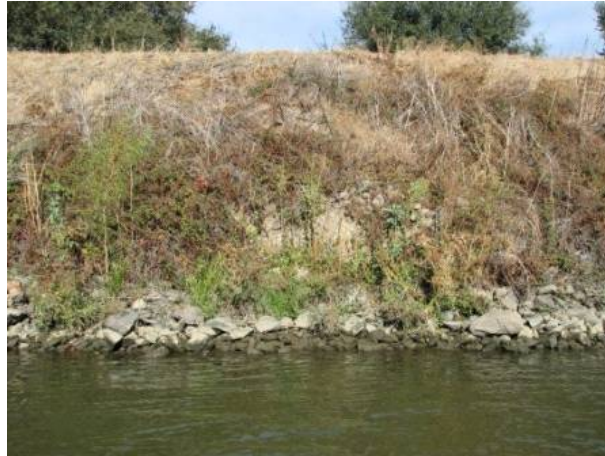
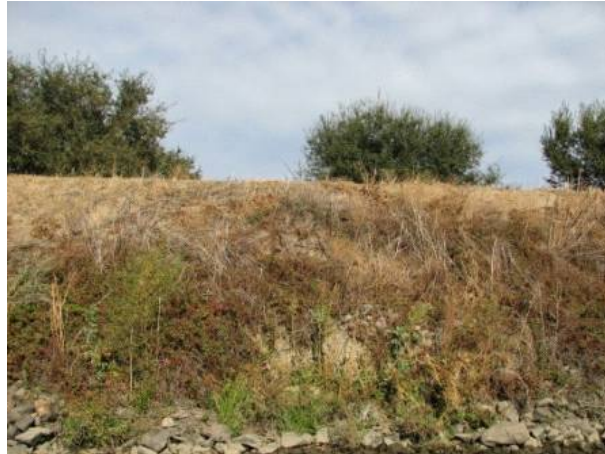
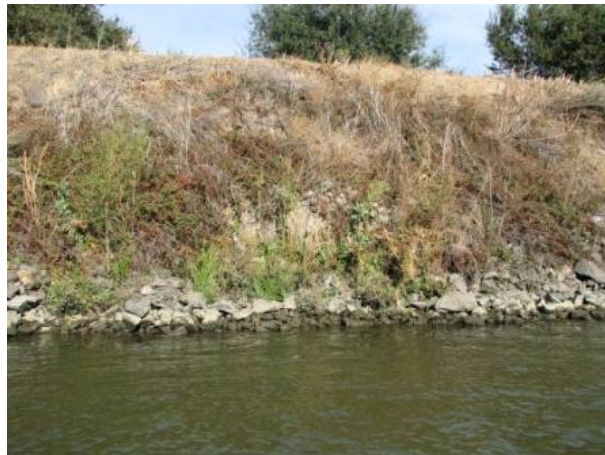
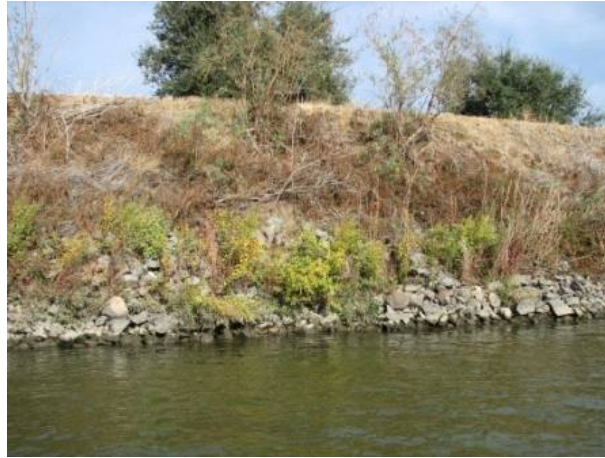
23	0.41	0.41	Supplemental DWR Erosion Survey		WS	M	Inspector Comments: 2009: rock protection placed on upper slope; images need to be updated; recommend annual assessment and monitoring of erosion site, per CLRO CES Evaluation 2008 Report; site # same as RM29.84, LM0.30; previously rated "M" [2009 SiteID:RD2089U1RM29.83]	37.809530 ° -121.392160 °	37.809530 ° -121.392160 °	4 Y
24	0.47	0.47	Earthen Levee	Encroachments	WS	W	Pipe	37.809494 ° -121.392787 °	37.809494 ° -121.392787 °	10 Y
25	0.49	0.49	Earthen Levee	Trim / Thin Trees	WS	M	Thin trees to allow visibility of the ground and room to flood fight.	37.809658 ° -121.393023 °	37.809658 ° -121.393023 °	949 Y

2009: rock protection placed on upper slope; images need to be updated; recommend annual assessment and monitoring of erosion site, per CLRO CES Evaluation 2008 Report; site # same as RM29.84,LM0.30; previously rated "M" [2009 SiteID:RD2089U1RM29.83]

2009: rock protection placed on upper slope; images need to be updated; recommend annual assessment and monitoring of erosion site, per CLRO CES Evaluation 2008 Report; site # same as RM29.84, LM0.30; previously rated "M" [2009 SiteID:RD2089U1RM29.83]

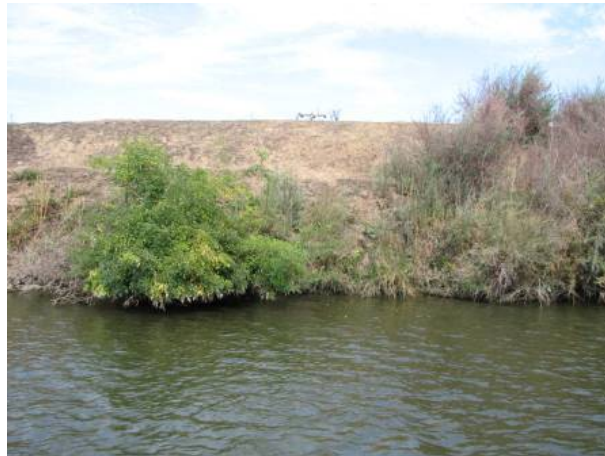
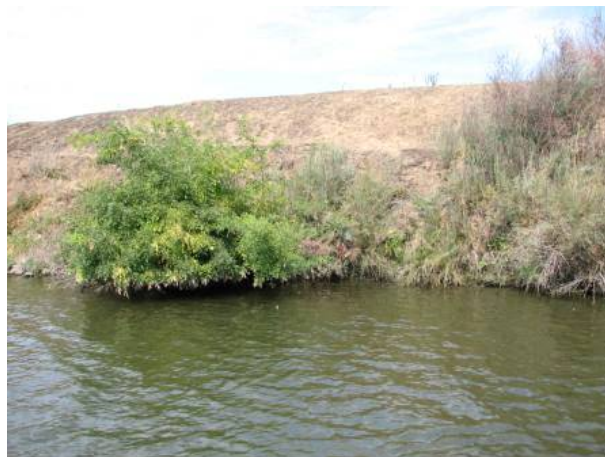
30	0.66	0.66	Supplemental	DWR Erosion Survey	WS	U	Inspector Comments: 2009: No major change observed; 5-ft vertical scarp is immediately downstream of where berm has tapered; recommend as local maintenance issue, per CLRO CES Evaluation 2008 Report; site is same as RM29.6,LM0.60; previously rated "U" [2009 SiteID:RD2089U1RM29.61]	37.809780 ° -121.396230 °	37.809780 ° -121.396230 °	5	Y	
31	0.72	0.77	Earthen Levee	Vegetation	LS	M	Remove the wild growth other than native grasses from the levee slopes. Inspector Comments: Wild Rose on levee toe block access and visibility.	37.809508 ° -121.397062 °	37.808975 ° -121.397528 °	952	Y	
32	0.78	0.78	Earthen Levee	Vegetation	WS	M	Remove the wild growth other than native grasses from the levee slopes. Inspector Comments: Tall brush on levee slope.	37.808857 ° -121.397412 °	37.808857 ° -121.397412 °	953	Y	
33	0.82	0.82	Earthen Levee	Encroachments	WS	W	Pipe Inspector Comments: Irrigation intake pump and pipe.	37.808427 ° -121.397827 °	37.808427 ° -121.397827 °	13	Y

2009: No major change observed; 5-ft vertical scarp is immediately downstream of where berm has tapered; recommend as local maintenance issue, per CLRO CES Evaluation 2008 Report; site is same as RM29.6,LM0.60; previously rated "U" [2009 SiteID:RD2089U1RM29.61]

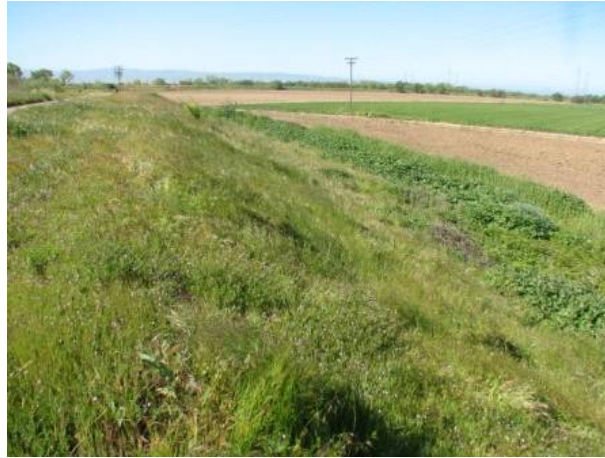
Levee Mile Report Line	31
Start Levee Mile	0.72
End Levee Mile	0.77
Location	Land Side
Category	Earthen Levee
Item	Vegetation
Wild rose and other vegetation on levee toe reduce access and visibility.	
jpaasch_s_20100412_273.jpg

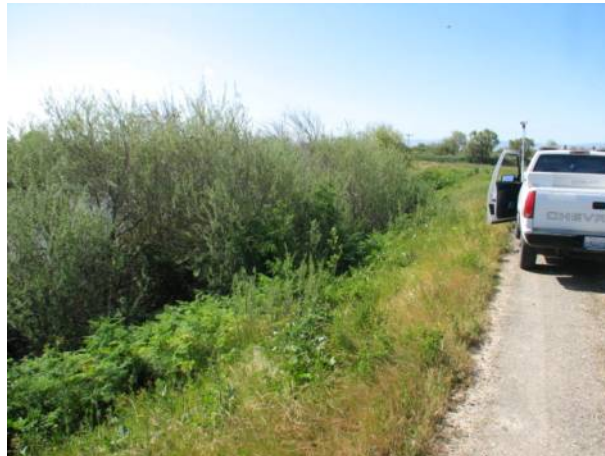
Levee Mile Report Line	32
Start Levee Mile	0.78
End Levee Mile	0.78
Location	Water Side
Category	Earthen Levee
Item	Vegetation
Brush and small trees on levee slope within 20' of the crown limit access and visibility.	
jpaasch_s_20100412_274.jpg

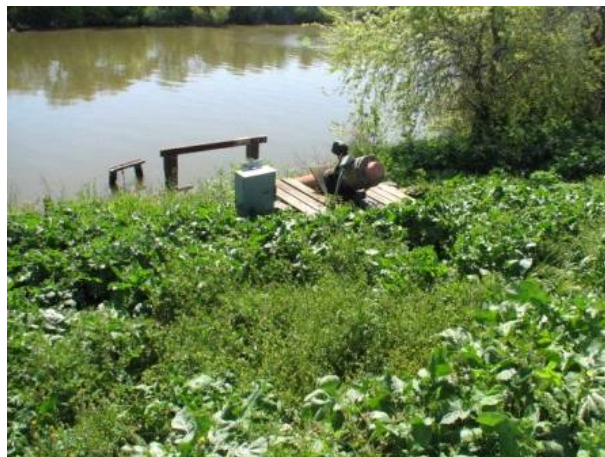
Levee Mile Report Line	33
Start Levee Mile	0.82
End Levee Mile	0.82
Location	Water Side
Category	Earthen Levee
Item	Encroachments
Irrigation intake pump and pipe on levee slope.	
jpaasch_s_20100412_275.jpg

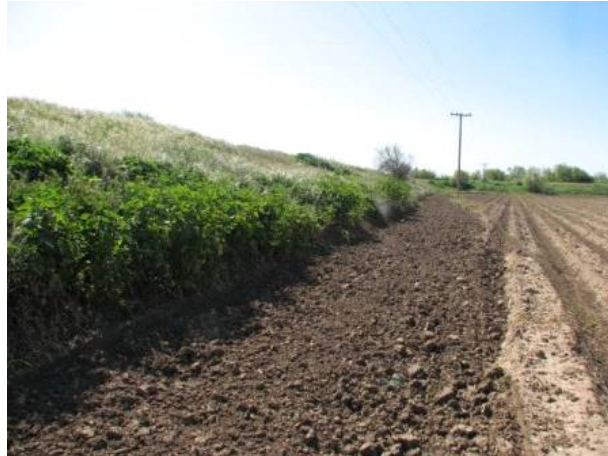
34	0.84	0.84	Earthen Levee	Encroachments	LS	M	Agricultural tilling	37.808091 ° -121.397880 °	37.808091 ° -121.397880 °	14	Y	
35	0.85	0.96	Earthen Levee	Vegetation	LS	M	Remove the wild growth other than native grasses from the levee slopes.	37.806115 ° -121.398676 °	37.806440 ° -121.397728 °	18		
36	0.86	0.89	Earthen Levee	Vegetation	WS	M	Remove the wild growth other than native grasses from the levee slopes.	37.807912 ° -121.397768 °	37.807423 ° -121.397727 °	954		
37	0.96	0.96	Earthen Levee	Vegetation	WS	M	Remove the wild growth other than native grasses from the levee slopes. Inspector Comments: Bamboo and Tobacco Leaf.	37.806412 ° -121.397783 °	37.806412 ° -121.397783 °	955	Y	
38	0.99	1.01	Earthen Levee	Vegetation	WS	M	Remove the wild growth other than native grasses from the levee slopes.	37.806223 ° -121.398158 °	37.806165 ° -121.398462 °	19	Y	
39	1.01	1.07	Earthen Levee	Trim / Thin Trees	LS	M	Trim trees to at least five feet above ground level.	37.806088 ° -121.398710 °	37.805903 ° -121.399857 °	15

Levee Mile Report Line	34
Start Levee Mile	0.84
End Levee Mile	0.84
Location	Land Side
Category	Earthen Levee
Item	Encroachments
Agricultural tilling on landside has encroached on levee toe.	
jpaasch_s_20100412_276.jpg

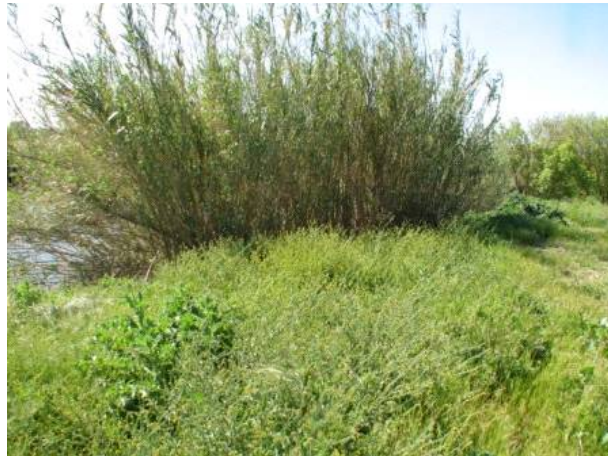
Levee Mile Report Line	37
Start Levee Mile	0.96
End Levee Mile	0.96
Location	Water Side
Category	Earthen Levee
Item	Vegetation
Tall vegetation on waterside hinge point and crown obstruct access and visibility.	
jpaasch_s_20100412_277.jpg

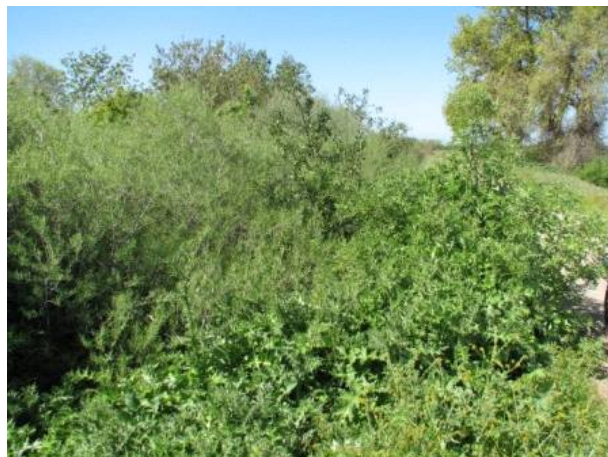
Levee Mile Report Line	38
Start Levee Mile	0.99
End Levee Mile	1.01
Location	Water Side
Category	Earthen Levee
Item	Vegetation
Vegetation on waterside crown and slope.	
jpaasch_s_20100412_278.jpg

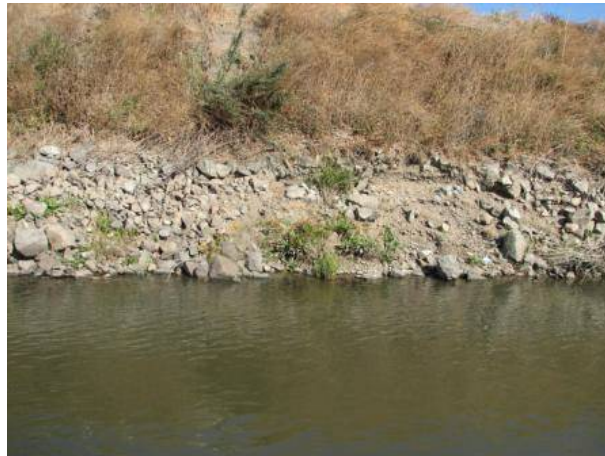
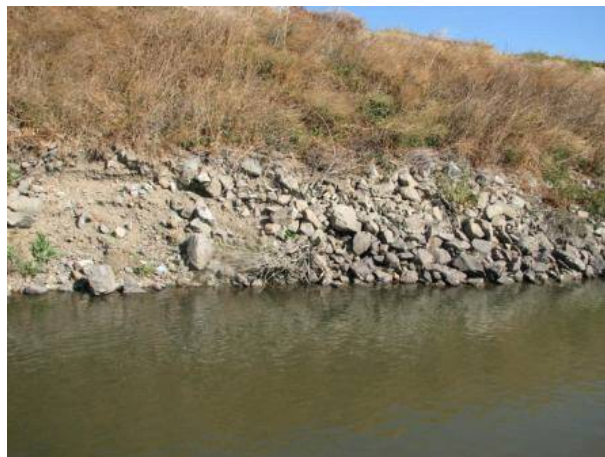
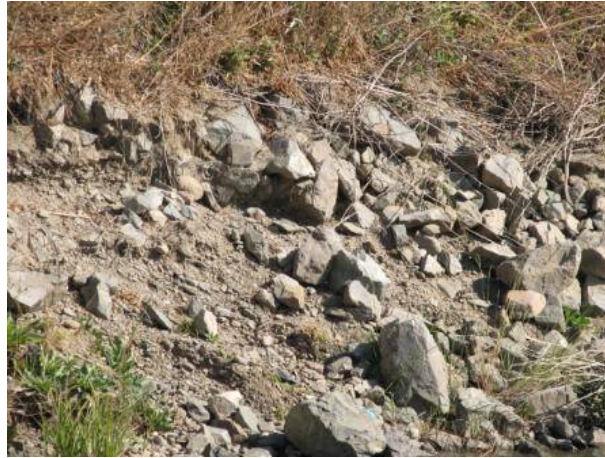
2009: existing revetment just above the toe is sloughing; recommend as a local maintenance issue, per CLRO CES Evaluation 2008 Report; site # is same as RM29.1,LM1.10; previously rated "M" [2009 SiteID:RD2089U1RM29.11]

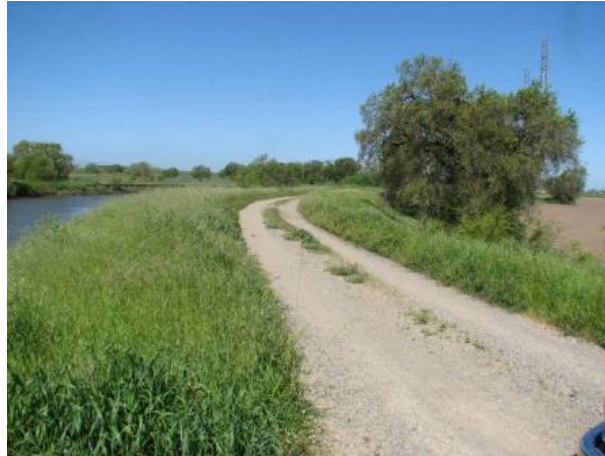
Levee Mile Report Line	1
Start Levee Mile	0.01
End Levee Mile	0.38
Location	Land Side
Category	Earthen Levee
Item	Vegetation
Annual grasses and vegetation on levee slope.	
jpaasch_s_20100412_285.jpg

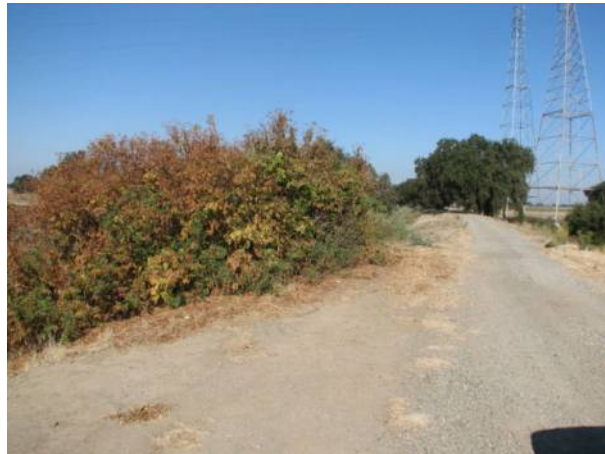
Levee Mile Report Line	4
Start Levee Mile	0.08
End Levee Mile	0.08
Location	Water Side
Category	Earthen Levee
Item	Vegetation
Fall 2009 photo of unacceptable vegetation on levee slope.	
jpaasch_s_20100330_114.jpg

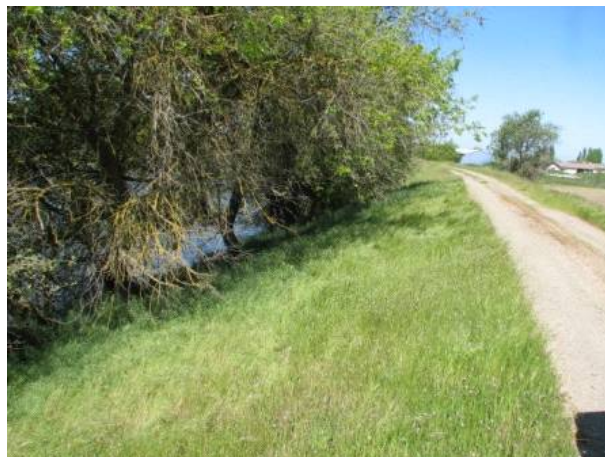
Levee Mile Report Line	6
Start Levee Mile	0.23
End Levee Mile	0.23
Location	Water Side
Category	Earthen Levee
Item	Trim / Thin Trees
Trees within 20' of crown on waterside slope should be trimmed to allow access and visibility.	
jpaasch_s_20100412_286.jpg

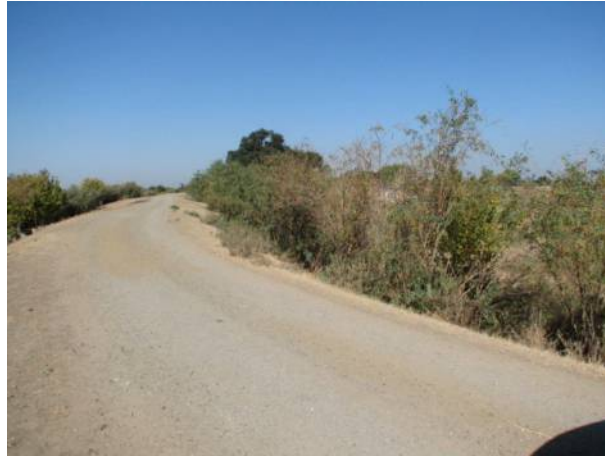
Levee Mile Report Line	9
Start Levee Mile	0.40
End Levee Mile	0.66
Location	Land Side
Category	Earthen Levee
Item	Vegetation
Fall 2009 photo: brush on landside toe limits visibility and accessibility.	
jpaasch_s_20100330_115.jpg

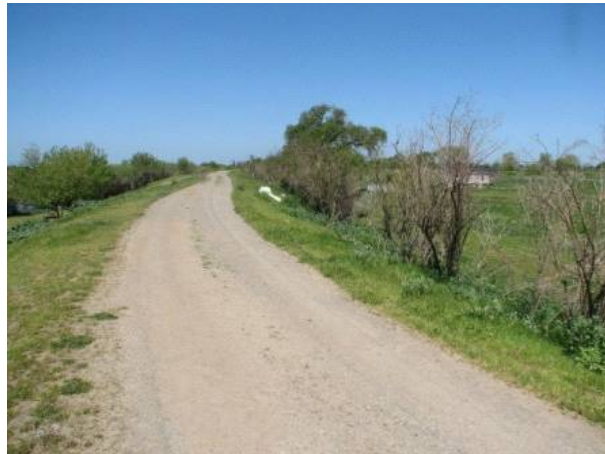
Levee Mile Report Line	9
Start Levee Mile	0.40
End Levee Mile	0.66
Location	Land Side
Category	Earthen Levee
Item	Vegetation
Brush on landside slope limits access.	
jpaasch_s_20100412_284.jpg

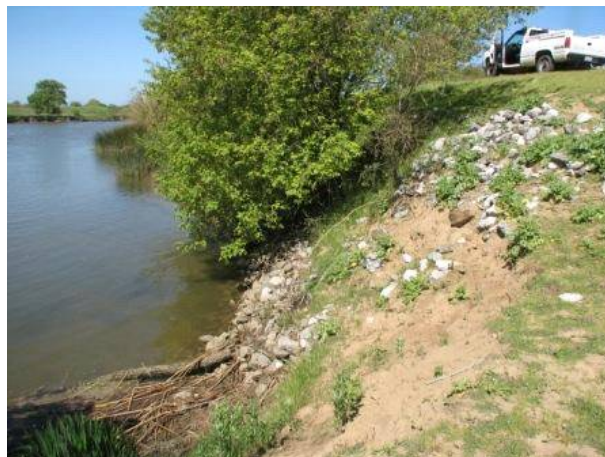
Levee Mile Report Line	10
Start Levee Mile	0.42
End Levee Mile	0.43
Location	Water Side
Category	Supplemental
Item	DWR Erosion Survey
Spring 2010 photo of erosion site.	
jpaasch_s_20100412_287.jpg
