**Flood Control Project Maintenance  
Levee Inspections**  
**LMA District Cover Sheet**  
**Spring 2011 Levee Inspection Results**

**Reclamation District No. 2089 Stark**

**Levee Inspection Report By Mile - Spring 2011**

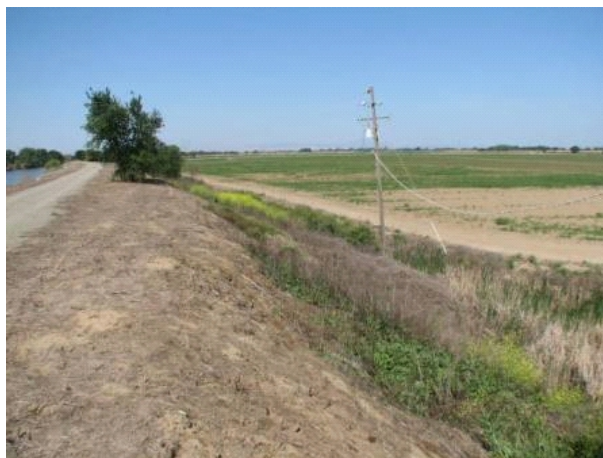
jeto\_s\_20110525\_482.jpg

| LMIR No. | Levee Mile | | Category | Item | Location | Rating | Action/Comment | GPS Latitude/Longitude | | Issue No. |
|---|---|---|---|---|---|---|--|---|---|---|
| 1 | 0.00 | 0.39 | Earthen Levee | Encroachments | LS | PO | Agricultural Ditch<br>Inspector Comments: 05/24/2011 Photo added of Ag ditch. | 37.811681 °<br>-121.384930 ° | 37.809755 °<br>-121.391520 ° | 9<br>Y |

05/24/2011 Ditch flows parallel with the utility line shown in the photo.

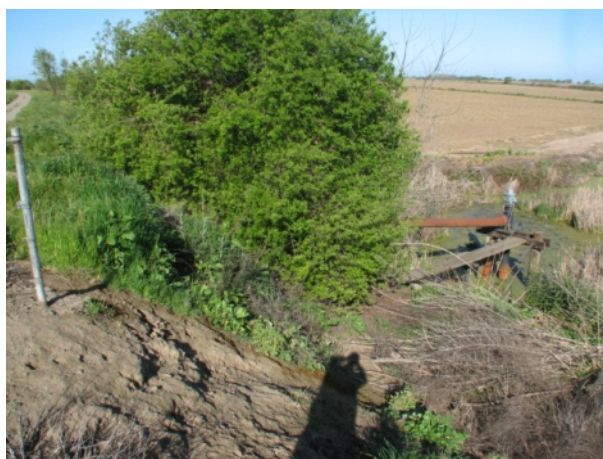
jeto\_s\_20110301\_210.jpg

Trees on landside slope limit access and visibility.

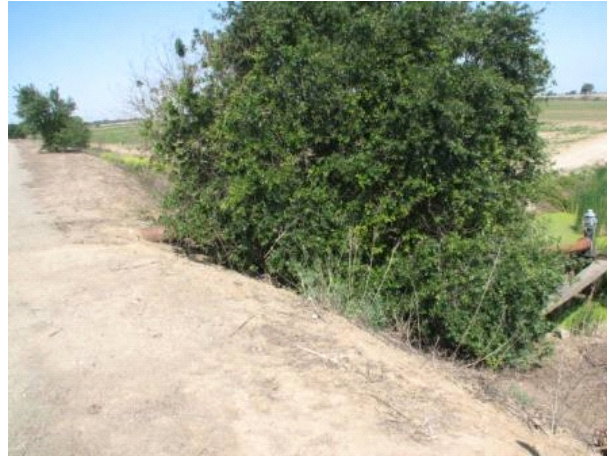
| jeto_s_20110525_483.jpg | |

| LMIR No. | Levee Mile | | Category | Item | Location | Rating | Action/Comment | GPS Latitude/Longitude | | Issue No. |
|---|---|---|---|---|---|---|--|---|---|---|
| 3 | 0.04 | 0.04 | Earthen Levee | Trim / Thin Trees | LS | M | Trim trees to at least five feet above ground level.<br>Inspector Comments: 05/24/2011 Issue is unchanged since Fall 2010 inspection photo attached. | 37.811467 °<br>-121.385569 ° | 37.811467 °<br>-121.385569 ° | 3<br>Y |

| 05/24/2011 Condition of tree has not changed since Fall 2010 inspection. | |

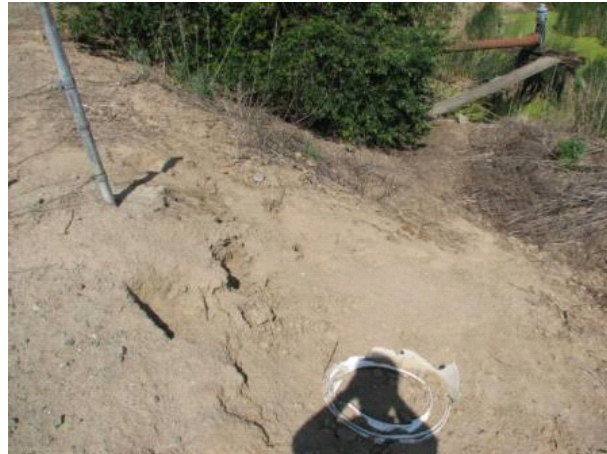
| jeto_s_20110525_484.jpg | |

| LMIR No. | Levee Mile | | Category | Item | Location | Rating | Action/Comment | GPS Latitude/Longitude | | Issue No. |
|---|---|---|---|---|---|---|--|---|---|---|
| 4 | 0.04 | 0.04 | Earthen Levee | Encroachments | LS | M | Stairways<br>Inspector Comments: Steps have been cut into the levee slope, this could become an erosion point, please fill and compact. | 37.811474 °<br>-121.385573 ° | 37.811474 °<br>-121.385573 ° | 1<br>Y |

| 05/24/2011 Steps are hard to discern in the photo, the top two steps are casting the two shadows located between the post and the photographer's shadow. | |

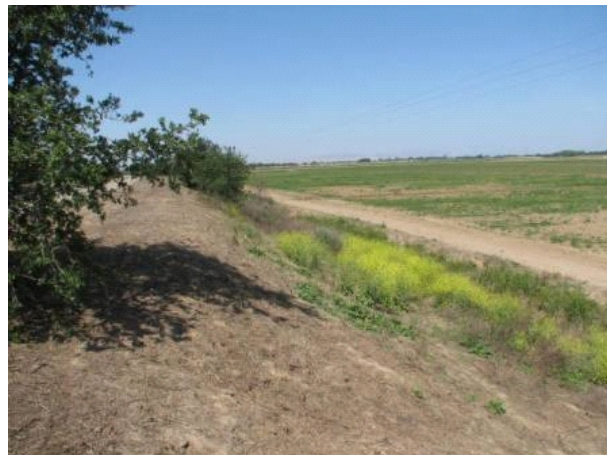
| jeto_s_20110525_485.jpg | |

| LMIR No. | Levee Mile | | Category | Item | Location | Rating | Action/Comment | GPS Latitude/Longitude | | Issue No. |
|---|---|---|---|---|---|---|--|---|---|---|
| 6 | 0.07 | 0.29 | Earthen Levee | Vegetation | LS | M | Control annual grass and weeds on the levee slopes and easements. | 37.811328 °<br>-121.386080 ° | 37.810235 °<br>-121.389852 ° | 5<br>Y |

| 05/24/2011 Landside vegetation has been controlled on the top of the slope, but must be controlled down to the toe and 10' beyond, per the Framework Agreement. | |

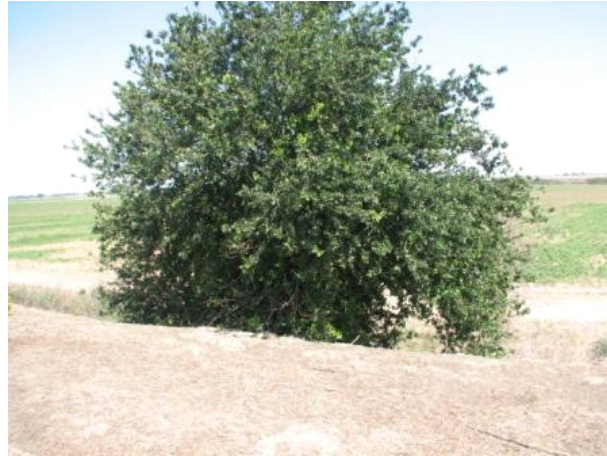
| jeto_s_20110525_486.jpg | |

| LMIR No. | Levee Mile | | Category | Item | Location | Rating | Action/Comment | GPS Latitude/Longitude | | Issue No. |
|---|---|---|---|---|---|---|--|---|---|---|
| 7 | 0.10 | 0.10 | Earthen Levee | Trim / Thin Trees | LS | M | Trim trees to at least five feet above ground level.<br>Inspector Comments: Two scrub oaks obstruct access to levee slope. 05/24/2011 Issue has not changed since Fall 2010 inspection, photo attached | 37.811272 °<br>-121.386703 ° | 37.811272 °<br>-121.386703 ° | 935<br>Y |

| 05/24/2011 Issue remains unchanged since noted in the Fall 2010 inspection. | |

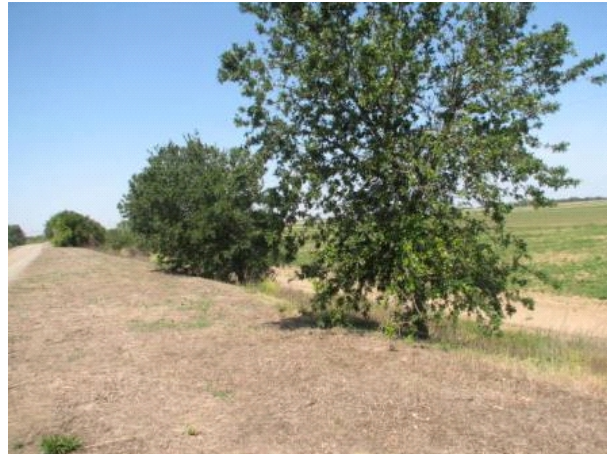
| jeto_s_20110525_487.jpg | |

| LMIR No. | Levee Mile | | Category | Item | Location | Rating | Action/Comment | GPS Latitude/Longitude | | Issue No. |
|---|---|---|---|---|---|---|--|---|---|---|
| 8 | 0.18 | 0.18 | Earthen Levee | Trim / Thin Trees | LS | M | Trim trees to at least five feet above ground level.<br>Inspector Comments: Trees are blocking visibility and access. | 37.810802 °<br>-121.387969 ° | 37.810802 °<br>-121.387969 ° | 2<br>Y |

| 05/24/2011 Both trees shown need to be trimmed up 5' to allow visibility of landside slope. | |

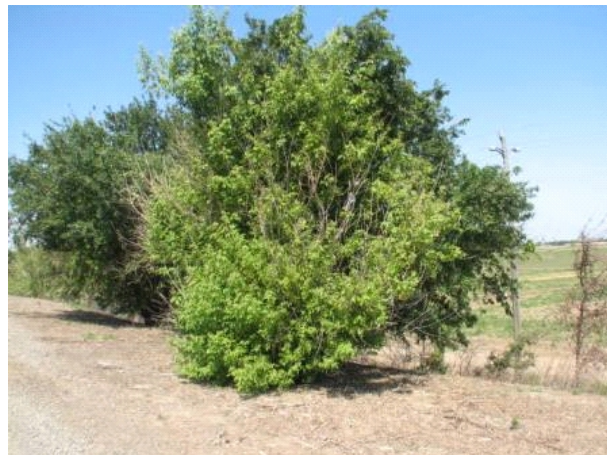
| jeto_s_20110525_488.jpg | |

| LMIR No. | Levee Mile | | Category | Item | Location | Rating | Action/Comment | GPS Latitude/Longitude | | Issue No. |
|---|---|---|---|---|---|---|--|---|---|---|
| 9 | 0.23 | 0.23 | Earthen Levee | Trim / Thin Trees | LS | M | Trim trees to at least five feet above ground level.<br>Inspector Comments: 05/24/2011 Issue is unchanged since Fall 2010. | 37.810532 °<br>-121.388823 ° | 37.810532 °<br>-121.388823 ° | 938<br>Y |

| 05/24/2011 Tree was also noted in the Fall 20110 inspection. | |

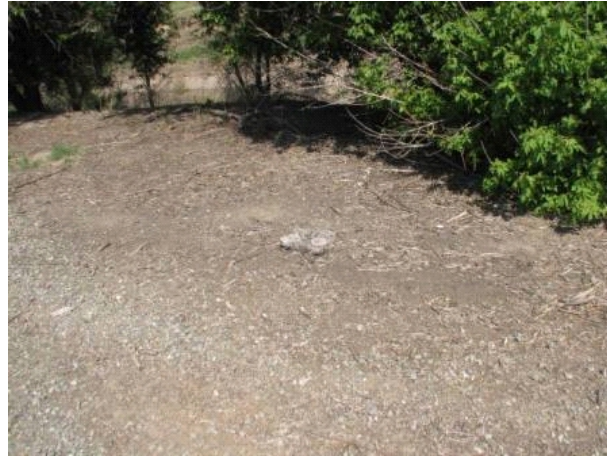
| jeto_s_20110525_489.jpg | |

| LMIR No. | Levee Mile | | Category | Item | Location | Rating | Action/Comment | GPS Latitude/Longitude | | Issue No. |
|---|---|---|---|---|---|---|--|---|---|---|
| 10 | 0.24 | 0.24 | Earthen Levee | Trim / Thin Trees | LS | N | Tree stumps.<br>Inspector Comments: Stump greater than 2" on landside crown. | 37.810499 °<br>-121.388884 ° | 37.810499 °<br>-121.388884 ° | 6<br>Y |

| 05/24/2011 Stump shown in center of photo. | |

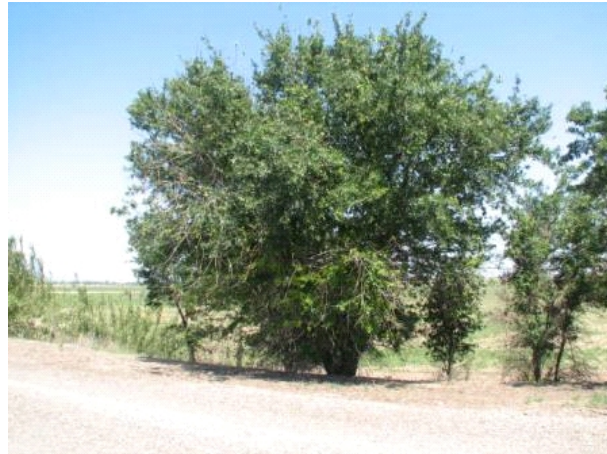
| jeto_s_20110525_490.jpg | |

| LMIR No. | Levee Mile | | Category | Item | Location | Rating | Action/Comment | GPS Latitude/Longitude | | Issue No. |
|---|---|---|---|---|---|---|--|---|---|---|
| 11 | 0.24 | 0.24 | Earthen Levee | Trim / Thin Trees | WS | M | Trim trees to at least five feet above ground level.<br>Inspector Comments: Issue has not changed since Fall 2010. | 37.810490 °<br>-121.389018 ° | 37.810490 °<br>-121.389018 ° | 939<br>Y |

| 05/24/2011 Tree must be trimmed up 5'. Issue noted in Fall 2010 inspection. | |

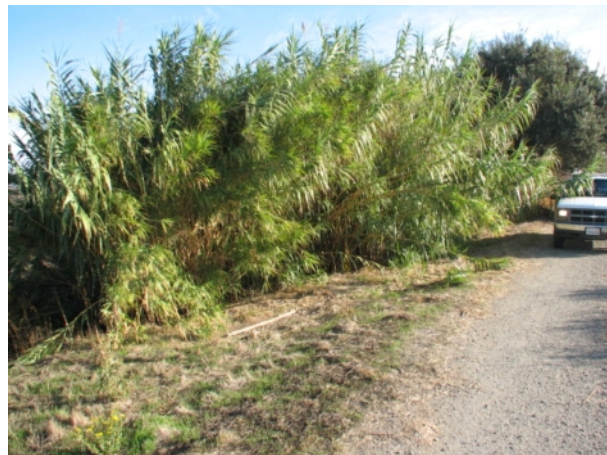
| jeto_s_20110301_227.jpg | |

| Bamboo on levee slope and crown obstruct access and visibility. | |

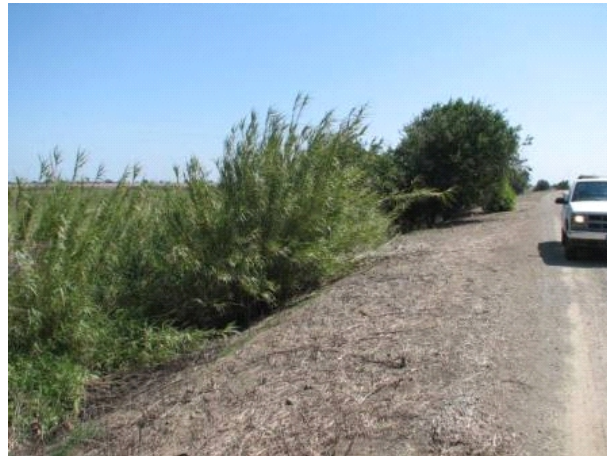
jeto\_s\_20110525\_491.jpg

| LMIR No. | Levee Mile | | Category | Item | Location | Rating | Action/Comment | GPS Latitude/Longitude | | Issue No. |
|---|---|---|---|---|---|---|--|---|---|---|
| 12 | 0.24 | 0.24 | Earthen Levee | Vegetation | LS | U | Remove the wild growth other than native grasses from the levee slopes.<br>Inspector Comments: Bamboo remains as an obstruction despite last years burning. 05/24/2011 Bamboo still remains, updated photo attached. | 37.810488 °<br>-121.389018 ° | 37.810488 °<br>-121.389018 ° | 940<br>Y |

05/24/2011 Bamboo has been trimmed back off of crown, but still completely blocks access and visibility.

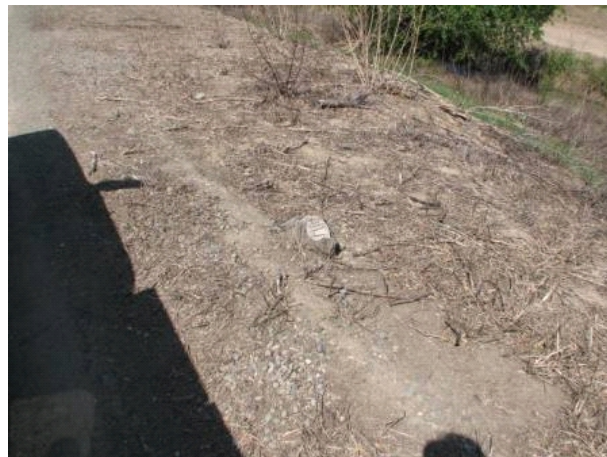
jeto\_s\_20110525\_492.jpg

| LMIR No. | Levee Mile | | Category | Item | Location | Rating | Action/Comment | GPS Latitude/Longitude | | Issue No.<br>Photo |
|---|---|---|---|---|---|---|--|---|---|---|
| 15 | 0.26 | 0.26 | Earthen Levee | Trim / Thin Trees | LS | N | Tree stumps.<br>Inspector Comments: Stump in levee crown. | 37.810376 °<br>-121.389290 ° | 37.810376 °<br>-121.389290 ° | 8<br>Y |

05/24/2011 Stump is located in center of photo.

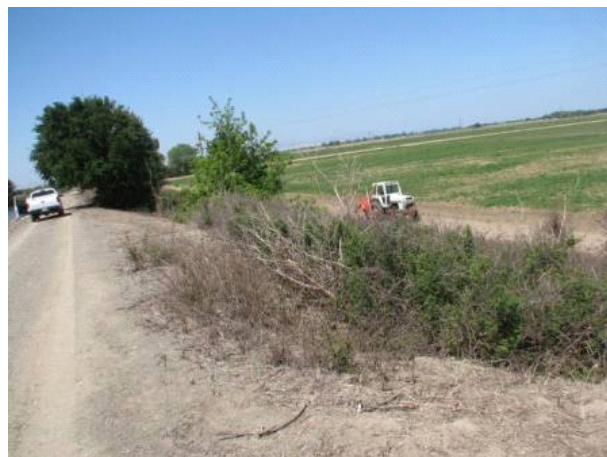
jeto\_s\_20110525\_493.jpg

| LMIR No. | Levee Mile | | Category | Item | Location | Rating | Action/Comment | GPS Latitude/Longitude | | Issue No.<br>Photo |
|---|---|---|---|---|---|---|--|---|---|---|
| 17 | 0.27 | 0.39 | Earthen Levee | Vegetation | LS | U | Remove the wild growth other than native grasses from the levee slopes.<br>Inspector Comments: Access and visibility completely blocked. | 37.810319 °<br>-121.389510 ° | 37.809740 °<br>-121.391645 ° | 12<br>Y |

05/24/2011 Thick brush and wild rose completely block access and visibility of landside slope and toe.

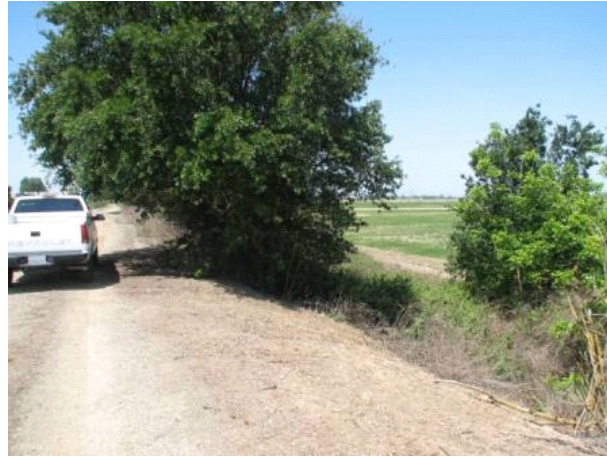
| jeto_s_20110525_494.jpg | |

| 05/24/2011 Numerous trees and thick vegetation in area, trees need to be trimmed to 12' above roadway and up 5' on landside slope and toe to allow access and visibility. | |

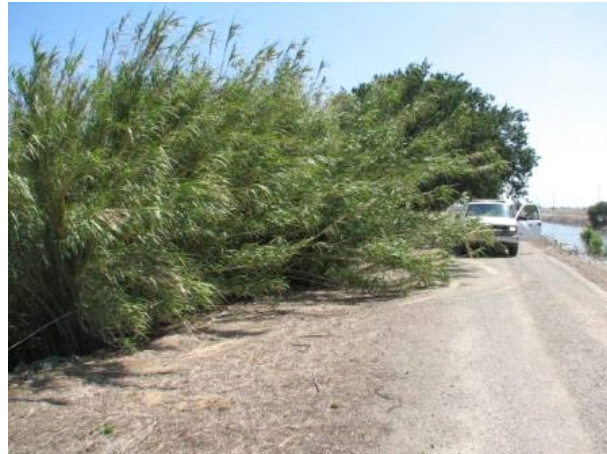
| jeto_s_20110525_495.jpg | |

| 05/24/2011 Large bamboo prevents any access and completely obstructs visibility of landside slope and toe. | |

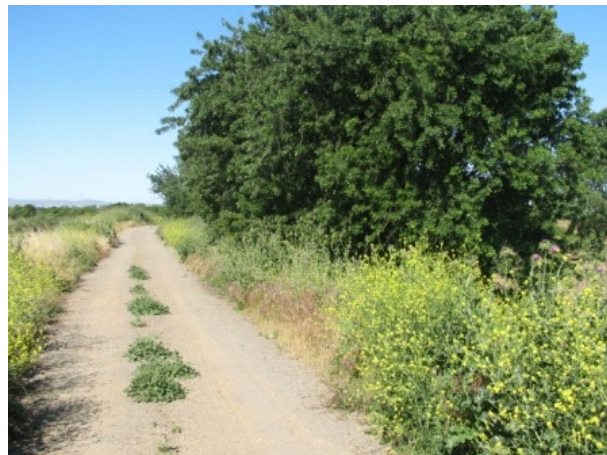
| jeto_s_20110301_230.jpg | |

| Trees on levee slope obstruct access and visibility. | |

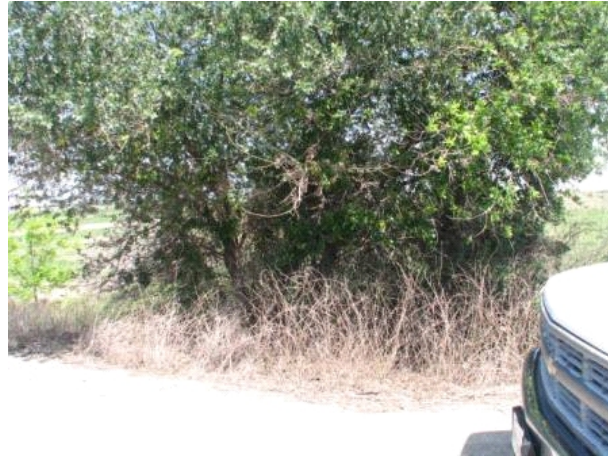
| jeto_s_20110525_496.jpg | |

| 05/24/2011 Tree needs to be trimmed up 5' to allow access and visibility to landside slope. | |

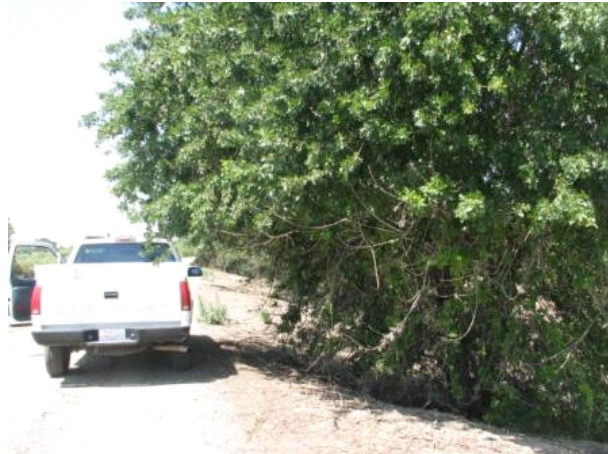
| jeto_s_20110525_497.jpg | |

| 05/24/2011 Trees need to be trimmed to 12' over roadway and up 5' on levee slope to allow access and visibility. | |

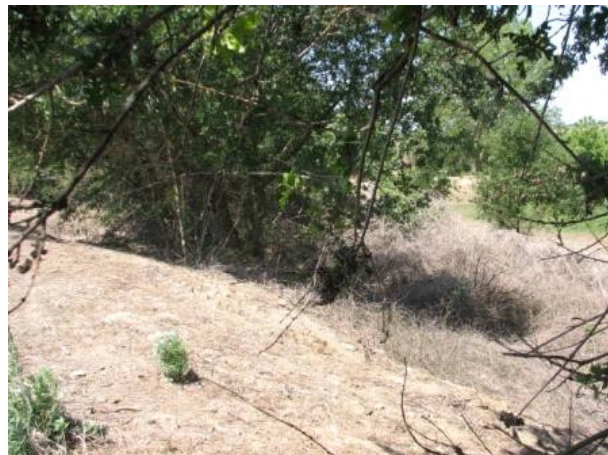
| jeto_s_20110525_498.jpg | |

| 05/24/2011 Photo shows thick dead vegetation and continuation of trees in area that are preventing access and visibility of landside slope and toe. | |

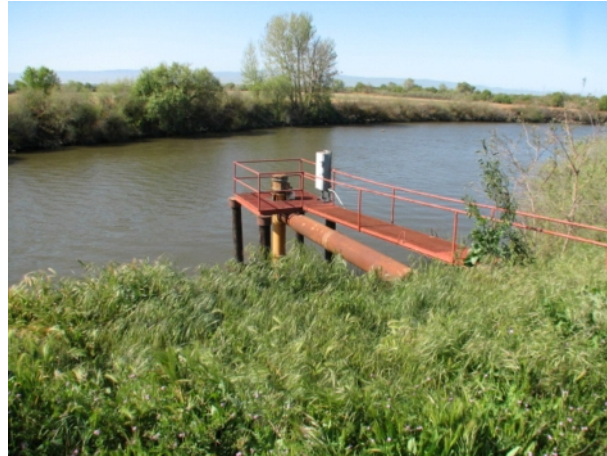
| jeto_s_20110301_216.jpg | |

| Irrigation intake pump and pipe at LM 0.46. | |

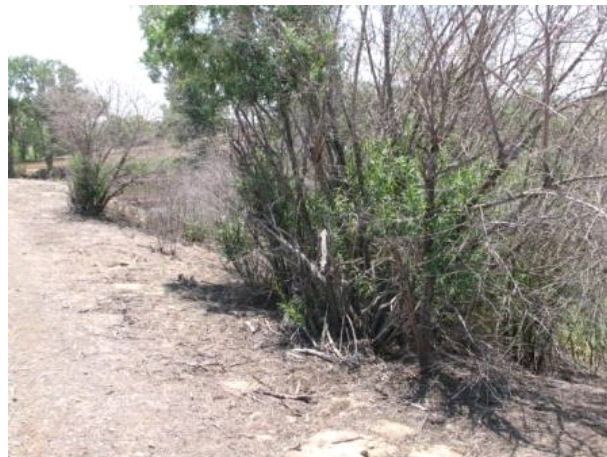
| jeto_s_20110525_499.jpg | |

| 05/24/2011 Trees on waterside need to be thinned to allow access and visibility of top 20' of waterside slope. | |

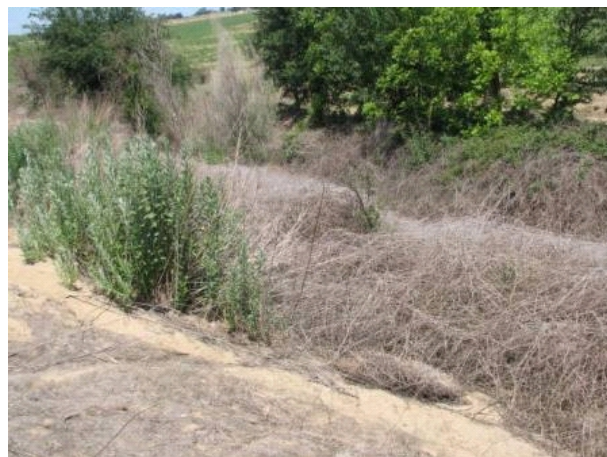
| jeto_s_20110525_500.jpg | |

| 05/24/2011 Dead brush is too thick to allow access and visibility of landside slope and toe. | |

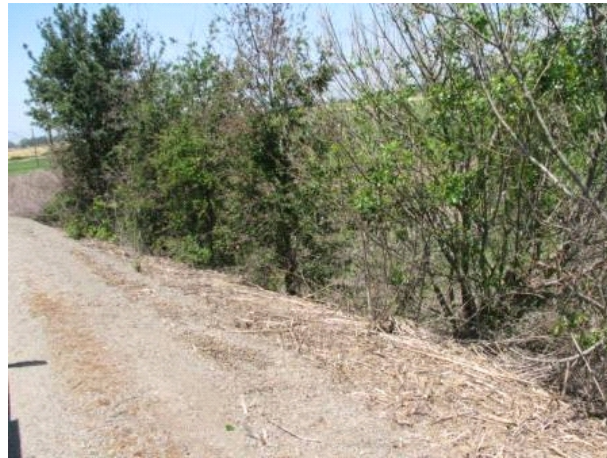
| jeto_s_20110525_501.jpg | |

| 05/24/2011 Issue was also noted in Fall 2010 inspection. | |

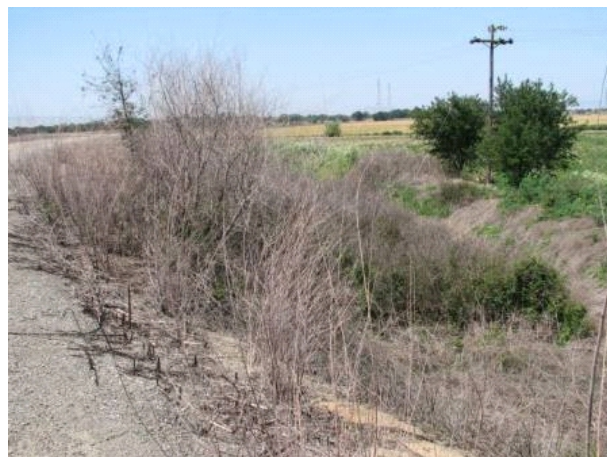
jeto\_s\_20110525\_502.jpg

05/24/2011 Vegetation is mostly dead but needs to be removed to allow access and visibility of slope and toe.

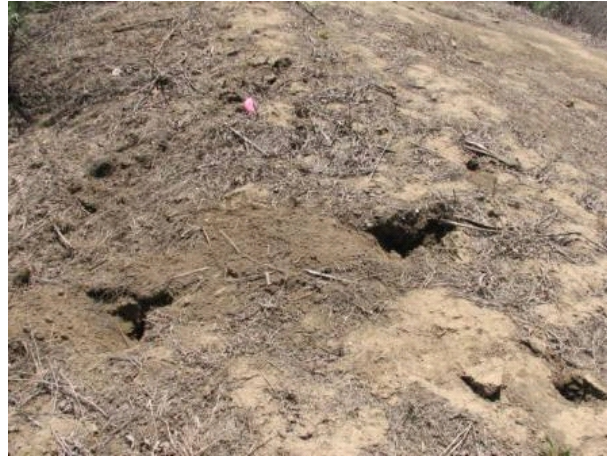
| jeto_s_20110525_503.jpg | |

| 05/24/2011 Two active burrows shown in photo. | |

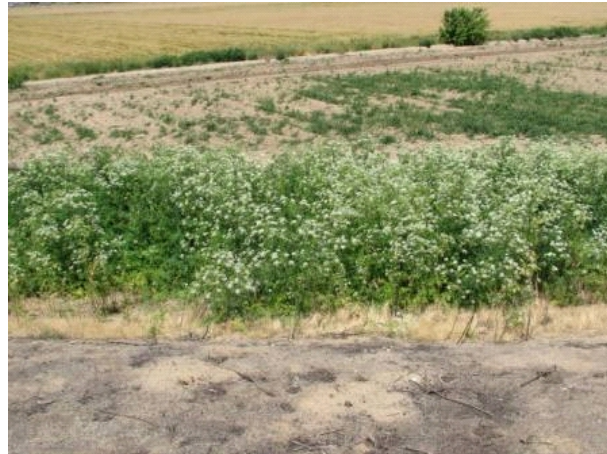
| jeto_s_20110525_504.jpg | |

| 05/24/2011 Vegetation on lower half of slope is blocking visibility of the landside toe. | |

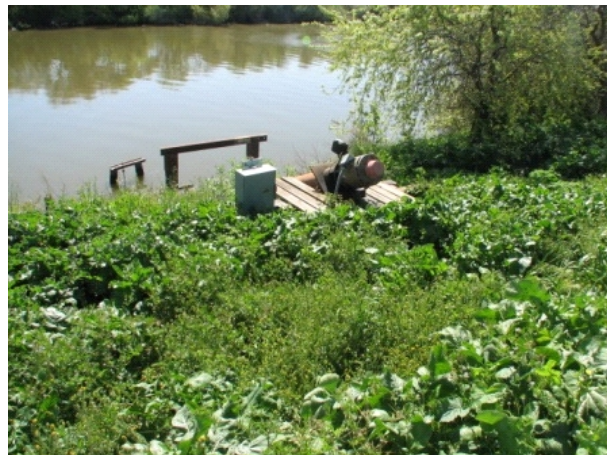
| jeto_s_20110301_218.jpg | |

| Irrigation intake pump and pipe on levee slope. | |

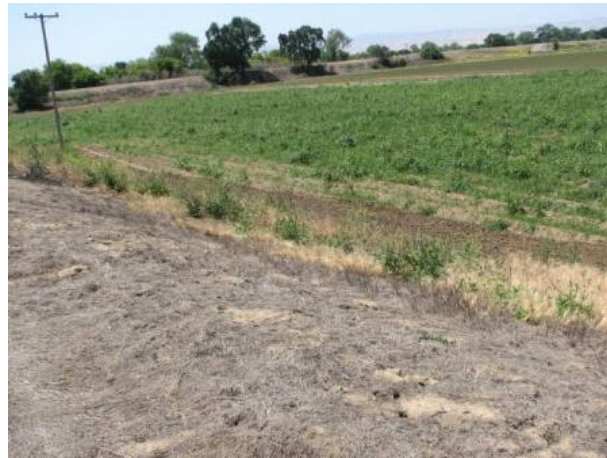
| jeto_s_20110525_506.jpg | |

| 05/24/2011 Vegetation on bottom half of slope prevent visibility of landside toe. Note, vegetation on top half of slope has been controlled. | |

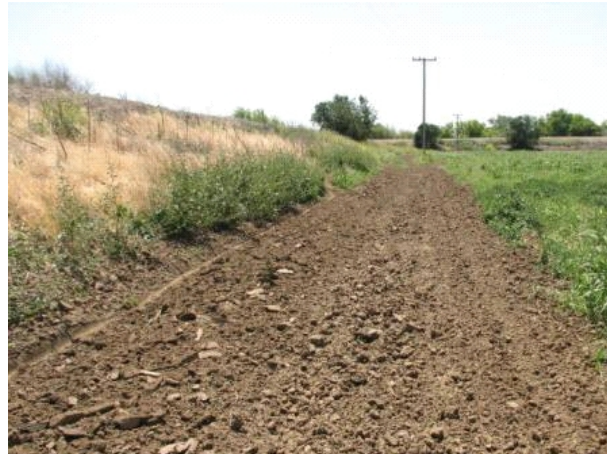
| jeto_s_20110525_505.jpg | |

| 05/24/2011 Photo shows tilling issue noted in Fall 2010 inspection has been corrected, tilling now stops at toe of landside slope. | |

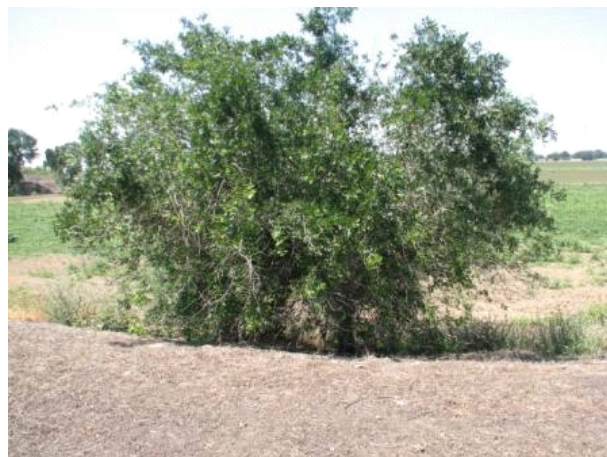
| jeto_s_20110525_507.jpg | |

| 05/24/2011 Tree needs to be trimmed up 5'. | |

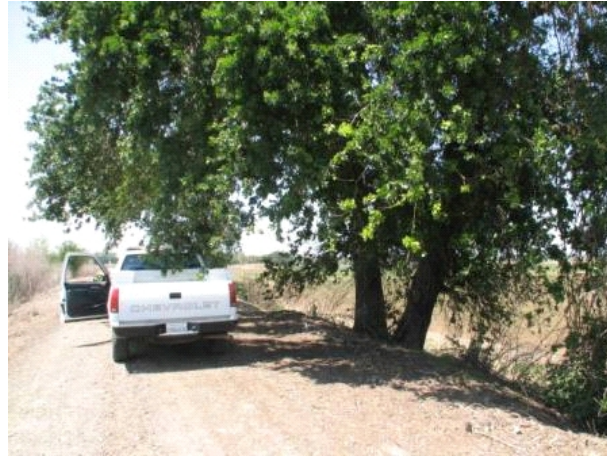
jeto\_s\_20110525\_508.jpg

05/24/2011 Tree needs to be trimmed to allow 12' clearance over road.

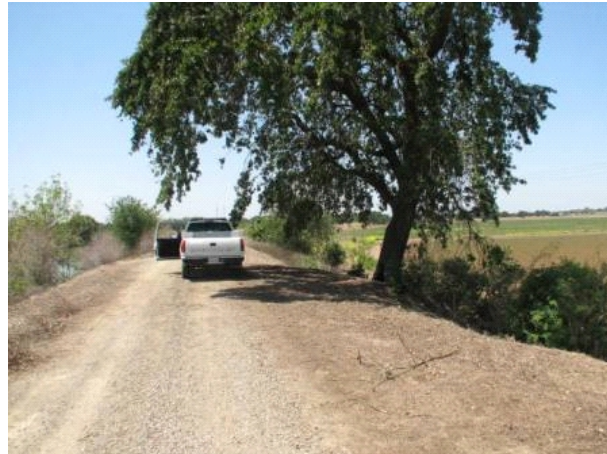
jeto\_s\_20110525\_509.jpg

05/24/2011 Tree needs to be trimmed to allow 12' clearance over road.

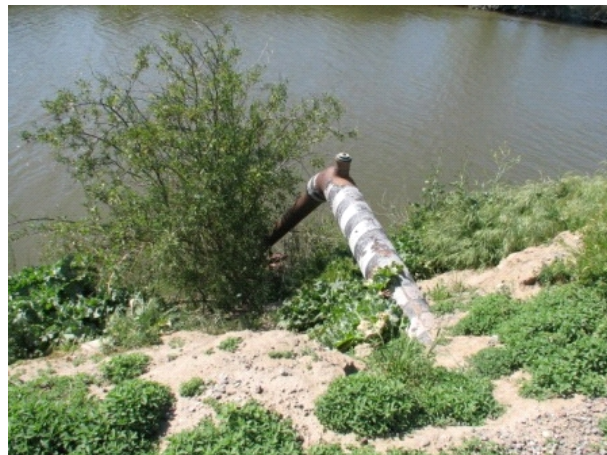
jeto\_s\_20110301\_222.jpg

Drainage discharge into Old River.

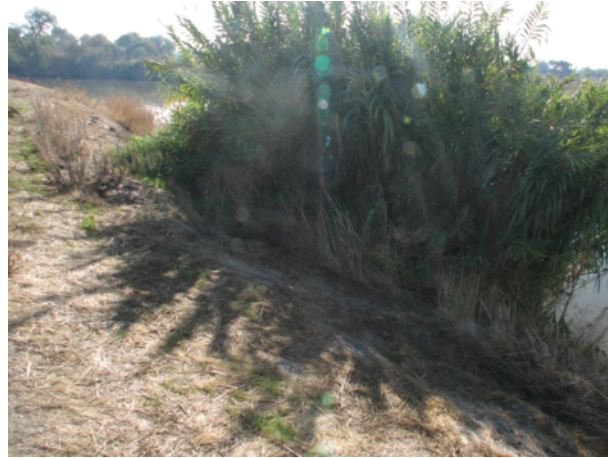
| jeto_s_20110301_224.jpg | |

| Bamboo on waterside levee slope obstructs access and visibility. | |

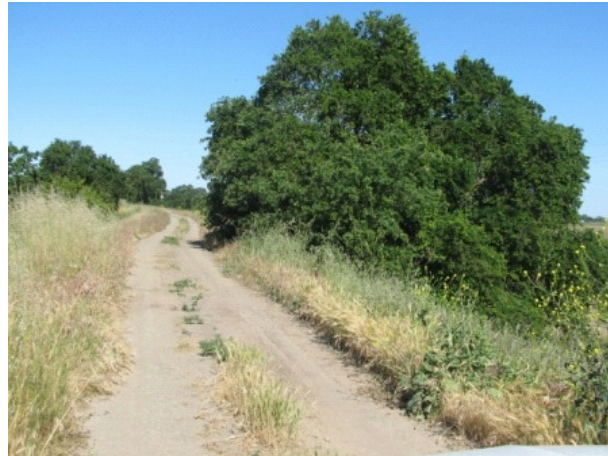
| jeto_s_20110301_220.jpg | |

| Trees on levee slope obstruct access and visibility. | |

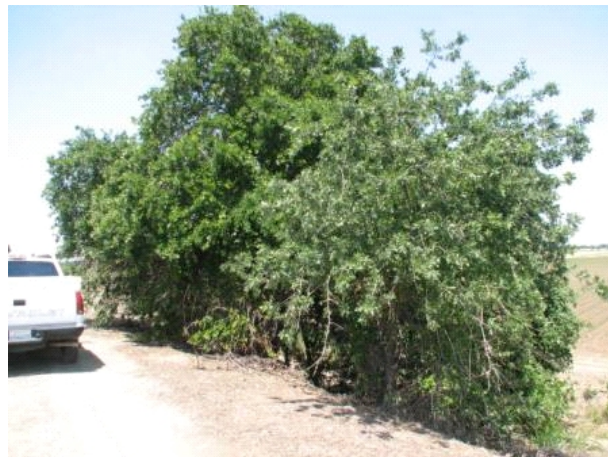
| jeto_s_20110525_510.jpg | |

| 05/24/2011 Trees have been trimmed since Fall 2010 inspection, however they still need to be trimmed up 5' to allow visibility of slope and access in a flood fight. | |

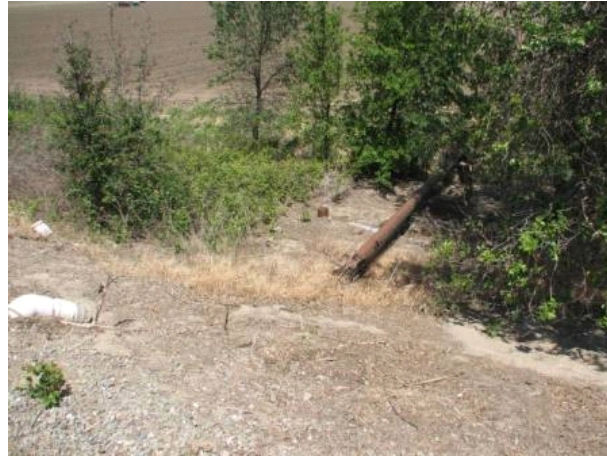
jeto\_s\_20110525\_511.jpg

05/24/2011 pipe through levee, not previously noted in inspection.

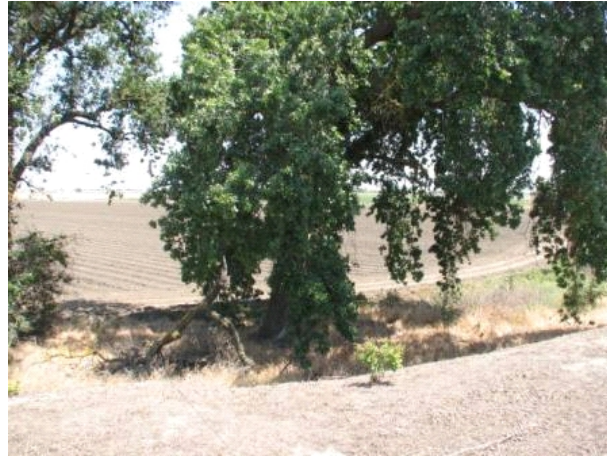
| jeto_s_20110525_512.jpg | |

| 05/24/2011 Issue noted in Fall 2010 inspection. Downed limb is visible beneath the overhanging limbs. | |

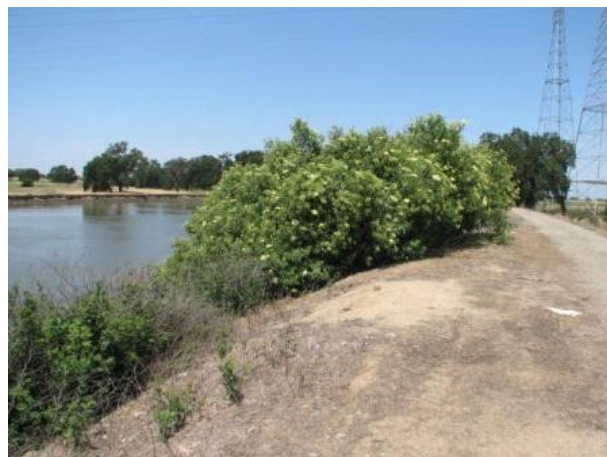
| jeto_s_20110525_513.jpg | |

| 05/24/2011 Updated photo of issue noted in Fall 2010 inspection. | |

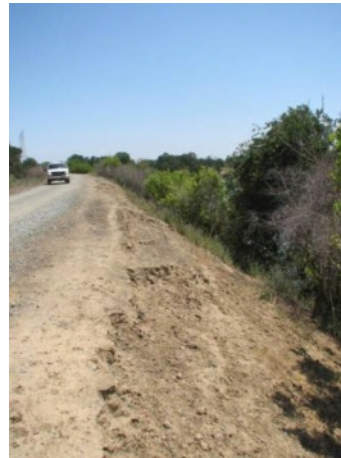
jeto\_s\_20110525\_519.jpg

| LMIR No. | Levee Mile | | Category | Item | Location | Rating | Action/Comment | GPS Latitude/Longitude | | Issue No.<br>Photo |
|---|---|---|---|---|---|---|---|---|---|---|
| 14 | 0.54 | 0.56 | Earthen Levee | Animal Control | WS | U | No rodents visible, but rodent burrows visible; need to backfill and compact or grout burrows.<br>Inspector Comments: No rodents present, but significant tracks and burrows, need to be corrected. May be the cause of the drop off on the waterside of the levee crown. See photos. | 37.811212 °<br>-121.414769 ° | 37.811480 °<br>-121.415141 ° | 35<br>Y |

05/24/2011 Photo taken from LM 0.56 showing length of damage and burrow evidence. Pickup is at beginning of damage area, LM 0.54.

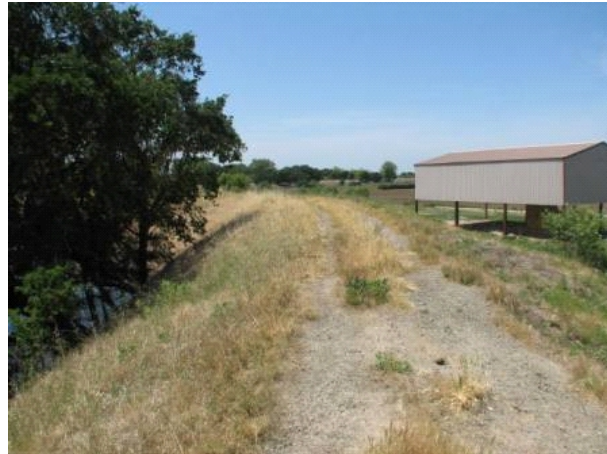
| jeto_s_20110525_524.jpg | |

| 05/24/2011 Tall weeds on top 20' of water side slope and crown. Condition continues to LM 1.29. | |
