**Flood Control Project Maintenance  
Levee Inspections****LMA District Cover Sheet****Spring 2012 Levee Inspection Results****Reclamation District No. 2089 Stark**

**Levee Inspection Report By Mile - Spring 2012**

**Reclamation District No. 2089 Stark**

Waterway				Bank	Unit Miles	Inspection Start/End	Inspector
Unit No. 01 Old River				Right	1.53	05/24/2012 05/24/2012	Max Khashchuk

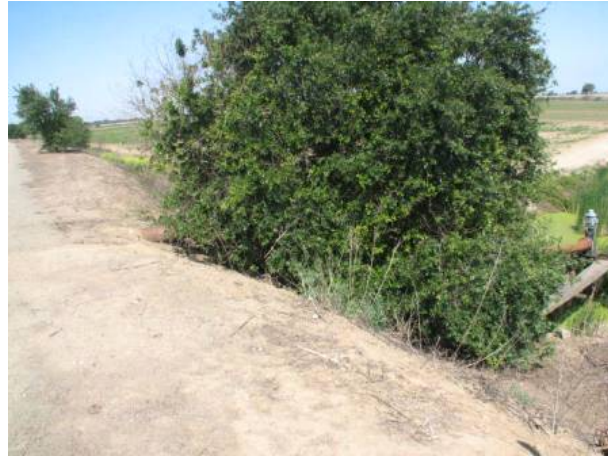
Levee Mile Report Line	6
Start Levee Mile	0.04
End Levee Mile	0.04
Location	Land Side
Category	Earthen Levee
Item	Trim / Thin Trees
05/24/2011 Condition of tree has not changed since Fall 2010 inspection.	
mkhashch_s_20120511_087.jpg

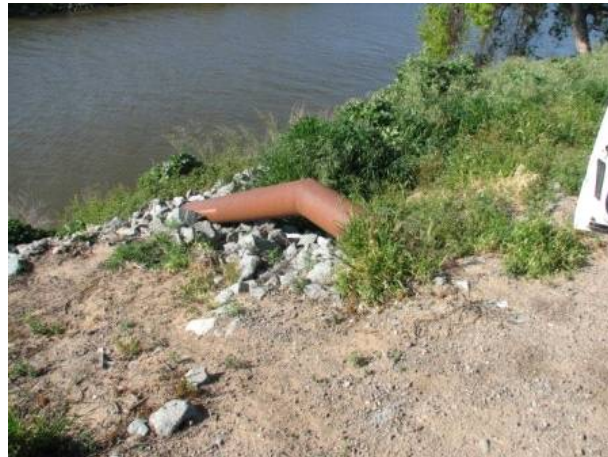
Levee Mile Report Line	7
Start Levee Mile	0.04
End Levee Mile	0.04
Location	Land Side
Category	Earthen Levee
Item	Encroachments
Waterside of drainage discharge to Old River.	
mkhashch_s_20120511_094.jpg

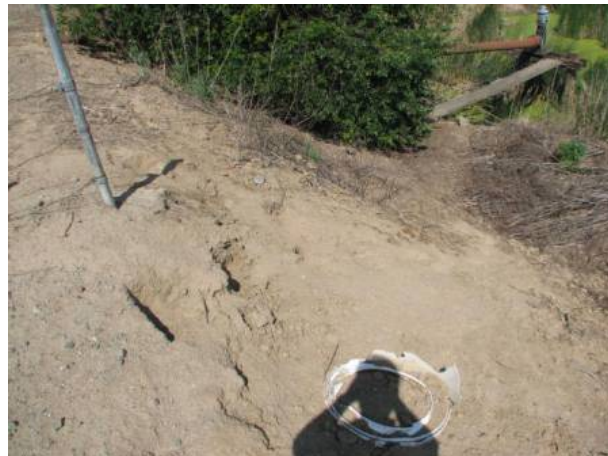
Levee Mile Report Line	8
Start Levee Mile	0.04
End Levee Mile	0.04
Location	Land Side
Category	Earthen Levee
Item	Encroachments
05/24/2011 Steps are hard to discern in the photo, the top two steps are casting the two shadows located between the post and the photographer's shadow.	
mkhashch_s_20120511_084.jpg

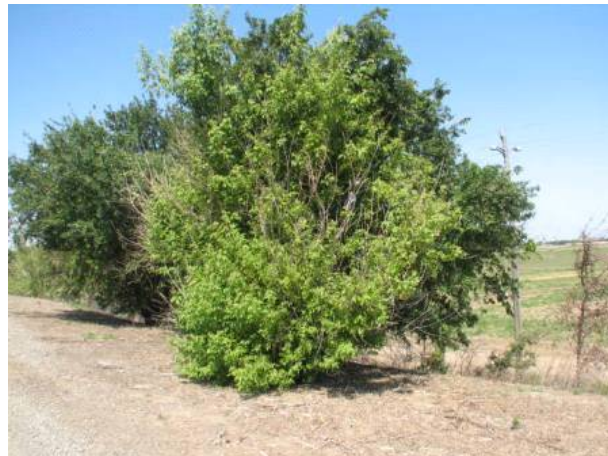
Levee Mile Report Line	13
Start Levee Mile	0.23
End Levee Mile	0.23
Location	Land Side
Category	Earthen Levee
Item	Trim / Thin Trees
05/24/2011 Tree was also noted in the Fall 20110 inspection.	
mkhashch_s_20120511_146.jpg

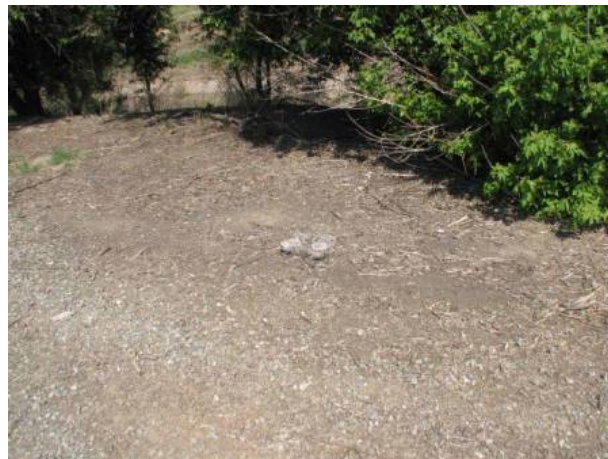
Levee Mile Report Line	15
Start Levee Mile	0.24
End Levee Mile	0.24
Location	Water Side
Category	Earthen Levee
Item	Trim / Thin Trees

05/24/2011 Tree must be trimmed up 5'. Issue noted in Fall 2010 inspection.

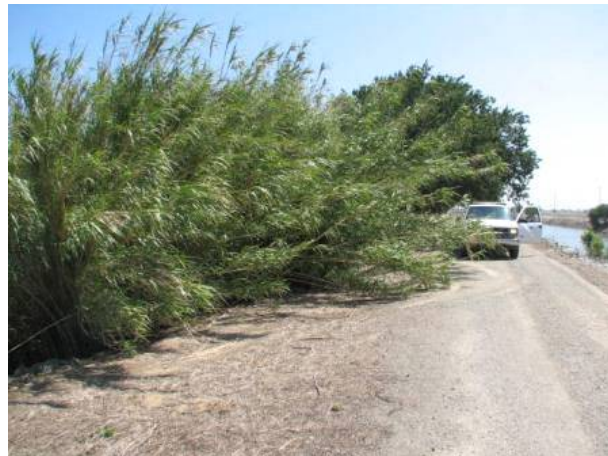
Levee Mile Report Line	21
Start Levee Mile	0.34
End Levee Mile	0.34
Location	Land Side
Category	Earthen Levee
Item	Vegetation
05/24/2011 Large bamboo prevents any access and completely obstructs visibility of landside slope and toe.	
mkhashch_s_20120511_106.jpg

LMR No.	Levee Mile		Category	Item	Location * + Rating + Ma	Action/Comment	GPS Latitude/Longitude		Issue No. Photo
	Start	End					Start	End	
21	0.34	0.34	Earthen Levee	Vegetation	LS U Ma	V2 : Remove the wild growth other than native grasses from the levee slopes. Inspector Comments: Bamboo completely blocks access and visibility. 11/10/2011 Arundo has been trimmed back from the roadway, but still completely blocks access and visibility to the landside slope. This plant was improperly identified as bamboo in previous inspections.	37.809978 ° -121.390704 °	37.809978 ° -121.390704 °	19 Y
DWR ID: DWR_RD2089_01_s_2012_19									
22	0.38	0.38	Earthen Levee	Trim / Thin Trees	LS U Ma	T1 : Trim trees to at least five feet above ground level.	37.809865 ° -121.391303 °	37.809865 ° -121.391303 °	946 Y
DWR ID: DWR_RD2089_01_s_2012_946									
23	0.39	0.39	Earthen Levee	Trim / Thin Trees	LS M Ma	T2 : Thin trees to allow visibility of the ground and room to flood fight.	37.809788 ° -121.391490 °	37.809788 ° -121.391490 °	26 Y

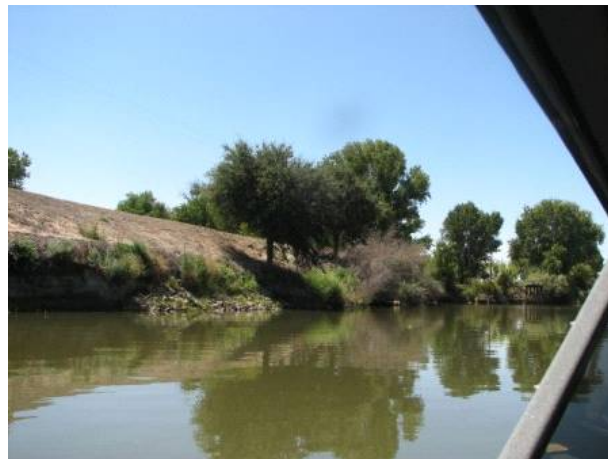
Levee Mile Report Line	24
Start Levee Mile	0.41
End Levee Mile	0.41
Location	Water Side
Category	Supplemental
Item	DWR Erosion Survey

Front view of the repaired site.

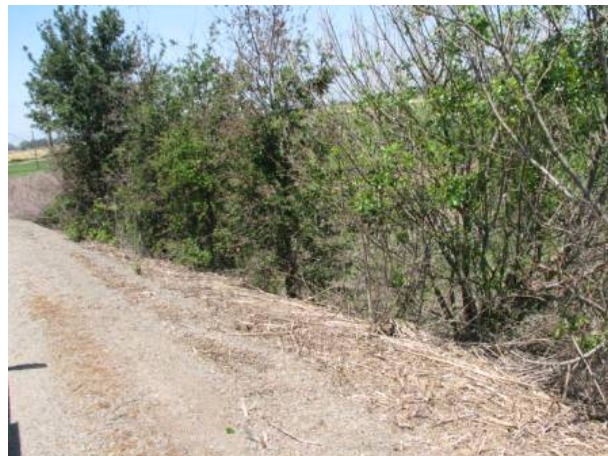
Levee Mile Report Line	32
Start Levee Mile	0.60
End Levee Mile	0.60
Location	Land Side
Category	Earthen Levee
Item	Trim / Thin Trees
05/24/2011 Issue was also noted in Fall 2010 inspection.	
mkhashch_s_20120511_153.jpg

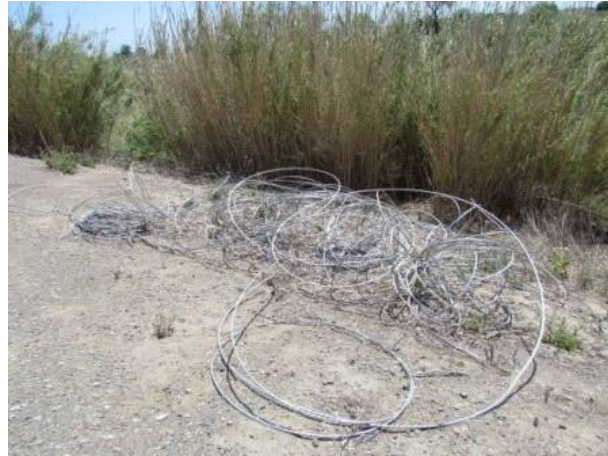
Levee Mile Report Line	49
Start Levee Mile	1.16
End Levee Mile	1.16
Location	Land Side
Category	Earthen Levee
Item	Encroachments

11/10/2011 Section of ductilie iron pipe that  
spears to be left from a pipe repair. Needs to be  
removed.

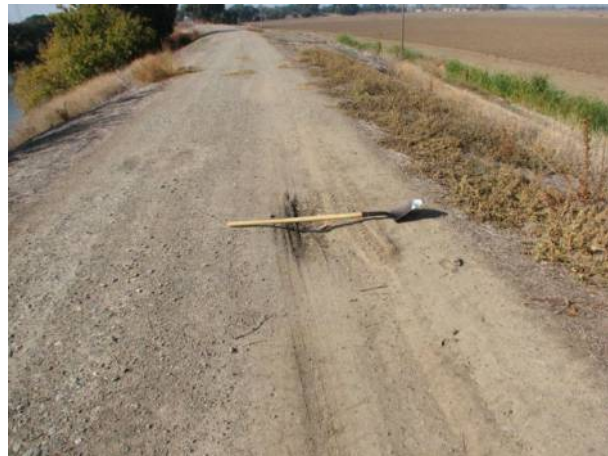
Levee Mile Report Line	55
Start Levee Mile	1.26
End Levee Mile	1.26
Location	Crown
Category	Earthen Levee
Item	Crown Surface / Depressions / Rutting
11/10/2011 Roadway depression.	
mkhashch_s_20120511_127.jpg

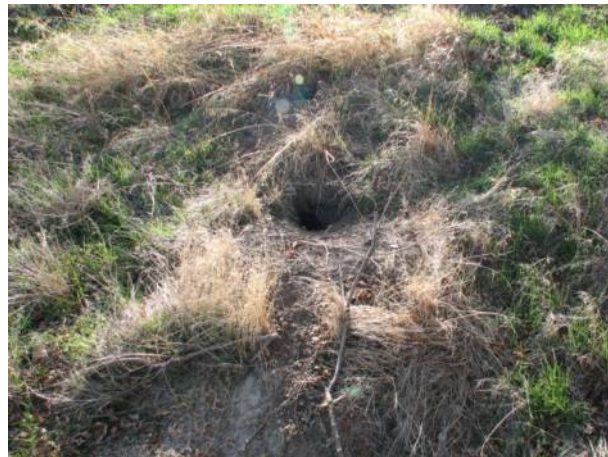
Levee Mile Report Line	57
Start Levee Mile	1.43
End Levee Mile	1.43
Location	Land Side
Category	Earthen Levee
Item	Animal Control
11/10/2011 Active rodent burrow on landside slope.	
mkhashch_s_20120511_130.jpg

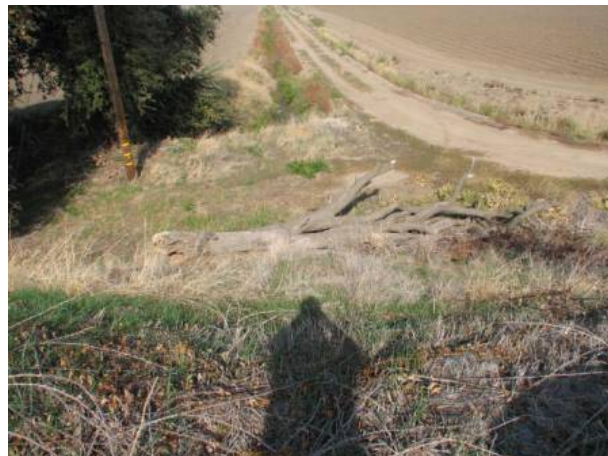
Levee Mile Report Line	58
Start Levee Mile	1.43
End Levee Mile	1.43
Location	Land Side
Category	Earthen Levee
Item	Encroachments
11/10/2011 Downed tree at toe needs to be removed.	
mkhashch_s_20120511_129.jpg

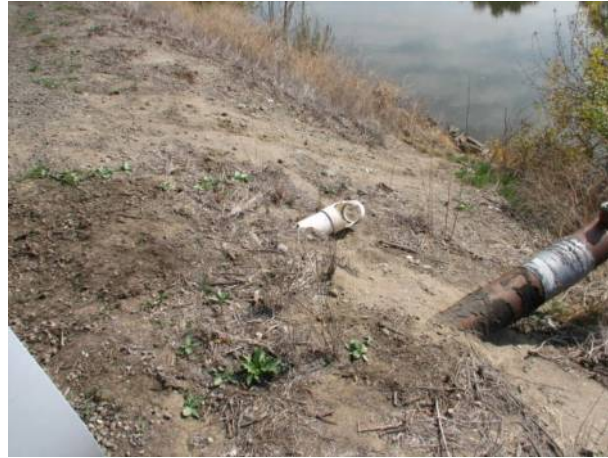
Levee Mile Report Line	59
Start Levee Mile	1.45
End Levee Mile	1.45
Location	Crown
Category	Earthen Levee
Item	Encroachments
11/10/2011 Broken PVC pipe on waterside.	
mkhashch_s_20120511_131.jpg

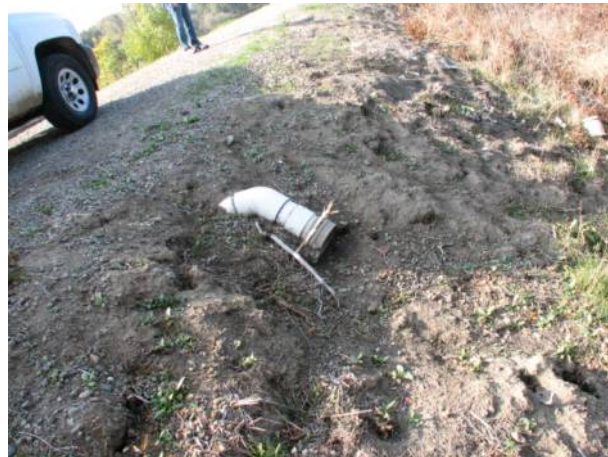
Levee Mile Report Line	59
Start Levee Mile	1.45
End Levee Mile	1.45
Location	Crown
Category	Earthen Levee
Item	Encroachments
11/10/2011 PVC pipe on landside slope. Pipe needs to be removed.	
mkhashch_s_20120511_132.jpg

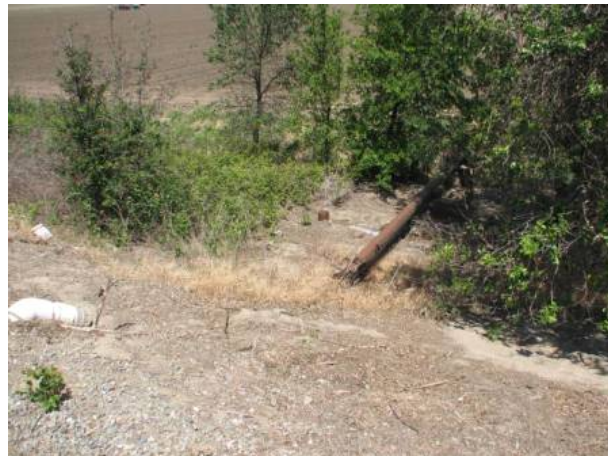
Levee Mile Report Line	60
Start Levee Mile	1.46
End Levee Mile	1.46
Location	Land Side
Category	Earthen Levee
Item	Encroachments
05/24/2011 pipe through levee, not previously noted in inspection.	
mkhashch_s_20120511_123.jpg

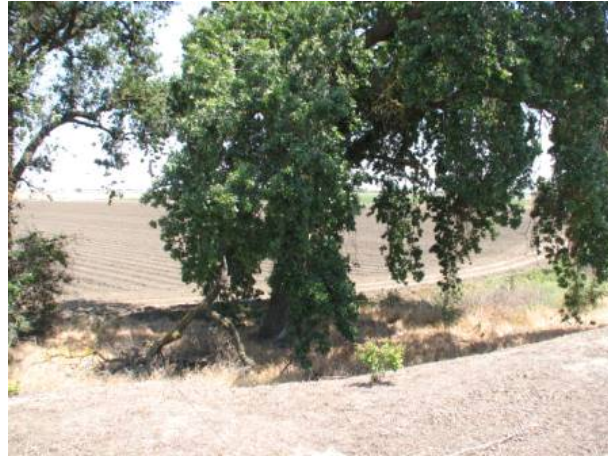
Levee Mile Report Line	2
Start Levee Mile	0.06
End Levee Mile	0.06
Location	Land Side
Category	Earthen Levee
Item	Trim / Thin Trees
05/24/2011 Issue noted in Fall 2010 inspection. Downed limb is visible beneath the overhanging limbs.	
mkhashch_s_20120511_158.jpg

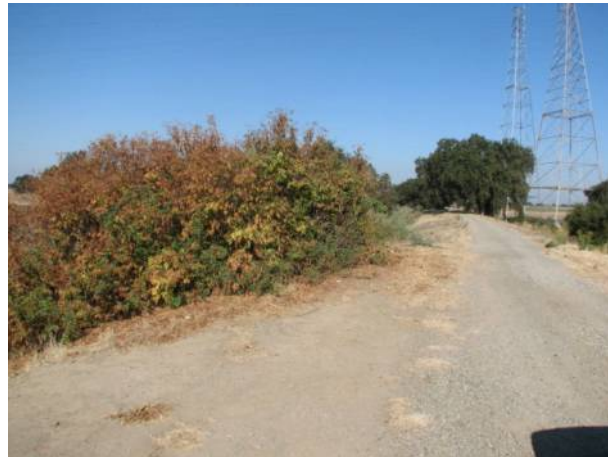
Levee Mile Report Line	3
Start Levee Mile	0.08
End Levee Mile	0.08
Location	Water Side
Category	Earthen Levee
Item	Vegetation
Fall 2009 photo of unacceptable vegetation on levee slope.	
mkhashch_s_20120511_159.jpg

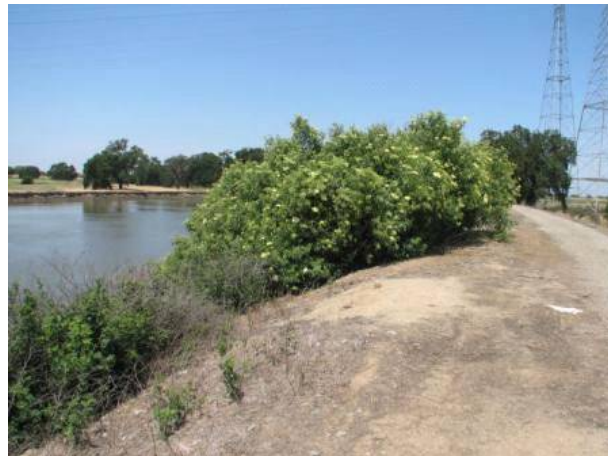
Levee Mile Report Line	3
Start Levee Mile	0.08
End Levee Mile	0.08
Location	Water Side
Category	Earthen Levee
Item	Vegetation
05/24/2011 Updated photo of issue noted in Fall 2010 inspection.	
mkhashch_s_20120511_160.jpg

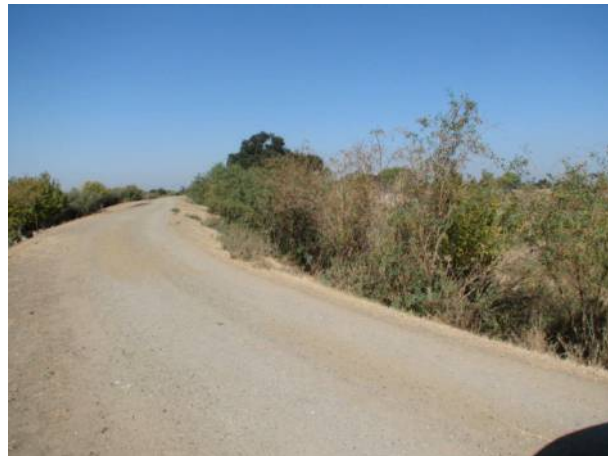
Levee Mile Report Line	7
Start Levee Mile	0.40
End Levee Mile	0.66
Location	Land Side
Category	Earthen Levee
Item	Vegetation
Fall 2009 photo: brush on landside toe limits visibility and accessibility.	
mkhashch_s_20120511_161.jpg

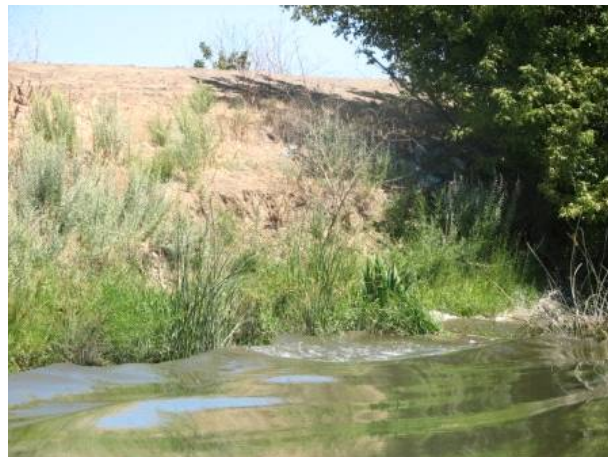
DWR ID: DWR_RD2089_02_s_2012_8										
8	0.42	0.43	Supplemental	DWR Erosion Survey	WS	U	Inspector Comments: 08/23/2011: No significant changes observed on site. 09/07/2010: Site consists of a jutting rip rap that has created an eddy, scouring the levee slope. Most sections of the toe and lower slope are lined with rip rap. However, the rip rap is sloughing on the mid slope and at the toe, exposing the underlying soils and tree roots. The remaining revetment is no longer adequately protecting the slope. There are 3 Sycamore trees at the toe with exposed tree roots. 08/05/2010: Recommended for repair, per CLRO.09/28/2009: Pocket erosion on lower slope just above the toe rip rap; protruding rip rap upstream is creating an eddy, scouring the levee slope; Site # is the same as RM28.40, LM0.30; previously rated "U"; pictures will be made available during the next survey. 11/05/2008: Cut into levee profile; riprap slide; rodent holes; pictures do not match GPS and current condition. [2011 Site ID: RD2089U02RM28.35]	37.809960 ° -121.413200 °	37.809960 ° -121.413200 °	1 Y

Levee Mile Report Line	8
Start Levee Mile	0.42
End Levee Mile	0.43
Location	Water Side
Category	Supplemental
Item	DWR Erosion Survey
Upstream view of the site where minor erosion activities observed.	
mkhashch_s_20120511_154.jpg

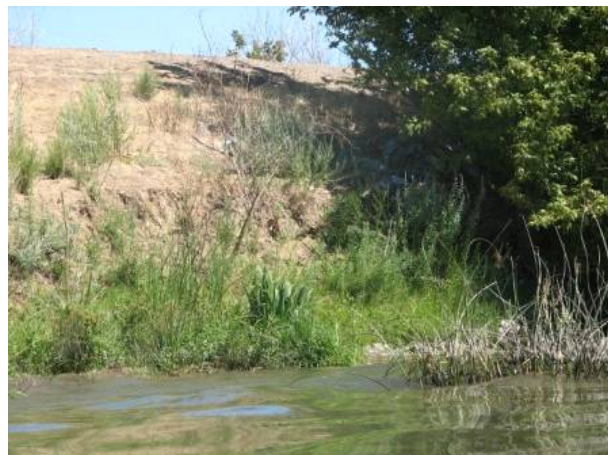
Levee Mile Report Line	8
Start Levee Mile	0.42
End Levee Mile	0.43
Location	Water Side
Category	Supplemental
Item	DWR Erosion Survey
A closer look of the site with minor erosions.	
mkhashch_s_20120511_155.jpg
