**Flood Control Project Maintenance  
Levee Inspections****LMA District Cover Sheet****Spring 2013 Levee Inspection Results****Reclamation District No. 2089 Stark**

**Levee Inspection Report By Mile - Spring 2013**

**Reclamation District No. 2089 Stark**

Waterway				Bank	Unit Miles	Inspection Start/End	Inspector
Unit No. 01 Old River				Right	1.53	05/16/2013 05/16/2013	Maksim Khashchuk

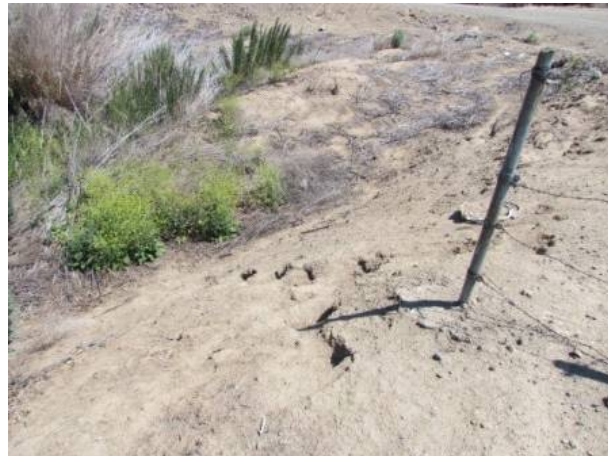
Levee Mile Report Line	8
Start Levee Mile	0.04
End Levee Mile	0.04
Location	Land Side
Category	
Item	Encroachments
View of steps in the landside slope just behind the post. 05/24/2012	
mkhashch_s_20130225_483.jpg

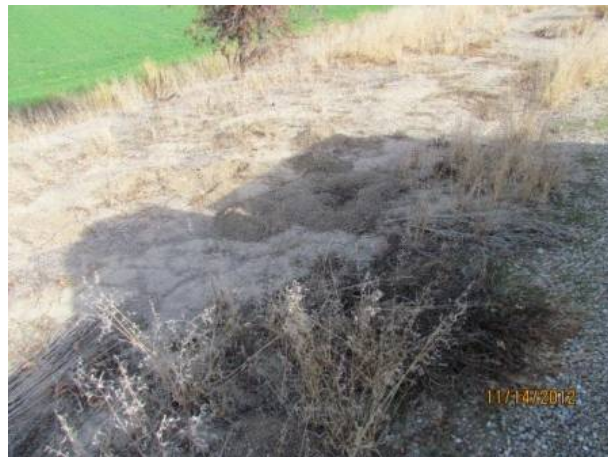
Levee Mile Report Line	11
Start Levee Mile	0.18
End Levee Mile	0.18
Location	Land Side
Category	
Item	Animal Control
View of rodent activity on landside slope.	
mkhashch_s_20130225_517.JPG

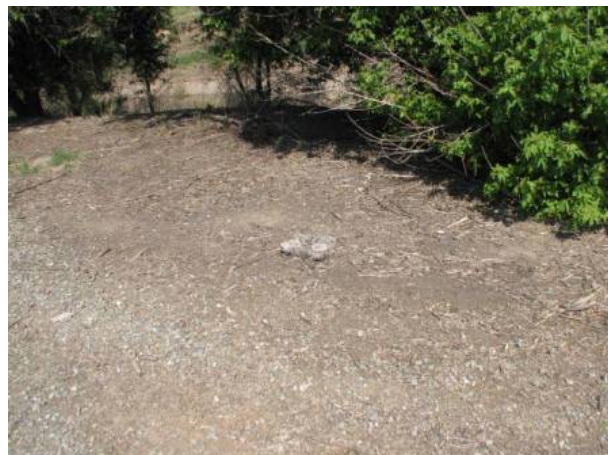
Levee Mile Report Line	13
Start Levee Mile	0.24
End Levee Mile	0.24
Location	Land Side
Category	
Item	Trim / Thin Trees
05/24/2011 Stump shown in center of photo.	
mkhashch_s_20130225_487.jpg

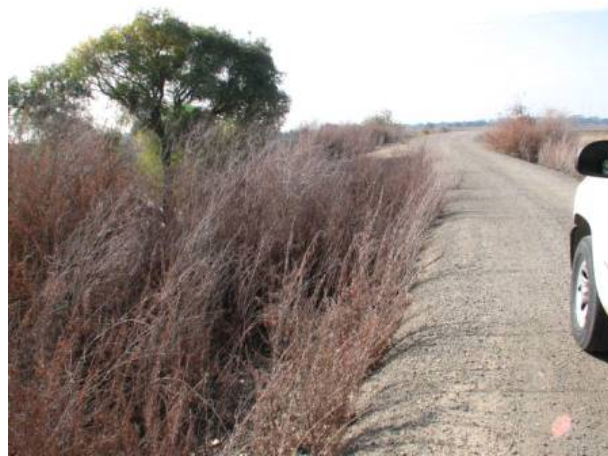
Levee Mile Report Line	31
Start Levee Mile	0.64
End Levee Mile	1.53
Location	Water Side
Category	
Item	Vegetation
11/10/2011 Vegetation needs to be cleared on the upper 20' of the waterside slope.	
mkhashch_s_20130225_499.jpg

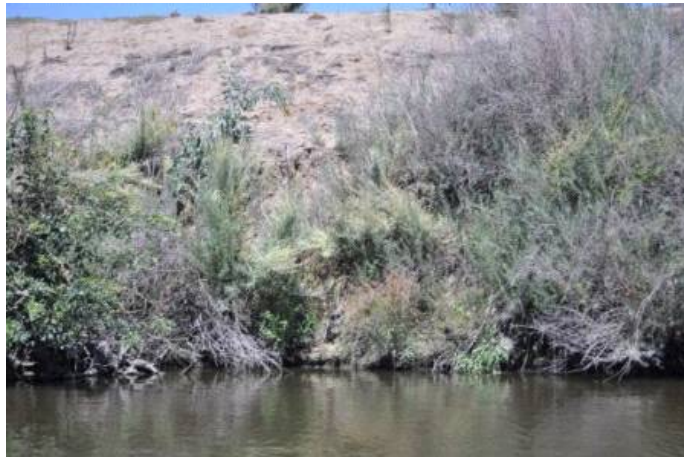
Levee Mile Report Line	33
Start Levee Mile	0.66
End Levee Mile	0.66
Location	Water Side
Category	Supplemental
Item	DWR Erosion Survey
Front view of the site. The scarp is visible on the slope.	
mkhashch_s_20130225_530.jpg

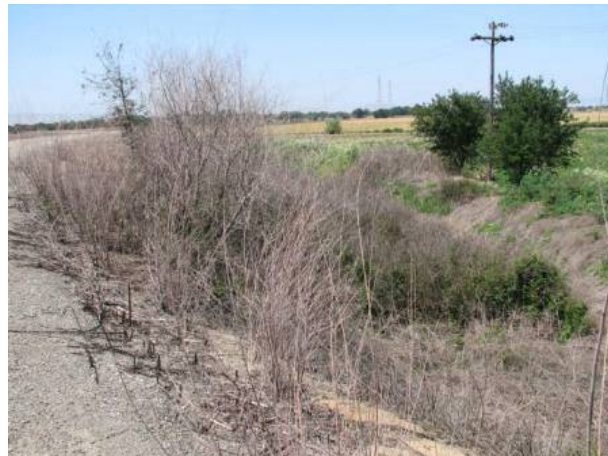
Levee Mile Report Line	34
Start Levee Mile	0.67
End Levee Mile	0.68
Location	Land Side
Category	
Item	Vegetation
05/24/2011 Vegetation is mostly dead but needs to be removed to allow access and visibility of slope and toe.	
mkhashch_s_20130225_511.jpg

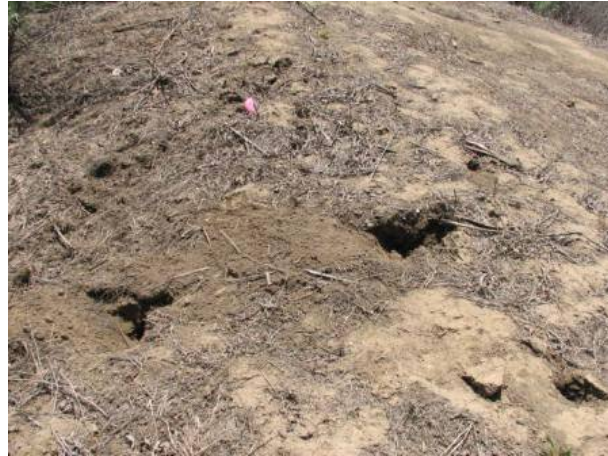
Levee Mile Report Line	35
Start Levee Mile	0.67
End Levee Mile	0.67
Location	Water Side
Category	
Item	Animal Control
05/24/2011 Two active burrows shown in photo.	
mkhashch_s_20130225_512.jpg

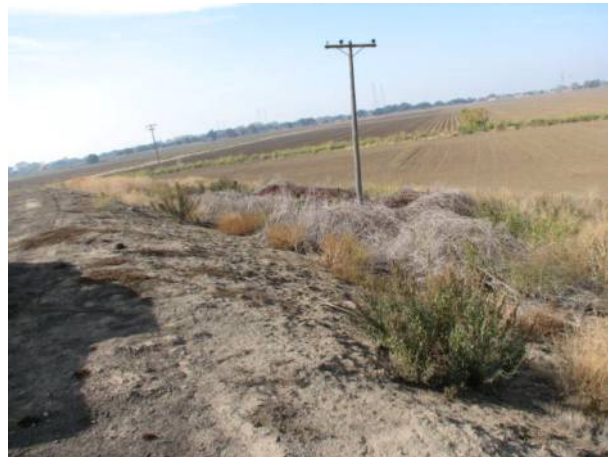
Levee Mile Report Line	36
Start Levee Mile	0.73
End Levee Mile	0.77
Location	Land Side
Category	
Item	Vegetation
11/10/2011 Vegetation obstructs visibility of slope and toe.	
mkhashch_s_20130225_501.jpg

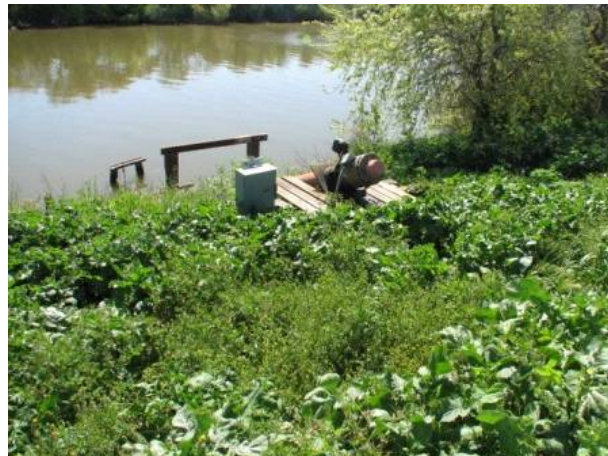
Levee Mile Report Line	37
Start Levee Mile	0.82
End Levee Mile	0.82
Location	Water Side
Category	
Item	Encroachments
Irrigation intake pump and pipe on levee slope.	
mkhashch_s_20130225_494.jpg

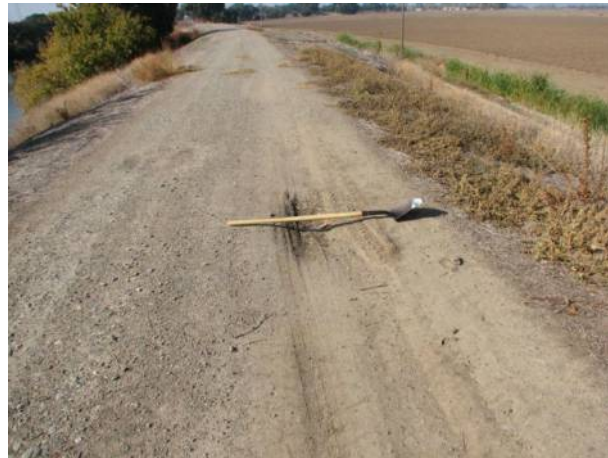
Levee Mile Report Line	52
Start Levee Mile	1.26
End Levee Mile	1.26
Location	Crown
Category	
Item	Crown Surface / Depressions / Rutting
11/10/2011 Roadway depression.	
mkhashch_s_20130225_522.jpg

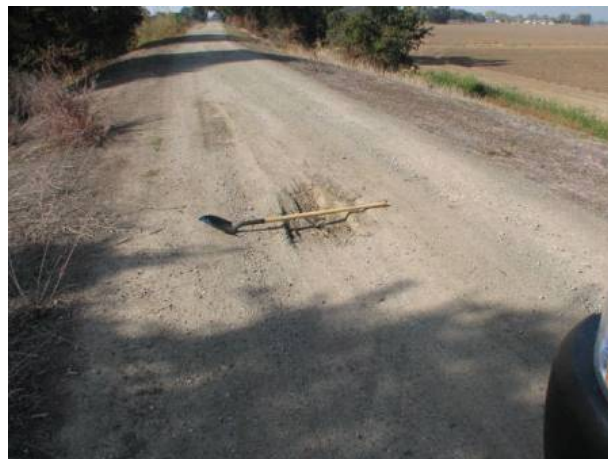
Levee Mile Report Line	53
Start Levee Mile	1.38
End Levee Mile	1.38
Location	Crown
Category	
Item	Crown Surface / Depressions / Rutting
11//10/2011 Roadway depression.	
mkhashch_s_20130225_523.jpg

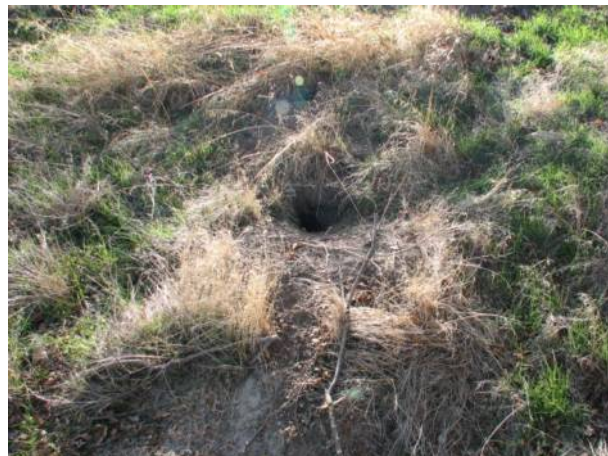
Levee Mile Report Line	54
Start Levee Mile	1.43
End Levee Mile	1.43
Location	Land Side
Category	
Item	Animal Control
11/10/2011 Active rodent burrow on landside slope.	
mkhashch_s_20130225_525.jpg

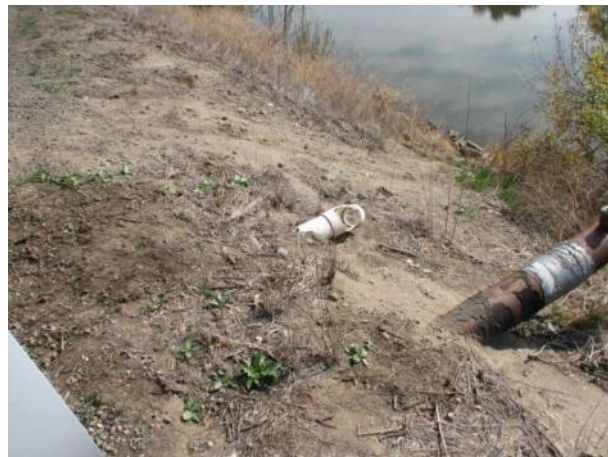
Levee Mile Report Line	56
Start Levee Mile	1.45
End Levee Mile	1.45
Location	Crown
Category	
Item	Encroachments
11/10/2011 Broken PVC pipe on waterside.	
mkhashch_s_20130225_526.jpg

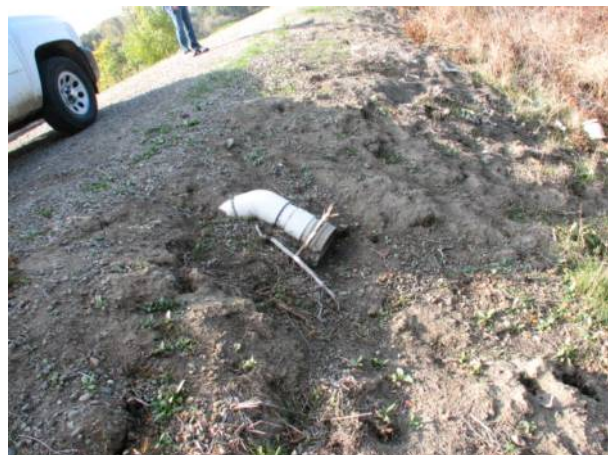
Levee Mile Report Line	56
Start Levee Mile	1.45
End Levee Mile	1.45
Location	Crown
Category	
Item	Encroachments
11/10/2011 PVC pipe on landside slope. Pipe needs to be removed.	
mkhashch_s_20130225_527.jpg

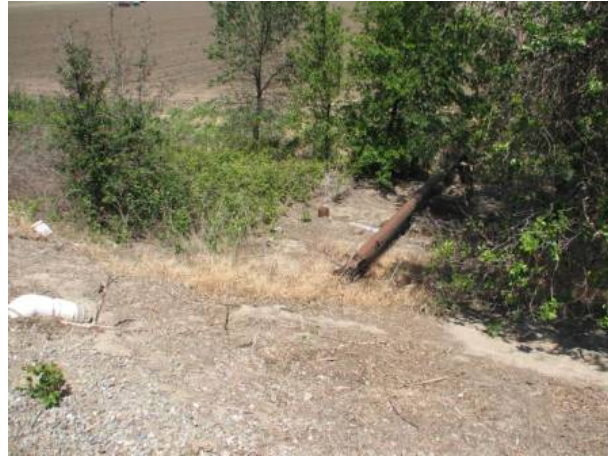
Levee Mile Report Line	57
Start Levee Mile	1.46
End Levee Mile	1.46
Location	Land Side
Category	
Item	Encroachments
05/24/2011 Pipe through levee, not previously noted in inspection.	
mkhashch_s_20130225_518.jpg

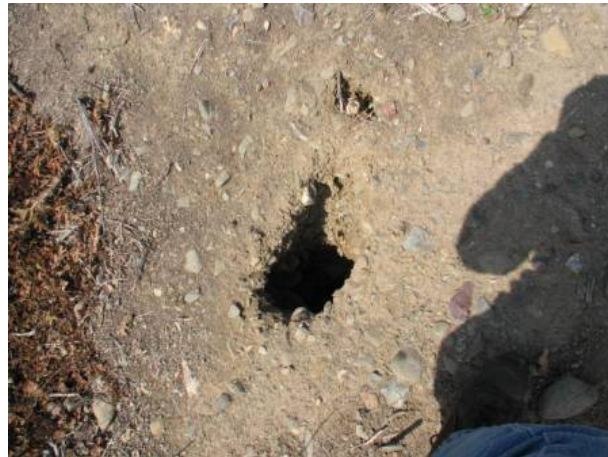
Levee Mile Report Line	58
Start Levee Mile	1.47
End Levee Mile	1.47
Location	Water Side
Category	
Item	Animal Control
11/10/2011 Deep burrow on waterside.	
mkhashch_s_20130225_528.jpg

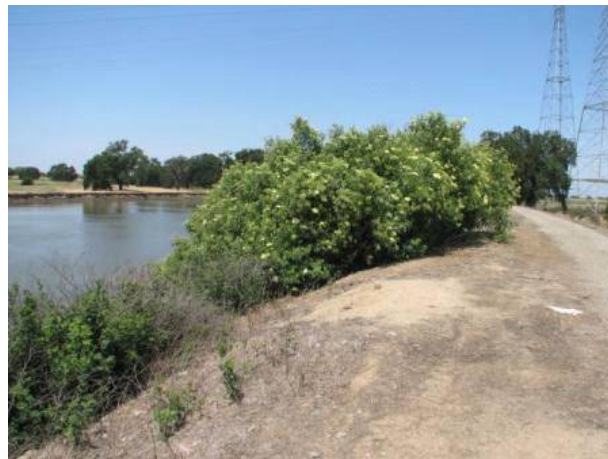
Levee Mile Report Line	3
Start Levee Mile	0.08
End Levee Mile	0.08
Location	Water Side
Category	
Item	Vegetation
05/24/2011 Updated photo of issue noted in Fall 2010 inspection.	
mkhashch_s_20130225_542.jpg

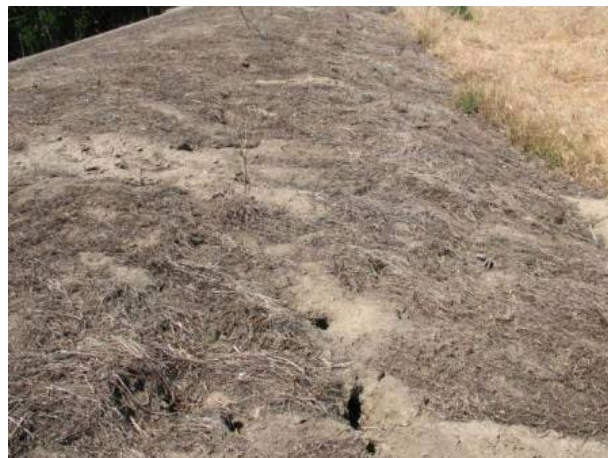
Levee Mile Report Line	4
Start Levee Mile	0.28
End Levee Mile	0.28
Location	Land Side
Category	
Item	Animal Control
05/24/2011 Active burrows, ground squirrel sighted in area.	
mkhashch_s_20130225_552.jpg

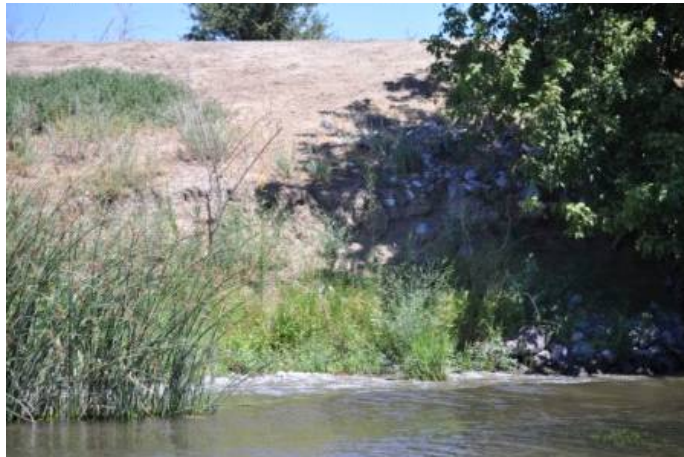
Levee Mile Report Line	8
Start Levee Mile	0.42
End Levee Mile	0.43
Location	Water Side
Category	Supplemental
Item	DWR Erosion Survey
Close view of the site	
mkhashch_s_20130225_538.jpg

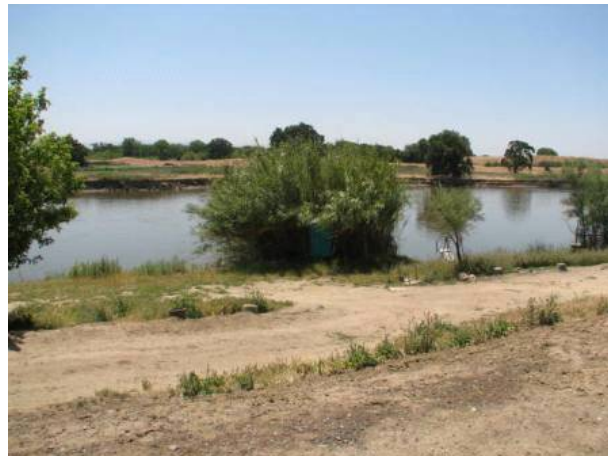
Levee Mile Report Line	9
Start Levee Mile	0.46
End Levee Mile	0.46
Location	Water Side
Category	
Item	Encroachments
05/24/2011 Portable toilet is in the shadows in the center of the photo at the water's edge.	
mkhashch_s_20130225_554.jpg

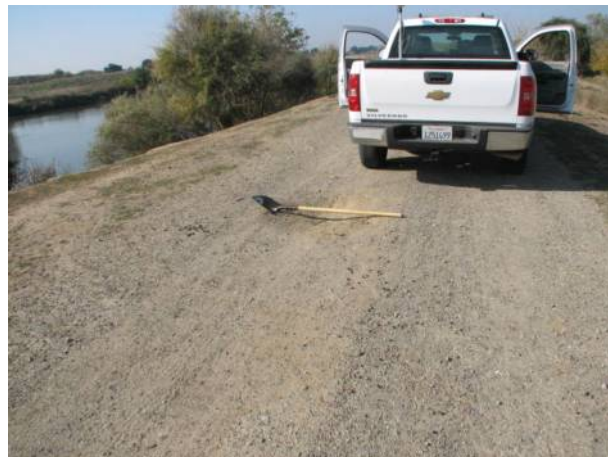
Levee Mile Report Line	11
Start Levee Mile	0.49
End Levee Mile	0.49
Location	Crown
Category	
Item	Crown Surface / Depressions / Rutting
11/10/2011 Depression in crown needs to be filled.	
mkhashch_s_20130225_545.jpg

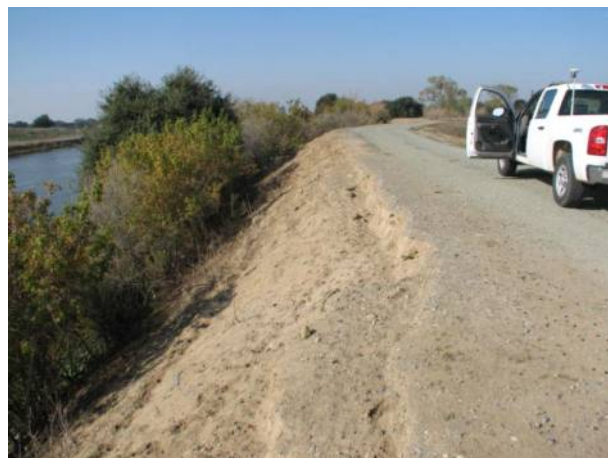
Levee Mile Report Line	12
Start Levee Mile	0.54
End Levee Mile	0.54
Location	Water Side
Category	
Item	Animal Control
11/10/2011 Approximately 1' scarp has been created by livestock travel.	
mkhashch_s_20130225_548.jpg

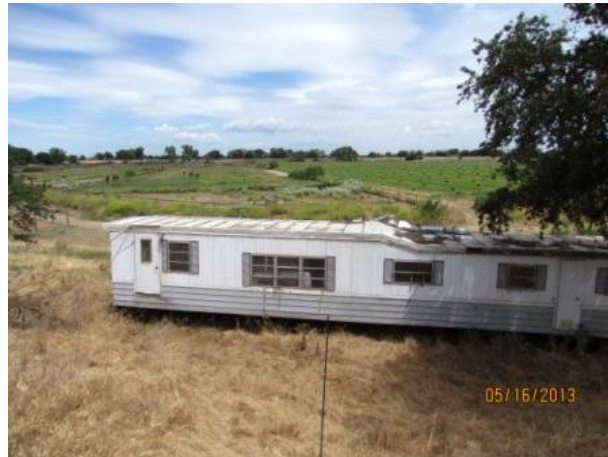
Levee Mile Report Line	23
Start Levee Mile	0.99
End Levee Mile	0.99
Location	Land Side
Category	
Item	Encroachments
View of the mobile home at the landside toe.	
mkhashch_s_20130520_741.JPG

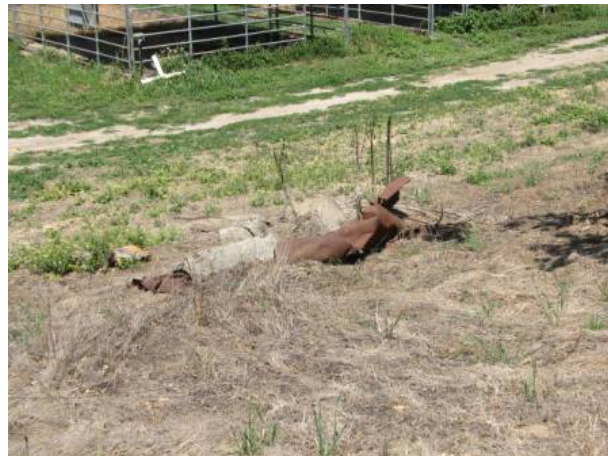
Levee Mile Report Line	24
Start Levee Mile	0.99
End Levee Mile	0.99
Location	Land Side
Category	
Item	Encroachments
05/24/2011 Concrete and metal debris at landside toe needs to be removed.	
mkhashch_s_20130225_555.jpg

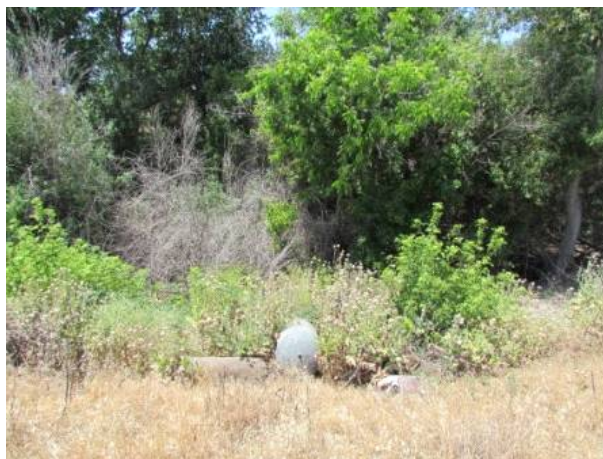
Levee Mile Report Line	27
Start Levee Mile	1.10
End Levee Mile	1.10
Location	Water Side
Category	
Item	Encroachments
View of water tanks disposed on waterside slope.	
mkhashch_s_20130225_549.jpg

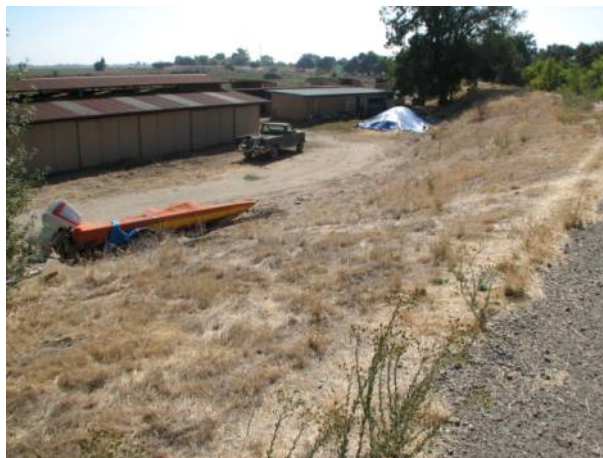
Levee Mile Report Line	30
Start Levee Mile	1.28
End Levee Mile	1.33
Location	Land Side
Category	
Item	Encroachments
Fall 2009 photo: Boat and equipment stored within 10-ft of levee slope are an encroachment.	
mkhashch_s_20130225_550.jpg
