**Flood Control Project Maintenance
Levee Inspections****LMA District Cover Sheet****Spring 2014 Levee Inspection Results****Reclamation District No. 2089 Stark**

Spring 2014 Levee Inspection Results

Reclamation District No. 2089 Stark

| Waterway | | | Bank | Unit Miles |
|--|---|---|---|---|
| Unit No. 01 Old River | | | Right | 1.53 |

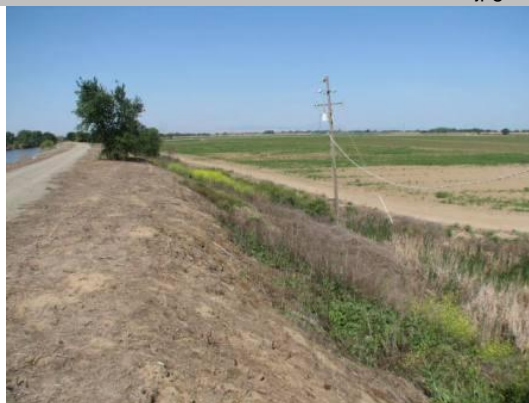
Photo 1 of 1 : mkhashch_s_20140428_00713.jpg

| Ditch | | | | | |
| Inspector Comments: 05/24/2011 Photo added of Ag ditch. | | | | | |

05/24/2011 Ditch flows parallel with the utility line shown in the photo.

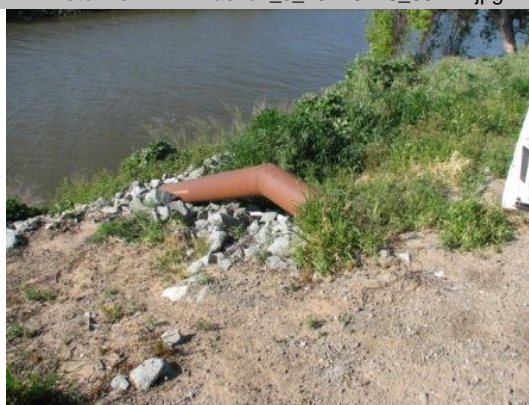
Photo 1 of 1 : mkhashch_s_20140428_00712.jpg

Waterside of drainage discharge to Old River.

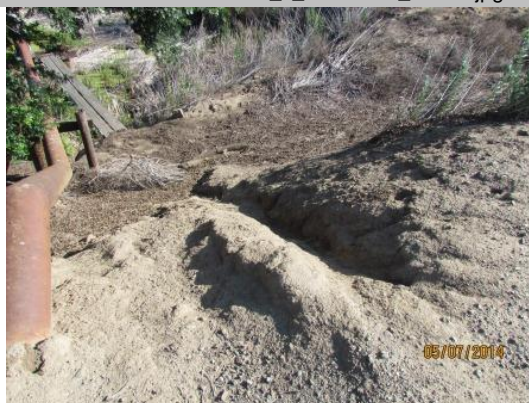
Photo 1 of 1 : mkhashch_s_20140512_00986.jpg

View of the stairs eroding into the landside levee slope.

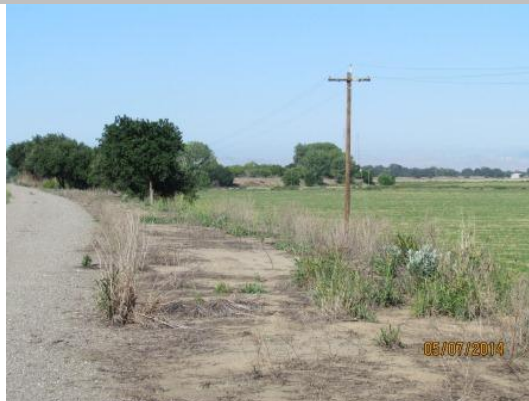
Photo 1 of 1 : mkhashch_s_20140512_00987.jpg

View of the tall vegetation obstructing visibility of the landside levee slope.

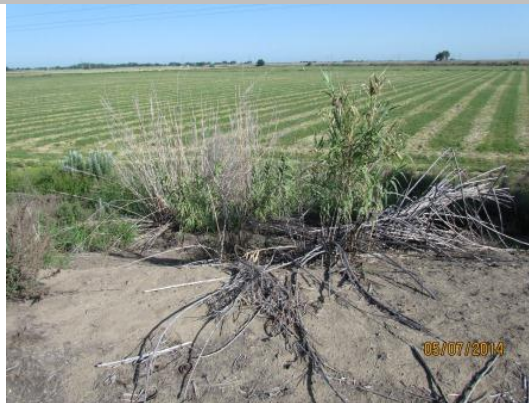
Photo 1 of 1 : mkhashch_s_20140512_00988.jpg

The LMA is actively trying to remove the vegetation on the landside levee slope and toe.

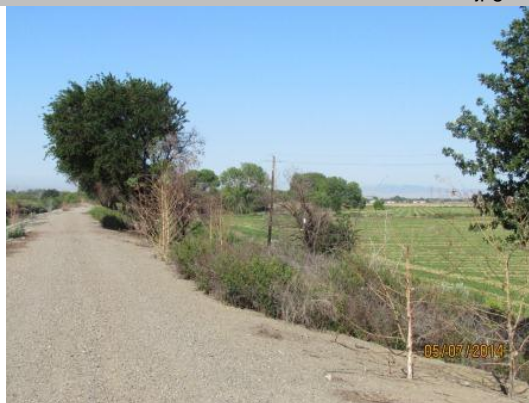
Photo 1 of 1 : mkhashch_s_20140512_00989.jpg

Thick brush and wild rose completely block access and visibility of landside slope and toe.

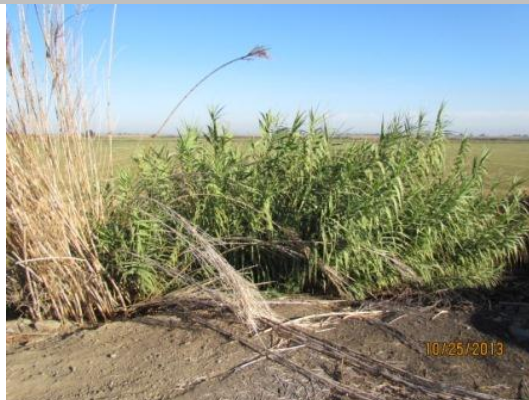
Photo 1 of 1 : mkhashch_s_20140428_00719.jpg

| Remove the wild growth other than native grasses from the levee slopes. Inspector Comments: Bamboo completely blocks access and visibility.11/10/2011 Arundo has been trimmed back from the roadway, but still completely blocks access and visibilito to the landside slope. This plant was improperly identified as bamboo in previous inspections. | | | | | |

Arundo has been trimmed back from the road, but needs to be removed to so that it does not obstruct visibility and access to the landside toe.

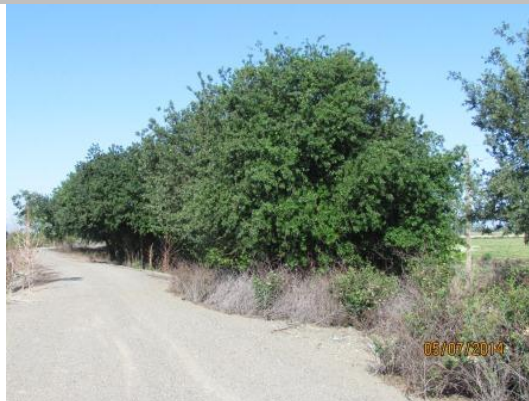
Photo 1 of 1 : mkhashch_s_20140512_00990.jpg

Trees on levee slope obstruct access and visibility.

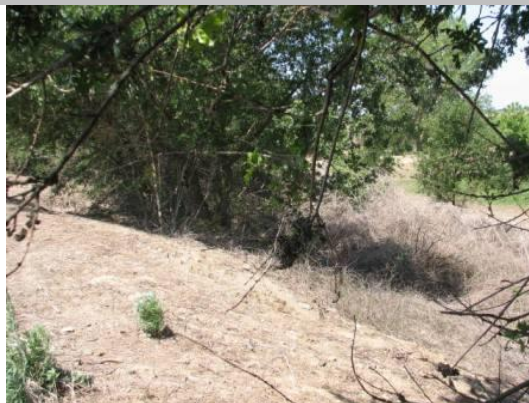
Photo 1 of 1 : mkhashch_s_20140428_00723.jpg

05/24/2011 Photo shows thick dead vegetation and continuation of trees in area that are preventing access and visibility of landside slope and toe.

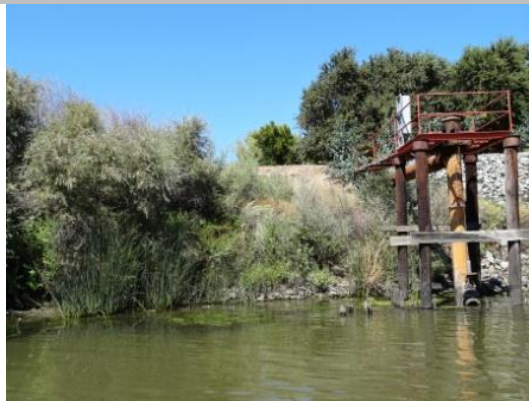
Photo 1 of 1 : mkhashch_s_20140428_00709.jpg

| Inspector Comments: 08/13/2013: No significant change observed. 08/07/2012: The site has been visited by boat survey. No significant change observed 08/23/2011: The site shows loose material around the pipe crossing. The operation of the pipe might have caused an impact on the levee. [2013 Site ID:RD2089U01RM29.8] | | | | | |

Front view of the site.

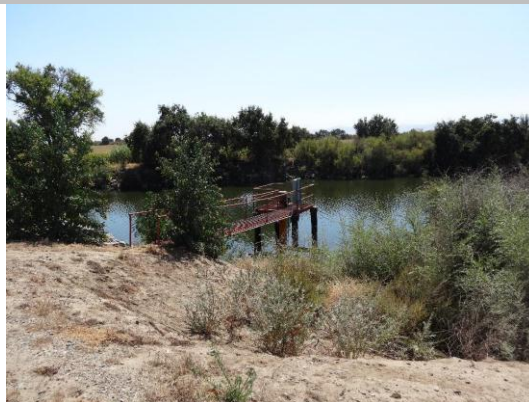
Photo 1 of 1 : UCIP_2649.jpg

| Inspector Comments: FS_ID:21635 EP_NO: 5641 Repair Type: Crossing Status: UCIP Comments: - damaged siphon breaker.most of the pipe on landside exposed on levee slope. FIELD_STRUCT_DESC: 20-inch steel pipe and electric conduit through the levee, 5.8 feet below the crown, pump on pile structure in the stream. Siphon breaker on the landward slope. (App. No. 5641- Ted Stark) FS Date: 9/12/2013 | | | | | |

WS view: walkway to pump platform and pump on steel piling structure in the channel.

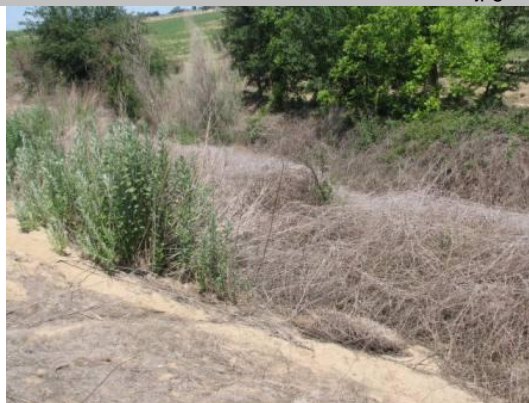
Photo 1 of 1 : mkhashch_s_20140428_00724.jpg

05/24/2011 Dead brush is too thick to allow access and visibility of landside slope and toe.

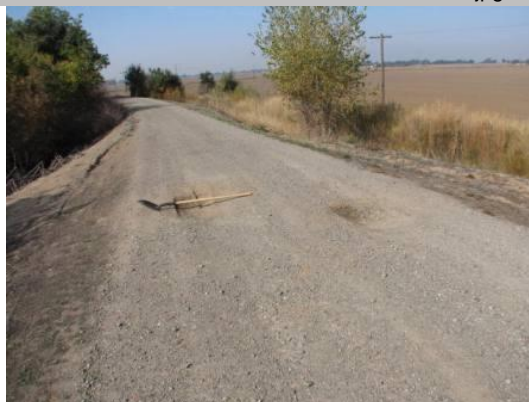
Photo 1 of 1 : mkhashch_s_20140428_00717.jpg

| Add appropriate gravel or road base. Grade and compact. Inspector Comments: 11/10/2011 Minor depressions will cause ponding. | | | | | |

11/10/2011 Depressions in crown.

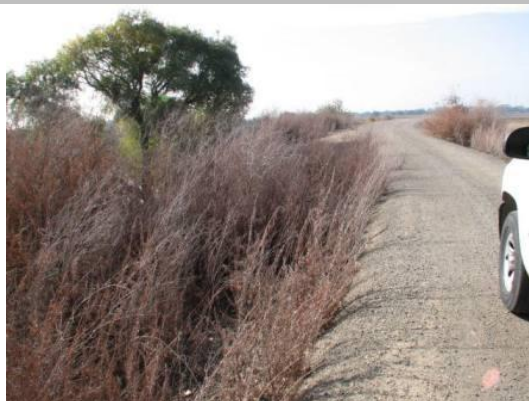
Photo 1 of 1 : mkhashch_s_20140428_00718.jpg

11/10/2011 Vegetation needs to be cleared on the upper 20' of the waterside slope.

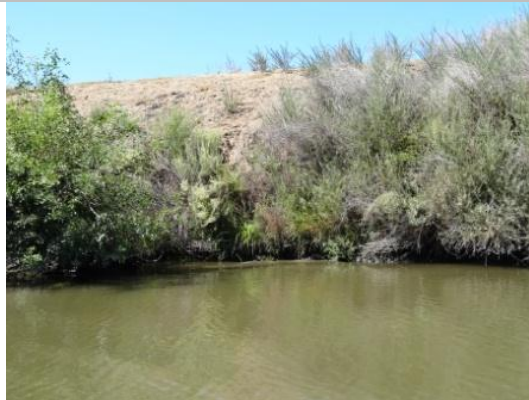
Photo 1 of 1 : mkhashch_s_20140428_00710.jpg

| Inspector Comments: 08/13/2013: No significant change observed. 08/07/2012: The site has been visited by boat survey. No significant change observed 08/23/2011: The 5-foot vertical scarp shows no significant change from the last year inspection. No new erosion activities observed. Dense white willow trees on site. 09/07/2010: It was difficult to view the erosion due to the thick Willow thickets and other vegetation at the water line. At the time of the inspection, there were no signs of repair on site. As noted during the last survey, there is a 5-foot vertical scarp along the lower slope that may be subjected to high flow velocities. 08/05/2010: Recommended for repair, per CLRO; "Erosion of this site may be subjective to rapid rates of erosion." 09/28/2009: No major change observed; 5-foot vertical scarp is immediately downstream of where berm has tapered; site is recommended as local maintenance issue, per CLRO CES Evaluation 2008 Report; Site # is the same as RM29.6, LM0.60; previously rated "U". 11/05/2008: No change observed; rodent holes on lower slope; wide levee crown. [2013 Site ID:RD2089U01RM29.61] | | | | | |

Front view of the site. The scarp is visible on the slope.

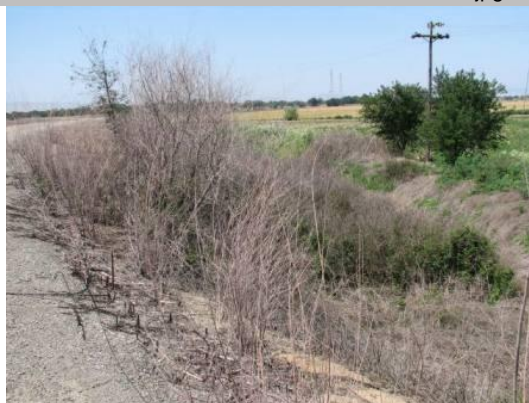
Photo 1 of 1 : mkhashch_s_20140428_00725.jpg

05/24/2011 Vegetation is mostly dead but needs to be removed to allow access and visibility of slope and toe.

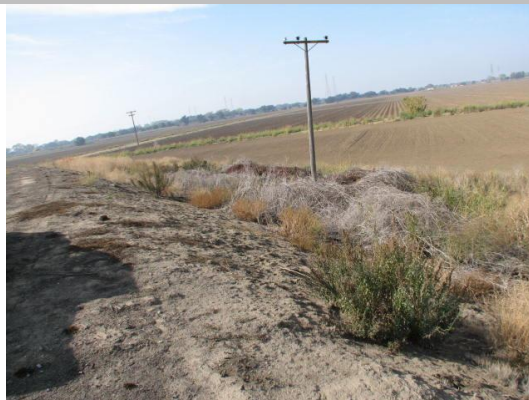
Photo 1 of 1 : mkhashch_s_20140428_00720.jpg

11/10/2011 Vegetation obstructs visibility of slope and toe.

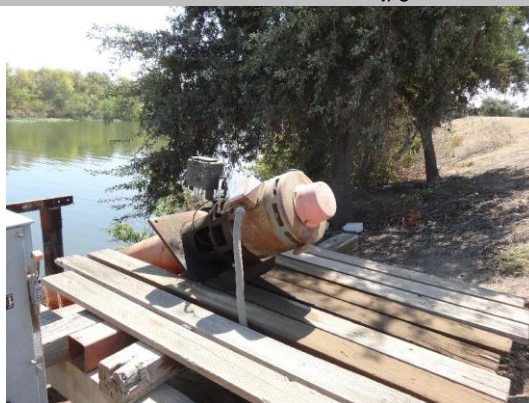
Photo 1 of 1 : UCIP_2562.jpg

WS view: slant pump on wooden platform. Oil leaks from the pump.

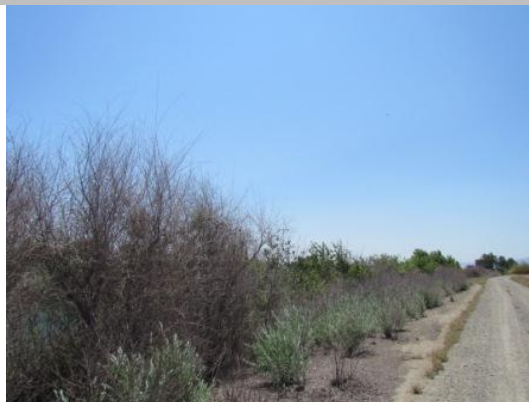
Photo 1 of 1 : mkhashch_s_20140428_00728.jpg

View of tall weeds and brush obstructing visibility on waterside slope.
05/24/2012

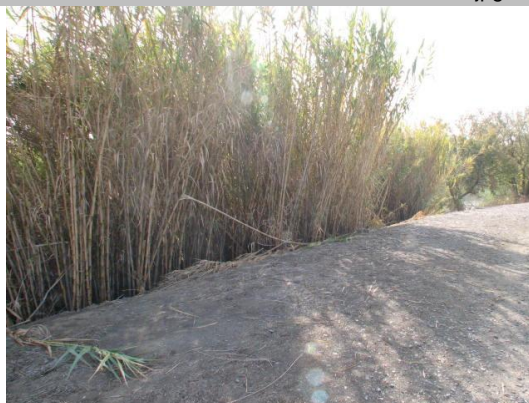
Photo 1 of 1 : mkhashch_s_20140428_00726.jpg

11/10/2011 Arundo on upper 20' of waterside slope.

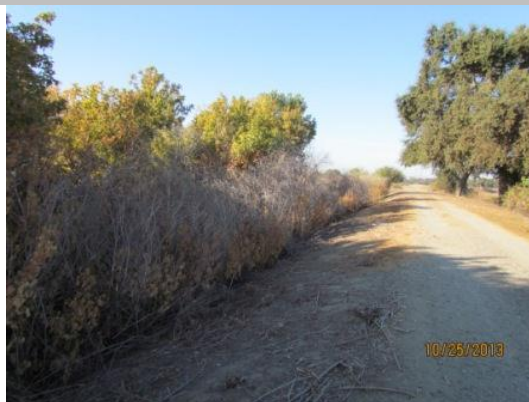
Photo 1 of 1 : mkhashch_s_20140428_00727.jpg

Thick vegetation on upper 20' of waterside slope obstructing visibility and access.

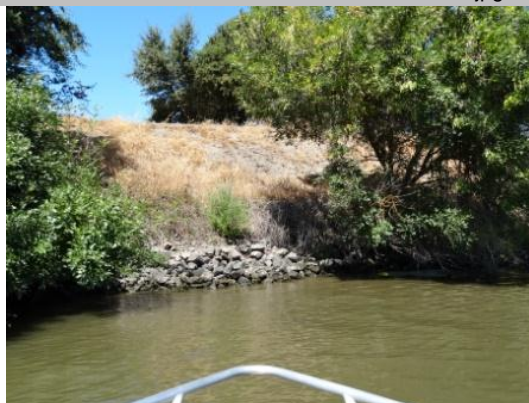
Photo 1 of 1 : mkhashch_s_20140428_00711.jpg

Close view of the site. Note the tree and the vegetation.

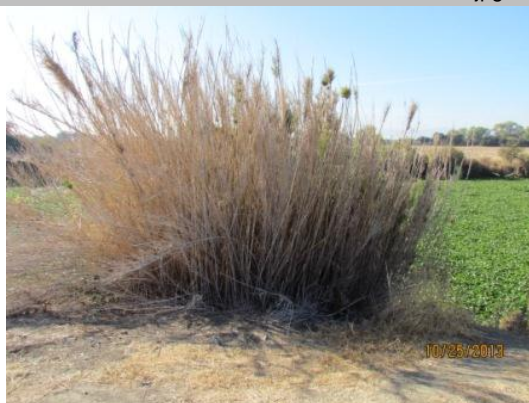
Photo 1 of 1 : mkhashch_s_20140428_00722.jpg

View of the Arundo on the waterside slope obstructing visibility. LMA is actively trying to remove the wild growth.

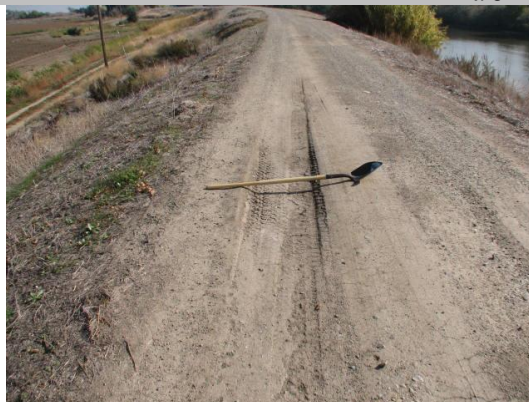
Photo 1 of 1 : mkhashch_s_20140428_00731.jpg

11/10/2011 Depression in roadway.

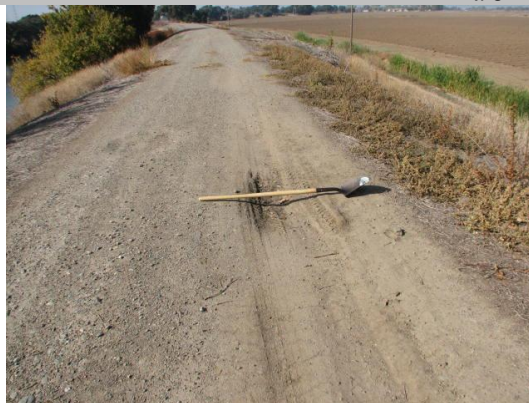
Photo 1 of 1 : mkhashch_s_20140428_00732.jpg

11/10/2011 Roadway depression.

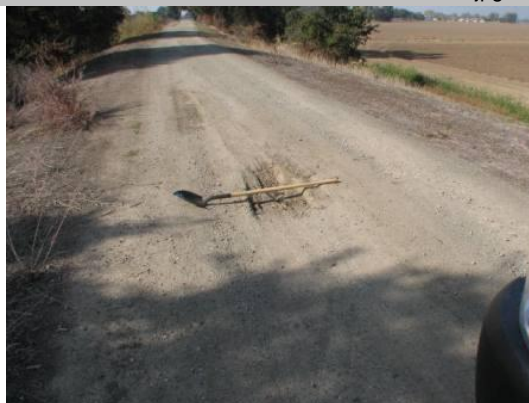
Photo 1 of 1 : mkhashch_s_20140428_00733.jpg

11//10/2011 Roadway depression.

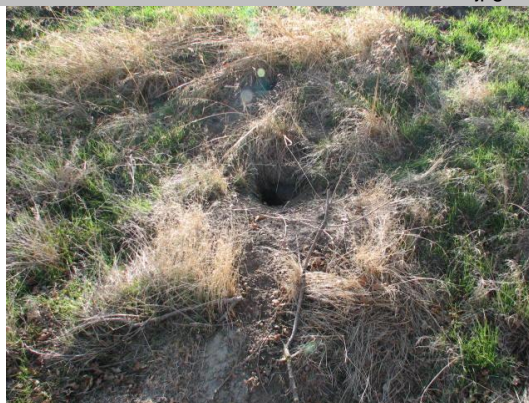
Photo 1 of 1 : mkhashch_s_20140428_00735.jpg

11/10/2011 Active rodent burrow on landside slope.

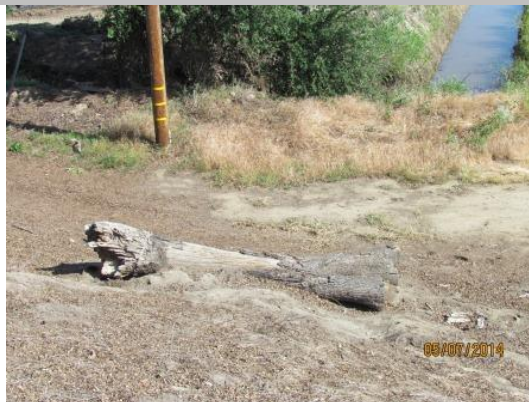
Photo 1 of 1 : mkhashch_s_20140512_00991.jpg

Decaying tree at the landside levee toe is obstructing visibility and access.

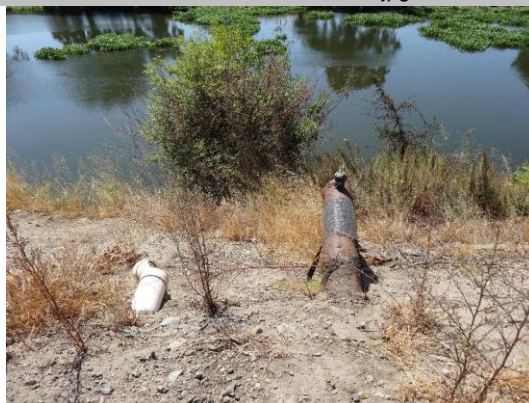
Photo 1 of 1 : UCIP_2552.jpg

WS view: 6-inch pvc pipe on levee slope. Pipe end open and damaged.

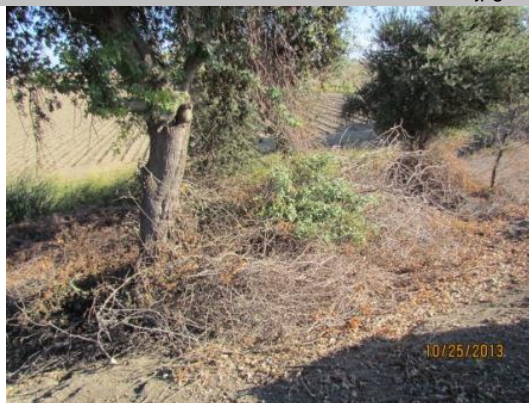
Photo 1 of 1 : mkhashch_s_20140428_00739.jpg

View of the tree branches obstructing landside levee slope.

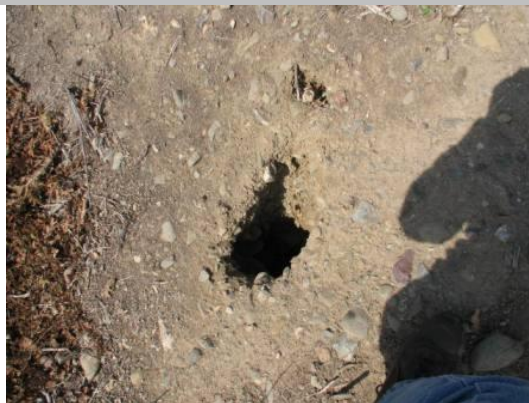
Photo 1 of 1 : mkhashch_s_20140428_00738.jpg

11/10/2011 Deep burrow on waterside.

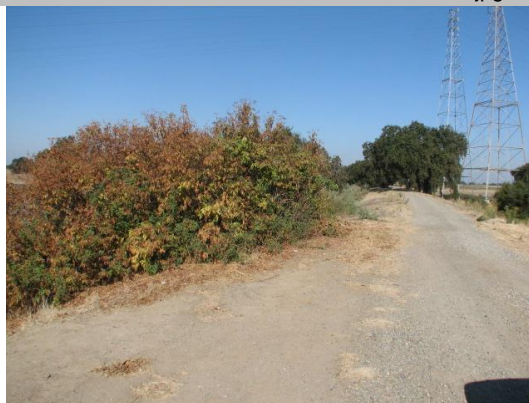
Photo 1 of 2 : mkhashch_s_20140428_00748.jpg

Fall 2009 photo of unacceptable vegetation on levee slope.

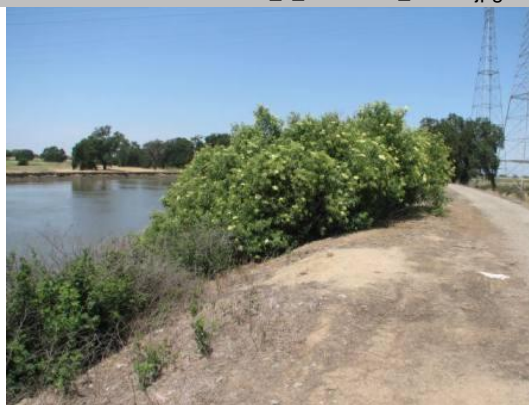
Photo 2 of 2 : mkhashch_s_20140428_00749.jpg

05/24/2011 Updated photo of issue noted in Fall 2010 inspection.

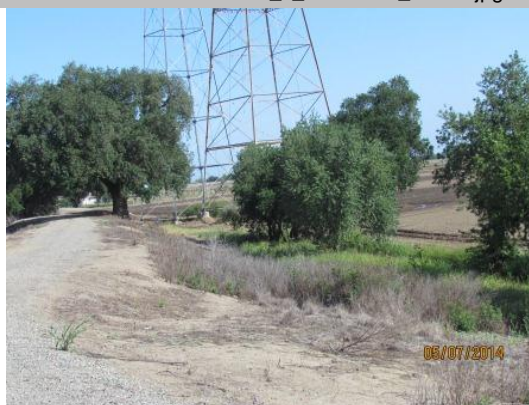
Photo 1 of 1 : mkhashch_s_20140512_00992.jpg

View of the vegetation on the landside levee slope.

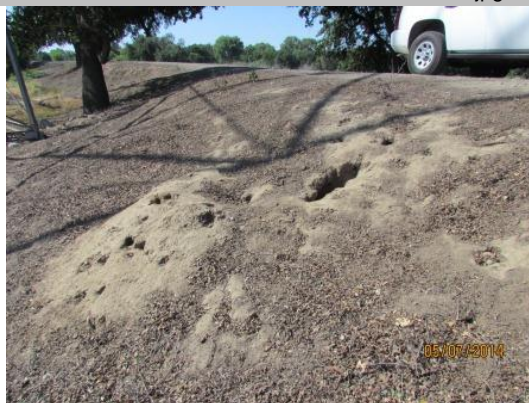
Photo 1 of 1 : mkhashch_s_20140512_00993.jpg

View of the rodent burrow on the landside levee slope.

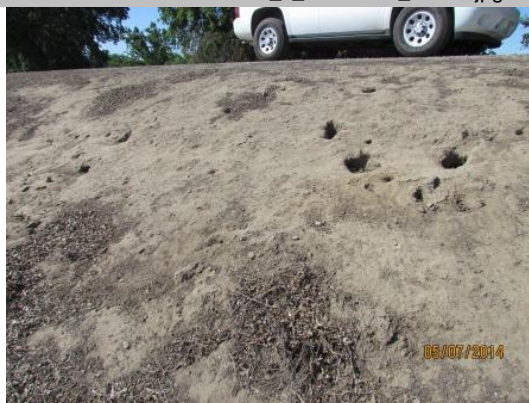
Photo 1 of 1 : mkhashch_s_20140512_00994.jpg

View of the multiple rodent burrows on the landside levee hinge and slope.

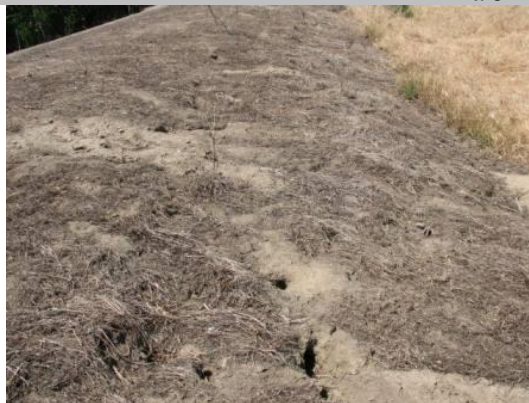
Photo 1 of 1 : mkhashch_s_20140428_00759.jpg

05/24/2011 Active burrows, ground squirrel sighted in area.

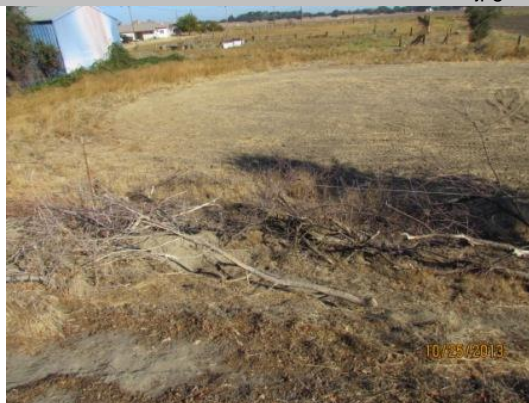
Photo 1 of 1 : mkhashch_s_20140428_00770.jpg

View of the tree branches on the landside levee toe obstructing access.

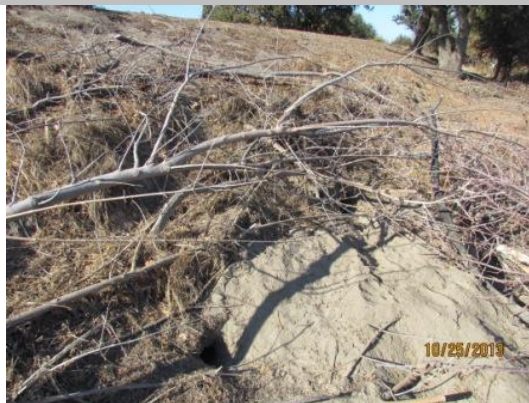
Photo 1 of 1 : mkhashch_s_20140428_00769.jpg

View of the rodent burrow on the landside levee toe.

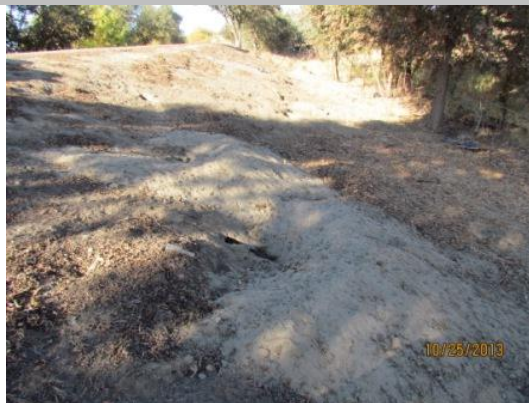
Photo 1 of 3 : mkhashch_s_20140428_00771.jpg

View of the multiple rodent burrows on the landside levee slope.

| Exterminate rodents and backfill and compact or grout burrows. Inspector Comments: Exterminating rodents and grouting the burros recommended. | | | | | |

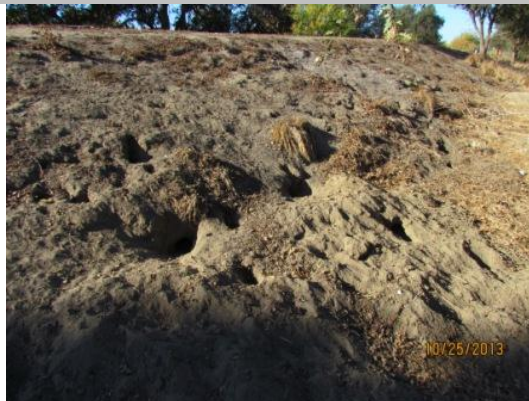
Photo 2 of 3 : mkhashch_s_20140428_00772.jpg

Another view of the multiple rodent burrows on the landside levee slope.

| Exterminate rodents and backfill and compact or grout burrows. Inspector Comments: Exterminating rodents and grouting the burros recommended. | | | | | |

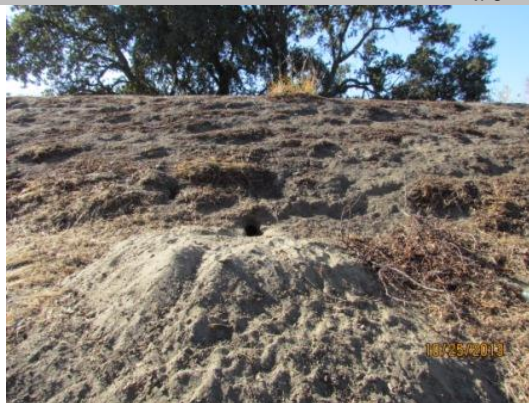
Photo 3 of 3 : mkhashch_s_20140428_00773.jpg

View of the rodent burrow on the landside levee slope.

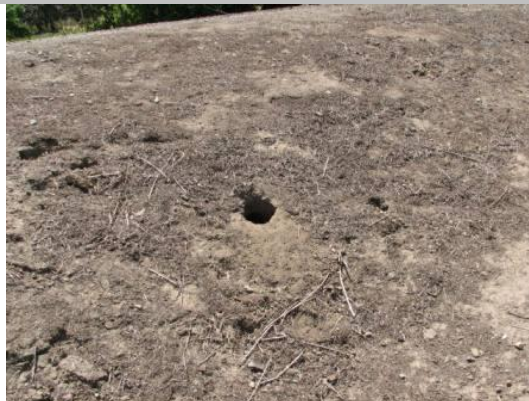
Photo 1 of 1 : mkhashch_s_20140428_00760.jpg

05/24/2011 Active rodent burrow.

| No rodents visible, but rodent burrows visible; need to backfill and compact or grout burrows. Inspector Comments: Active burrow needs to be repaired. | | | | | |

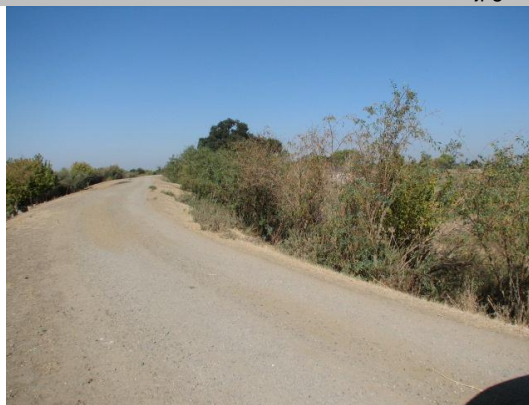
Photo 1 of 2 : mkhashch_s_20140428_00750.jpg

Fall 2009 photo: Brush on landside toe limits visibility and accessibility.

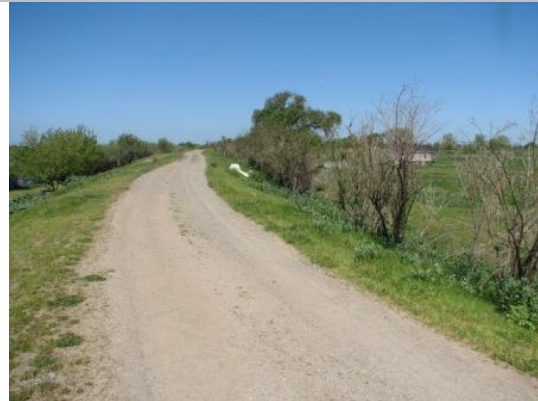
Photo 2 of 2 : mkhashch_s_20140428_00751.jpg

Brush on landside slope limits access.

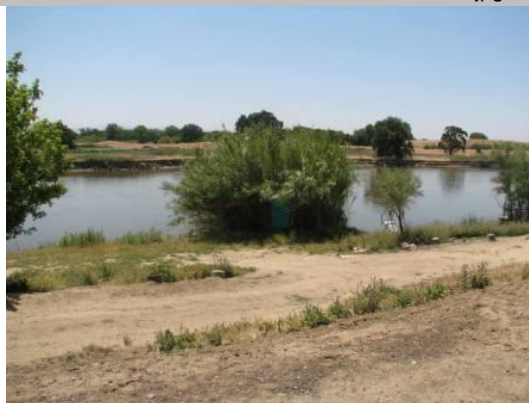
Photo 1 of 1 : mkhashch_s_20140428_00761.jpg

05/24/2011 Portable toilet is in the shadows in the center of the photo at the water's edge.

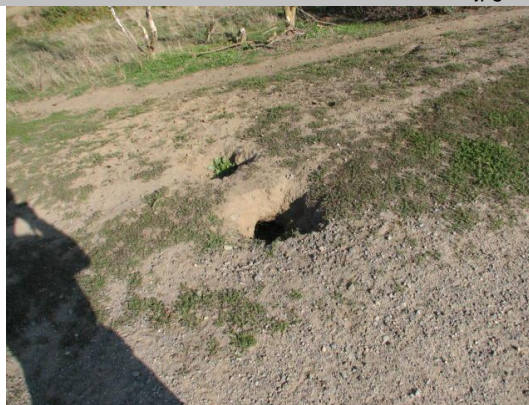
Photo 1 of 1 : mkhashch_s_20140428_00755.jpg

11/10/2011 Two large burrows on crown, need to be filled.

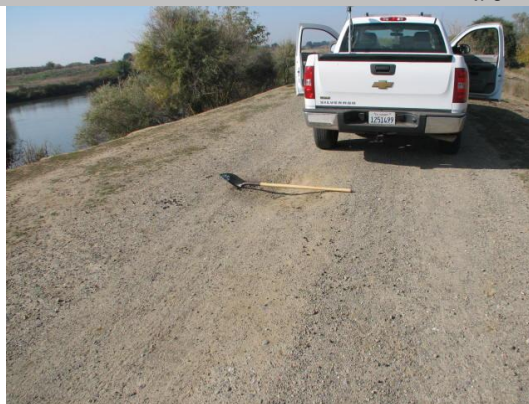
Photo 1 of 1 : mkhashch_s_20140428_00753.jpg

11/10/2011 Depression in crown needs to be filled.

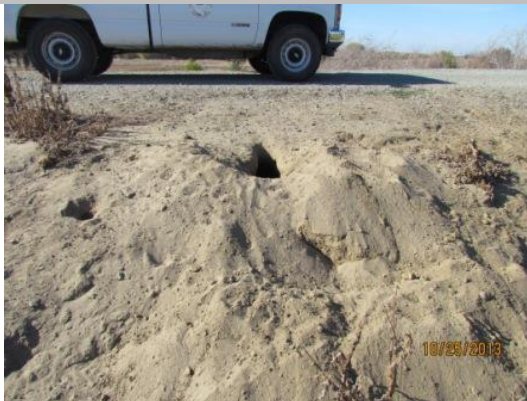
Photo 1 of 1 : mkhashch_s_20140428_00774.jpg

View of the rodent burrow on the landside levee slope.

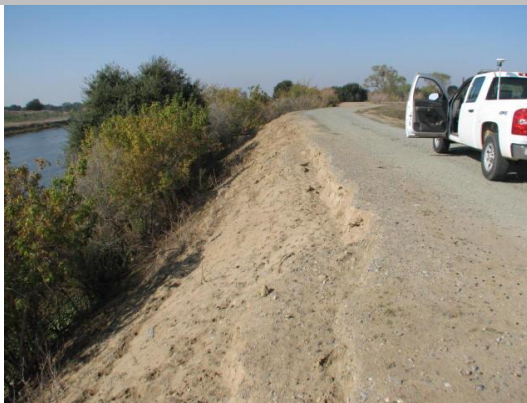
Photo 1 of 1 : mkhashch_s_20140428_00756.jpg

11/10/2011 Approximately 1' scarp has been created by livestock travel.

| Repair the levee slope damaged by livestock and prevent large animal access. | | | | | |
| Inspector Comments: 11/10/2011 Repair damage to slope caused by livestock. | | | | | |

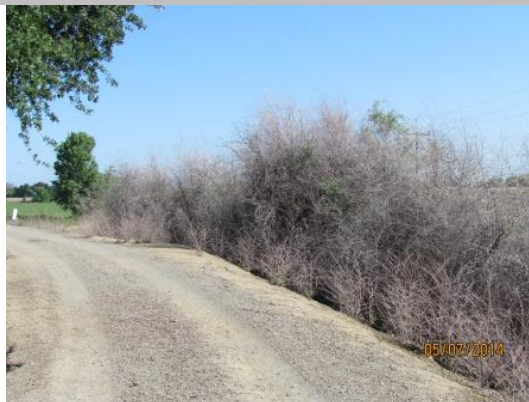
Photo 1 of 1 : mkhashch_s_20140512_00995.jpg

Extremely thick dead brush prevents access and visibility.

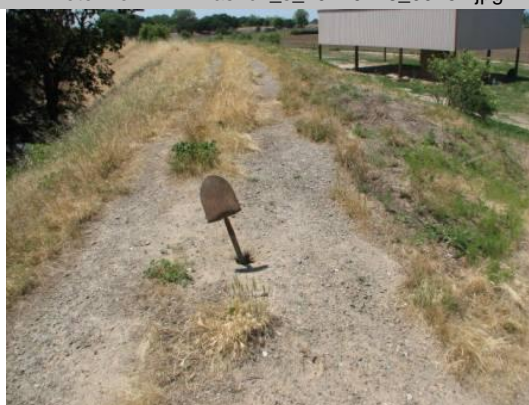
Photo 1 of 2 : mkhashch_s_20140428_00764.jpg

05/24/2011 Deep vertical burrow in levee crown.

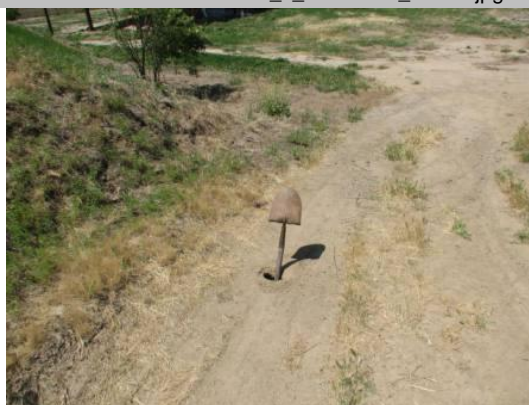
Photo 2 of 2 : mkhashch_s_20140428_00765.jpg

05/24/2011 Deep vertical burrow in ramp on land side of levee.

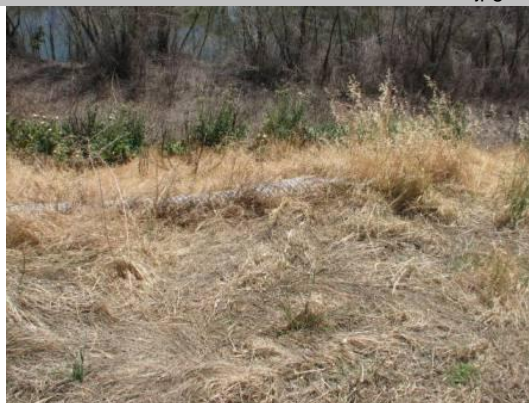
Photo 1 of 1 : mkhashch_s_20140428_00766.jpg

05/24/2011 Old CMP left on waterside levee slope, needs to be removed.

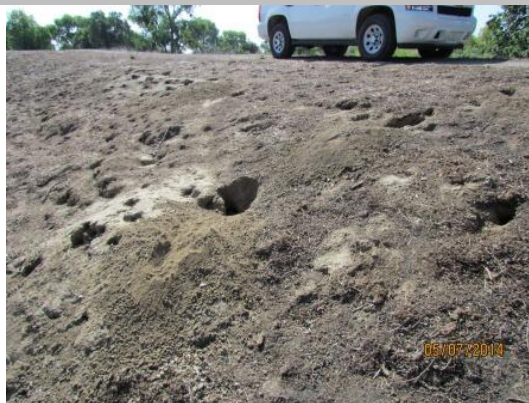
Photo 1 of 1 : mkhashch_s_20140512_00996.jpg

View of the rodent holes on the landside levee slope.

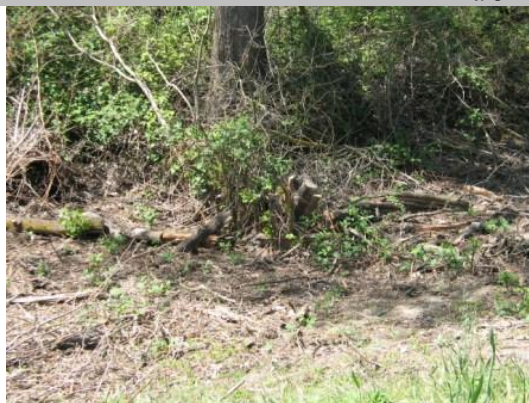
Photo 1 of 1 : mkhashch_s_20140428_00762.jpg

Tree stump >2" left after vegetation and tree removal.

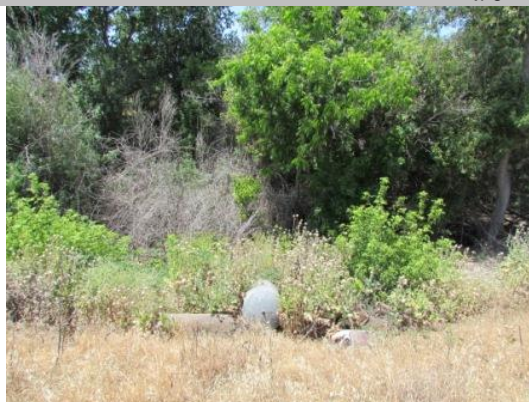
Photo 1 of 1 : mkhashch_s_20140428_00757.jpg

View of water tanks disposed on waterside slope.

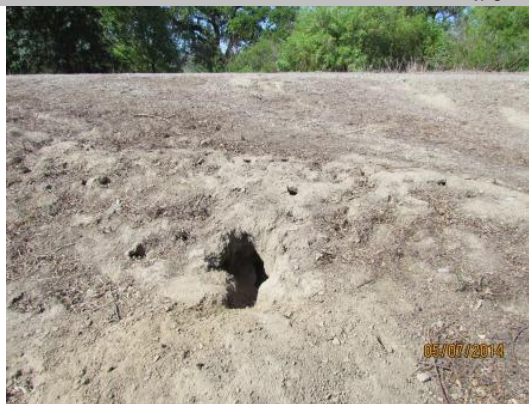
Photo 1 of 1 : mkhashch_s_20140512_00997.jpg

View of the large rodent hole on the landside levee slope.

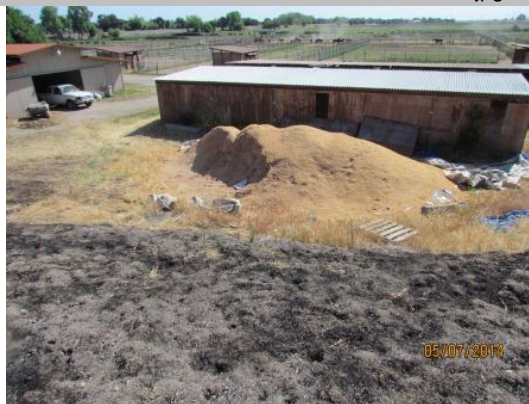
Photo 1 of 1 : mkhashch_s_20140512_00998.jpg

View of the animal feed stockpiled at the landside levee toe.

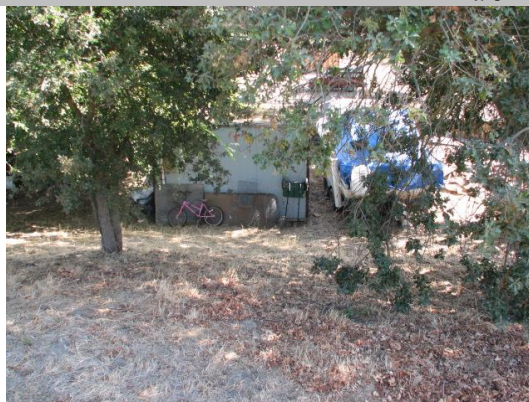
Photo 1 of 1 : mkhashch_s_20140428_00758.jpg

Fall 2009 photo: Buildings and patio decks are built within 10-ft of the levee slope.
