**Flood Control Project Maintenance
Levee Inspections**
LMA District Cover Sheet
Spring 2015 Levee Inspection Results

Reclamation District No. 2089 Stark

Spring 2015 Levee Inspection Results

Levee Inspection Report By Mile - Spring 2015

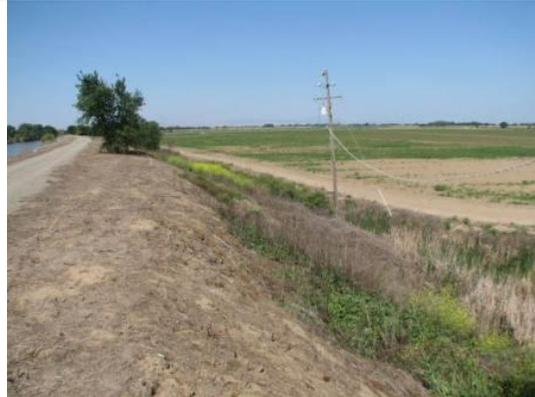
Photo 1 of 1 : SP_2015_RD2089_316_9_20150317_00006.jpg

05/24/2011 Ditch flows parallel with the utility line shown in the photo.

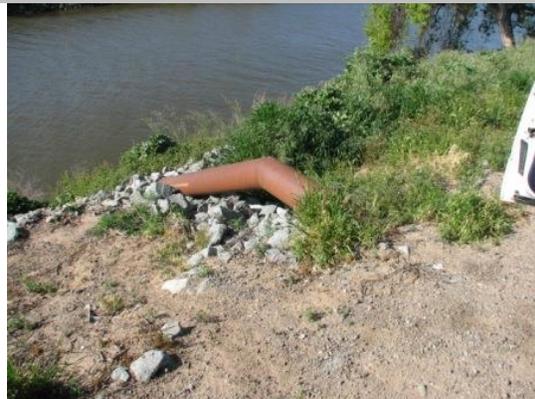
Photo 1 of 1 : SP_2015_RD2089_316_7_20150317_00005.jpg

LM Start	0.04	Rating **	A/W	Issue No.	7
LM End	0.04	Issue Type +	Ma	Location *	LS
Category	Earthen Levee		GPS Latitude/Longitude		
			Start	End	
Item	Encroachments		37.811467 °	37.811467 °	
			-121.385569 °	-121.385569 °	
DWR ID	DWR_RD2089_01_s_2012_7				
Action/Comments					
Pipe Inspector Comments: Drainage pump

Waterside of drainage discharge to Old River.

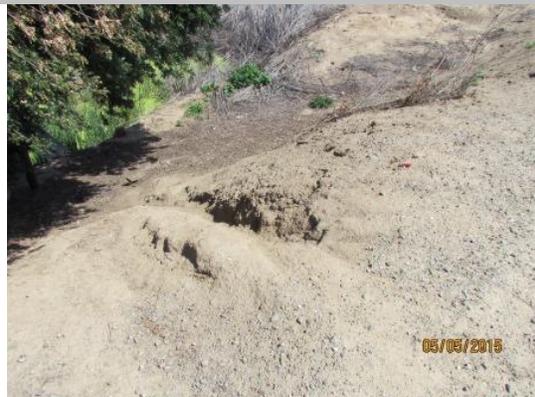
Photo 1 of 1 : SP_2015_RD2089_316_1_20150511_00036.jpg

LM Start	0.04	Rating **	M	Issue No.	1
LM End	0.04	Issue Type +	Ma	Location *	LS
Category	Earthen Levee		GPS Latitude/Longitude		
			Start	End	
Item	Encroachments		37.811474 °	37.811474 °	
			-121.385573 °	-121.385573 °	
DWR ID	DWR_RD2089_01_s_2012_1				
Action/Comments					
Stairway Inspector Comments: Steps have been cut into the levee slope, this could become an erosion point, please fill and compact.

View of the stairs eroding into the landside levee slope.

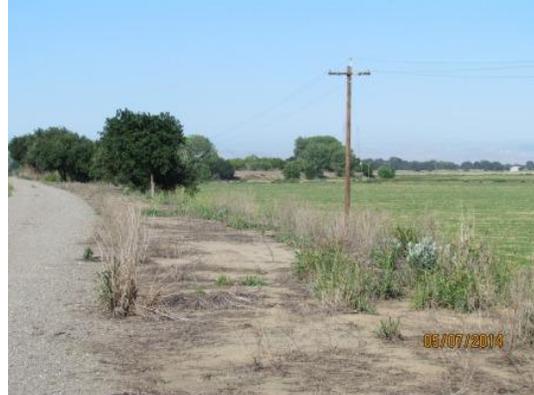
Photo 1 of 1 : SP_2015_RD2089_316_42_20150317_00022.jpg

View of the tall vegetation obstructing visibility of the landside levee slope.

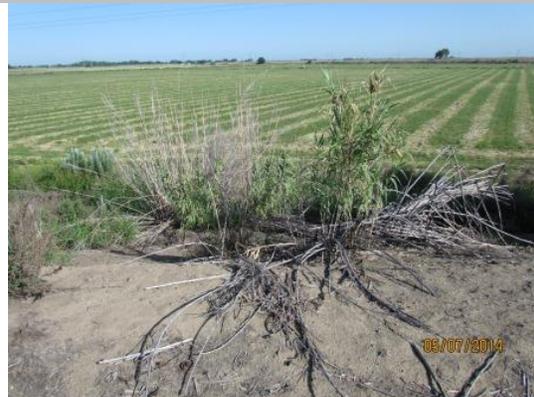
Photo 1 of 1 : SP_2015_RD2089_316_940_20150317_00030.jpg

LM Start	0.24	Rating **	M	Issue No.	940
LM End	0.24	Issue Type +	Ma	Location *	LS
Category	Earthen Levee		GPS Latitude/Longitude		
			Start	End	
Item	Vegetation		37.810412 °	37.810412 °	
			-121.389115 °	-121.389115 °	
DWR ID	DWR_RD2089_01_s_2012_940				
Action/Comments					
Remove the wild growth other than native grasses from the levee slopes. Inspector Comments: Arundo has been trimmed back from the crown but still remains as an obstruction to the slope and obstructs visibility, needs to be removed.

The LMA is actively trying to remove the vegetation on the landside levee slope and toe.

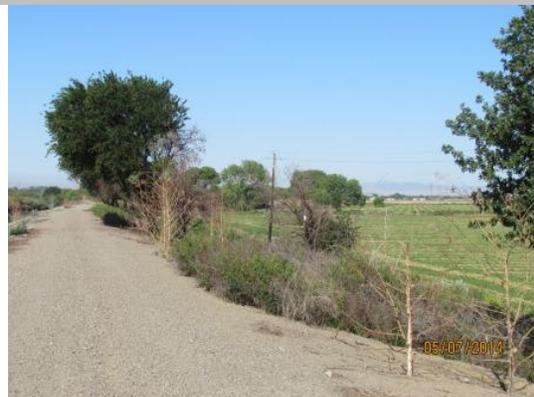
Photo 1 of 1 : SP_2015_RD2089_316_12_20150317_00007.jpg

LM Start	0.27	Rating **	U	Issue No.	12
LM End	0.39	Issue Type +	Ma	Location *	LS
Category	Earthen Levee		GPS Latitude/Longitude		
			Start	End	
Item	Vegetation		37.810319 °	37.809740 °	
			-121.389510 °	-121.391645 °	
DWR ID	DWR_RD2089_01_s_2012_12				
Action/Comments					
Remove the wild growth other than native grasses from the levee slopes. Inspector Comments: Access and visibility completely blocked. 11/10/2011 issue has not changed.

Thick brush and wild rose completely block access and visibility of landside slope and toe.

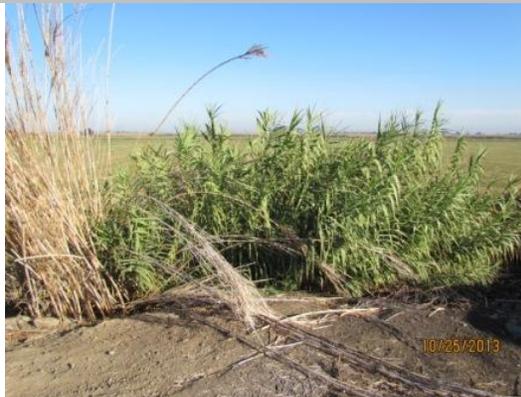
Photo 1 of 1 : SP_2015_RD2089_316_19_20150317_00012.jpg

LM Start	0.34	Rating **	M	Issue No.	19
LM End	0.34	Issue Type +	Ma	Location *	LS
Category	Earthen Levee			GPS Latitude/Longitude	
				Start	End
Item	Vegetation			37.809978 °	37.809978 °
				-121.390704 °	-121.390704 °
DWR ID	DWR_RD2089_01_s_2012_19				
Action/Comments					
Remove the wild growth other than native grasses from the levee slopes. Inspector Comments: Bamboo completely blocks access and visibility.11/10/2011 Arundo has been trimmed back from the roadway, but still completely blocks access and visibilit to the landside slope. This plant was improperly identified as bamboo in previous inspections.

Arundo has been trimmed back from the road, but needs to be removed to so that it does not obstruct visibility and access to the landside toe.

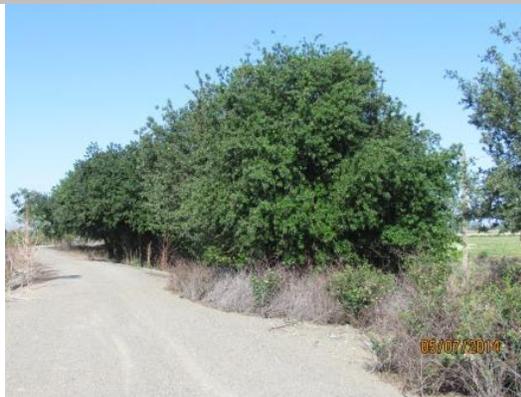
Photo 1 of 1 : SP_2015_RD2089_316_946_20150317_00031.jpg

LM Start	0.37	Rating **	U	Issue No.	946
LM End	0.37	Issue Type +	Ma	Location *	LS
Category	Earthen Levee			GPS Latitude/Longitude	
				Start	End
Item	Trim / Thin Trees			37.809865 °	37.809865 °
				-121.391303 °	-121.391303 °
DWR ID	DWR_RD2089_01_s_2012_946				
Action/Comments					
Trim trees to at least five feet above ground level.

Trees on levee slope obstruct access and visibility.

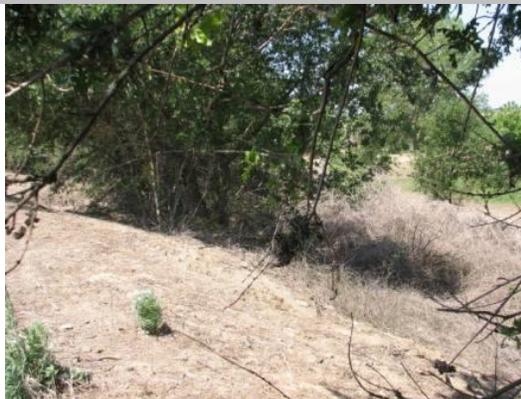
Photo 1 of 1 : SP_2015_RD2089_316_28_20150317_00016.jpg

LM Start	0.41	Rating **	U	Issue No.	28
LM End	0.46	Issue Type +	Ma	Location *	LS
Category	Earthen Levee			GPS Latitude/Longitude	
				Start	End
Item	Vegetation			37.809593 °	37.809507 °
				-121.391963 °	-121.392907 °
DWR ID	DWR_RD2089_01_s_2012_28				
Action/Comments					
Remove the wild growth other than native grasses from the levee slopes. Inspector Comments: Vegetation is too thick to allow access and visibility.

05/24/2011 Photo shows thick dead vegetation and continuation of trees in area that are preventing access and visibility of landside slope and toe.

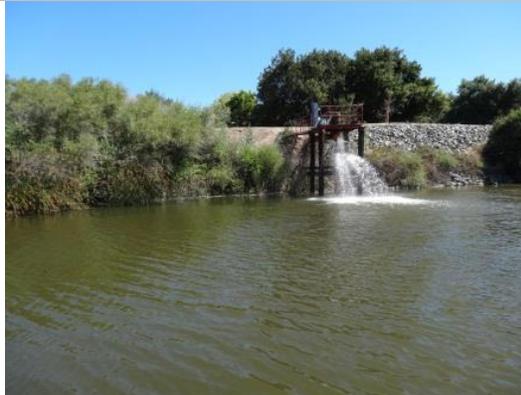
Photo 1 of 1 : SP_2015_RD2089_316_5_20150317_00004.jpg

LM Start	0.46	Rating **	M	Issue No.	5
LM End	0.46	Issue Type +	Ma	Location *	WS
Category	Supplemental			GPS Latitude/Longitude	
				Start	End
Item	DWR Erosion Survey			37.809394 °	37.809394 °
				-121.392791 °	-121.392791 °
DWR ID	DWR_RD2089_01_s_2015_5				
Action/Comments					
Inspector Comments: 07/02/2014: No significant change observed. 08/13/2013: No significant change observed. 08/07/2012: The site has been visited by boat survey. No significant change observed 08/23/2011: The site shows loose material around the pipe crossing. The operation of the pipe might have caused an impact on the levee. [2014 Site ID:RD2089U01RM29.8]

Front view of the site.

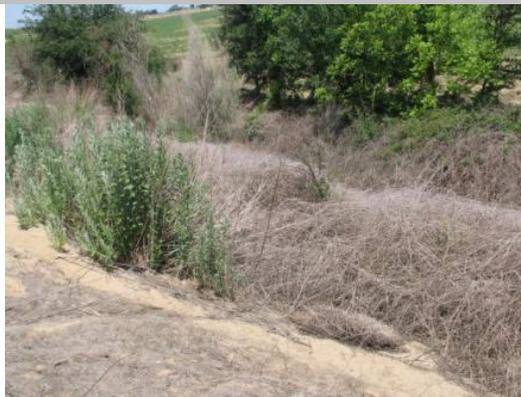
Photo 1 of 1 : SP_2015_RD2089_316_30_20150317_00017.jpg

05/24/2011 Dead brush is too thick to allow access and visibility of landside slope and toe.

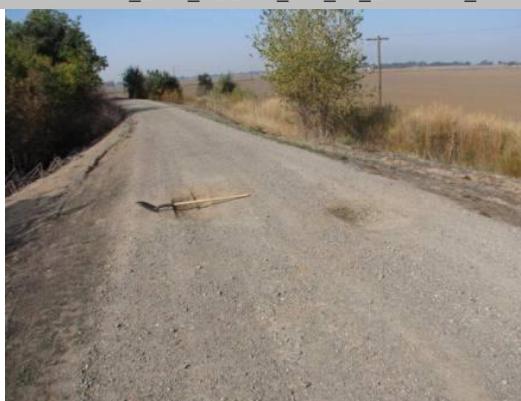
Photo 1 of 1 : SP_2015_RD2089_316_14_20150317_00008.jpg

LM Start	0.54	Rating **	M	Issue No.	14
LM End	0.54	Issue Type +	Ma	Location *	CR
Category	Earthen Levee		GPS Latitude/Longitude		
			Start	End	
Item	Crown Surface / Depressions / Rutting		37.810087 °	37.810087 °	
			-121.394200 °	-121.394200 °	
DWR ID	DWR_RD2089_01_s_2012_14				
Action/Comments					
Add appropriate gravel or road base. Grade and compact. Inspector Comments: 11/10/2011 Minor depressions will cause ponding.

11/10/2011 Depressions in crown.

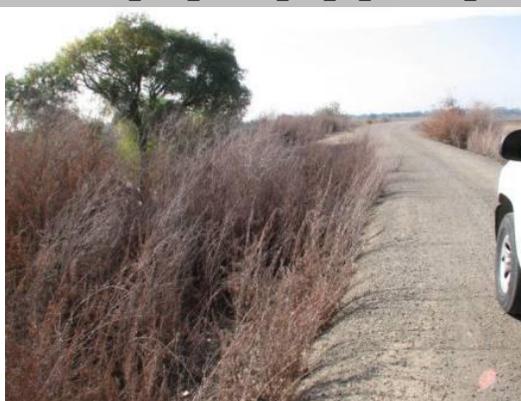
Photo 1 of 1 : SP_2015_RD2089_316_18_20150317_00011.jpg

11/10/2011 Vegetation needs to be cleared on the upper 20' of the waterside slope.

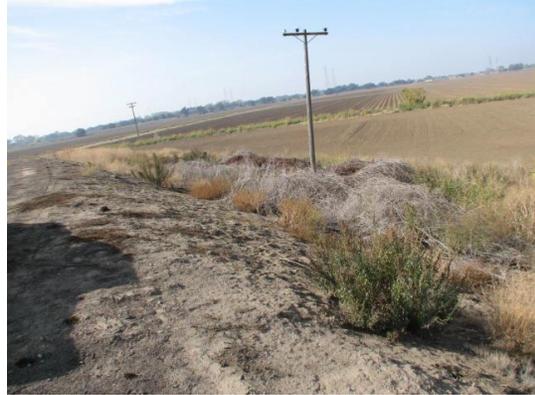
Photo 1 of 1 : SP_2015_RD2089_316_20_20150317_00013.jpg

11/10/2011 Vegetation obstructs visibility of slope and toe.

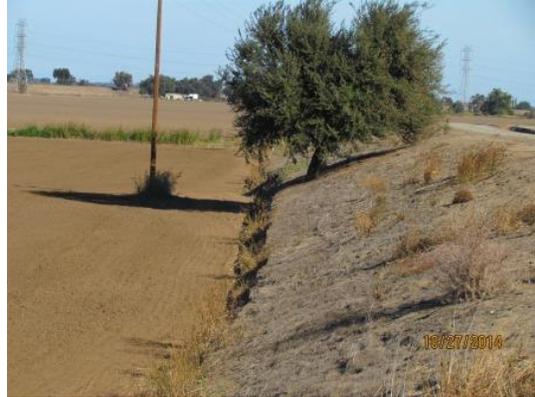
Photo 1 of 1 : SP_2015_RD2089_316_17_20150317_00010.jpg

LM Start	0.81	Rating **	M	Issue No.	17
LM End	0.94	Issue Type +	Ma	Location *	LS
Category	Earthen Levee		GPS Latitude/Longitude		
			Start	End	
Item	Slope Stability		37.808319 °	37.806453 °	
			-121.397881 °	-121.397755 °	
DWR ID	DWR_RD2089_01_f_2014_17				
Action/Comments					
Repair slope instability. Inspector Comments: Landside levee toe cut due to farming.

View of the vertical cut along the landside levee toe.

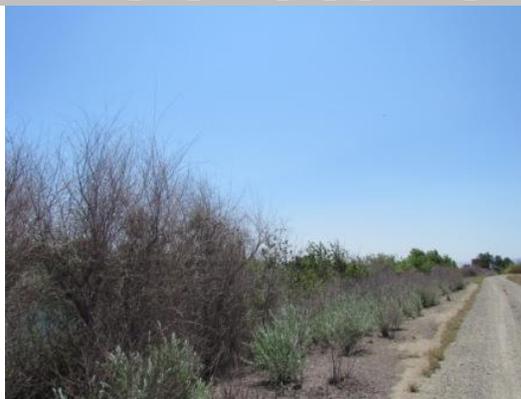
Photo 1 of 1 : SP_2015_RD2089_316_36_20150317_00021.jpg

View of tall weeds and brush obstructing visibility on waterside slope.
05/24/2012

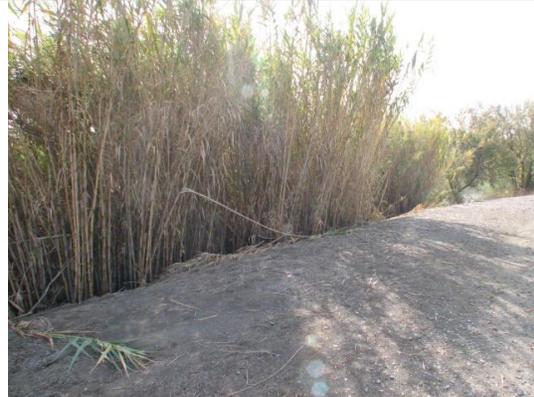
Photo 1 of 1 : SP_2015_RD2089_316_33_20150317_00019.jpg

11/10/2011 Arundo on upper 20' of waterside slope.

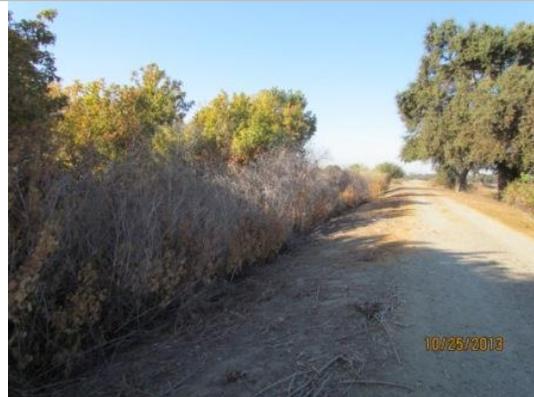
Photo 1 of 1 : SP_2015_RD2089_316_35_20150317_00020.jpg

Thick vegetation on upper 20' of waterside slope obstructing visibility and access.

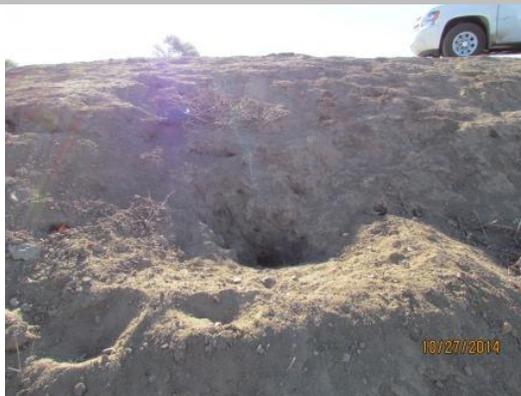
Photo 1 of 1 : SP_2015_RD2089_316_16_20150317_00009.jpg

View of the rodent burrow on the landside levee slope.

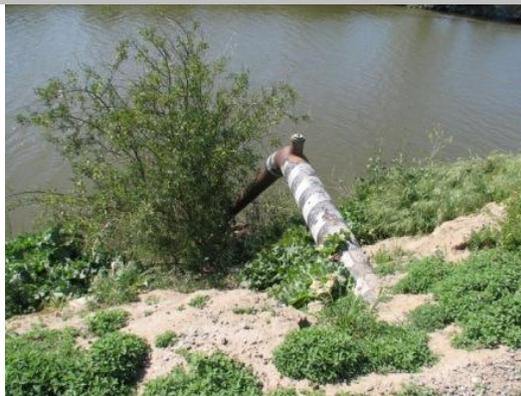
Photo 1 of 1 : SP_2015_RD2089_316_21_20150317_00014.jpg

Drainage discharge into Old River.

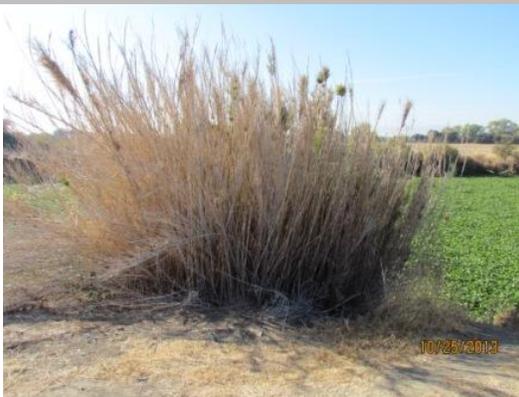
Photo 1 of 1 : SP_2015_RD2089_316_25_20150317_00015.jpg

View of the Arundo on the waterside slope obstructing visibility. LMA is actively trying to remove the wild growth.

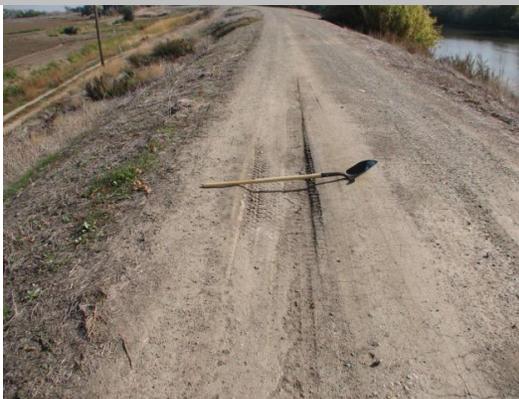
Photo 1 of 1 : SP_2015_RD2089_316_43_20150317_00023.jpg

11/10/2011 Depression in roadway.

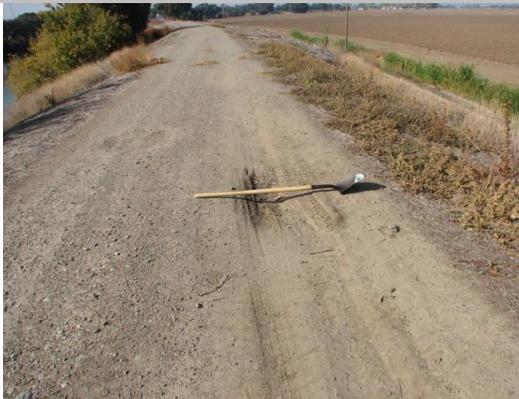
Photo 1 of 1 : SP_2015_RD2089_316_44_20150317_00024.jpg

11/10/2011 Roadway depression.

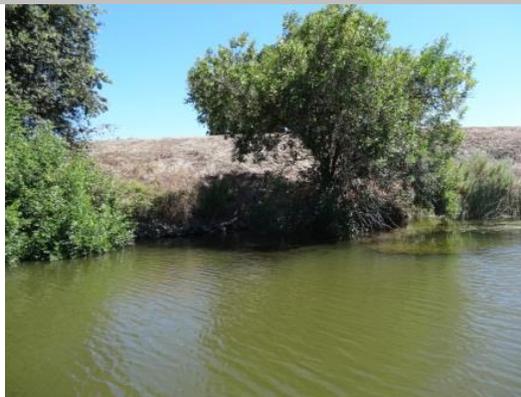
Photo 1 of 1 : SP_2015_RD2089_316_2_20150317_00002.jpg

LM Start	1.23	Rating **	M	Issue No.	2
LM End	1.23	Issue Type +	Ma	Location *	WS
Category	Supplemental			GPS Latitude/Longitude	
				Start	End
Item	DWR Erosion Survey			37.805580 °	37.805580 °
				-121.403010 °	-121.403010 °
DWR ID	DWR_RD2089_01_s_2015_2				
Action/Comments					
Inspector Comments: 07/02/2014: No significant change observed. 08/13/2013: The erosion is around a tree at the levee toe. Dense vegetation is visible. [2014 Site ID:RD2089U01RM29.04]

Close view of the site. Note the tree and the vegetation.

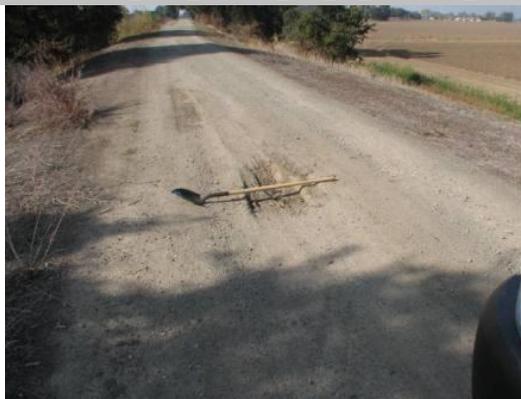
Photo 1 of 1 : SP_2015_RD2089_316_45_20150317_00025.jpg

11//10/2011 Roadway depression.

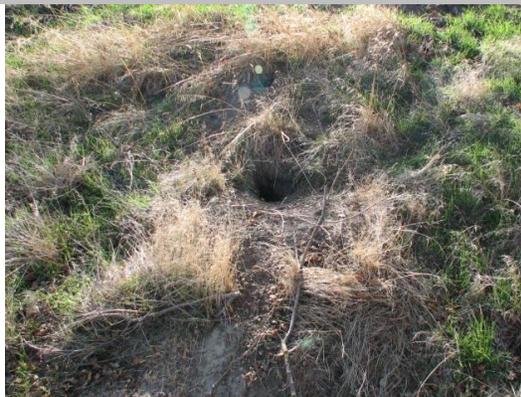
Photo 1 of 1 : SP_2015_RD2089_316_47_20150317_00027.jpg

11/10/2011 Active rodent burrow on landside slope.

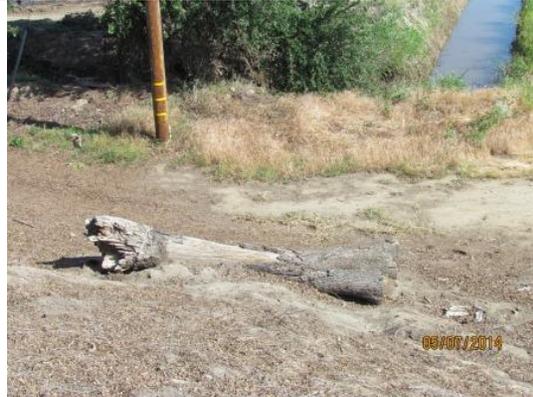
Photo 1 of 1 : SP_2015_RD2089_316_46_20150317_00026.jpg

Decaying tree at the landside levee toe is obstructing visibility and access.

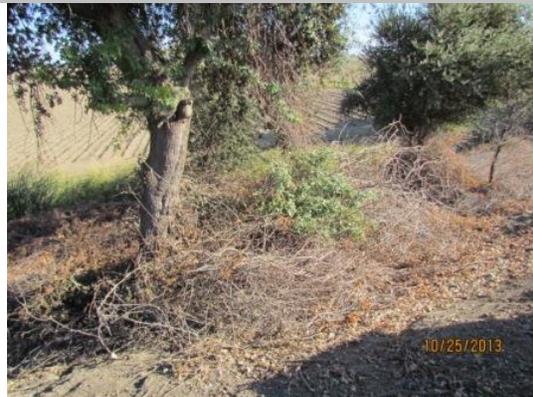
Photo 1 of 1 : SP_2015_RD2089_316_52_20150317_00029.jpg

View of the tree branches obstructing landside levee slope.

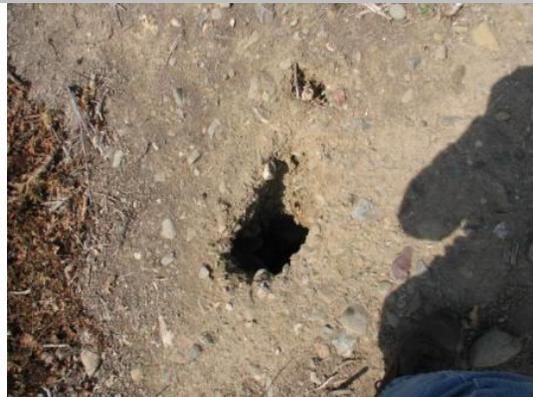
Photo 1 of 1 : SP_2015_RD2089_316_49_20150317_00028.jpg

11/10/2011 Deep burrow on waterside.

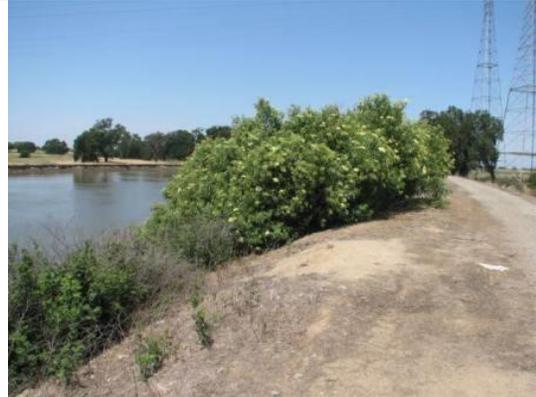
Photo 1 of 2 : SP_2015_RD2089_317_4_20150317_00003.jpg

05/24/2011 Updated photo of issue noted in Fall 2010 inspection.

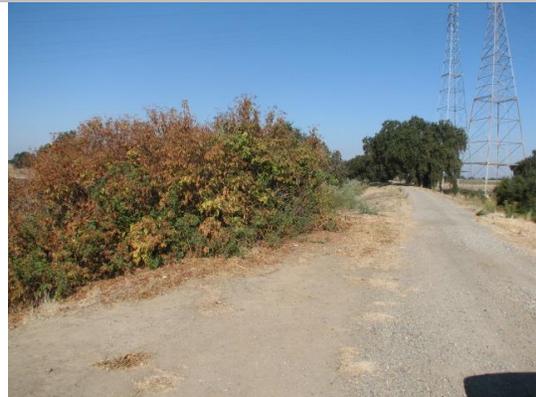
Photo 2 of 2 : SP_2015_RD2089_317_4_20150317_00004.jpg

LM Start	0.07	Rating **	U	Issue No.	4 (cont)
LM End	0.07	Issue Type +	Ma	Location *	WS

Fall 2009 photo of unacceptable vegetation on levee slope.

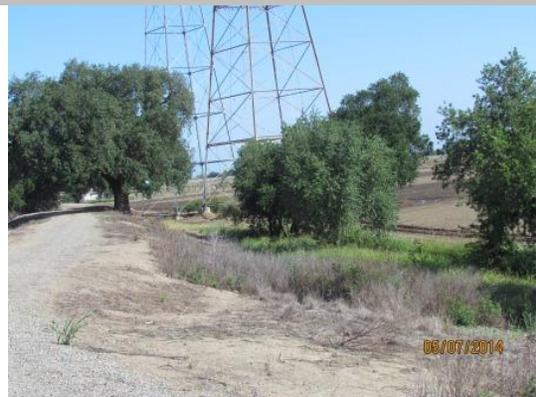
Photo 1 of 1 : SP_2015_RD2089_317_19_20150317_00019.jpg

View of the vegetation on the landside levee slope.

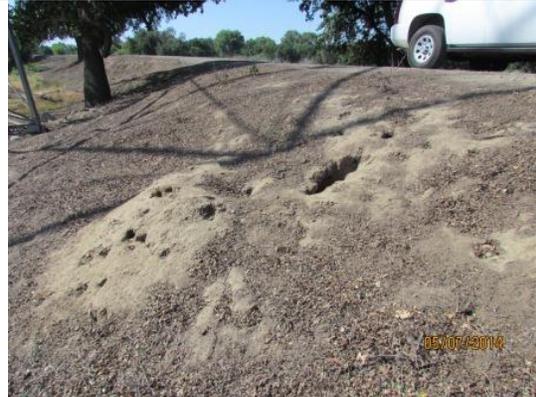
Photo 1 of 1 : SP_2015_RD2089_317_48_20150317_00029.jpg

View of the rodent burrow on the landside levee slope.

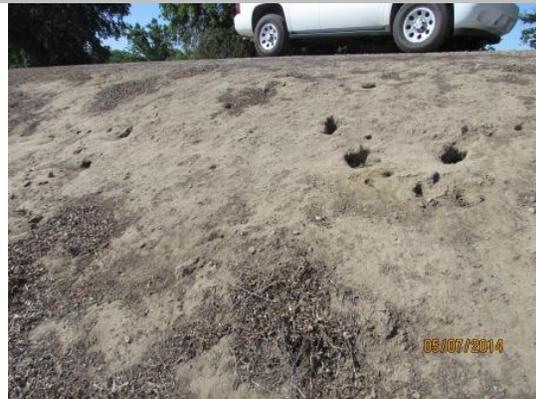
Photo 1 of 1 : SP_2015_RD2089_317_49_20150317_00030.jpg

View of the multiple rodent burrows on the landside levee hinge and slope.

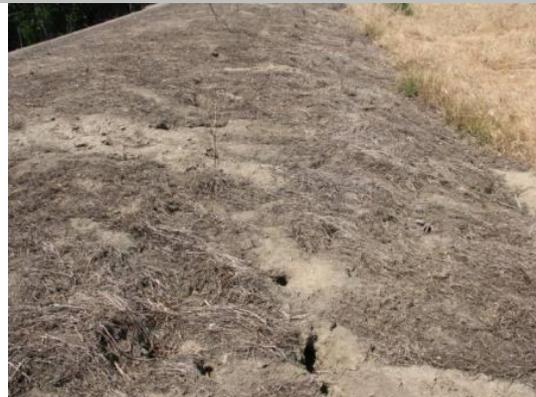
Photo 1 of 1 : SP_2015_RD2089_317_24_20150317_00021.jpg

05/24/2011 Active burrows, ground squirrel sighted in area.

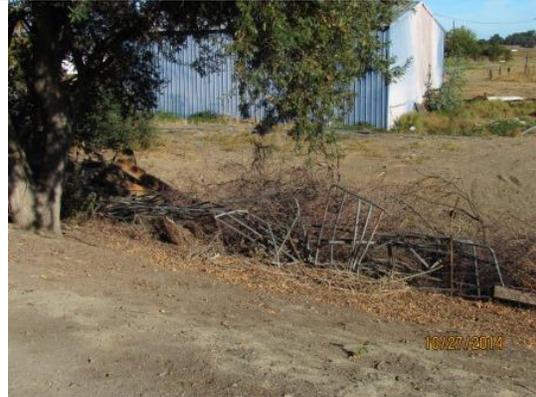
Photo 1 of 1 : SP_2015_RD2089_317_52_20150317_00032.jpg

View of the tree branches on the landside levee toe obstructing access.

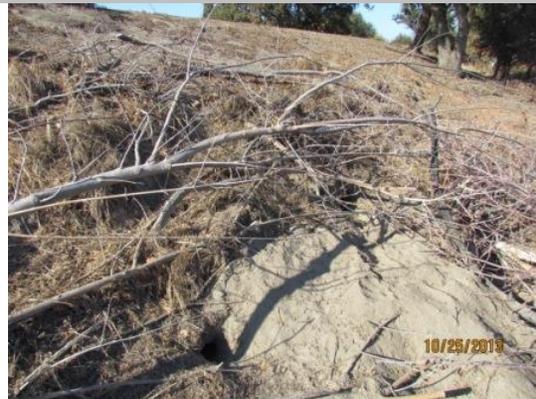
Photo 1 of 1 : SP_2015_RD2089_317_51_20150317_00031.jpg

View of the rodent burrow on the landside levee toe.

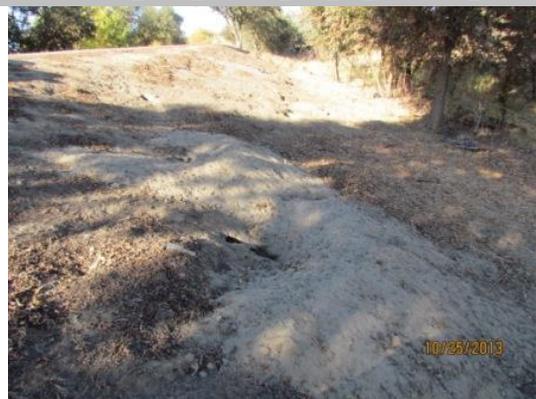
Photo 1 of 3 : SP_2015_RD2089_317_53_20150317_00033.jpg

LM Start	0.30	Rating **	U	Issue No.	53
LM End	0.31	Issue Type +	Ma	Location *	LS
Category	Earthen Levee			GPS Latitude/Longitude	
				Start	End
Item	Animal Control			37.809977 °	37.810022 °
				-121.411189 °	-121.411387 °
DWR ID	DWR_RD2089_02_f_2013_53				
Action/Comments					
Exterminate rodents and backfill and compact or grout burrows. Inspector Comments: Exterminating rodents and grouting the burrows recommended.

View of the multiple rodent burrows on the landside levee slope.

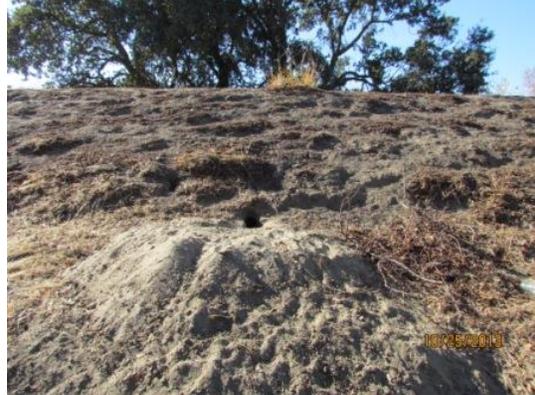
Photo 2 of 3 : SP_2015_RD2089_317_53_20150317_00034.jpg

LM Start	0.30	Rating **	U	Issue No.	53 (cont)
LM End	0.31	Issue Type +	Ma	Location *	LS
Category	Earthen Levee			GPS Latitude/Longitude	
				Start	End
Item	Animal Control			37.809977 °	37.810022 °
				-121.411189 °	-121.411387 °
DWR ID	DWR_RD2089_02_f_2013_53				
Action/Comments					
Exterminate rodents and backfill and compact or grout burrows. Inspector Comments: Exterminating rodents and grouting the burrows recommended.

View of the rodent burrow on the landside levee slope.

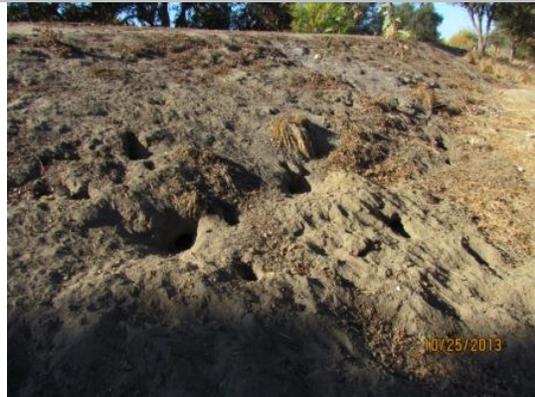
Photo 3 of 3 : SP_2015_RD2089_317_53_20150317_00035.jpg

LM Start	0.30	Rating **	U	Issue No.	53 (cont)
LM End	0.31	Issue Type +	Ma	Location *	LS

Another view of the multiple rodent burrows on the landside levee slope.

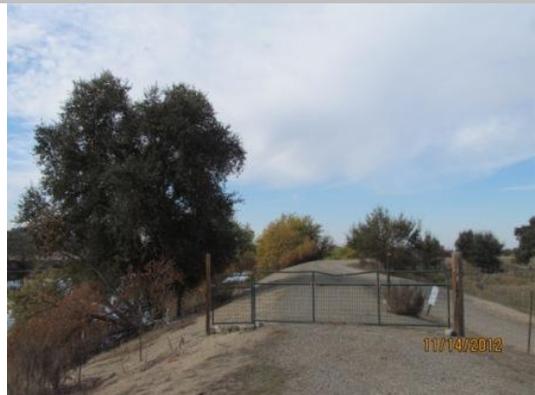
Photo 1 of 1 : SP_2015_RD2089_317_2_20150317_00002.jpg

View of gate across levee crown.

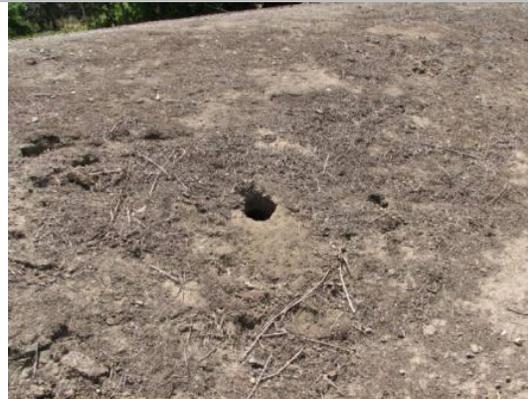
Photo 1 of 1 : SP_2015_RD2089_317_26_20150317_00022.jpg

LM Start	0.36	Rating **	M	Issue No.	26
LM End	0.36	Issue Type +	Ma	Location *	LS
Category	Earthen Levee		GPS Latitude/Longitude		
			Start	End	
Item	Animal Control		37.810125 °	37.810125 °	
			-121.412317 °	-121.412317 °	
DWR ID	DWR_RD2089_02_s_2012_26				
Action/Comments					
No rodents visible, but rodent burrows visible; need to backfill and compact or grout burrows. Inspector Comments: Active burrow needs to be repaired.

05/24/2011 Active rodent burrow.

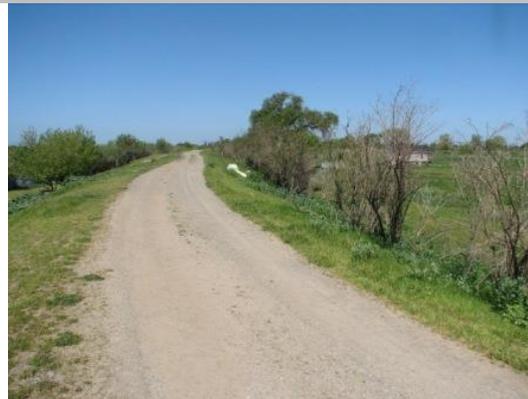
Photo 1 of 2 : SP_2015_RD2089_317_8_20150317_00008.jpg

Brush on landside slope limits access.

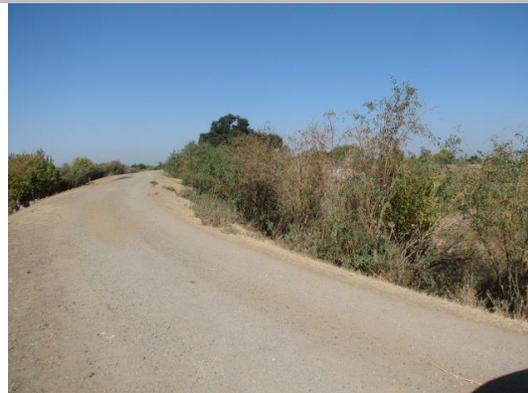
Photo 2 of 2 : SP_2015_RD2089_317_8_20150317_00009.jpg

Fall 2009 photo: Brush on landside toe limits visibility and accessibility.

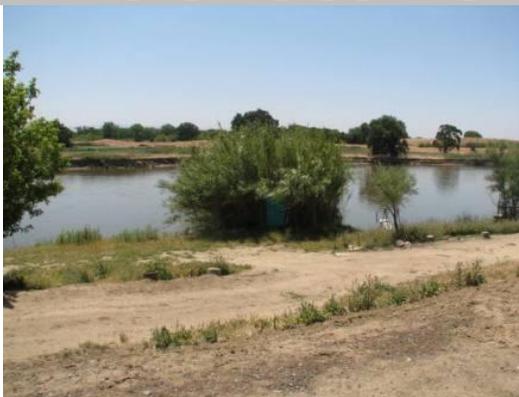
Photo 1 of 1 : SP_2015_RD2089_317_27_20150317_00023.jpg

05/24/2011 Portable toilet is in the shadows in the center of the photo at the water's edge.

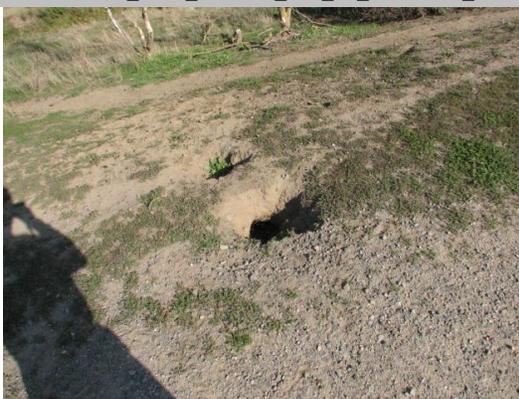
Photo 1 of 1 : SP_2015_RD2089_317_13_20150317_00015.jpg

11/10/2011 Two large burrows on crown, need to be filled.

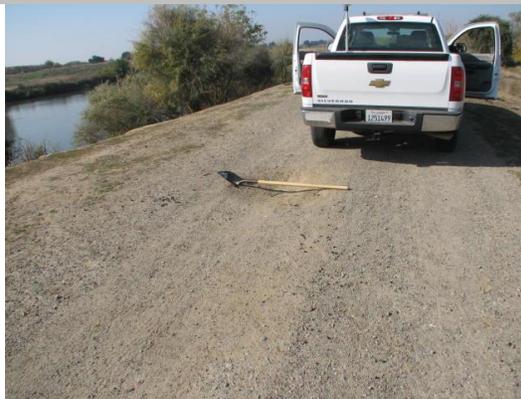
Photo 1 of 1 : SP_2015_RD2089_317_10_20150317_00011.jpg

11/10/2011 Depression in crown needs to be filled.

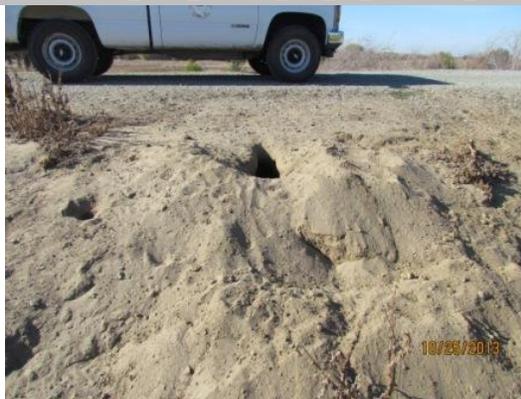
Photo 1 of 1 : SP_2015_RD2089_317_54_20150317_00036.jpg

View of the rodent burrow on the landside levee slope.

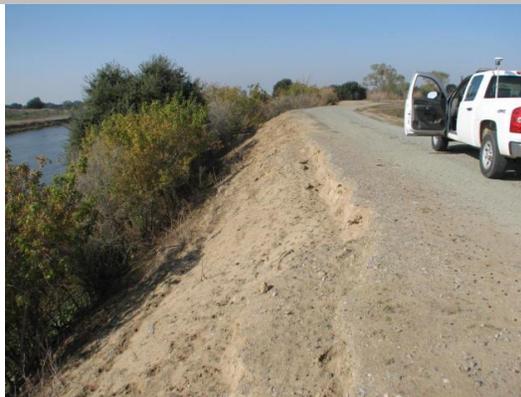
Photo 1 of 1 : SP_2015_RD2089_317_14_20150317_00016.jpg

11/10/2011 Approximately 1' scarp has been created by livestock travel.

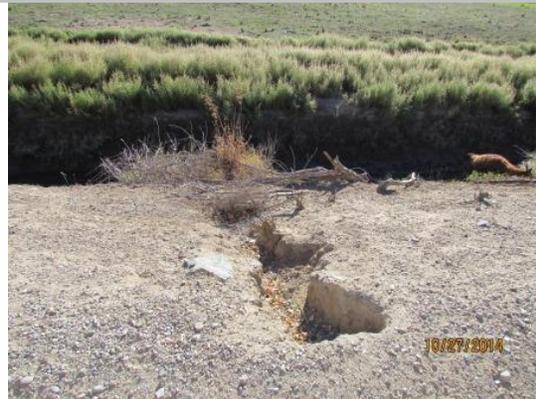
Photo 1 of 1 : SP_2015_RD2089_317_15_20150317_00017.jpg

View of the scour from surface runoff on the landside levee slope.

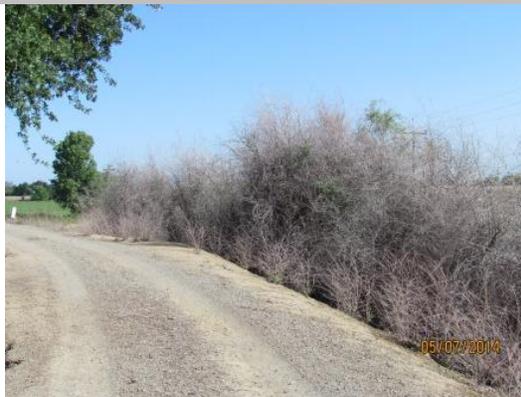
Photo 1 of 1 : SP_2015_RD2089_317_36_20150317_00025.jpg

Extremely thick dead brush prevents access and visibility.

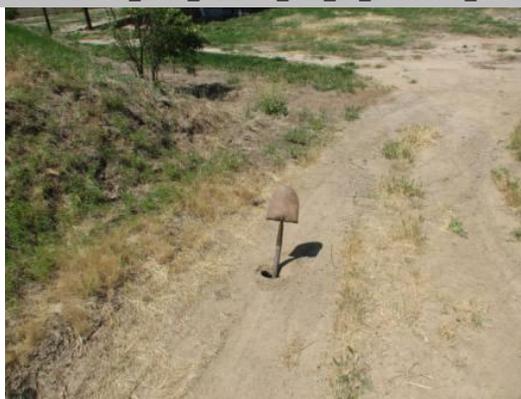
Photo 1 of 2 : SP_2015_RD2089_317_40_20150317_00026.jpg

05/24/2011 Deep vertical burrow in ramp on land side of levee.

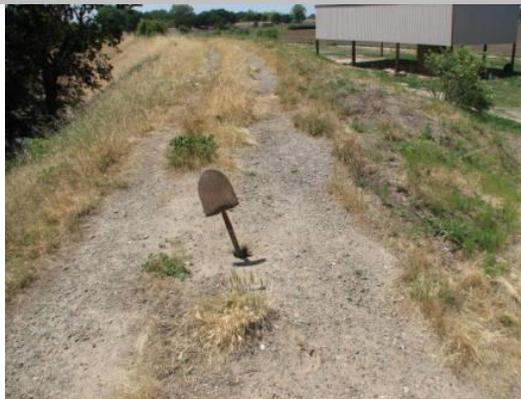
Photo 2 of 2 : SP_2015_RD2089_317_40_20150317_00027.jpg

05/24/2011 Deep vertical burrow in levee crown.

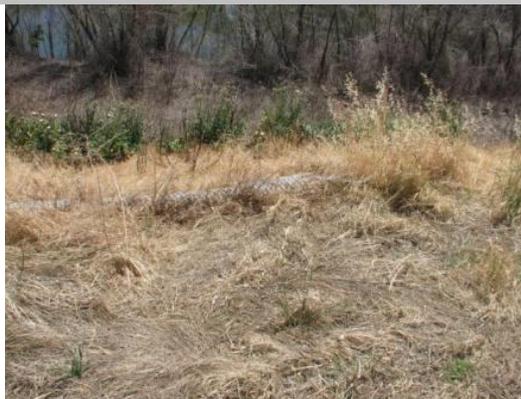
Photo 1 of 1 : SP_2015_RD2089_317_41_20150317_00028.jpg

05/24/2011 Old CMP left on waterside levee slope, needs to be removed.

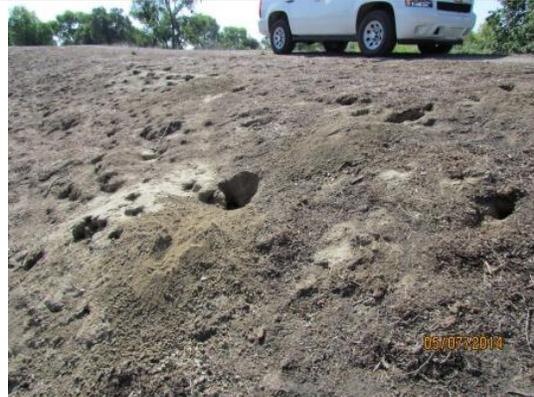
Photo 1 of 1 : SP_2015_RD2089_317_5_20150317_00005.jpg

View of the rodent holes on the landside levee slope.

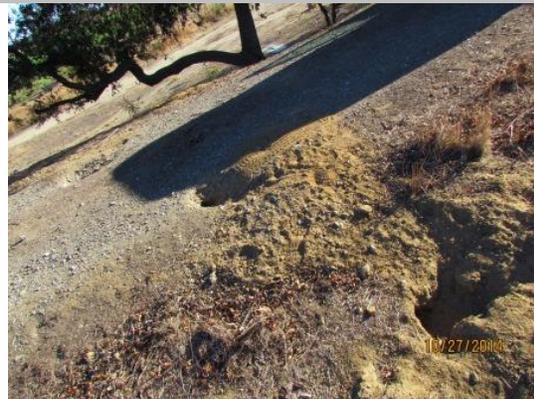
Photo 1 of 2 : SP_2015_RD2089_317_12_20150317_00013.jpg

View of several large rodent holes on the levee crown.

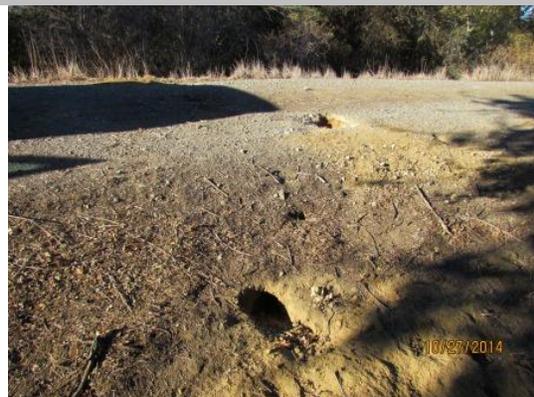
Photo 2 of 2 : SP_2015_RD2089_317_12_20150317_00014.jpg

View of several rodent burrows on landside levee hinge and crown.

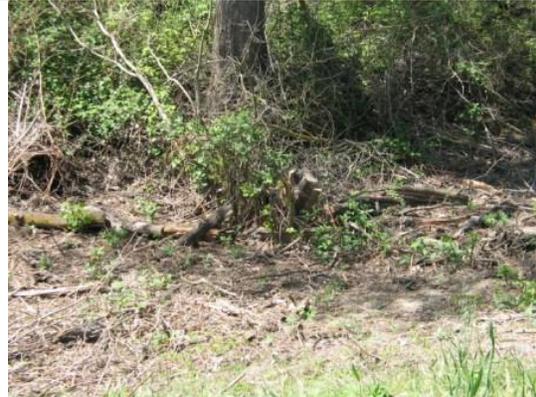
Photo 1 of 1 : SP_2015_RD2089_317_29_20150317_00024.jpg

Tree stump >2" left after vegetation and tree removal.

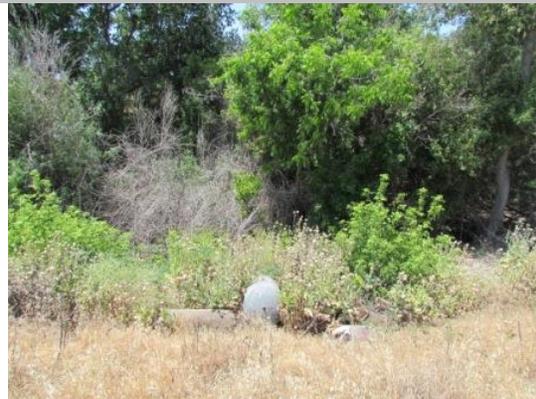
Photo 1 of 1 : SP_2015_RD2089_317_17_20150317_00018.jpg

View of water tanks disposed on waterside slope.

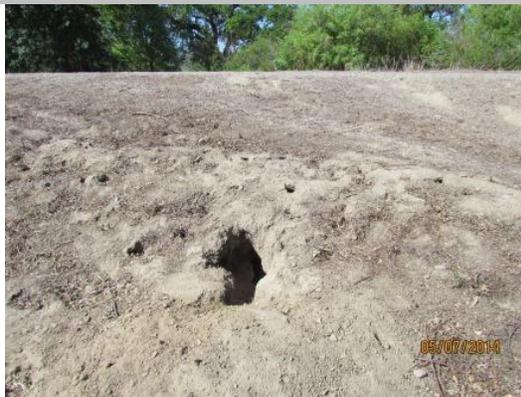
Photo 1 of 1 : SP_2015_RD2089_317_6_20150317_00006.jpg

View of the large rodent hole on the landside levee slope.

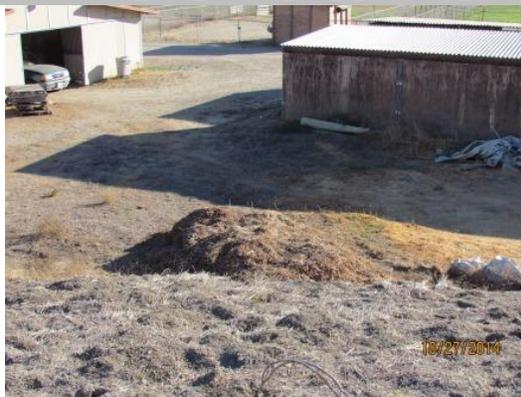
Photo 1 of 1 : SP_2015_RD2089_317_7_20150317_00007.jpg

View of the animal feed stockpiled at the landside levee toe.

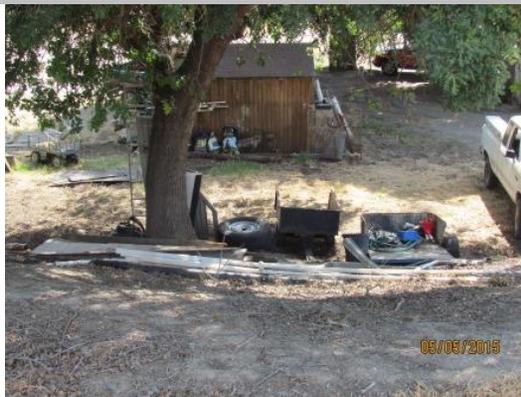
Photo 1 of 1 : SP_2015_RD2089_317_20_20150511_00041.jpg

View of the materials stored at the landside levee toe.

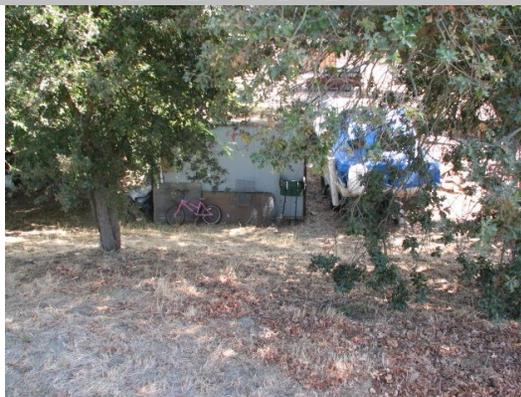
Photo 1 of 1 : SP_2015_RD2089_317_23_20150317_00020.jpg

Fall 2009 photo: Buildings and patio decks are built within 10-ft of the levee slope.

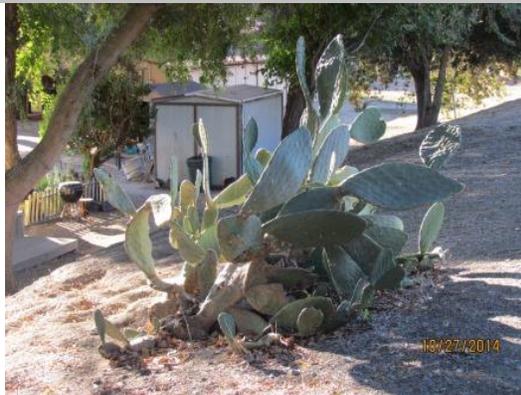
Photo 1 of 1 : SP_2015_RD2089_317_57_20150317_00037.jpg

View of the cactus on the landside levee shoulder.

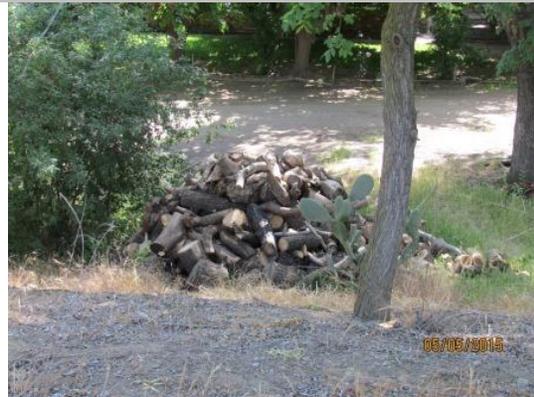
Photo 1 of 1 : SP_2015_RD2089_317_18_20150511_00040.jpg

View of the firewood piled at the landside levee toe.

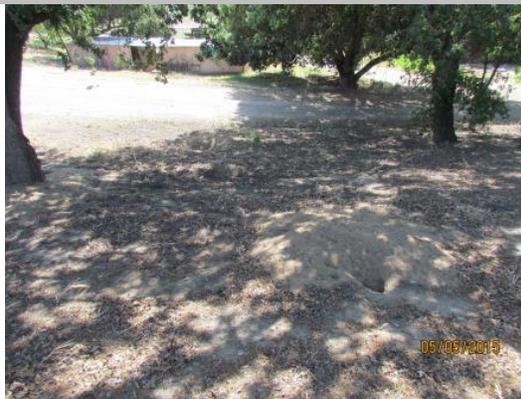
Photo 1 of 1 : SP_2015_RD2089_317_11_20150511_00039.jpg

View of the multiple rodent burrows on the landside levee slope.
