**Flood Control Project Maintenance
Levee Inspections**
LMA District Cover Sheet
Spring 2016 Levee Inspection Results

Reclamation District No. 2089 Stark

Spring 2016 Levee Inspection Results

Waterway			Bank	Unit Miles
Unit No. 01 Old River			Right	1.51
	Spring (March - May)	Summer (June - August)	(September - November) Fall	Winter (December - February)
Unit Maintenance Rating (Fall Only)				
Date of Inspection	3/15/2016 - 3/15/2016			
DWR Inspector	Maksim Khashchuk			
Accompanied By

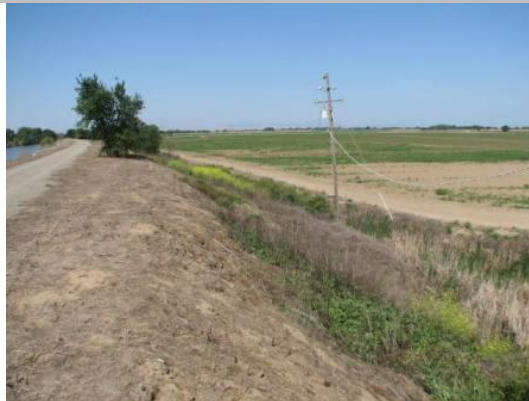
Photo 1 of 1 : SP_2016_RD2089_316_9_20160229_00010.jpg

05/24/2011 Ditch flows parallel with the utility line shown in the photo.

LM Start	0.04	Rating **	M	Issue No.	1
LM End	0.04	Issue Type +	Ma	Location *	LS
Category	Earthen Levee			GPS Latitude/Longitude	
				Start	End
Item	Encroachments			37.811474 °	37.811474 °
				-121.385573 °	-121.385573 °
DWR ID	DWR_RD2089_01_s_2012_1				
Comment Code					
ST : Stairway					
Inspector Comment					
Steps have been cut into the levee slope, this could become an erosion point, please fill and compact.

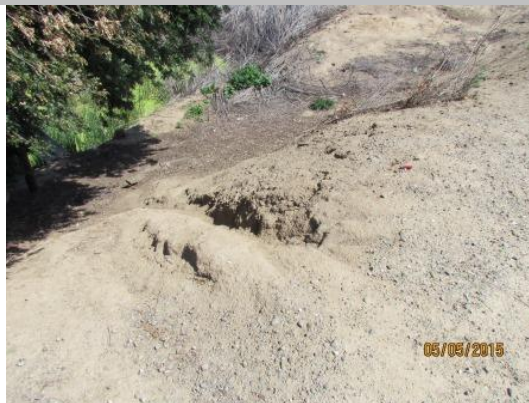
Photo 1 of 1 : SP_2016_RD2089_316_1_20160229_00001.jpg

View of the stairs eroding into the landside levee slope.

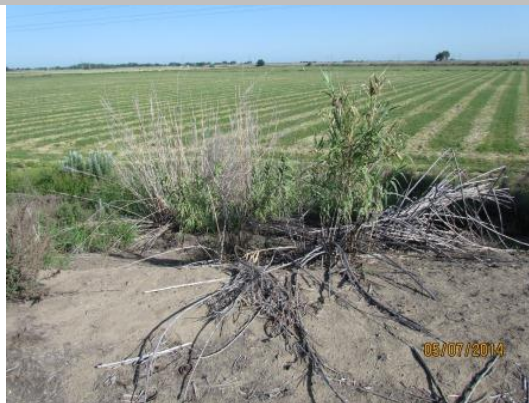
Photo 1 of 1 : SP_2016_RD2089_316_940_20160229_00035.jpg

The LMA is actively trying to remove the vegetation on the landside levee slope and toe.

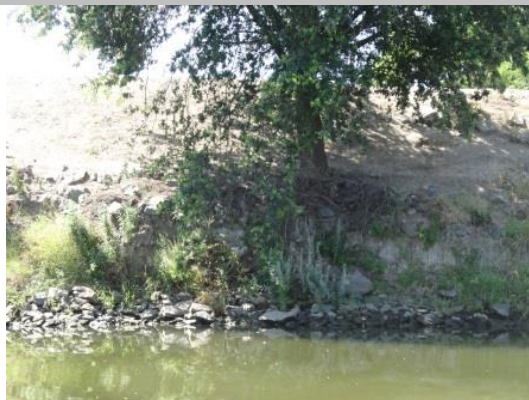
Photo 1 of 1 : SP_2016_RD2089_316_6_20160229_00009.jpg

Front view of the erosion site. Note the large tree above the erosion.

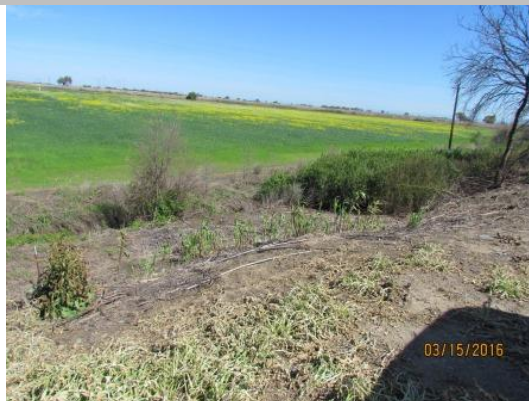
Photo 1 of 1 : SP_2016_RD2089_316_19_20160321_00054.jpg

Arundo was trimmed back from the road and needs to be maintained so that it does not obstruct visibility and access to the landside toe.

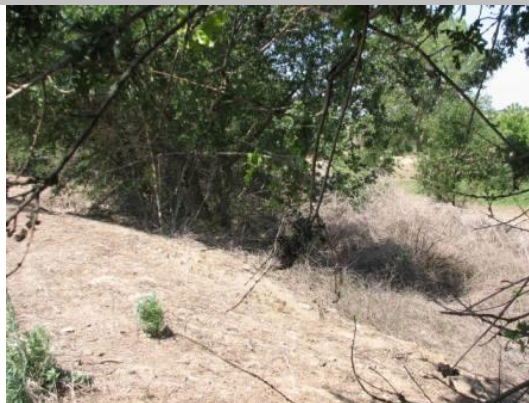
Photo 1 of 1 : SP_2016_RD2089_316_28_20160229_00021.jpg

05/24/2011 Photo shows thick dead vegetation and continuation of trees in area that are preventing access and visibility of landside slope and toe.

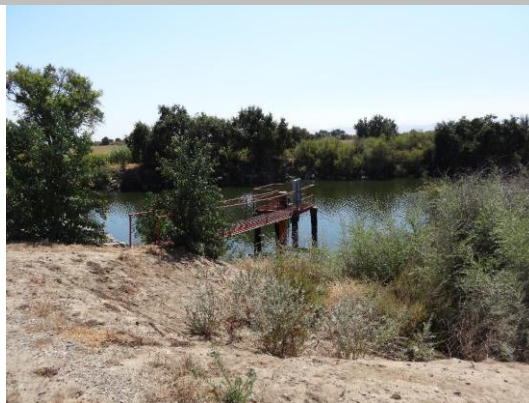
Photo 1 of 2 : UCIP_SP_2016_21635_36742.jpg

LM Start	0.46	Rating **	M	Issue No.	961
LM End	0.46	Issue Type +	En	Location *	LS
Category	Supplemental			GPS Latitude/Longitude	
				Start	End
Item	DWR UCIP Field Study			37.809501 °	37.809501 °
				-121.392798 °	-121.392798 °
DWR ID					
Comment Code					
Inspector Comment					
FS_ID:21635					
DS_ID:23042					
EP_NO: 5641					
Repair Type: Non-Urgent					
Crossing Status: Found					
UCIP Comments: - damaged siphon breaker.- most of the pipe on					
landside exposed on levee slope.					
FIELD_STRUCT_DESC: 20-inch steel pipe and electric conduit through					
the levee, 5.8 feet below the crown, pump on pile structure in the					
stream. Siphon breaker on the landward slope. (App. No. 5641- Ted					
Stark)					
FS Date: 9/12/2013

WS view: walkway to pump platform and pump on steel piling structure in the channel.

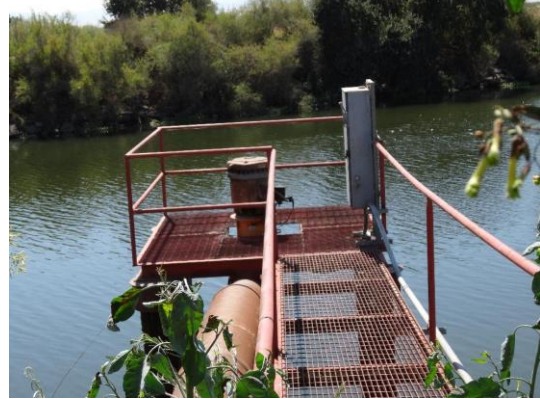
Photo 2 of 2 : UCIP_SP_2016_21635_36741.jpg

LM Start	0.46	Rating **	M	Issue No.	961 (cont)	
LM End	0.46	Issue Type +	En	Location *	LS	
Category	Supplemental			GPS Latitude/Longitude		
				Start		End
Item	DWR UCIP Field Study			37.809501 °		37.809501 °
				-121.392798 °		-121.392798 °
DWR ID						
Comment Code						
Inspector Comment						
FS_ID:21635						
DS_ID:23042						
EP_NO: 5641						
Repair Type: Non-Urgent						
Crossing Status: Found						
UCIP Comments: - damaged siphon breaker.- most of the pipe on						
landside exposed on levee slope.						
FIELD_STRUCT_DESC: 20-inch steel pipe and electric conduit through						
the levee, 5.8 feet below the crown, pump on pile structure in the						
stream. Siphon breaker on the landward slope. (App. No. 5641- Ted						
Stark)						
FS Date: 9/12/2013

WS view: steel walkway, electric control box, and pump on steel piling structure in the channel.

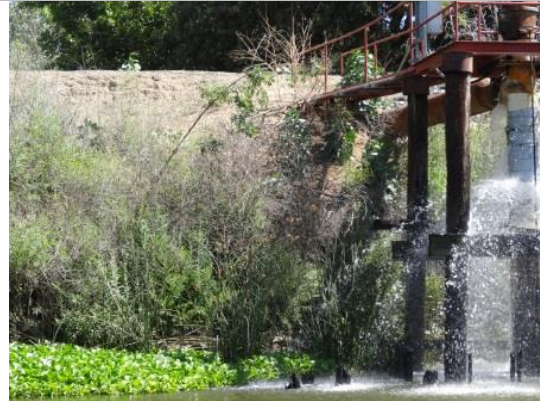
Photo 1 of 2 : SP_2016_RD2089_316_5_20160229_00007.jpg

LM Start	0.46	Rating **	M	Issue No.	5
LM End	0.46	Issue Type +	Ma	Location *	WS
Category	Supplemental			GPS Latitude/Longitude	
				Start	End
Item	DWR Erosion Survey			37.809394 °	37.809394 °
				-121.392791 °	-121.392791 °
DWR ID	DWR_RD2089_01_s_2016_5				
Comment Code					
Inspector Comment					
06/25/2015: No significant change observed.					
07/02/2014: No significant change observed.					
08/13/2013: No significant change observed.					
08/07/2012: The site has been visited by boat survey. No significant change observed					
08/23/2011: The site shows loose material around the pipe crossing.					
The operation of the pipe might have caused an impact on the levee.					
[2015 Site ID:RD2089U01RM29.8]

Close view of the site.

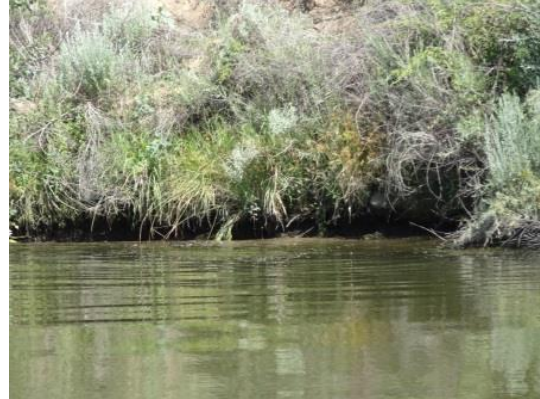
Photo 1 of 3 : SP_2016_RD2089_316_3_20160229_00004.jpg

Comment Code					
Inspector Comment					
06/25/2015: No significant change observed. 07/02/2014: No significant change observed. 08/13/2013: No significant change observed. 08/07/2012: The site has been visited by boat survey. No significant change observed 08/23/2011: The 5-foot vertical scarp shows no significant change from the last year inspection. No new erosion activities observed. Dense white willow trees on site. 09/07/2010: It was difficult to view the erosion due to the thick Willow thickets and other vegetation at the water line. At the time of the inspection, there were no signs of repair on site. As noted during the last survey, there is a 5-foot vertical scarp along the lower slope that may be subjected to high flow velocities. 08/05/2010: Recommended for repair, per CLRO; "Erosion of this site may be subjective to rapid rates of erosion." 09/28/2009: No major change observed; 5-foot vertical scarp is immediately downstream of where berm has tapered; site is recommended as local maintenance issue, per CLRO CES Evaluation 2008 Report; Site # is the same as RM29.6, LM0.60; previously rated "U". 11/05/2008: No change observed; rodent holes on lower slope; wide levee crown. [2015 Site ID:RD2089U01RM29.61]

Front view of the site. Note the erosion is invisible because of the dense vegetation.

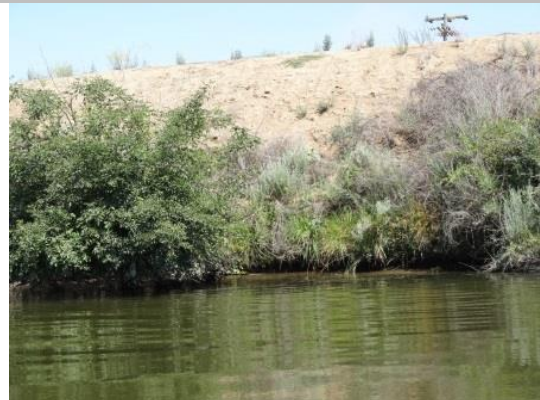
Photo 2 of 3 : SP_2016_RD2089_316_3_20160229_00005.jpg

Front view of the site. The scarp is visible on the slope.

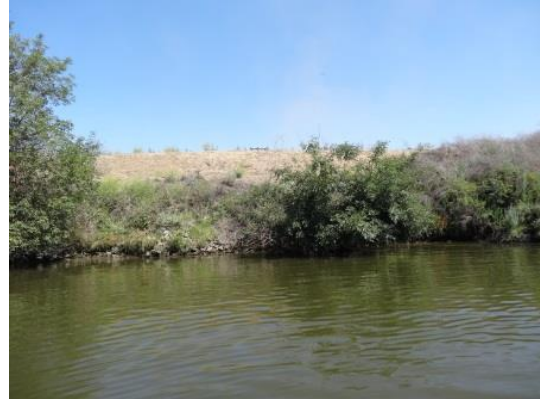
Photo 3 of 3 : SP_2016_RD2089_316_3_20160229_00006.jpg

Comment Code						
Inspector Comment						
06/25/2015: No significant change observed.						
07/02/2014: No significant change observed.						
08/13/2013: No significant change observed.						
08/07/2012: The site has been visited by boat survey. No significant change observed						
08/23/2011: The 5-foot vertical scarp shows no significant change from the last year inspection. No new erosion activities observed. Dense white willow trees on site.						
09/07/2010: It was difficult to view the erosion due to the thick Willow thickets and other vegetation at the water line. At the time of the inspection, there were no signs of repair on site. As noted during the last survey, there is a 5-foot vertical scarp along the lower slope that may be subjected to high flow velocities.						
08/05/2010: Recommended for repair, per CLRO; "Erosion of this site may be subjective to rapid rates of erosion."

09/28/2009: No major change observed; 5-foot vertical scarp is immediately downstream of where berm has tapered; site is recommended as local maintenance issue, per CLRO CES Evaluation 2008 Report; Site # is the same as RM29.6, LM0.60; previously rated "U".						
11/05/2008: No change observed; rodent holes on lower slope; wide levee crown. [2015 Site ID:RD2089U01RM29.61]

Front view of the site.

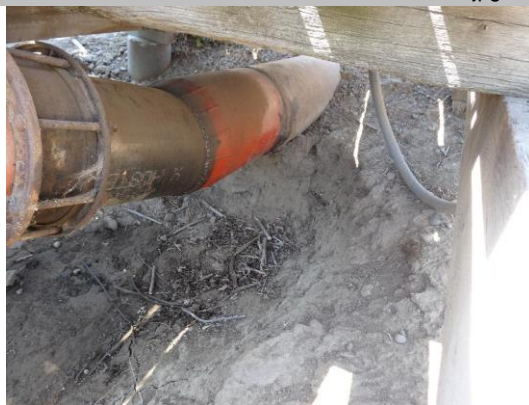
Photo 2 of 2 : UCIP_SP_2016_21587_36634.jpg

WS view: soil erosion under pump platform. Needs mitigation measures to stop erosion.

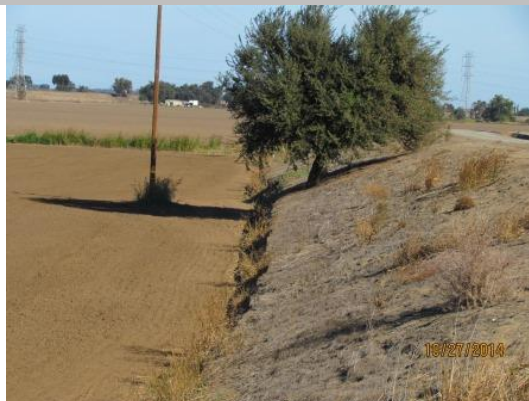
Photo 1 of 1 : SP_2016_RD2089_316_17_20160229_00014.jpg

LM Start	0.81	Rating **	M	Issue No.	17
LM End	0.94	Issue Type +	Ma	Location *	LS
Category	Earthen Levee			GPS Latitude/Longitude	
				Start	End
Item	Slope Stability			37.808319 °	37.806453 °
				-121.397881 °	-121.397755 °
DWR ID	DWR_RD2089_01_f_2014_17				
Comment Code					
S1 : Repair slope instability.					
Inspector Comment					
Landside levee toe cut due to farming.

View of the vertical cut along the landside levee toe.

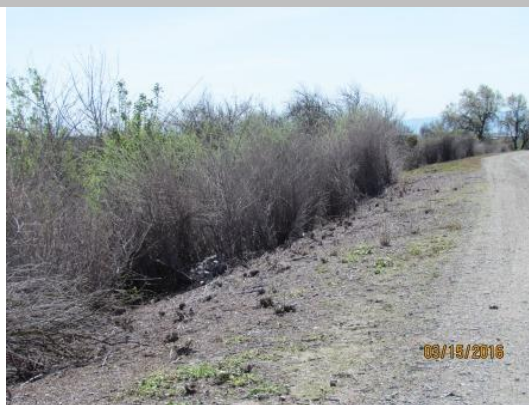
Photo 1 of 1 : SP_2016_RD2089_316_36_20160321_00055.jpg

View of tall willows on waterside slope.

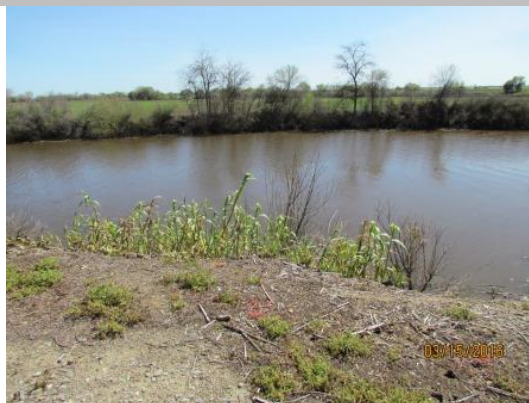
Photo 1 of 1 : SP_2016_RD2089_316_33_20160321_00056.jpg

Arundo was trimmed back and needs to be maintained to allow visibility and access.

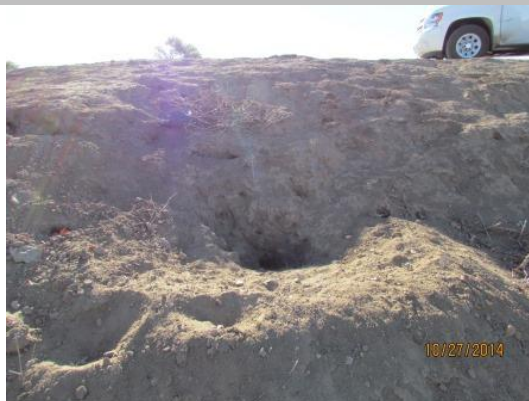
Photo 1 of 1 : SP_2016_RD2089_316_16_20160229_00013.jpg

View of the rodent burrow on the landside levee slope.

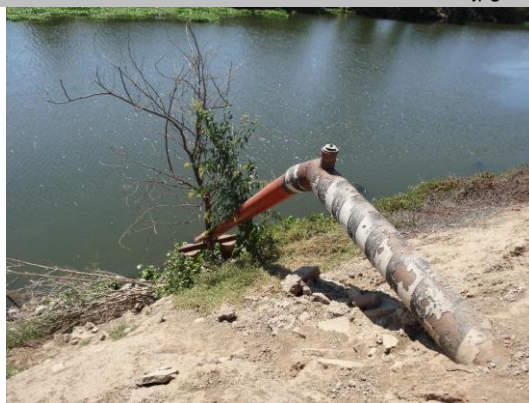
Photo 1 of 2 : UCIP_SP_2016_21754_36965.jpg

LM Start	1.14	Rating **	U	Issue No.	958
LM End	1.14	Issue Type +	En	Location *	LS
Category	Supplemental			GPS Latitude/Longitude	
				Start	End
Item	DWR UCIP Field Study			37.805644 °	37.805644 °
				-121.401177 °	-121.401177 °
DWR ID					
Comment Code					
Inspector Comment					
FS_ID:21754					
DS_ID:23044					
EP_NO: 3585					
Repair Type: Urgent					
Crossing Status: Found					
UCIP Comments: - huge slope erosion on landside slope.- most of the pipe exposed on levee slope.- service pole on landside.					
FIELD_STRUCT_DESC: 12-inch pipe through levee, 3.0 feet below the crown. Pump over concrete pipe in drain ditch on the landside. Siphon breaker on the waterside slope and air vent on landside. (App. No. 3585 - Elinore Lawrence). Originally included in O+M (1968)					
FS Date: 9/12/2013

WS view: most of the waterside pipe exposed on levee slope.

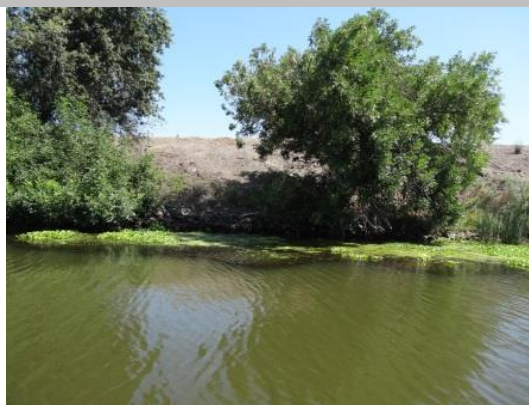
Photo 1 of 2 : SP_2016_RD2089_316_2_20160229_00002.jpg

LM Start	1.23	Rating **	M	Issue No.	2
LM End	1.24	Issue Type +	Ma	Location *	WS
Category	Supplemental			GPS Latitude/Longitude	
				Start	End
Item	DWR Erosion Survey			37.805580 °	37.805580 °
				-121.403010 °	-121.403010 °
DWR ID	DWR_RD2089_01_s _ 2016_2				
Comment Code					
Inspector Comment					
06/25/2015: No significant change observed.					
07/02/2014: No significant change observed.					
08/13/2013: The erosion is around a tree at the levee toe. Dense vegetation is visible. [2015 Site ID:RD2089U01RM29.04]

View of the erosion from the survey boat.

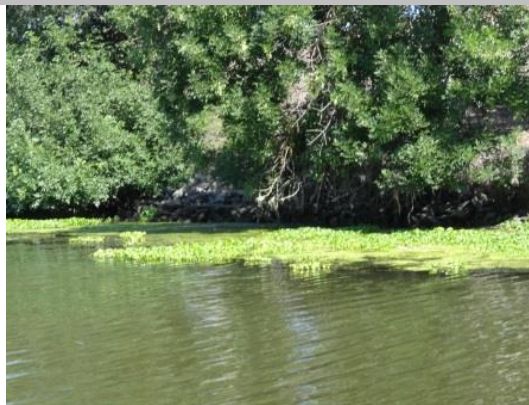
Photo 2 of 2 : SP_2016_RD2089_316_2_20160229_00003.jpg

Close view of the site. Note the tree and the vegetation.

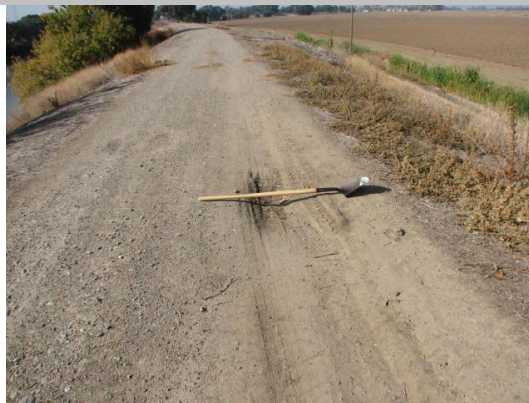
Photo 1 of 1 : SP_2016_RD2089_316_44_20160229_00029.jpg

11/10/2011 Roadway depression.

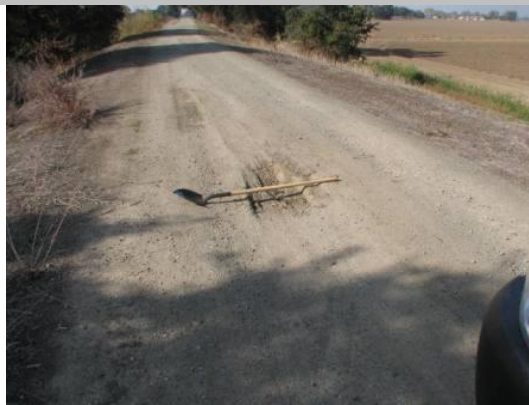
Photo 1 of 1 : SP_2016_RD2089_316_45_20160229_00030.jpg

11/10/2011 Roadway depression.

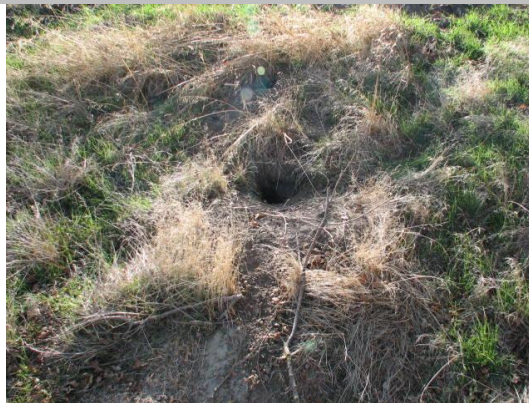
Photo 1 of 1 : SP_2016_RD2089_316_47_20160229_00032.jpg

11/10/2011 Active rodent burrow on landside slope.

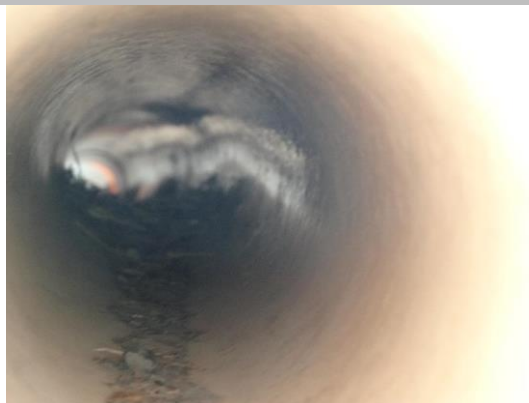
Photo 2 of 2 : UCIP_SP_2016_46720_36610.jpg

WS view: inside view of pvc pipe. Sediments found inside the pipe.

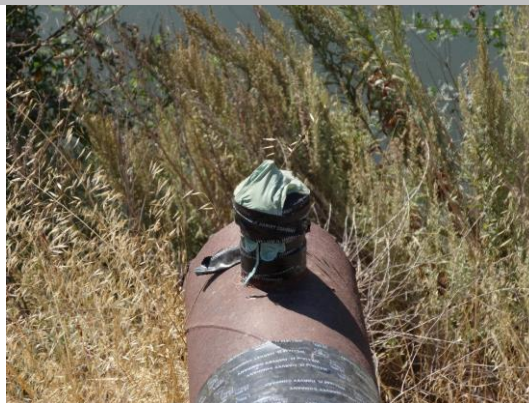
Photo 2 of 2 : UCIP_SP_2016_21585_36623.jpg

WS view: exposed steel pipe with siphon breaker. Looks siphon breaker needs repair.

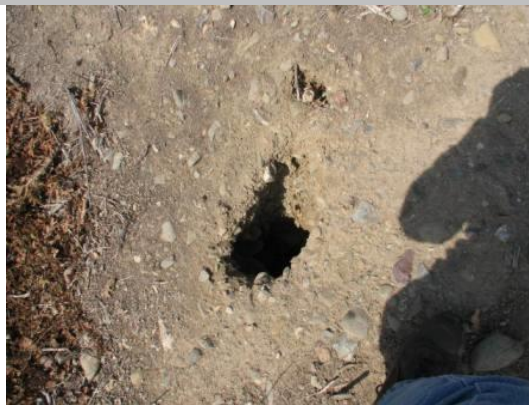
Photo 1 of 1 : SP_2016_RD2089_316_49_20160229_00033.jpg

11/10/2011 Deep burrow on waterside.

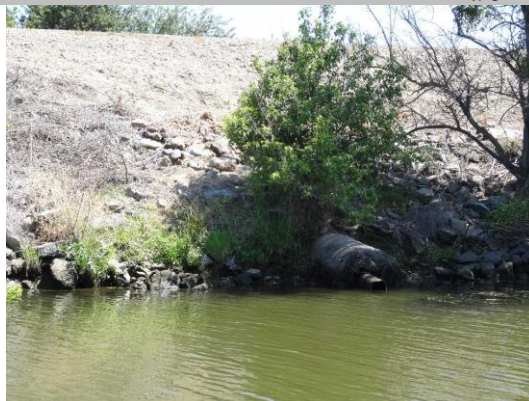
Photo 1 of 2 : UCIP_SP_2016_46090_74506.jpg

View up WS slope from water. Pipe does not cross channel.

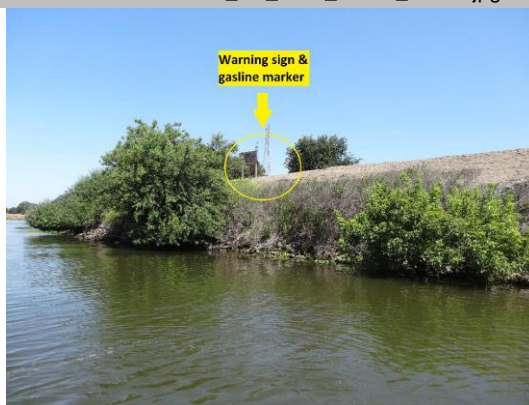
Photo 2 of 2 : UCIP_SP_2016_46090_74508.jpg

Gasline marker (for crossing with DS ID 25121) appr. 100 ft west of crossing.

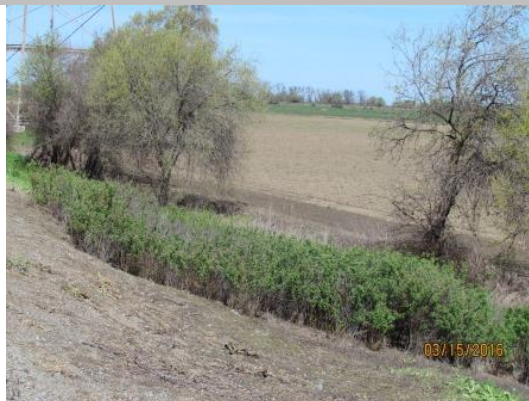
Photo 1 of 1 : SP_2016_RD2089_317_20_20160321_00048.jpg

View of the vegetation on the landside levee slope.

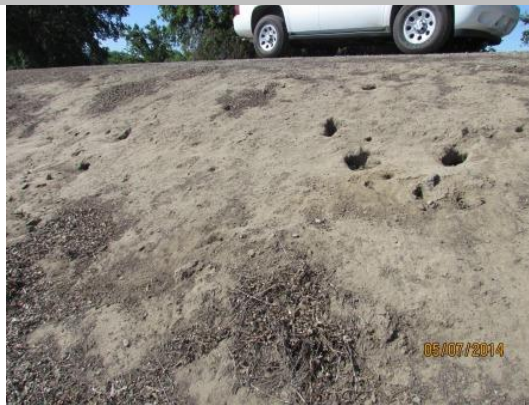
Photo 1 of 1 : SP_2016_RD2089_317_49_20160229_00037.jpg

View of the multiple rodent burrows on the landside levee hinge and slope.

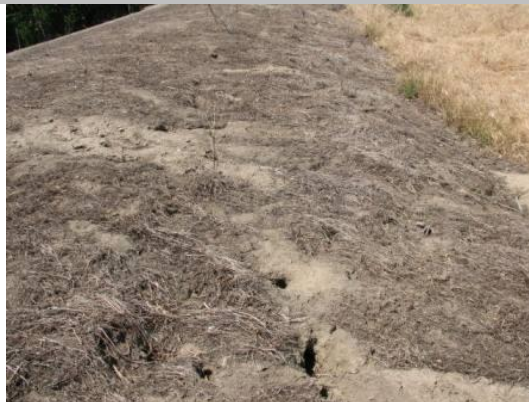
Photo 1 of 1 : SP_2016_RD2089_317_24_20160229_00022.jpg

05/24/2011 Active burrows, ground squirrel sighted in area.

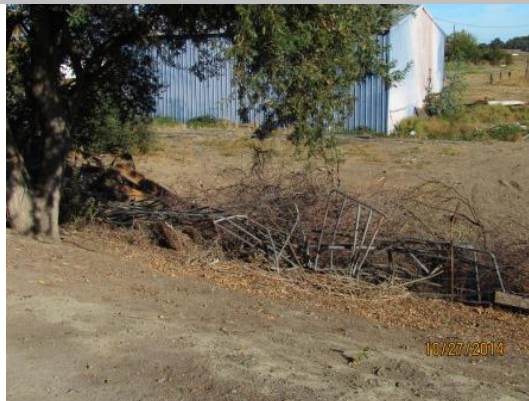
Photo 1 of 1 : SP_2016_RD2089_317_52_20160229_00039.jpg

View of the tree branches on the landside levee toe obstructing access.

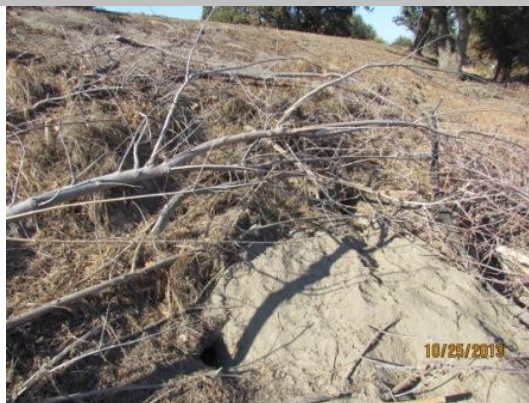
Photo 1 of 1 : SP_2016_RD2089_317_51_20160229_00038.jpg

View of the rodent burrow on the landside levee toe.

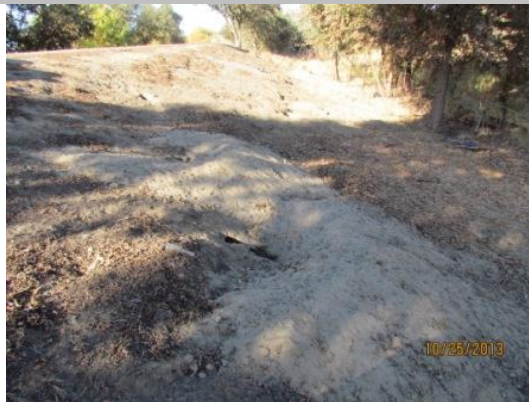
Photo 1 of 3 : SP_2016_RD2089_317_53_20160229_00040.jpg

View of the multiple rodent burrows on the landside levee slope.

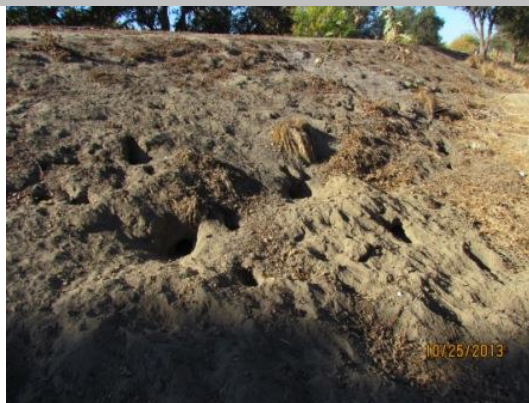
Photo 3 of 3 : SP_2016_RD2089_317_53_20160229_00042.jpg

Another view of the multiple rodent burrows on the landside levee slope.

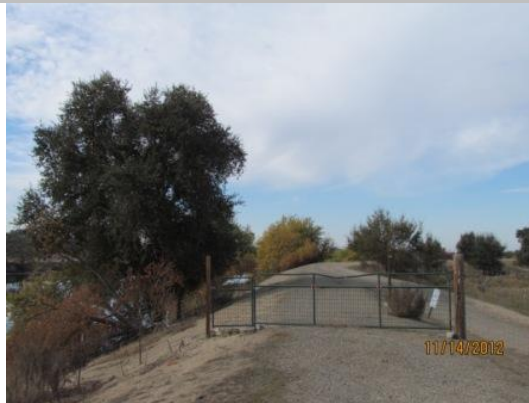
Photo 1 of 1 : SP_2016_RD2089_317_2_20160229_00003.jpg

View of gate across levee crown.

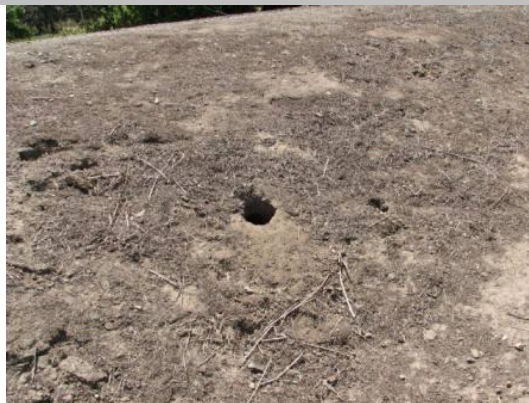
Photo 1 of 1 : SP_2016_RD2089_317_26_20160229_00023.jpg

05/24/2011 Active rodent burrow.

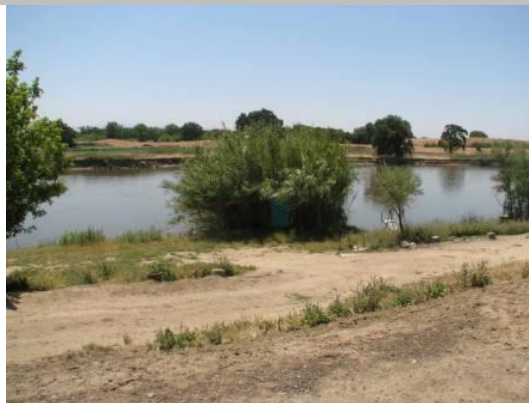
Photo 1 of 1 : SP_2016_RD2089_317_27_20160229_00024.jpg

05/24/2011 Portable toilet is in the shadows in the center of the photo at the water's edge.

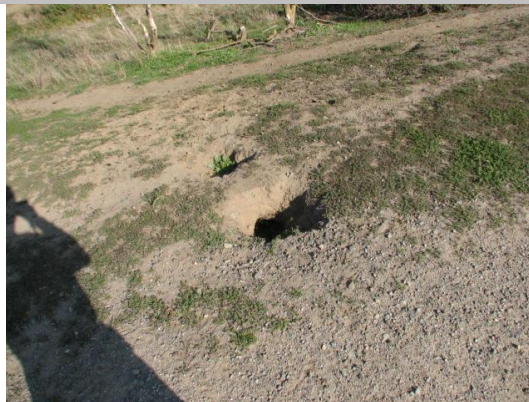
Photo 1 of 1 : SP_2016_RD2089_317_13_20160229_00015.jpg

11/10/2011 Two large burrows on crown, need to be filled.

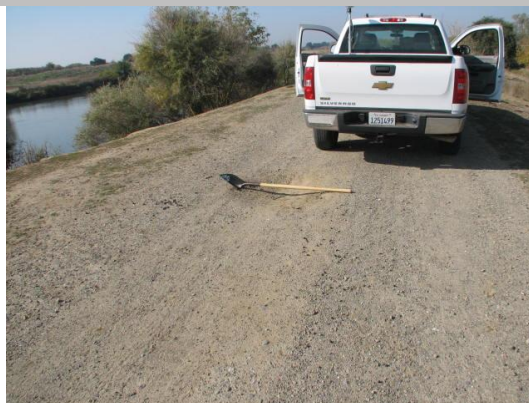
Photo 1 of 1 : SP_2016_RD2089_317_10_20160229_00011.jpg

11/10/2011 Depression in crown needs to be filled.

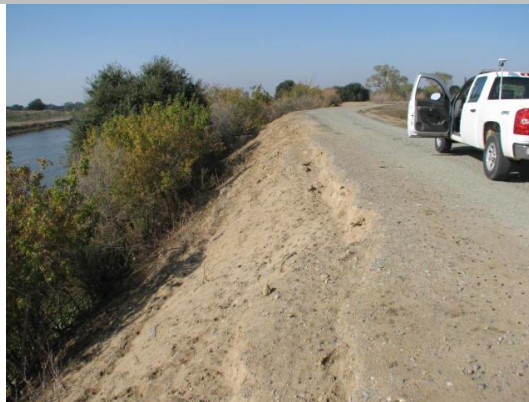
Photo 1 of 1 : SP_2016_RD2089_317_14_20160229_00016.jpg

11/10/2011 Approximately 1' scarp has been created by livestock travel.

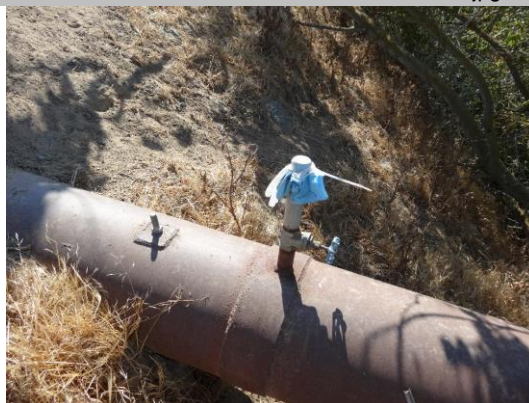
Photo 2 of 2 : UCIP_SP_2016_21676_36860.jpg

WS view: air relief valve on pipe. Pipe exposed in levee slope.

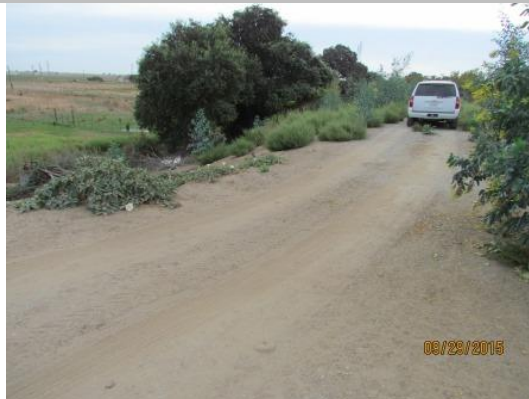
Photo 1 of 4 : SP_2016_RD2089_317_35_20160229_00027.jpg

View of the levee crown depression looking upstream.

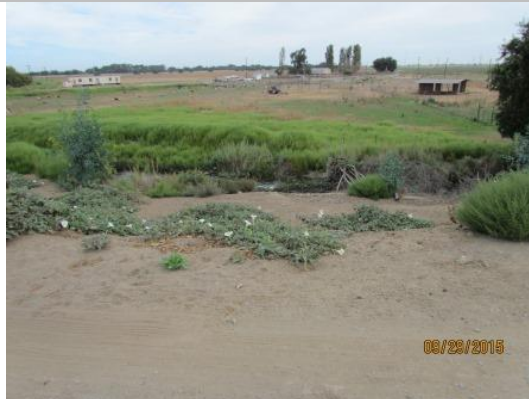
Photo 3 of 4 : SP_2016_RD2089_317_35_20160229_00029.jpg

View of the levee crown depression looking to the landside.

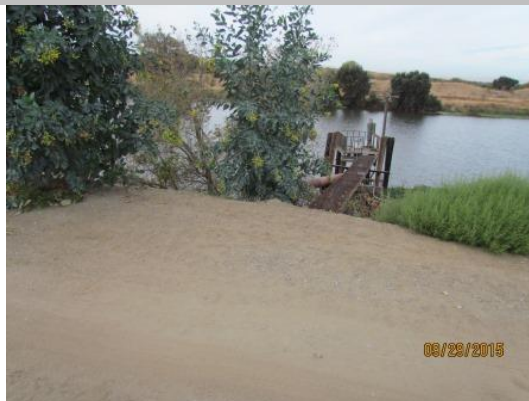
Photo 4 of 4 : SP_2016_RD2089_317_35_20160229_00030.jpg

View of the levee crown depression looking to the waterside.

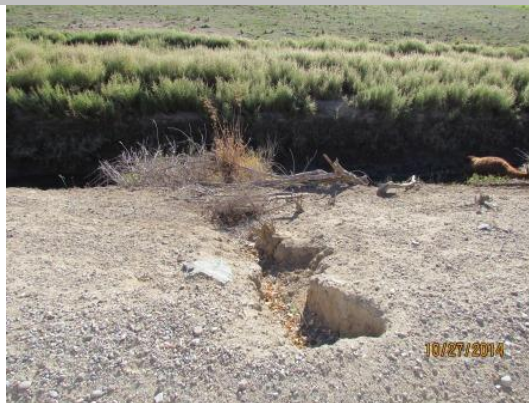
Photo 1 of 1 : SP_2016_RD2089_317_15_20160229_00017.jpg

View of the scour from surface runoff on the landside levee slope.

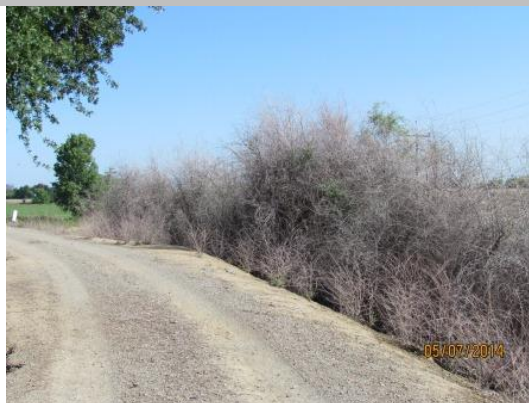
Photo 1 of 1 : SP_2016_RD2089_317_36_20160229_00031.jpg

Extremely thick dead brush prevents access and visibility.

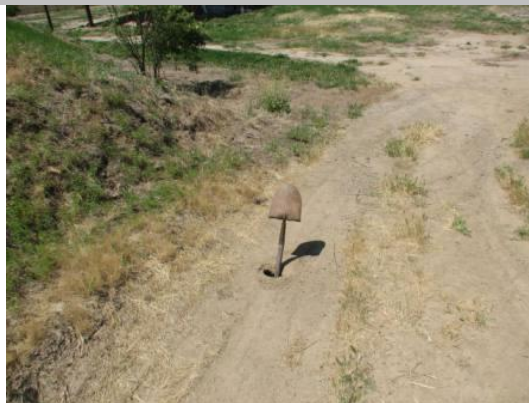
Photo 1 of 3 : SP_2016_RD2089_317_40_20160229_00032.jpg

05/24/2011 Deep vertical burrow in ramp on land side of levee.

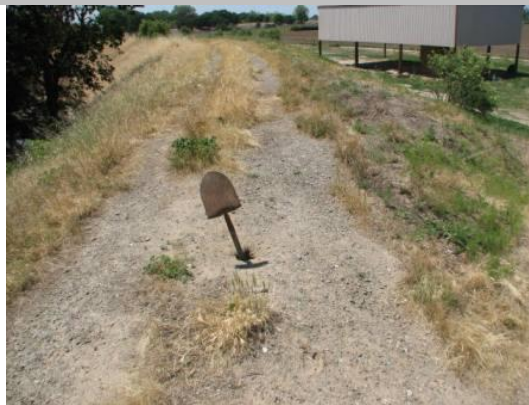
Photo 2 of 3 : SP_2016_RD2089_317_40_20160229_00033.jpg

05/24/2011 Deep vertical burrow in levee crown.

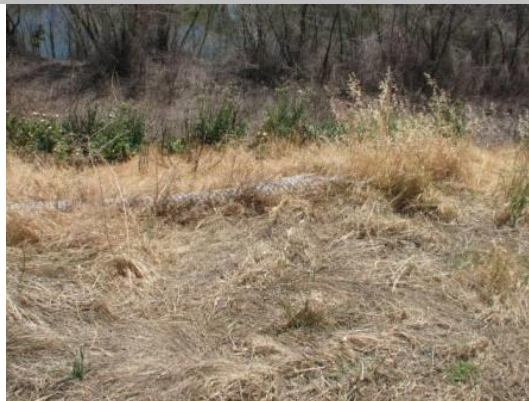
Photo 1 of 1 : SP_2016_RD2089_317_41_20160229_00035.jpg

05/24/2011 Old CMP left on waterside levee slope, needs to be removed.

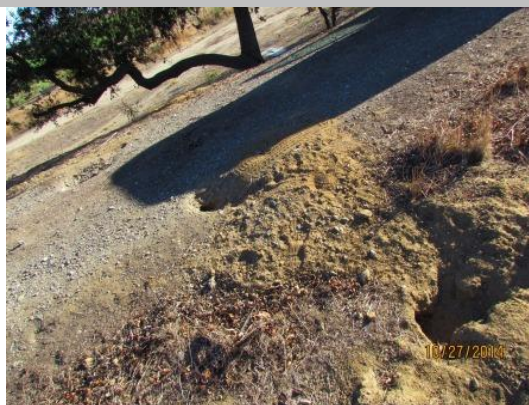
Photo 1 of 2 : SP_2016_RD2089_317_12_20160229_00013.jpg

View of several large rodent holes on the levee crown.

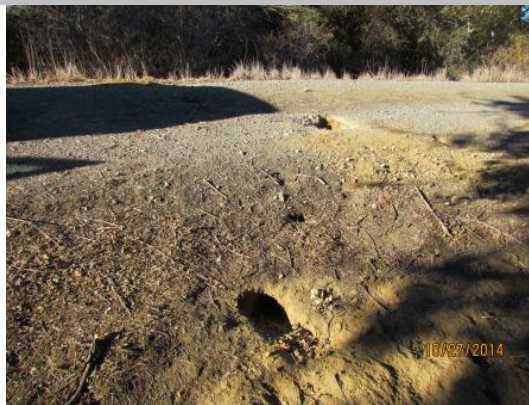
Photo 2 of 2 : SP_2016_RD2089_317_12_20160229_00014.jpg

View of several rodent burrows on landside levee hinge and crown.

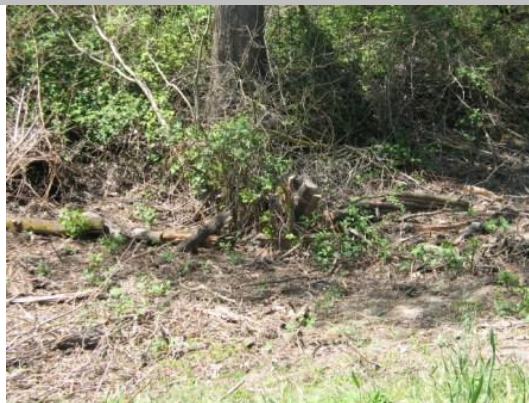
Photo 1 of 1 : SP_2016_RD2089_317_29_20160229_00026.jpg

Tree stump >2" left after vegetation and tree removal.

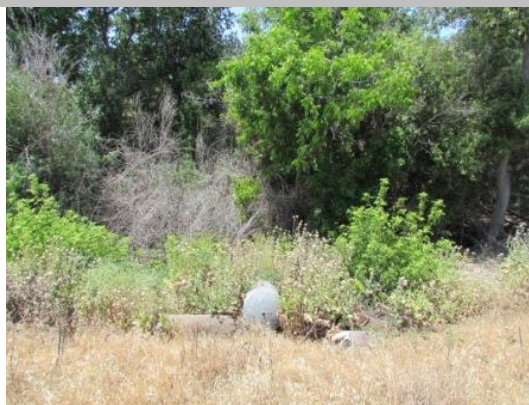
Photo 1 of 1 : SP_2016_RD2089_317_17_20160229_00018.jpg

View of water tanks disposed on waterside slope.

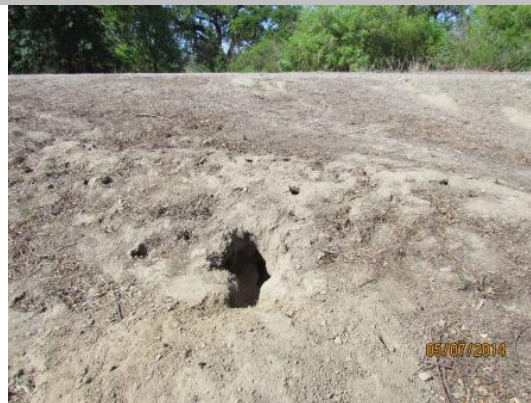
Photo 1 of 1 : SP_2016_RD2089_317_6_20160229_00007.jpg

View of the large rodent hole on the landside levee slope.

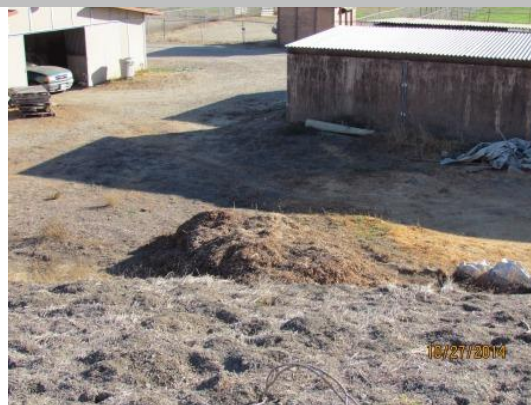
Photo 1 of 1 : SP_2016_RD2089_317_7_20160229_00008.jpg

View of the animal feed stockpiled at the landside levee toe.

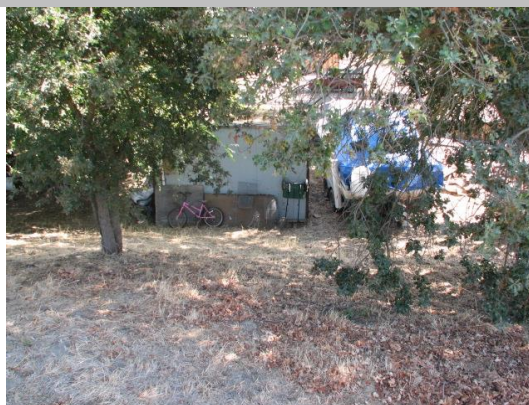
Photo 1 of 1 : SP_2016_RD2089_317_23_20160229_00021.jpg

Fall 2009 photo: Buildings and patio decks are built within 10-ft of the levee slope.

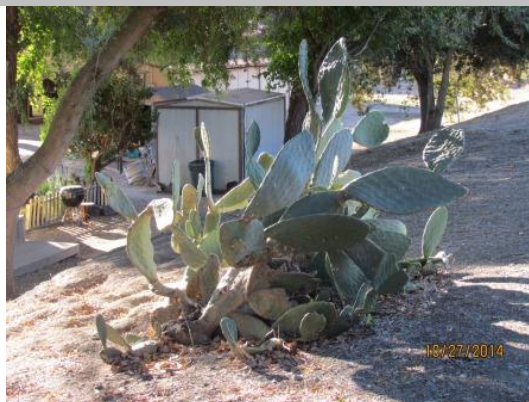
Photo 1 of 1 : SP_2016_RD2089_317_57_20160229_00044.jpg

View of the cactus on the landside levee shoulder.

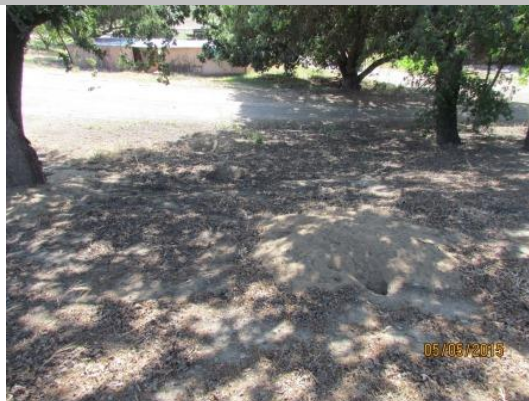
Photo 1 of 1 : SP_2016_RD2089_317_11_20160229_00012.jpg

View of the multiple rodent burrows on the landside levee slope.
