**Flood Control Project Maintenance
Levee Inspections**
LMA District Cover Sheet
Spring 2017 Levee Inspection Results

Reclamation District No. 2089 Stark

Spring 2017 Levee Inspection Results

Waterway	Bank	Unit Miles
Unit No. 01 Old River	Right	1.51

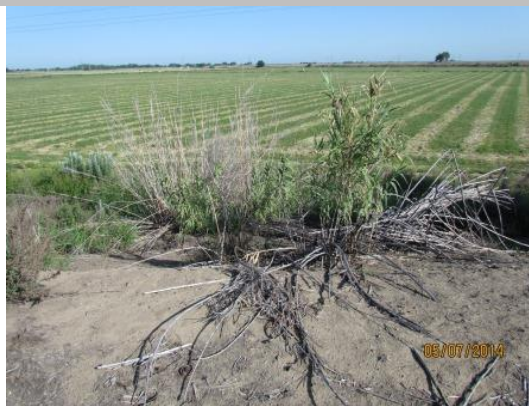
Photo 1 of 1 : SP_2017_RD2089_316_940_20170407_00030.jpg

The LMA is actively trying to remove the vegetation on the landside levee slope and toe.

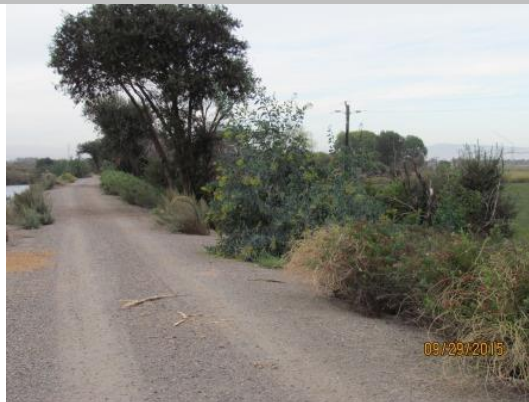
Photo 1 of 1 : SP_2017_RD2089_316_12_20170407_00008.jpg

LM Start	0.27	Rating **	U	Issue No.	12
LM End	0.39	Issue Type +	Ma	Location *	LS
Category	Earthen Levee			GPS Latitude/Longitude	
				Start	End
Item	Vegetation			37.810319 °	37.809740 °
				-121.389510 °	-121.391645 °
DWR ID	DWR_RD2089_01_s_2012_12				
Comment Code					
V2 : Remove the wild growth other than native grasses from the levee slopes.					
Inspector Comment					
Access and visibility completely blocked. 11/10/2011 issue has not changed.

Thick brush and wild rose completely block access and visibility of landside slope and toe.

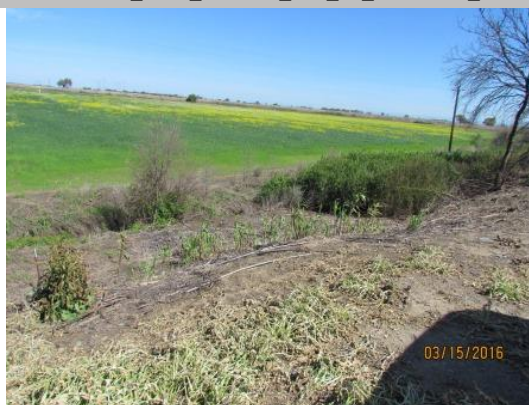
Photo 2 of 2 : SP_2017_RD2089_316_19_20170407_00013.jpg

Arundo was trimmed back from the road and needs to be maintained so that it does not obstruct visibility and access to the landside toe.

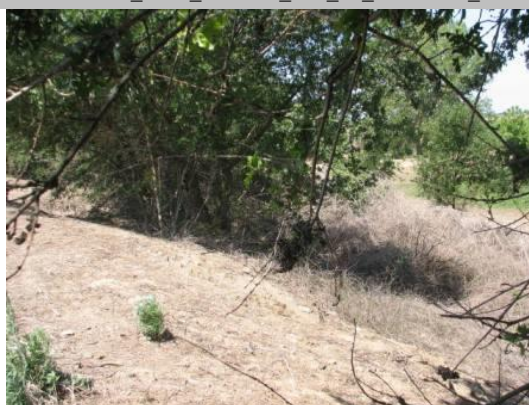
Photo 1 of 1 : SP_2017_RD2089_316_28_20170407_00020.jpg

LM Start	0.41	Rating **	M	Issue No.	28
LM End	0.46	Issue Type +	Ma	Location *	LS
Category	Earthen Levee			GPS Latitude/Longitude	
				Start	End
Item	Vegetation			37.809593 °	37.809507 °
				-121.391963 °	-121.392907 °
DWR ID	DWR_RD2089_01_s_2012_28				
Comment Code					
V2 : Remove the wild growth other than native grasses from the levee slopes.					
Inspector Comment					
Vegetation is too thick to allow access and visibility. Some thick patches of shrubs remain and continue to block visibility and access.

05/24/2011 Photo shows thick dead vegetation and continuation of trees in area that are preventing access and visibility of landside slope and toe.

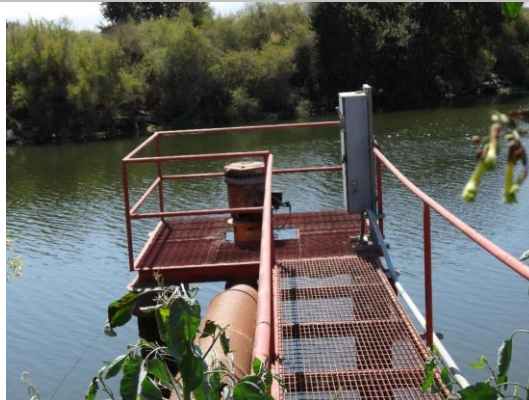
Photo 2 of 3 : UCIP_SP_2017_21635_36741.jpg

LM Start	0.46	Rating **	M	Issue No.	958
LM End	0.46	Issue Type +	En	Location *	LS
Category	Supplemental			GPS Latitude/Longitude	
				Start	End
Item	DWR UCIP Field Study			37.809501 °	37.809501 °
				-121.392798 °	-121.392798 °
DWR ID					
Comment Code					
Inspector Comment					
FS_ID:21635					
DS_ID:23042					
EP_NO: 5641					
Repair Type: Non-Urgent					
Crossing Status: Found					
UCIP Comments: - damaged siphon breaker.- most of the pipe on					
landside exposed on levee slope.					
FIELD_STRUCT_DESC: 20-inch steel pipe and electric conduit through					
the levee, 5.8 feet below the crown, pump on pile structure in the					
stream. Siphon breaker on the landward slope. (App. No. 5641- Ted					
Stark)					
FS Date: 9/12/2013

WS view: steel walkway, electric control box, and pump on steel piling structure in the channel.

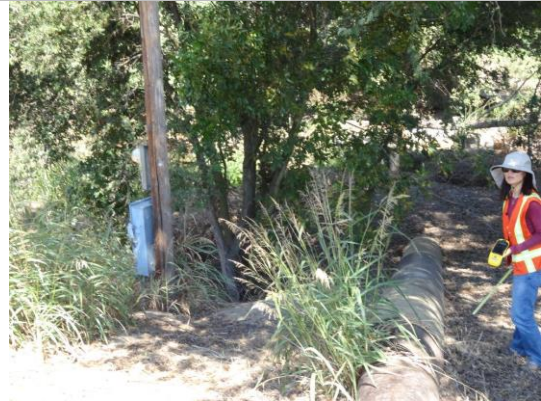
Photo 3 of 3 : UCIP_SP_2017_21635_36740.jpg

LM Start	0.46	Rating **	M	Issue No.	958 (cont)	
LM End	0.46	Issue Type +	En	Location *	LS	
Category	Supplemental			GPS Latitude/Longitude		
				Start		End
Item	DWR UCIP Field Study			37.809501 °	37.809501 °	
				-121.392798 °	-121.392798 °	
DWR ID						
Comment Code						
Inspector Comment						
FS_ID:21635						
DS_ID:23042						
EP_NO: 5641						
Repair Type: Non-Urgent						
Crossing Status: Found						
UCIP Comments: - damaged siphon breaker.- most of the pipe on						
landside exposed on levee slope.						
FIELD_STRUCT_DESC: 20-inch steel pipe and electric conduit through						
the levee, 5.8 feet below the crown, pump on pile structure in the						
stream. Siphon breaker on the landward slope. (App. No. 5641- Ted						
Stark)						
FS Date: 9/12/2013

LS view: overview of exposed steel pipe (right) on levee slope and service pole (left).

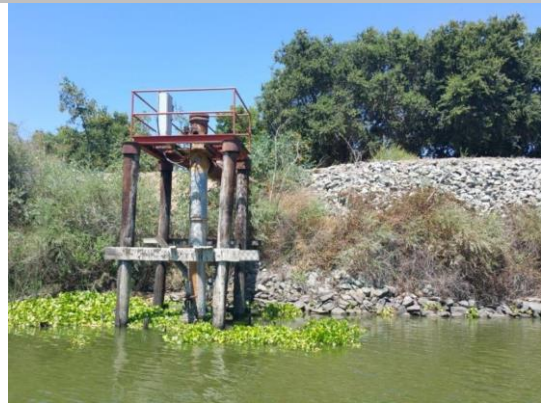
Photo 1 of 2 : SP_2017_RD2089_316_5_20170407_00005.jpg

LM Start	0.46	Rating **	M	Issue No.	5
LM End	0.46	Issue Type +	Ma	Location *	WS
Category	Supplemental			GPS Latitude/Longitude	
				Start	End
Item	DWR Erosion Survey			37.809394 °	37.809394 °
				-121.392791 °	-121.392791 °
DWR ID	DWR_RD2089_01_s_2017_5				
Comment Code					
Inspector Comment					
07/25/2016: No significant change observed.					
06/25/2015: No significant change observed.					
07/02/2014: No significant change observed.					
08/13/2013: No significant change observed.					
08/07/2012: The site has been visited by boat survey. No significant change observed					
08/23/2011: The site shows loose material around the pipe crossing.					
The operation of the pipe might have caused an impact on the levee.					
[2016 Site ID:RD2089U01RM29.8]

Front view of the site. Note the irrigation pipe on the site.

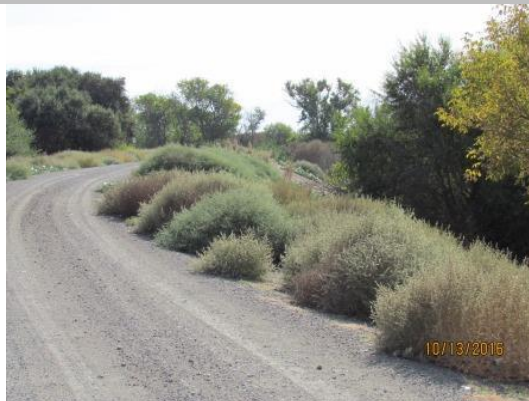
Photo 2 of 2 : SP_2017_RD2089_316_29_20170407_00021.jpg

View of the vegetation on the waterside levee slope.

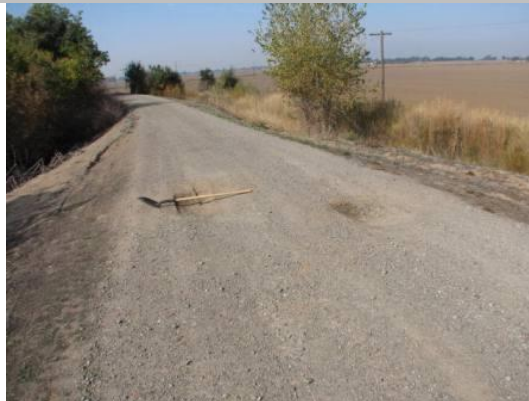
Photo 1 of 1 : SP_2017_RD2089_316_14_20170407_00009.jpg

LM Start	0.54	Rating **	M	Issue No.	14
LM End	0.54	Issue Type +	Ma	Location *	CR
Category	Earthen Levee			GPS Latitude/Longitude	
				Start	End
Item	Crown Surface / Depressions / Rutting			37.810087 °	37.810087 °
				-121.394200 °	-121.394200 °
DWR ID	DWR_RD2089_01_s_2012_14				
Comment Code					
C3 : Add appropriate gravel or road base. Grade and compact.					
Inspector Comment					
11/10/2011 Minor depressions will cause ponding.

11/10/2011 Depressions in crown.

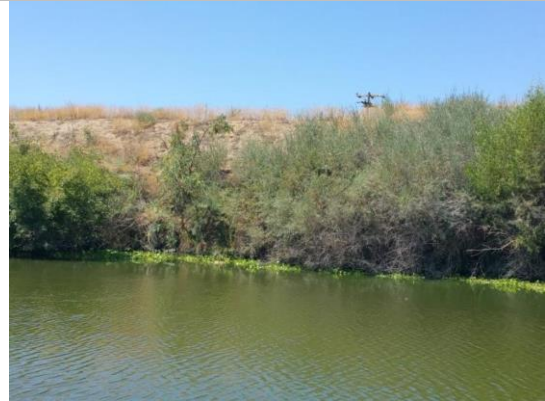
Photo 1 of 1 : SP_2017_RD2089_316_3_20170407_00004.jpg

Comment Code					
Inspector Comment					
07/25/2016: No significant change observed.					
06/25/2015: No significant change observed.					
07/02/2014: No significant change observed.					
08/13/2013: No significant change observed.					
08/07/2012: The site has been visited by boat survey. No significant change observed					
08/23/2011: The 5-foot vertical scarp shows no significant change from the last year inspection. No new erosion activities observed. Dense white willow trees on site.					
09/07/2010: It was difficult to view the erosion due to the thick Willow thickets and other vegetation at the water line. At the time of the inspection, there were no signs of repair on site. As noted during the last survey, there is a 5-foot vertical scarp along the lower slope that may be subjected to high flow velocities.					
08/05/2010: Recommended for repair, per CLRO; "Erosion of this site may be subjective to rapid rates of erosion."

09/28/2009: No major change observed; 5-foot vertical scarp is immediately downstream of where berm has tapered; site is recommended as local maintenance issue, per CLRO CES Evaluation 2008 Report; Site # is the same as RM29.6, LM0.60; previously rated "U".					
11/05/2008: No change observed; rodent holes on lower slope; wide levee crown. [2016 Site ID:RD2089U01RM29.61]

Front view of the site. Note the very dense white willow thickets on site.

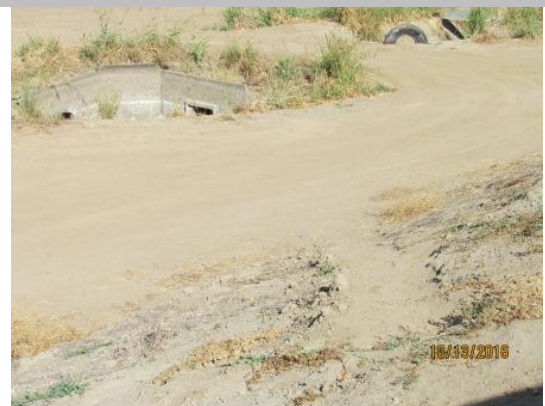
Photo 1 of 1 : SP_2017_RD2089_316_22_20170407_00016.jpg

LM Start	0.80	Rating **	M	Issue No.	22
LM End	0.80	Issue Type +	Ma	Location *	LS
Category	Earthen Levee			GPS Latitude/Longitude	
				Start	End
Item	Slope Stability			37.808466 °	37.808466 °
				-121.397847 °	-121.397847 °
DWR ID	DWR_RD2089_01_f_2016_22				
Comment Code					
S2 : Repair the levee slope damaged by foot traffic and prevent access where possible.					
Inspector Comment

View of the footpath on the landside levee slope.

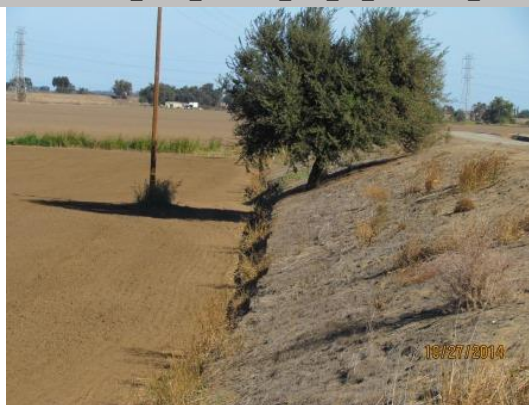
Photo 1 of 1 : SP_2017_RD2089_316_17_20170407_00011.jpg

LM Start	0.81	Rating **	M	Issue No.	17
LM End	0.94	Issue Type +	Ma	Location *	LS
Category	Earthen Levee			GPS Latitude/Longitude	
				Start	End
Item	Slope Stability			37.808319 °	37.806453 °
				-121.397881 °	-121.397755 °
DWR ID	DWR_RD2089_01_f_ 2014_17				
Comment Code					
S1 : Repair slope instability.					
Inspector Comment					
Landside levee toe cut due to farming.

View of the vertical cut along the landside levee toe.

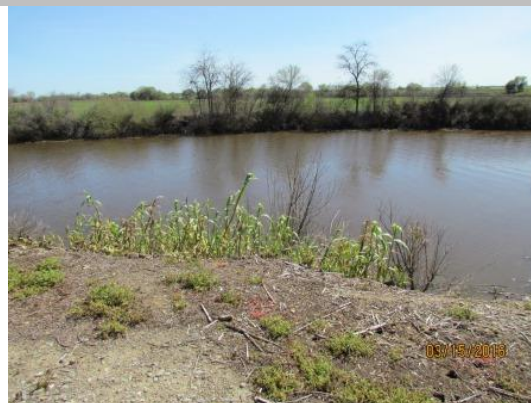
Photo 1 of 1 : SP_2017_RD2089_316_33_20170407_00023.jpg

Arundo was trimmed back and needs to be maintained to allow visibility and access.

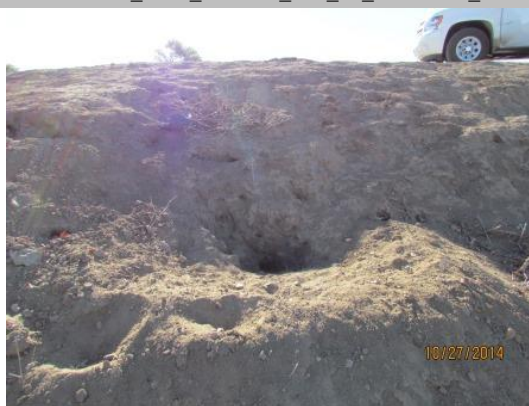
Photo 1 of 1 : SP_2017_RD2089_316_16_20170407_00010.jpg

View of the rodent burrow on the landside levee slope.

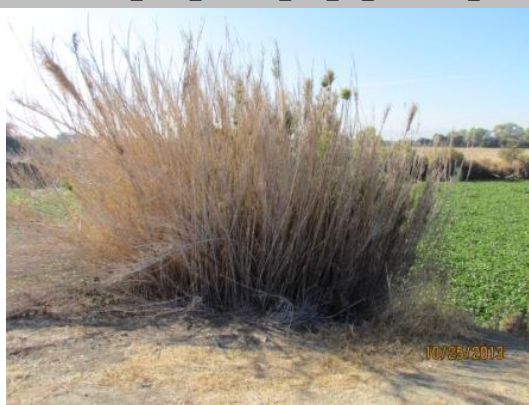
Photo 1 of 1 : SP_2017_RD2089_316_25_20170407_00017.jpg

View of the Arrundo on the waterside slope obstructing visibility. LMA is actively trying to remove the wild growth.

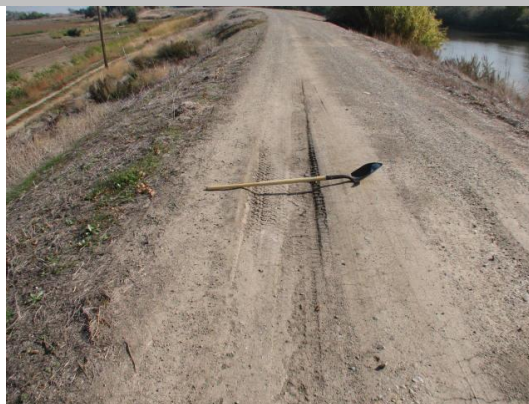
Photo 1 of 1 : SP_2017_RD2089_316_43_20170407_00024.jpg

11/10/2011 Depression in roadway.

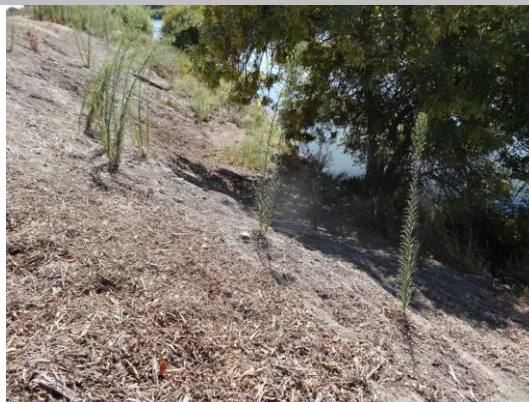
Photo 2 of 2 : SP_2017_RD2089_316_2_20170407_00003.jpg

LM Start	1.23	Rating **	M	Issue No.	2
LM End	1.24	Issue Type +	Ma	Location *	WS
Category	Supplemental			GPS Latitude/Longitude	
				Start	End
Item	DWR Erosion Survey			37.805580 °	37.805580 °
				-121.403010 °	-121.403010 °
DWR ID	DWR_RD2089_01_s_2017_2				
Comment Code					
Inspector Comment					
09/16/2016: The river was not navigable near the site due to the dense water grass, so the site was visited by land survey. No significant change observed.					
06/25/2015: No significant change observed.					
07/02/2014: No significant change observed.					
08/13/2013: The erosion is around a tree at the levee toe. Dense vegetation is visible. [2016 Site ID:RD2089U01RM29.04]

Close view of the erosion.

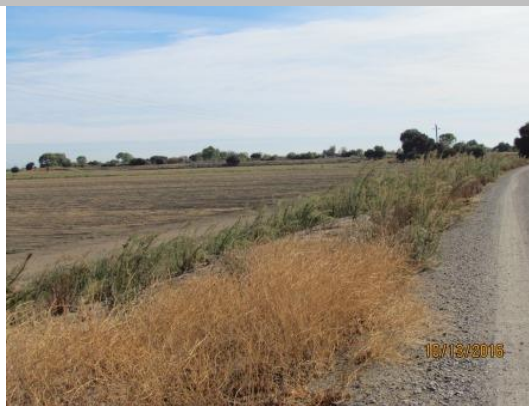
Photo 1 of 1 : SP_2017_RD2089_316_20_20170407_00014.jpg

View of the vegetation on the landside levee slope.

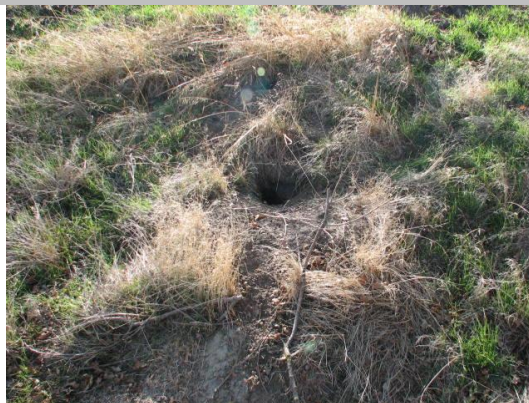
Photo 1 of 1 : SP_2017_RD2089_316_47_20170407_00028.jpg

11/10/2011 Active rodent burrow on landside slope.

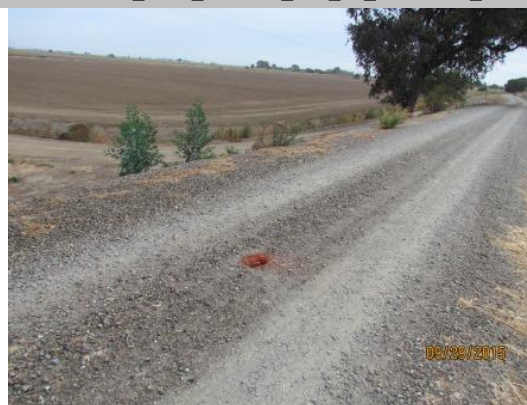
Photo 1 of 1 : SP_2017_RD2089_316_26_20170407_00018.jpg

View of the rodent hole on the levee crown.

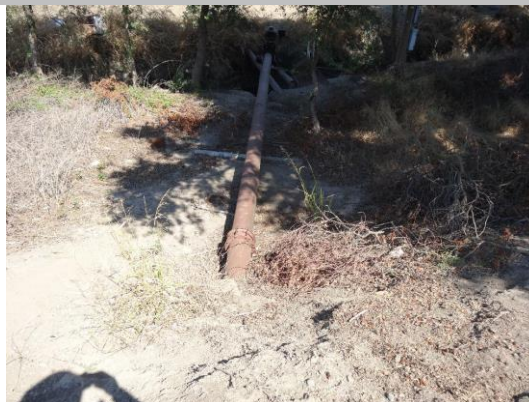
Photo 3 of 3 : UCIP_SP_2017_21585_36622.jpg

LS view: exposed steel pipe on levee slope.

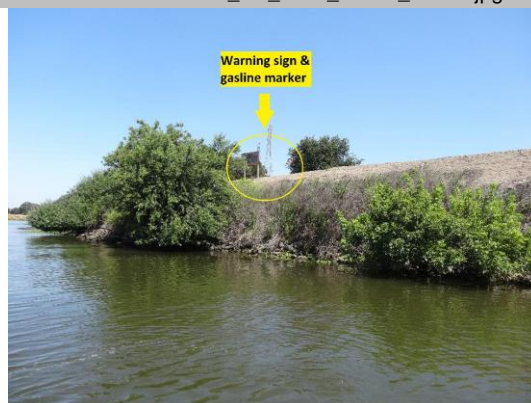
Photo 2 of 3 : UCIP_SP_2017_50736_74508.jpg

Gasline marker (for crossing with DS ID 25121) appr. 100 ft west of crossing.

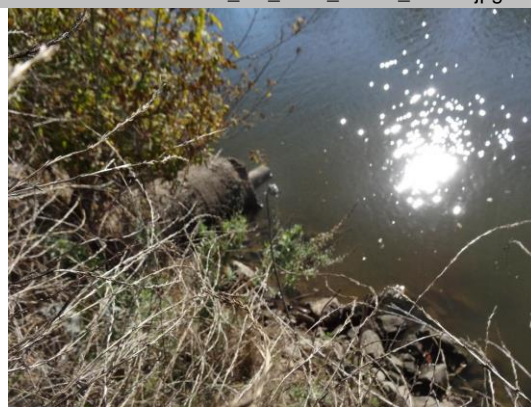
Photo 3 of 3 : UCIP_SP_2017_50736_76207.jpg

WS view of pipe

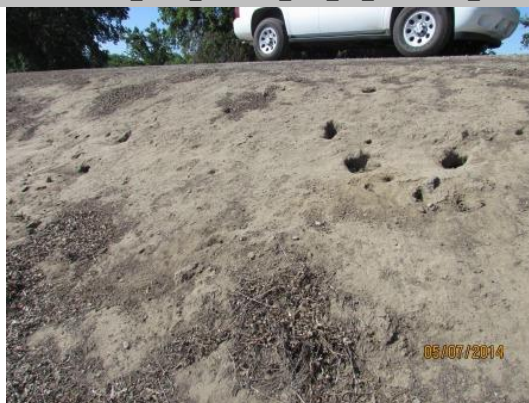
Photo 1 of 1 : SP_2017_RD2089_317_49_20170407_00043.jpg

View of the multiple rodent burrows on the landside levee hinge and slope.

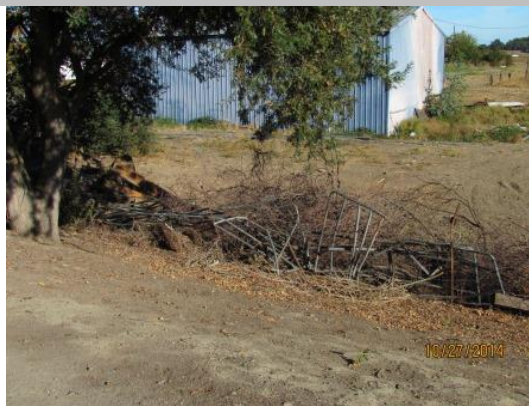
Photo 1 of 1 : SP_2017_RD2089_317_52_20170407_00045.jpg

View of the tree branches on the landside levee toe obstructing access.

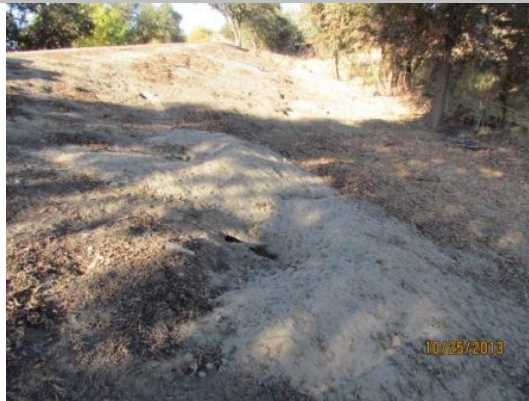
Photo 1 of 3 : SP_2017_RD2089_317_53_20170407_00046.jpg

View of the multiple rodent burrows on the landside levee slope.

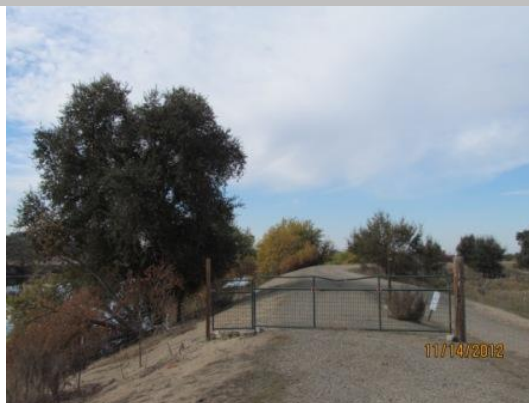
Photo 1 of 1 : SP_2017_RD2089_317_2_20170407_00003.jpg

View of gate across levee crown.

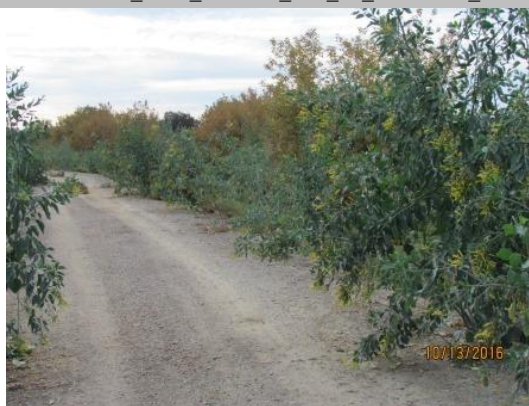
Photo 1 of 1 : SP_2017_RD2089_317_44_20170407_00041.jpg

View of the vegetation on the levee slopes.

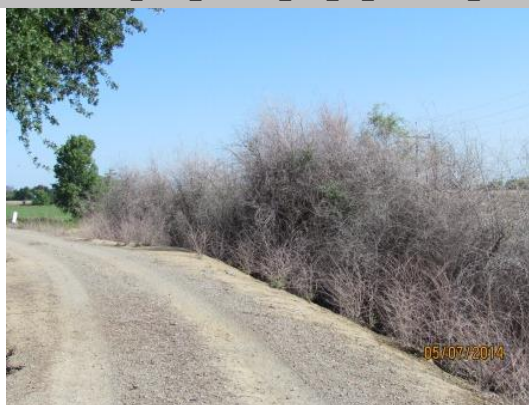
Photo 1 of 2 : SP_2017_RD2089_317_36_20170407_00031.jpg

Extremely thick dead brush prevents access and visibility.

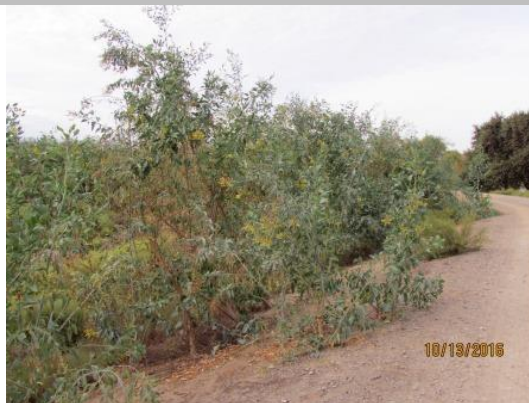
Photo 2 of 2 : SP_2017_RD2089_317_36_20170407_00032.jpg

Another view of the thick vegetation on the landside levee slope.

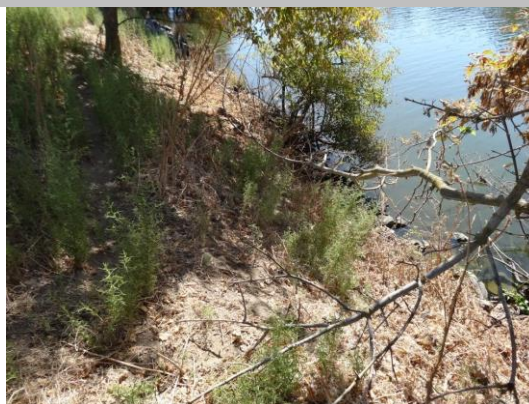
Photo 2 of 2 : SP_2017_RD2089_317_1_20170407_00002.jpg

Close view of the erosion. Note the vegetation at the site.

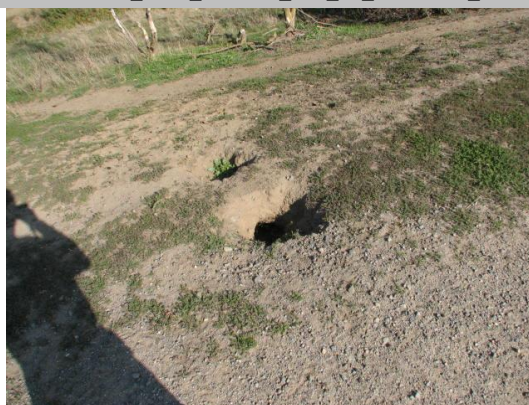
Photo 1 of 1 : SP_2017_RD2089_317_13_20170407_00013.jpg

11/10/2011 Two large burrows on crown, need to be filled.

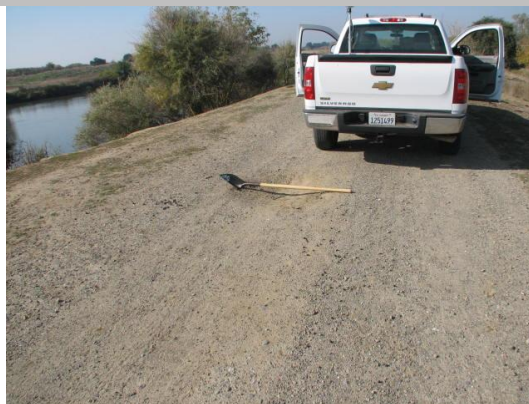
Photo 1 of 1 : SP_2017_RD2089_317_10_20170407_00009.jpg

11/10/2011 Depression in crown needs to be filled.

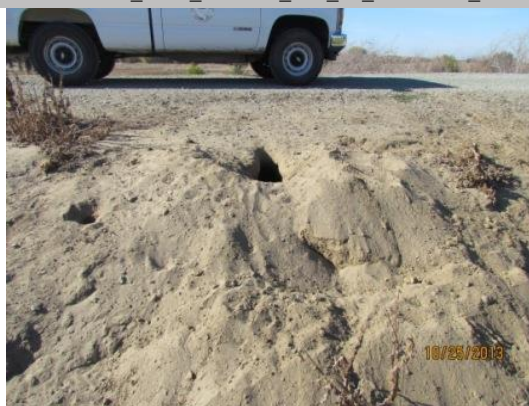
Photo 1 of 1 : SP_2017_RD2089_317_54_20170407_00049.jpg

View of the rodent burrow on the landside levee slope.

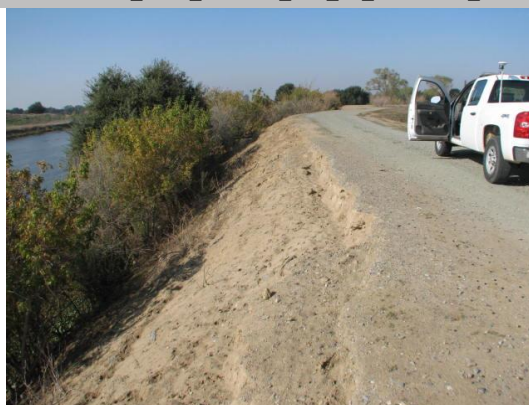
Photo 1 of 1 : SP_2017_RD2089_317_14_20170407_00014.jpg

11/10/2011 Approximately 1' scarp has been created by livestock travel.

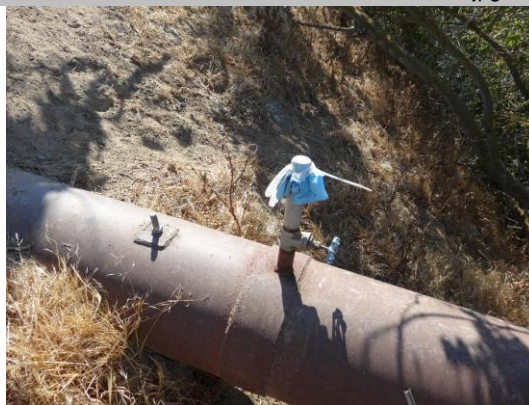
Photo 2 of 3 : UCIP_SP_2017_21676_36860.jpg

WS view: air relief valve on pipe. Pipe exposed in levee slope.

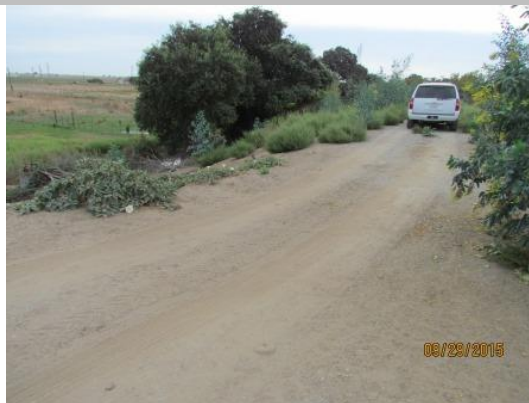
Photo 1 of 4 : SP_2017_RD2089_317_35_20170407_00027.jpg

View of the levee crown depression looking upstream.

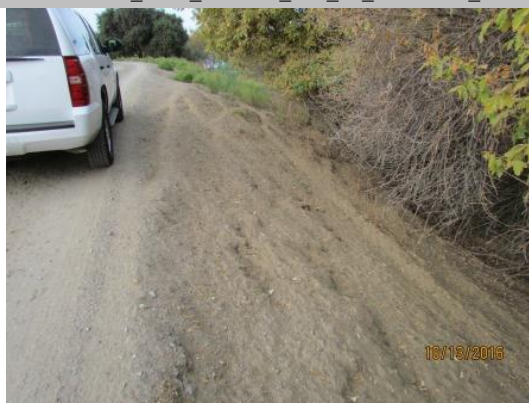
Photo 1 of 1 : SP_2017_RD2089_317_43_20170407_00040.jpg

View of the animal paths on the waterside levee slope.

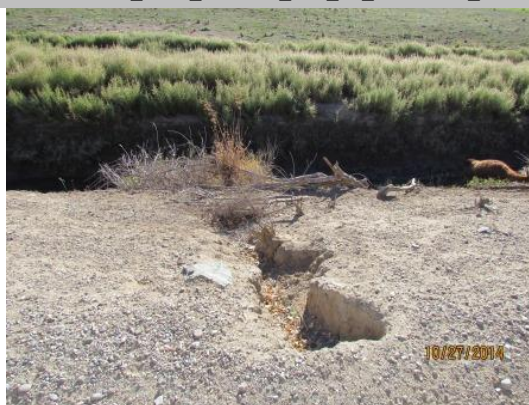
Photo 1 of 1 : SP_2017_RD2089_317_15_20170407_00015.jpg

View of the scour from surface runoff on the landside levee slope.

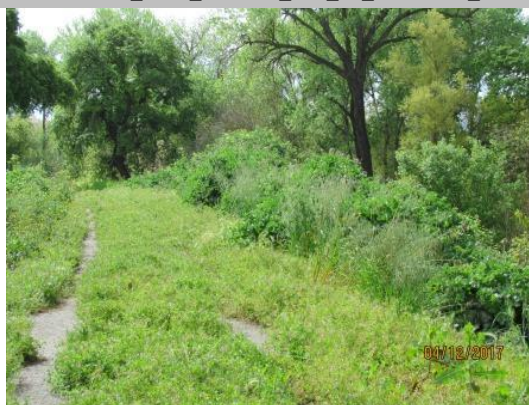
Photo 1 of 1 : SP_2017_RD2089_317_47_20170417_00059.jpg

View of the tall vegetation on the levee slope.

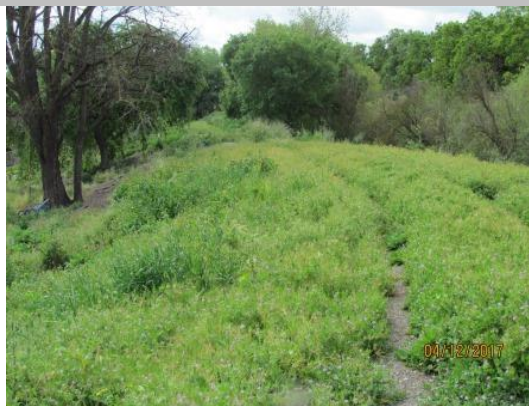
Photo 1 of 1 : SP_2017_RD2089_317_50_20170417_00057.jpg

View of the vegetation on the levee crown.

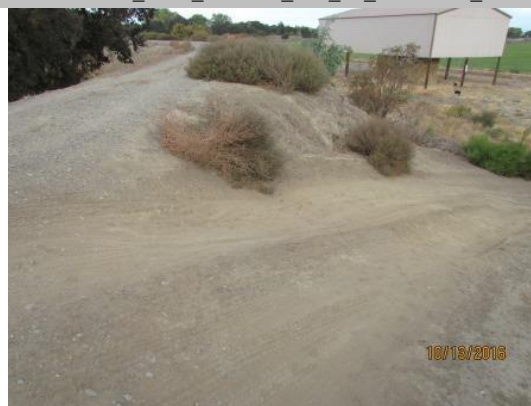
Photo 1 of 1 : SP_2017_RD2089_317_42_20170407_00039.jpg

View of the ramp on the landside levee slope.

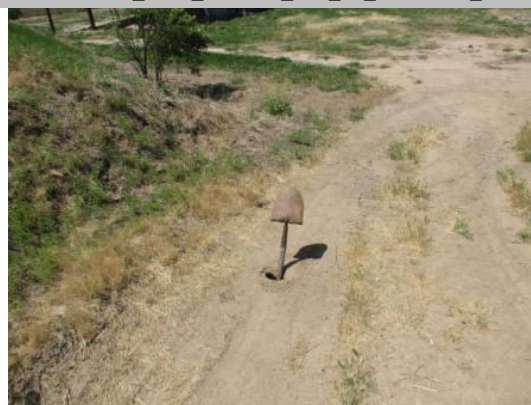
Photo 1 of 3 : SP_2017_RD2089_317_40_20170407_00035.jpg

05/24/2011 Deep vertical burrow in ramp on land side of levee.

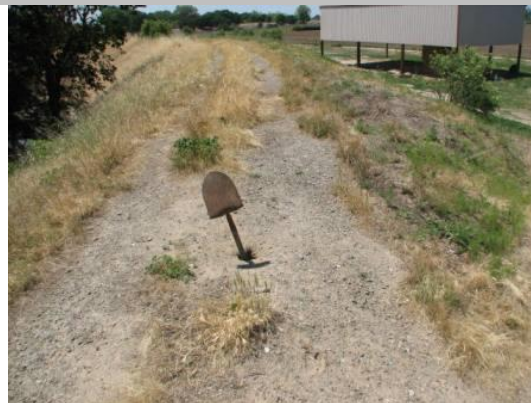
Photo 2 of 3 : SP_2017_RD2089_317_40_20170407_00036.jpg

05/24/2011 Deep vertical burrow in levee crown.

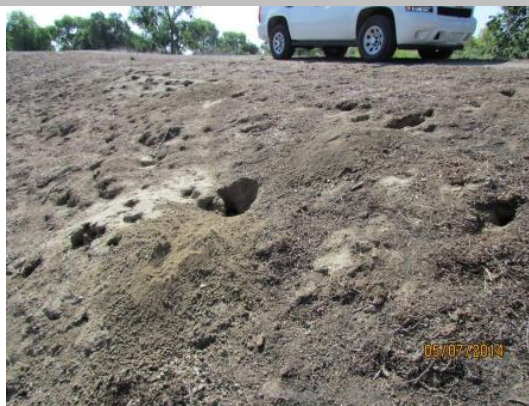
Photo 1 of 1 : SP_2017_RD2089_317_5_20170407_00004.jpg

View of the rodent holes on the landside levee slope.

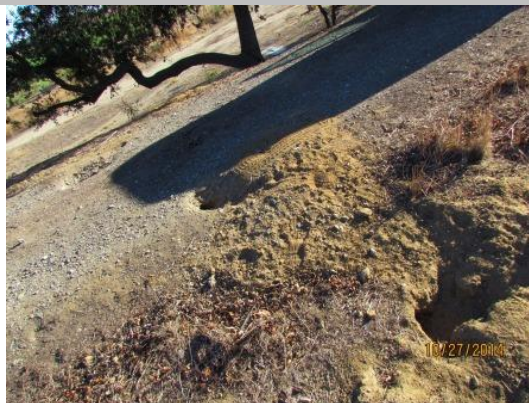
Photo 1 of 2 : SP_2017_RD2089_317_12_20170407_00011.jpg

View of several large rodent holes on the levee crown.

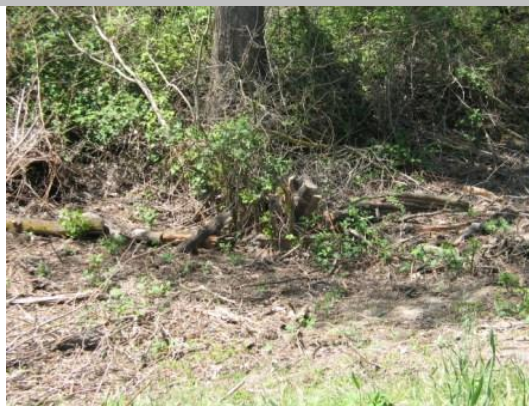
Photo 1 of 1 : SP_2017_RD2089_317_29_20170407_00026.jpg

Tree stump >2" left after vegetation and tree removal.

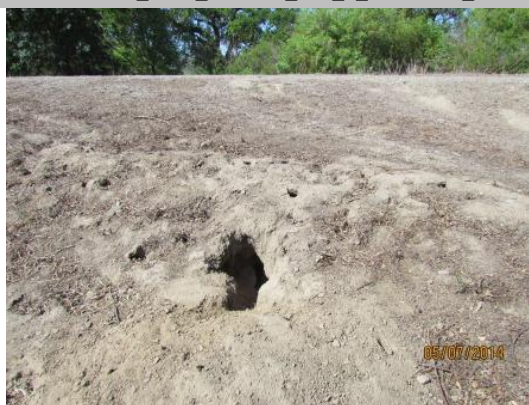
Photo 1 of 1 : SP_2017_RD2089_317_6_20170407_00005.jpg

View of the large rodent hole on the landside levee slope.

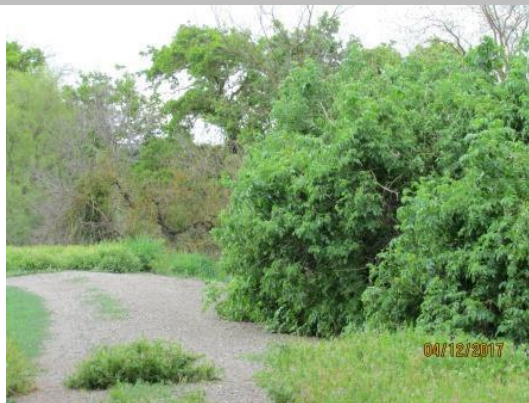
Photo 1 of 1 : SP_2017_RD2089_317_31_20170417_00056.jpg

View of the overgrown shrub on the levee slope.

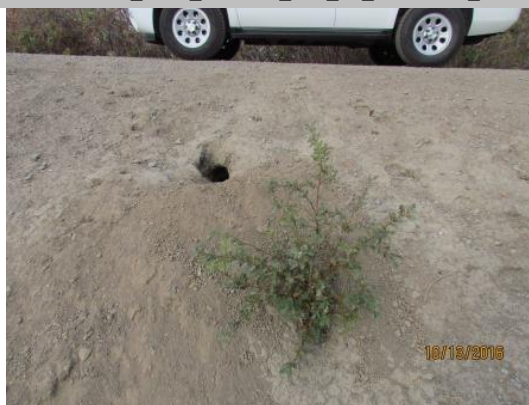
Photo 1 of 1 : SP_2017_RD2089_317_28_20170407_00025.jpg

View of the rodent burrow in the landside levee slope.

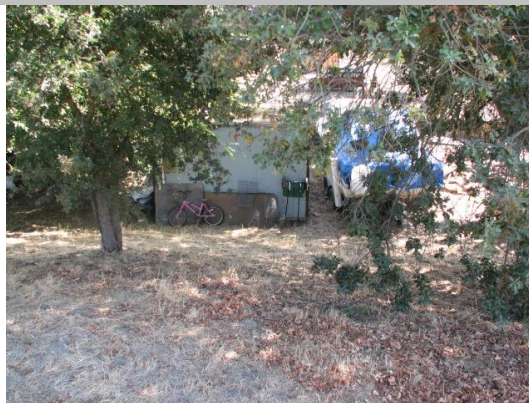
Photo 1 of 1 : SP_2017_RD2089_317_23_20170407_00021.jpg

Fall 2009 photo: Buildings and patio decks are built within 10-ft of the levee slope.

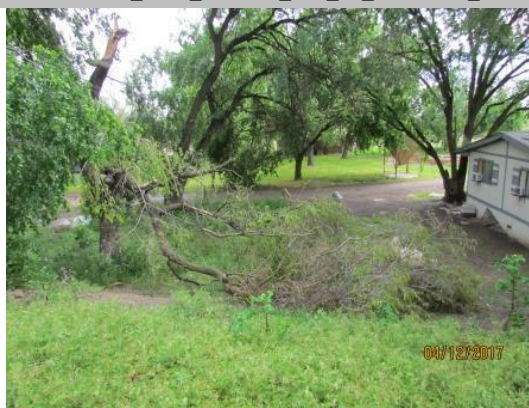
Photo 1 of 1 : SP_2017_RD2089_317_45_20170417_00055.jpg

View of the down tree limb on the levee slope.

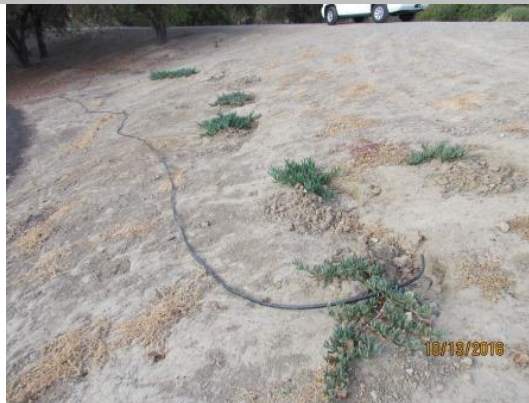
Photo 2 of 2 : SP_2017_RD2089_317_8_20170407_00007.jpg

View of the ice plant and irrigation line on the landside levee slope, looking upstream.

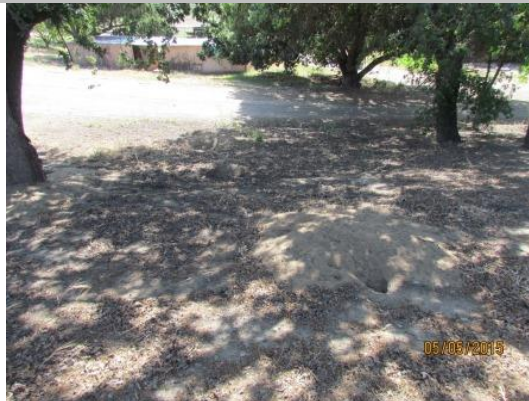
Photo 1 of 1 : SP_2017_RD2089_317_11_20170407_00010.jpg

View of the multiple rodent burrows on the landside levee slope.
