**Flood Control Project Maintenance
Levee Inspections**
LMA District Cover Sheet
Spring 2018 Levee Inspection Results

Reclamation District No. 2089 Stark

Spring 2018 Levee Inspection Results

Waterway			Bank	Unit Miles
Unit No. 01 Old River			Right	1.51
	Spring (March - May)	Summer (June - August)	(September - November) Fall	Winter (December - February)
Unit Maintenance Rating (Fall Only)				
Date of Inspection	5/15/2018 - 5/15/2018			
DWR Inspector	Zach Jojola			
Accompanied By	Luz Dial DWR

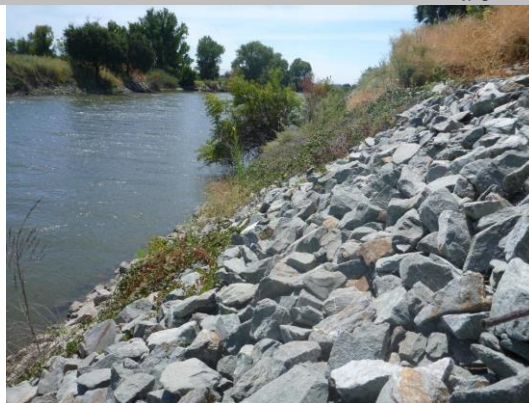
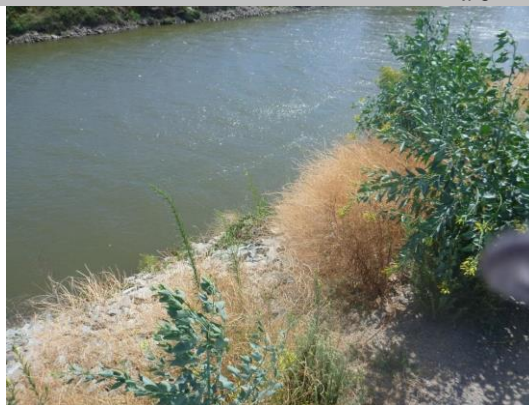
Photo 1 of 2 : LEVAL_SP_2018_513_4443.jpg

LM Start	0.26	Rating **	M	Issue No.	13
LM End	0.27	Issue Type +	Ma	Location *	
Category	Supplemental			GPS Latitude/Longitude	
				Start	End
Item	2017 Storm Damage			37.810300 °	37.810300 °
				-121.389300 °	-121.389500 °
DWR ID	DWR_RD2089_01_f_2017_13				
Comment Code					
Inspector Comment					
Levee Evaluation Comments					
Description:Slope protection repairs are needed along the waterside slope due to erosion and riprap displacement from high water. Based upon levee inspections, it was determined the waterside levee slope is eroding, deteriorating, and degrading. The eroded levee sections need to be restored back to design standards to prevent further deterioration and damage.					
Site ID No:513					
Site Designation:LMA-419					
Repair Type: Erosion					
Rating:Area of Concern					
Field Date:8/14/2017					
Notes: Small erosion at toe.

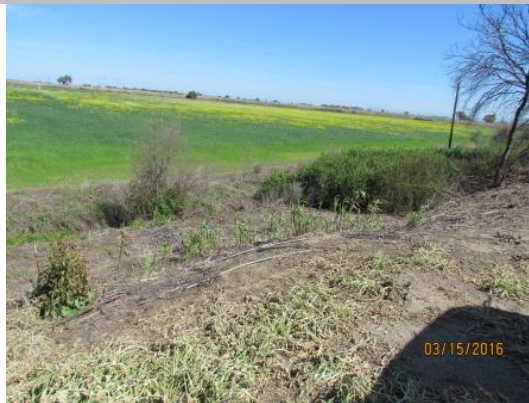
Photo 2 of 2 : SP_2018_RD2089_316_19_20180507_00018.jpg

Arundo was trimmed back from the road and needs to be maintained so that it does not obstruct visibility and access to the landside toe.

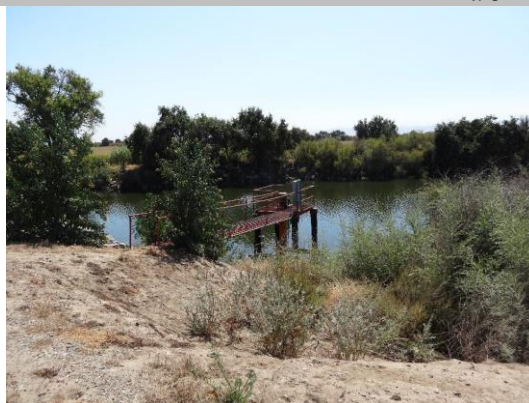
Photo 1 of 3 : UCIP_SP_2018_21635_36742.jpg

Comment Code						
Inspector Comment						
FS_ID:21635 DS_ID:23042 EP_NO: 5641 Repair Type: Non-Urgent Crossing Status: Found UCIP Comments: - damaged siphon breaker.- most of the pipe on landside exposed on levee slope. FIELD_STRUCT_DESC: 20-inch steel irrigation discharge pipe and electrical conduit through the levee, 5.8 feet below the crown. Pump on a pile structure in the stream. Siphon breaker on the landside (LS) slope. (Plans to replace a rusted out irrigation discharge pipe through the levee authorized under Permit No. 5641, 1967 - Theodore Stark). [Additional Reference(s): DWR Levee Log, 1991. USACE San Joaquin O&M Manual 8, 1968, (HLM 0.46), 21-inch pipe referenced]. FS Date: 9/12/2013

WS view: walkway to pump platform and pump on steel piling structure in the channel.

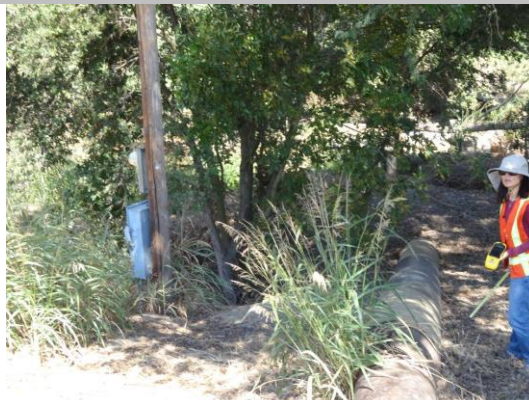
Photo 3 of 3 : UCIP_SP_2018_21635_36740.jpg

Comment Code						
Inspector Comment						
FS_ID:21635 DS_ID:23042 EP_NO: 5641 Repair Type: Non-Urgent Crossing Status: Found UCIP Comments: - damaged siphon breaker.- most of the pipe on landside exposed on levee slope. FIELD_STRUCT_DESC: 20-inch steel irrigation discharge pipe and electrical conduit through the levee, 5.8 feet below the crown. Pump on a pile structure in the stream. Siphon breaker on the landside (LS) slope. (Plans to replace a rusted out irrigation discharge pipe through the levee authorized under Permit No. 5641, 1967 - Theodore Stark). [Additional Reference(s): DWR Levee Log, 1991. USACE San Joaquin O&M Manual 8, 1968, (HLM 0.46), 21-inch pipe referenced]. FS Date: 9/12/2013

LS view: overview of exposed steel pipe (right) on levee slope and service pole (left).

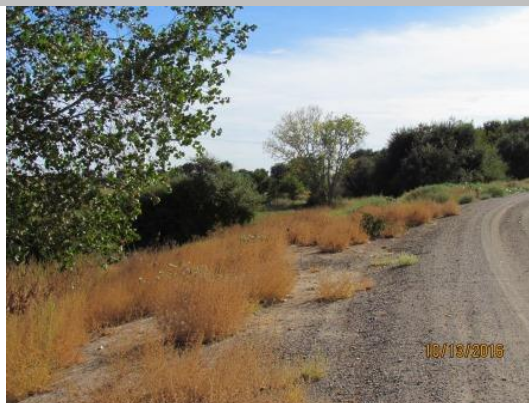
Photo 1 of 1 : SP_2018_RD2089_316_27_20180507_00027.jpg

View of the vegetation on the landside levee slope.

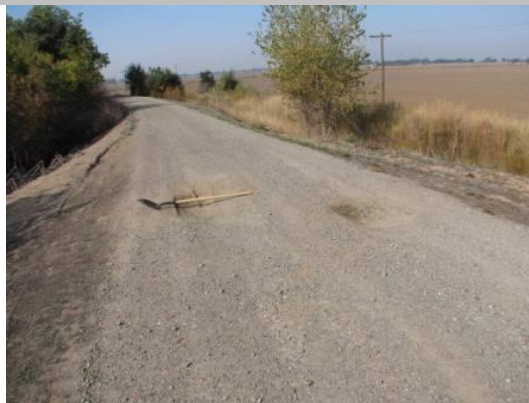
Photo 1 of 1 : SP_2018_RD2089_316_14_20180507_00013.jpg

LM Start	0.54	Rating **	M	Issue No.	14
LM End	0.54	Issue Type +	Ma	Location *	CR
Category	Earthen Levee			GPS Latitude/Longitude	
				Start	End
Item	Crown Surface / Depressions / Rutting			37.810087 °	37.810087 °
				-121.394200 °	-121.394200 °
DWR ID	DWR_RD2089_01_s_2012_14				
Comment Code					
C3 : Add appropriate gravel or road base. Grade and compact.					
Inspector Comment					
11/10/2011 Minor depressions will cause ponding.

11/10/2011 Depressions in crown.

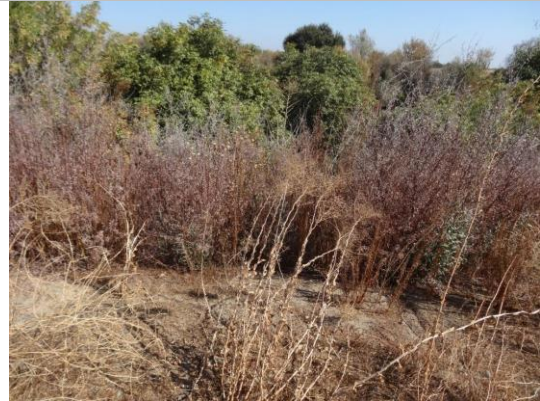
Photo 1 of 2 : SP_2018_RD2089_316_5_20180507_00007.jpg

Comment Code					
Inspector Comment					
09/13/2017: No significant change observed.					
07/25/2016: No significant change observed.					
06/25/2015: No significant change observed.					
07/02/2014: No significant change observed.					
08/13/2013: No significant change observed.					
08/07/2012: The site has been visited by boat survey. No significant change observed					
08/23/2011: The 5-foot vertical scarp shows no significant change from the last year inspection. No new erosion activities observed. Dense white willow trees on site.					
09/07/2010: It was difficult to view the erosion due to the thick Willow thickets and other vegetation at the water line. At the time of the inspection, there were no signs of repair on site. As noted during the last survey, there is a 5-foot vertical scarp along the lower slope that may be subjected to high flow velocities.					
08/05/2010: Recommended for repair, per CLRO; "Erosion of this site may be subjective to rapid rates of erosion."

09/28/2009: No major change observed; 5-foot vertical scarp is immediately downstream of where berm has tapered; site is recommended as local maintenance issue, per CLRO CES Evaluation 2008 Report; Site # is the same as RM29.6, LM0.60; previously rated "U".					
11/05/2008: No change observed; rodent holes on lower slope; wide levee crown. [2017 Site ID:RD2089U01RM29.61]

Front view of the site. The scarp erosion is at the levee slope but is not visible due to the dense vegetation at the site.

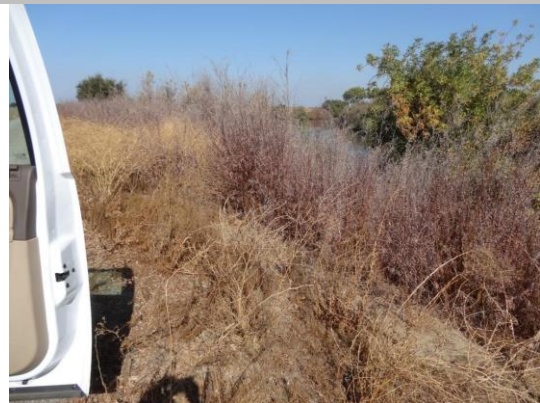
Photo 2 of 2 : SP_2018_RD2089_316_5_20180507_00008.jpg

Front view of the site. Note the very dense white willow thickets on site.

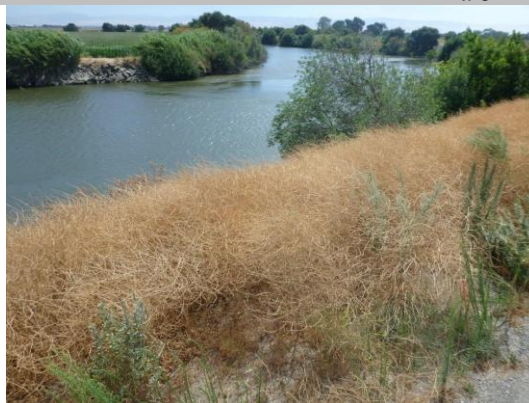
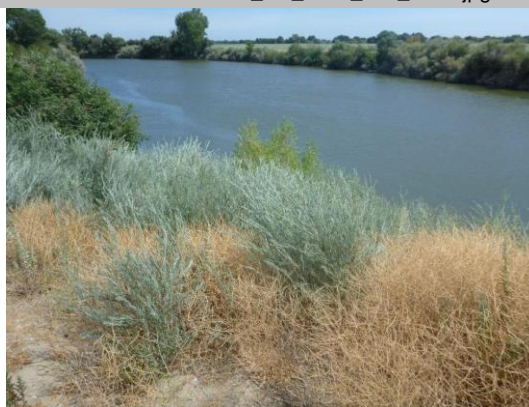
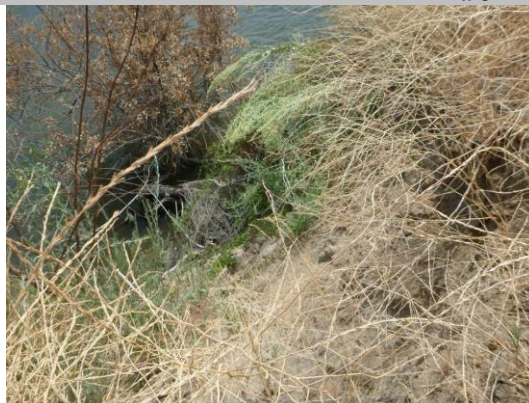
LM Start	0.67	Rating **	A/W	Issue No.	20
LM End	0.68	Issue Type +	Ma	Location *	
Category	Supplemental			GPS Latitude/Longitude	
				Start	End
Item	2017 Storm Damage			37.809700 °	37.809700 °
				-121.396300 °	-121.396400 °
DWR ID	DWR_RD2089_01_f _ 2017_20				
Comment Code					
Inspector Comment					
Levee Evaluation Comments					
Description:Slope protection repairs are needed along the waterside slope due to erosion and riprap displacement from high water. Based upon levee inspections, it was determined the waterside levee slope is eroding, deteriorating, and degrading. The eroded levee sections need to be restored back to design standards to prevent further deterioration and damage.					
Site ID No:512					
Site Designation:LMA-418					
Repair Type: Erosion					
Rating:Serious					
Field Date:8/14/2017					
Notes: deep erosion more than half way up slope.

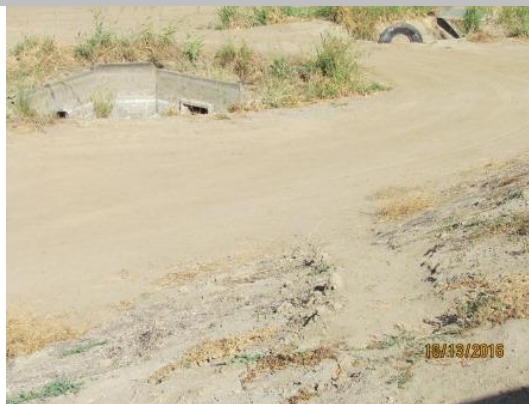
Photo 1 of 1 : SP_2018_RD2089_316_22_20180507_00024.jpg

LM Start	0.80	Rating **	M	Issue No.	22
LM End	0.80	Issue Type +	Ma	Location *	LS
Category	Earthen Levee			GPS Latitude/Longitude	
				Start	End
Item	Slope Stability			37.808466 °	37.808466 °
				-121.397847 °	-121.397847 °
DWR ID	DWR_RD2089_01_f_2016_22				
Comment Code					
S2 : Repair the levee slope damaged by foot traffic and prevent access where possible.					
Inspector Comment

View of the footpath on the landside levee slope.

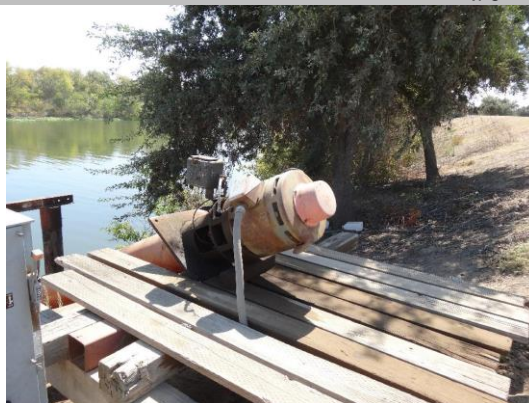
Photo 1 of 3 : UCIP_SP_2018_21587_36635.jpg

Comment Code						
Inspector Comment						
FS_ID:21587 DS_ID:23043 EP_NO: 3385 Repair Type: Non-Urgent Crossing Status: Found UCIP Comments: - powerline on landside.- electric control box on waterside.- waterside slope erosion under pump platform. FIELD_STRUCT_DESC: 16-inch irrigation discharge pipe of an unknown material through the levee, 5.5 feet below the crown. Two cutoff walls. Slant pump in a pump house on the waterside (WS) slope. Siphon breaker on the landside (LS) slope. (Plans for installation of a pumping plant on the riverbank and a pipe that crosses the levee authorized under Permit No. 3385, 1960 - Eleanor M. Lawrence). [Additional Reference(s): DWR Levee Log, 1991. USACE San Joaquin O&M Manual 8, 1968, (HLM 0.81)]. FS Date: 9/12/2013

WS view: slant pump on wooden platform. Oil leaks from the pump.

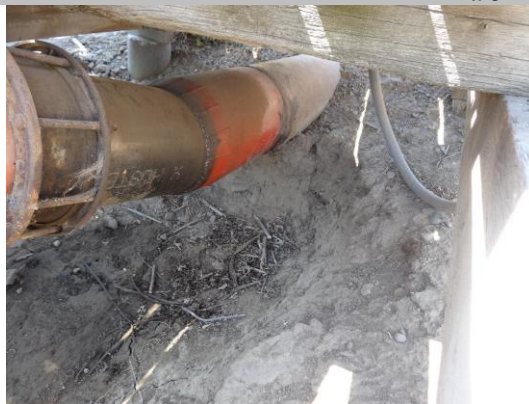
Photo 2 of 3 : UCIP_SP_2018_21587_36634.jpg

WS view: soil erosion under pump platform. Needs mitigation measures to stop erosion.

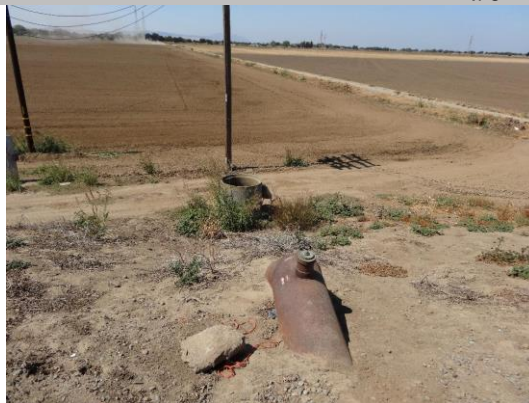
Photo 3 of 3 : UCIP_SP_2018_21587_36633.jpg

Comment Code						
Inspector Comment						
FS_ID:21587 DS_ID:23043 EP_NO: 3385 Repair Type: Non-Urgent Crossing Status: Found UCIP Comments: - powerline on landside.- electric control box on waterside.- waterside slope erosion under pump platform. FIELD_STRUCT_DESC: 16-inch irrigation discharge pipe of an unknown material through the levee, 5.5 feet below the crown. Two cutoff walls. Slant pump in a pump house on the waterside (WS) slope. Siphon breaker on the landside (LS) slope. (Plans for installation of a pumping plant on the riverbank and a pipe that crosses the levee authorized under Permit No. 3385, 1960 - Eleanor M. Lawrence). [Additional Reference(s): DWR Levee Log, 1991. USACE San Joaquin O&M Manual 8, 1968, (HLM 0.81)]. FS Date: 9/12/2013

LS view: exposed pipe with siphon breaker on levee slope. Concrete standpipe on levee toe.

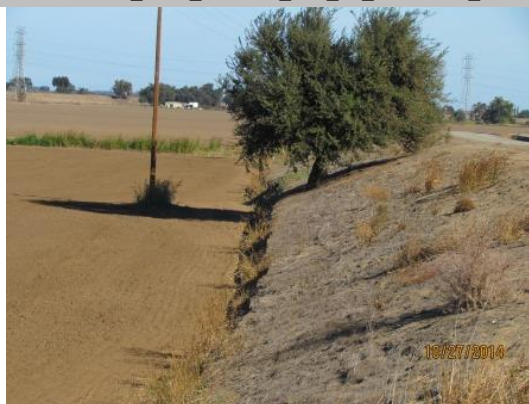
Photo 1 of 1 : SP_2018_RD2089_316_17_20180507_00015.jpg

View of the vertical cut along the landside levee toe.

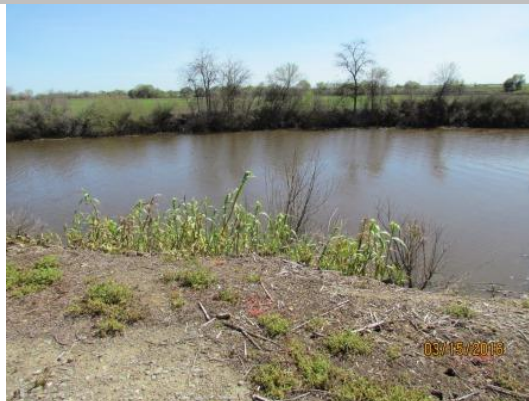
Photo 1 of 1 : SP_2018_RD2089_316_33_20180507_00036.jpg

Arundo was trimmed back and needs to be maintained to allow visibility and access.

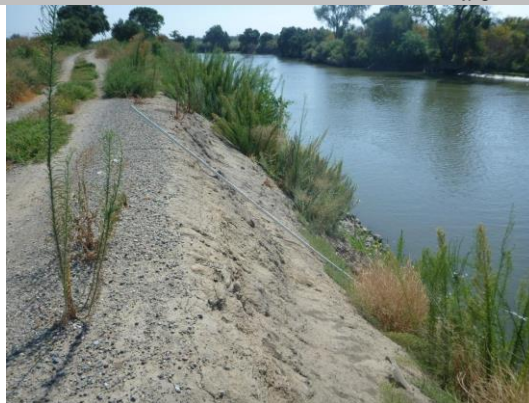
Photo 3 of 3 : LEVAL_SP_2018_511_4305.jpg

LM Start	1.16	Rating **	A/W	Issue No.	30 (cont)
LM End	1.18	Issue Type +	Ma	Location *	WS
Category	Supplemental			GPS Latitude/Longitude	
				Start	End
Item	2017 Storm Damage			37.805600 °	37.805600 °
				-121.401700 °	-121.401900 °
DWR ID	DWR_RD2089_01_f _ 2017_30				
Comment Code					
Inspector Comment					
Levee Evaluation Comments					
Description:Slope protection repairs are needed along the waterside slope due to erosion and riprap displacement from high water. Based upon levee inspections, it was determined the waterside levee slope is eroding, deteriorating, and degrading. The eroded levee sections need to be restored back to design standards to prevent further deterioration and damage.					
Site ID No:511					
Site Designation:LMA-417					
Repair Type: Erosion					
Rating:Critical					
Field Date:8/16/2017					
Notes: Narrow levee with over steep slope

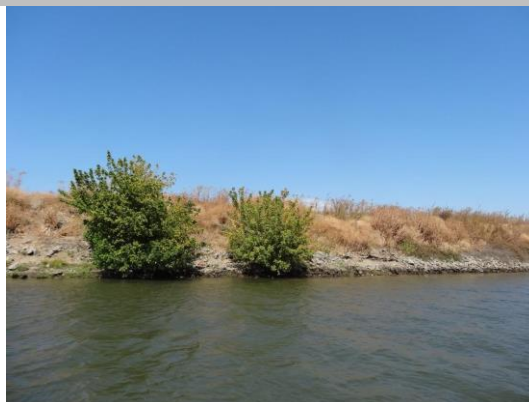
Photo 1 of 3 : SP_2018_RD2089_316_3_20180507_00004.jpg

LM Start	1.17	Rating **	A/W	Issue No.	3	
LM End	1.17	Issue Type +	Ma	Location *	WS	
Category	Supplemental			GPS Latitude/Longitude		
				Start		End
Item	DWR Erosion Survey			37.805523 °	37.805523 °	
				-121.401718 °	-121.401718 °	
DWR ID	RD2089U01RM29.1					
Comment Code						
Inspector Comment						
09/13/2017: The erosion is at the upstream of a small tree, inside of a slight river bend. [2017 Site ID:RD2089U01RM29.1]

Front view of the erosion. Note the trees next to the erosion site.

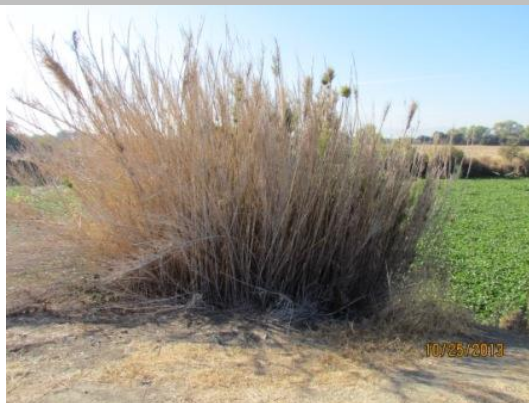
Photo 1 of 1 : SP_2018_RD2089_316_25_20180507_00025.jpg

View of the Arundo on the waterside slope obstructing visibility. LMA is actively trying to remove the wild growth.

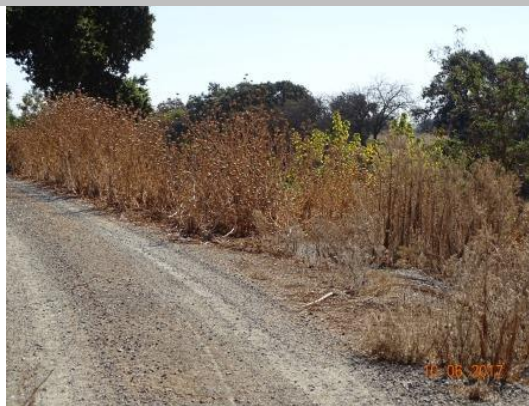
Photo 1 of 1 : SP_2018_RD2089_316_31_20180507_00034.jpg

View of the tall vegetation on the levee slope.

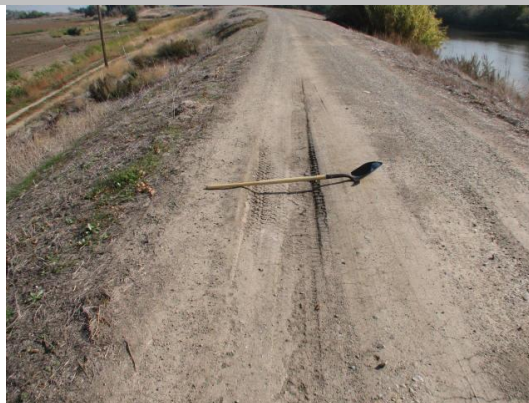
Photo 1 of 1 : SP_2018_RD2089_316_43_20180507_00037.jpg

11/10/2011 Depression in roadway.

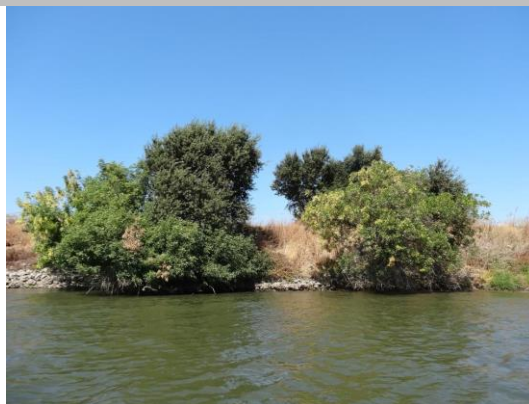
Photo 2 of 2 : SP_2018_RD2089_316_2_20180507_00003.jpg

LM Start	1.23	Rating **	M	Issue No.	2
LM End	1.24	Issue Type +	Ma	Location *	WS
Category	Supplemental			GPS Latitude/Longitude	
				Start	End
Item	DWR Erosion Survey			37.805580 °	37.805580 °
				-121.403010 °	-121.403010 °
DWR ID	RD2089U01RM29.04				
Comment Code					
Inspector Comment					
09/13/2017: No significant change observed. More vegetation observed at the site.					
09/16/2016: The river was not navigable near the site due to the dense water grass, so the site was visited by land survey. No significant change observed.					
06/25/2015: No significant change observed.					
07/02/2014: No significant change observed.					
08/13/2013: The erosion is around a tree at the levee toe. Dense vegetation is visible. [2017 Site ID:RD2089U01RM29.04]

Close view of the erosion.

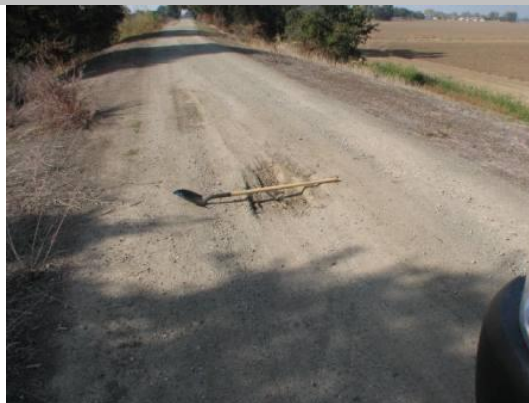
Photo 1 of 1 : SP_2018_RD2089_316_45_20180507_00039.jpg

11/10/2011 Roadway depression.

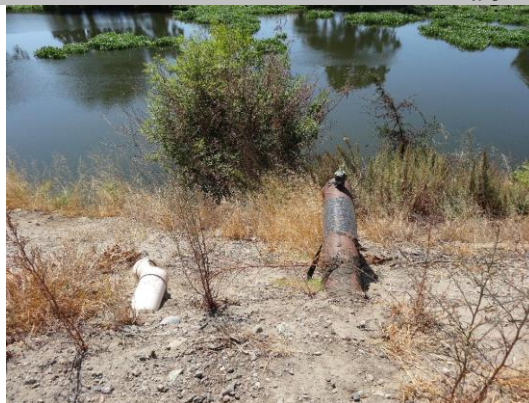
Photo 1 of 3 : UCIP_SP_2018_50737_36611.jpg

WS view: 6-inch pvc pipe on levee slope. Pipe end open and damaged.

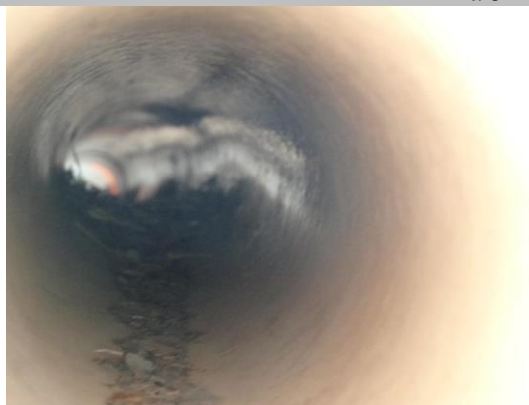
Photo 2 of 3 : UCIP_SP_2018_50737_36610.jpg

WS view: inside view of pvc pipe. Sediments found inside the pipe.

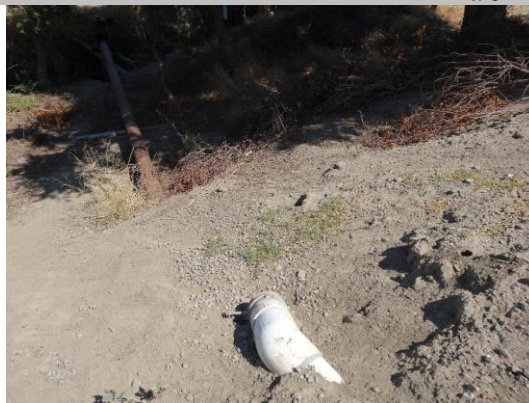
Photo 3 of 3 : UCIP_SP_2018_50737_36609.jpg

LS view: 6-inch pvc pipe on levee slope. Pipe end open.

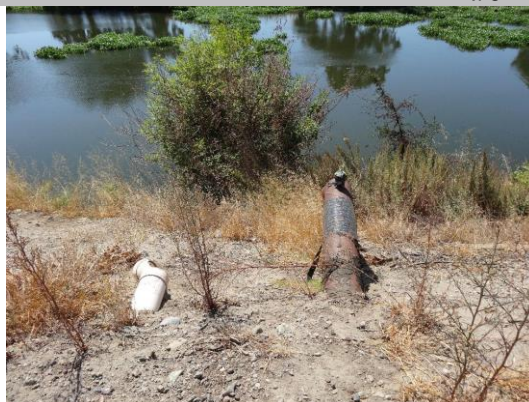
Photo 1 of 3 : UCIP_SP_2018_21585_36624.jpg

WS view: exposed steel pipe on levee slope. A pvc pipe on left.

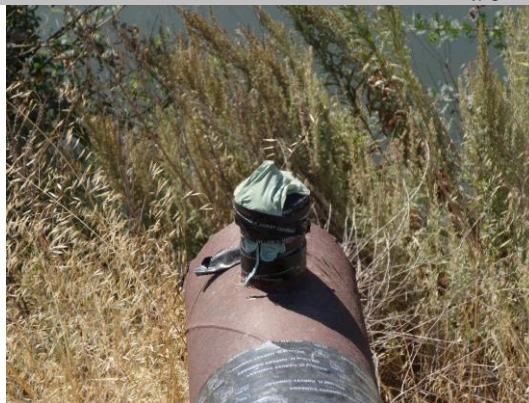
Photo 2 of 3 : UCIP_SP_2018_21585_36623.jpg

WS view: exposed steel pipe with siphon breaker. Looks siphon breaker needs repair.

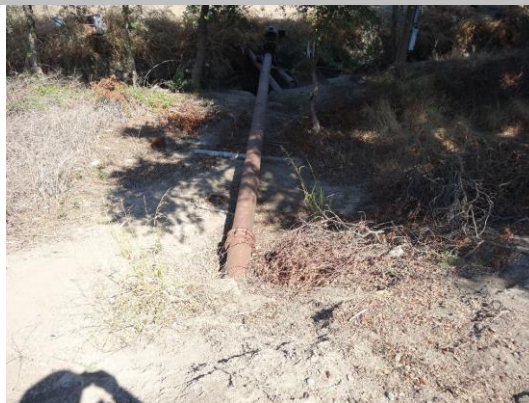
Photo 3 of 3 : UCIP_SP_2018_21585_36622.jpg

LS view: exposed steel pipe on levee slope.

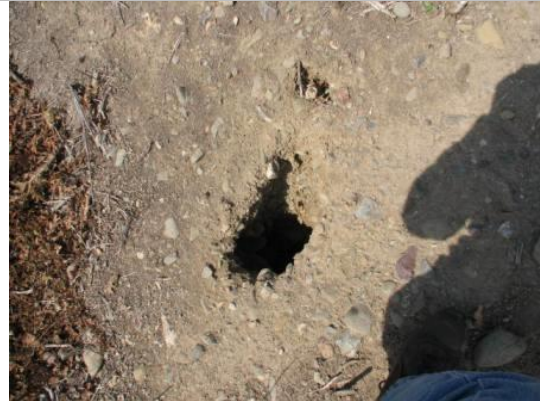
Photo 1 of 1 : SP_2018_RD2089_316_49_20180507_00041.jpg

11/10/2011 Deep burrow on waterside.

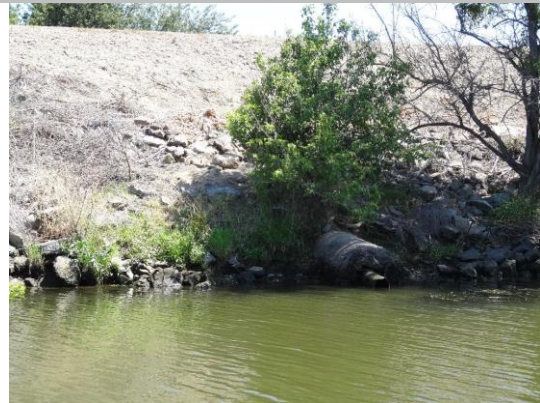
Photo 1 of 3 : UCIP_SP_2018_50736_74506.jpg

View up WS slope from water. Pipe does not cross channel.

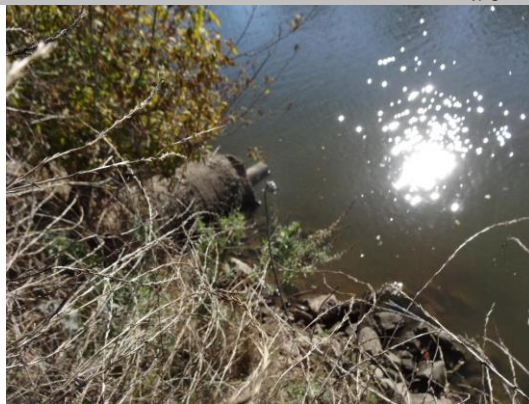
Photo 3 of 3 : UCIP_SP_2018_50736_76207.jpg

WS view of pipe

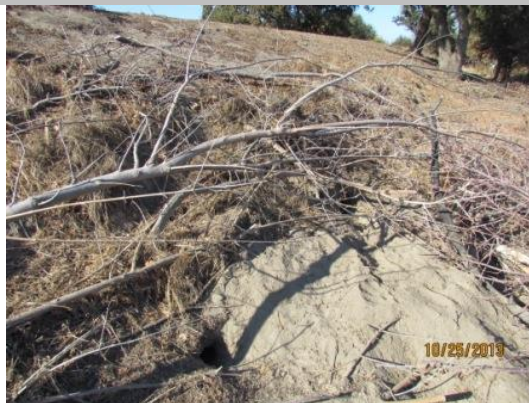
Photo 1 of 1 : SP_2018_RD2089_317_51_20180507_00058.jpg

View of the rodent burrow on the landside levee toe.

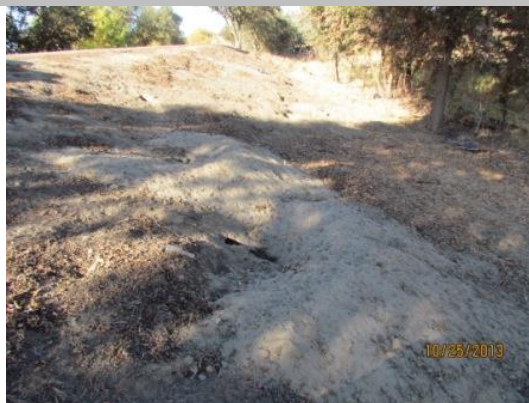
Photo 1 of 3 : SP_2018_RD2089_317_53_20180507_00060.jpg

View of the multiple rodent burrows on the landside levee slope.

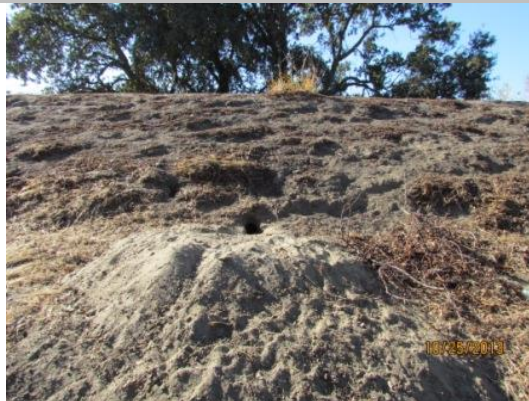
Photo 2 of 3 : SP_2018_RD2089_317_53_20180507_00061.jpg

View of the rodent burrow on the landside levee slope.

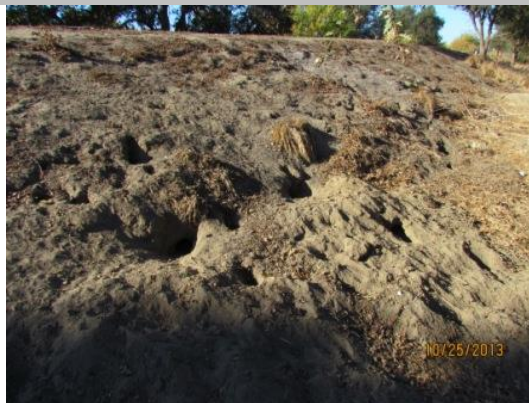
Photo 3 of 3 : SP_2018_RD2089_317_53_20180507_00062.jpg

Another view of the multiple rodent burrows on the landside levee slope.

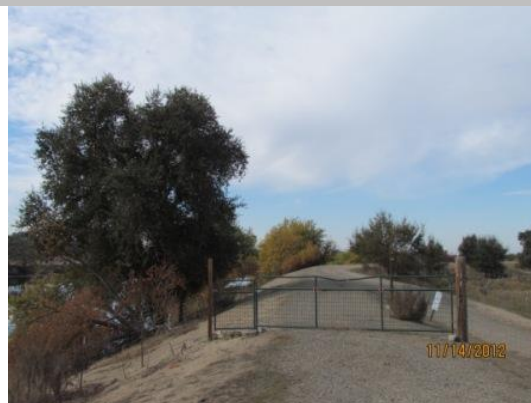
Photo 1 of 1 : SP_2018_RD2089_317_2_20180507_00004.jpg

View of gate across levee crown.

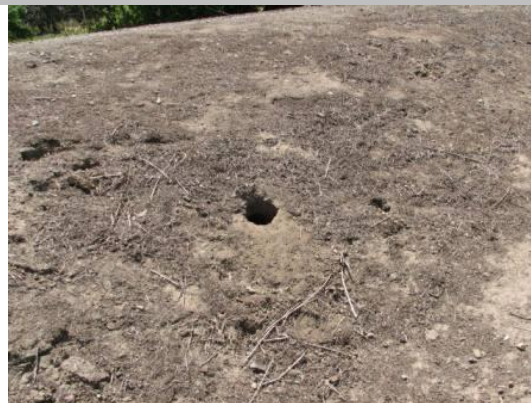
Photo 1 of 1 : SP_2018_RD2089_317_26_20180507_00025.jpg

05/24/2011 Active rodent burrow.

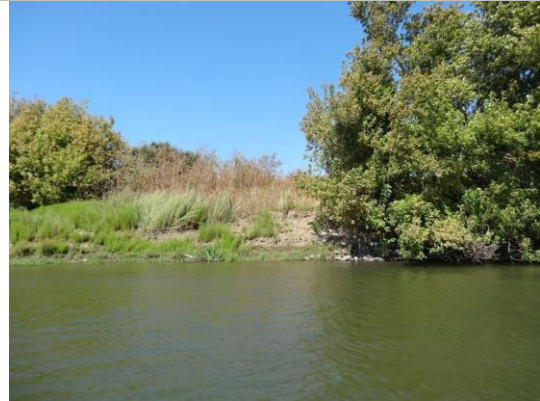
Photo 1 of 3 : SP_2018_RD2089_317_1_20180507_00001.jpg

Front view of the site.

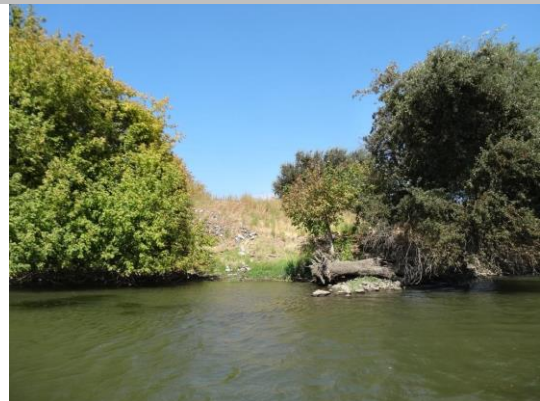
Photo 2 of 3 : SP_2018_RD2089_317_1_20180507_00002.jpg

Close view of the erosion.

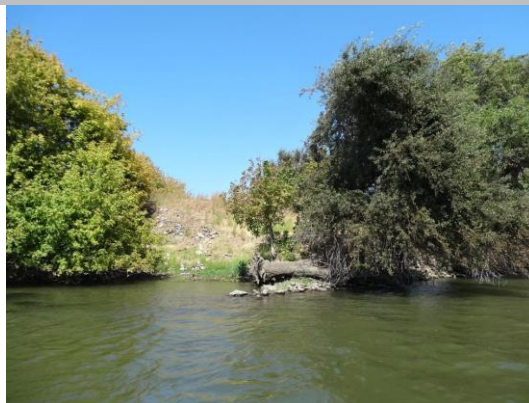
Photo 3 of 3 : SP_2018_RD2089_317_1_20180507_00003.jpg

Close view of the erosion.

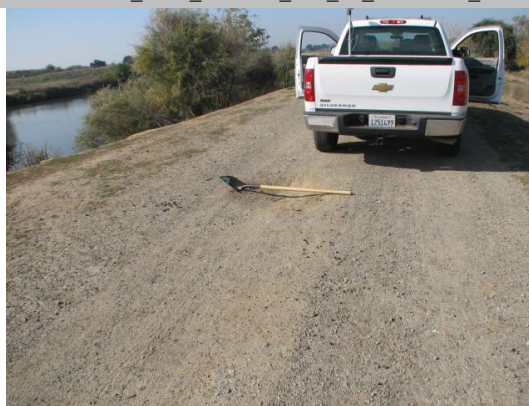
Photo 1 of 1 : SP_2018_RD2089_317_10_20180507_00011.jpg

11/10/2011 Depression in crown needs to be filled.

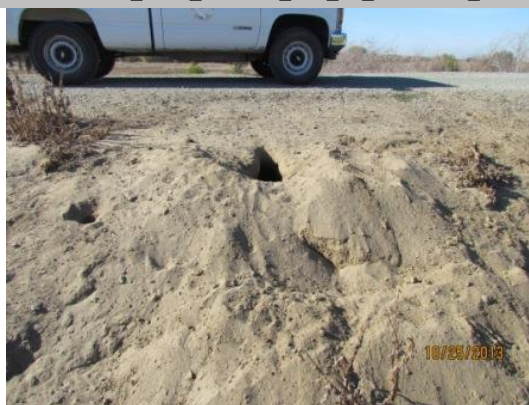
Photo 1 of 1 : SP_2018_RD2089_317_54_20180507_00063.jpg

View of the rodent burrow on the landside levee slope.

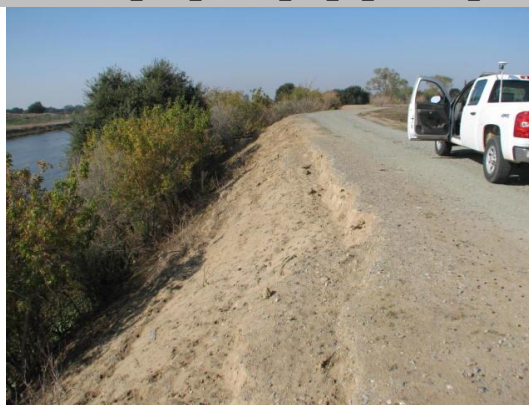
Photo 1 of 1 : SP_2018_RD2089_317_14_20180507_00016.jpg

11/10/2011 Approximately 1' scarp has been created by livestock travel.

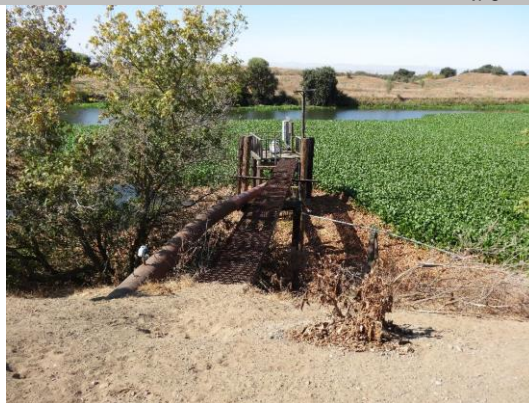
Photo 1 of 3 : UCIP_SP_2018_21676_36861.jpg

WS view: pipe and pump on piling structure in water channel.

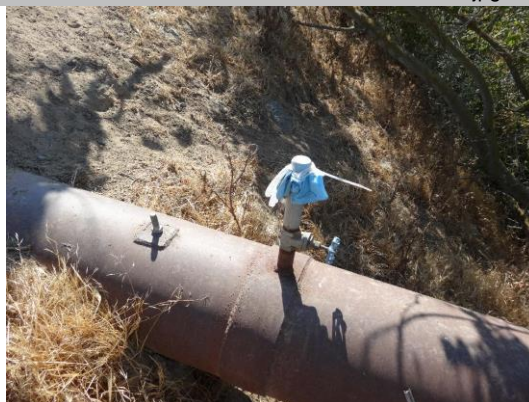
Photo 2 of 3 : UCIP_SP_2018_21676_36860.jpg

WS view: air relief valve on pipe. Pipe exposed in levee slope.

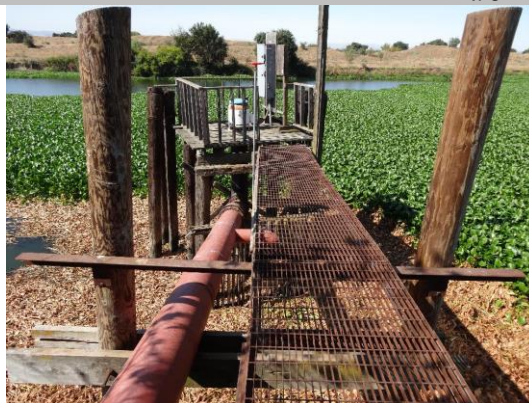
Photo 3 of 3 : UCIP_SP_2018_21676_36859.jpg

WS view: pipe (left) and steel walkway to pump on piling structure in the channel.

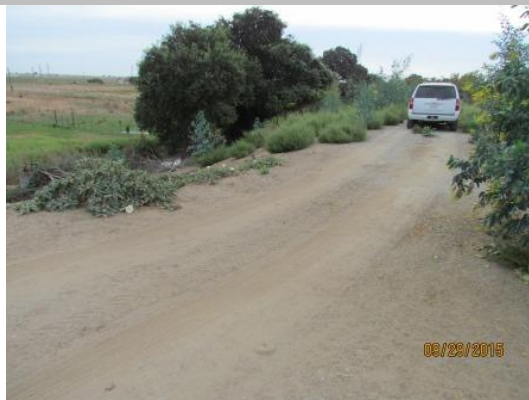
Photo 1 of 4 : SP_2018_RD2089_317_35_20180507_00031.jpg

View of the levee crown depression looking upstream.

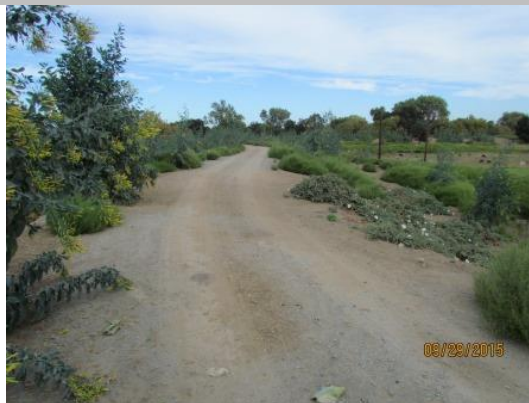
Photo 2 of 4 : SP_2018_RD2089_317_35_20180507_00032.jpg

View of the levee crown depression looking downstream.

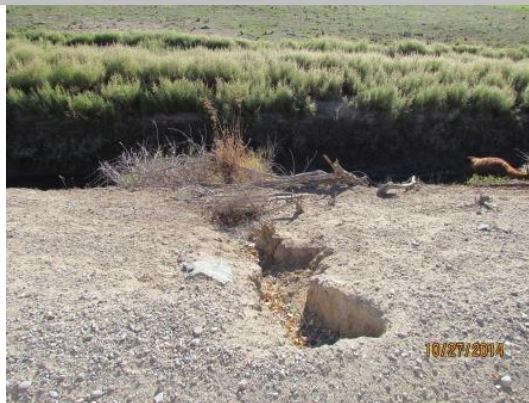
Photo 1 of 1 : SP_2018_RD2089_317_15_20180507_00017.jpg

View of the scour from surface runoff on the landside levee slope.

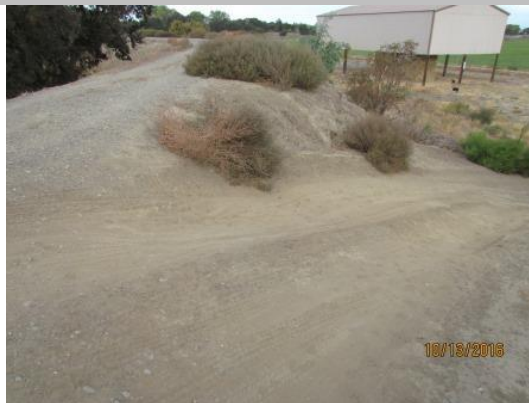
Photo 1 of 1 : SP_2018_RD2089_317_42_20180507_00043.jpg

View of the ramp on the landside levee slope.

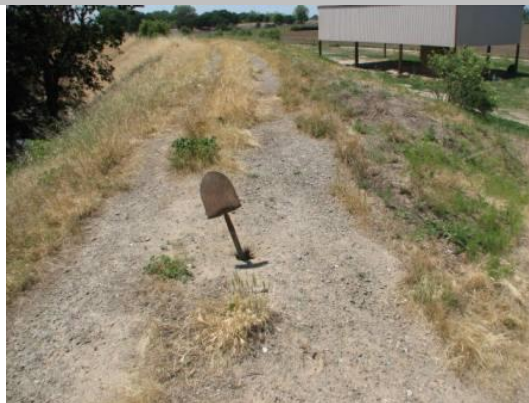
Photo 2 of 3 : SP_2018_RD2089_317_40_20180507_00040.jpg

05/24/2011 Deep vertical burrow in levee crown.

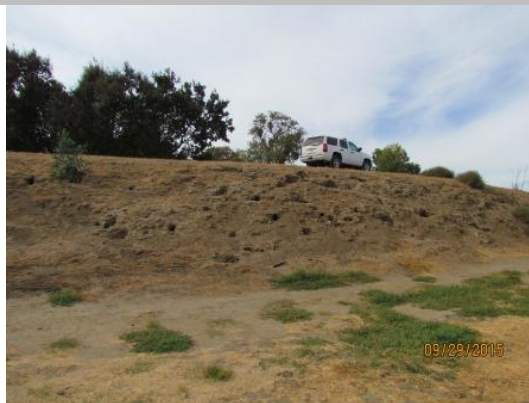
Photo 3 of 3 : SP_2018_RD2089_317_40_20180507_00041.jpg

View of the multiple rodent holes on the landside levee slope.

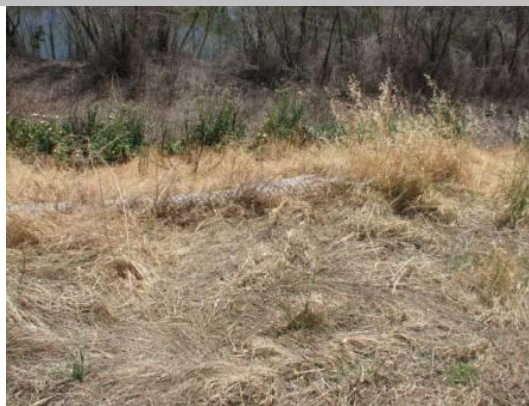
Photo 1 of 1 : SP_2018_RD2089_317_41_20180507_00042.jpg

05/24/2011 Old CMP left on waterside levee slope, needs to be removed.

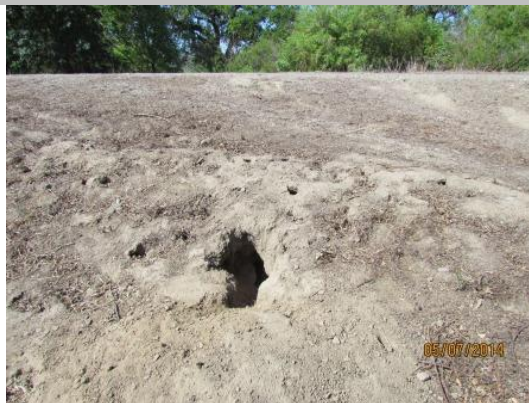
Photo 1 of 1 : SP_2018_RD2089_317_6_20180507_00006.jpg

View of the large rodent hole on the landside levee slope.

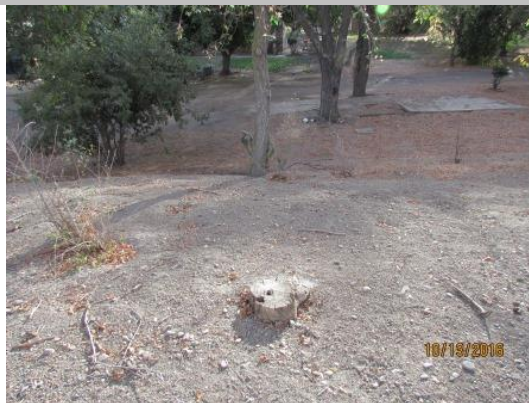
Photo 1 of 1 : SP_2018_RD2089_317_18_20180507_00020.jpg

View of the tree stump from the levee crown.

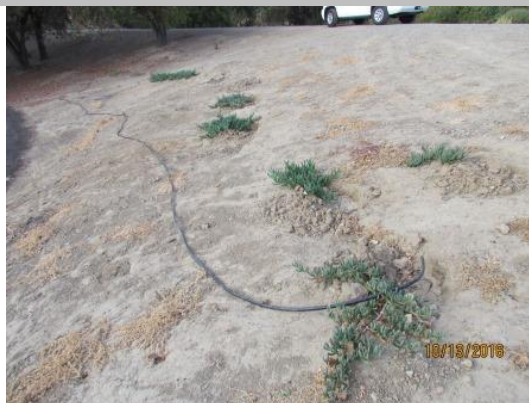
Photo 2 of 2 : SP_2018_RD2089_317_8_20180507_00009.jpg

View of the ice plant and irrigation line on the landside levee slope, looking upstream.

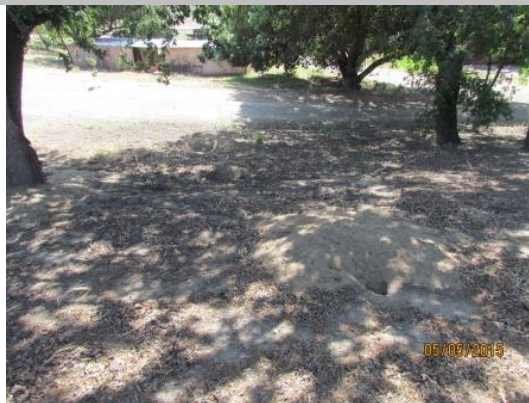
Photo 1 of 1 : SP_2018_RD2089_317_11_20180507_00012.jpg

View of the multiple rodent burrows on the landside levee slope.
