**Flood Control Project Maintenance
Levee Inspections**
LMA District Cover Sheet
Spring 2019 Levee Inspection Results

Reclamation District No. 2089 Stark

Spring 2019 Levee Inspection Results

Waterway			Bank	Unit Miles
Unit No. 01 Old River			Right	1.51
	Spring (March - May)	Summer (June - August)	(September - November) Fall	Winter (December - February)
Unit Maintenance Rating (Fall Only)				
Date of Inspection	4/4/2019 - 4/4/2019			
DWR Inspector	Alberto De Leon			
Accompanied By	Wade Wylie DWR

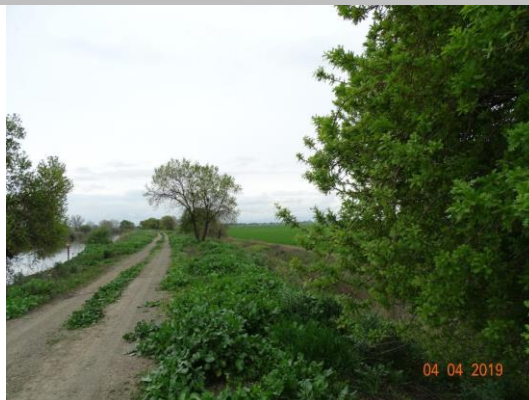
Photo 2 of 2 : SP_2019_RD2089_316_24_20190422_00056.jpg

Typical view of vegetation on landside slope. (Spring 2019)

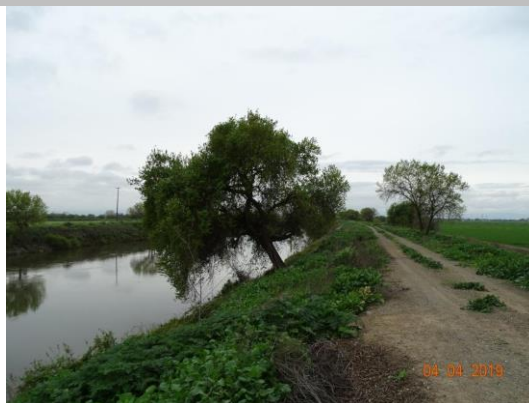
Photo 2 of 2 : SP_2019_RD2089_316_16_20190422_00055.jpg

Typical view of vegetation on waterside slope. (Spring 2019)

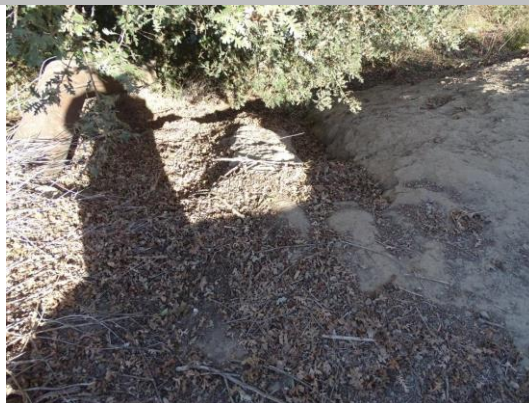
Photo 2 of 2 : SP_2019_RD2089_316_1_20190313_00002.jpg

View of the stairs eroding into the landside levee slope. (Fall 2018)

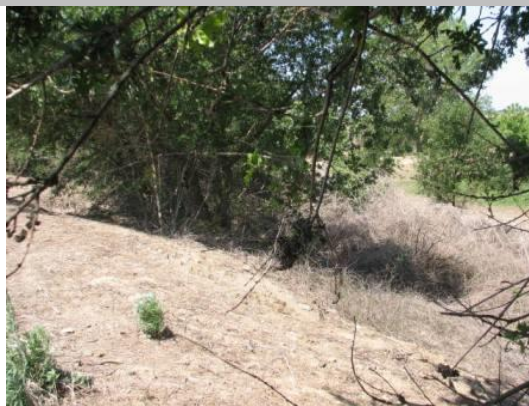
Photo 1 of 2 : SP_2019_RD2089_316_28_20190313_00027.jpg

Photo shows thick dead vegetation and continuation of trees in area.
5/24/2011

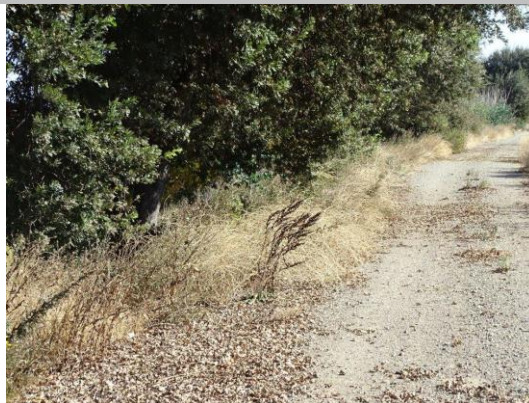
Photo 2 of 2 : SP_2019_RD2089_316_28_20190313_00028.jpg

Looking at dense veg on landward slope. (Fall 2018)

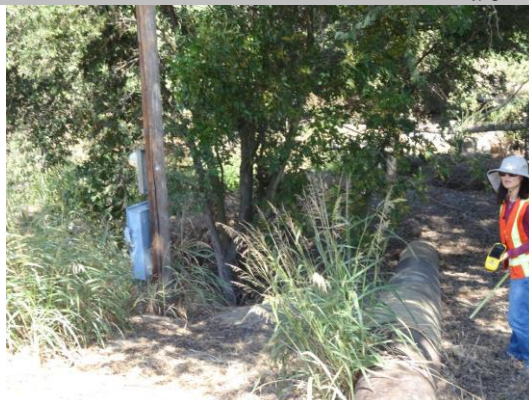
Photo 3 of 3 : UCIP_SP_2019_21635_36740.jpg

Comment Code						
Inspector Comment						
FS_ID:21635 DS_ID:23042 EP_NO: 5641 Repair Type: Non-Urgent Crossing Status: Found UCIP Comments: - damaged siphon breaker.- most of the pipe on landside exposed on levee slope. FIELD_STRUCT_DESC: 20-inch steel irrigation discharge pipe and electrical conduit through the levee, 5.8 feet below the crown. Pump on a pile structure in the stream. Siphon breaker on the landside (LS) slope. (Plans to replace a rusted out irrigation discharge pipe through the levee authorized under Permit No. 5641, 1967 - Theodore Stark). [Additional Reference(s): DWR Levee Log, 1991. USACE San Joaquin O&M Manual 8, 1968, (HLM 0.46), 21-inch pipe referenced]. FS Date: 9/12/2013

LS view: overview of exposed steel pipe (right) on levee slope and service pole (left).

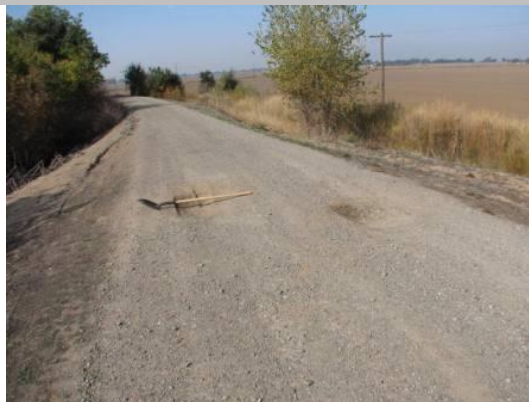
Photo 1 of 1 : SP_2019_RD2089_316_14_20190313_00013.jpg

LM Start	0.54	Rating **	M	Issue No.	14
LM End	0.54	Issue Type +	Ma	Location *	CR
Category	Earthen Levee			GPS Latitude/Longitude	
				Start	End
Item	Crown Surface / Depressions / Rutting			37.810087 °	37.810087 °
				-121.394200 °	-121.394200 °
DWR ID	DWR_RD2089_01_s_2012_14				
Comment Code					
C3 : Add appropriate gravel or road base. Grade and compact.					
Inspector Comment					
Minor depressions will cause ponding.

11/10/2011 Depressions in crown.

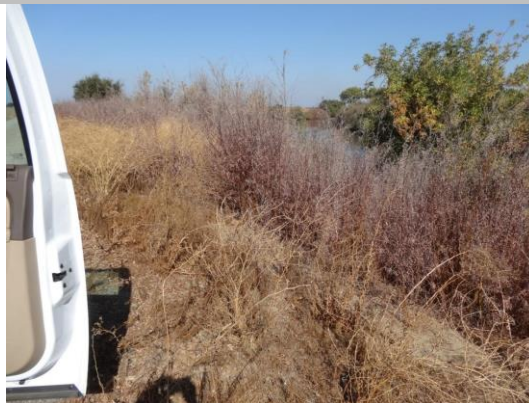
Photo 2 of 2 : SP_2019_RD2089_316_5_20190313_00009.jpg

Comment Code					
Inspector Comment					
09/13/2017: No significant change observed.					
07/25/2016: No significant change observed.					
06/25/2015: No significant change observed.					
07/02/2014: No significant change observed.					
08/13/2013: No significant change observed.					
08/07/2012: The site has been visited by boat survey. No significant change observed					
08/23/2011: The 5-foot vertical scarp shows no significant change from the last year inspection. No new erosion activities observed. Dense white willow trees on site.					
09/07/2010: It was difficult to view the erosion due to the thick Willow thickets and other vegetation at the water line. At the time of the inspection, there were no signs of repair on site. As noted during the last survey, there is a 5-foot vertical scarp along the lower slope that may be subjected to high flow velocities.					
08/05/2010: Recommended for repair, per CLRO; "Erosion of this site may be subjective to rapid rates of erosion."

09/28/2009: No major change observed; 5-foot vertical scarp is immediately downstream of where berm has tapered; site is recommended as local maintenance issue, per CLRO CES Evaluation 2008 Report; Site # is the same as RM29.6, LM0.60; previously rated "U".					
11/05/2008: No change observed; rodent holes on lower slope; wide levee crown. [2017 Site ID:RD2089U01RM29.61]

Front view of the site. Note the very dense white willow thickets on site.

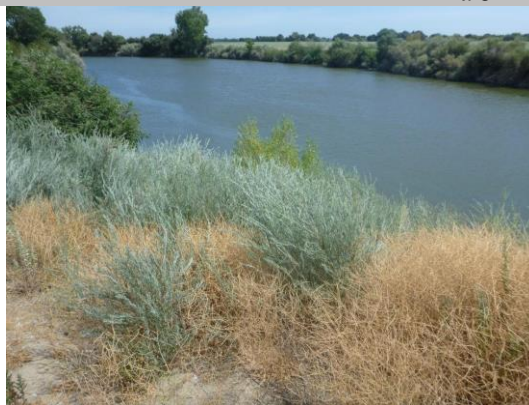
LM Start	0.67	Rating **	A/W	Issue No.	20
LM End	0.68	Issue Type +	Ma	Location *	
Category	Supplemental			GPS Latitude/Longitude	
				Start	End
Item	2017 Storm Damage			37.809700 °	37.809700 °
				-121.396300 °	-121.396400 °
DWR ID	DWR_RD2089_01_f_2017_20				
Comment Code					
Inspector Comment					
Levee Evaluation Comments					
Description:Slope protection repairs are needed along the waterside slope due to erosion and riprap displacement from high water. Based upon levee inspections, it was determined the waterside levee slope is eroding, deteriorating, and degrading. The eroded levee sections need to be restored back to design standards to prevent further deterioration and damage.					
Site ID No:512					
Site Designation:LMA-418					
Repair Type: Erosion					
Rating:Serious					
Field Date:8/14/2017					
Notes: deep erosion more than half way up slope.

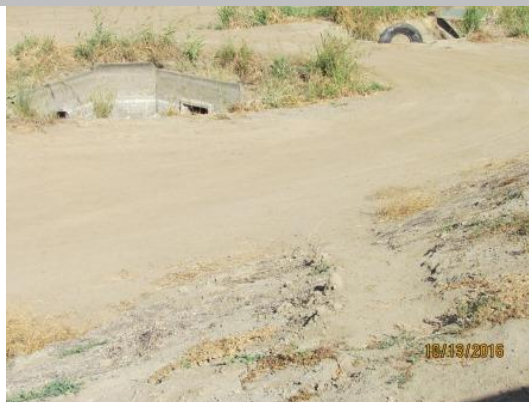
Photo 1 of 1 : SP_2019_RD2089_316_22_20190313_00023.jpg

LM Start	0.80	Rating **	M	Issue No.	22
LM End	0.80	Issue Type +	Ma	Location *	LS
Category	Earthen Levee			GPS Latitude/Longitude	
				Start	End
Item	Slope Stability			37.808466 °	37.808466 °
				-121.397847 °	-121.397847 °
DWR ID	DWR_RD2089_01_f_2016_22				
Comment Code					
S2 : Repair the levee slope damaged by foot traffic and prevent access where possible.					
Inspector Comment

View of the footpath on the landside levee slope.

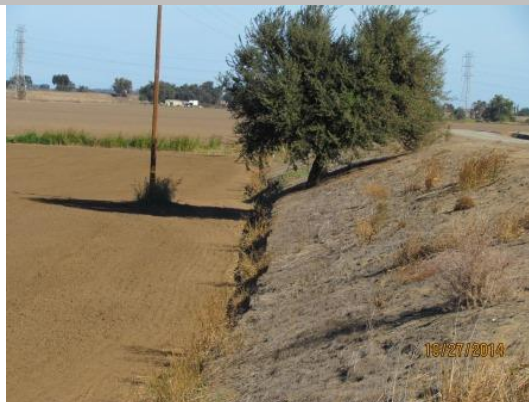
Photo 1 of 2 : SP_2019_RD2089_316_17_20190313_00015.jpg

View of the vertical cut along the landside levee toe.

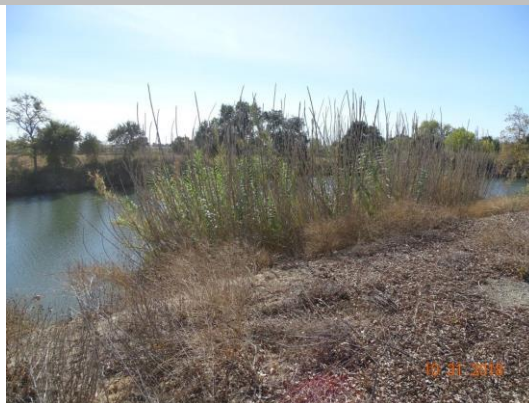
Photo 1 of 2 : SP_2019_RD2089_316_33_20190313_00032.jpg

Re-establishing of Arundo on waterward slope. (Fall 2018)

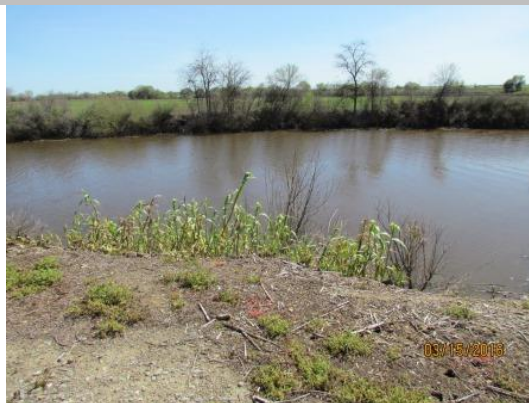
Photo 2 of 2 : SP_2019_RD2089_316_33_20190313_00033.jpg

View of when Arundo was trimmed back. Spring 2016

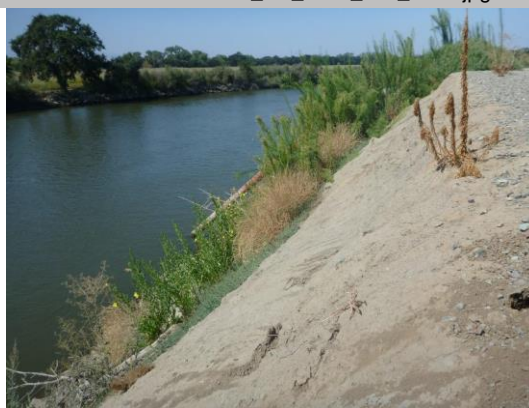
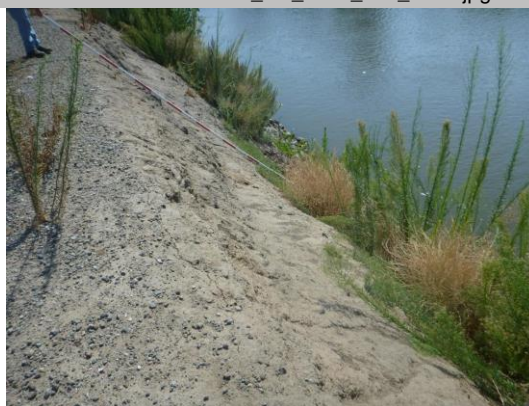
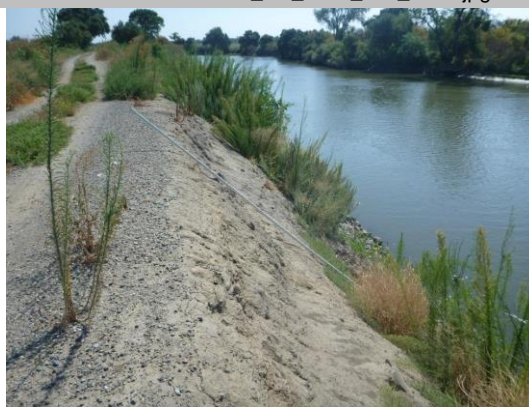
LM Start	1.16	Rating **	A/W	Issue No.	30
LM End	1.18	Issue Type +	Ma	Location *	WS
Category	Supplemental			GPS Latitude/Longitude	
				Start	End
Item	2017 Storm Damage			37.805600 °	37.805600 °
				-121.401700 °	-121.401900 °
DWR ID	DWR_RD2089_01_f _ 2017_30				
Comment Code					
Inspector Comment					
Levee Evaluation Comments					
Description:Slope protection repairs are needed along the waterside slope due to erosion and riprap displacement from high water. Based upon levee inspections, it was determined the waterside levee slope is eroding, deteriorating, and degrading. The eroded levee sections need to be restored back to design standards to prevent further deterioration and damage.					
Site ID No:511					
Site Designation:LMA-417					
Repair Type: Erosion					
Rating:Critical					
Field Date:8/16/2017					
Notes: Narrow levee with over steep slope

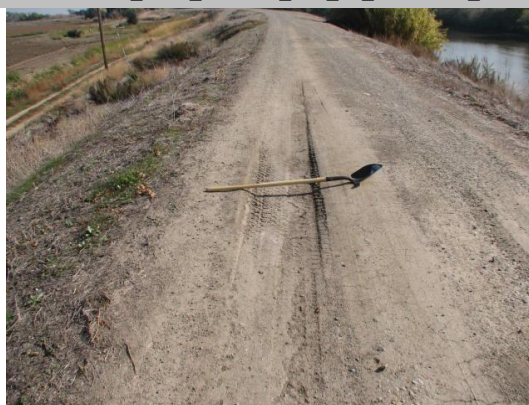
Photo 1 of 1 : SP_2019_RD2089_316_43_20190313_00034.jpg

View of depression in roadway. 11/10/2011

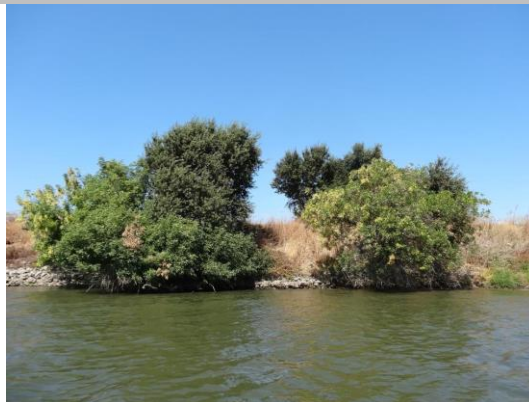
Photo 2 of 2 : SP_2019_RD2089_316_2_20190313_00004.jpg

LM Start	1.23	Rating **	M	Issue No.	2
LM End	1.24	Issue Type +	Ma	Location *	WS
Category	Supplemental			GPS Latitude/Longitude	
				Start	End
Item	DWR Erosion Survey			37.805580 °	37.805580 °
				-121.403010 °	-121.403010 °
DWR ID	RD2089U01RM29.04				
Comment Code					
Inspector Comment					
09/13/2017: No significant change observed. More vegetation observed at the site.					
09/16/2016: The river was not navigable near the site due to the dense water grass, so the site was visited by land survey. No significant change observed.					
06/25/2015: No significant change observed.					
07/02/2014: No significant change observed.					
08/13/2013: The erosion is around a tree at the levee toe. Dense vegetation is visible. [2017 Site ID:RD2089U01RM29.04]

Close view of the erosion.

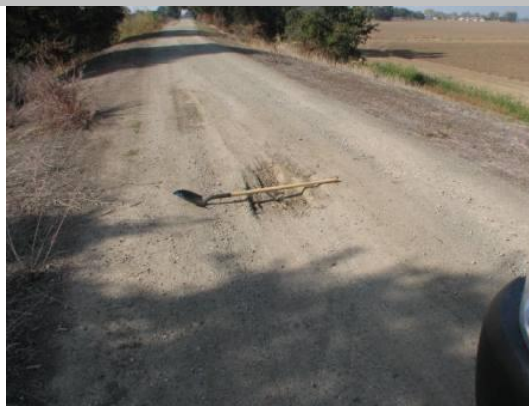
Photo 1 of 1 : SP_2019_RD2089_316_45_20190313_00036.jpg

View of roadway depression. 11/10/2011

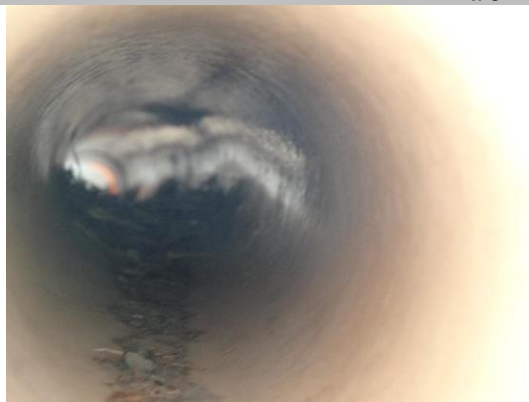
Photo 2 of 3 : UCIP_SP_2019_53379_36610.jpg

WS view: inside view of pvc pipe. Sediments found inside the pipe.

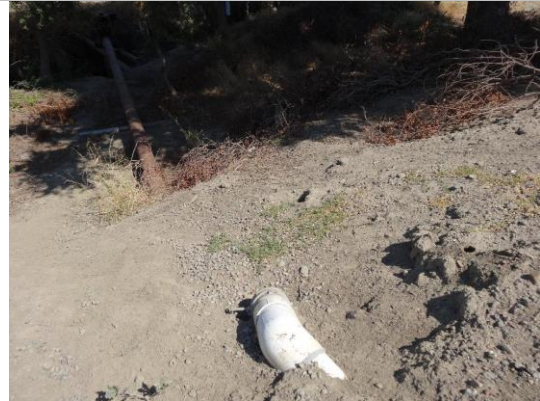
Photo 3 of 3 : UCIP_SP_2019_53379_36609.jpg

LS view: 6-inch pvc pipe on levee slope. Pipe end open.

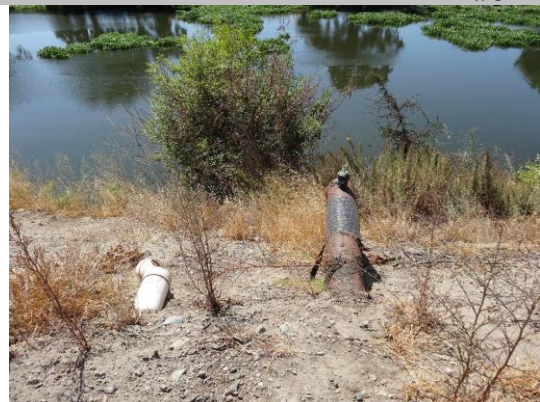
Photo 1 of 3 : UCIP_SP_2019_21585_36624.jpg

LM Start	1.41	Rating **	M	Issue No.	944
LM End	1.41	Issue Type +	Ma	Location *	
Category	Supplemental			GPS Latitude/Longitude	
				Start	End
Item	DWR UCIP LMA Responsibility			37.806323 °	37.806323 °
				-121.406155 °	-121.406155 °
DWR ID	23045				
Comment Code					
Inspector Comment					
FS_ID:21585 DS_ID:23045 EP_NO: N/A Repair Type: Non-Urgent Crossing Status: Found UCIP Comments: - siphon breaker needs repair. FIELD_STRUCT_DESC: 10-inch steel drainage discharge pipe through the levee, 2.4 feet below the crown. Pump in a drainage ditch on the landside (LS). Siphon breaker on the waterside (WS) shoulder. [Additional Reference(s): DWR Levee Log, 1991]. FS Date: 9/12/2013

WS view: exposed steel pipe on levee slope. A pvc pipe on left.

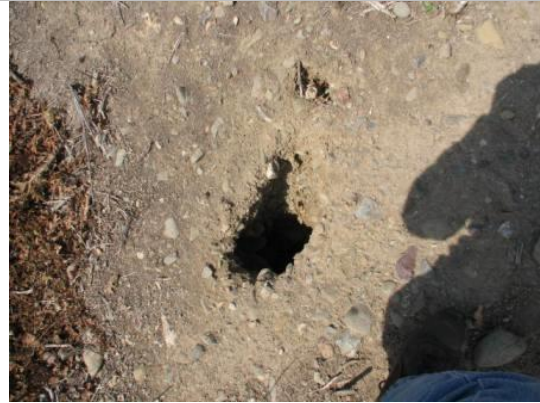
Photo 1 of 1 : SP_2019_RD2089_316_49_20190313_00038.jpg

View of deep burrow on waterside. 11/10/2011

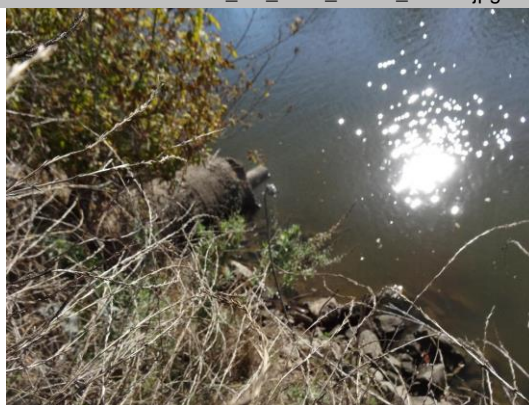
Photo 3 of 3 : UCIP_SP_2019_53182_76207.jpg

WS view of pipe

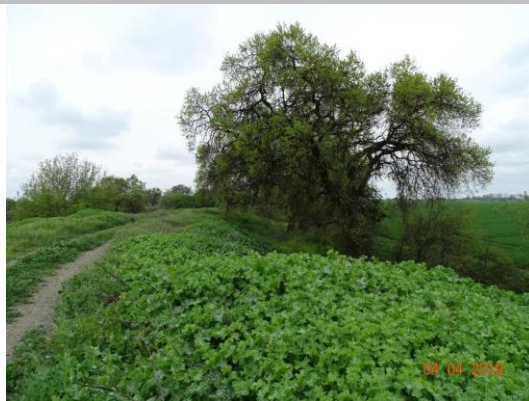
Photo 3 of 3 : SP_2019_RD2089_317_20_20190422_00069.jpg

Typical view of vegetation on landside slope. (Spring 2019)

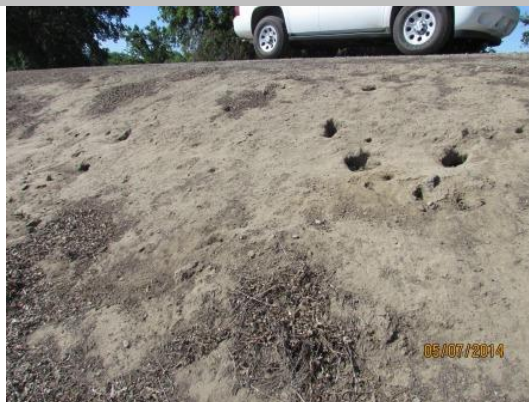
Photo 1 of 1 : SP_2019_RD2089_317_49_20190313_00050.jpg

LM Start	0.21	Rating **	M	Issue No.	49
LM End	0.21	Issue Type +	Ma	Location *	LS
Category	Earthen Levee			GPS Latitude/Longitude	
				Start	End
Item	Animal Control			37.809148 °	37.809148 °
				-121.409897 °	-121.409897 °
DWR ID	DWR_RD2089_02_s_2018_49				
Comment Code					
A3 : No rodents visible, but rodent burrows visible; need to backfill and compact or grout burrows.					
Inspector Comment

View of the multiple rodent burrows on the landside levee hinge and slope.

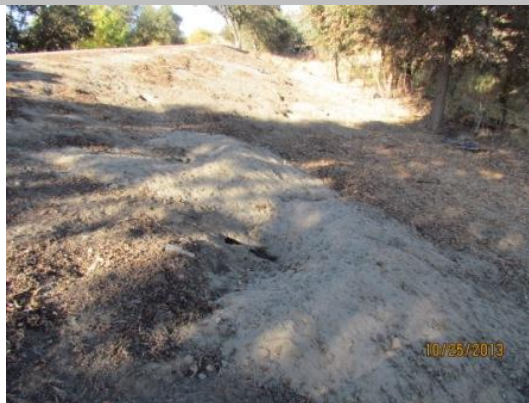
Photo 1 of 3 : SP_2019_RD2089_317_53_20190313_00056.jpg

View of the multiple rodent burrows on the landside levee slope.

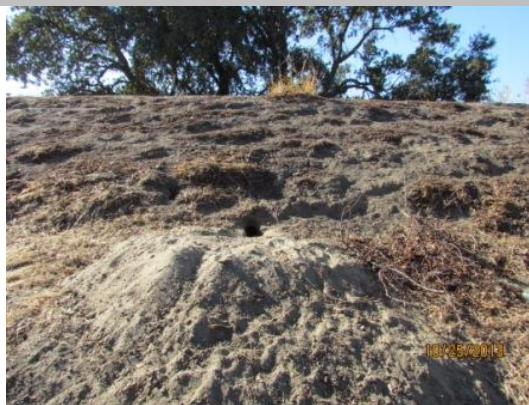
Photo 2 of 3 : SP_2019_RD2089_317_53_20190313_00057.jpg

View of the rodent burrow on the landside levee slope.

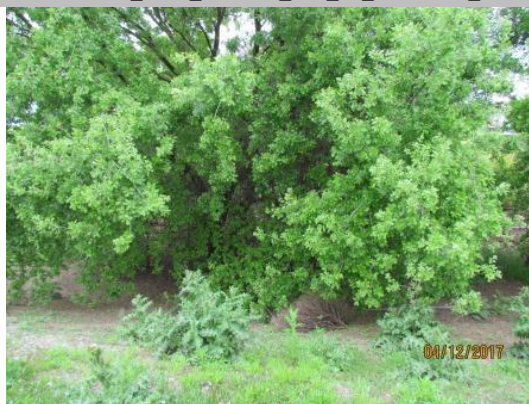
Photo 1 of 1 : SP_2019_RD2089_317_55_20190313_00060.jpg

LM Start	0.34	Rating **	M	Issue No.	55
LM End	0.34	Issue Type +	Ma	Location *	LS
Category	Earthen Levee			GPS Latitude/Longitude	
				Start	End
Item	Trim / Thin Trees			37.810052 °	37.810052 °
				-121.411966 °	-121.411966 °
DWR ID	DWR_RD2089_02_s_2017_55				
Comment Code					
T1 : Trim trees to at least five feet above ground level.					
Inspector Comment

View of the overgrown tree on the levee slope.

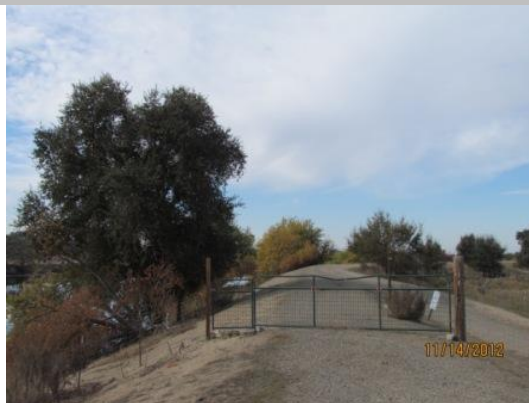
Photo 1 of 1 : SP_2019_RD2089_317_2_20190313_00004.jpg

View of gate across levee crown.

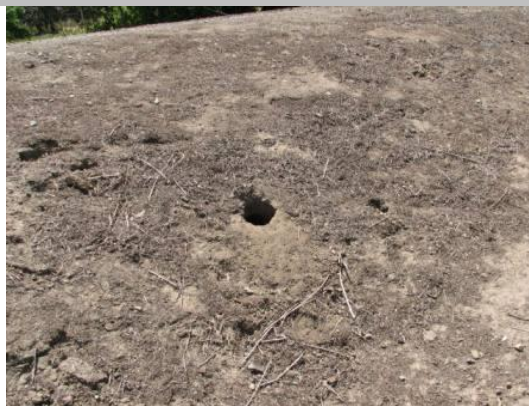
Photo 1 of 1 : SP_2019_RD2089_317_26_20190313_00026.jpg

View of active rodent burrow. 05/24/2011

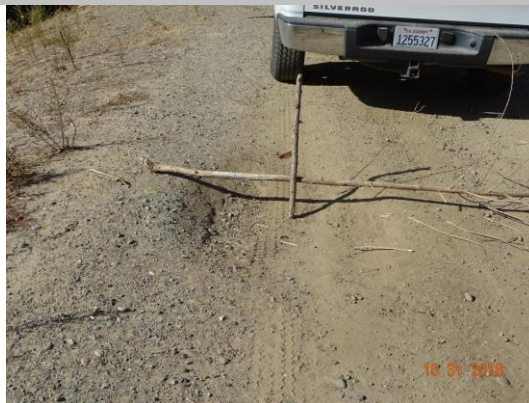
Photo 1 of 1 : SP_2019_RD2089_317_7_20190313_00007.jpg

View of depression greater than six inches on levee crown. (Fall 2018)

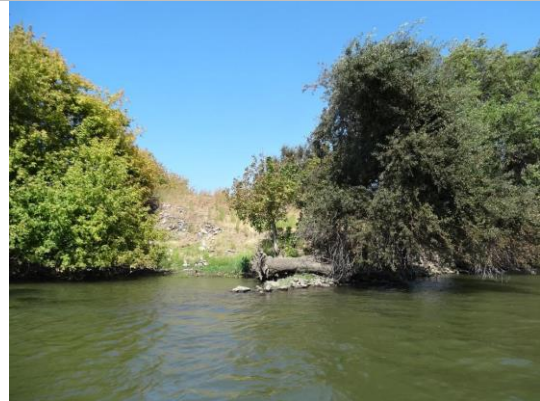
Photo 3 of 3 : SP_2019_RD2089_317_1_20190313_00003.jpg

Close view of the erosion.

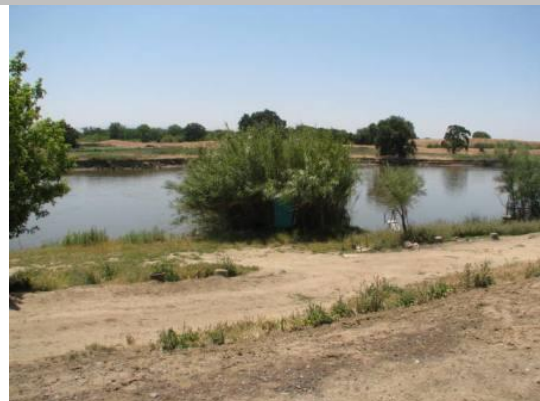
Photo 1 of 3 : SP_2019_RD2089_317_27_20190313_00027.jpg

View of portable toilet is in the shadows in the center of the photo at the water's edge. 05/24/2011

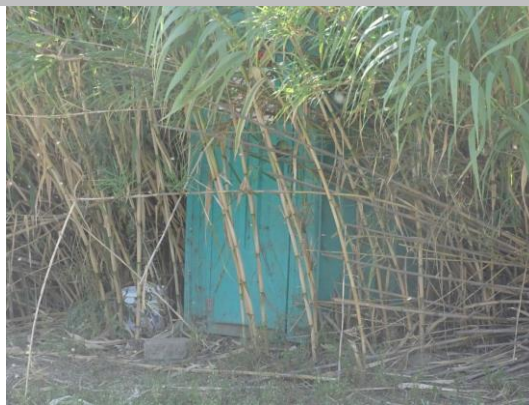
Photo 3 of 3 : SP_2019_RD2089_317_27_20190313_00029.jpg

Close-up view of portable toilet at water's edge. (Fall 2018)

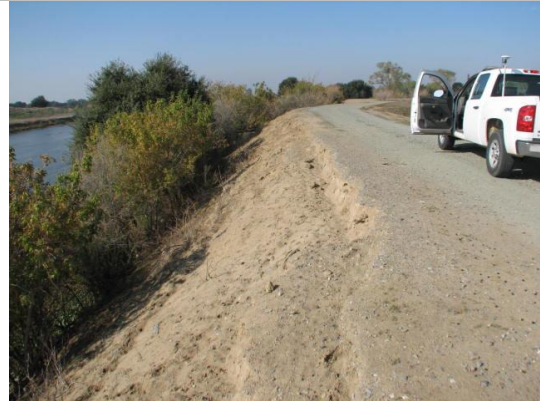
Photo 1 of 1 : SP_2019_RD2089_317_14_20190313_00016.jpg

View of the approximately 1' scarp that has been created by livestock travel. 11/10/2011

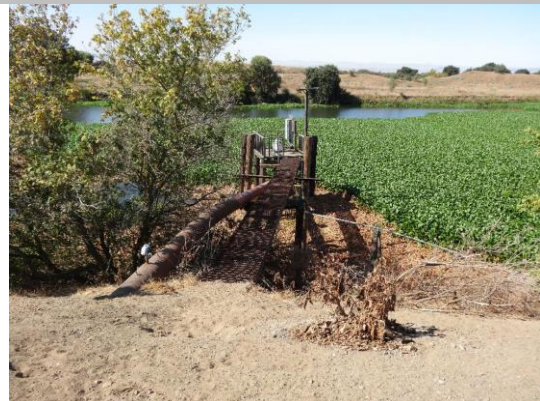
Photo 1 of 3 : UCIP_SP_2019_21676_36861.jpg

WS view: pipe and pump on piling structure in water channel.

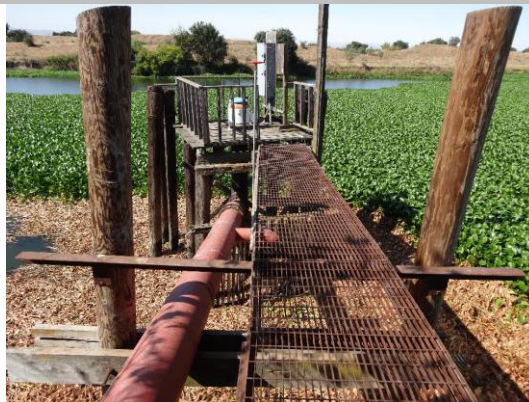
Photo 3 of 3 : UCIP_SP_2019_21676_36859.jpg

WS view: pipe (left) and steel walkway to pump on piling structure in the channel.

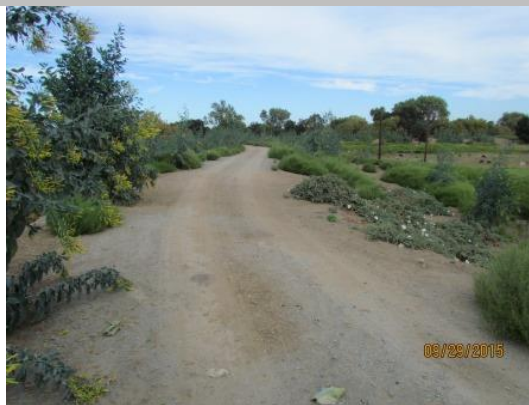
Photo 2 of 4 : SP_2019_RD2089_317_35_20190313_00034.jpg

View of the levee crown depression looking downstream.

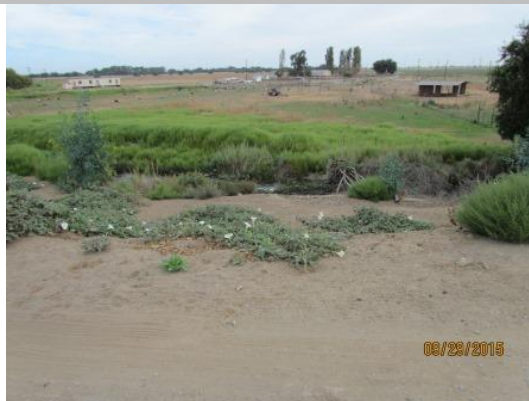
Photo 3 of 4 : SP_2019_RD2089_317_35_20190313_00035.jpg

View of the levee crown depression looking to the landside.

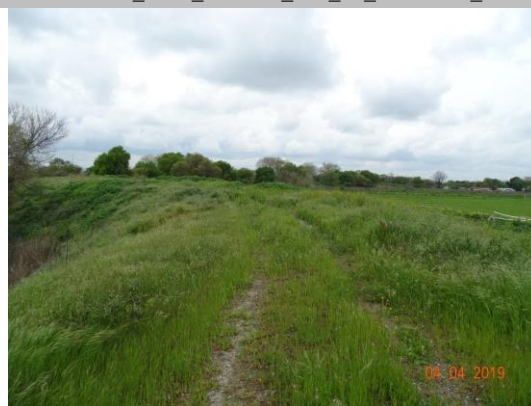
Photo 1 of 1 : SP_2019_RD2089_317_36_20190422_00071.jpg

View of vegetation on levee crown. (Spring 2019)

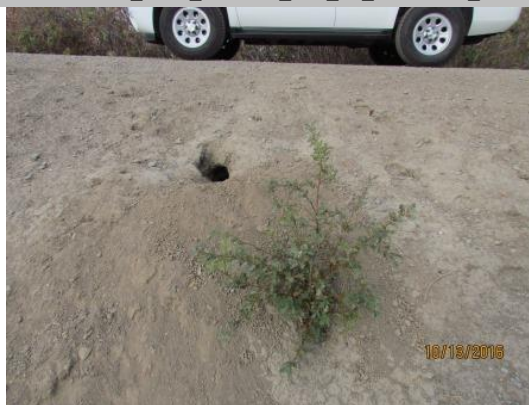
Photo 1 of 1 : SP_2019_RD2089_317_28_20190313_00030.jpg

View of the rodent burrow in the landside levee slope.

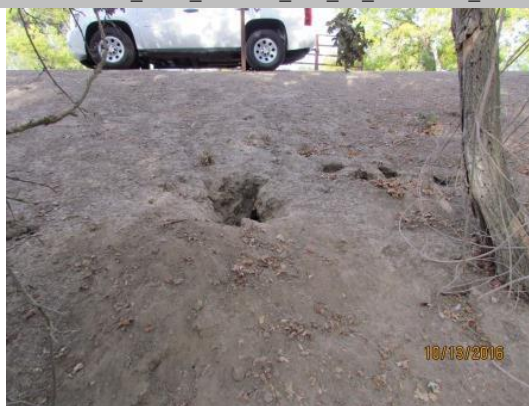
Photo 1 of 1 : SP_2019_RD2089_317_16_20190313_00018.jpg

View of the rodent burrow in the landside levee slope.

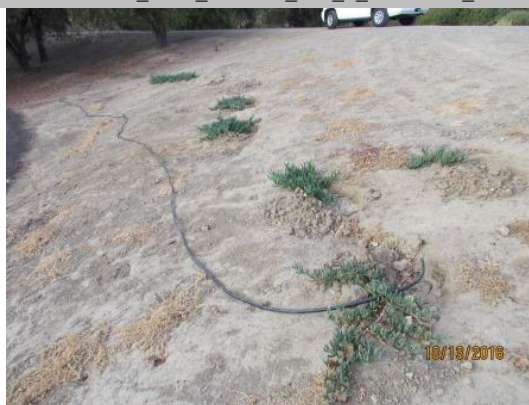
Photo 2 of 2 : SP_2019_RD2089_317_8_20190313_00009.jpg

View of the ice plant and irrigation line on the landside levee slope, looking upstream.
