**Flood Control Project Maintenance
Levee Inspections**
LMA District Cover Sheet
Spring 2020 Levee Inspection Results

Reclamation District No. 2089 Stark

Spring 2020 Levee Inspection Results

| Waterway | | | Bank | Unit Miles |
|--|---|---|---|---|
| Unit No. 01 Old River | | | Right | 1.51 |

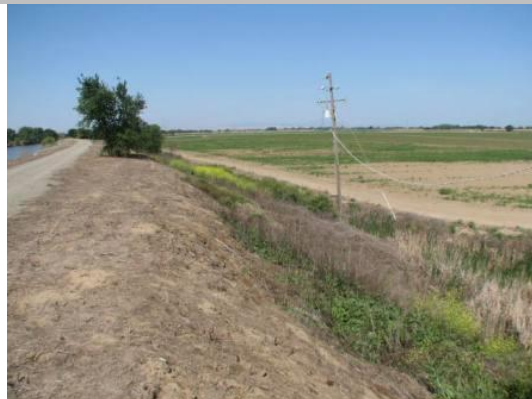
Photo 1 of 1 : SP_2020_RD2089_316_9_20200228_00009.jpg

Ditch flows parallel with the utility line shown in the photo. 05/24/2011

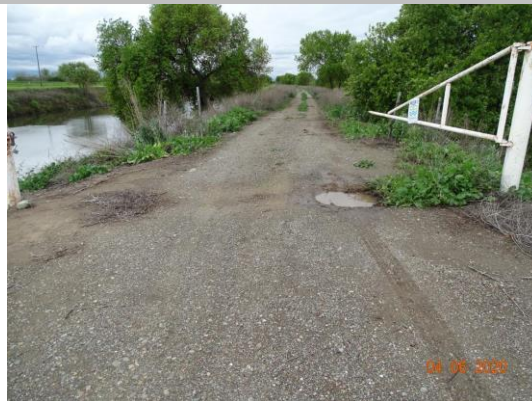
Photo 1 of 1 : SP_2020_RD2089_316_12_20200504_00051.jpg

View of depression on surface road near landside hinge. Spring 2020

| C2 : Repair depressions or ruts in the crown or slope. | | | | | |

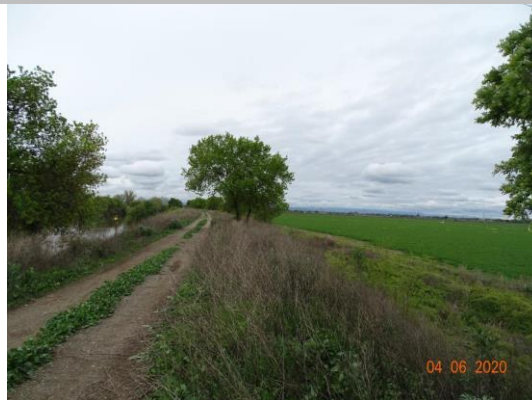
Photo 1 of 1 : SP_2020_RD2089_316_24_20200504_00052.jpg

View of overgrown vegetation on landside slope. Spring 2020

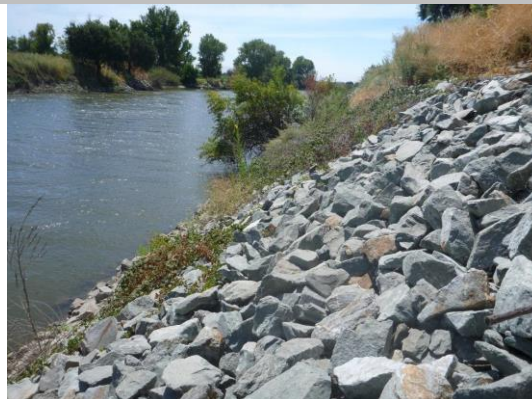
Photo 1 of 1 : LEVAL_SP_2020_513_4443.jpg

| 2017 Storm Damage Site, ID No. 513, LMA 419. Slope protection repairs are needed along the waterside slope due to erosion and riprap displacement from high water. | | | | | |

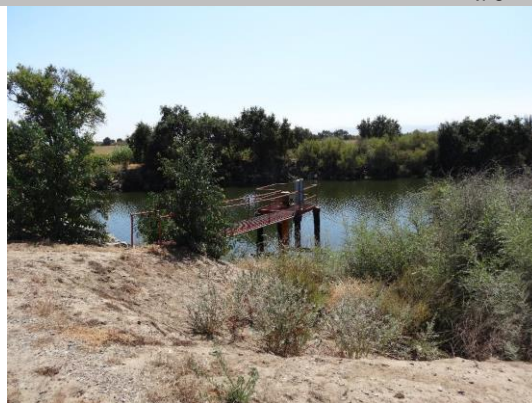
Photo 1 of 3 : UCIP_SP_2020_21635_36742.jpg

| DS_ID:23042 FS_ID:21635 EP_NO: 5641 Repair Type: Non-Urgent Crossing Status: Found UCIP Comments: - damaged siphon breaker.- most of the pipe on landside exposed on levee slope. FIELD_STRUCT_DESC: 20-inch steel irrigation discharge pipe and electrical conduit through the levee, 5.8 feet below the crown. Pump on a pile structure in the stream. Siphon breaker on the landside (LS) slope. (Plans to replace a rusted out irrigation discharge pipe through the levee authorized under Permit No. 5641, 1967 - Theodore Stark). [Additional Reference(s): DWR Levee Log, 1991. USACE San Joaquin O&M Manual 8, 1968, (HLM 0.46), 21-inch pipe referenced]. FS Date: 9/12/2013 | | | | | | |

WS view: walkway to pump platform and pump on steel piling structure in the channel.

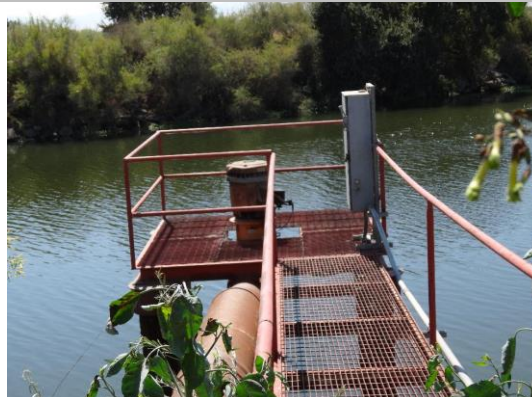
Photo 2 of 3 : UCIP_SP_2020_21635_36741.jpg

WS view: steel walkway, electric control box, and pump on steel piling structure in the channel.

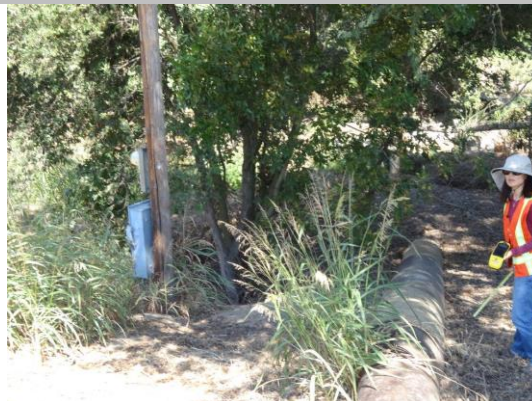
Photo 3 of 3 : UCIP_SP_2020_21635_36740.jpg

LS view: overview of exposed steel pipe (right) on levee slope and service pole (left).

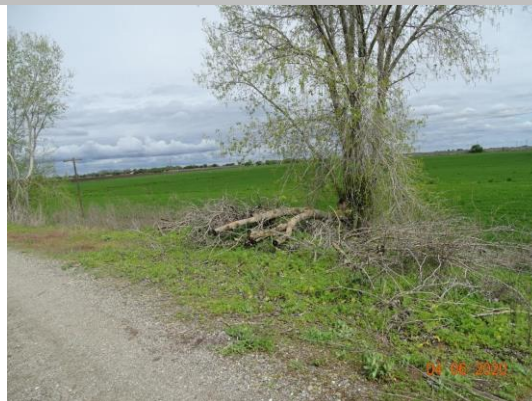
Photo 1 of 1 : SP_2020_RD2089_316_29_20200504_00054.jpg

View of downed tree limb on landside slope. Spring 2020

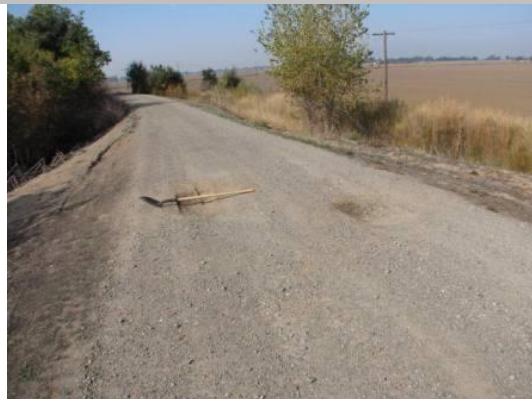
Photo 1 of 1 : SP_2020_RD2089_316_14_20200228_00012.jpg

11/10/2011 Depressions in crown.

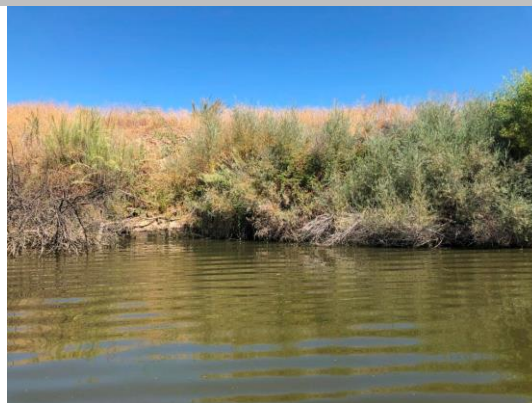
Photo 1 of 2 : SP_2020_RD2089_316_5_20200228_00007.jpg

| 08/23/2011: The 5-foot vertical scarp shows no significant change from the last year inspection. No new erosion activities observed. Dense white willow trees on site. | | | | | | |
| 09/28/2009: No major change observed; 5-foot vertical scarp is immediately downstream of where berm has tapered; site is recommended as local maintenance issue, per CLRO CES Evaluation 2008 Report; Site # is the same as RM29.6, LM0.60; previously rated "U". | | | | | | |

Front view of the site.

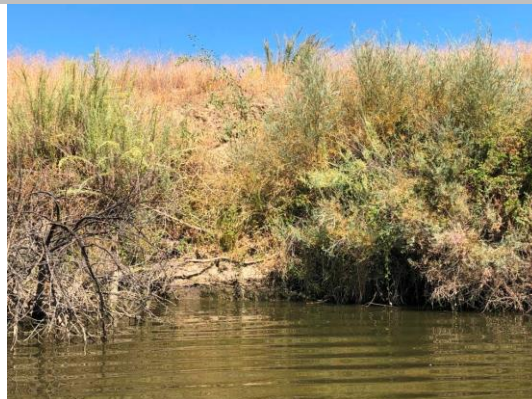
Photo 2 of 2 : SP_2020_RD2089_316_5_20200228_00008.jpg

Front view of the site. Note the very dense white willow thickets on site.

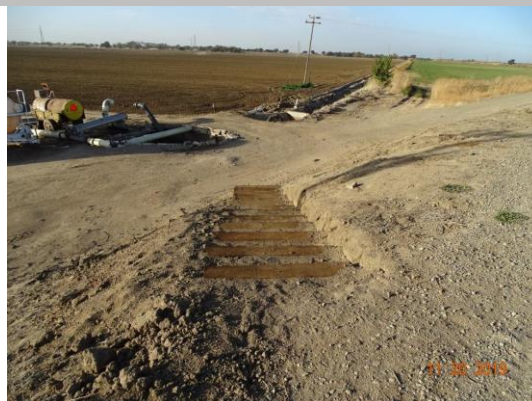
Photo 1 of 2 : SP_2020_RD2089_316_22_20200228_00021.jpg

View of steps on landside slope. Fall 2019

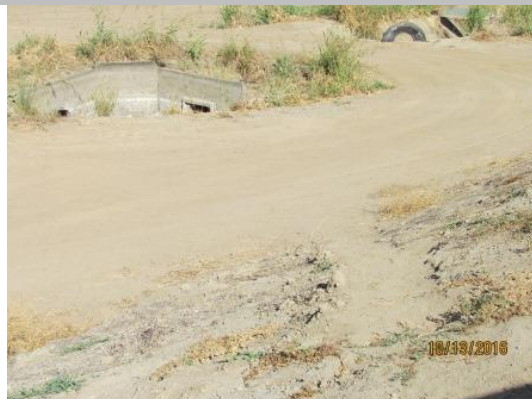
Photo 2 of 2 : SP_2020_RD2089_316_22_20200228_00022.jpg

View of the footpath on the landside levee slope.

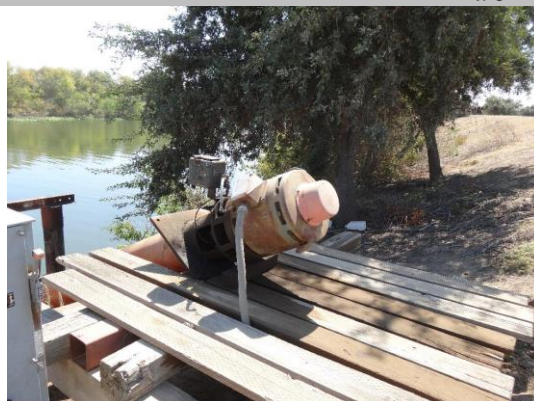
Photo 1 of 3 : UCIP_SP_2020_21587_36635.jpg

| DS_ID:23043 FS_ID:21587 EP_NO: 3385 Repair Type: Non-Urgent Crossing Status: Found UCIP Comments: - powerline on landside.- electric control box on waterside.- waterside slope erosion under pump platform. FIELD_STRUCT_DESC: 16-inch irrigation discharge pipe of an unknown material through the levee, 5.5 feet below the crown. Two cutoff walls. Slant pump in a pump house on the waterside (WS) slope. Siphon breaker on the landside (LS) slope. (Plans for installation of a pumping plant on the riverbank and a pipe that crosses the levee authorized under Permit No. 3385, 1960 - Eleanor M. Lawrence). [Additional Reference(s): DWR Levee Log, 1991. USACE San Joaquin O&M Manual 8, 1968, (HLM 0.81)]. FS Date: 9/12/2013 | | | | | | |

WS view: slant pump on wooden platform. Oil leaks from the pump.

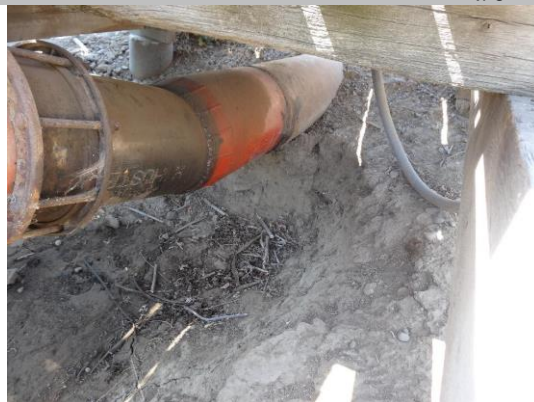
Photo 2 of 3 : UCIP_SP_2020_21587_36634.jpg

WS view: soil erosion under pump platform. Needs mitigation measures to stop erosion.

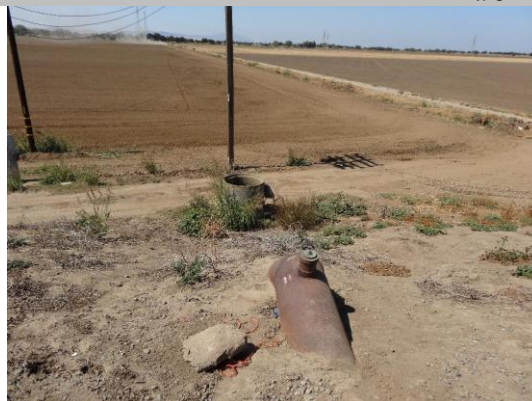
Photo 3 of 3 : UCIP_SP_2020_21587_36633.jpg

LS view: exposed pipe with siphon breaker on levee slope. Concrete standpipe on levee toe.

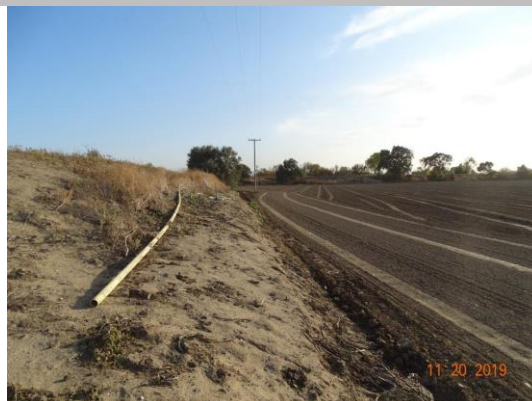
Photo 1 of 2 : SP_2020_RD2089_316_17_20200228_00015.jpg

View of vertical cut along the landside toe. (Fall 2019)

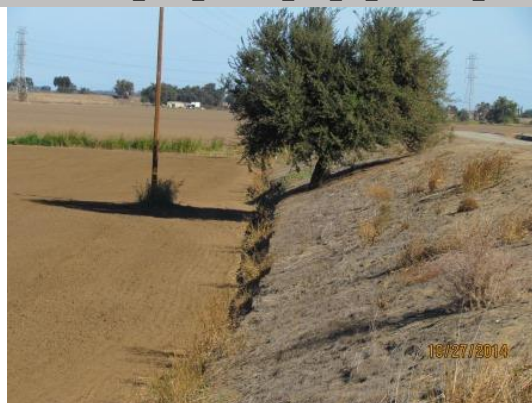
Photo 2 of 2 : SP_2020_RD2089_316_17_20200228_00016.jpg

View of the vertical cut along the landside levee toe.

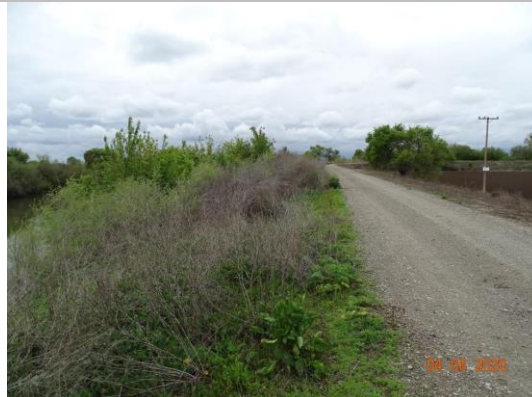
Photo 1 of 1 : SP_2020_RD2089_316_54_20200504_00056.jpg

View of overgrown vegetation on waterside slope. Spring 2020

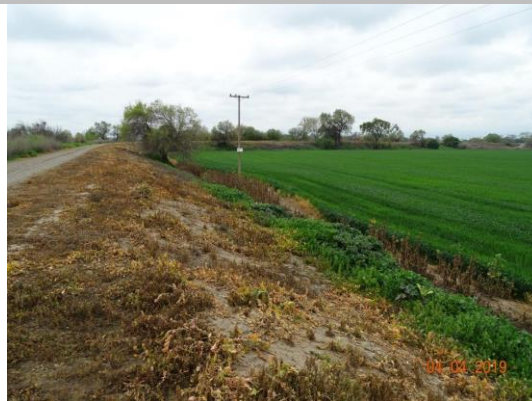
Photo 1 of 1 : SP_2020_RD2089_316_27_20200228_00025.jpg

View of vegetation on landside slope. (spring 2019)

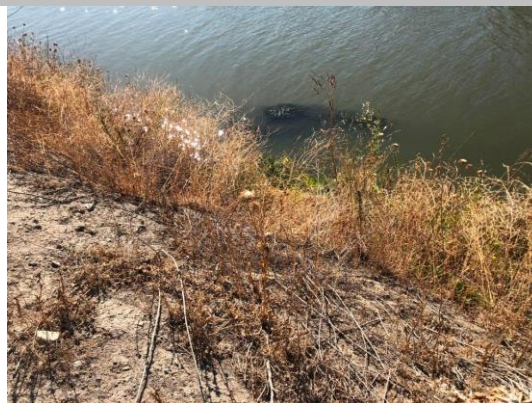
Photo 1 of 1 : SP_2020_RD2089_316_3_20200228_00005.jpg

Looking at the erosion from levee top.

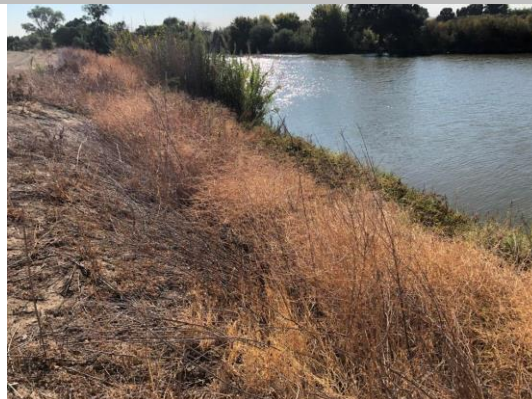
Photo 1 of 1 : SP_2020_RD2089_316_2_20200228_00003.jpg

| Site ID: RD2089U01RM29.04 09/26/2019: No significant change observed. 09/13/2017: No significant change observed. More vegetation observed at the site. 09/16/2016: The river was not navigable near the site due to the dense water grass, so the site was visited by land survey. No significant change observed. 06/25/2015: No significant change observed. 07/02/2014: No significant change observed. 08/13/2013: The erosion is around a tree at the levee toe. Dense vegetation is visible. | | | | | |

Looking at the erosion from levee top.

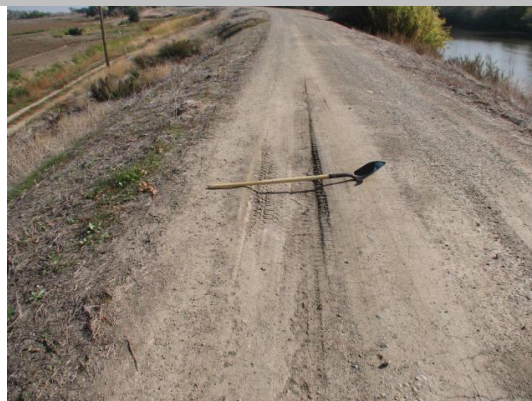
Photo 1 of 1 : SP_2020_RD2089_316_43_20200228_00031.jpg

View of depression in roadway. 11/10/2011

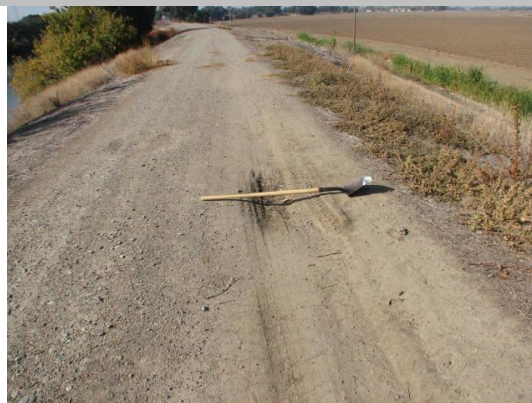
Photo 1 of 1 : SP_2020_RD2089_316_44_20200228_00032.jpg

View of roadway depression. 11/10/2011

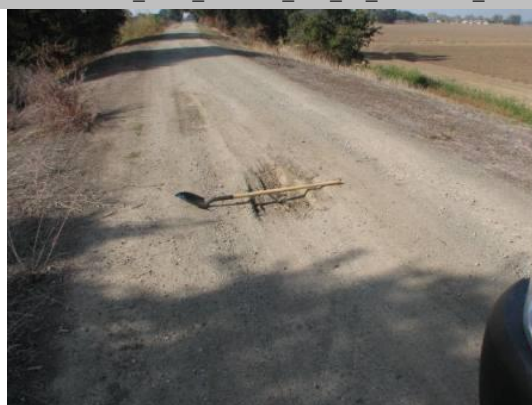
Photo 1 of 1 : SP_2020_RD2089_316_45_20200228_00033.jpg

View of roadway depression. 11/10/2011

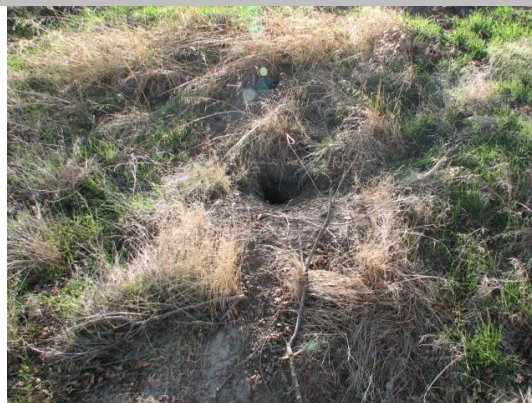
Photo 1 of 1 : SP_2020_RD2089_316_47_20200228_00034.jpg

View of active rodent burrow on landside slope. 11/10/2011

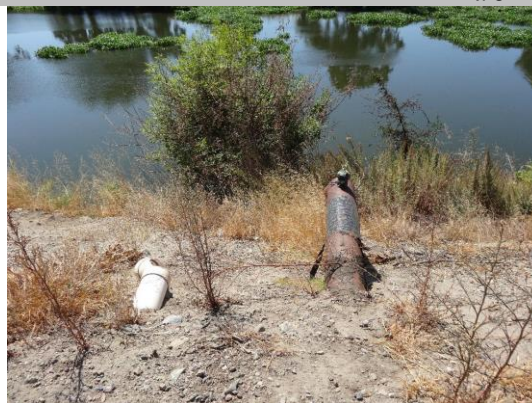
Photo 1 of 3 : UCIP_SP_2020_53379_36611.jpg

| DS_ID:24667 FS_ID:53379 EP_NO: N/A Repair Type: Non-Urgent Crossing Status: Found UCIP Comments: 10/12/2018 Same as last inspection. Down grading to Non-Urgent due to abandonment and no visual threat to pipe or levee integrity (D. Sanoski - DWR UCIP).11/15/2016 Same as last inspection. (K. Fazel - UCIP)09/12/2013:- if abandoned, it needs proper abandonment. Pipe damaged and open on both ends. (P. Amatya - DWR) FIELD_STRUCT_DESC: *ABANDONED* 6-inch polyvinyl chloride (PVC) irrigation discharge pipe through the levee, 2 feet below the crown. Pipe was installed due to pump failure, but never removed. Field study discovered pipe. FS Date: 10/12/2018 5:16:00 PM | | | | | | |

WS view: 6-inch pvc pipe on levee slope. Pipe end open and damaged.

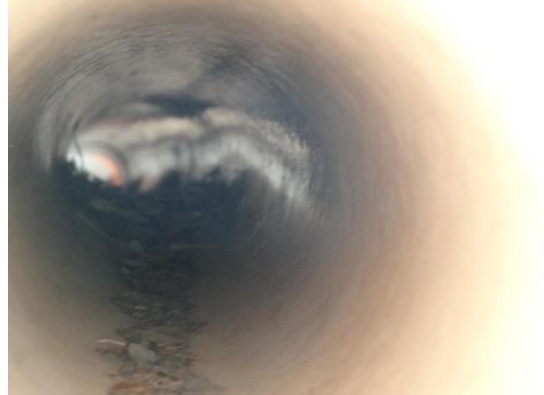
Photo 2 of 3 : UCIP_SP_2020_53379_36610.jpg

WS view: inside view of pvc pipe. Sediments found inside the pipe.

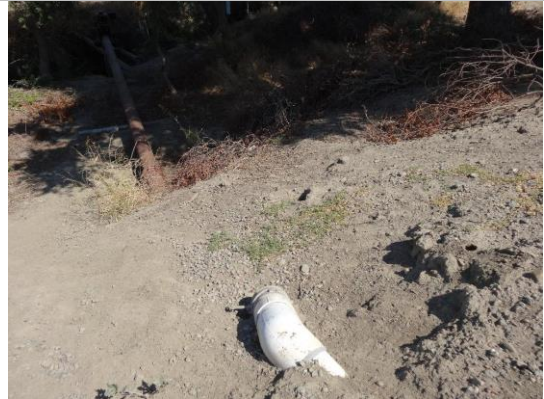
Photo 3 of 3 : UCIP_SP_2020_53379_36609.jpg

LS view: 6-inch pvc pipe on levee slope. Pipe end open.

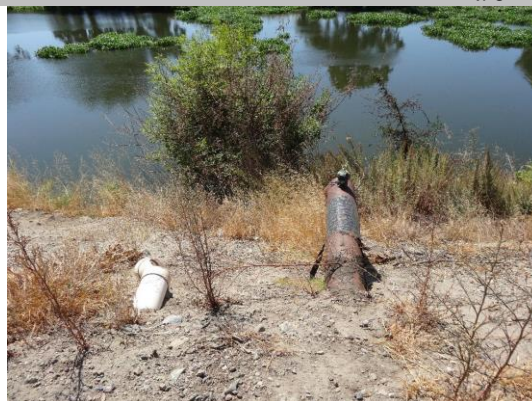
Photo 1 of 3 : UCIP_SP_2020_21585_36624.jpg

| DS_ID:23045 FS_ID:21585 EP_NO: N/A Repair Type: Non-Urgent Crossing Status: Found UCIP Comments: - siphon breaker needs repair. FIELD_STRUCT_DESC: 10-inch steel drainage discharge pipe through the levee, 2.4 feet below the crown. Pump in a drainage ditch on the landside (LS). Siphon breaker on the waterside (WS) shoulder. [Additional Reference(s): DWR Levee Log, 1991]. FS Date: 9/12/2013 | | | | | | |

WS view: exposed steel pipe on levee slope. A pvc pipe on left.

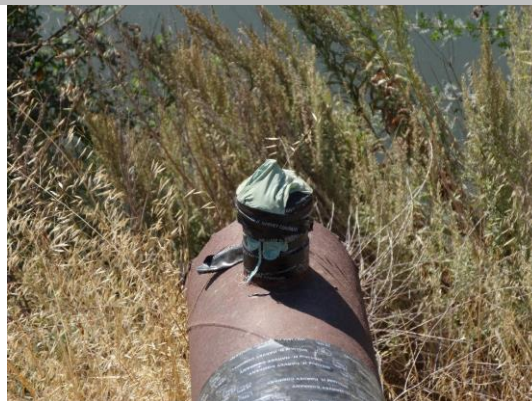
Photo 2 of 3 : UCIP_SP_2020_21585_36623.jpg

WS view: exposed steel pipe with siphon breaker. Looks siphon breaker needs repair.

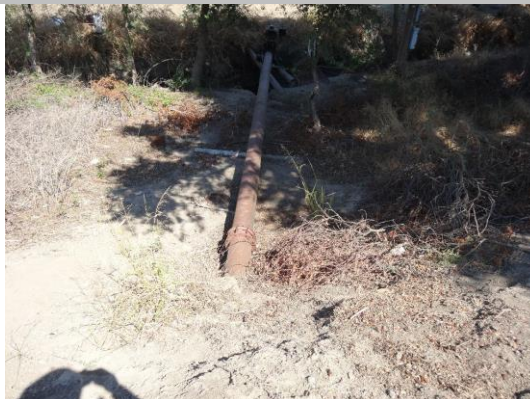
Photo 3 of 3 : UCIP_SP_2020_21585_36622.jpg

LS view: exposed steel pipe on levee slope.

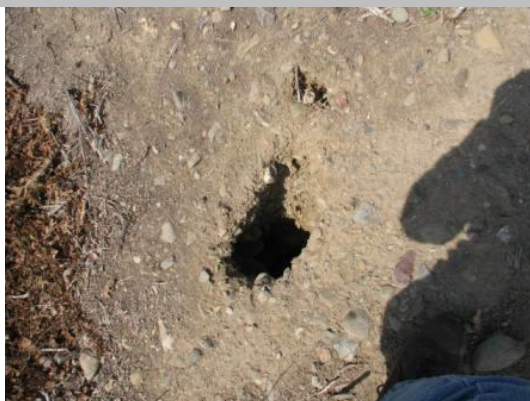
Photo 1 of 1 : SP_2020_RD2089_316_49_20200228_00035.jpg

View of deep burrow on waterside. 11/10/2011

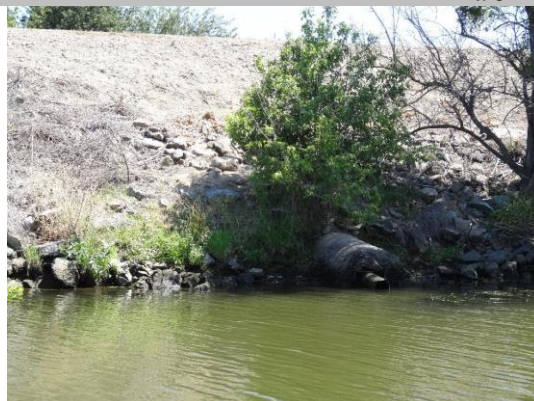
Photo 1 of 3 : UCIP_SP_2020_53182_74506.jpg

DS_ID:23046
FS_ID:53182
EP_NO: N/A
Repair Type: Non-Urgent
Crossing Status: Found
UCIP Comments: 10/12/2018 Same as last inspection; downgrading to Non-Urgent due to no visual pipe or levee threat (D. Sanoski - DWR UCIP).11/15/2016 Pipe found on WS only. Same as last inspection. (K. Fazel - UCIP)06/25/2015 Crossing appears abandoned; if so, should be done so properly. Pipe open on WS. Holes and cracks visible on pipe. (K. Fazel - UCIP)
FIELD_STRUCT_DESC: *ABANDONED* 12-inch reinforced concrete pipe of an unknown purpose possibly through the levee, approximately 8 feet below the crown. Smaller steel pipe sleeved through the 12-inch pipe with annular space grouted. Pipe does not cross channel and may not cross levee. May be related to the gas line crossing with DS ID 25121. Discovered from boat on 2015 DWR Erosion Survey.
FS Date: 10/12/2018 5:22:43 PM

View up WS slope from water. Pipe does not cross channel.

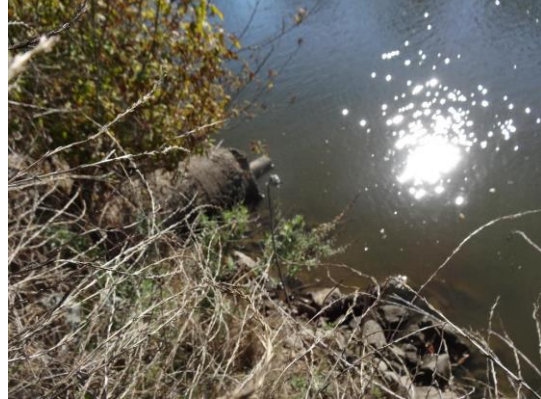
Photo 3 of 3 : UCIP_SP_2020_53182_76207.jpg

WS view of pipe

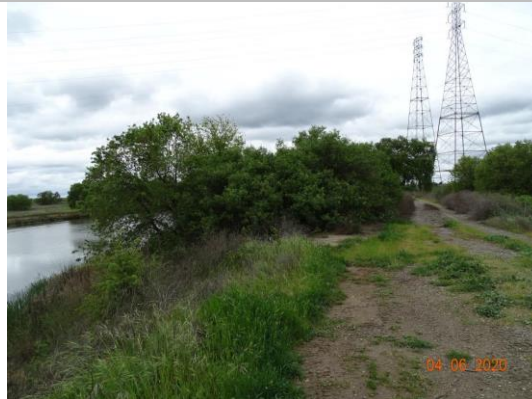
Photo 1 of 1 : SP_2020_RD2089_317_58_20200504_00069.jpg

View of overgrown vegetation on waterside slope. Spring 2020

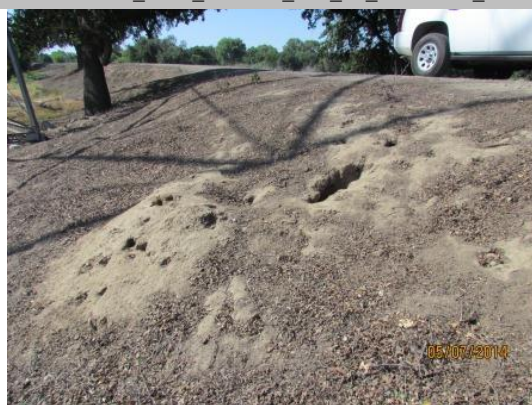
Photo 1 of 1 : SP_2020_RD2089_317_48_20200228_00046.jpg

View of the rodent burrow on the landside levee slope.

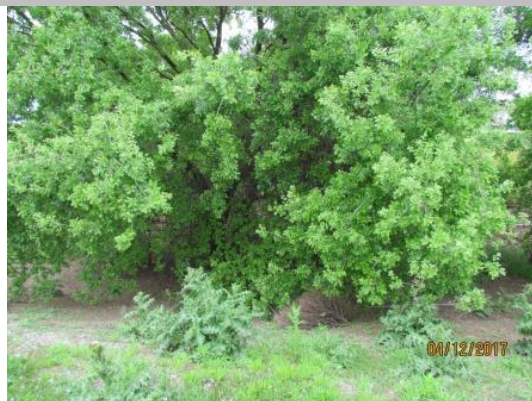
Photo 1 of 1 : SP_2020_RD2089_317_55_20200228_00057.jpg

View of the overgrown tree on the levee slope.

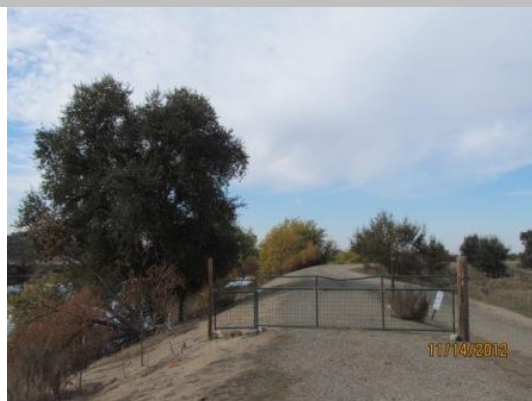
Photo 1 of 1 : SP_2020_RD2089_317_2_20200228_00004.jpg

View of gate across levee crown.

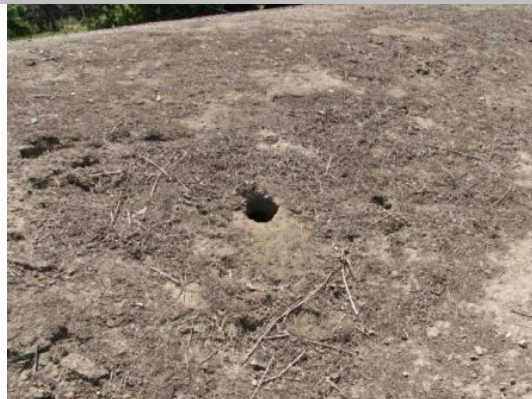
Photo 1 of 1 : SP_2020_RD2089_317_26_20200228_00022.jpg

View of active rodent burrow. 05/24/2011

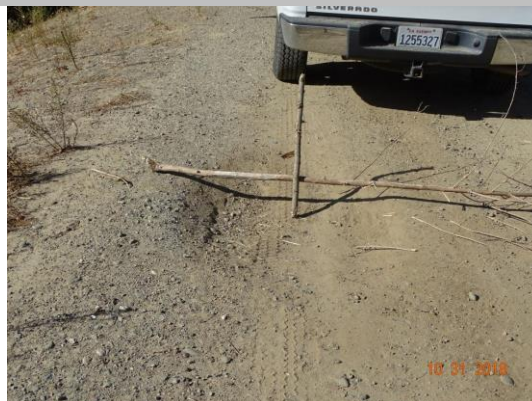
Photo 1 of 1 : SP_2020_RD2089_317_7_20200228_00007.jpg

View of depression greater than six inches on levee crown. (Fall 2018)

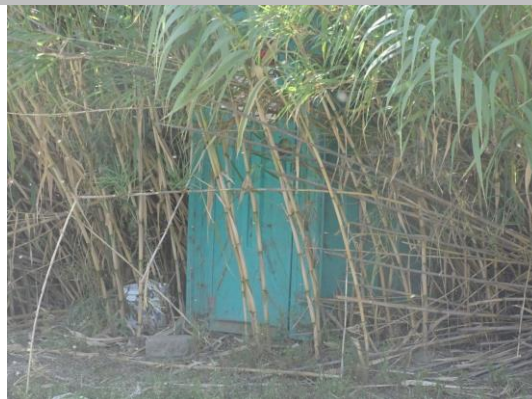
Photo 1 of 1 : SP_2020_RD2089_317_27_20200228_00025.jpg

Close-up view of portable toilet at water's edge. (Fall 2018)

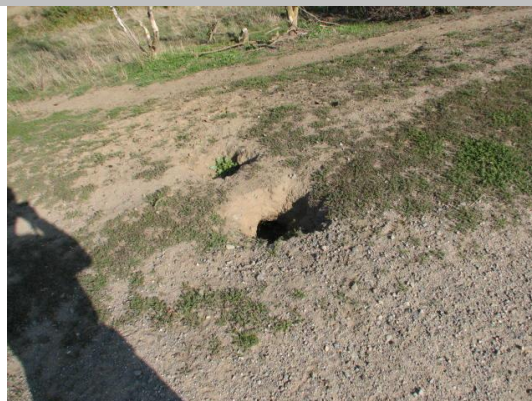
Photo 1 of 1 : SP_2020_RD2089_317_13_20200228_00013.jpg

View of two large burrows on crown, need to be filled. 11/10/2011

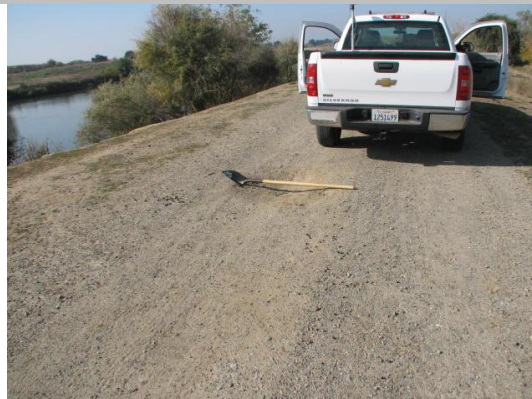
Photo 1 of 1 : SP_2020_RD2089_317_10_20200228_00009.jpg

Depression in crown needs to be filled. 11/10/2011

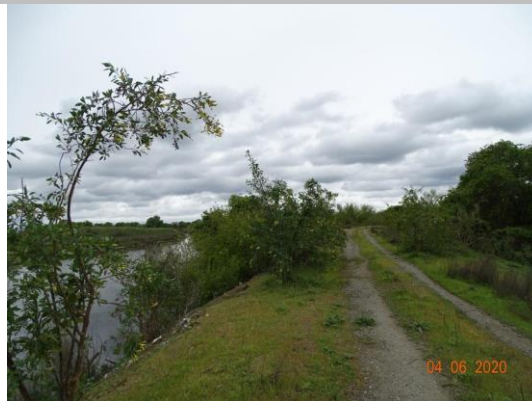
Photo 1 of 1 : SP_2020_RD2089_317_62_20200504_00072.jpg

View of overgrown vegetation on waterside slope. Spring 2020

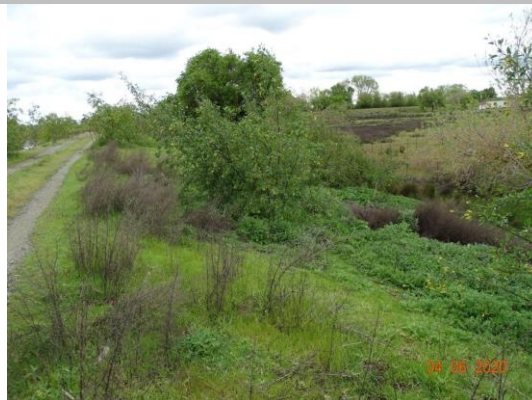
Photo 1 of 1 : SP_2020_RD2089_317_39_20200504_00071.jpg

View of overgrown vegetation on landside slope. Spring 2020

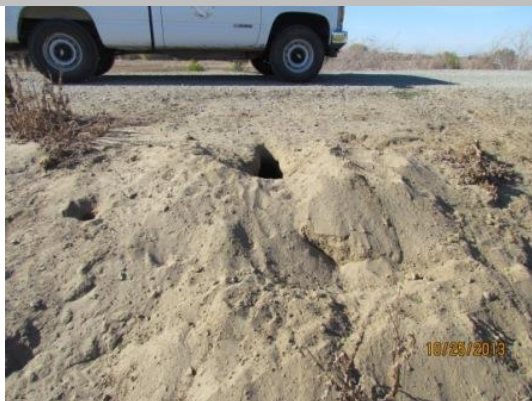
Photo 1 of 1 : SP_2020_RD2089_317_54_20200228_00056.jpg

View of the rodent burrow on the landside levee slope.

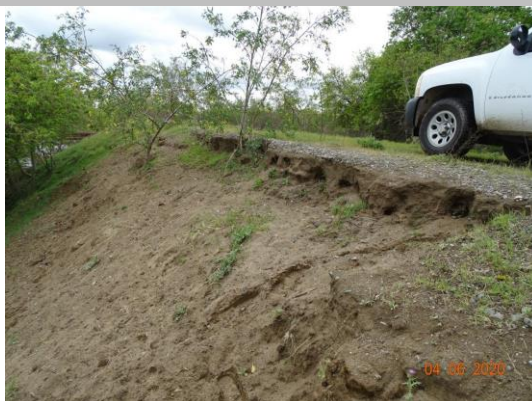
Photo 1 of 1 : SP_2020_RD2089_317_14_20200504_00078.jpg

View of the approximately 1' scarp that has been created by livestock.
Spring 2020

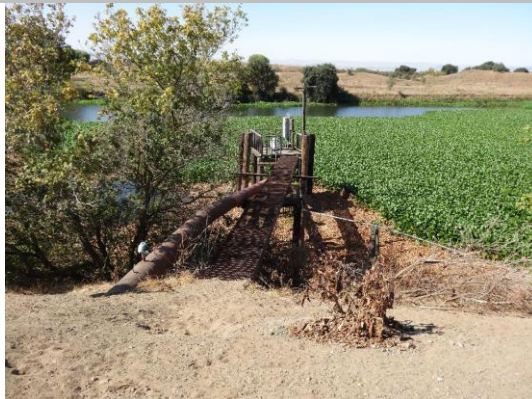
Photo 1 of 3 : UCIP_SP_2020_21676_36861.jpg

WS view: pipe and pump on piling structure in water channel.

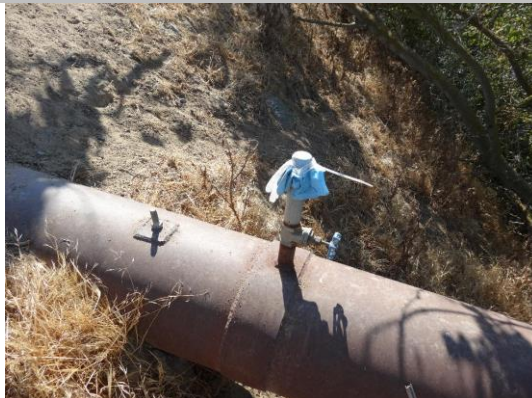
Photo 2 of 3 : UCIP_SP_2020_21676_36860.jpg

WS view: air relief valve on pipe. Pipe exposed in levee slope.

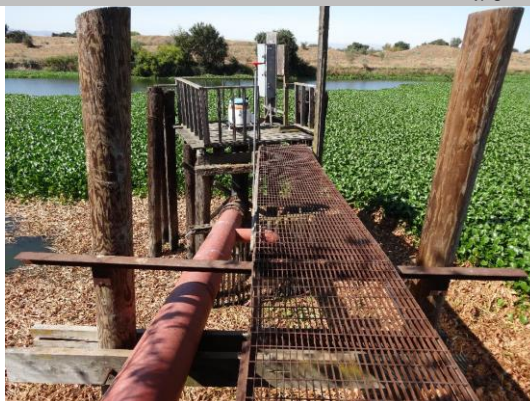
Photo 3 of 3 : UCIP_SP_2020_21676_36859.jpg

WS view: pipe (left) and steel walkway to pump on piling structure in the channel.

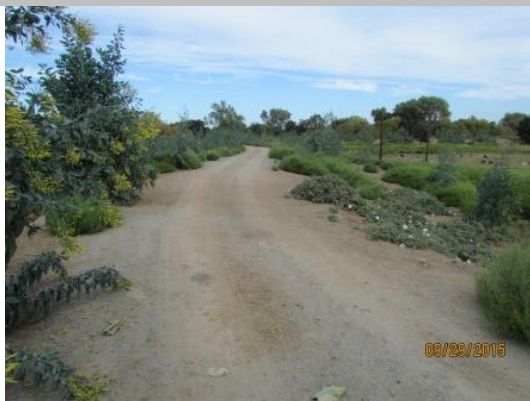
Photo 1 of 1 : SP_2020_RD2089_317_35_20200228_00030.jpg

View of the levee crown depression looking downstream.

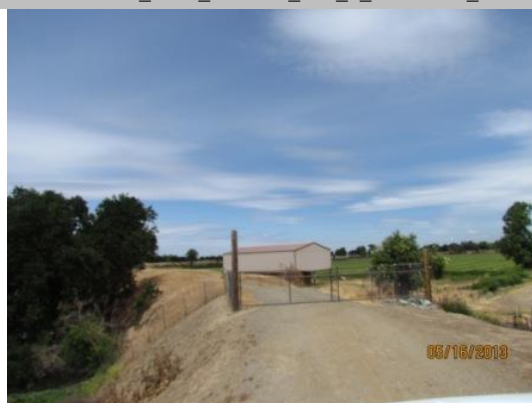
Photo 1 of 1 : SP_2020_RD2089_317_9_20200228_00008.jpg

View of the fence gate across levee crown.

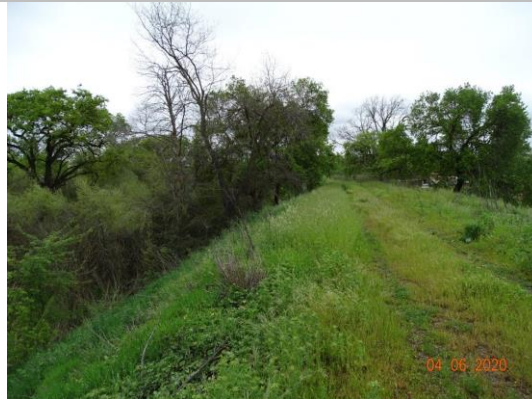
Photo 1 of 1 : SP_2020_RD2089_317_67_20200504_00082.jpg

View of overgrown vegetation on waterside slope. Spring 2020

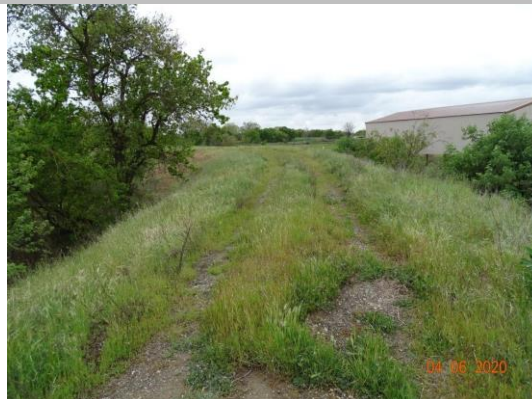
Photo 1 of 1 : SP_2020_RD2089_317_36_20200504_00081.jpg

View of overgrown vegetation on surface road. Spring 2020

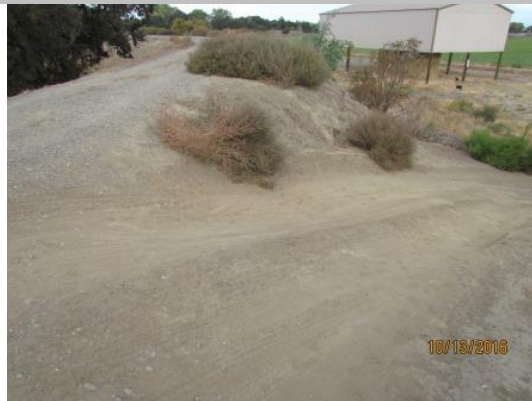
Photo 1 of 1 : SP_2020_RD2089_317_42_20200228_00039.jpg

View of the ramp on the landside levee slope.

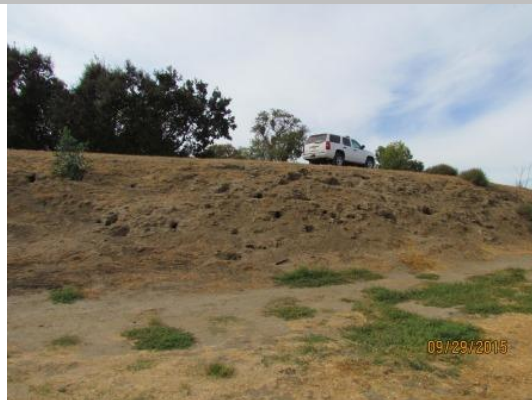
Photo 1 of 1 : SP_2020_RD2089_317_40_20200228_00037.jpg

View of the multiple rodent holes on the landside levee slope.

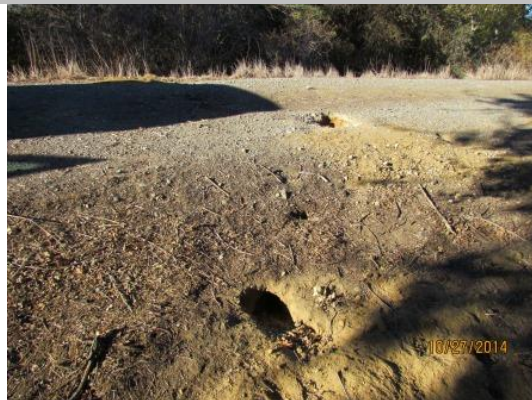
Photo 1 of 1 : SP_2020_RD2089_317_12_20200228_00012.jpg

View of several rodent burrows on landside levee hinge and crown.

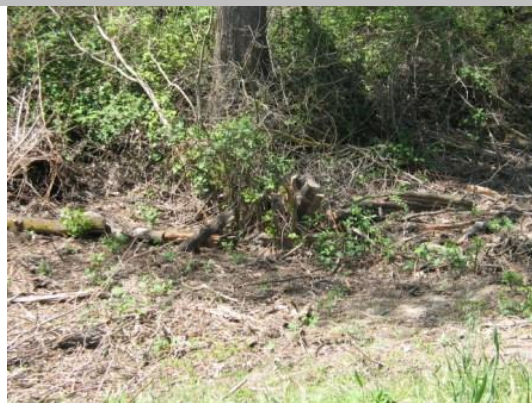
Photo 1 of 1 : SP_2020_RD2089_317_29_20200228_00027.jpg

View of tree stump left after vegetation and tree removal.

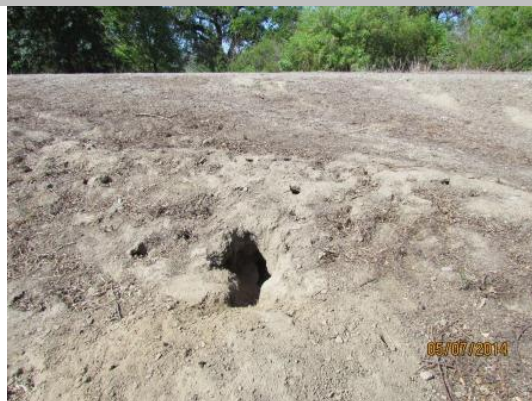
Photo 1 of 1 : SP_2020_RD2089_317_6_20200228_00006.jpg

View of the large rodent hole on the landside levee slope.

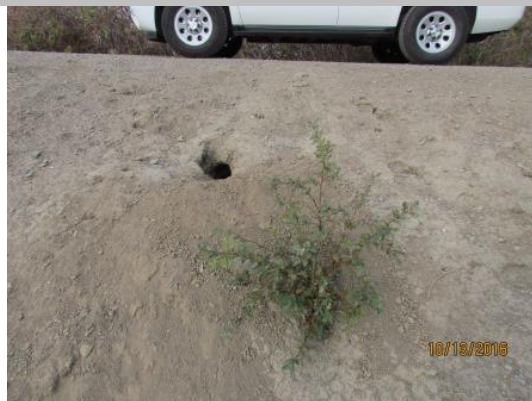
Photo 1 of 1 : SP_2020_RD2089_317_28_20200228_00026.jpg

View of the rodent burrow in the landside levee slope.

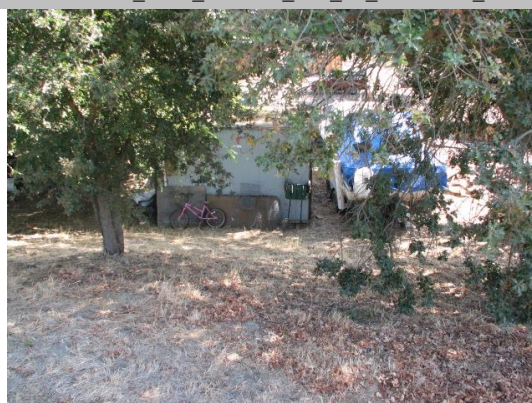
Photo 1 of 1 : SP_2020_RD2089_317_23_20200228_00020.jpg

View of buildings and patio decks within 10-ft of the levee slope. Fall 2009

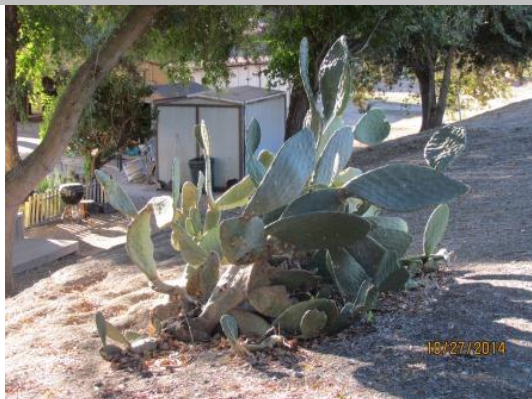
Photo 1 of 1 : SP_2020_RD2089_317_57_20200228_00061.jpg

View of the cactus on the crown at the landside levee shoulder.

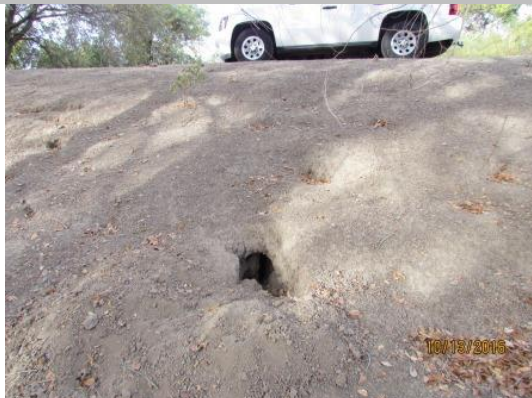
Photo 1 of 1 : SP_2020_RD2089_317_19_20200228_00019.jpg

View of the rodent burrow in the landside levee slope.

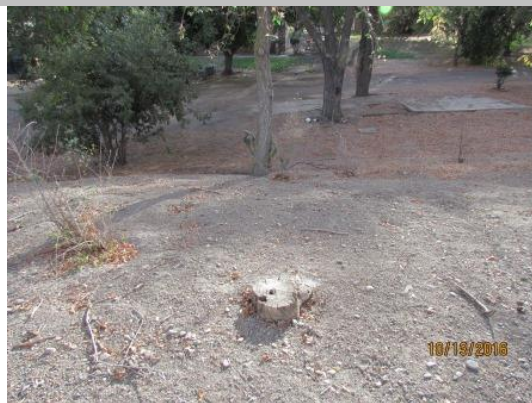
Photo 1 of 1 : SP_2020_RD2089_317_18_20200228_00018.jpg

View of the tree stump from the levee crown.

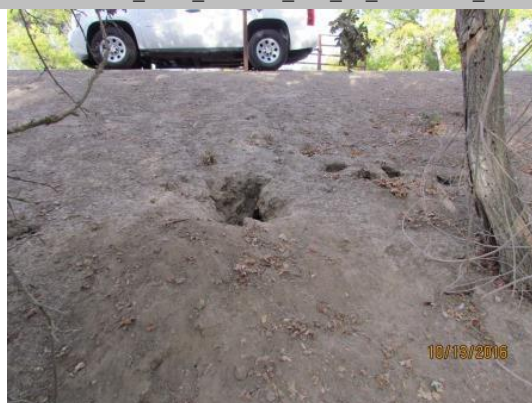
Photo 1 of 1 : SP_2020_RD2089_317_16_20200228_00016.jpg

View of the rodent burrow in the landside levee slope.

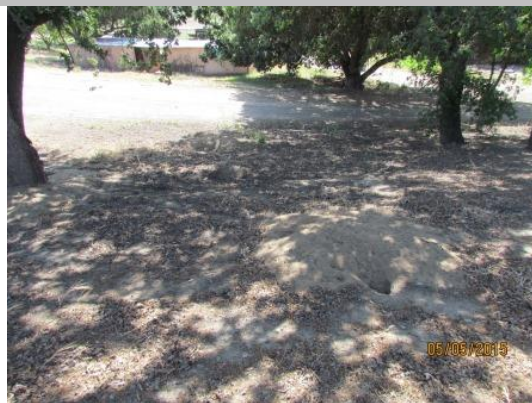
Photo 1 of 1 : SP_2020_RD2089_317_11_20200228_00010.jpg

View of the multiple rodent burrows on the landside levee slope.
