Flood Control Project Maintenance Levee Inspections LMA District Cover Sheet

Reclamation District No. 2089 Stark

Levee Inspection Report By Mile - Spring 2021

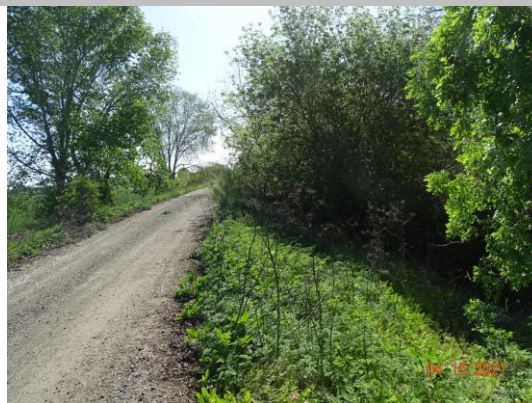
Photo 1 of 1 : SP_2021_RD2089_316_59_20210504_00044.jpg

LM Start	0.02	Rating **	U	Issue No.	59
LM End	0.59	Issue Type +	Ma	Location *	WS
Category	Earthen Levee			GPS Latitude/Longitude	
				Start	End
Item	Vegetation			37.811578 °	37.810255 °
				-121.385272 °	-121.394940 °
DWR ID	DWR_RD2089_01_s_2021_59				
Comment Code					
V2 : Remove the wild growth other than native grasses from the levee slopes.					
Inspector Comment

View of wild growth vegetation along the waterside slope. Spring 2021

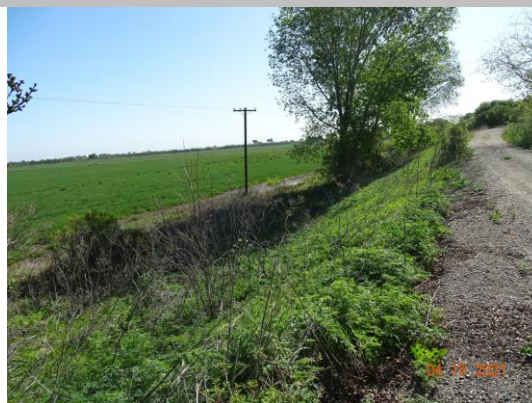
Photo 1 of 1 : SP_2021_RD2089_316_58_20210504_00043.jpg

LM Start	0.02	Rating **	U	Issue No.	58
LM End	0.59	Issue Type +	Ma	Location *	LS
Category	Earthen Levee			GPS Latitude/Longitude	
				Start	End
Item	Vegetation			37.811578 °	37.810241 °
				-121.385272 °	-121.394960 °
DWR ID	DWR_RD2089_01_s_2021_58				
Comment Code					
V2 : Remove the wild growth other than native grasses from the levee slopes.					
Inspector Comment

View of wild growth vegetation along the landside slope and easement. Spring 2021

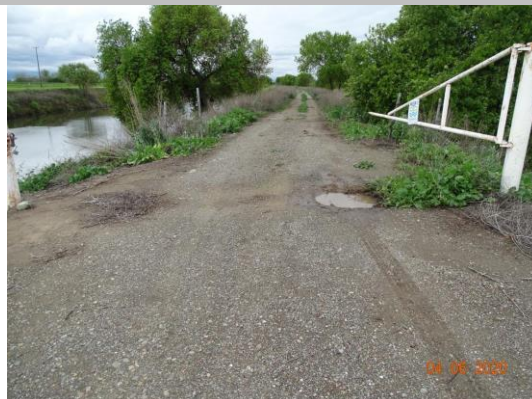
Photo 1 of 1 : SP_2021_RD2089_316_12_20210210_00008.jpg

LM Start	0.02	Rating **	M	Issue No.	12
LM End	0.02	Issue Type +	Ma	Location *	CR
Category	Earthen Levee			GPS Latitude/Longitude	
				Start	End
Item	Crown Surface / Depressions / Rutting			37.811537 °	37.811537 °
				-121.385354 °	-121.385354 °
DWR ID	DWR_RD2089_01_s_2019_12				
Comment Code					
C2 : Repair depressions or ruts in the crown or slope.					
Inspector Comment

View of depression on surface road near landside hinge. Spring 2020

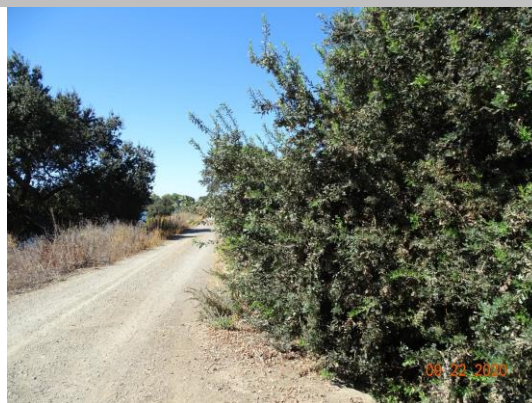
Photo 1 of 1 : SP_2021_RD2089_316_18_20210210_00013.jpg

LM Start	0.03	Rating **	U	Issue No.	18
LM End	0.03	Issue Type +	Ma	Location *	LS
Category	Earthen Levee			GPS Latitude/Longitude	
				Start	End
Item	Trim / Thin Trees			37.811518 °	37.811518 °
				-121.385430 °	-121.385430 °
DWR ID	DWR_RD2089_01_f_2018_18				
Comment Code					
T3 : Trim and thin trees to allow visibility of the ground and room to flood fight.					
Inspector Comment

View of untrimmed tree on landside slope. Fall 2020

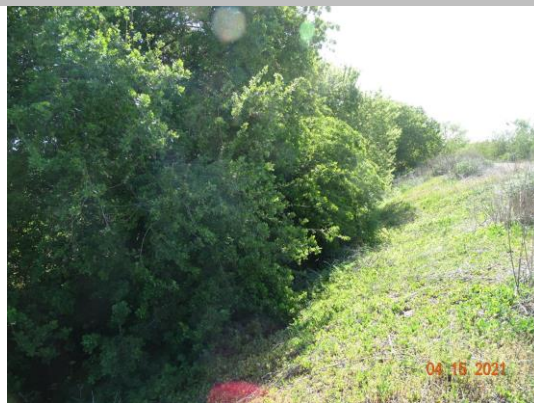
Photo 1 of 1 : SP_2021_RD2089_316_23_20210504_00045.jpg

View of untrimmed trees along the landside slope. Spring 2021

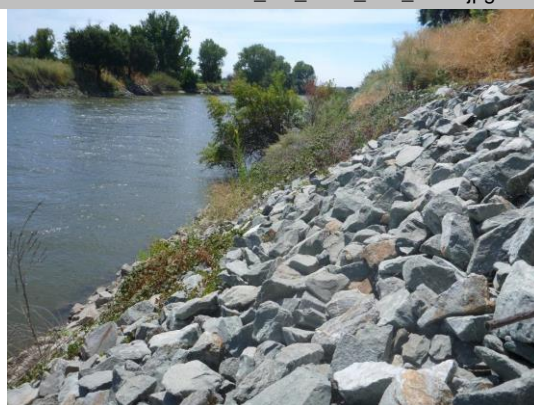
Photo 1 of 1 : LEVAL_SP_2021_513_4443.jpg

LM Start	0.26	Rating **	A/W	Issue No.	13
LM End	0.27	Issue Type +	Ma	Location *	WS
Category	Earthen Levee			GPS Latitude/Longitude	
				Start	End
Item	Erosion / Bank Caving			37.810300 °	37.810300 °
				-121.389300 °	-121.389500 °
DWR ID	LMA-419				
Comment Code					
E1 : Note and monitor erosion site.					
Inspector Comment					
2017 Storm Damage Site, ID No. 513, LMA 419. Slope protection repairs are needed along the waterside slope due to erosion and riprap displacement from high water.					
.

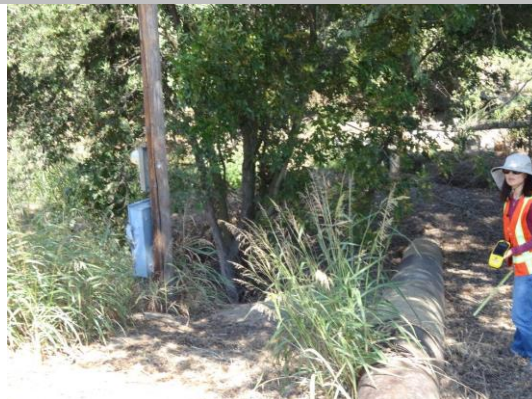
Photo 3 of 3 : UCIP_SP_2021_21635_36740.jpg

LS view: overview of exposed steel pipe (right) on levee slope and service pole (left).

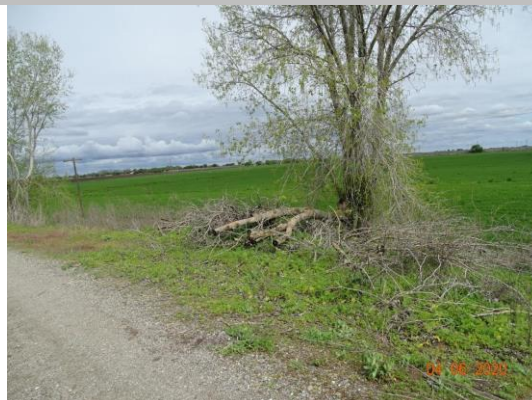
Photo 1 of 1 : SP_2021_RD2089_316_29_20210210_00018.jpg

View of downed tree limb on landside slope. Spring 2020

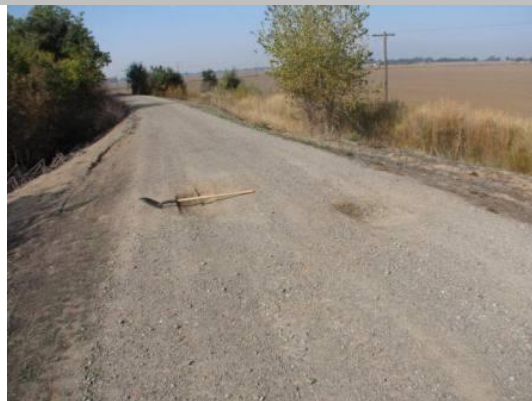
Photo 1 of 1 : SP_2021_RD2089_316_14_20210210_00010.jpg

11/10/2011 Depressions in crown.

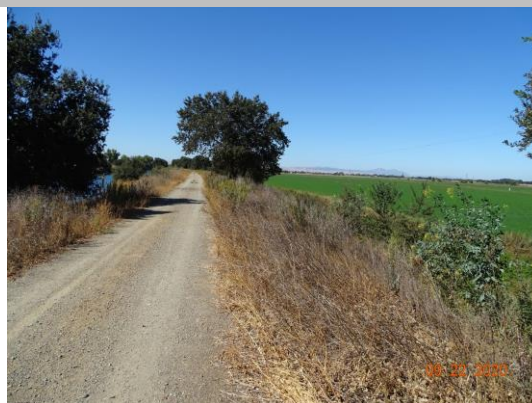
Photo 1 of 1 : SP_2021_RD2089_316_24_20210210_00016.jpg

Typical view of overgrown vegetation on landside slope. Fall 2020

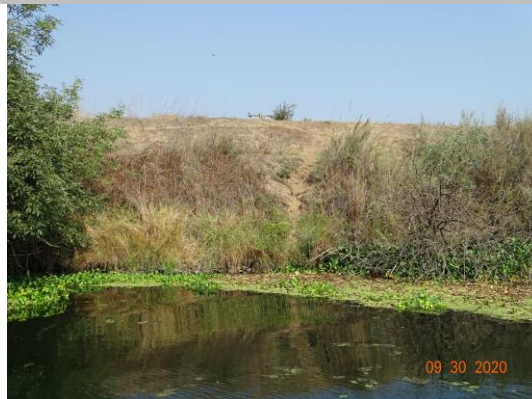
Photo 1 of 2 : SP_2021_RD2089_316_3_20210210_00003.jpg

08/14/2019: From 2012 to 2019, no significant changes were observed during the annual survey.

08/23/2011: The 5-foot vertical scarp shows no significant change from the last year inspection. No new erosion activities observed. Dense white willow trees on site.

09/07/2010: It was difficult to view the erosion due to the thick Willow thickets and other vegetation at the water line. At the time of the inspection, there were no signs of repair on site. As noted during the last survey, there is a 5-foot vertical scarp along the lower slope that may be subjected to high flow velocities.

09/28/2009: No major change observed; 5-foot vertical scarp is immediately downstream of where berm has tapered; site is recommended as local maintenance issue, per CLRO CES Evaluation 2008 Report; Site # is the same as RM29.6, LM0.60; previously rated "U".

9/30/2020: Front view of the eroded slope.

08/05/2010: Recommended for repair, per CLRO; "Erosion of this site may be subjective to rapid rates of erosion."

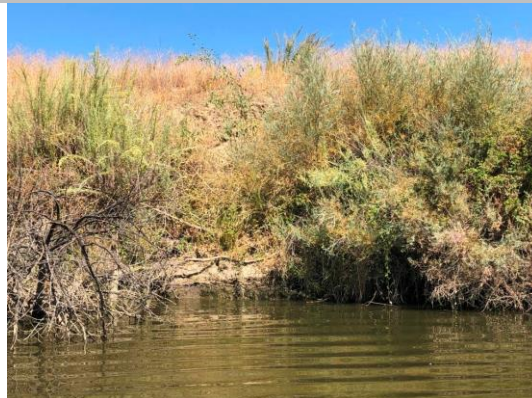
Photo 2 of 2 : SP_2021_RD2089_316_3_20210210_00004.jpg

8/14/2019: Front view of the site. Note the very dense white willow thickets on site.

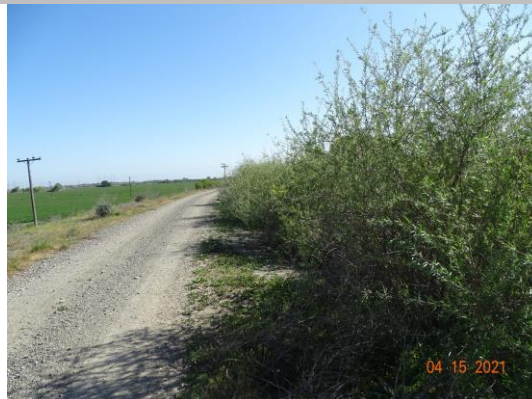
Photo 1 of 1 : SP_2021_RD2089_316_57_20210504_00042.jpg

View of wild growth vegetation along the landside slope. Spring 2021

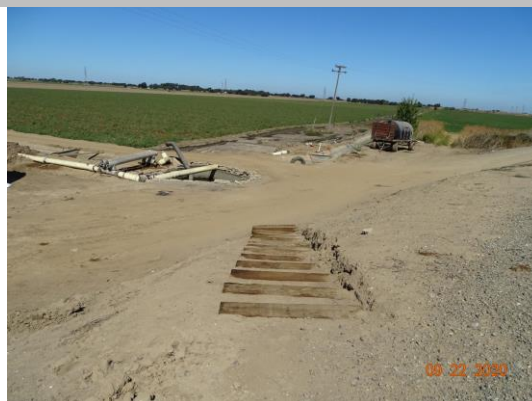
Photo 1 of 1 : SP_2021_RD2089_316_22_20210210_00014.jpg

View of steps on landside slope. Fall 2020

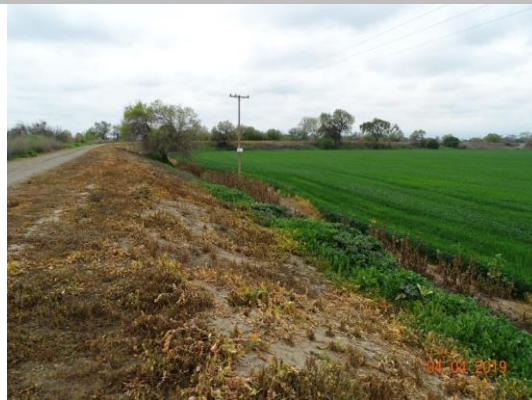
Photo 1 of 1 : SP_2021_RD2089_316_27_20210210_00017.jpg

View of vegetation on landside slope. (spring 2019)

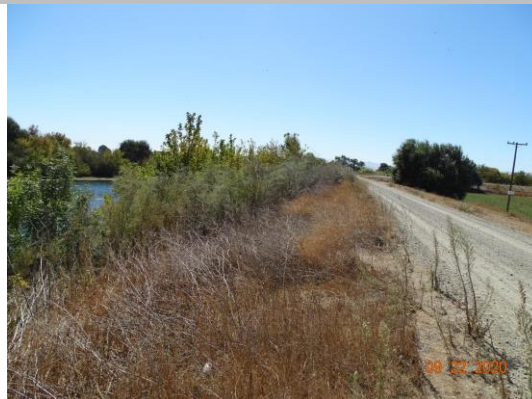
Photo 1 of 1 : SP_2021_RD2089_316_54_20210210_00023.jpg

Typical view of overgrown vegetation on waterside slope. Fall 2020

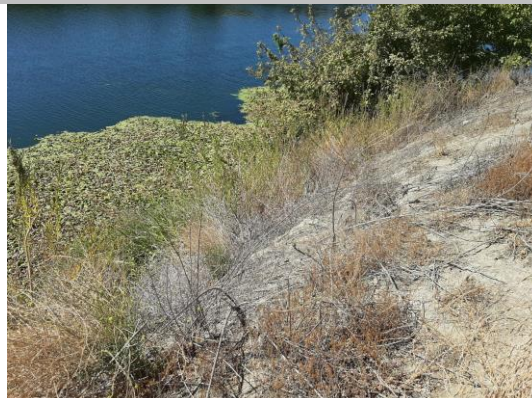
Photo 2 of 2 : SP_2021_RD2089_316_5_20210210_00006.jpg

9/22/2020: The erosion is visible on the lower levee slope.

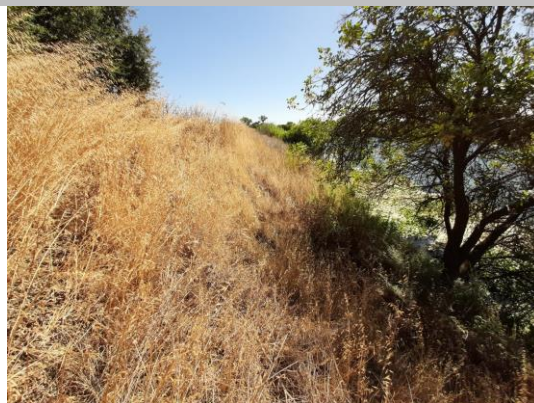
Photo 1 of 2 : SP_2021_RD2089_316_2_20210210_00001.jpg

LM Start	1.22	Rating **	U	Issue No.	2
LM End	1.23	Issue Type +	Ma	Location *	WS
Category	Supplemental			GPS Latitude/Longitude	
				Start	End
Item	DWR Erosion Survey			37.805800 °	37.805800 °
				-121.402868 °	-121.402868 °
DWR ID	RD2089U01RM29.04				
Comment Code					
Inspector Comment					
Site ID: RD2089U01RM29.04					
9/22/2020: From 2014 to present, no significant changes were observed during the annual survey. Noticed signs of burrowing activity.					
08/13/2013: The erosion is around a tree at the levee toe. Dense vegetation is visible.

9/22/2020: View of the erosion around the tree looking upstream. Despite the dense vegetation, the scarp above the tree is visible.

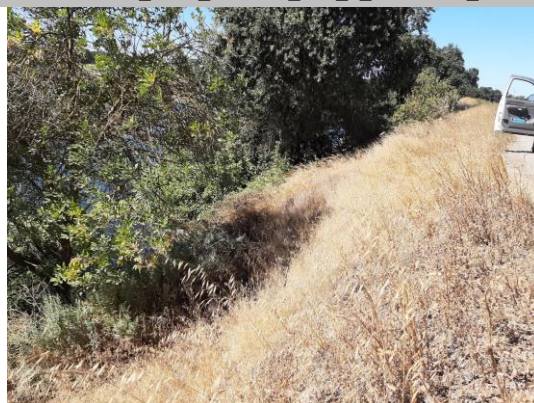
Photo 2 of 2 : SP_2021_RD2089_316_2_20210210_00002.jpg

9/22/2020: View of the erosion looking downstream.

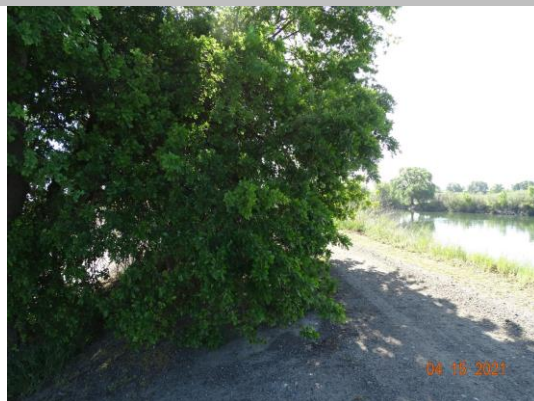
Photo 1 of 1 : SP_2021_RD2089_316_42_20210504_00041.jpg

View of an untrimmed tree on the landside slope. Spring 2021

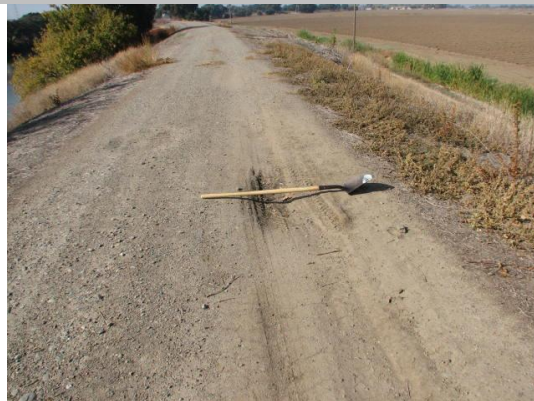
Photo 1 of 1 : SP_2021_RD2089_316_44_20210210_00019.jpg

View of roadway depression. 11/10/2011

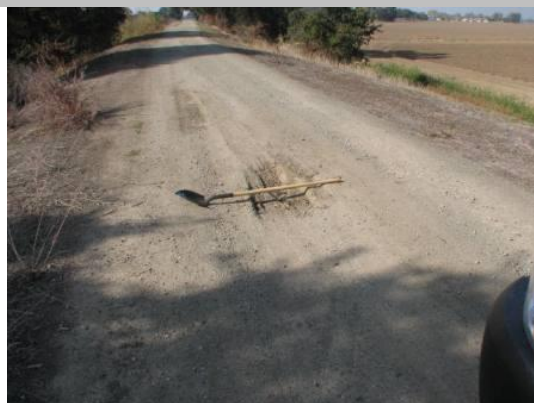
Photo 1 of 1 : SP_2021_RD2089_316_45_20210210_00020.jpg

View of roadway depression. 11/10/2011

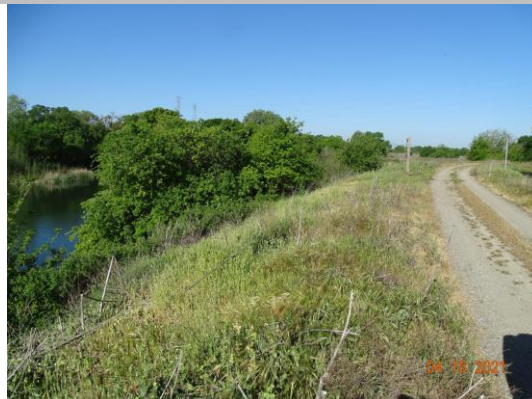
Photo 1 of 1 : SP_2021_RD2089_316_31_20210504_00040.jpg

View of vegetation along the waterside slope. Spring 2021

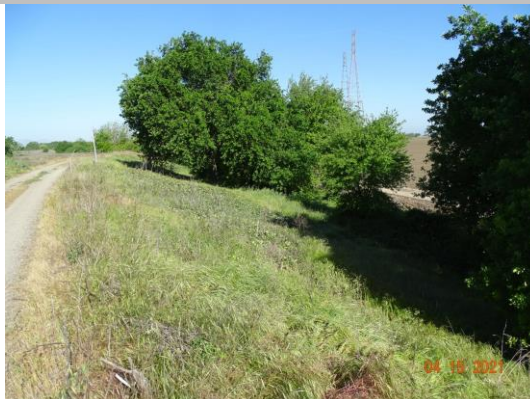
Photo 1 of 1 : SP_2021_RD2089_316_11_20210504_00039.jpg

View of vegetation along the landside slope and easement. Spring 2021

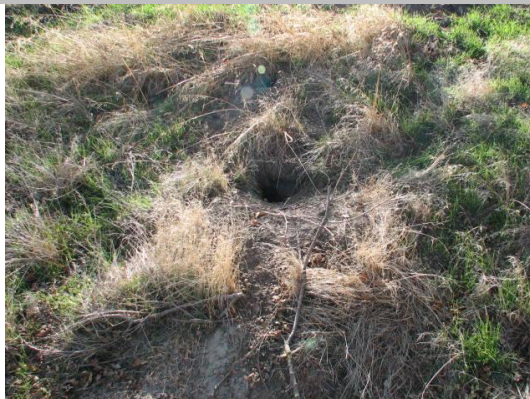
Photo 1 of 1 : SP_2021_RD2089_316_47_20210210_00021.jpg

View of active rodent burrow on landside slope. 11/10/2011

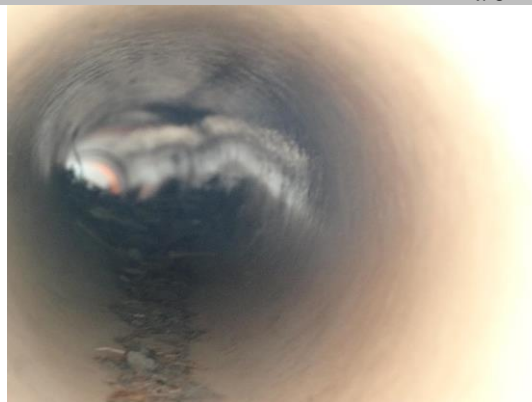
Photo 2 of 3 : UCIP_SP_2021_53379_36610.jpg

WS view: inside view of pvc pipe. Sediments found inside the pipe.

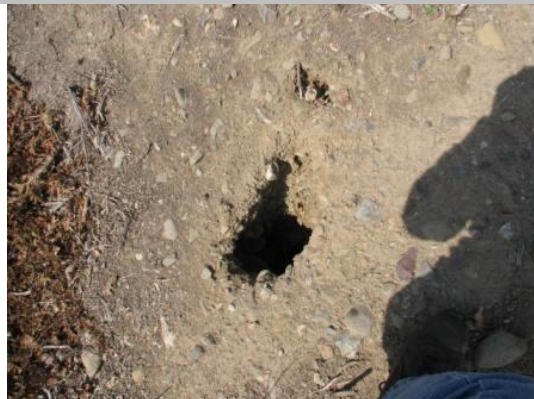
Photo 1 of 1 : SP_2021_RD2089_316_49_20210210_00022.jpg

View of deep burrow on waterside. 11/10/2011

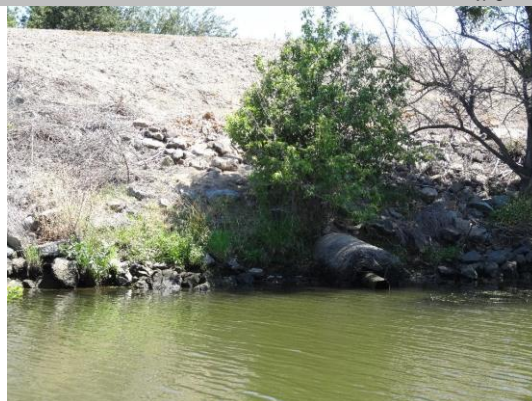
Photo 1 of 3 : UCIP_SP_2021_53182_74506.jpg

FS_ID:53182
DS_ID:23046
EP_NO: N/A
Repair Type: Non-Urgent
Crossing Status: Found
UCIP Comments: 10/12/2018 Same as last inspection; downgrading to Non-Urgent due to no visual pipe or levee threat (D. Sanoski - DWR UCIP).11/15/2016 Pipe found on WS only. Same as last inspection. (K. Fazel - UCIP)06/25/2015 Crossing appears abandoned; if so, should be done so properly. Pipe open on WS. Holes and cracks visible on pipe. (K. Fazel - UCIP)
FIELD_STRUCT_DESC: *ABANDONED* 12-inch reinforced concrete pipe of an unknown purpose possibly through the levee, approximately 8 feet below the crown. Smaller steel pipe sleeved through the 12-inch pipe with annular space grouted. Pipe does not cross channel and may not cross levee. May be related to the gas line crossing with DS ID 25121. Discovered from boat on 2015 DWR Erosion Survey.
FS Date: 10/12/2018 5:22:43 PM

View up WS slope from water. Pipe does not cross channel.

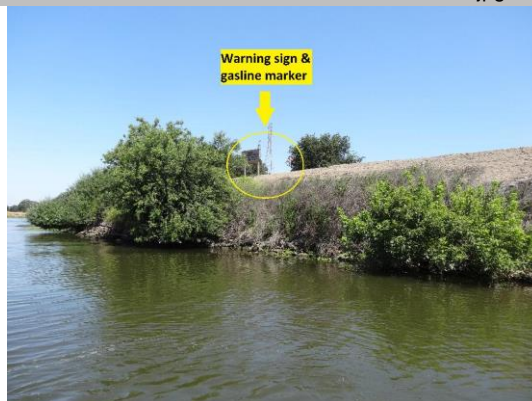
Photo 2 of 3 : UCIP_SP_2021_53182_74508.jpg

Gasline marker (for crossing with DS ID 25121) appr. 100 ft west of crossing.

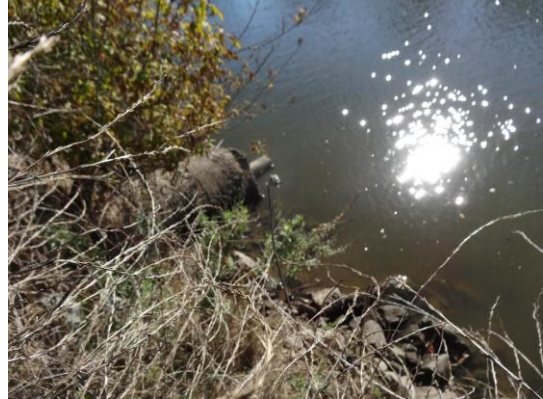
Photo 3 of 3 : UCIP_SP_2021_53182_76207.jpg

WS view of pipe

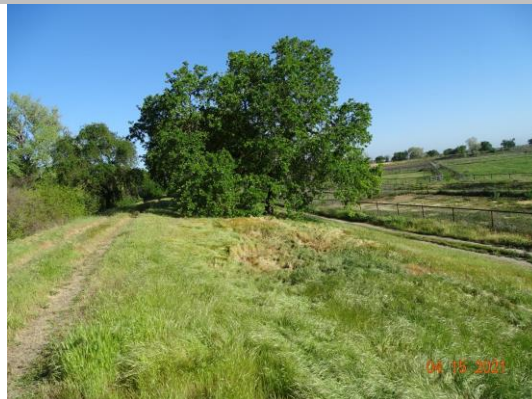
Photo 1 of 1 : SP_2021_RD2089_317_10_20210504_00040.jpg

View of vegetation on the landside slope and easement. Spring 2021

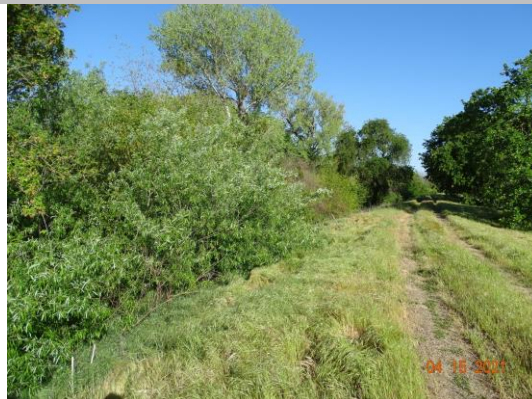
Photo 1 of 1 : SP_2021_RD2089_317_13_20210504_00042.jpg

View of vegetation along the waterside slope. Spring 2021

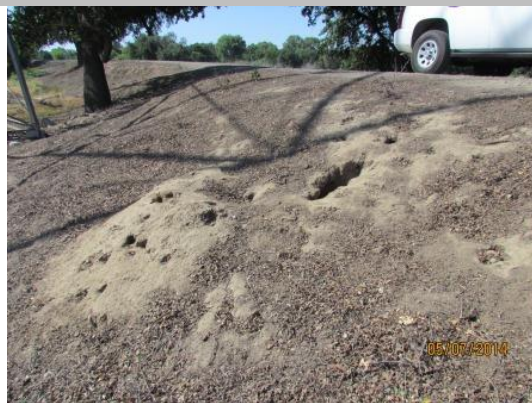
Photo 1 of 1 : SP_2021_RD2089_317_48_20210210_00026.jpg

View of the rodent burrow on the landside levee slope.

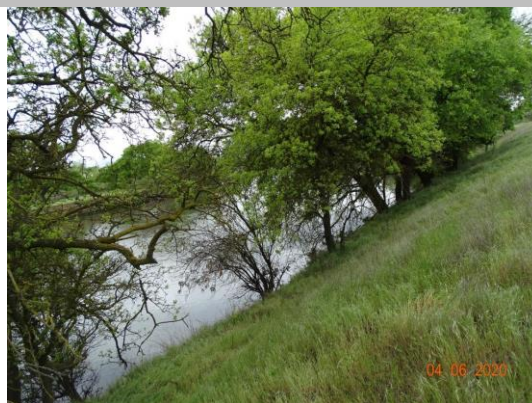
Photo 1 of 1 : SP_2021_RD2089_317_46_20210210_00024.jpg

View of erosion site on waterside slope. Spring 2020

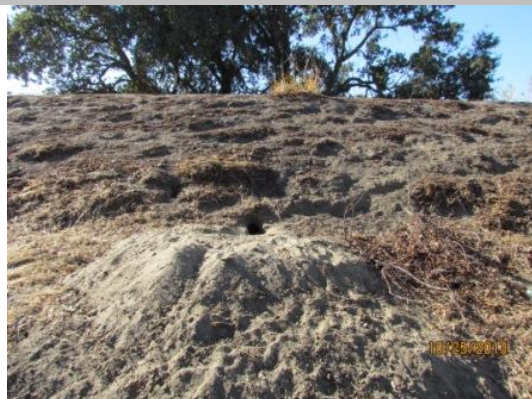
Photo 1 of 1 : SP_2021_RD2089_317_53_20210210_00028.jpg

View of the rodent burrow on the landside levee slope.

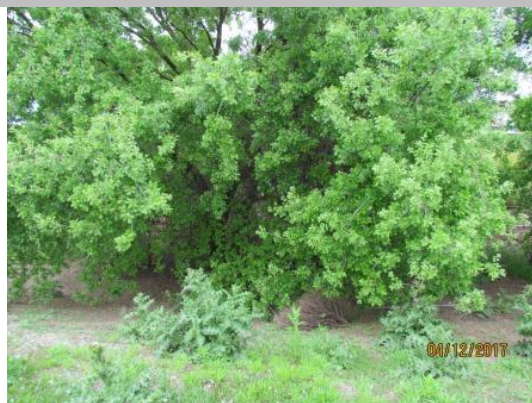
Photo 1 of 1 : SP_2021_RD2089_317_55_20210210_00030.jpg

LM Start	0.34	Rating **	M	Issue No.	55
LM End	0.34	Issue Type +	Ma	Location *	LS
Category	Earthen Levee			GPS Latitude/Longitude	
				Start	End
Item	Trim / Thin Trees			37.810052 °	37.810052 °
				-121.411966 °	-121.411966 °
DWR ID	DWR_RD2089_02_s_2017_55				
Comment Code					
T3 : Trim and thin trees to allow visibility of the ground and room to flood fight.					
Inspector Comment

View of the overgrown tree on the levee slope.

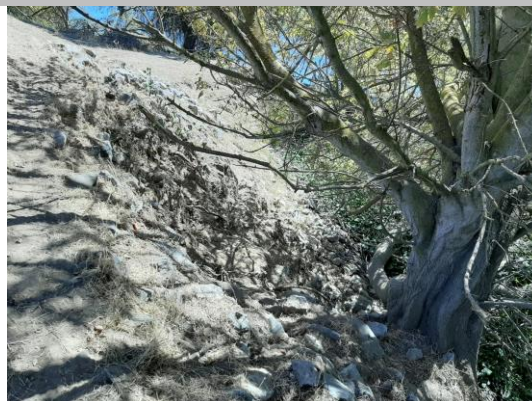
Photo 1 of 2 : SP_2021_RD2089_317_1_20210210_00001.jpg

9/22/2020: View of the erosion and scattered riprap on the levee slope.

08/05/2010: Recommended for repair, per CLRO.

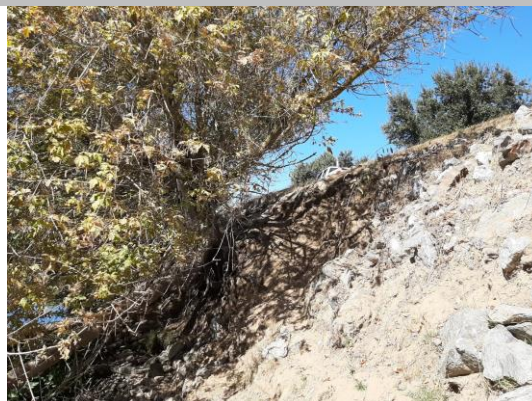
Photo 2 of 2 : SP_2021_RD2089_317_1_20210210_00002.jpg

9/22/2020: Close-up view of the eroded levee slope.

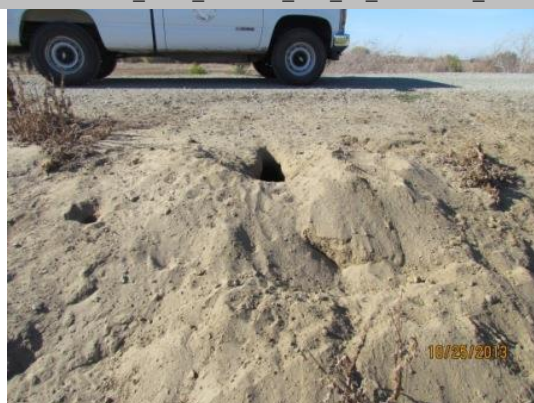
Photo 1 of 1 : SP_2021_RD2089_317_54_20210210_00029.jpg

View of the rodent burrow on the landside levee slope.

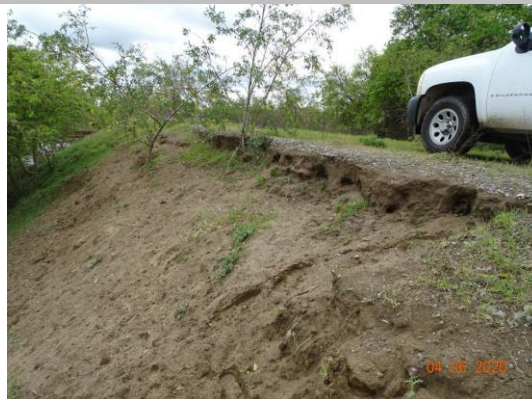
Photo 1 of 1 : SP_2021_RD2089_317_14_20210210_00011.jpg

View of the approximately 1' scarp that has been created by livestock. Spring 2020

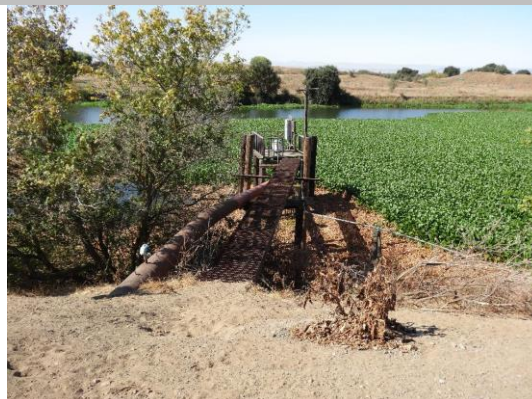
Photo 1 of 3 : UCIP_SP_2021_21676_36861.jpg

WS view: pipe and pump on piling strucure in water channel.

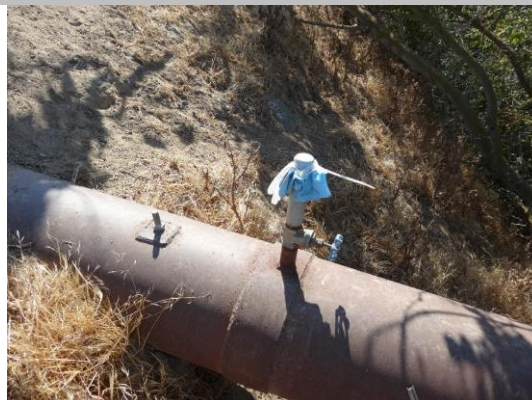
Photo 2 of 3 : UCIP_SP_2021_21676_36860.jpg

WS view: air relief valve on pipe. Pipe exposed in levee slope.

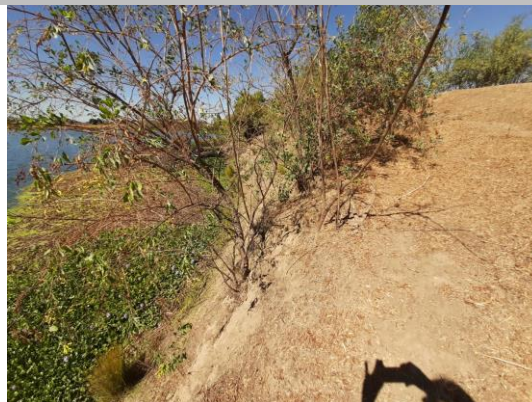
Photo 1 of 2 : SP_2021_RD2089_317_3_20210210_00004.jpg

9/22/2020: View of the vertical cut on the river bank looking downstream.

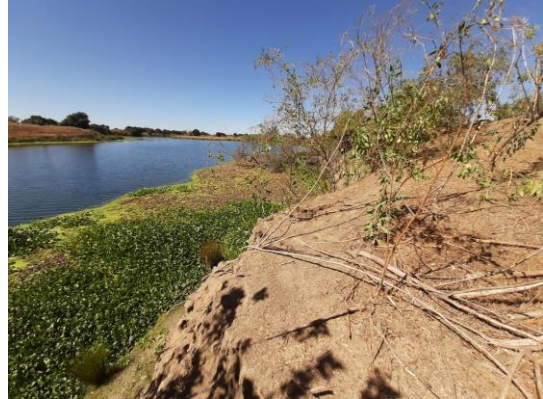
Photo 2 of 2 : SP_2021_RD2089_317_3_20210210_00005.jpg

9/22/2020: View of the bank erosion further upstream.

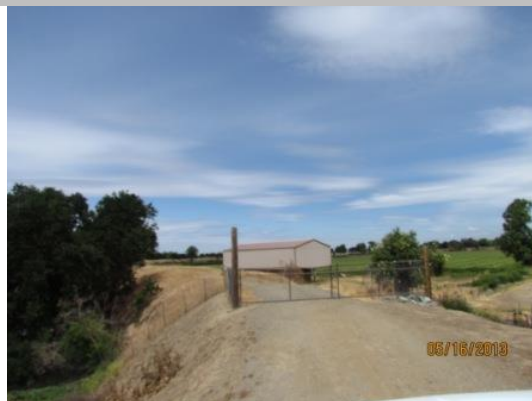
Photo 1 of 1 : SP_2021_RD2089_317_9_20210210_00008.jpg

View of the fence gate across levee crown.

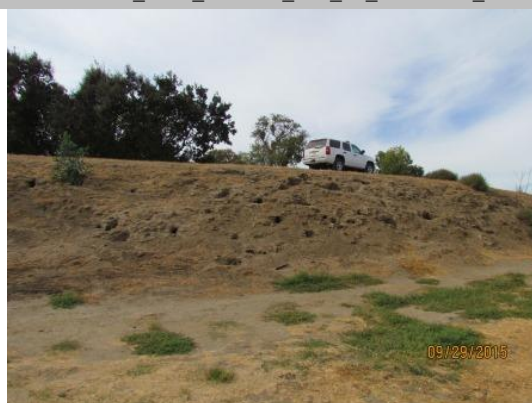
Photo 1 of 1 : SP_2021_RD2089_317_40_20210210_00023.jpg

View of the multiple rodent holes on the landside levee slope.

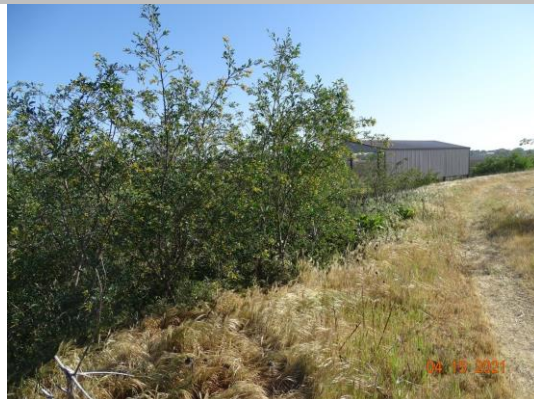
Photo 1 of 1 : SP_2021_RD2089_317_56_20210504_00043.jpg

View of an untrimmed tree on the landside slope. Spring 2021

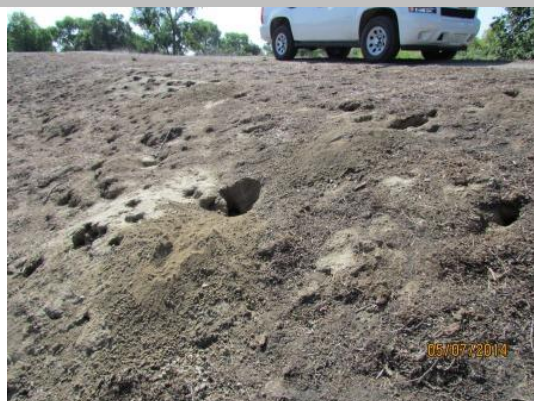
Photo 1 of 1 : SP_2021_RD2089_317_5_20210210_00006.jpg

View of the rodent holes on the landside levee slope.

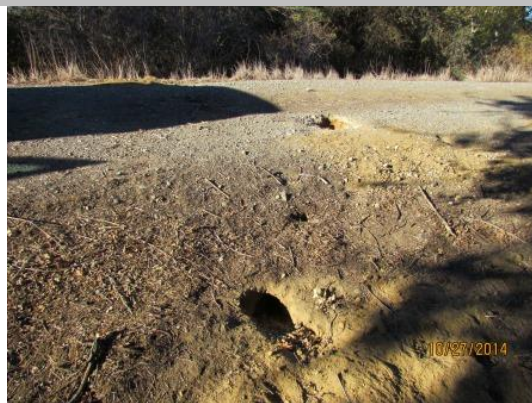
Photo 1 of 1 : SP_2021_RD2089_317_12_20210210_00010.jpg

View of several rodent burrows on landside levee hinge and crown.

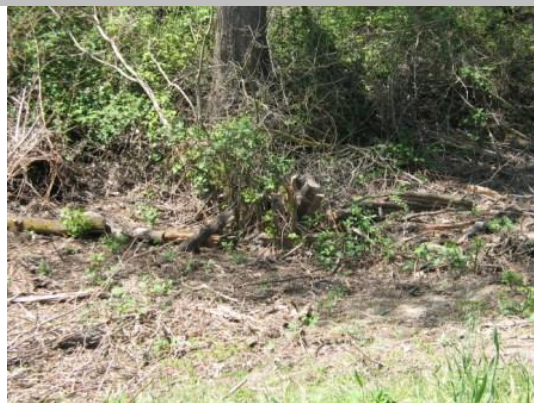
Photo 1 of 1 : SP_2021_RD2089_317_29_20210210_00021.jpg

View of tree stump left after vegetation and tree removal.

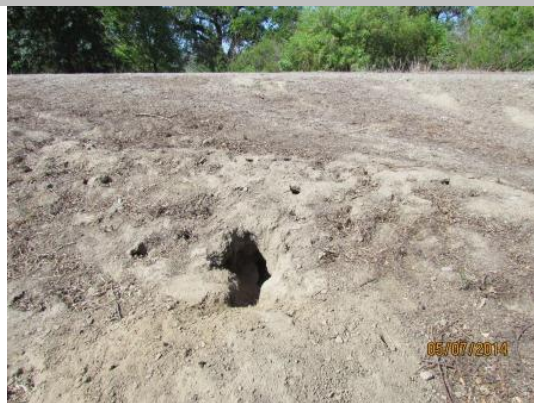
Photo 1 of 1 : SP_2021_RD2089_317_6_20210210_00007.jpg

View of the large rodent hole on the landside levee slope.

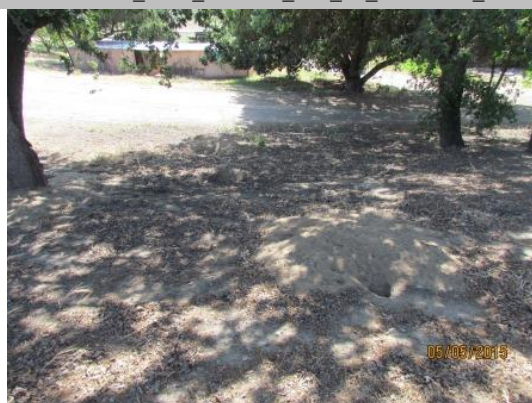
Photo 1 of 1 : SP_2021_RD2089_317_11_20210210_00009.jpg

View of the multiple rodent burrows on the landside levee slope.
