**Flood Control Project Maintenance  
Levee Inspections  
LMA District Cover Sheet**

**Reclamation District No. 2089 Stark**

Waterway	Bank	Unit Miles
Unit No. 01 Old River	Right	1.51

**Levee Inspection Report By Mile - Spring 2022**

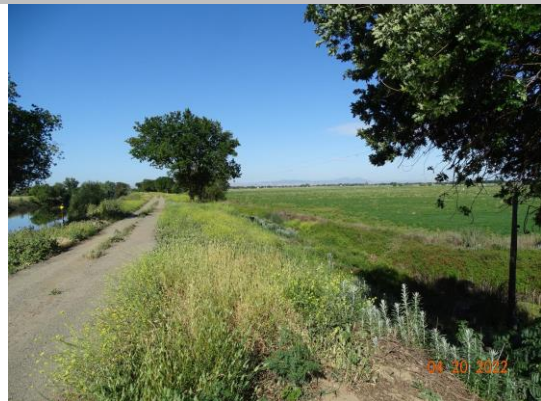
Photo 1 of 1 : SP\_2022\_RD2089\_316\_58\_20220421\_00038.jpg

LM Start	0.02	Rating **	U	Issue No.	58
LM End	0.75	Issue Type +	Ma	Location *	LS
Category	Earthen Levee			GPS Latitude/Longitude	
				Start	End
Item	Vegetation			37.811578 °	37.809091 °
				-121.385272 °	-121.397409 °
DWR ID	DWR_RD2089_01_s_2021_58				
Comment Code					
V1 : Control annual grass and weeds on the levee slopes and easements.					
Inspector Comment

View of vegetation along the landside slope and easement. Spring 2022

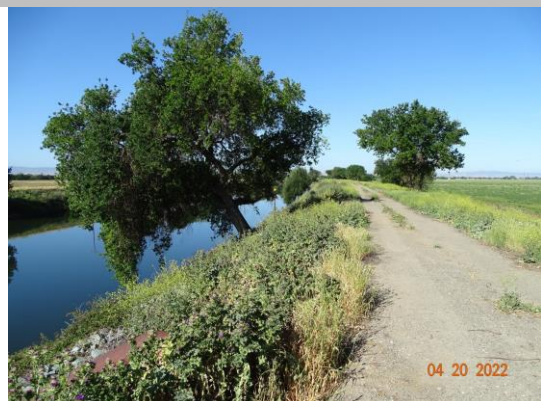
Photo 1 of 1 : SP\_2022\_RD2089\_316\_59\_20220421\_00037.jpg

LM Start	0.02	Rating **	U	Issue No.	59
LM End	0.75	Issue Type +	Ma	Location *	WS
Category	Earthen Levee			GPS Latitude/Longitude	
				Start	End
Item	Vegetation			37.811578 °	37.809091 °
				-121.385272 °	-121.397409 °
DWR ID	DWR_RD2089_01_s_2021_59				
Comment Code					
V1 : Control annual grass and weeds on the levee slopes and easements.					
Inspector Comment

View of vegetation along the waterside slope. Spring 2022

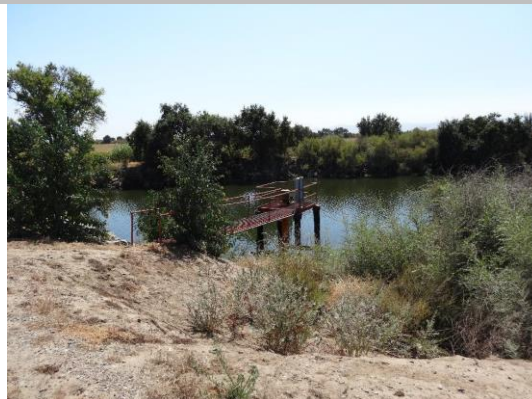
Photo 1 of 3 : UCIP\_SP\_2022\_21635\_36742.jpg

Comment Code						
Inspector Comment						
FS_ID:21635 DS_ID:23042 EP_NO: 5641 Repair Type: Non-Urgent Crossing Status: Found UCIP Comments: - damaged siphon breaker.- most of the pipe on landside exposed on levee slope. FIELD_STRUCT_DESC: 20-inch steel irrigation discharge pipe and electrical conduit through the levee, 5.8 feet below the crown. Pump on a pile structure in the stream. Siphon breaker on the landside (LS) slope. (Plans to replace a rusted out irrigation discharge pipe through the levee authorized under Permit No. 5641, 1967 - Theodore Stark). [Additional Reference(s): DWR Levee Log, 1991. USACE San Joaquin O&M Manual 8, 1968, (HLM 0.46), 21-inch pipe referenced]. FS Date: 9/12/2013

WS view: walkway to pump platform and pump on steel piling structure in the channel.

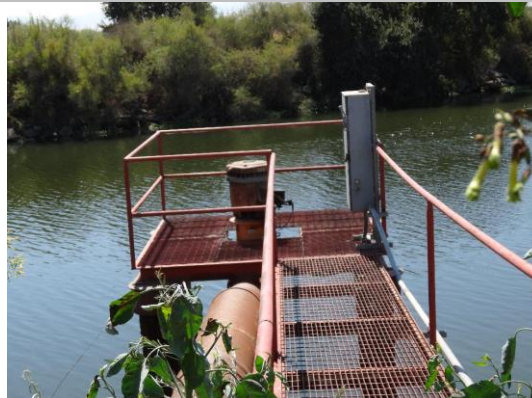
Photo 2 of 3 : UCIP\_SP\_2022\_21635\_36741.jpg

WS view: steel walkway, electric control box, and pump on steel piling structure in the channel.

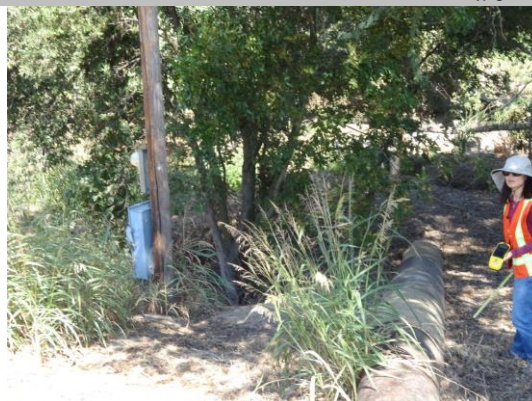
Photo 3 of 3 : UCIP\_SP\_2022\_21635\_36740.jpg

LS view: overview of exposed steel pipe (right) on levee slope and service pole (left).

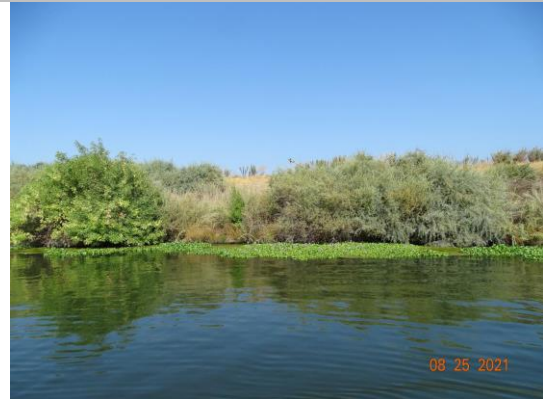
Photo 1 of 2 : SP\_2022\_RD2089\_316\_3\_20220406\_00003.jpg

Site ID: RD2089U01RM29.61  
 8/25/21: Less levee slope vegetation has exposed bank undercutting. Increased erosion length to 100 feet.  
 09/30/2020: Noticed less vegetation on the upper levee slope and surface erosion above the pocket erosion.  
 08/14/2019: From 2012 to 2019, no significant changes were observed during the annual survey.  
 08/23/2011: The 5-foot vertical scarp shows no significant change from the last year inspection. No new erosion activities observed. Dense white willow trees on site.  
 09/07/2010: It was difficult to view the erosion due to the thick Willow thickets and other vegetation at the water line. At the time of the inspection, there were no signs of repair on site. As noted during the last survey, there is a 5-foot vertical scarp along the lower slope that may be subjected to high flow velocities.  
 08/05/2010: Recommended for repair, per CLRO; "Erosion of this site may be subjective to rapid rates of erosion."

09/28/2009: No major change observed; 5-foot vertical scarp is immediately downstream of where berm has tapered; site is recommended as local maintenance issue, per CLRO CES Evaluation 2008 Report; Site # is the same as RM29.6, LM0.60; previously rated "U".  
 11/05/2008: No change observed; rodent holes on lower slope; wide levee crown.

8/25/2021: Front view of the eroded slope.

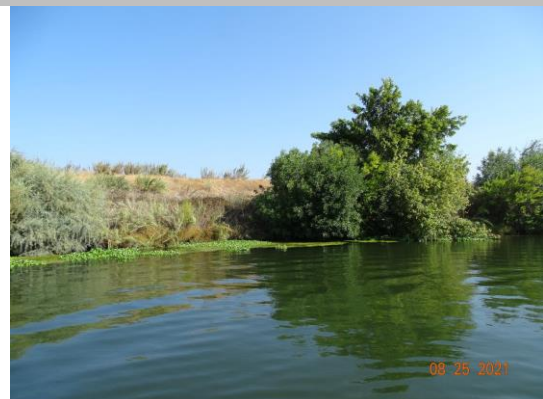
Photo 2 of 2 : SP\_2022\_RD2089\_316\_3\_20220406\_00004.jpg

8/25/2021: Front view of the site. Note the very dense white willow thickets on site.

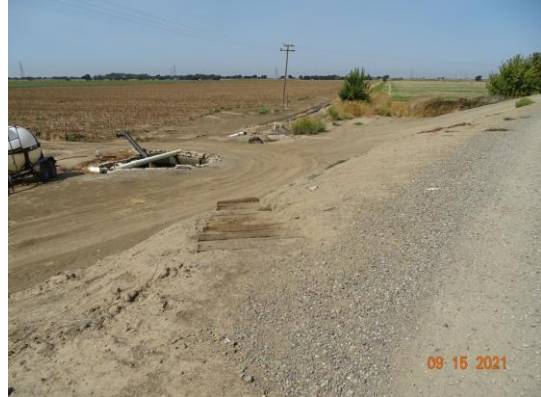
Photo 1 of 1 : SP\_2022\_RD2089\_316\_22\_20220406\_00013.jpg

View of steps on landside slope. Fall 2021

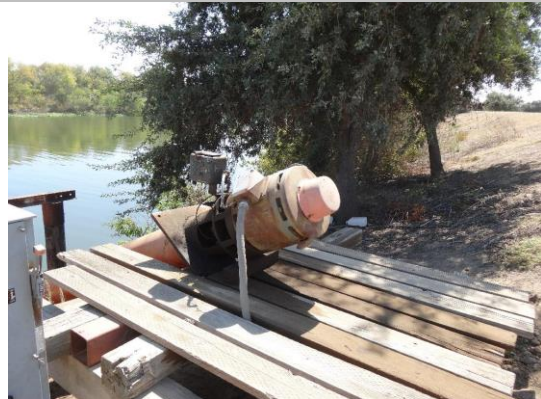
Photo 1 of 3 : UCIP\_SP\_2022\_21587\_36635.jpg

Comment Code						
Inspector Comment						
FS_ID:21587						
DS_ID:23043						
EP_NO: 3385						
Repair Type: Non-Urgent						
Crossing Status: Found						
UCIP Comments: - powerline on landside.- electric control box on waterside.- waterside slope erosion under pump platform.						
FIELD_STRUCT_DESC: 16-inch irrigation discharge pipe of an unknown material through the levee, 5.5 feet below the crown. Two cutoff walls. Slant pump in a pump house on the waterside (WS) slope. Siphon breaker on the landside (LS) slope. (Plans for installation of a pumping plant on the riverbank and a pipe that crosses the levee authorized under Permit No. 3385, 1960 - Eleanor M. Lawrence).						
[Additional Reference(s): DWR Levee Log, 1991. USACE San Joaquin O&M Manual 8, 1968, (HLM 0.81)].						
FS Date: 9/12/2013

WS view: slant pump on wooden platform. Oil leaks from the pump.

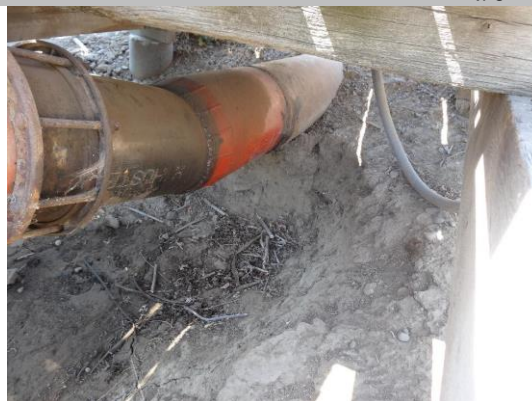
Photo 2 of 3 : UCIP\_SP\_2022\_21587\_36634.jpg

WS view: soil erosion under pump platform. Needs mitigation measures to stop erosion.

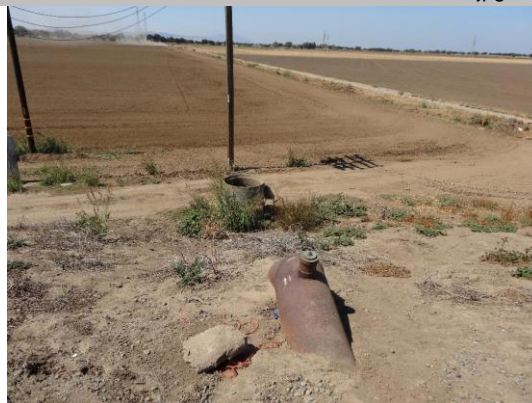
Photo 3 of 3 : UCIP\_SP\_2022\_21587\_36633.jpg

LS view: exposed pipe with siphon breaker on levee slope. Concrete standpipe on levee toe.

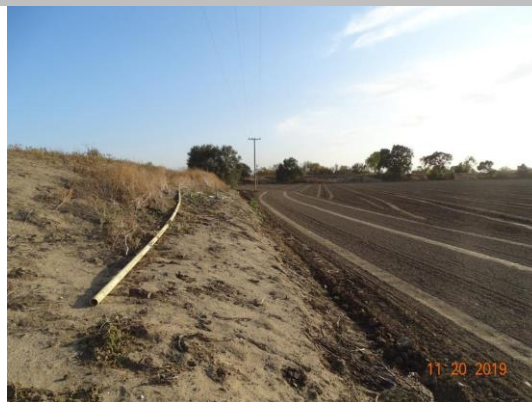
Photo 1 of 1 : SP\_2022\_RD2089\_316\_17\_20220406\_00010.jpg

LM Start	0.81	Rating **	M	Issue No.	17
LM End	0.94	Issue Type +	En	Location *	LS
Category	Earthen Levee			GPS Latitude/Longitude	
				Start	End
Item	Encroachments			37.808319 °	37.806453 °
				-121.397881 °	-121.397755 °
DWR ID	DWR_RD2089_01_f_2014_17				
Comment Code					
AT : Agricultural tilling					
Inspector Comment					
The landside levee toe is cut due to farming.

View of vertical cut along the landside toe. (Fall 2019)

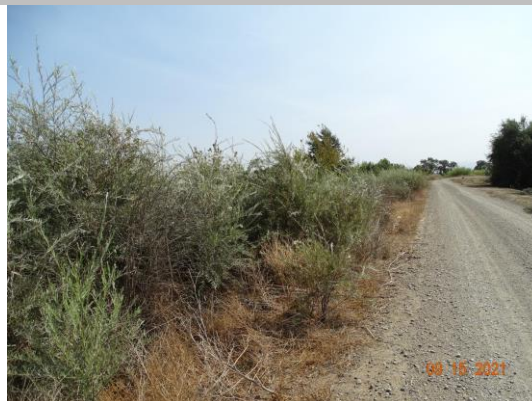
Photo 1 of 1 : SP\_2022\_RD2089\_316\_19\_20220406\_00012.jpg

View of overgrown vegetation along the waterside slope. Fall 2021

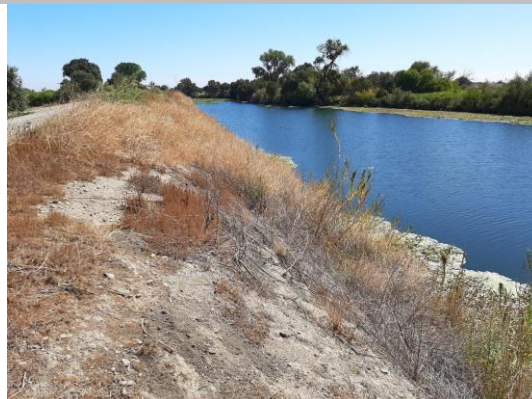
Photo 1 of 2 : SP\_2022\_RD2089\_316\_2\_20220406\_00001.jpg

9/22/2020: View of the eroded slope looking upstream with bare soil off the levee shoulder.

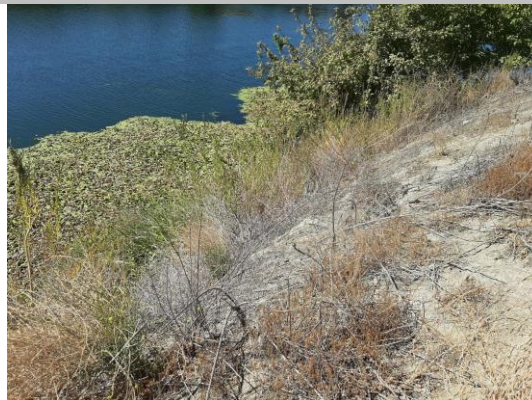
Photo 2 of 2 : SP\_2022\_RD2089\_316\_2\_20220406\_00002.jpg

9/22/2020: The erosion is visible on the lower levee slope.

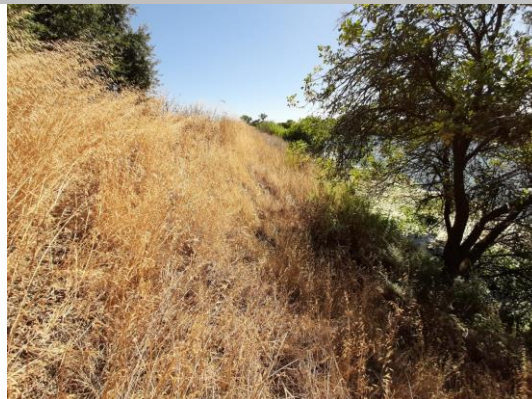
Photo 1 of 2 : SP\_2022\_RD2089\_316\_5\_20220406\_00005.jpg

LM Start	1.22	Rating **	U	Issue No.	5
LM End	1.23	Issue Type +	Ma	Location *	WS
Category	Supplemental			GPS Latitude/Longitude	
				Start	End
Item	DWR Erosion Survey			37.805800 °	37.805800 °
				-121.402868 °	-121.402868 °
DWR ID	RD2089U01RM29.04				
Comment Code					
Inspector Comment					
Site ID: RD2089U01RM29.04					
8/25/2021: Unable to perform the inspection due to dense vegetation on the land and water.					
9/22/2020: From 2014 to present, no significant changes were observed during the annual survey. Noticed signs of burrowing activity.					
08/13/2013: The erosion is around a tree at the levee toe. Dense vegetation is visible.

9/22/2020: View of the erosion around the tree looking upstream. Despite the dense vegetation, the scarp above the tree is visible.

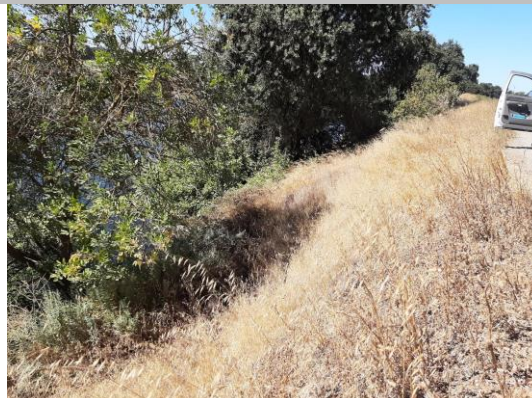
Photo 2 of 2 : SP\_2022\_RD2089\_316\_5\_20220406\_00006.jpg

9/22/2020: View of the erosion looking downstream.

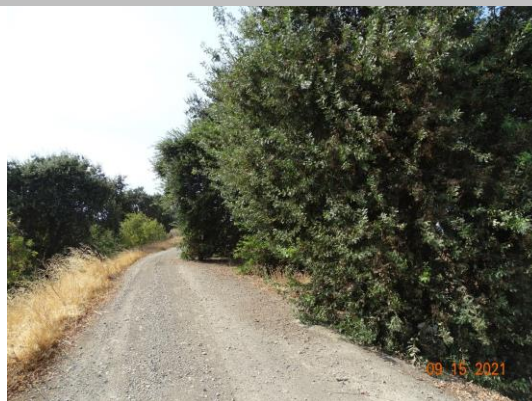
Photo 1 of 1 : SP\_2022\_RD2089\_316\_42\_20220406\_00016.jpg

View of an untrimmed tree on the landside slope. Fall 2021

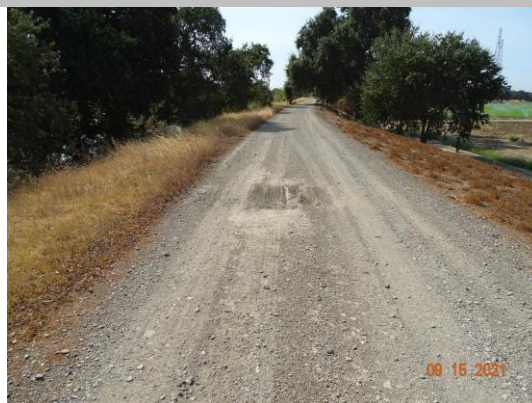
Photo 1 of 1 : SP\_2022\_RD2089\_316\_45\_20220406\_00018.jpg

LM Start	1.34	Rating **	M	Issue No.	45
LM End	1.34	Issue Type +	Ma	Location *	CR
Category	Earthen Levee			GPS Latitude/Longitude	
				Start	End
Item	Crown Surface / Depressions / Rutting			37.806128 °	37.806128 °
				-121.404890 °	-121.404890 °
DWR ID	DWR_RD2089_01_s_2012_45				
Comment Code					
C3 : Add appropriate gravel or road base. Grade and compact.					
Inspector Comment

View of roadway depression. Fall 2021

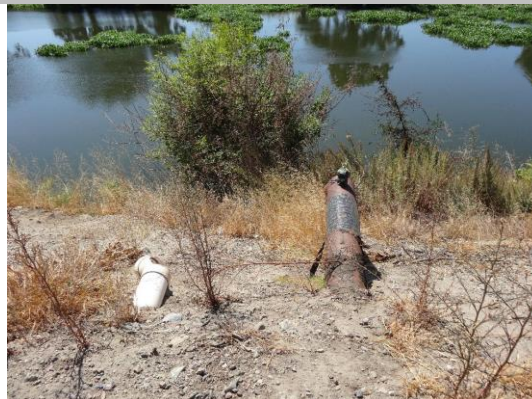
Photo 1 of 3 : UCIP\_SP\_2022\_53379\_36611.jpg

Comment Code						
Inspector Comment						
FS_ID:53379 DS_ID:24667 EP_NO: N/A Repair Type: Non-Urgent Crossing Status: Found UCIP Comments: 10/12/2018 Same as last inspection. Down grading to Non-Urgent due to abandonment and no visual threat to pipe or levee integrity (D. Sanoski - DWR UCIP).11/15/2016 Same as last inspection. (K. Fazel - UCIP)09/12/2013:- if abandoned, it needs proper abandonment. Pipe damaged and open on both ends. (P. Amatya - DWR) FIELD_STRUCT_DESC: *ABANDONED* 6-inch polyvinyl chloride (PVC) irrigation discharge pipe through the levee, 2 feet below the crown. Pipe was installed due to pump failure, but never removed. Field study discovered pipe. FS Date: 10/12/2018 5:16:00 PM

WS view: 6-inch pvc pipe on levee slope. Pipe end open and damaged.

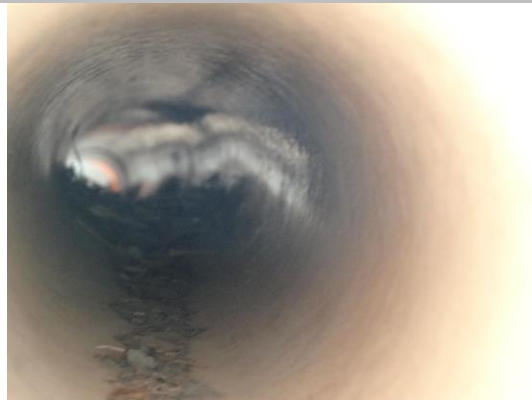
Photo 2 of 3 : UCIP\_SP\_2022\_53379\_36610.jpg

WS view: inside view of pvc pipe. Sediments found inside the pipe.

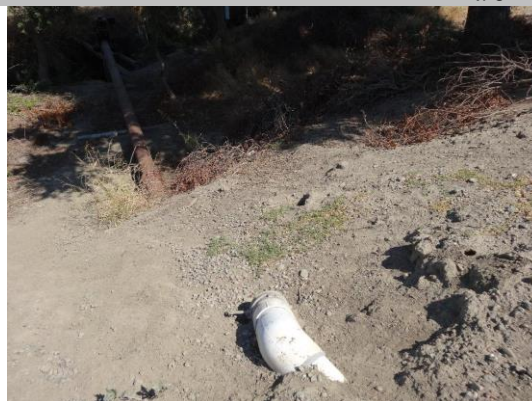
Photo 3 of 3 : UCIP\_SP\_2022\_53379\_36609.jpg

LS view: 6-inch pvc pipe on levee slope. Pipe end open.

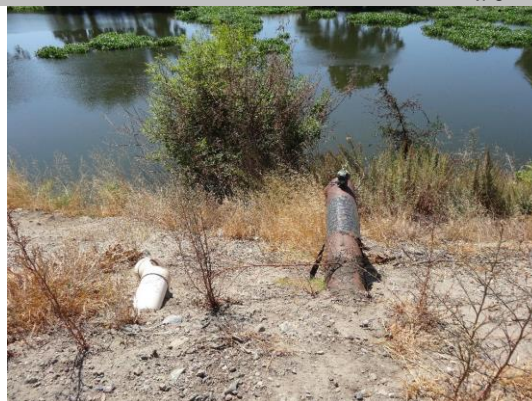
Photo 1 of 3 : UCIP\_SP\_2022\_21585\_36624.jpg

FS\_ID:21585  
 DS\_ID:23045  
 EP\_NO: N/A  
 Repair Type: Non-Urgent  
 Crossing Status: Found  
 UCIP Comments: - siphon breaker needs repair.  
 FIELD\_STRUCT\_DESC: 10-inch steel drainage discharge pipe through the levee, 2.4 feet below the crown. Pump in a drainage ditch on the landside (LS). Siphon breaker on the waterside (WS) shoulder.  
 [Additional Reference(s): DWR Levee Log, 1991].  
 FS Date: 9/12/2013

WS view: exposed steel pipe on levee slope. A pvc pipe on left.

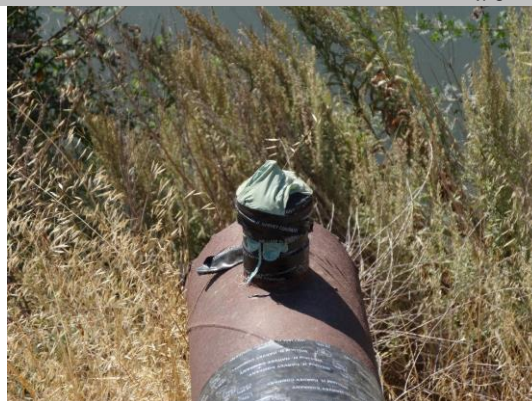
Photo 2 of 3 : UCIP\_SP\_2022\_21585\_36623.jpg

WS view: exposed steel pipe with siphon breaker. Looks siphon breaker needs repair.

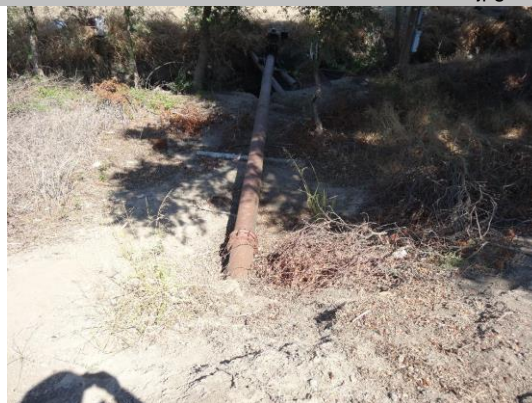
Photo 3 of 3 : UCIP\_SP\_2022\_21585\_36622.jpg

LS view: exposed steel pipe on levee slope.

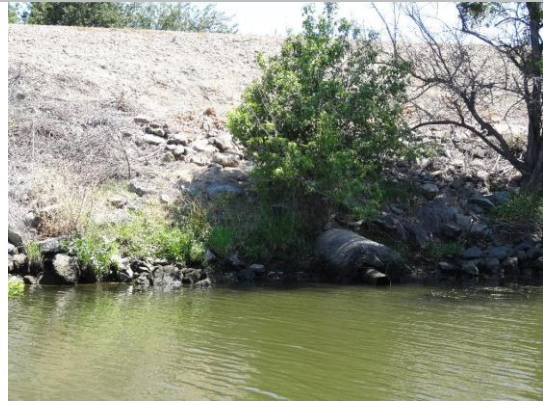
Photo 1 of 3 : UCIP\_SP\_2022\_53182\_74506.jpg

Comment Code						
Inspector Comment						
FS_ID:53182 DS_ID:23046 EP_NO: N/A Repair Type: Non-Urgent Crossing Status: Found UCIP Comments: 10/12/2018 Same as last inspection; downgrading to Non-Urgent due to no visual pipe or levee threat (D. Sanoski - DWR UCIP).11/15/2016 Pipe found on WS only. Same as last inspection. (K. Fazel - UCIP)06/25/2015 Crossing appears abandoned; if so, should be done so properly. Pipe open on WS. Holes and cracks visible on pipe. (K. Fazel - UCIP) FIELD_STRUCT_DESC: *ABANDONED* 12-inch reinforced concrete pipe of an unknown purpose possibly through the levee, approximately 8 feet below the crown. Smaller steel pipe sleeved through the 12-inch pipe with annular space grouted. Pipe does not cross channel and may not cross levee. May be related to the gas line crossing with DS ID 25121. Discovered from boat on 2015 DWR Erosion Survey. FS Date: 10/12/2018 5:22:43 PM

View up WS slope from water. Pipe does not cross channel.

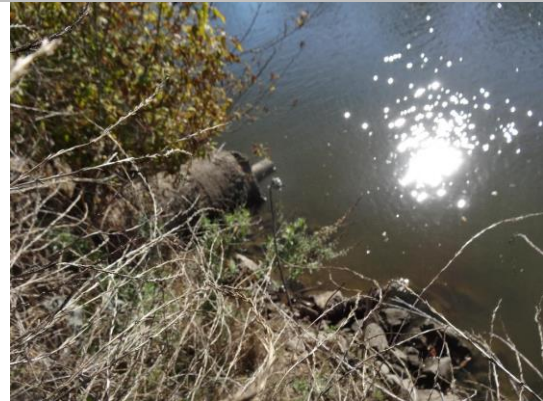
Photo 3 of 3 : UCIP\_SP\_2022\_53182\_76207.jpg

WS view of pipe

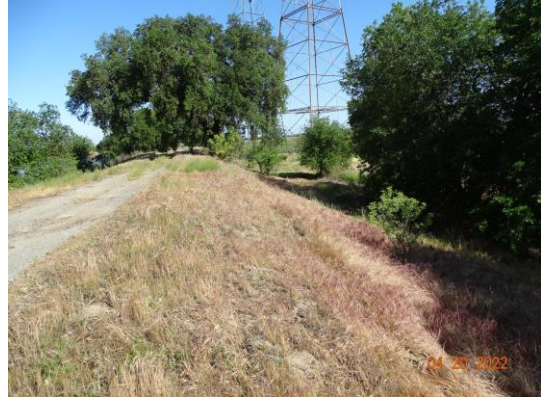
Photo 1 of 1 : SP\_2022\_RD2089\_317\_8\_20220421\_00028.jpg

View of vegetation along the landside slope and easement. Spring 2022

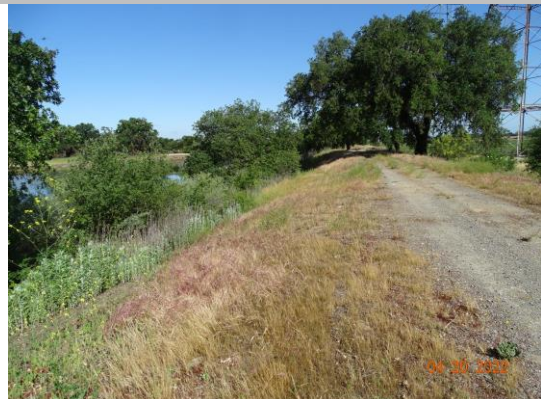
Photo 1 of 1 : SP\_2022\_RD2089\_317\_10\_20220421\_00027.jpg

View of vegetation along the waterside slope. Spring 2022

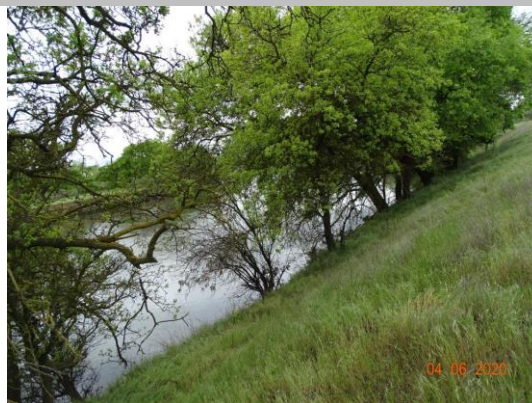
Photo 1 of 1 : SP\_2022\_RD2089\_317\_46\_20220406\_00020.jpg

View of erosion site on waterside slope. Spring 2020

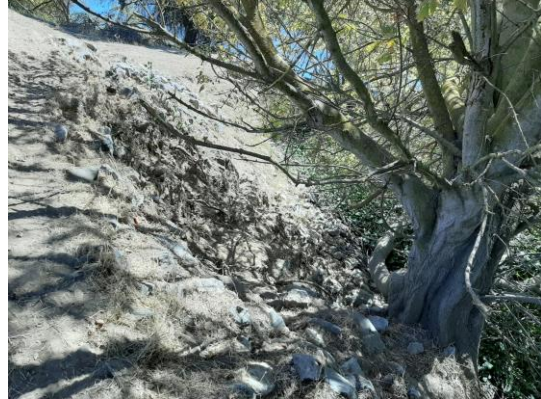
Photo 1 of 2 : SP\_2022\_RD2089\_317\_3\_20220406\_00004.jpg

11/05/2008: Cut into levee profile; riprap slide; rodent holes; pictures do not match GPS and current condition.

9/22/2020: View of the erosion and scattered riprap on the levee slope.

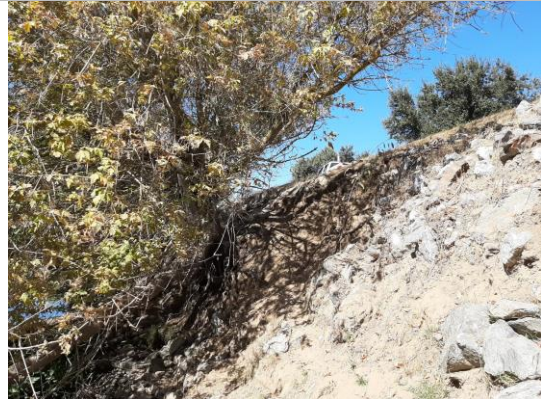
Photo 2 of 2 : SP\_2022\_RD2089\_317\_3\_20220406\_00005.jpg

9/22/2020: Close-up view of the eroded levee slope.

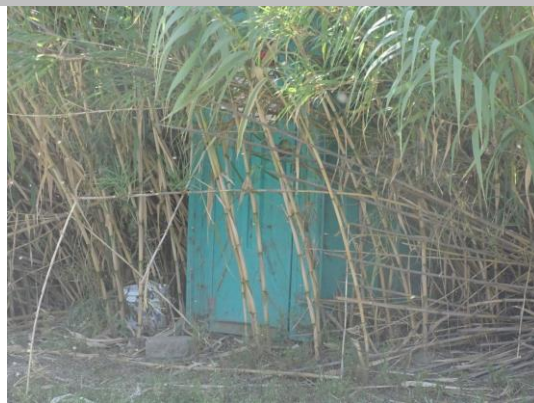
Photo 1 of 1 : SP\_2022\_RD2089\_317\_27\_20220406\_00015.jpg

Close-up view of portable toilet at water's edge. (Fall 2018)

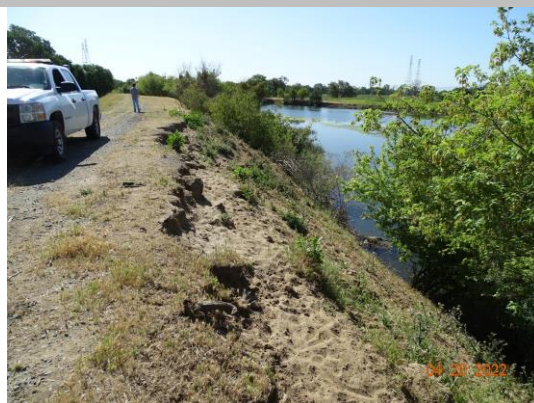
Photo 1 of 1 : SP\_2022\_RD2089\_317\_7\_20220421\_00029.jpg

View of eroded waterside slope caused by livestock. Spring 2022

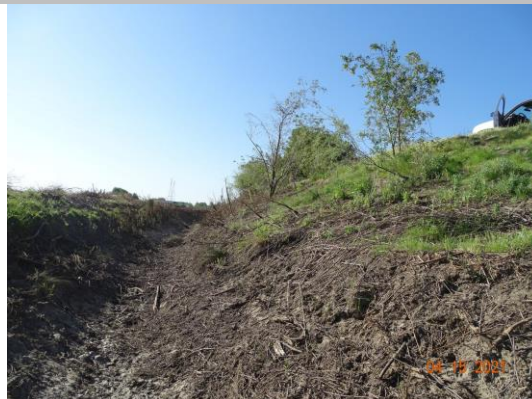
Photo 1 of 1 : SP\_2022\_RD2089\_317\_62\_20220406\_00023.jpg

View of an irrigation ditch within the landside easement. Spring 2021

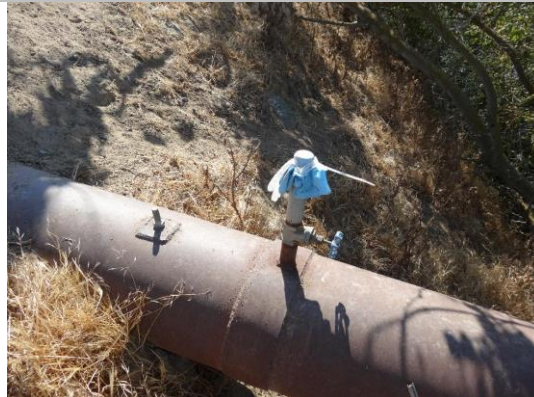
Photo 2 of 3 : UCIP\_SP\_2022\_21676\_36860.jpg

WS view: air relief valve on pipe. Pipe exposed in levee slope.

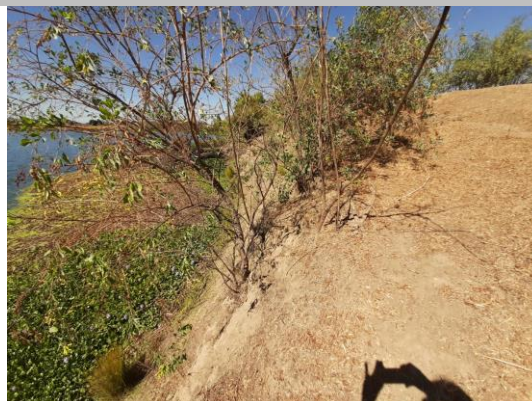
Photo 1 of 2 : SP\_2022\_RD2089\_317\_1\_20220406\_00001.jpg

9/22/2020: View of the vertical cut on the river bank looking downstream.

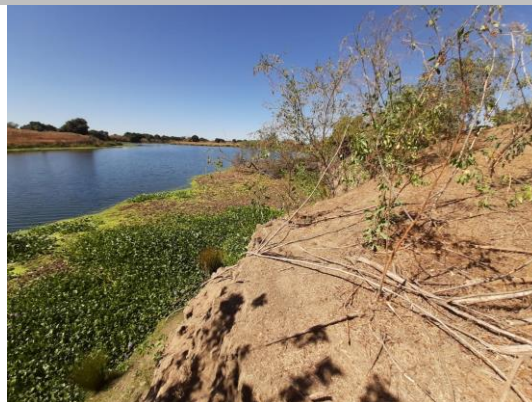
Photo 2 of 2 : SP\_2022\_RD2089\_317\_1\_20220406\_00002.jpg

9/22/2020: View of the bank erosion further upstream.

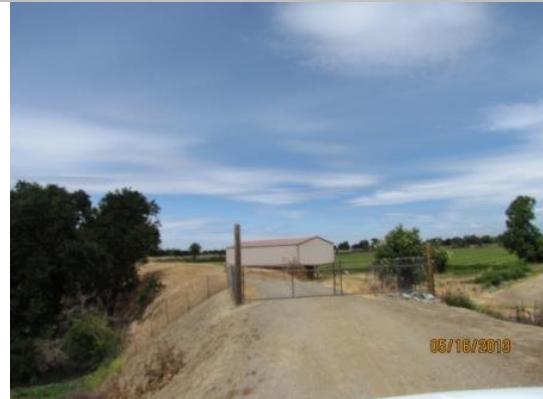
Photo 1 of 1 : SP\_2022\_RD2089\_317\_9\_20220406\_00008.jpg

View of the fence gate across levee crown.

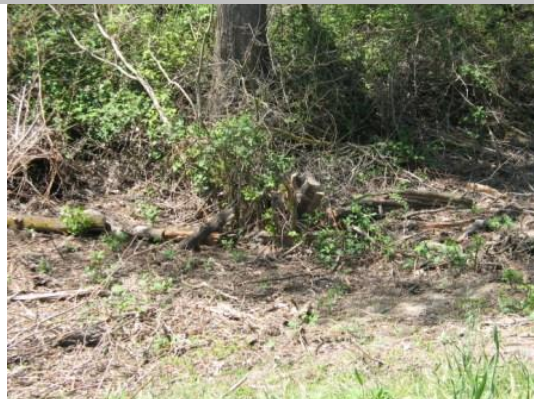
Photo 1 of 1 : SP\_2022\_RD2089\_317\_29\_20220406\_00017.jpg

View of tree stump left after vegetation and tree removal.

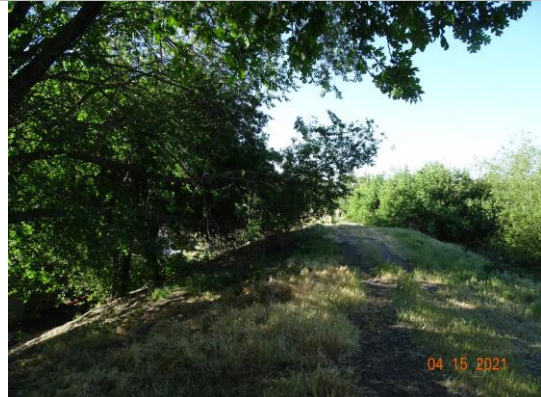
Photo 1 of 1 : SP\_2022\_RD2089\_317\_33\_20220406\_00018.jpg

View of an untrimmed tree over the surface road. Spring 2021

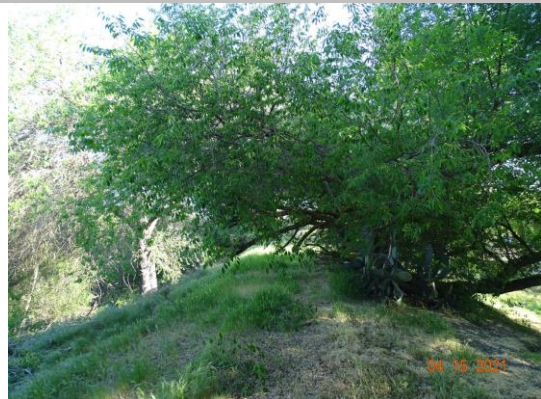
Photo 1 of 1 : SP\_2022\_RD2089\_317\_35\_20220406\_00019.jpg

View of an untrimmed tree over the surface road. Spring 2021

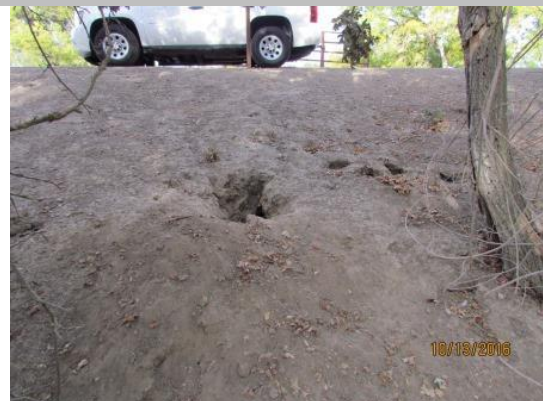
Photo 1 of 1 : SP\_2022\_RD2089\_317\_16\_20220406\_00012.jpg

View of the rodent burrow in the landside levee slope.

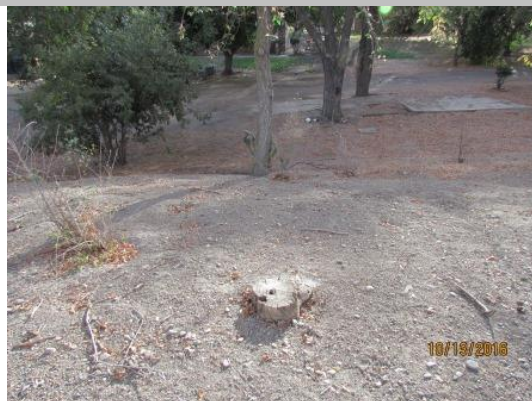
Photo 1 of 1 : SP\_2022\_RD2089\_317\_18\_20220406\_00013.jpg

View of the tree stump from the levee crown.

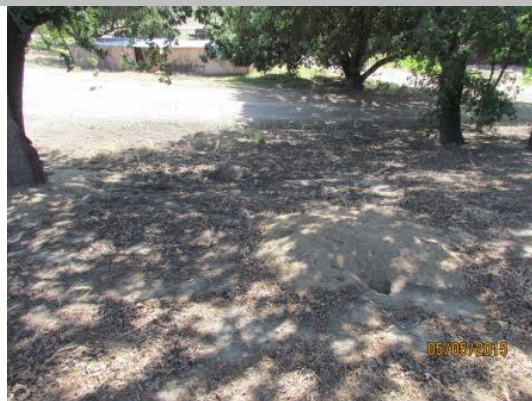
Photo 1 of 1 : SP\_2022\_RD2089\_317\_11\_20220406\_00010.jpg

View of the multiple rodent burrows on the landside levee slope.
