**Flood Control Project Maintenance  
Levee Inspections**

**Levee Inspection Report By Mile - Spring 2023**

**Reclamation District No. 2089 Stark**

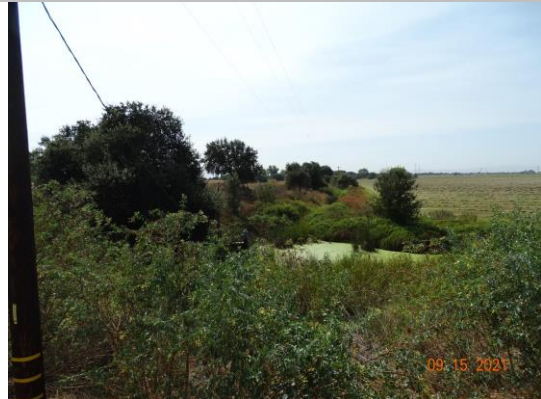
Photo 1 of 1 : SP\_2023\_RD2089\_316\_9\_20230306\_00006.jpg

View of an irrigation ditch within the landside easement. Fall 2021

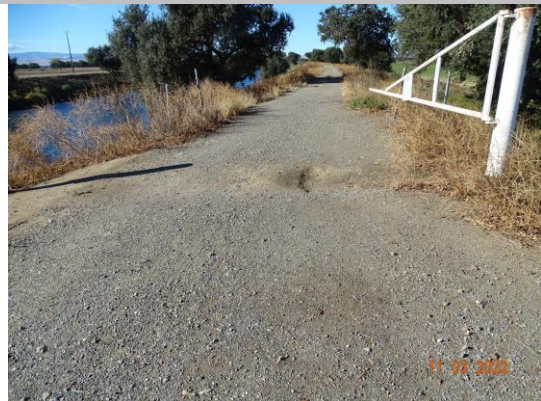
Photo 1 of 1 : SP\_2023\_RD2089\_316\_14\_20230306\_00009.jpg

LM Start	0.02	Rating **	M	Issue No.	14
LM End	0.02	Issue Type +	Ma	Location *	CR
Category	Earthen Levee			GPS Latitude/Longitude	
				Start	End
Item	Crown Surface / Depressions / Rutting			37.811551°	37.811551°
				-121.385287°	-121.385287°
DWR ID	DWR_RD2089_01_f_2022_14				
Comment Code					
C2 : Repair depressions or ruts in the crown or slope.					
Inspector Comment

View of depression on crown of road. Fall 2022

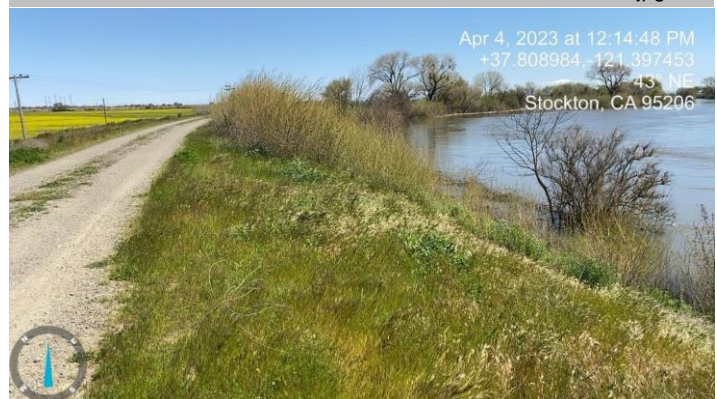
Photo 1 of 1 : SP\_2023\_RD2089\_316\_21\_20230412\_00036.jpg

LM Start	0.03	Rating **	U	Issue No.	21
LM End	0.76	Issue Type +	Ma	Location *	WS
Category	Earthen Levee			GPS Latitude/Longitude	
				Start	End
Item	Vegetation			37.811508°	37.808966°
				-121.385449°	-121.397533°
DWR ID	DWR_RD2089_01_f_2022_21				
Comment Code					
V1 : Control annual grass and weeds on the levee slopes and easements.					
Inspector Comment

Typical view of vegetation along the waterside slope. Spring 2023

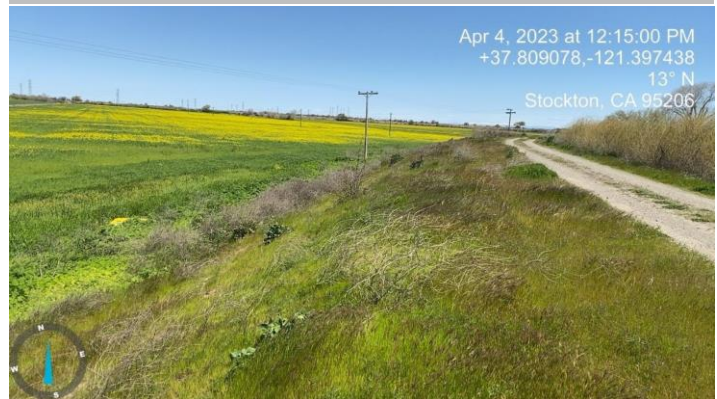
Photo 1 of 1 : SP\_2023\_RD2089\_316\_19\_20230412\_00037.jpg

Typical view of vegetation along the landside slope. Spring 2023

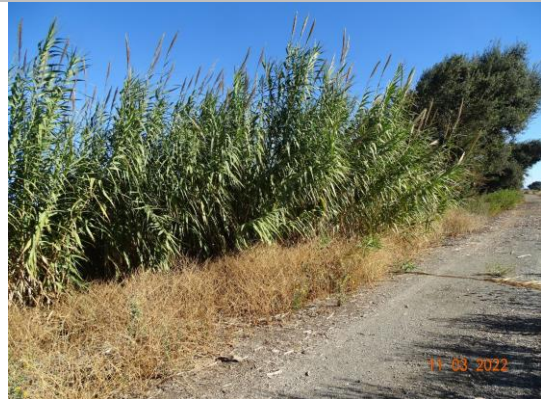
Photo 1 of 1 : SP\_2023\_RD2089\_316\_18\_20230306\_00011.jpg

View of Arundo growing along the landside slope. Fall 2022

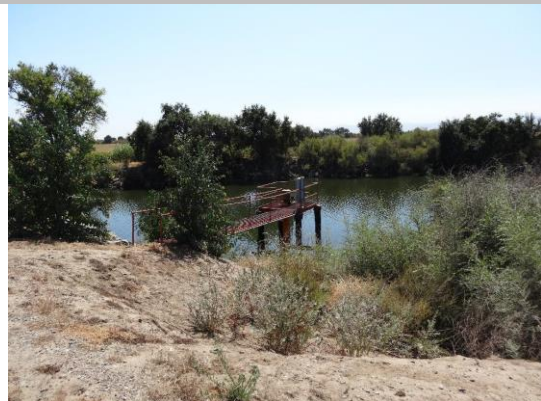
Photo 1 of 3 : UCIP\_SP\_2023\_21635\_36742.jpg

Comment Code					
Inspector Comment					
DS_ID:23042 FS_ID:21635 EP_NO: 5641 Repair Type: Non-Urgent EVAL Issue: Crossing Status: Found UCIP Comments: - damaged siphon breaker.- most of the pipe on landside exposed on levee slope. FIELD_STRUCT_DESC: 20-inch steel irrigation discharge pipe and electrical conduit through the levee, 5.8 feet below the crown. Pump on a pile structure in the stream. Siphon breaker on the landside (LS) slope. (Plans to replace a rusted out irrigation discharge pipe through the levee authorized under Permit No. 5641, 1967 - Theodore Stark). [Additional Reference(s): DWR Levee Log, 1991. USACE San Joaquin O&M Manual 8, 1968, (HLM 0.46), 21-inch pipe referenced]. FS Date: 9/12/2013

WS view: walkway to pump platform and pump on steel piling structure in the channel.

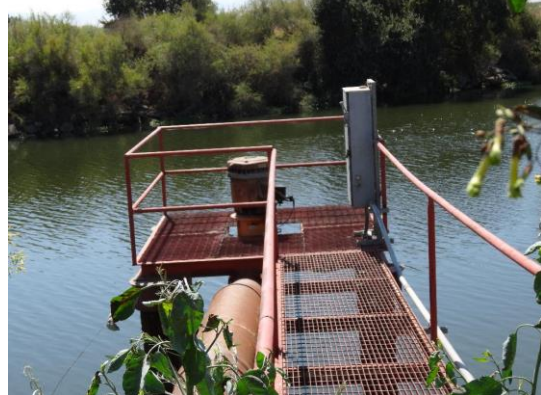
Photo 2 of 3 : UCIP\_SP\_2023\_21635\_36741.jpg

WS view: steel walkway, electric control box, and pump on steel piling structure in the channel.

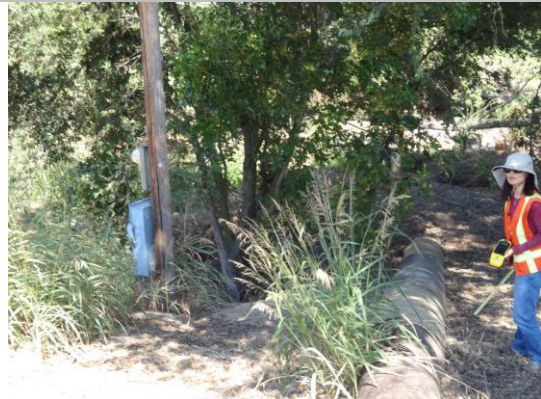
Photo 3 of 3 : UCIP\_SP\_2023\_21635\_36740.jpg

LS view: overview of exposed steel pipe (right) on levee slope and service pole (left).

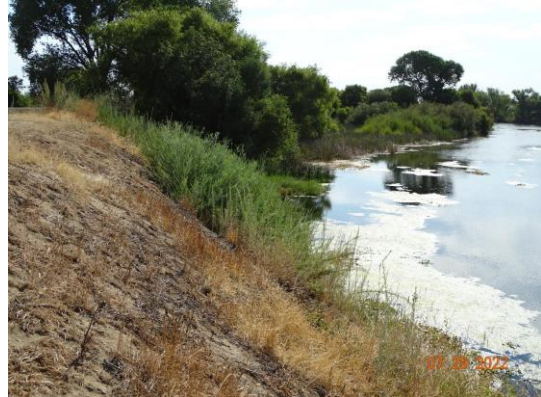
Photo 1 of 3 : SP\_2023\_RD2089\_316\_3\_20230306\_00002.jpg

09/07/2010: It was difficult to view the erosion due to the Willow thickets and other vegetation at the water line. At the time of the inspection, there were no signs of repair on site. As noted during the last survey, there is a 5-foot vertical scarp along the lower slope that may be subjected to high flow velocities.

09/28/2009: No major change observed; 5-foot vertical scarp is immediately downstream of where berm has tapered; site is recommended as local maintenance issue, per CLRO CES Evaluation 2008 Report; Site # is the same as RM29.6, LM0.60; previously rated "U".

7/29/2022: View of the erosion looking upstream.

08/05/2010: Recommended for repair, per CLRO; "Erosion of this site may be subjective to rapid rates of erosion."

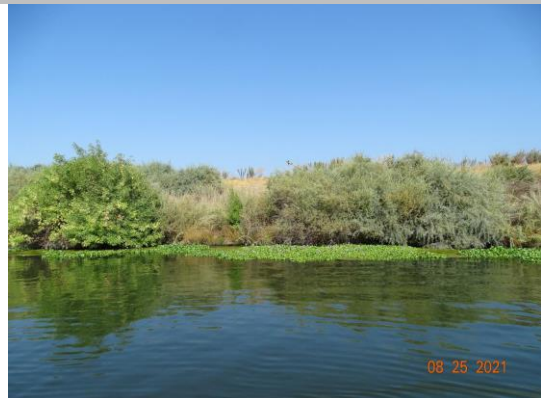
Photo 2 of 3 : SP\_2023\_RD2089\_316\_3\_20230306\_00003.jpg

8/25/2021: Front view of the eroded slope.

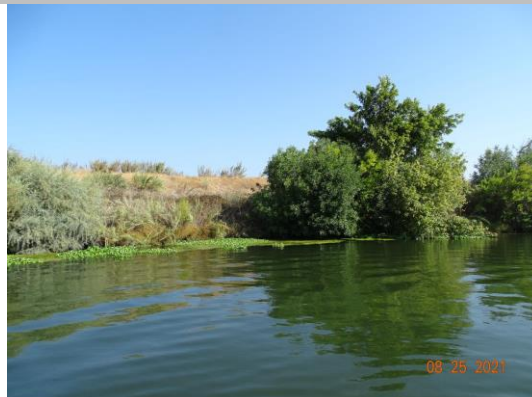
Photo 3 of 3 : SP\_2023\_RD2089\_316\_3\_20230306\_00004.jpg

8/25/2021: Front view of the site. Note the very dense white willow thickets on site.

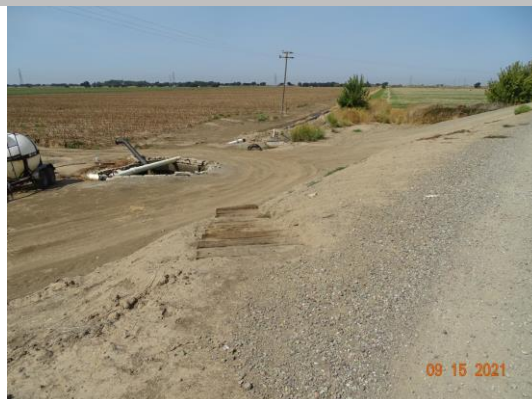
Photo 1 of 1 : SP\_2023\_RD2089\_316\_22\_20230306\_00014.jpg

LM Start	0.80	Rating **	M	Issue No.	22
LM End	0.80	Issue Type +	En	Location *	LS
Category	Earthen Levee			GPS Latitude/Longitude	
				Start	End
Item	Encroachments			37.808466°	37.808466°
				-121.397847°	-121.397847°
DWR ID	DWR_RD2089_01_f_2016_22				
Comment Code					
ST : Stairway					
Inspector Comment

View of steps on landside slope. Fall 2021

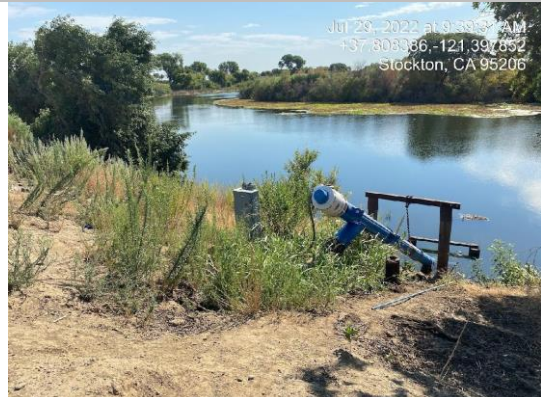
Photo 1 of 3 : UCIP\_SP\_2023\_77043\_115335.jpg

Comment Code						
Inspector Comment						
DS_ID:23043 FS_ID:77043 EP_NO: 3385 Repair Type: Urgent EVAL Issue: Crossing Status: Found UCIP Comments: 08/01/2022 Record updated from Non-Urgent to Urgent. DWR levee inspector reported that pipe has a leak near the waterside shoulder. The leak is causing erosion on the waterside slope under and near the pipe. Water leak on landside slope was noticed, concrete standpipe at landside toe leaks through its joints and overtops. (O.Yakimov - DWR UCIP) 09/12/2013 Powerline on landside. Electric control box on waterside, waterside slope erosion under pump platform. (P.Amatya - DWR UCIP) FIELD_STRUCT_DESC: 16-inch irrigation discharge pipe of an unknown material through the levee, 5.5 feet below the crown. Two cutoff walls. Slant pump in a pump house on the waterside (WS) slope. Siphon breaker on the landside (LS) slope. (Plans for installation of a pumping plant on the riverbank and a pipe that crosses the levee authorized under Permit No. 3385, 1960 - Eleanor M. Lawrence). [Additional Reference(s): DWR Levee Log, 1991. USACE San Joaquin O&M Manual 8, 1968, (HLM 0.81)]. FS Date: 9/12/2013

Water-Side: Water pump at riverbank. Levee slope erosion around the pipe. Photo courtesy by DWR inspector Alberto De Leon

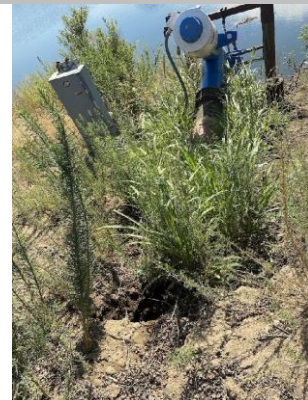
Photo 2 of 3 : UCIP\_SP\_2023\_77043\_115336.jpg

Water-Side: Closeup view of levee slope erosion around the pipe. Photo courtesy by DWR inspector Alberto De Leon

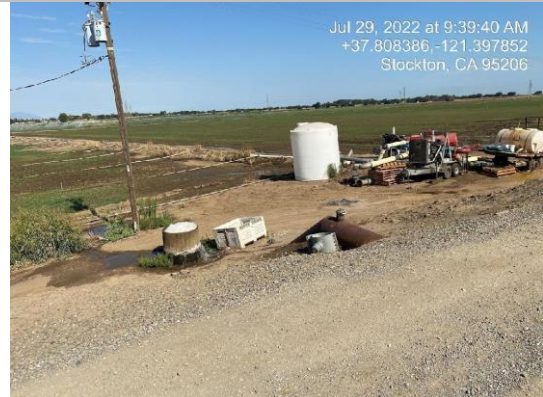
Photo 3 of 3 : UCIP\_SP\_2023\_77043\_115337.jpg

Land-Side: View of levee slope looking from crown. Water leak on levee slope, erosion around overtopping concrete standpipe

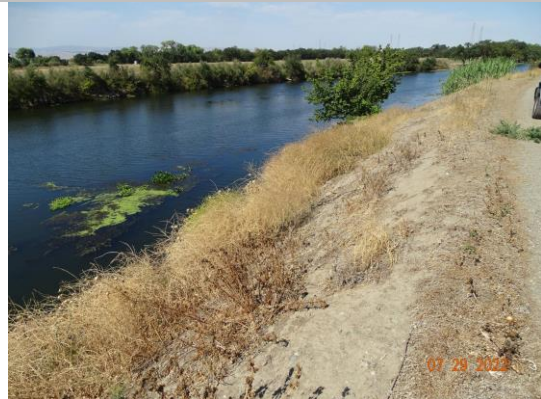
Photo 1 of 1 : SP\_2023\_RD2089\_316\_2\_20230306\_00001.jpg

LM Start	1.17	Rating **	M	Issue No.	2
LM End	1.18	Issue Type +	Ma	Location *	WS
Category	Supplemental			GPS Latitude/Longitude	
				Start	End
Item	DWR Erosion Survey			37.805523°	37.805523°
				-121.401718°	-121.401718°
DWR ID	RD2089U01RM29.1				
Comment Code					
Inspector Comment					
Site ID: RD2089U01RM29.1 07/29/2022: From 2021 to present, no significant changes were observed during the annual survey. 09/22/2020: Noticed signs of animal burrowing activity. The upper levee slope has areas with exposed soil. Vegetation is limiting the view of the scarp. 09/26/2019: No significant change observed. 09/13/2017: The erosion is at the upstream of a small tree, inside of a slight river bend.

7/29/2022: View of the eroded slope looking downstream with bare soil off the levee shoulder.

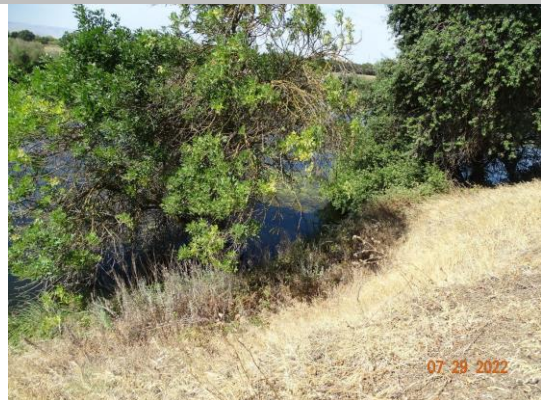
Photo 1 of 1 : SP\_2023\_RD2089\_316\_5\_20230306\_00005.jpg

LM Start	1.22	Rating **	U	Issue No.	5
LM End	1.23	Issue Type +	Ma	Location *	WS
Category	Supplemental			GPS Latitude/Longitude	
				Start	End
Item	DWR Erosion Survey			37.805800°	37.805800°
				-121.402868°	-121.402868°
DWR ID	RD2089U01RM29.04				
Comment Code					
Inspector Comment					
Site ID: RD2089U01RM29.04 07/29/2022: From 2014 to present, no significant changes were observed during the annual survey. 08/13/2013: The erosion is around a tree at the levee toe. Dense vegetation is visible.

7/29/2022: View of the erosion around the tree looking downstream.

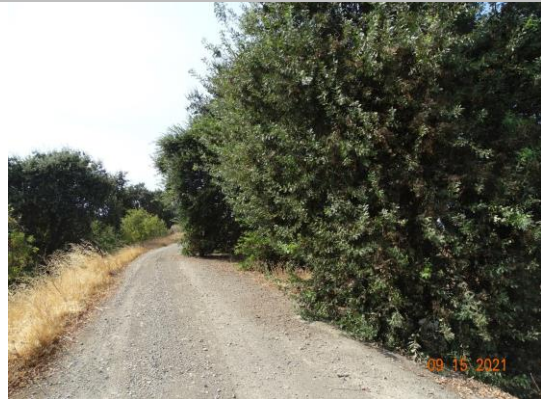
Photo 1 of 1 : SP\_2023\_RD2089\_316\_42\_20230306\_00015.jpg

View of an untrimmed tree on the landside slope. Fall 2021

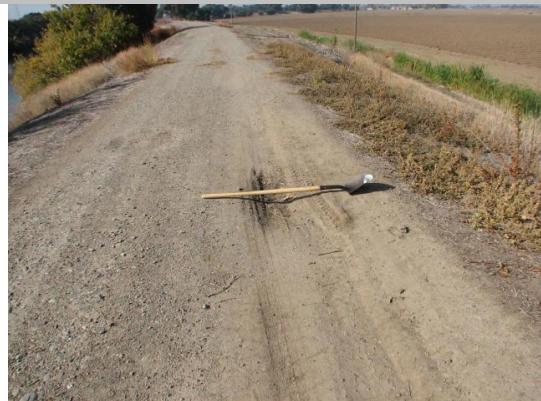
Photo 1 of 1 : SP\_2023\_RD2089\_316\_44\_20230306\_00016.jpg

LM Start	1.25	Rating **	M	Issue No.	44
LM End	1.25	Issue Type +	Ma	Location *	LS
Category	Earthen Levee			GPS Latitude/Longitude	
				Start	End
Item	Crown Surface / Depressions / Rutting			37.805889°	37.805889°
				-121.403277°	-121.403277°
DWR ID	DWR_RD2089_01_s_2012_44				
Comment Code					
C3 : Add appropriate gravel or road base. Grade and compact.					
Inspector Comment

View of roadway depression. 11/10/2011

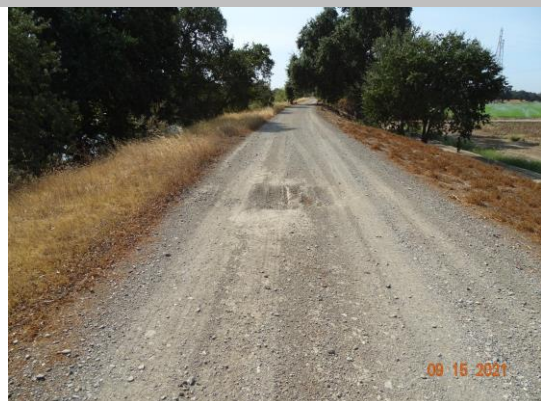
Photo 1 of 1 : SP\_2023\_RD2089\_316\_45\_20230306\_00017.jpg

LM Start	1.34	Rating **	M	Issue No.	45
LM End	1.34	Issue Type +	Ma	Location *	CR
Category	Earthen Levee			GPS Latitude/Longitude	
				Start	End
Item	Crown Surface / Depressions / Rutting			37.806128°	37.806128°
				-121.404890°	-121.404890°
DWR ID	DWR_RD2089_01_s_2012_45				
Comment Code					
C3 : Add appropriate gravel or road base. Grade and compact.					
Inspector Comment

View of roadway depression. Fall 2021

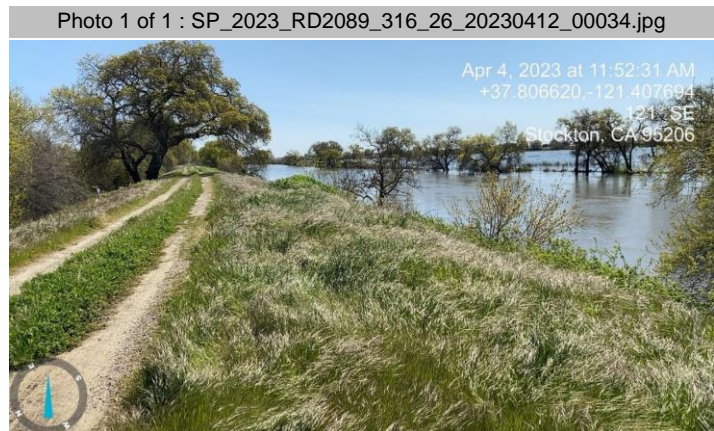
LM Start	1.40	Rating **	U	Issue No.	26
LM End	1.51	Issue Type +	Ma	Location *	WS
Category	Earthen Levee			GPS Latitude/Longitude	
				Start	End
Item	Vegetation			37.806305°	37.806660°
				-121.405944°	-121.407865°
DWR ID	DWR_RD2089_01_f_2022_26				
Comment Code					
V1 : Control annual grass and weeds on the levee slopes and easements.					
Inspector Comment

Typical view of vegetation along the waterside slope. Spring 2023

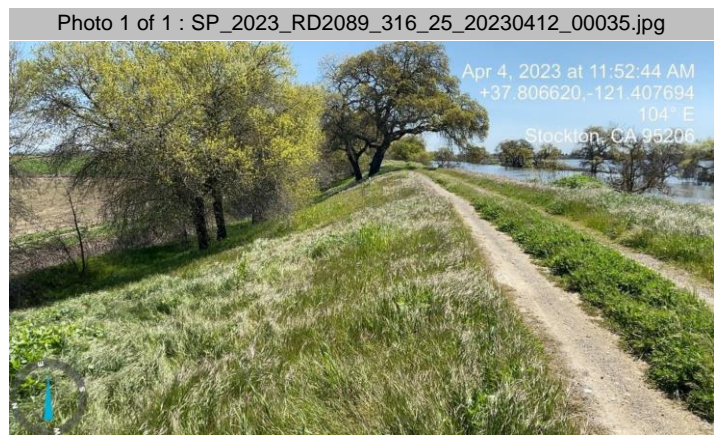
LM Start	1.40	Rating **	U	Issue No.	25
LM End	1.51	Issue Type +	Ma	Location *	LS
Category	Earthen Levee			GPS Latitude/Longitude	
				Start	End
Item	Vegetation			37.806309°	37.806659°
				-121.405950°	-121.407865°
DWR ID	DWR_RD2089_01_f_2022_25				
Comment Code					
V1 : Control annual grass and weeds on the levee slopes and easements.					
Inspector Comment

Typical view of vegetation along the landside slope. Spring 2023

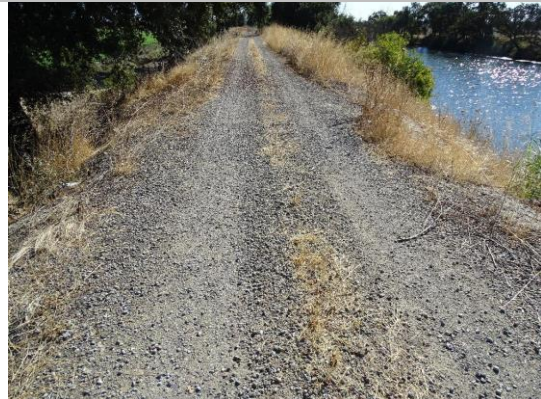
Photo 1 of 3 : UCIP\_SP\_2023\_53379\_78552.jpg

Comment Code						
Inspector Comment						
DS_ID:24667 FS_ID:53379 EP_NO: N/A Repair Type: Non-Urgent EVAL Issue: Crossing Status: Found UCIP Comments: 10/12/2018 Same as last inspection. Down grading to Non-Urgent due to abandonment and no visual threat to pipe or levee integrity (D. Sanoski - DWR UCIP).11/15/2016 Same as last inspection. (K. Fazel - UCIP)09/12/2013:- if abandoned, it needs proper abandonment. Pipe damaged and open on both ends. (P. Amatya - DWR) FIELD_STRUCT_DESC: *ABANDONED* 6-inch polyvinyl chloride (PVC) irrigation discharge pipe through the levee, 2 feet below the crown. Pipe was installed due to pump failure, but never removed. Field study discovered pipe. FS Date: 10/12/2018 5:16:00 PM

Crown view - looks in good condition.

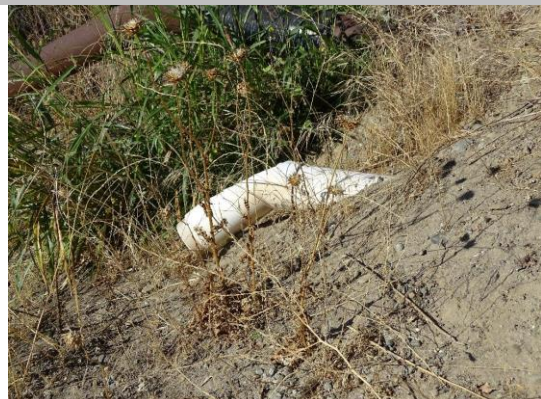
Photo 2 of 3 : UCIP\_SP\_2023\_53379\_78553.jpg

WS view - disconnected at end and not in use; levee looks in good condition.

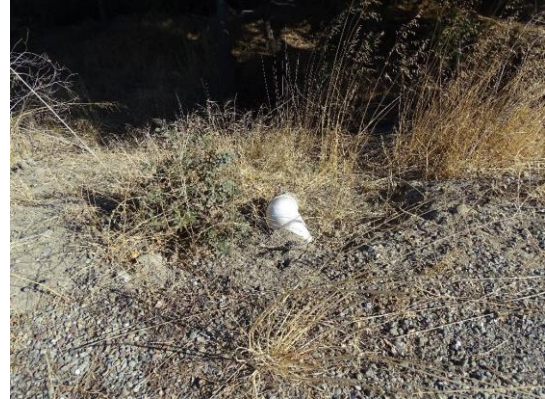
Photo 3 of 3 : UCIP\_SP\_2023\_53379\_78554.jpg

LS view - pipe open at end.

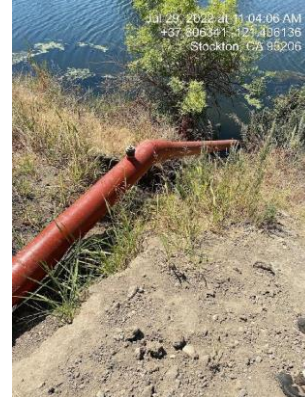
Photo 1 of 3 : UCIP\_SP\_2023\_77040\_115339.jpg

Comment Code						
Inspector Comment						
DS_ID:23045 FS_ID:77040 EP_NO: N/A Repair Type: Urgent EVAL Issue: Crossing Status: Found UCIP Comments: 08/09/2022 NTC Enforcement Case 2022-15621 was issued to this crossing. Excavation on landside slope measured 3-feet wide by 20-feet long by 5-feet deep. Excavation on waterside slope measured 3-feet wide by 20-feet long by 3-feet deep. Annular space between sleeved pipes not grouted. (O.Yakimov - DWR UCIP) 08/01/2022 Record updated from Non-Urgent to Urgent. DWR levee inspector reported that this pipe has been replaced with a new pipe, unable to locate a permit for modifications. Landside slope has an open trench and the waterside slope has a significant erosion under the pipe. Both landside and waterside slope need to be recompacted in accordance with O&M standards. Unauthorized encroachment recorded in Levee Log. (O. Yakimov - DWR UCIP) 09/12/2013 siphon breaker needs repair. (P. Amatya - DWR UCIP) FIELD_STRUCT_DESC: 8-inch steel drainage discharge pipe sleeved through 10-inch pipe through the levee, 2.4 feet below the crown, annular space not grouted. Pipe diameter on waterside grows to 10-inch, 8-inch pipe is connected to existing 10-inch pipe at landside toe via coupler with welded diameter reduction. Pump in a drainage ditch on the landside (LS). Siphon breaker on the waterside (WS) shoulder. (10-inch pipe authorized under Permit No. 7981, 1972 - Frank Pellegrini). [Additional Reference(s): DWR Levee Log, 1991]. FS Date: 9/12/2013

Water-Side: View of erosion around the pipe. Photo courtesy by DWR inspector Alberto De Leon

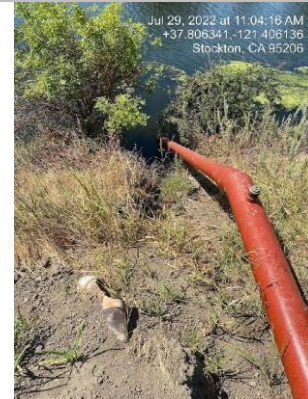
Photo 2 of 3 : UCIP\_SP\_2023\_77040\_115334.jpg

Water-Side: New pipe with air release valve at riverbank. Photo courtesy by DWR inspector Alberto De Leon

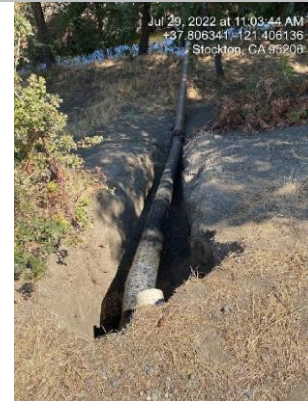
Photo 3 of 3 : UCIP\_SP\_2023\_77040\_115333.jpg

Water-Side: Replaced pipe exposed in trench on levee slope. Photo courtesy by DWR inspector Alberto De Leon

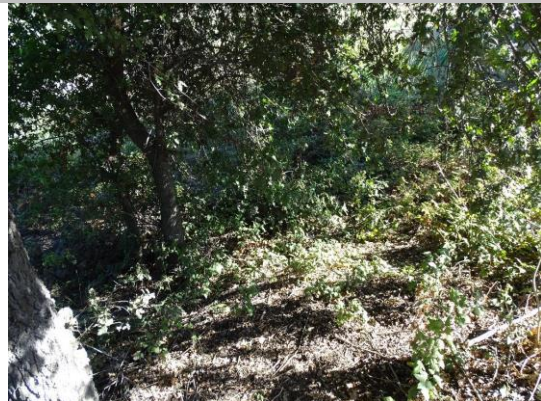
Photo 1 of 3 : UCIP\_SP\_2023\_53182\_78555.jpg

Comment Code					
Inspector Comment					
DS_ID:23046 FS_ID:53182 EP_NO: N/A Repair Type: Non-Urgent EVAL Issue: Crossing Status: Found UCIP Comments: 10/12/2018 Same as last inspection; downgrading to Non-Urgent due to no visual pipe or levee threat (D. Sanoski - DWR UCIP).11/15/2016 Pipe found on WS only. Same as last inspection. (K. Fazel - UCIP)06/25/2015 Crossing appears abandoned; if so, should be done so properly. Pipe open on WS. Holes and cracks visible on pipe. (K. Fazel - UCIP) FIELD_STRUCT_DESC: *ABANDONED* 12-inch reinforced concrete pipe of an unknown purpose possibly through the levee, approximately 8 feet below the crown. Smaller steel pipe sleeved through the 12-inch pipe with annular space grouted. Pipe does not cross channel and may not cross levee. May be related to the gas line crossing with DS ID 25121. Discovered from boat on 2015 DWR Erosion Survey. FS Date: 10/12/2018 5:22:43 PM

LS view - overgrown vegetation did not allow for visual inspection.

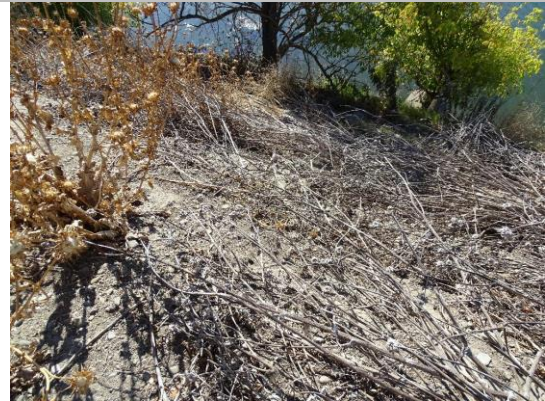
Photo 2 of 3 : UCIP\_SP\_2023\_53182\_78556.jpg

WS view - no visual signs of any levee threat.

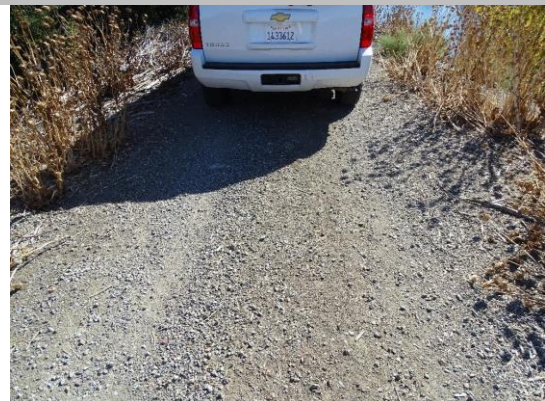
Photo 3 of 3 : UCIP\_SP\_2023\_53182\_78557.jpg

Crown view - looks in good condition.

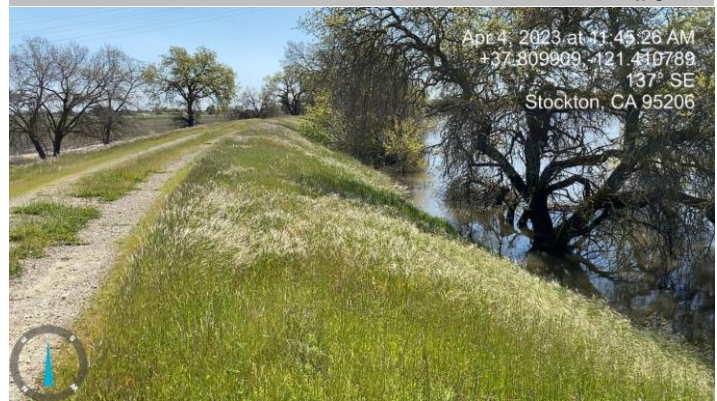
Photo 1 of 1 : SP\_2023\_RD2089\_317\_10\_20230412\_00024.jpg

Typical view of vegetation along the waterside slope. Spring 2023

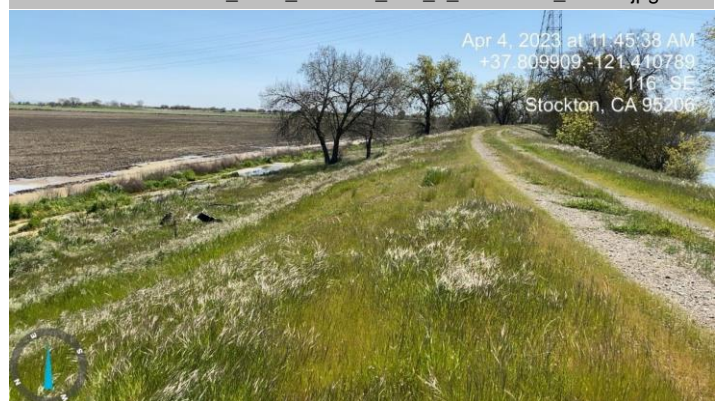
Photo 1 of 1 : SP\_2023\_RD2089\_317\_8\_20230412\_00025.jpg

Typical view of vegetation along the landside slope. Spring 2023

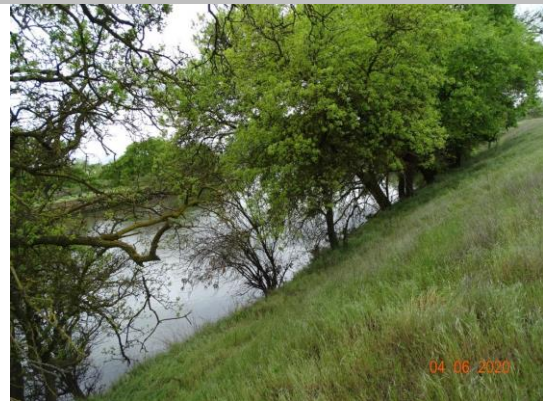
Photo 1 of 1 : SP\_2023\_RD2089\_317\_46\_20230306\_00013.jpg

LM Start	0.20	Rating **	A/W	Issue No.	46
LM End	0.21	Issue Type +	Ma	Location *	WS
Category	Earthen Levee			GPS Latitude/Longitude	
				Start	End
Item	Erosion / Bank Caving			37.809100°	37.809200°
				-121.409800°	-121.409900°
DWR ID	LMA-415				
Comment Code					
E1 : Note and monitor erosion site.					
Inspector Comment					
2017 Storm Damage Site, ID No. 509, LMA 415, displaced riprap at toe. Inspected: Fall 2020, vegetation did not allow inspection of rip rap.

View of erosion site on waterside slope. Spring 2020

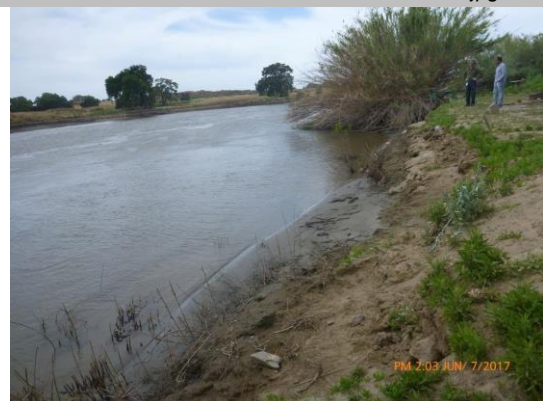
Photo 1 of 1 : LEVAL\_SP\_2023\_109\_1298.jpg

LM Start	0.32	Rating **	A/W	Issue No.	47
LM End	0.57	Issue Type +	Ma	Location *	WS
Category	Earthen Levee			GPS Latitude/Longitude	
				Start	End
Item	Erosion / Bank Caving			37.810020°	37.811810°
				-121.411550°	-121.415390°
DWR ID	335-103				
Comment Code					
E1 : Note and monitor erosion site.					
Inspector Comment					
2017 Storm Damage Site, ID No: 109

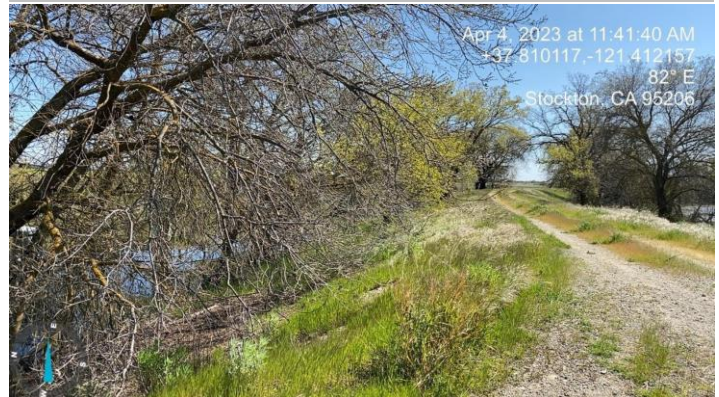
Photo 1 of 1 : SP\_2023\_RD2089\_317\_55\_20230412\_00023.jpg

View of tree branches that need to be thin and trimmed on the landside levee slope. Spring 2023

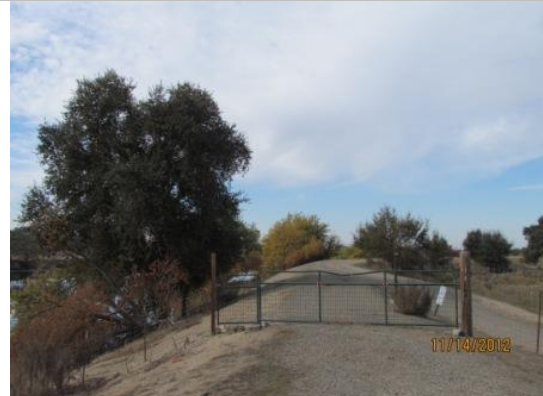
Photo 1 of 1 : SP\_2023\_RD2089\_317\_2\_20230306\_00002.jpg

View of gate across levee crown.

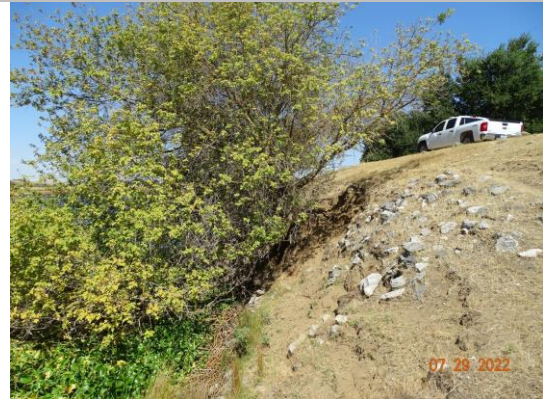
Photo 1 of 1 : SP\_2023\_RD2089\_317\_1\_20230306\_00001.jpg

11/05/2008: Cut into levee profile; riprap slide; rodent holes; pictures do not match GPS and current condition.

7/29/2022: Close-up view of the eroded levee slope.

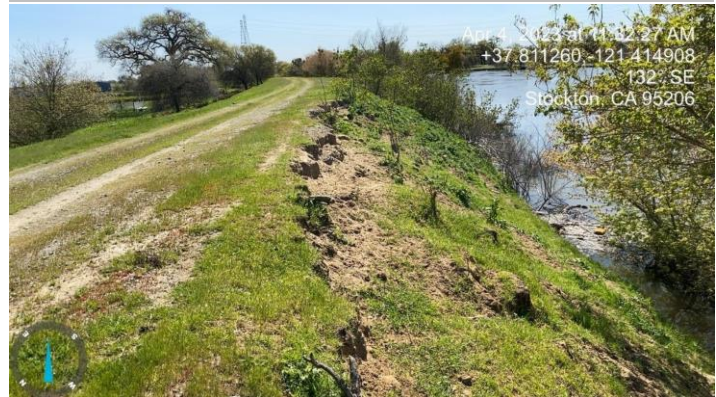
Photo 1 of 1 : SP\_2023\_RD2089\_317\_7\_20230412\_00022.jpg

View of eroded waterside slope caused by livestock. Spring 2023

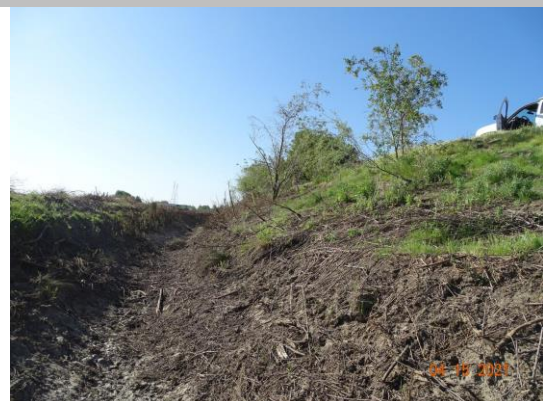
Photo 1 of 1 : SP\_2023\_RD2089\_317\_62\_20230306\_00016.jpg

View of an irrigation ditch within the landside easement. Spring 2021

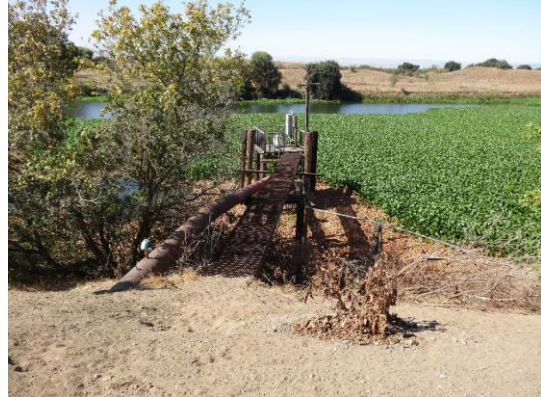
Photo 1 of 3 : UCIP\_SP\_2023\_21676\_36861.jpg

WS view: pipe and pump on piling structure in water channel.

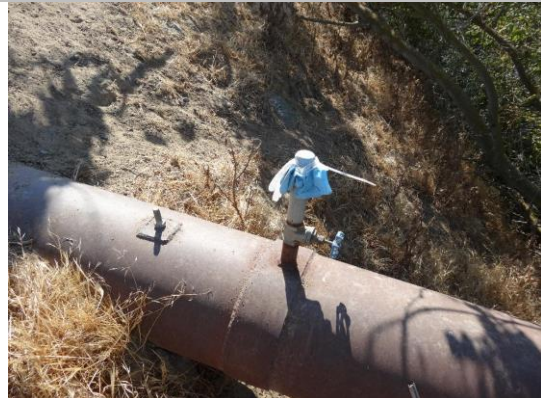
Photo 2 of 3 : UCIP\_SP\_2023\_21676\_36860.jpg

WS view: air relief valve on pipe. Pipe exposed in levee slope.

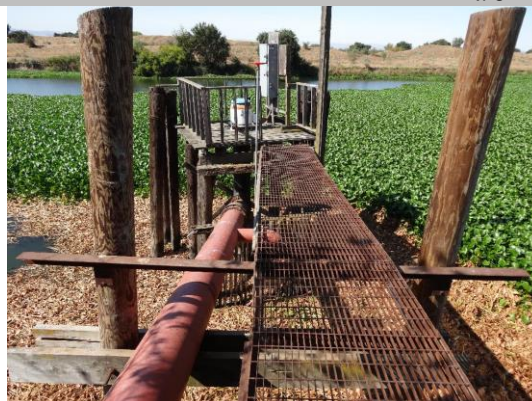
Photo 3 of 3 : UCIP\_SP\_2023\_21676\_36859.jpg

WS view: pipe (left) and steel walkway to pump on piling structure in the channel.

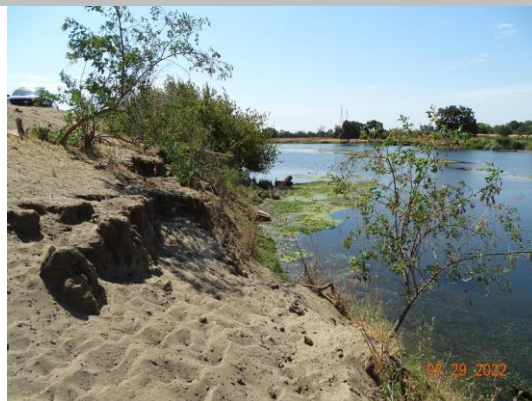
Photo 1 of 1 : SP\_2023\_RD2089\_317\_3\_20230306\_00003.jpg

7/29/2022: View of the erosion looking upstream.

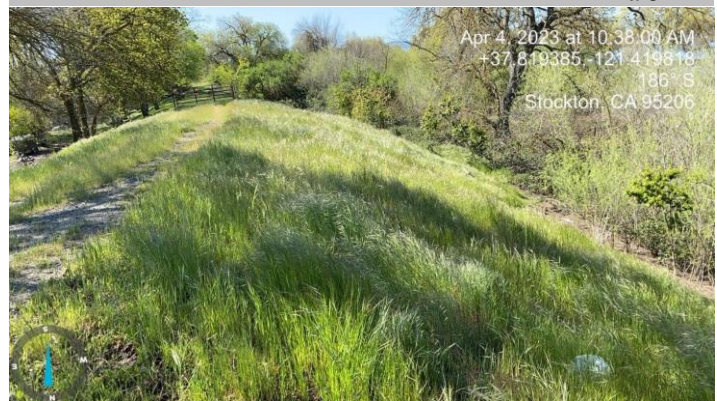
Photo 1 of 1 : SP\_2023\_RD2089\_317\_6\_20230412\_00021.jpg

Typical view of vegetation along the waterside slope. Spring 2023

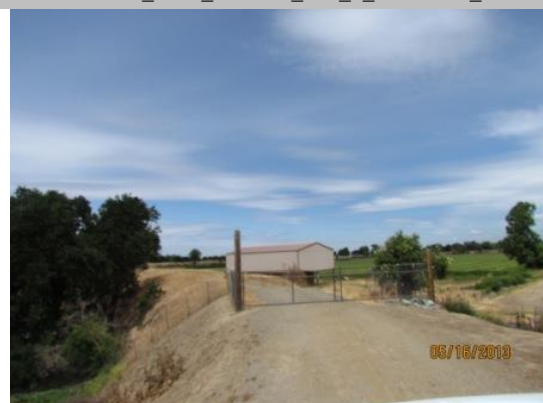
Photo 1 of 1 : SP\_2023\_RD2089\_317\_9\_20230306\_00006.jpg

View of the fence gate across levee crown.

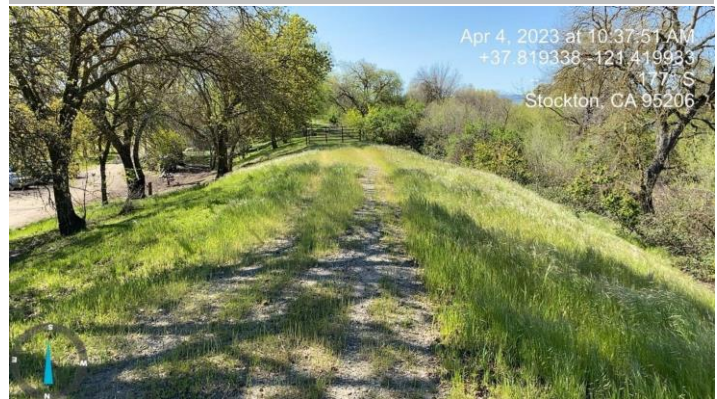
Photo 1 of 1 : SP\_2023\_RD2089\_317\_12\_20230412\_00020.jpg

View of vegetation on levee crown. Spring 2023

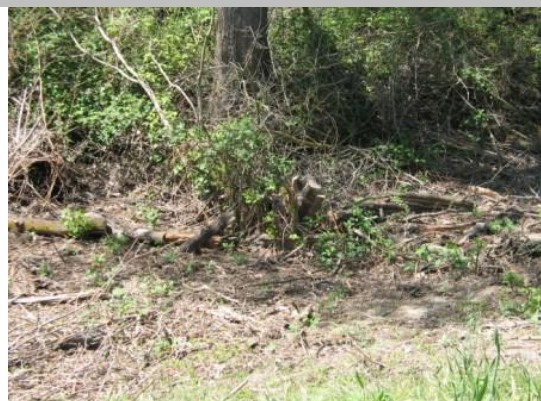
Photo 1 of 1 : SP\_2023\_RD2089\_317\_29\_20230306\_00012.jpg

View of tree stump left after vegetation and tree removal.

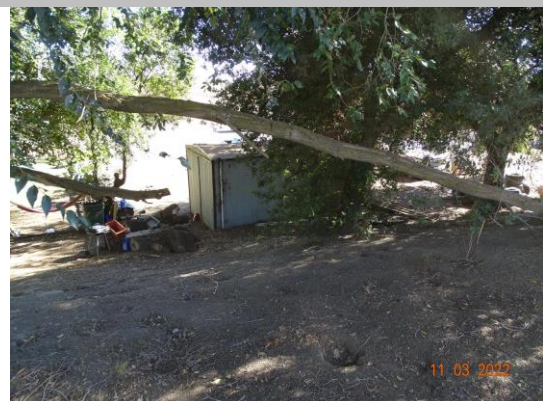
Photo 1 of 1 : SP\_2023\_RD2089\_317\_23\_20230306\_00010.jpg

View of storage container along the landside easement. Fall 2022

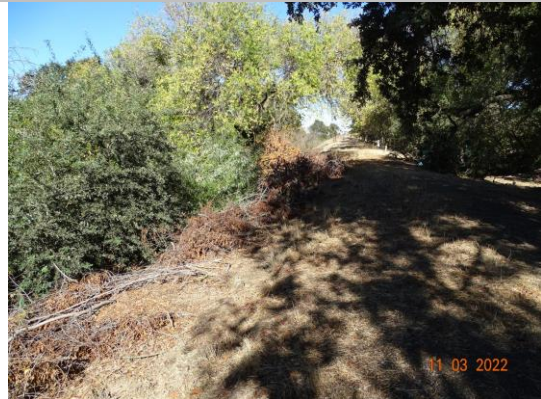
Photo 1 of 1 : SP\_2023\_RD2089\_317\_22\_20230306\_00009.jpg

View of prunings along the waterside slope. Fall 2022

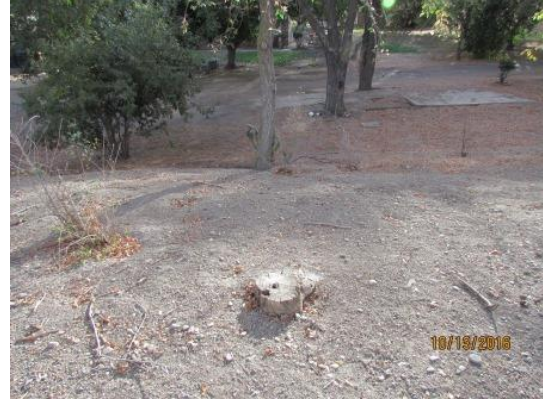
Photo 1 of 1 : SP\_2023\_RD2089\_317\_18\_20230306\_00008.jpg

View of the tree stump from the levee crown.
