Flood Control Project Maintenance
Levee Inspections
LMA District Cover Sheet

Reclamation District No. 2089 Stark

Levee Inspection Report By Mile - Spring 2024

Waterway	Bank	Unit Miles	Inspection Start/End	Inspector
Unit No. 01 Old River	Right	1.51	04/03/2024 04/03/2024	Alberto De Leon

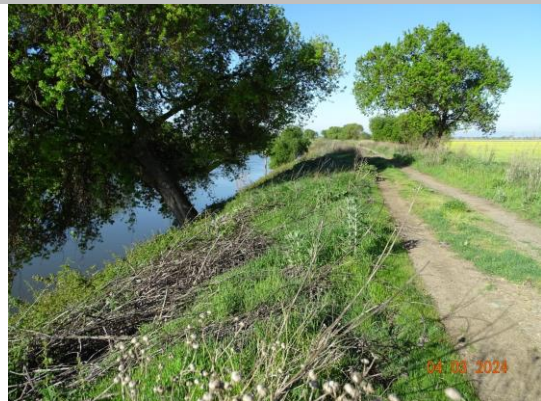
Photo 1 of 1 : SP_2024_RD2089_316_19_20240403_00028.jpg

LM Start	0.02	Rating **	U	Issue No.	19
LM End	1.51	Issue Type +	Ma	Location *	WS
Category	Earthen Levee			GPS Latitude/Longitude	
				Start	End
Item	Vegetation			37.811576°	37.806646°
				-121.385215°	-121.407861°
DWR ID	DWR_RD2089_01_f_2023_19				
Comment Code					
V2 : Remove the wild growth and woody vegetation other than native grasses from the levee slopes.					
Inspector Comment

Typical view of overgrown vegetation along the waterside slope. Spring 2024

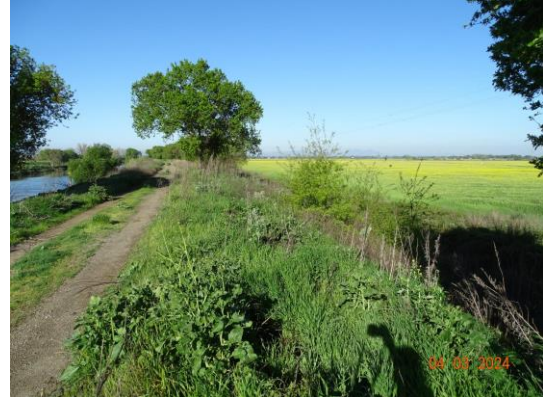
Photo 1 of 1 : SP_2024_RD2089_316_17_20240403_00027.jpg

Typical view of overgrown vegetation along the landside slope and easement. Spring 2024

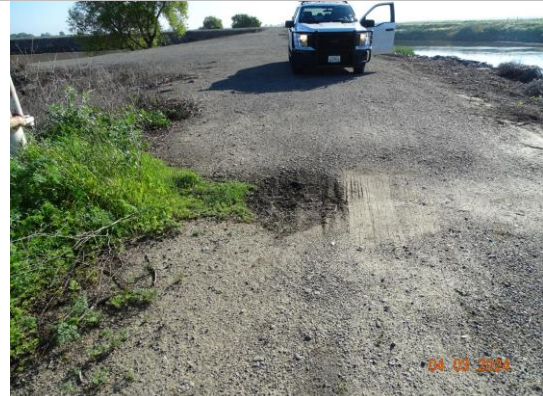
Photo 1 of 1 : SP_2024_RD2089_316_14_20240403_00026.jpg

LM Start	0.02	Rating **	M	Issue No.	14
LM End	0.02	Issue Type +	Ma	Location *	CR
Category	Earthen Levee			GPS Latitude/Longitude	
				Start	End
Item	Crown Surface / Depressions / Rutting			37.811551°	37.811551°
				-121.385287°	-121.385287°
DWR ID	DWR_RD2089_01_f_2022_14				
Comment Code					
C2 : Repair depressions or ruts in the crown or slope.					
Inspector Comment

View of depression on crown of road. Spring 2024

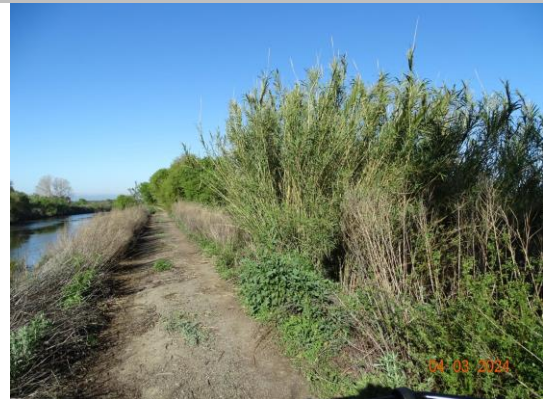
Photo 1 of 1 : SP_2024_RD2089_316_18_20240403_00029.jpg

View of Arundo growing along the landside slope. Spring 2024

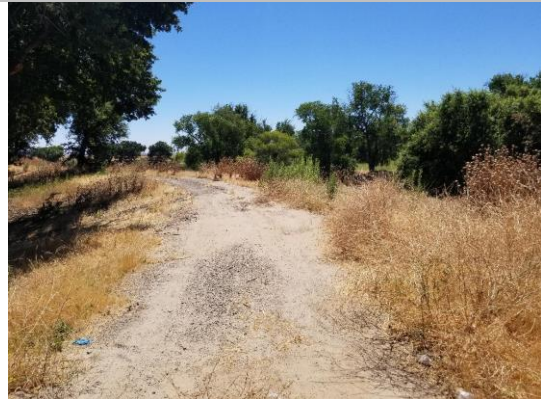
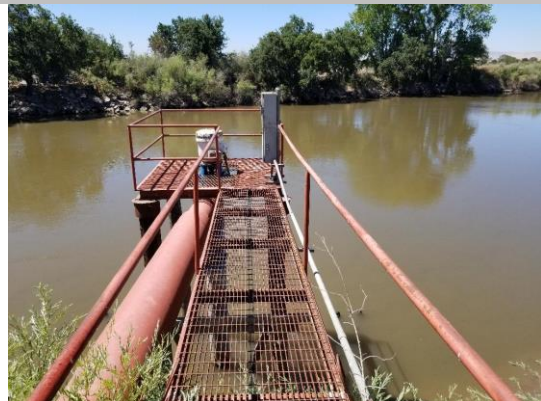
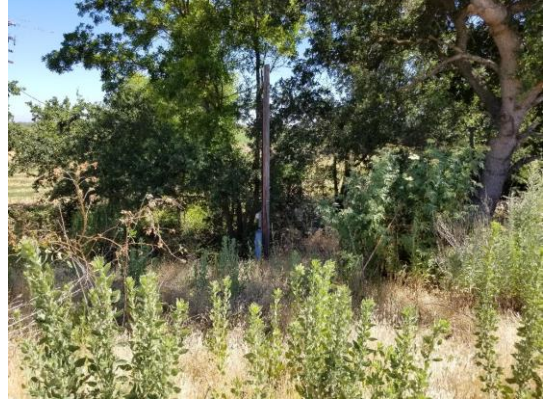
DS_ID:23042
FS_ID:80813
EP_NO: 5641
Repair Type: Non-Urgent
EVAL Issue: 11, Maintenance Compliance Issue
Crossing Status: Found
UCIP Comments: 07/13/2023: Siphon breaker on landside still appears to be damaged. The pipe may be abandoned and no longer in use. (J. Singh - DWR UCIP)09/12/2013: damaged siphon breaker, most of the pipe on landside exposed on levee slope.
FIELD_STRUCT_DESC: 20-inch steel irrigation discharge pipe and electrical conduit through the levee, 5.8 feet below the crown. Pump on a pile structure in the stream. Siphon breaker on the landside (LS) slope. (Plans to replace a rusted out irrigation discharge pipe through the levee authorized under Permit No. 5641, 1967 - Theodore Stark).
[Additional Reference(s): DWR Levee Log, 1991. USACE San Joaquin O&M Manual 8, 1968, (HLM 0.46), 21-inch pipe referenced].
FS Date: 7/13/2023

View of levee crown looking downstream.

View of waterside with steel walkway, electric box, and pump.

View of landside with service pole and electric meter visible.

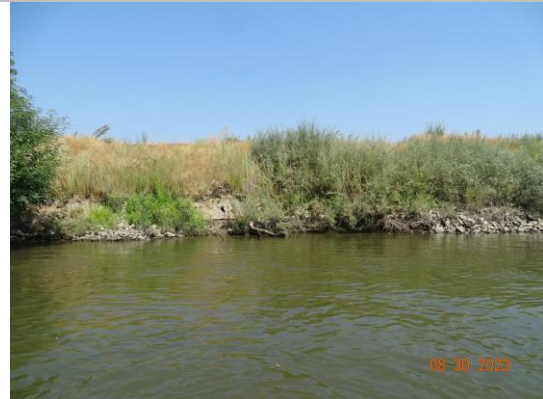
Photo 1 of 1 : SP_2024_RD2089_316_2_20240214_00002.jpg

Comment Code					
Inspector Comment					
Site ID: RD2089U01RM29.61					
8/30/2023: From 2021 to present, no significant changes were observed during the annual survey.					
8/25/21: Less levee slope vegetation has exposed bank undercutting. Increased erosion length to 100 feet.					
09/30/2020: Noticed less vegetation on the upper levee slope and surface erosion above the pocket erosion.					
08/14/2019: From 2011 to 2019, no significant changes were observed during the annual survey.					
09/07/2010: It was difficult to view the erosion due to the Willow thickets and other vegetation at the water line. At the time of the inspection, there were no signs of repair on site. As noted during the last survey, there is a 5-foot vertical scarp along the lower slope that may be subjected to high flow velocities.					
08/05/2010: Recommended for repair, per CLRO; "Erosion of this site may be subjective to rapid rates of erosion."

09/28/2009: No major change observed; 5-foot vertical scarp is immediately downstream of where berm has tapered; site is recommended as local maintenance issue, per CLRO CES Evaluation 2008 Report; Site # is the same as RM29.6, LM0.60; previously rated "U".					
11/05/2008: No change observed; rodent holes on lower slope; wide levee crown.

8/30/2023: View of the erosion.

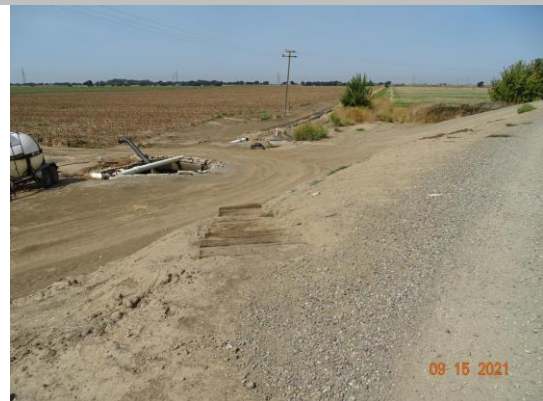
Photo 1 of 1 : SP_2024_RD2089_316_22_20240214_00010.jpg

LM Start	0.80	Rating **	M	Issue No.	22
LM End	0.80	Issue Type +	En	Location *	LS
Category	Earthen Levee			GPS Latitude/Longitude	
				Start	End
Item	Encroachments			37.808466 °	37.808466 °
				-121.397847 °	-121.397847 °
DWR ID	DWR_RD2089_01_f_2016_22				
Comment Code					
ST : Stairway					
Inspector Comment

View of steps on landside slope. Fall 2021

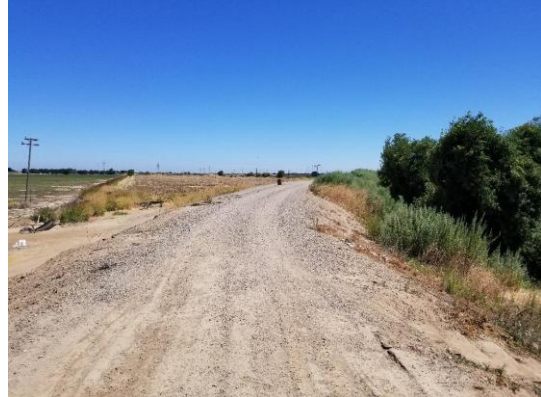
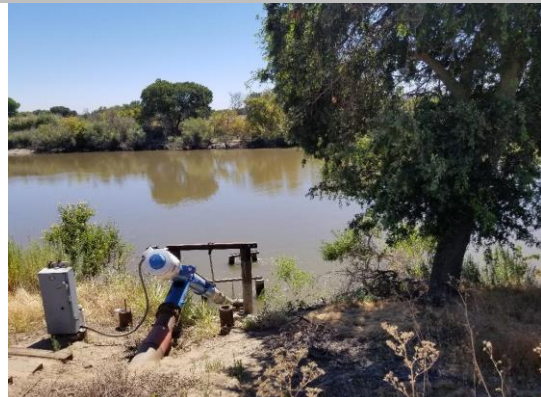
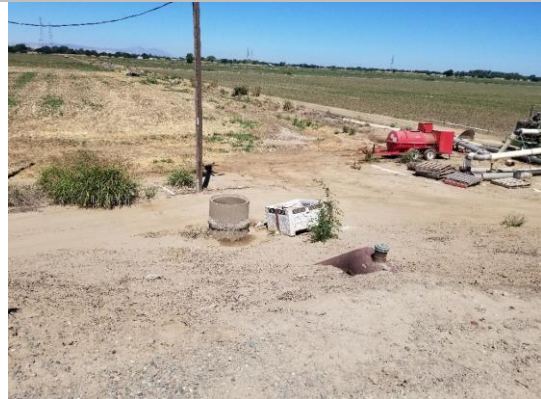
Comment Code						
Inspector Comment						
DS_ID:23043 FS_ID:80758 EP_NO: 3385 Repair Type: Urgent EVAL Issue: 2b, Levee Integrity Crossing Status: Found UCIP Comments: 07/13/2023: Record remains urgent. Erosion visible on waterside slope and crest. No leak in pipe was found during inspection. 08/01/2022 Record updated from Non-Urgent to Urgent. DWR levee inspector reported that pipe has a leak near the waterside shoulder. The leak is causing erosion on the waterside slope under and near the pipe. Water leak on landside slope was noticed, concrete standpipe at landside toe leaks through its joints and overtops. (O.Yakimov - DWR UCIP) 09/12/2013 Powerline on landside. Electric control box on waterside, waterside slope erosion under pump platform. (P.Amatya - DWR UCIP) FIELD_STRUCT_DESC: 16-inch irrigation discharge pipe of an unknown material through the levee, 5.5 feet below the crown. Two cutoff walls. Slant pump in a pump house on the waterside (WS) slope. Siphon breaker on the landside (LS) slope. (Plans for installation of a pumping plant on the riverbank and a pipe that crosses the levee authorized under Permit No. 3385, 1960 - Eleanor M. Lawrence). [Additional Reference(s): DWR Levee Log, 1991. USACE San Joaquin O&M Manual 8, 1968, (HLM 0.81)]. FS Date: 7/13/2023

View of crown looking downstream.

View of waterside with water pump and electric control box.

View of landside with siphon breaker on the slope and concrete standpipe at the toe.

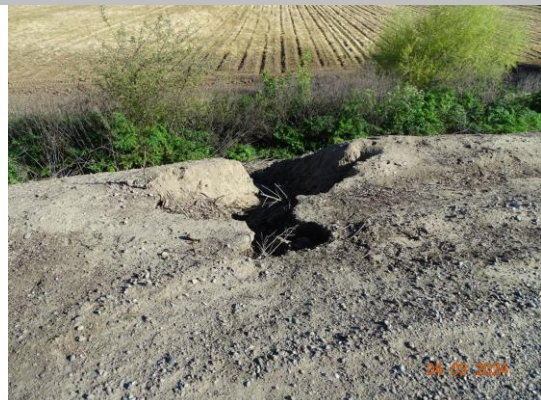
Photo 1 of 1 : SP_2024_RD2089_316_23_20240403_00030.jpg

LM Start	0.99	Rating **	U	Issue No.	23
LM End	0.99	Issue Type +	Ma	Location *	LS
Category	Earthen Levee			GPS Latitude/Longitude	
				Start	End
Item	Erosion / Rills			37.806128°	37.806128°
				-121.398648°	-121.398648°
DWR ID	DWR_RD2089_01_f_2023_23				
Comment Code					
E5 : Schedule repair of rills prior to the next inspection.					
Inspector Comment

View of erosion rills on the landside slope. Spring 2024

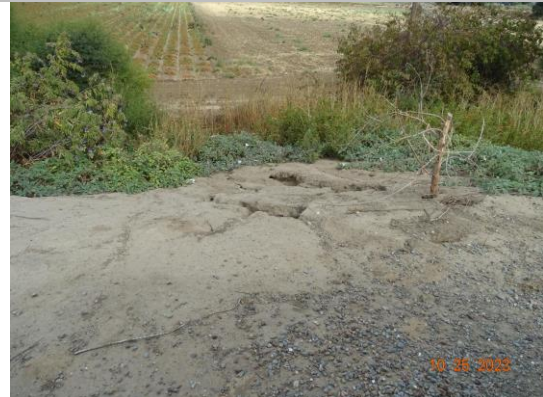
Photo 1 of 1 : SP_2024_RD2089_316_21_20240214_00009.jpg

View of animal burrows on the landside slope. Fall 2023

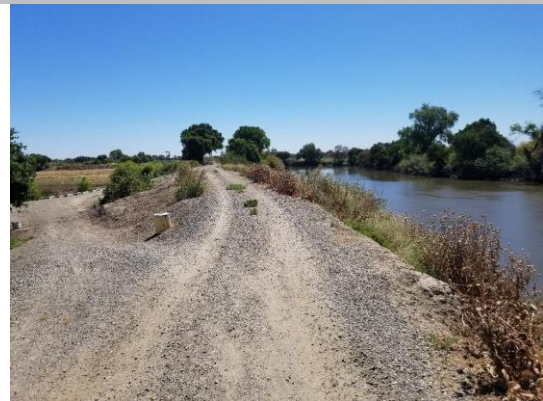
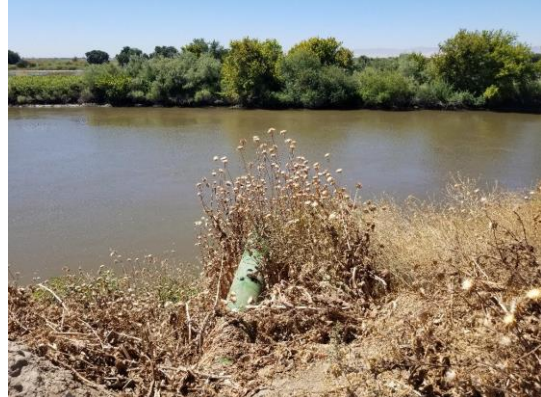
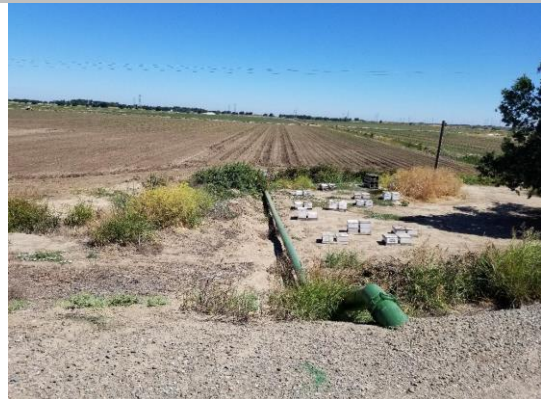
LM Start	1.14	Rating **	U	Issue No.	51
LM End	1.14	Issue Type +	En	Location *	
Category	Supplemental			GPS Latitude/Longitude	
				Start	End
Item	DWR UCIP Field Study			37.805644°	37.805644°
				-121.401177°	-121.401177°
DWR ID	23044

Comment Code					
Inspector Comment					
DS_ID:23044 FS_ID:80815 EP_NO: 3585 Repair Type: Urgent EVAL Issue: 2b, Levee Integrity Crossing Status: Found UCIP Comments: 07/13/2023: Erosion on both slopes. Erosion was greater than 1-ft. Pipe leaks at coupling on landside. (J. Singh - DWR UCIP)11/15/2016: Section of previously-deteriorated pipe along LS berm has been replaced. LS slope and berm have been backfilled and repaired. Crossing has been downgraded from Urgent to No Action Needed. (K. Fazel - UCIP)09/12/2013: huge slope erosion on landside slope, most of the pipe exposed on levee slope, service pole on landside. FIELD_STRUCT_DESC: 12-inch steel drainage discharge pipe through the levee, 3 feet below the crown. Pump over concrete pipe in drainage ditch off the landside (LS) toe. Siphon breaker on the waterside (WS) slope. Air vent on the LS. Landowner is Kent Gikas, (209) 224-4652, kgikas@g-rem.com. (Plans for an existing 12-inch steel discharge pipe over the levee authorized under Permit No. 3585, 1961 - Eleanor Lawrence). [Additional Reference(s): DWR Levee Log, 1991. USACE San Joaquin O&M Manual 8, 1968, (HLM 1.15)]. FS Date: 7/13/2023

View of levee crown looking downstream.

Waterside view of pipe. Dense vegetation is visible

View of landside berm and pipe.

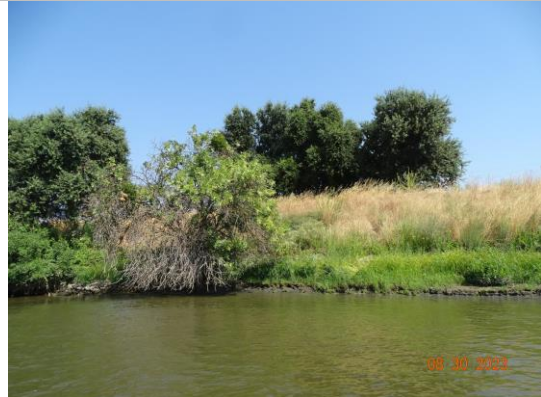
Photo 1 of 1 : SP_2024_RD2089_316_3_20240214_00003.jpg

LM Start	1.22	Rating **	U	Issue No.	3
LM End	1.23	Issue Type +	Ma	Location *	WS
Category	Supplemental			GPS Latitude/Longitude	
				Start	End
Item	DWR Erosion Survey			37.805800°	37.805800°
				-121.402868°	-121.402868°
DWR ID	RD2089U01RM29.04				
Comment Code					
Inspector Comment					
Site ID: RD2089U01RM29.04					
8/30/2023: From 2013 to present, no significant changes were observed during the annual survey.					
08/13/2013: The erosion is around a tree at the levee toe. Dense vegetation is visible.

8/30/2023: View of the erosion.

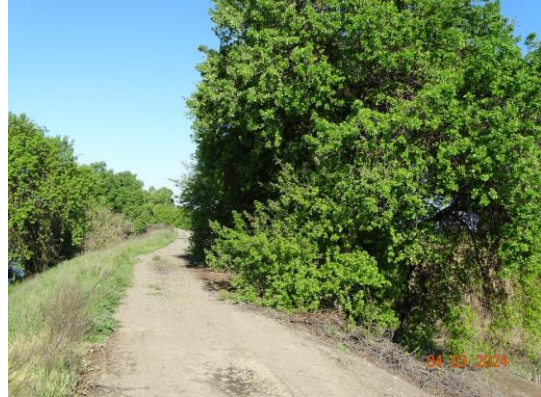
Photo 1 of 1 : SP_2024_RD2089_316_42_20240403_00031.jpg

View of an untrimmed tree on the landside slope. Spring 2024

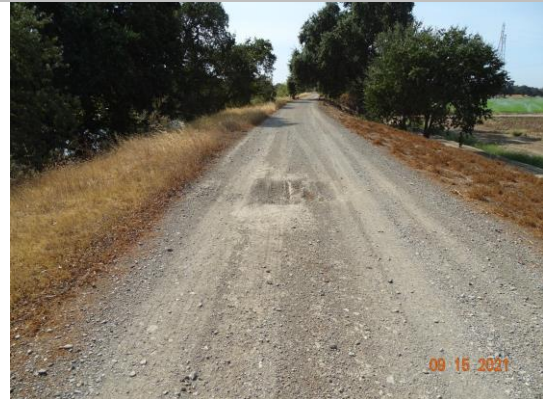
Photo 1 of 1 : SP_2024_RD2089_316_45_20240214_00013.jpg

View of roadway depression. Fall 2021

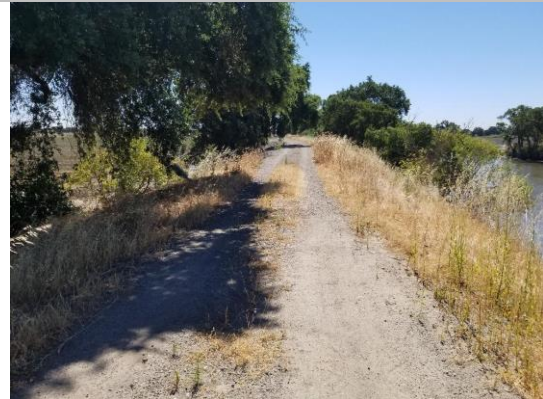
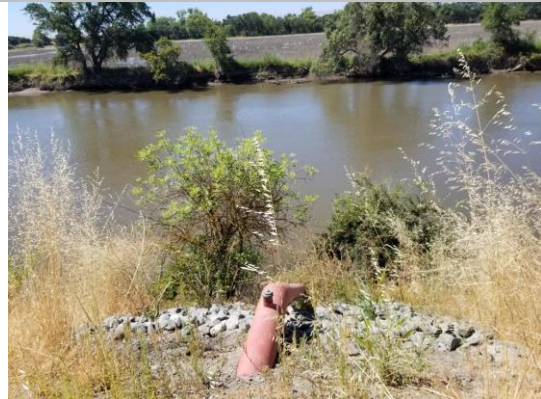
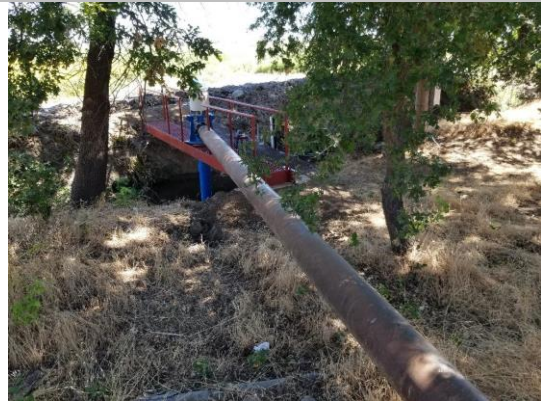
Comment Code					
Inspector Comment					
DS_ID:23045 FS_ID:80816 EP_NO: 7891 Repair Type: Urgent EVAL Issue: 2a, Levee Integrity Crossing Status: Found UCIP Comments: 07/13/2023: Excavation has been backfilled. It is unclear is the compaction is in accordance with O&M standards. Rip-rap also placed on waterside slope. Enforcement Case 2022-15621 remains active. (J. Singh - DWR UCIP) 08/09/2022 NTC Enforcement Case 2022-15621 was issued to this crossing. Excavation on landside slope measured 3-feet wide by 20-feet long by 5-feet deep. Excavation on waterside slope measured 3-feet wide by 20-feet long by 3-feet deep. Annular space between sleeved pipes not grouted. (O.Yakimov - DWR UCIP) 08/01/2022 Record updated from Non-Urgent to Urgent. DWR levee inspector reported that this pipe has been replaced with a new pipe, unable to locate a permit for modifications. Landside slope has an open trench and the waterside slope has a significant erosion under the pipe. Both landside and waterside slope need to be recompacted in accordance with O&M standards. Unauthorized encroachment recorded in Levee Log. (O. Yakimov - DWR UCIP) 09/12/2013: siphon breaker needs repair. (P. Amatya - DWR UCIP) FIELD_STRUCT_DESC: 8-inch steel drainage discharge pipe sleeved through 10-inch pipe through the levee, 2.4 feet below the crown, annular space not grouted. Pipe diameter on waterside grows to 10-inch, 8-inch pipe is connected to existing 10-inch pipe at landside toe via coupler with welded diameter reduction. Pump in a drainage ditch on the landside (LS). Siphon breaker on the waterside (WS) shoulder. (10-inch pipe authorized under Permit No. 7981, 1972 - Frank Pellegri). [Additional Reference(s): DWR Levee Log, 1991]. FS Date: 7/13/2023

View of levee crown looking downstream.

View of waterside steel pipe with siphon breaker. Rip-rap placed along the slope.

View of landside with steel pipe and pump in the drainage ditch.

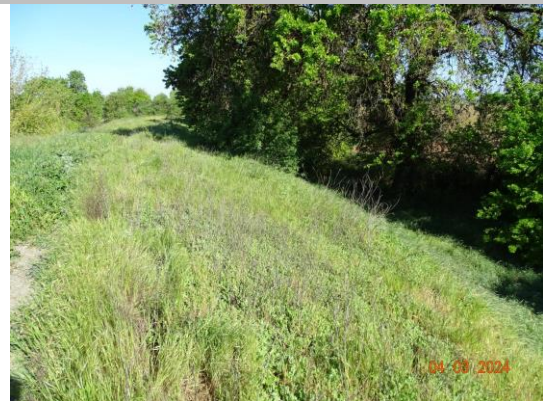
Photo 1 of 1 : SP_2024_RD2089_317_19_20240403_00017.jpg

Typical view of overgrown vegetation along the landside slope and easement. Spring 2024

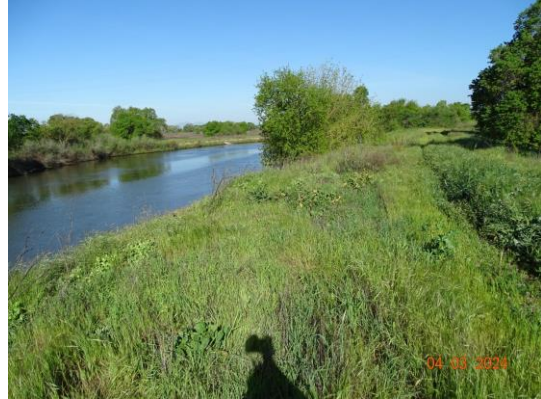
Photo 1 of 1 : SP_2024_RD2089_317_21_20240403_00018.jpg

Typical view of overgrown vegetation along the waterside slope. Spring 2024

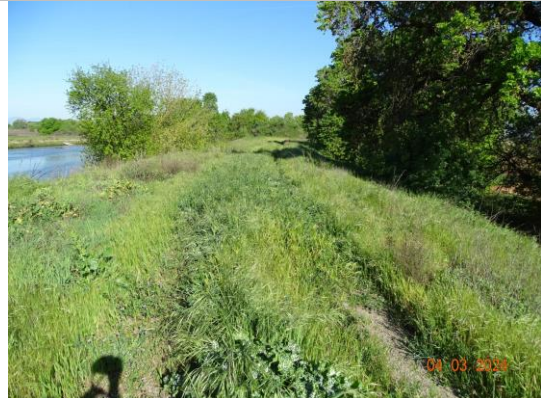
Photo 1 of 1 : SP_2024_RD2089_317_5_20240403_00019.jpg

LM Start	0.00	Rating **	U	Issue No.	5
LM End	0.35	Issue Type +	Ma	Location *	CR
Category	Earthen Levee			GPS Latitude/Longitude	
				Start	End
Item	Vegetation			37.806652°	37.810068°
				-121.407886°	-121.412168°
DWR ID	DWR_RD2089_02_s_2024_5				
Comment Code					
V2 : Remove the wild growth and woody vegetation other than native grasses from the levee slopes.					
Inspector Comment

Typical view of vegetation along the crown surface. Spring 2024

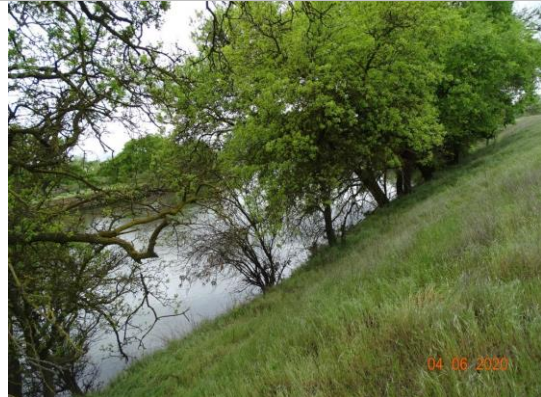
Photo 1 of 1 : SP_2024_RD2089_317_46_20240214_00014.jpg

LM Start	0.20	Rating **	A/W	Issue No.	46
LM End	0.21	Issue Type +	Ma	Location *	WS
Category	Earthen Levee			GPS Latitude/Longitude	
				Start	End
Item	Erosion / Bank Caving			37.809100°	37.809200°
				-121.409800°	-121.409900°
DWR ID	LMA-415				
Comment Code					
E1 : Note and monitor erosion site.					
Inspector Comment					
2017 Storm Damage Site, ID No. 509, LMA 415, displaced riprap at toe. Inspected: Fall 2020, vegetation did not allow inspection of rip rap.

View of erosion site on waterside slope. Spring 2020

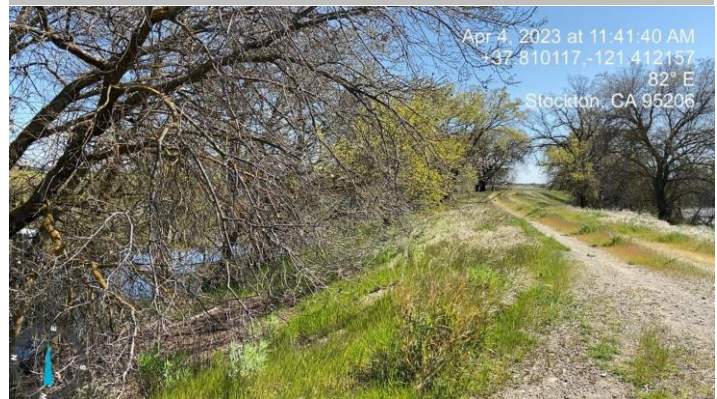
Photo 1 of 1 : SP_2024_RD2089_317_55_20240214_00015.jpg

LM Start	0.33	Rating **	M	Issue No.	55
LM End	0.34	Issue Type +	Ma	Location *	LS
Category	Earthen Levee			GPS Latitude/Longitude	
				Start	End
Item	Trim / Thin Trees			37.810030°	37.810052°
				-121.411672°	-121.411966°
DWR ID	DWR_RD2089_02_s_2017_55				
Comment Code					
T1 : Trim and thin trees to at least five feet above ground level to allow visibility of the ground and room to flood fight.					
Inspector Comment

View of tree branches that need to be thinned and trimmed on the landside levee slope. Spring 2023

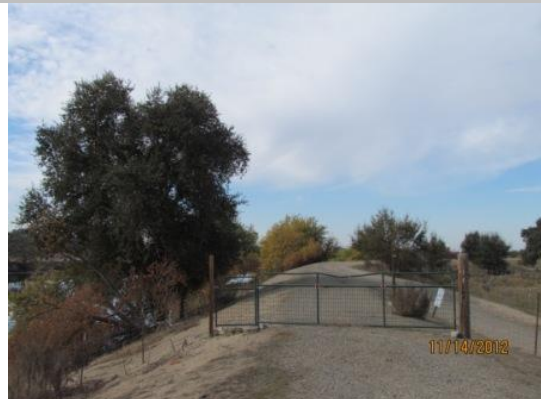
Photo 1 of 1 : SP_2024_RD2089_317_2_20240214_00002.jpg

View of gate across levee crown.

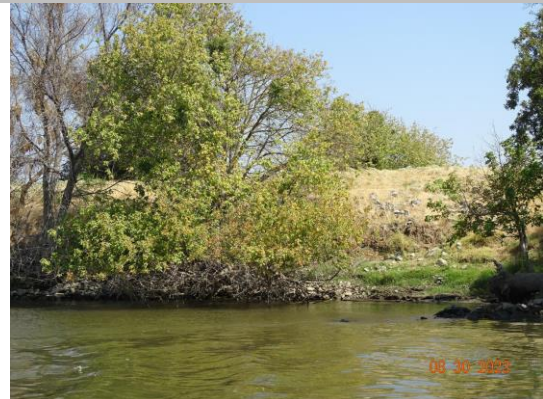
Photo 1 of 1 : SP_2024_RD2089_317_1_20240214_00001.jpg

Comment Code					
Inspector Comment					
Site ID: RD2089U02RM28.35					
8/30/2023: From 2020 to present, no significant changes were observed during the annual survey.					
09/22/2020: Observed less vegetation on the levee slope, loose soil, and scattered riprap.					
09/26/2019: From 2011 to 2019, no significant changes were observed during the annual survey.					
09/07/2010: Site consists of a jutting rip rap that has created an eddy, scouring the levee slope. Most sections of the toe and lower slope are lined with rip rap. However, the rip rap is sloughing on the mid slope and at the toe, exposing the underlying soils and tree roots. The remaining revetment is no longer adequately protecting the slope. There are 3 Sycamore trees at the toe with exposed tree roots.					
08/05/2010: Recommended for repair, per CLRO.					
09/28/2009: Pocket erosion on lower slope just above the toe rip rap; protruding rip rap upstream is creating an eddy, scouring the levee slope; Site # is the same as RM28.40,LM0.30; previously rated "U"; pictures will be made available during the next survey.

11/05/2008: Cut into levee profile; riprap slide; rodent holes; pictures do not match GPS and current condition.

8/30/2023: Close-up view of the eroded levee slope.

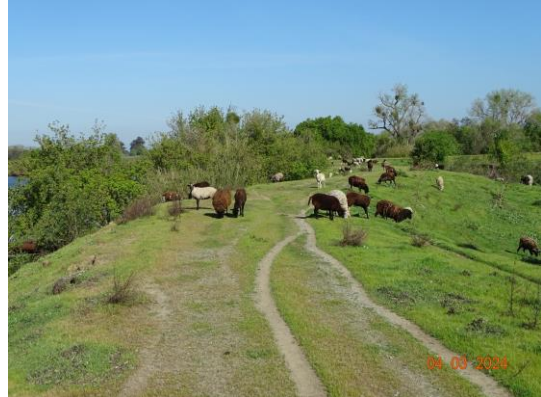
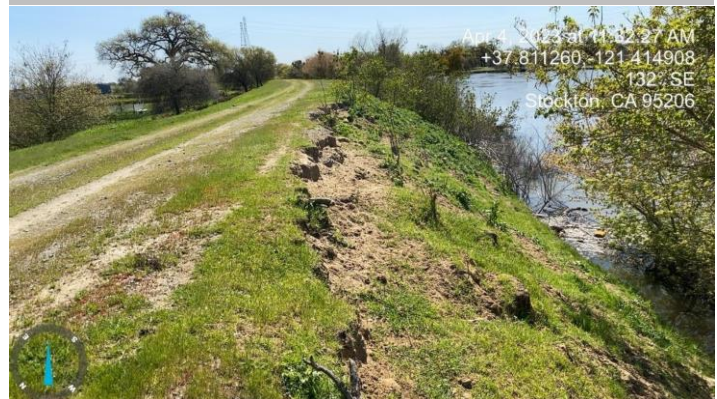
LM Start	0.50	Rating **	U	Issue No.	7
LM End	0.54	Issue Type +	Ma	Location *	WS
Category	Earthen Levee			GPS Latitude/Longitude	
				Start	End
Item	Erosion / Livestock			37.810999°	37.811380°
				-121.414532°	-121.415059°
DWR ID	DWR_RD2089_02_s_2022_7				
Comment Code					
E4 : Repair the levee slope damaged by livestock and prevent large animal access.					
Inspector Comment					
The slope near the waterside hinge is eroded caused by grazing livestock.

View of livestock grazing on levee slopes. Spring 2024

View of eroded waterside slope caused by livestock. Spring 2023

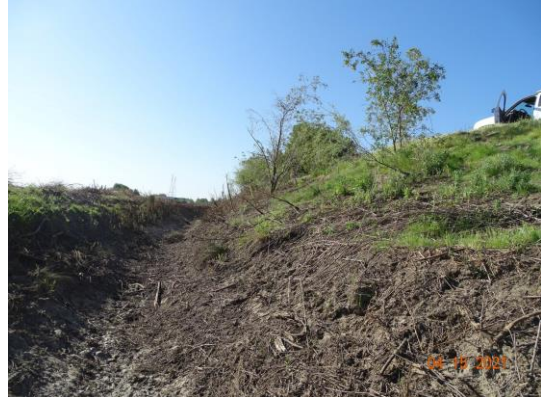
Photo 1 of 1 : SP_2024_RD2089_317_62_20240214_00016.jpg

View of an irrigation ditch within the landside easement. Spring 2021

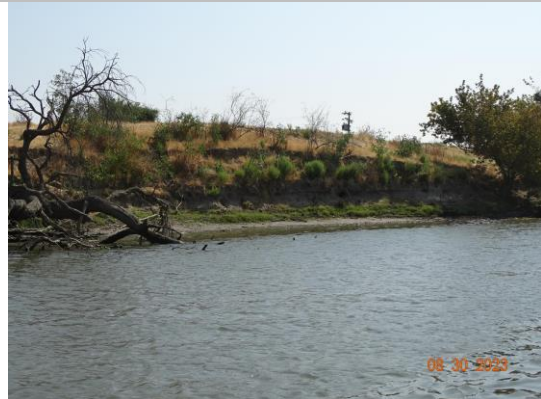
Photo 1 of 1 : SP_2024_RD2089_317_3_20240214_00003.jpg

8/30/2023: View of the erosion.

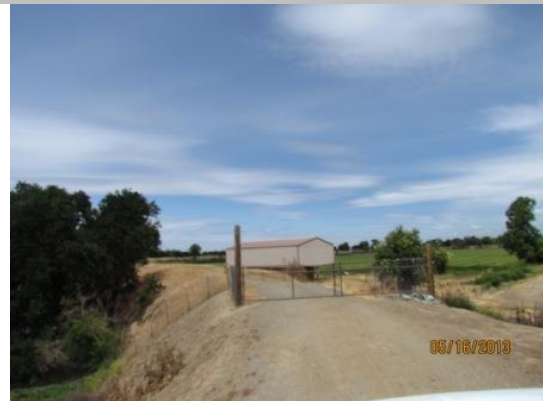
Photo 1 of 1 : SP_2024_RD2089_317_9_20240214_00005.jpg

View of the fence gate across levee crown.

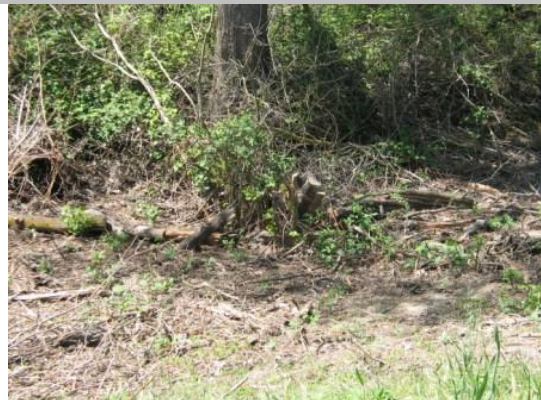
Photo 1 of 1 : SP_2024_RD2089_317_29_20240214_00013.jpg

View of tree stump left after vegetation and tree removal.

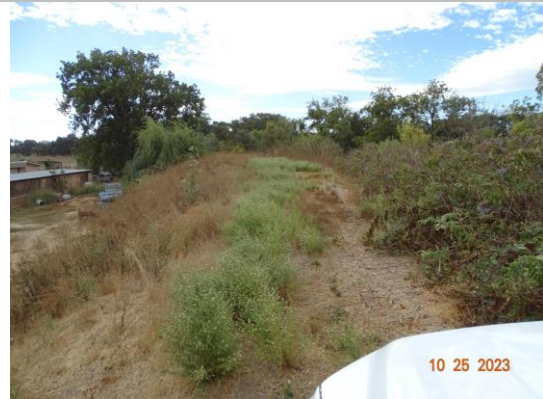
Photo 1 of 1 : SP_2024_RD2089_317_20_20240214_00009.jpg

Typical view of overgrown vegetation along the crown. Fall 2023

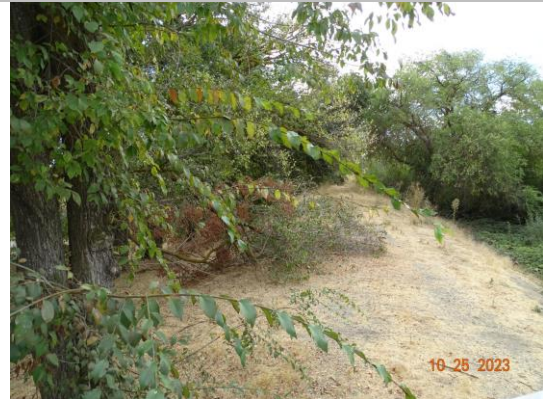
Photo 1 of 1 : SP_2024_RD2089_317_13_20240214_00006.jpg

View of untrimmed trees over the crown. Fall 2023

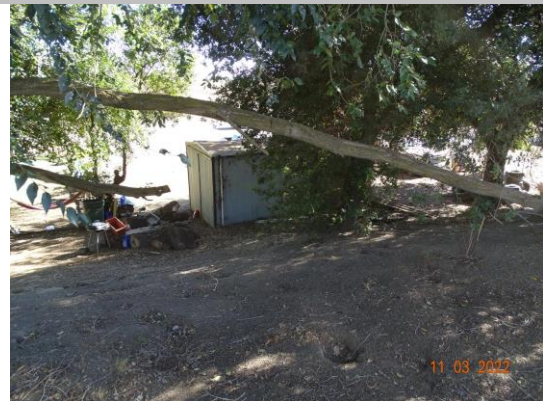
Photo 1 of 1 : SP_2024_RD2089_317_23_20240214_00012.jpg

View of storage container along the landside easement. Fall 2022

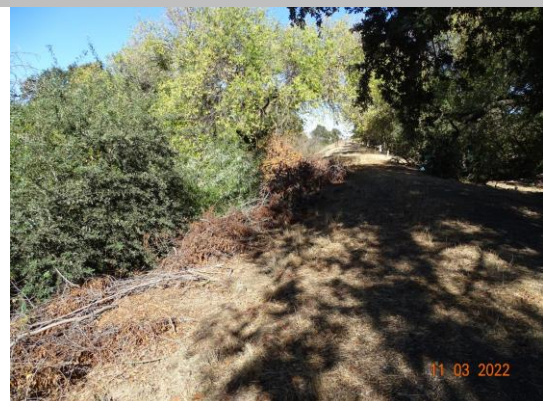
Photo 1 of 1 : SP_2024_RD2089_317_22_20240214_00011.jpg

View of prunings along the waterside slope. Fall 2022

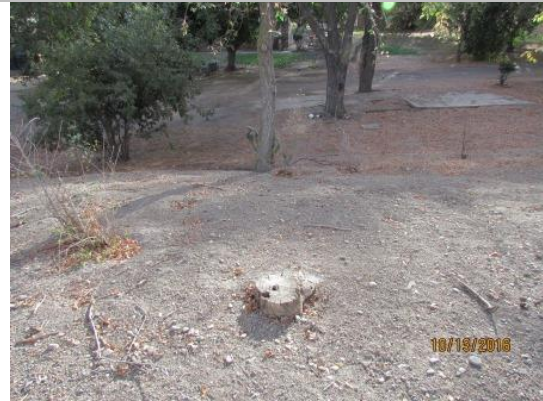
Photo 1 of 1 : SP_2024_RD2089_317_18_20240214_00007.jpg

View of the tree stump from the levee crown.
