**Flood Control Project Maintenance
Levee Inspections**

Maintenance Issue Types Only, Levee Inspection Report By Mile - Fall 2014

Reclamation District No. 2089 Stark

Waterway	Bank	Unit Miles	Inspection Start/End	Inspector
Unit No. 01 Old River	Right	1.51	10/27/2014 10/27/2014	Maksim Khashchuk

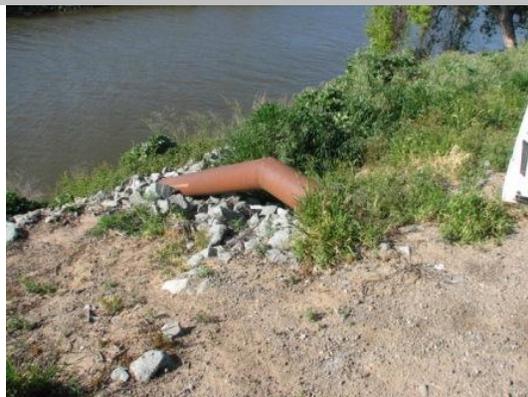
Photo 1 of 1 : FA_2014_RD2089_316_7_20141001_00005.jpg

LM Start	0.04	Rating **	A/W	Issue No.	7
LM End	0.04	Issue Type +	Ma	Location *	LS
Category	Earthen Levee		GPS Latitude/Longitude		
			Start	End	
Item	Encroachments		37.811467 °	37.811467 °	
			-121.385569 °	-121.385569 °	
DWR ID	DWR_RD2089_01_s_2012_7				
Action/Comments					
Pipe Inspector Comments: Drainage pump

Waterside of drainage discharge to Old River.

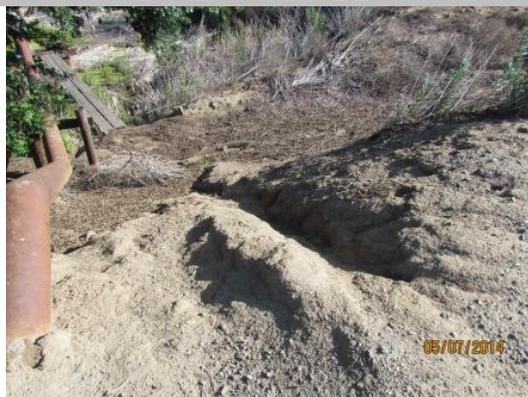
Photo 1 of 1 : FA_2014_RD2089_316_1_20141001_00001.jpg

LM Start	0.04	Rating **	M	Issue No.	1
LM End	0.04	Issue Type +	Ma	Location *	LS
Category	Earthen Levee		GPS Latitude/Longitude		
			Start	End	
Item	Encroachments		37.811474 °	37.811474 °	
			-121.385573 °	-121.385573 °	
DWR ID	DWR_RD2089_01_s_2012_1				
Action/Comments					
Stairway Inspector Comments: Steps have been cut into the levee slope, this could become an erosion point, please fill and compact.

View of the stairs eroding into the landside levee slope.

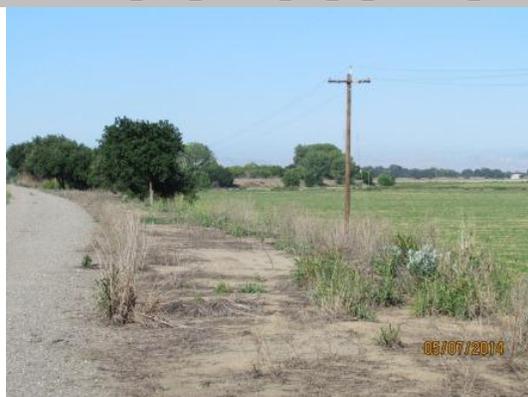
Photo 1 of 1 : FA_2014_RD2089_316_42_20141001_00020.jpg

LM Start	0.07	Rating **	M	Issue No.	42
LM End	0.14	Issue Type +	Ma	Location *	LS
Category	Earthen Levee		GPS Latitude/Longitude		
			Start	End	
Item	Vegetation		37.811368 °	37.811048 °	
			-121.386085 °	-121.387242 °	
DWR ID	DWR_RD2089_01_f_2013_42				
Action/Comments					
Remove the wild growth other than native grasses from the levee slopes.

View of the tall vegetation obstructing visibility of the landside levee slope.

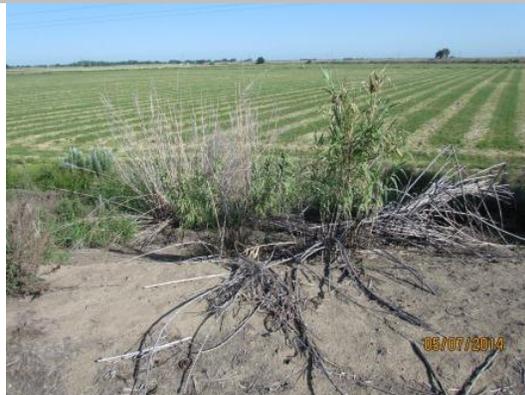
Photo 1 of 1 : FA_2014_RD2089_316_940_20141001_00028.jpg

LM Start	0.25	Rating **	M	Issue No.	940
LM End	0.25	Issue Type +	Ma	Location *	LS
Category	Earthen Levee		GPS Latitude/Longitude		
			Start	End	
Item	Vegetation		37.810412 °	37.810412 °	
			-121.389115 °	-121.389115 °	
DWR ID	DWR_RD2089_01_s_2012_940				
Action/Comments					
Remove the wild growth other than native grasses from the levee slopes. Inspector Comments: Arundo has been trimmed back from the crown but still remains as an obstruction to the slope and obstructs visibility, needs to be removed.

The LMA is actively trying to remove the vegetation on the landside levee slope and toe.

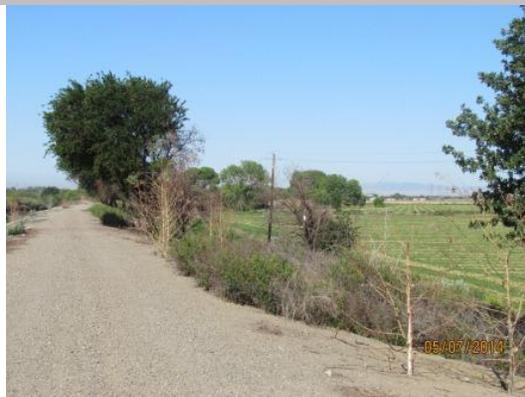
Photo 1 of 1 : FA_2014_RD2089_316_12_20141001_00007.jpg

LM Start	0.27	Rating **	U	Issue No.	12
LM End	0.39	Issue Type +	Ma	Location *	LS
Category	Earthen Levee		GPS Latitude/Longitude		
			Start	End	
Item	Vegetation		37.810319 °	37.809740 °	
			-121.389510 °	-121.391645 °	
DWR ID	DWR_RD2089_01_s_2012_12				
Action/Comments					
Remove the wild growth other than native grasses from the levee slopes. Inspector Comments: Access and visibility completely blocked. 11/10/2011 issue has not changed.

Thick brush and wild rose completely block access and visibility of landside slope and toe.

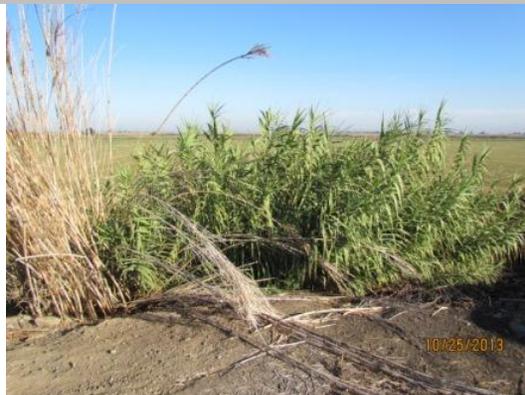
Photo 1 of 1 : FA_2014_RD2089_316_19_20141001_00010.jpg

LM Start	0.34	Rating **	M	Issue No.	19
LM End	0.34	Issue Type +	Ma	Location *	LS
Category	Earthen Levee		GPS Latitude/Longitude		
			Start	End	
Item	Vegetation		37.809978 °	37.809978 °	
			-121.390704 °	-121.390704 °	
DWR ID	DWR_RD2089_01_s_2012_19				
Action/Comments					
Remove the wild growth other than native grasses from the levee slopes. Inspector Comments: Bamboo completely blocks access and visibility. 11/10/2011 Arundo has been trimmed back from the roadway, but still completely blocks access and visibility to the landside slope. This plant was improperly identified as bamboo in previous inspections.

Arundo has been trimmed back from the road, but needs to be removed so that it does not obstruct visibility and access to the landside toe.

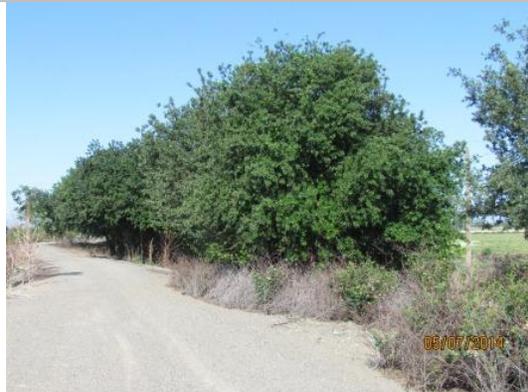
Photo 1 of 1 : FA_2014_RD2089_316_946_20141001_00029.jpg

Trees on levee slope obstruct access and visibility.

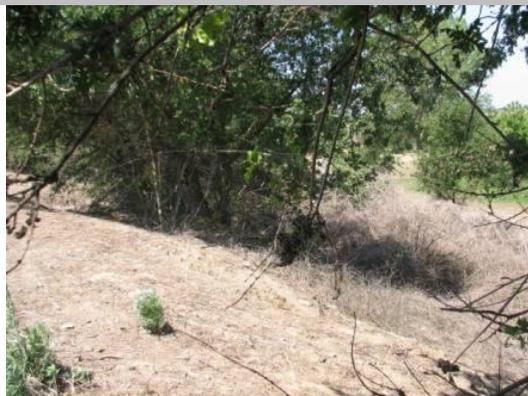
Photo 1 of 1 : FA_2014_RD2089_316_28_20141001_00014.jpg

LM Start	0.42	Rating **	U	Issue No.	28
LM End	0.48	Issue Type +	Ma	Location *	LS
Category	Earthen Levee			GPS Latitude/Longitude	
				Start	End
Item	Vegetation			37.809593 °	37.809507 °
				-121.391963 °	-121.392907 °
DWR ID	DWR_RD2089_01_s_2012_28				
Action/Comments					
Remove the wild growth other than native grasses from the levee slopes. Inspector Comments: Vegetation is too thick to allow access and visibility.

05/24/2011 Photo shows thick dead vegetation and continuation of trees in area that are preventing access and visibility of landside slope and toe.

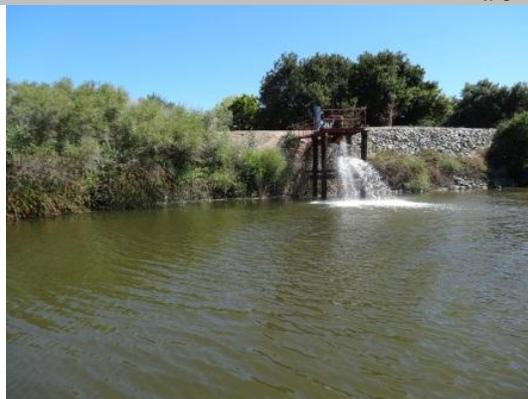
Photo 1 of 1 : SJR2014_RD2089U01RM29.8_1.jpg

LM Start	0.45	Rating **	M	Issue No.	5
LM End	0.45	Issue Type +	Ma	Location *	WS
Category	Supplemental			GPS Latitude/Longitude	
				Start	End
Item	DWR Erosion Survey			37.809394 °	37.809394 °
				-121.392791 °	-121.392791 °
DWR ID					
Action/Comments					
Inspector Comments: 07/02/2014: No significant change observed. 08/13/2013: No significant change observed. 08/07/2012: The site has been visited by boat survey. No significant change observed 08/23/2011: The site shows loose material around the pipe crossing. The operation of the pipe might have caused an impact on the levee. [2014 Site ID:RD2089U01RM29.8]

Front view of the site.

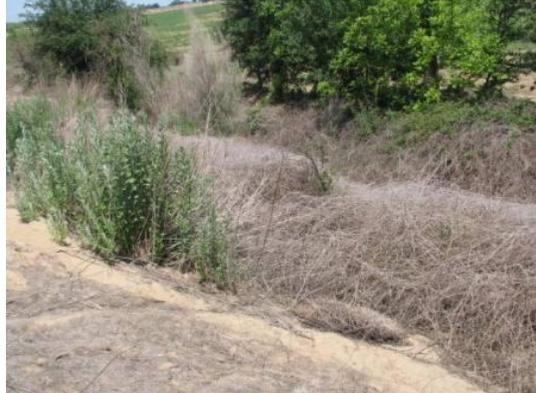
Photo 1 of 1 : FA_2014_RD2089_316_30_20141001_00015.jpg

05/24/2011 Dead brush is too thick to allow access and visibility of landside slope and toe.

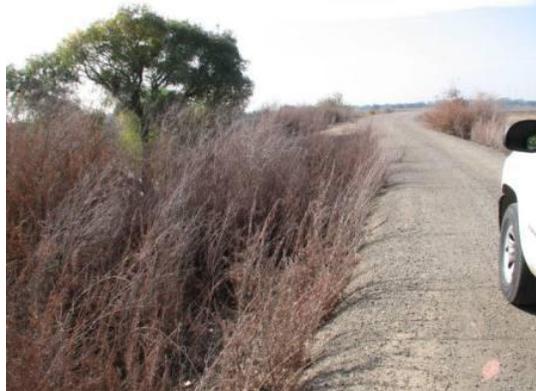
Photo 1 of 1 : FA_2014_RD2089_316_18_20141001_00009.jpg

LM Start	0.64	Rating **	M	Issue No.	18
LM End	1.53	Issue Type +	Ma	Location *	WS
Category	Earthen Levee		GPS Latitude/Longitude		
			Start	End	
Item	Vegetation		37.810048 °	37.806534 °	
			-121.395762 °	-121.407531 °	
DWR ID	DWR_RD2089_01_s_2012_18				
Action/Comments					
Remove the wild growth other than native grasses from the levee slopes. Inspector Comments: 11/10/2011 Waterside vegetation is too thick to allow access and visibility.

11/10/2011 Vegetation needs to be cleared on the upper 20' of the waterside slope.

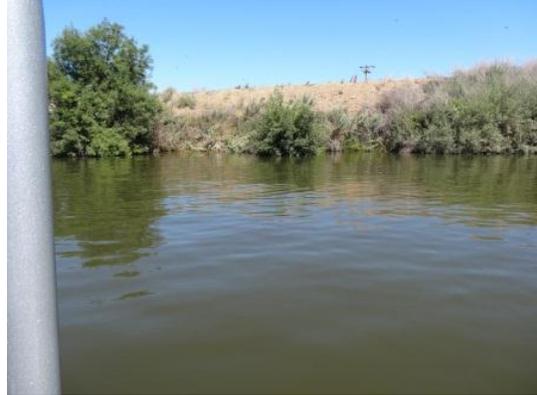
Photo 1 of 1 : SJR2014_RD2089U01RM29.61_1.jpg

LM Start	0.66	Rating **	U	Issue No.	3
LM End	0.66	Issue Type +	Ma	Location *	WS
Category	Supplemental		GPS Latitude/Longitude		
			Start	End	
Item	DWR Erosion Survey		37.809780 °	37.809780 °	
			-121.396230 °	-121.396230 °	
DWR ID					
Action/Comments					
<p>Inspector Comments: 07/02/2014: No significant change observed. 08/13/2013: No significant change observed. 08/07/2012: The site has been visited by boat survey. No significant change observed 08/23/2011: The 5-foot vertical scarp shows no significant change from the last year inspection. No new erosion activities observed. Dense white willow trees on site. 09/07/2010: It was difficult to view the erosion due to the thick Willow thickets and other vegetation at the water line. At the time of the inspection, there were no signs of repair on site. As noted during the last survey, there is a 5-foot vertical scarp along the lower slope that may be subjected to high flow velocities. 08/05/2010: Recommended for repair, per CLRO; "Erosion of this site may be subjective to rapid rates of erosion." 09/28/2009: No major change observed; 5-foot vertical scarp is immediately downstream of where berm has tapered; site is recommended as local maintenance issue, per CLRO CES Evaluation 2008 Report; Site # is the same as RM29.6, LM0.60; previously rated "U". 11/05/2008: No change observed; rodent holes on lower slope; wide levee crown. [2014 Site ID:RD2089U01RM29.61]</p>

Front view of the site. The scarp is visible on the slope.

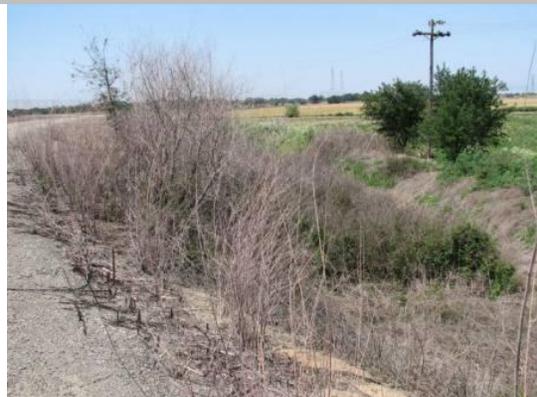
Photo 1 of 1 : FA_2014_RD2089_316_31_20141001_00016.jpg

LM Start	0.67	Rating **	U	Issue No.	31
LM End	0.68	Issue Type +	Ma	Location *	LS
Category	Earthen Levee		GPS Latitude/Longitude		
			Start	End	
Item	Vegetation		37.809975 °	37.809822 °	
			-121.396107 °	-121.396376 °	
DWR ID	DWR_RD2089_01_s_2012_31				
Action/Comments					
<p>Remove the wild growth other than native grasses from the levee slopes. Inspector Comments: Dead brush needs to be removed, too thick to allow access and obstructs visibility of levee slope and toe</p>

05/24/2011 Vegetation is mostly dead but needs to be removed to allow access and visibility of slope and toe.

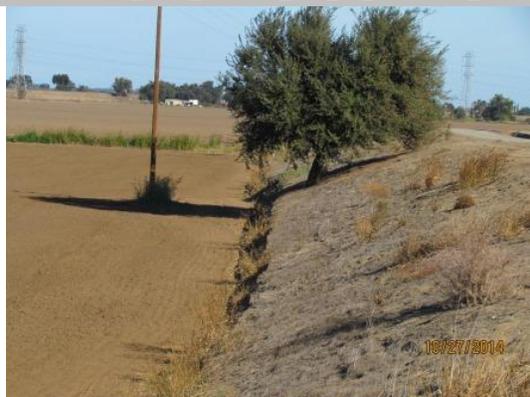
Photo 1 of 1 : FA_2014_RD2089_316_17_20141027_00035.jpg

LM Start	0.83	Rating **	M	Issue No.	17
LM End	0.96	Issue Type +	Ma	Location *	LS
Category	Earthen Levee		GPS Latitude/Longitude		
			Start	End	
Item	Slope Stability		37.808319 °	37.806453 °	
			-121.397881 °	-121.397755 °	
DWR ID	DWR_RD2089_01_f_2014_17				
Action/Comments					
Repair slope instability. Inspector Comments: Landside levee toe cut due to farming.

View of the vertical cut along the landside levee toe.

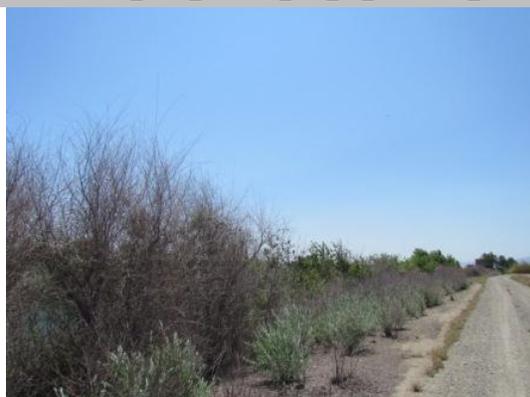
Photo 1 of 1 : FA_2014_RD2089_316_36_20141001_00019.jpg

LM Start	0.85	Rating **	M	Issue No.	36
LM End	0.97	Issue Type +	Ma	Location *	WS
Category	Earthen Levee		GPS Latitude/Longitude		
			Start	End	
Item	Vegetation		37.807938 °	37.806361 °	
			-121.397898 °	-121.397778 °	
DWR ID	DWR_RD2089_01_s_2012_36				
Action/Comments					
Remove the wild growth other than native grasses from the levee slopes. Inspector Comments: Tall weeds and brush on top 20' of waterside slope obstruct visibility.

View of tall weeds and brush obstructing visibility on waterside slope.
05/24/2012

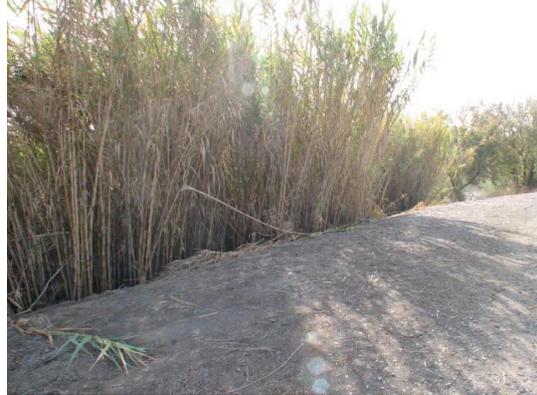
Photo 1 of 1 : FA_2014_RD2089_316_33_20141001_00017.jpg

11/10/2011 Arundo on upper 20' of waterside slope.

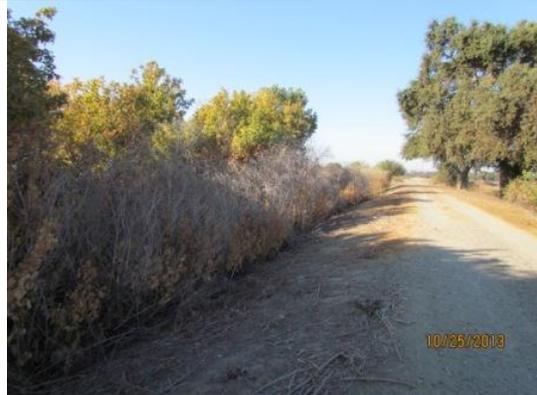
Photo 1 of 1 : FA_2014_RD2089_316_35_20141001_00018.jpg

Thick vegetation on upper 20' of waterside slope obstructing visibility and access.

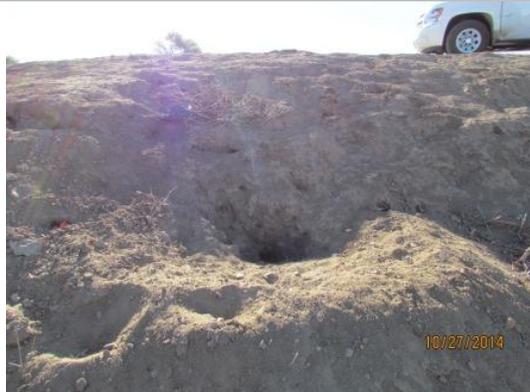
Photo 1 of 1 : FA_2014_RD2089_316_16_20141027_00034.jpg

View of the rodent burrow on the landside levee slope.

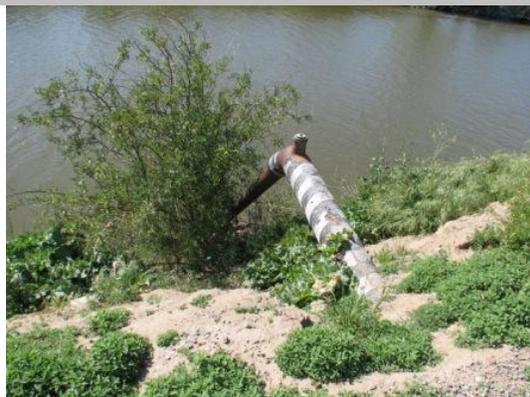
Photo 1 of 1 : FA_2014_RD2089_316_21_20141001_00012.jpg

Drainage discharge into Old River.

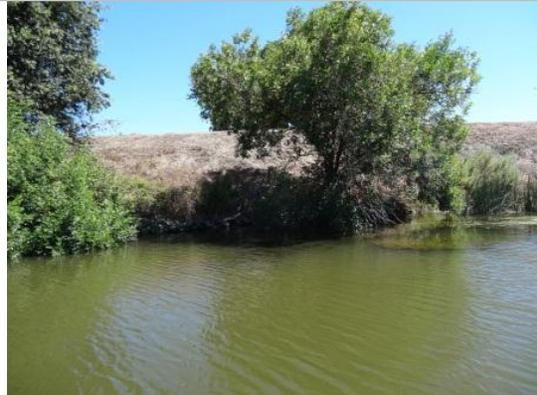
Photo 1 of 1 : SJR2014_RD2089U01RM29.04_1.jpg

LM Start	1.22	Rating **	M	Issue No.	2
LM End	1.23	Issue Type +	Ma	Location *	WS
Category	Supplemental		GPS Latitude/Longitude		
			Start	End	
Item	DWR Erosion Survey		37.805580 °	37.805580 °	
			-121.403010 °	-121.403010 °	
DWR ID					
Action/Comments					
Inspector Comments: 07/02/2014: No significant change observed. 08/13/2013: The erosion is around a tree at the levee toe. Dense vegetation is visible. [2014 Site ID:RD2089U01RM29.04]

Close view of the site. Note the tree and the vegetation.

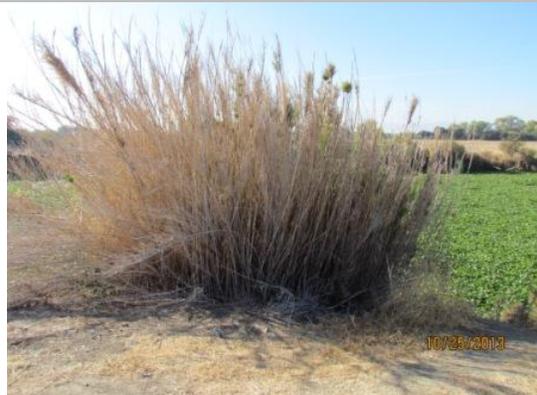
Photo 1 of 1 : FA_2014_RD2089_316_25_20141001_00013.jpg

View of the Arundo on the waterside slope obstructing visibility. LMA is actively trying to remove the wild growth.

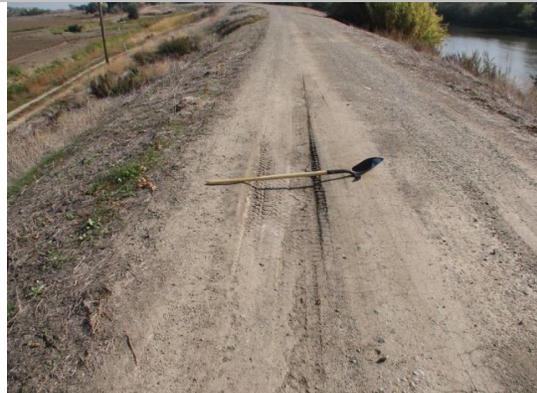
Photo 1 of 1 : FA_2014_RD2089_316_43_20141001_00021.jpg

11/10/2011 Depression in roadway.

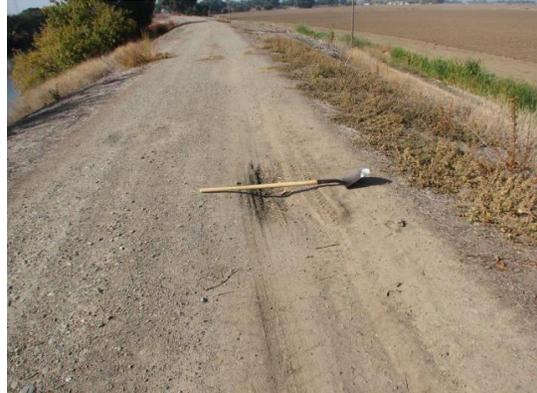
Photo 1 of 1 : FA_2014_RD2089_316_44_20141001_00022.jpg

11/10/2011 Roadway depression.

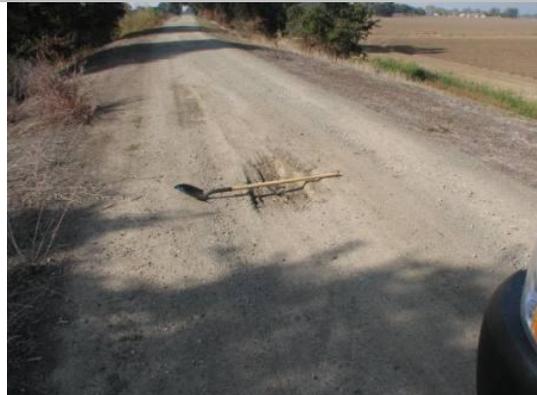
Photo 1 of 1 : FA_2014_RD2089_316_45_20141001_00023.jpg

11/10/2011 Roadway depression.

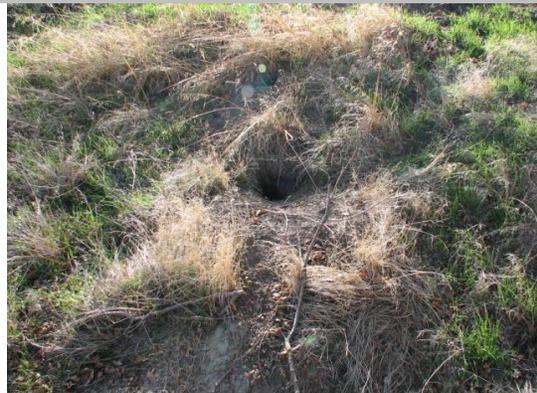
Photo 1 of 1 : FA_2014_RD2089_316_47_20141001_00025.jpg

11/10/2011 Active rodent burrow on landside slope.

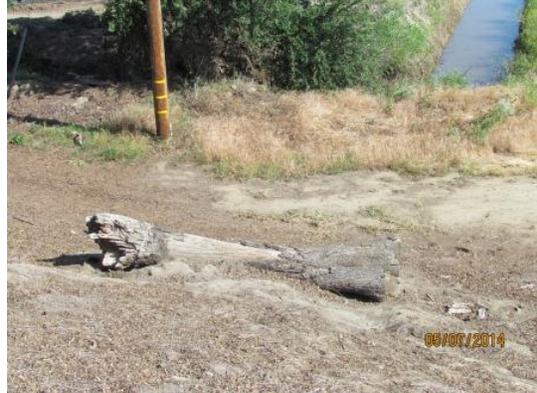
Photo 1 of 1 : FA_2014_RD2089_316_46_20141001_00024.jpg

Decaying tree at the landside levee toe is obstructing visibility and access.

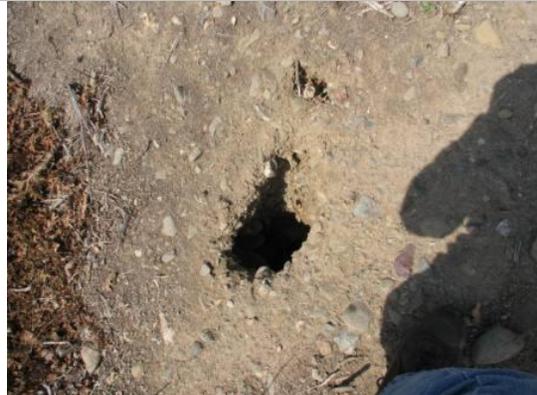
Photo 1 of 1 : FA_2014_RD2089_316_49_20141001_00026.jpg

11/10/2011 Deep burrow on waterside.

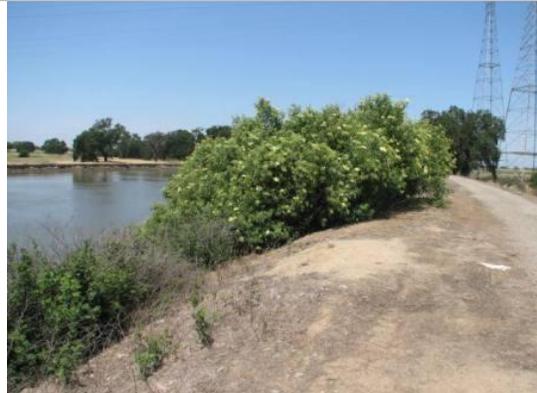
Photo 1 of 2 : FA_2014_RD2089_317_4_20141001_00003.jpg

05/24/2011 Updated photo of issue noted in Fall 2010 inspection.

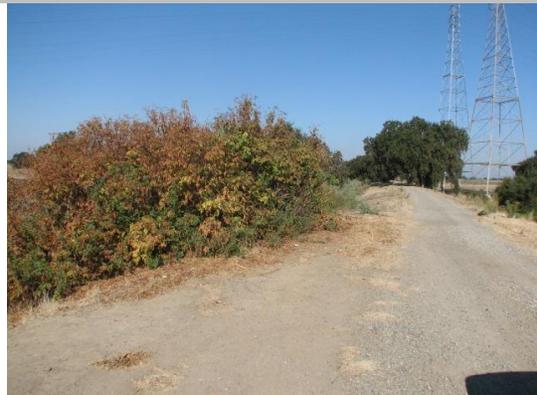
Photo 2 of 2 : FA_2014_RD2089_317_4_20141001_00004.jpg

Fall 2009 photo of unacceptable vegetation on levee slope.

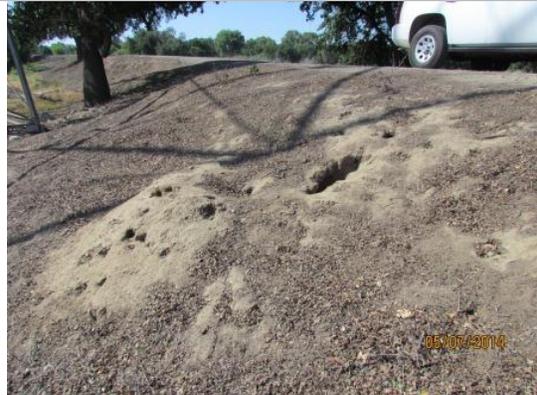
Photo 1 of 1 : FA_2014_RD2089_317_48_20141001_00025.jpg

View of the rodent burrow on the landside levee slope.

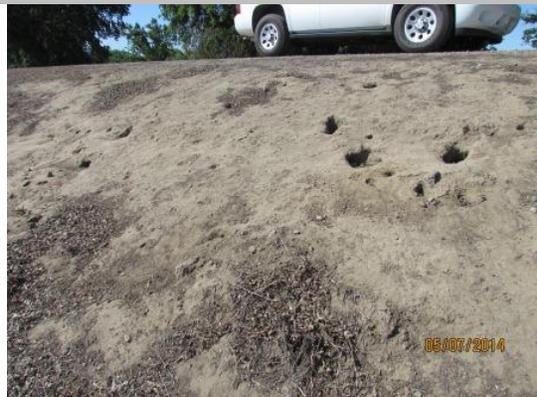
Photo 1 of 1 : FA_2014_RD2089_317_49_20141001_00026.jpg

View of the multiple rodent burrows on the landside levee hinge and slope.

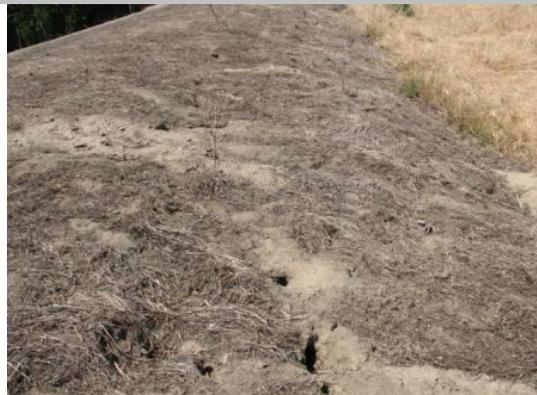
Photo 1 of 1 : FA_2014_RD2089_317_24_20141001_00017.jpg

05/24/2011 Active burrows, ground squirrel sighted in area.

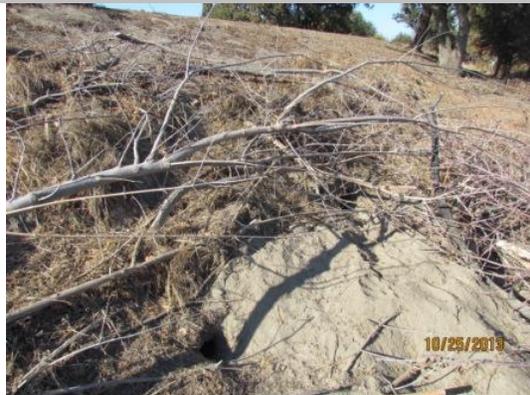
Photo 1 of 1 : FA_2014_RD2089_317_51_20141001_00027.jpg

View of the rodent burrow on the landside levee toe.

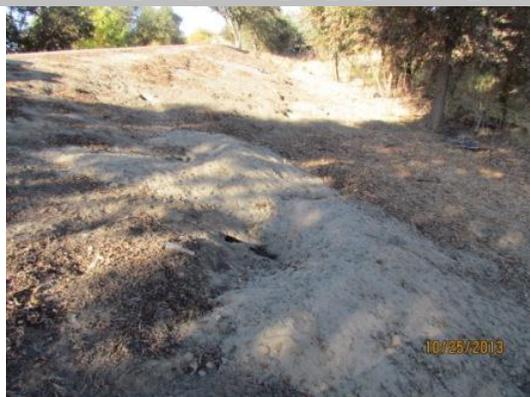
Photo 1 of 3 : FA_2014_RD2089_317_53_20141001_00029.jpg

LM Start	0.32	Rating **	U	Issue No.	53
LM End	0.33	Issue Type +	Ma	Location *	N/A
Category	Earthen Levee		GPS Latitude/Longitude		
			Start	End	
Item	Animal Control		37.809977 °	37.810022 °	
			-121.411189 °	-121.411387 °	
DWR ID	DWR_RD2089_02_f_2013_53				
Action/Comments					
Exterminate rodents and backfill and compact or grout burrows. Inspector Comments: Exterminating rodents and grouting the burrows recommended.

View of the multiple rodent burrows on the landside levee slope.

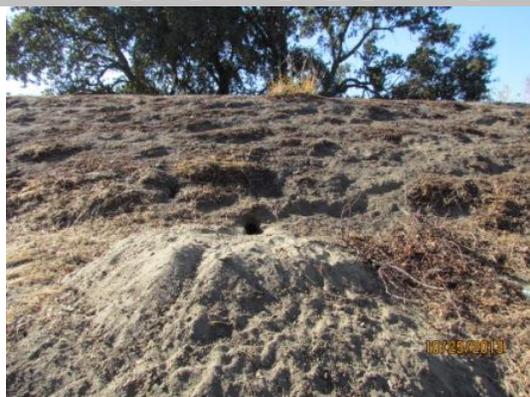
Photo 2 of 3 : FA_2014_RD2089_317_53_20141001_00030.jpg

View of the rodent burrow on the landside levee slope.

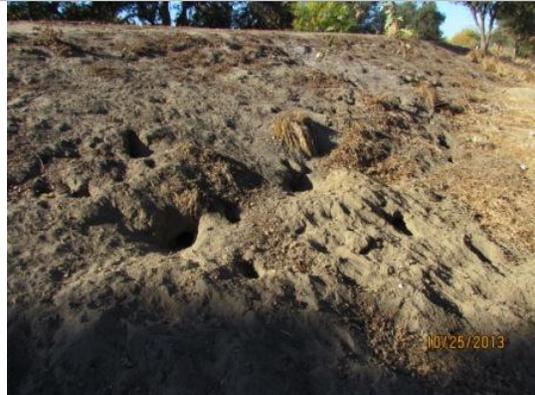
Photo 3 of 3 : FA_2014_RD2089_317_53_20141001_00031.jpg

LM Start	0.32	Rating **	U	Issue No.	53 (cont)
LM End	0.33	Issue Type +	Ma	Location *	N/A
Category	Earthen Levee		GPS Latitude/Longitude		
			Start	End	
Item	Animal Control		37.809977 °	37.810022 °	
			-121.411189 °	-121.411387 °	
DWR ID	DWR_RD2089_02_f_2013_53				
Action/Comments					
Exterminate rodents and backfill and compact or grout burrows. Inspector Comments: Exterminating rodents and grouting the burrows recommended.

Another view of the multiple rodent burrows on the landside levee slope.

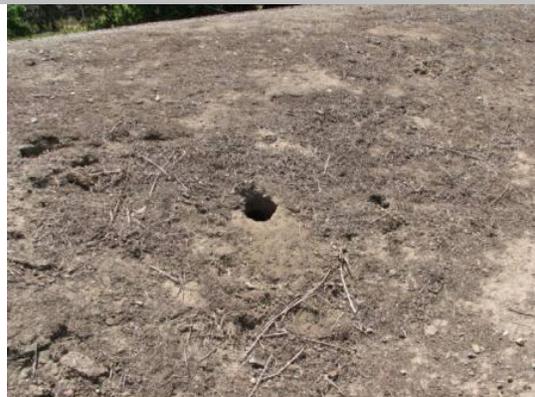
Photo 1 of 1 : FA_2014_RD2089_317_26_20141001_00018.jpg

LM Start	0.38	Rating **	M	Issue No.	26
LM End	0.38	Issue Type +	Ma	Location *	LS
Category	Earthen Levee		GPS Latitude/Longitude		
			Start	End	
Item	Animal Control		37.810125 °	37.810125 °	
			-121.412317 °	-121.412317 °	
DWR ID	DWR_RD2089_02_s_2012_26				
Action/Comments					
No rodents visible, but rodent burrows visible; need to backfill and compact or grout burrows. Inspector Comments: Active burrow needs to be repaired.

05/24/2011 Active rodent burrow.

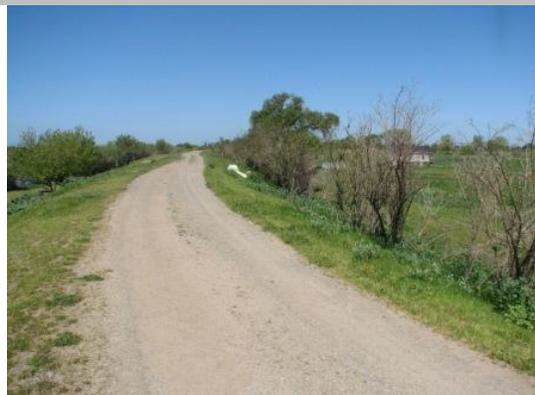
Photo 1 of 2 : FA_2014_RD2089_317_8_20141001_00008.jpg

Brush on landside slope limits access.

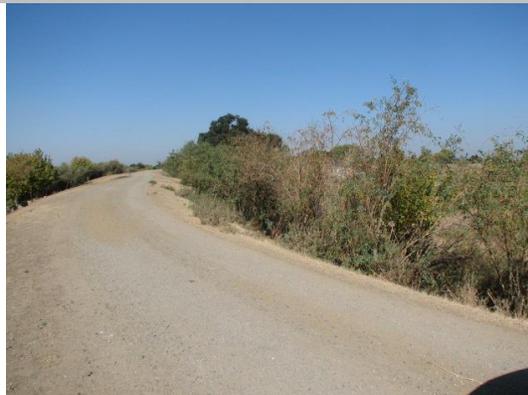
Photo 2 of 2 : FA_2014_RD2089_317_8_20141001_00009.jpg

Fall 2009 photo: Brush on landside toe limits visibility and accessibility.

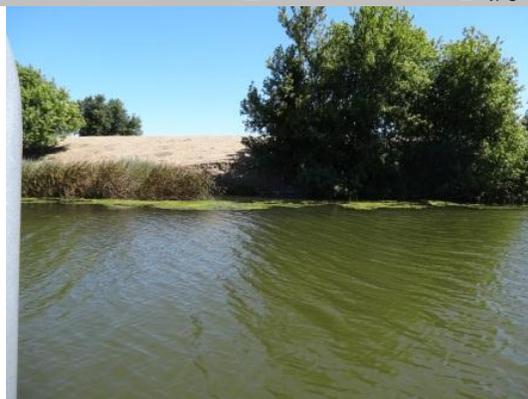
Photo 1 of 1 : SJR2014_RD2089U02RM28.35_1.jpg

LM Start	0.42	Rating **	M	Issue No.	1
LM End	0.43	Issue Type +	Ma	Location *	WS
Category	Supplemental			GPS Latitude/Longitude	
				Start	End
Item	DWR Erosion Survey			37.809960 °	37.809960 °
				-121.413200 °	-121.413200 °
DWR ID					
Action/Comments					
Inspector Comments: 07/02/2014: No significant change observed. 08/13/2013: No significant change observed. 08/07/2012: The site has been visited by boat survey. No significant change observed. 08/23/2011: No significant change observed on site. 09/07/2010: Site consists of a jutting rip rap that has created an eddy, scouring the levee slope. Most sections of the toe and lower slope are lined with rip rap. However, the rip rap is sloughing on the mid slope and at the toe, exposing the underlying soils and tree roots. The remaining revetment is no longer adequately protecting the slope. There are 3 Sycamore trees at the toe with exposed tree roots. 08/05/2010: Recommended for repair, per CLRO. 09/28/2009: Pocket erosion on lower slope just above the toe rip rap; protruding rip rap upstream is creating an eddy, scouring the levee slope; Site # is the same as RM28.40,LM0.30; previously rated "U"; pictures will be made available during the next survey. 11/05/2008: Cut into levee profile; riprap slide; rodent holes; pictures do not match GPS and current condition. [2014 Site ID:RD2089U02RM28.35]

View of the site from the survey boat.

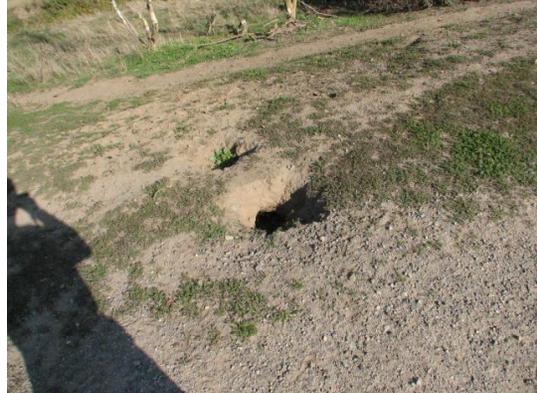
Photo 1 of 1 : FA_2014_RD2089_317_13_20141001_00012.jpg

11/10/2011 Two large burrows on crown, need to be filled.

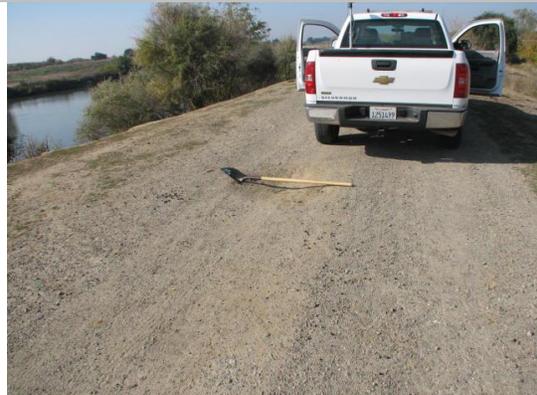
Photo 1 of 1 : FA_2014_RD2089_317_10_20141001_00011.jpg

11/10/2011 Depression in crown needs to be filled.

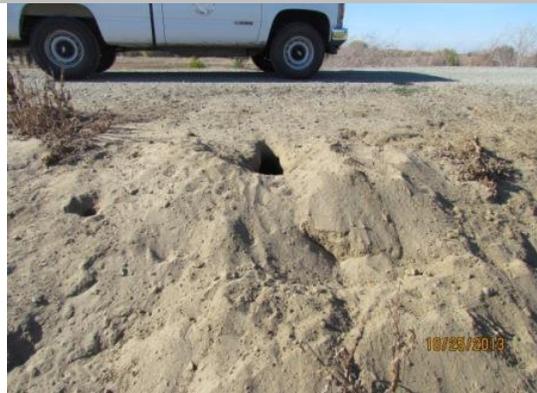
Photo 1 of 1 : FA_2014_RD2089_317_54_20141001_00032.jpg

View of the rodent burrow on the landside levee slope.

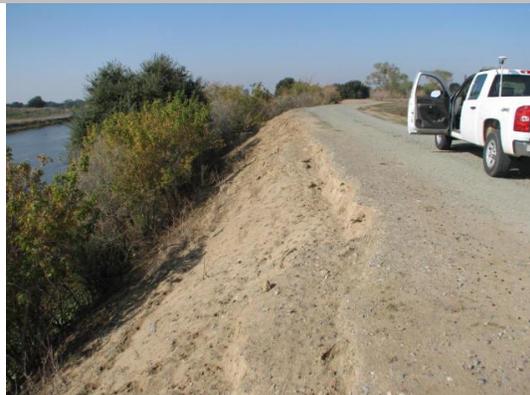
Photo 1 of 1 : FA_2014_RD2089_317_14_20141001_00013.jpg

LM Start	0.54	Rating **	U	Issue No.	14
LM End	0.54	Issue Type +	Ma	Location *	WS
Category	Earthen Levee		GPS Latitude/Longitude		
			Start	End	
Item	Animal Control		37.811150 °	37.811150 °	
			-121.414748 °	-121.414748 °	
DWR ID	DWR_RD2089_02_s_2012_14				
Action/Comments					
Repair the levee slope damaged by livestock and prevent large animal access. Inspector Comments: 11/10/2011 Repair damage to slope caused by livestock.

11/10/2011 Approximately 1' scarp has been created by livestock travel.

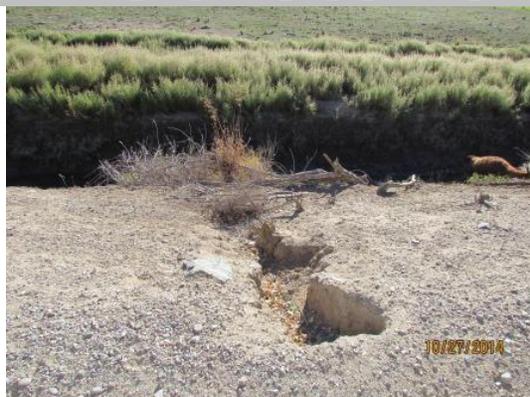
Photo 1 of 1 : FA_2014_RD2089_317_15_20141027_00039.jpg

LM Start	0.79	Rating **	M	Issue No.	15
LM End	0.79	Issue Type +	Ma	Location *	LS
Category	Earthen Levee		GPS Latitude/Longitude		
			Start	End	
Item	Slope Stability		37.813969 °	37.813969 °	
			-121.414324 °	-121.414324 °	
DWR ID	DWR_RD2089_02_f_2014_15				
Action/Comments					
Repair slope instability.

View of the scour from surface runoff on the landside levee slope.

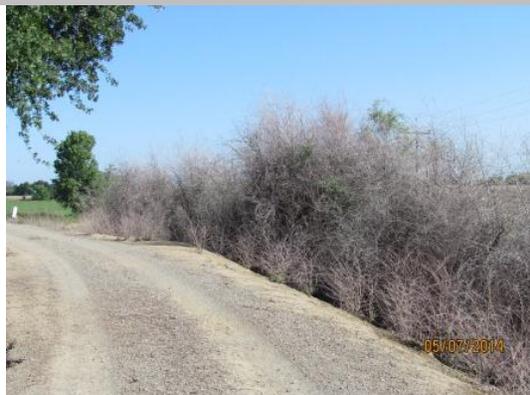
Photo 1 of 1 : FA_2014_RD2089_317_36_20141001_00021.jpg

Extremely thick dead brush prevents access and visibility.

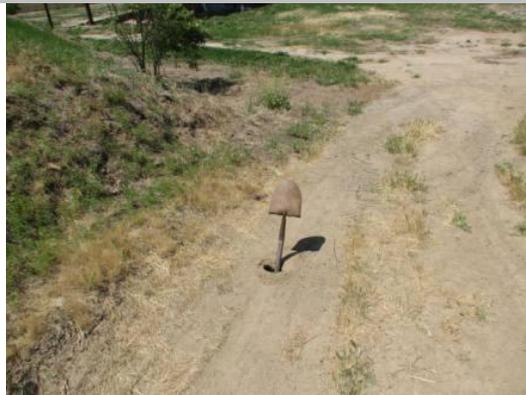
Photo 1 of 2 : FA_2014_RD2089_317_40_20141001_00022.jpg

05/24/2011 Deep vertical burrow in ramp on land side of levee.

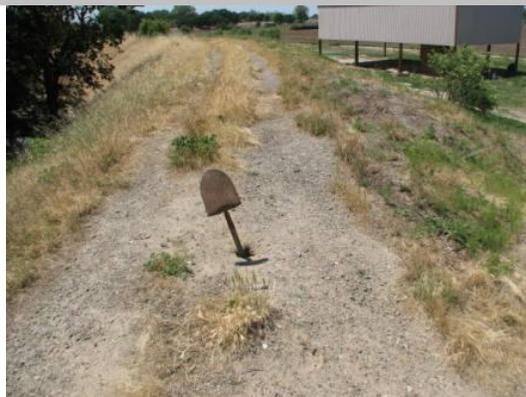
Photo 2 of 2 : FA_2014_RD2089_317_40_20141001_00023.jpg

05/24/2011 Deep vertical burrow in levee crown.

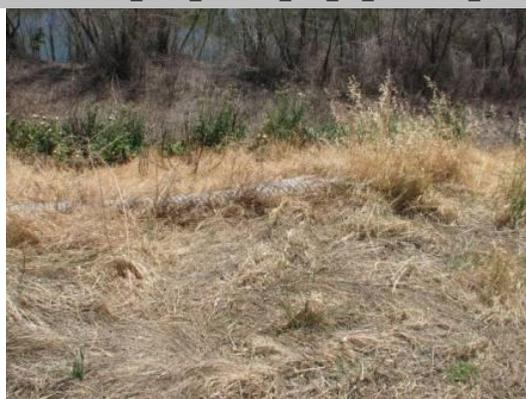
Photo 1 of 1 : FA_2014_RD2089_317_41_20141001_00024.jpg

05/24/2011 Old CMP left on waterside levee slope, needs to be removed.

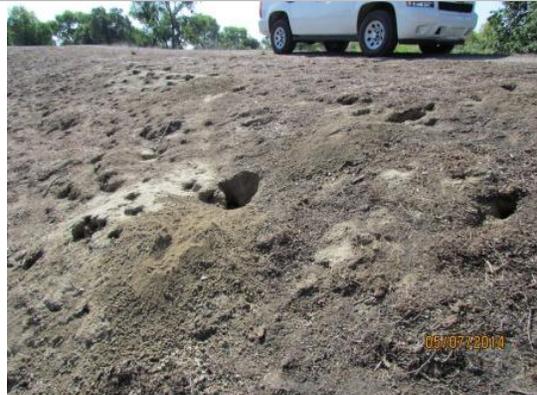
Photo 1 of 1 : FA_2014_RD2089_317_5_20141001_00005.jpg

View of the rodent holes on the landside levee slope.

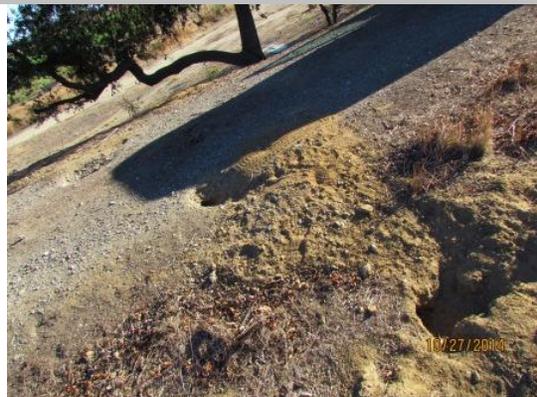
Photo 1 of 2 : FA_2014_RD2089_317_12_20141027_00037.jpg

View of several large rodent holes on the levee crown.

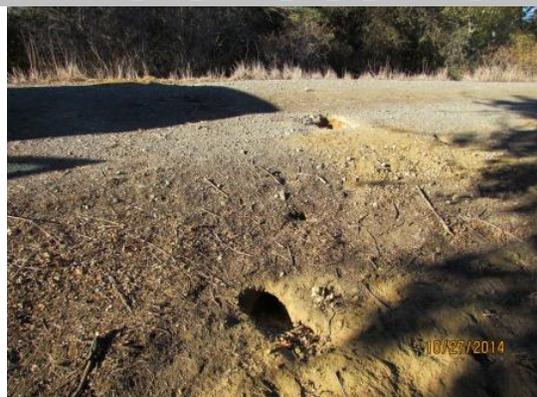
Photo 2 of 2 : FA_2014_RD2089_317_12_20141027_00038.jpg

View of several rodent burrows on landside levee hinge and crown.

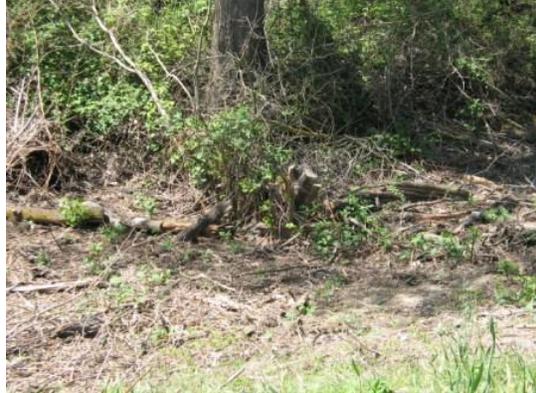
Photo 1 of 1 : FA_2014_RD2089_317_29_20141001_00020.jpg

Tree stump >2" left after vegetation and tree removal.

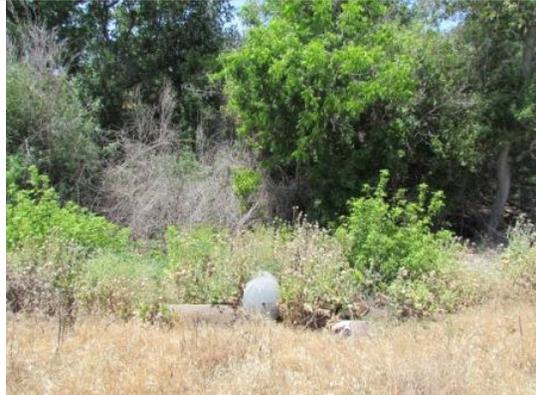
Photo 1 of 1 : FA_2014_RD2089_317_17_20141001_00014.jpg

View of water tanks disposed on waterside slope.

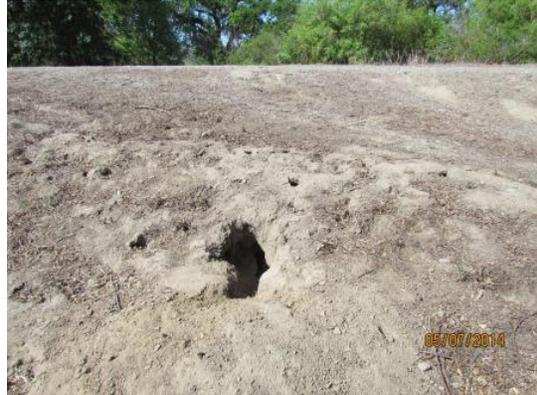
Photo 1 of 1 : FA_2014_RD2089_317_6_20141001_00006.jpg

View of the large rodent hole on the landside levee slope.
