**Flood Control Project Maintenance
Levee Inspections**

Fall 2011 Levee Maintenance Deficiency Summary Report

San Joaquin River Basin

Reclamation District No. 2091 Chase

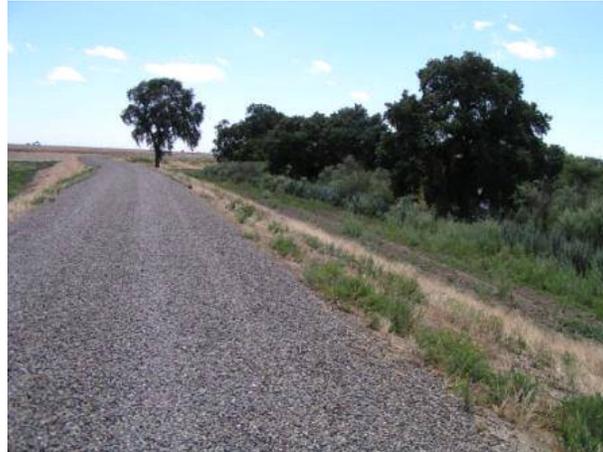
Levee Mile Report Line	1
Start Levee Mile	0.00
End Levee Mile	7.59
Location	Crown
Category	Earthen Levee
Item	Vegetation

Looking at typical view of levee crown

LMIR No.	Levee Mile		Category	Item	* Location	** Rating	Action/Comment	GPS Latitude/Longitude		Issue No. Photo
	Start	End						Start	End	
1	0.00	7.59	Earthen Levee	Vegetation	CR	A	Remove the wild growth other than native grasses from the levee slopes.	37.541479 ° -121.092845 °	37.478860 ° -121.044650 °	6 Y
2	4.20	4.20	Earthen Levee	Animal Control	LS	M	No rodents visible, but rodent burrows visible; need to backfill and compact or grout burrows.	37.503555 ° -121.081932 °	37.503555 ° -121.081932 °	1 Y
3	6.84	6.84	Earthen Levee	Seepage / Sandboils	LS	A	Inspector Comments: Several boils was actived doing the 2006 flood event. The LMA repaired the site with geo-farbic and drain rock this summer.	37.481305 ° -121.053302 °	37.481305 ° -121.053302 °	2 Y
4	7.55	7.55	Earthen Levee	Slope Stability	LS	U	Repair slope instability. Inspector Comments: Slide appears to be 100' + feet long on landside slope. Cracks are approx. 4-9" wide and 12-18" deep. Slide extends from the middle of the landside slope to landside toe.	37.479203 ° -121.044695 °	37.479203 ° -121.044695 °	3 Y

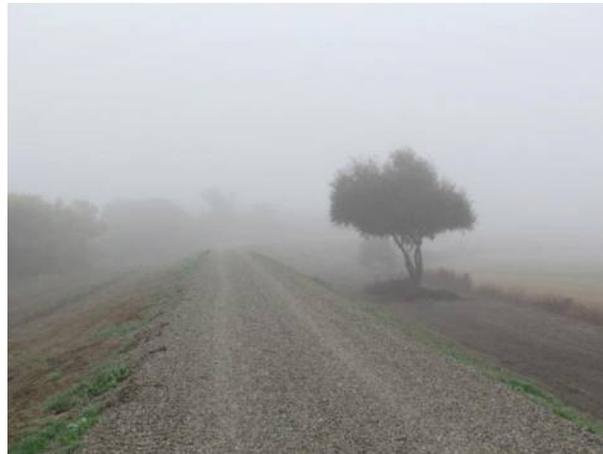
Levee Mile Report Line	1
Start Levee Mile	0.00
End Levee Mile	7.59
Location	Crown
Category	Earthen Levee
Item	Vegetation

Looking north at typical view of levee slopes.

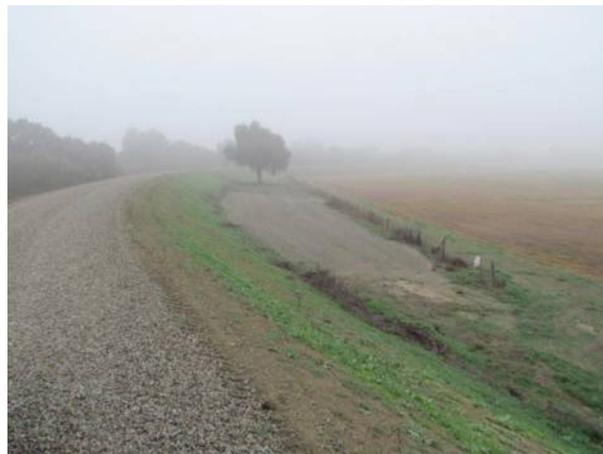
Levee Mile Report Line	3
Start Levee Mile	6.84
End Levee Mile	6.84
Location	Land Side
Category	Earthen Levee
Item	Seepage / Sandboils

Looking north at sandboils repair on landside berm.

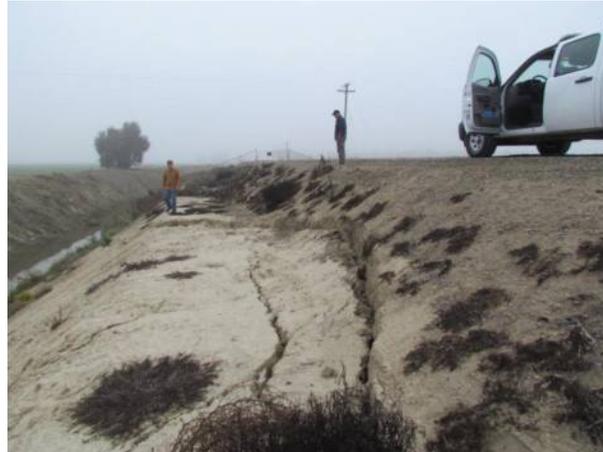
Levee Mile Report Line	4
Start Levee Mile	7.55
End Levee Mile	7.55
Location	Land Side
Category	Earthen Levee
Item	Slope Stability
Looking south at slide on landside slope next to irrigation ditch.	
richard_f_20111130_468.jpg

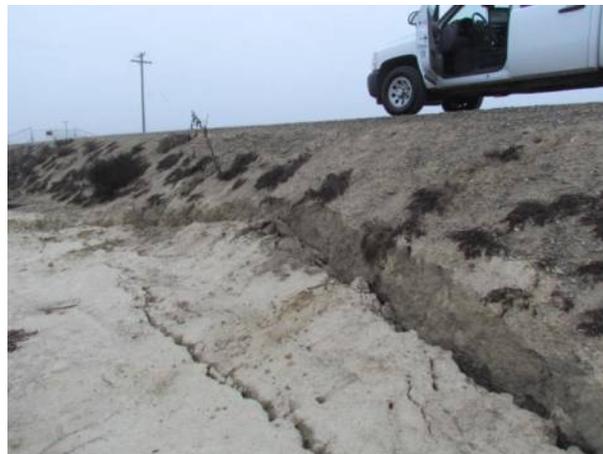
Levee Mile Report Line	4
Start Levee Mile	7.55
End Levee Mile	7.55
Location	Land Side
Category	Earthen Levee
Item	Slope Stability
Looking southwest a slide on landside slope.	
richard_f_20111130_469.jpg

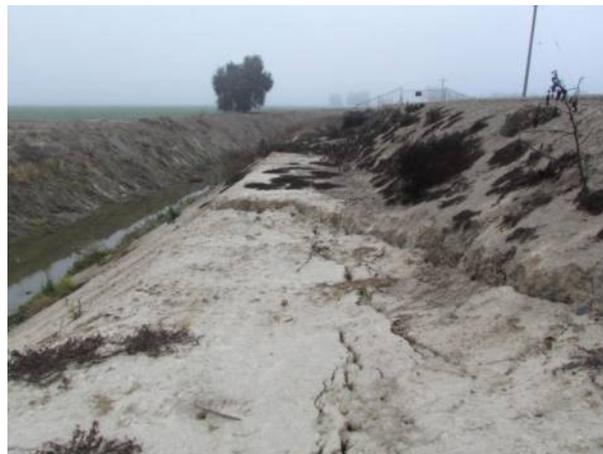
Levee Mile Report Line	4
Start Levee Mile	7.55
End Levee Mile	7.55
Location	Land Side
Category	Earthen Levee
Item	Slope Stability
Looking at south end of slide.	
richard_f_20111130_470.jpg

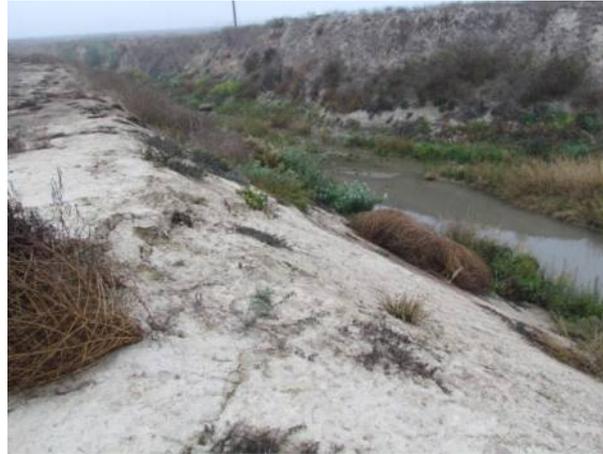
Levee Mile Report Line	4
Start Levee Mile	7.55
End Levee Mile	7.55
Location	Land Side
Category	Earthen Levee
Item	Slope Stability

Looking at north end of slide next to irrigation ditch.

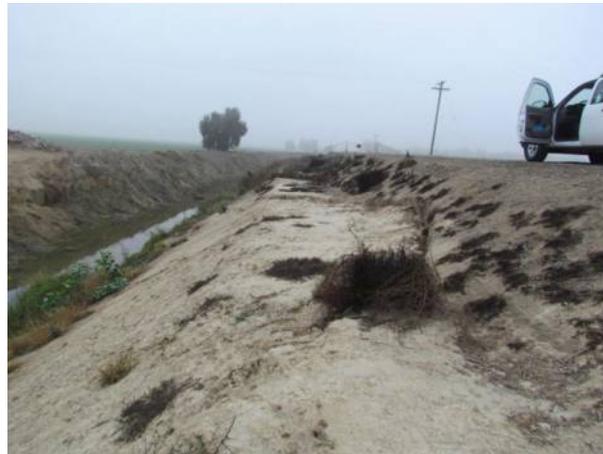
Levee Mile Report Line	4
Start Levee Mile	7.55
End Levee Mile	7.55
Location	Land Side
Category	Earthen Levee
Item	Slope Stability

Looking south at irrigation ditch at landside toe.

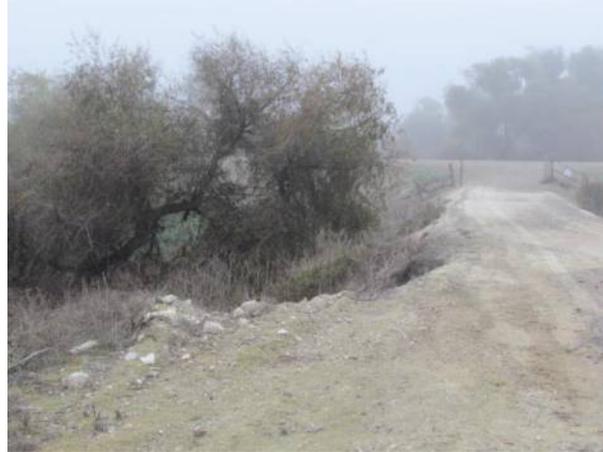
Levee Mile Report Line	1
Start Levee Mile	0.03
End Levee Mile	0.03
Location	Water Side
Category	Earthen Levee
Item	Trim / Thin Trees
Looking southeast at tree on waterside toe and berm.	
richard_f_20111130_473.jpg

LMIR No.	Levee Mile		Category	Item	* Location	** Rating	Action/Comment	GPS Latitude/Longitude		Issue No. Photo
	Start	End						Start	End	
1	0.03	0.03	Earthen Levee	Trim / Thin Trees	WS	M	Thin trees to allow visibility of the ground and room to flood fight.	37.482523 ° -121.051103 °	37.482523 ° -121.051103 °	1 Y
