**Flood Control Project Maintenance
Levee Inspections**

Fall 2013 Levee Maintenance Deficiency Summary Report

San Joaquin River Basin

Reclamation District No. 2091 Chase

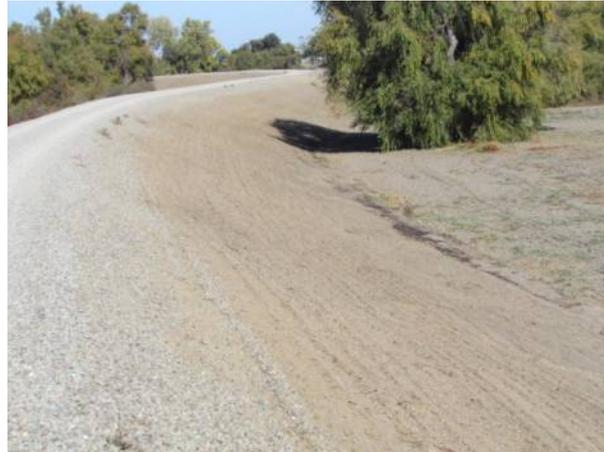
Levee Mile Report Line	4
Start Levee Mile	0.00
End Levee Mile	7.59
Location	Land Side
Category	Earthen Levee
Item	Vegetation

Looking north at landward slope.

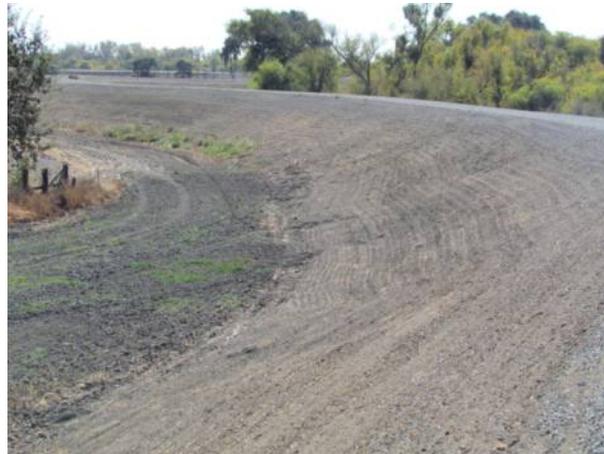
Levee Mile Report Line	4
Start Levee Mile	0.00
End Levee Mile	7.59
Location	Land Side
Category	Earthen Levee
Item	Vegetation

Looking south at landward slope.

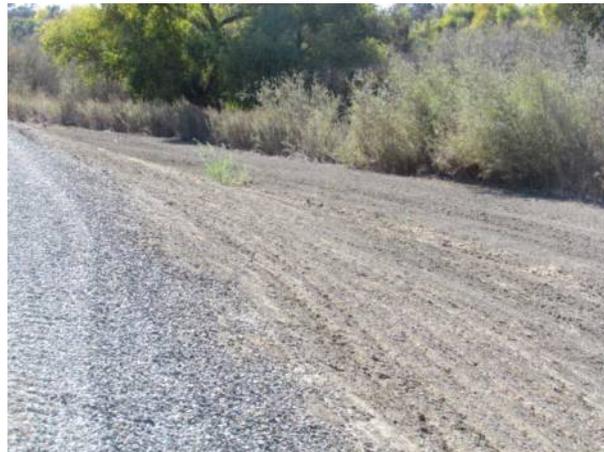
Levee Mile Report Line	5
Start Levee Mile	0.00
End Levee Mile	7.59
Location	Water Side
Category	Earthen Levee
Item	Vegetation

Looking south at waterward slope.

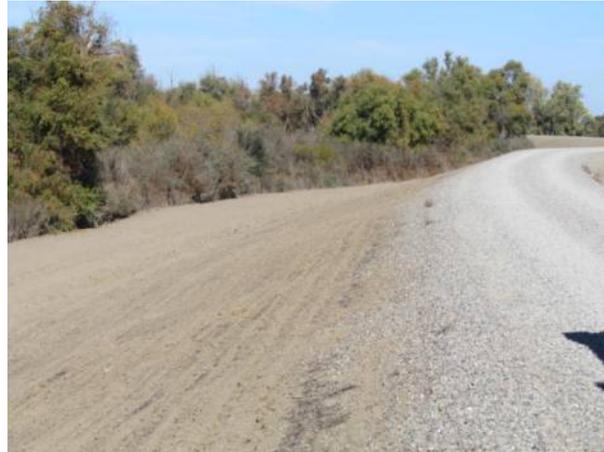
Levee Mile Report Line	5
Start Levee Mile	0.00
End Levee Mile	7.59
Location	Water Side
Category	Earthen Levee
Item	Vegetation
Looking north at waterward slope.	
richard_f_20131106_150.JPG

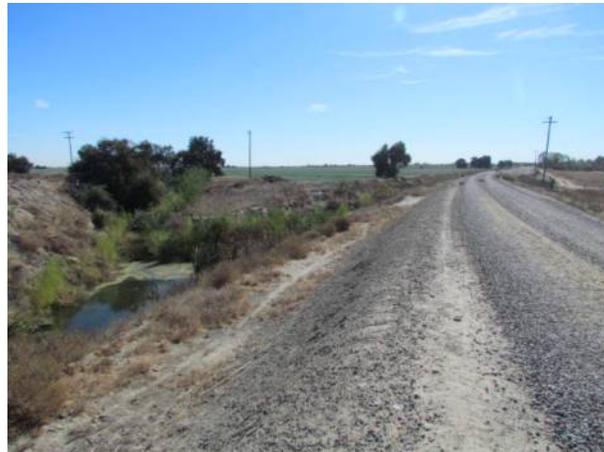
DWR ID: DWR_RD2091_01_s_2012_54										
7	4.20	4.20	Earthen Levee	Animal Control	LS A/W	A Ma	A3 : No rodents visible, but rodent burrows visible; need to backfill and compact or grout burrows.	37.503555 ° -121.081932 °	37.503555 ° -121.081932 °	1
DWR ID: DWR_RD2091_01_s_2012_1										
8	7.55	7.55	Earthen Levee	Encroachments	LS	U En	DT : Ditch Inspector Comments: Ditch has been in place for several years. Ditch is 10' to 15' from the landward toe and is 15" to 20' deep.	°	°	8 Y
DWR ID: DWR_RD2091_01_f_2013_8										
9	7.55	7.55	Earthen Levee	Slope Stability	LS A/W	A Ma	S1 : Repair slope instability. Inspector Comments: Slide appears to be 100' + feet long on landside slope. Cracks are approx. 4-9" wide and 12-18" deep. Slide extends from the middle of the landside slope to landside toe. District indicated that the landowner repaired erosion/slip with no supervisor from LMA or State. No compaction results was provided. Site does appear to be stable at time of inspection, but should be monitored by LMA.	37.479203 ° -121.044695 °	37.479203 ° -121.044695 °	3 Y

Levee Mile Report Line	8
Start Levee Mile	7.55
End Levee Mile	7.55
Location	Land Side
Category	Earthen Levee
Item	Encroachments
Looking southeast at drainage ditch at landward toe.	
richard_f_20131106_155.JPG

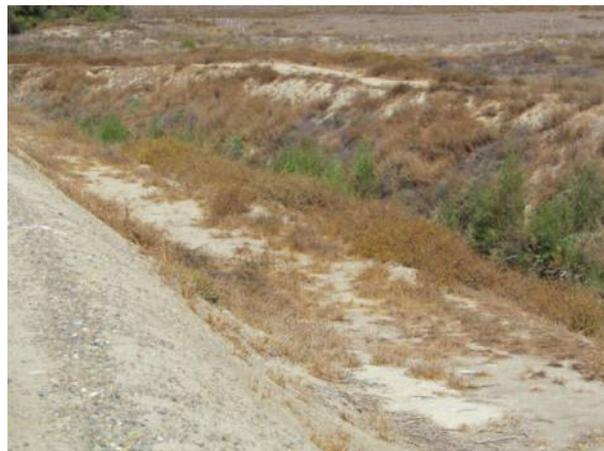
Levee Mile Report Line	8
Start Levee Mile	7.55
End Levee Mile	7.55
Location	Land Side
Category	Earthen Levee
Item	Encroachments
Looking east at drainage ditch at landward toe.	
richard_f_20131106_156.JPG

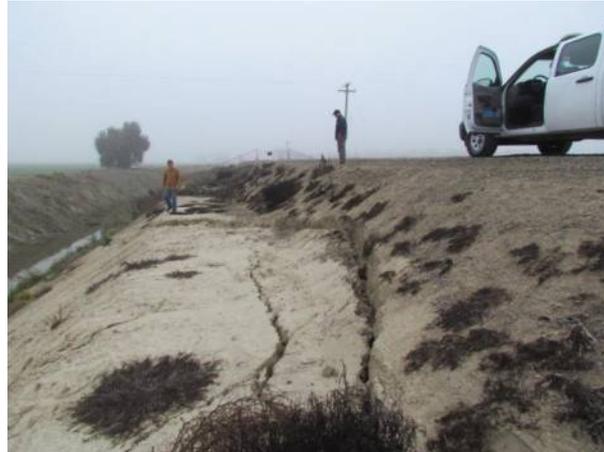
Levee Mile Report Line	9
Start Levee Mile	7.55
End Levee Mile	7.55
Location	Land Side
Category	Earthen Levee
Item	Slope Stability
Looking south at slide on landside slope next to irrigation ditch.	
richard_f_20130930_029.jpg

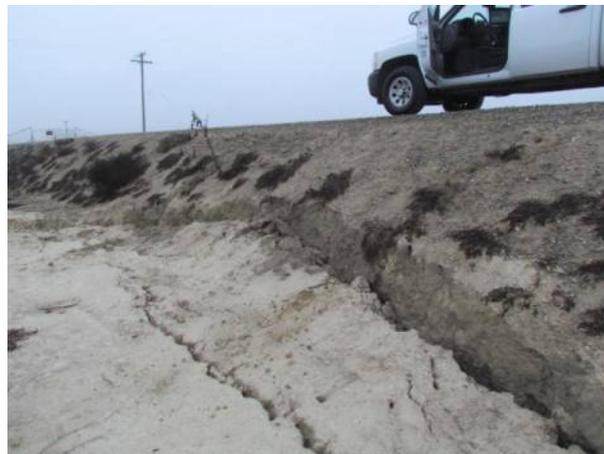
Levee Mile Report Line	9
Start Levee Mile	7.55
End Levee Mile	7.55
Location	Land Side
Category	Earthen Levee
Item	Slope Stability
Looking southwest a slide on landside slope.	
richard_f_20130930_030.jpg

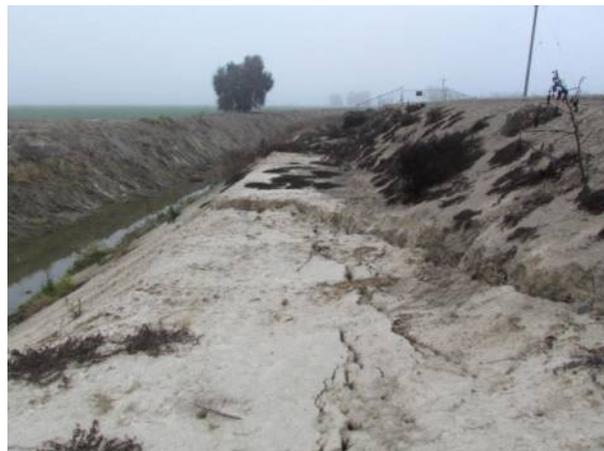
Levee Mile Report Line	9
Start Levee Mile	7.55
End Levee Mile	7.55
Location	Land Side
Category	Earthen Levee
Item	Slope Stability
Looking at south end of slide.	
richard_f_20130930_031.jpg

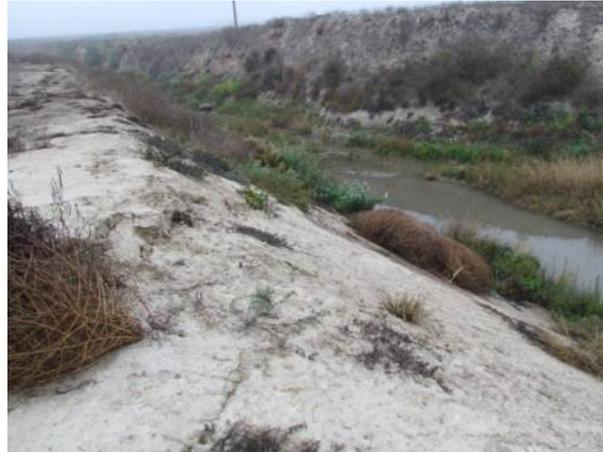
Levee Mile Report Line	9
Start Levee Mile	7.55
End Levee Mile	7.55
Location	Land Side
Category	Earthen Levee
Item	Slope Stability
Looking at north end of slide next to irrigation ditch.	
richard_f_20130930_032.jpg

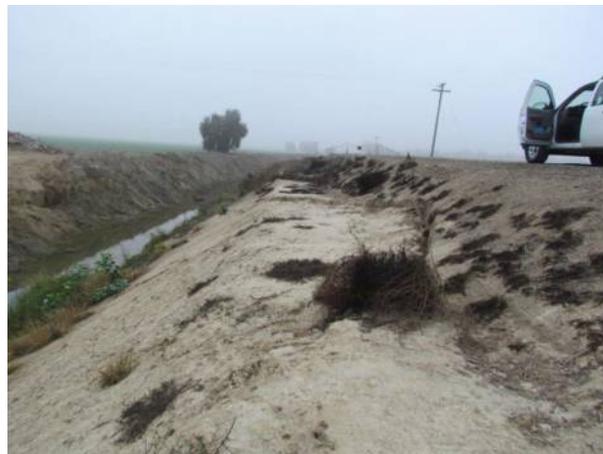
Levee Mile Report Line	9
Start Levee Mile	7.55
End Levee Mile	7.55
Location	Land Side
Category	Earthen Levee
Item	Slope Stability
Looking south at irrigation ditch at landside toe.	
richard_f_20130930_033.jpg

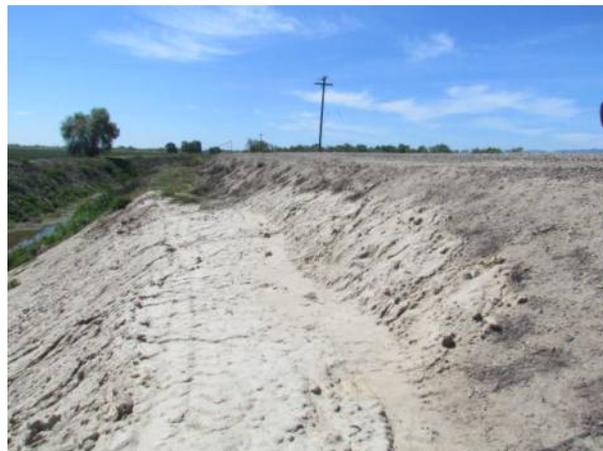
Levee Mile Report Line	9
Start Levee Mile	7.55
End Levee Mile	7.55
Location	Land Side
Category	Earthen Levee
Item	Slope Stability
Looking south at repaired erosion/slip on landside slope.	
richard_f_20130930_034.jpg

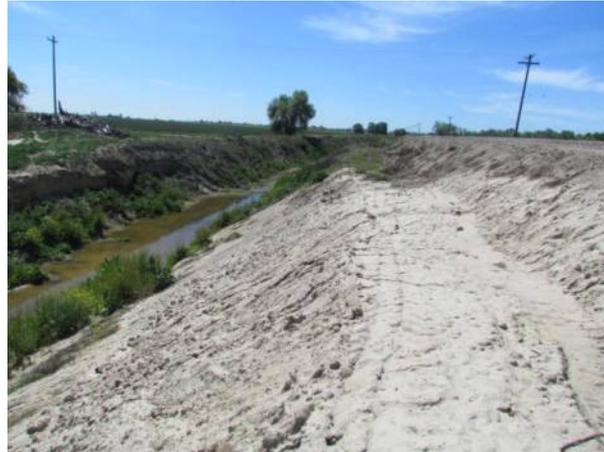
Levee Mile Report Line	9
Start Levee Mile	7.55
End Levee Mile	7.55
Location	Land Side
Category	Earthen Levee
Item	Slope Stability
Looking southeast at repaired erosion/slip on landside slope next to irrigation canal.	
richard_f_20130930_035.jpg

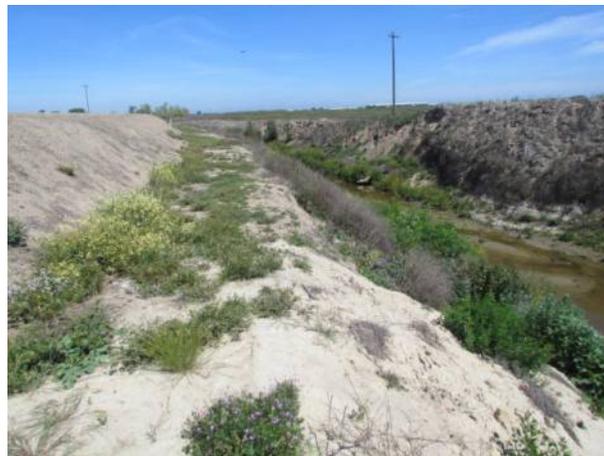
Levee Mile Report Line	9
Start Levee Mile	7.55
End Levee Mile	7.55
Location	Land Side
Category	Earthen Levee
Item	Slope Stability
Looking north at repaired erosion/slip on landside slope next to irrigation canal.	
richard_f_20130930_036.jpg

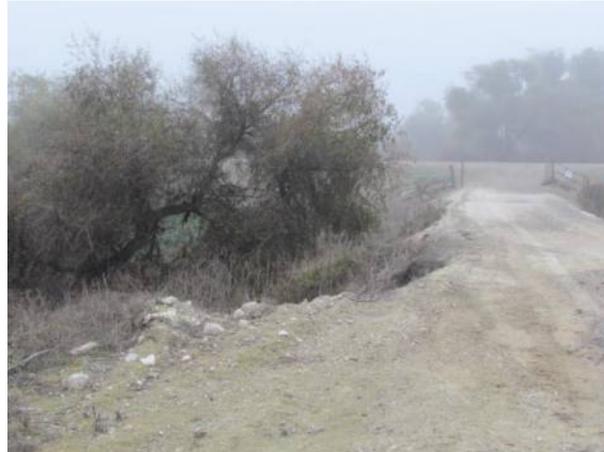
Levee Mile Report Line	1
Start Levee Mile	0.03
End Levee Mile	0.03
Location	Water Side
Category	Earthen Levee
Item	Trim / Thin Trees

LMIR No.	Levee Mile		Category	Item	Location * + Rating	Action/Comment	GPS Latitude/Longitude		Issue No. Photo
	Start	End					Start	End	
1	0.03	0.03	Earthen Levee	Trim / Thin Trees	WSA/W Ma	T2 : Thin trees to allow visibility of the ground and room to flood fight.	37.482523 ° -121.051103 °	37.482523 ° -121.051103 °	1 Y
DWR ID: DWR_RD2091_02_s_2012_1									
2	0.06	0.10	Earthen Levee	Vegetation	LS A/W Ma	V2 : Remove the wild growth other than native grasses from the levee slopes.	37.482815 ° -121.050849 °	37.483306 ° -121.050302 °	2 Y
DWR ID: DWR_RD2091_02_f_2012_2									
3	0.18	0.18	Earthen Levee	Trim / Thin Trees	WSA/W Ma	T1 : Trim trees to at least five feet above ground level.	37.484342 ° -121.049848 °	37.484342 ° -121.049848 °	3 Y
DWR ID: DWR_RD2091_02_f_2012_3									
4	0.20	0.20	Earthen Levee	Encroachments	LS M En	RW : Retaining Wall Inspector Comments: Retaining walls has been in place for several years.	° °	° °	6 Y

Looking west at tree on waterside toe and berm.

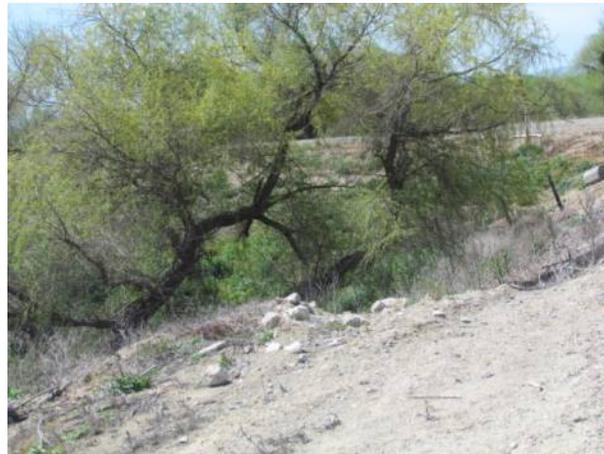
Levee Mile Report Line	1
Start Levee Mile	0.03
End Levee Mile	0.03
Location	Water Side
Category	Earthen Levee
Item	Trim / Thin Trees

Looking west at untrimmed tree on waterside slope.

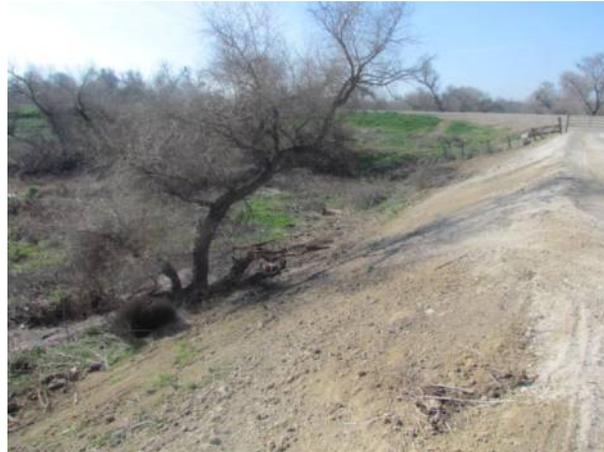
Levee Mile Report Line	1
Start Levee Mile	0.03
End Levee Mile	0.03
Location	Water Side
Category	Earthen Levee
Item	Trim / Thin Trees

Looking west at trimmed tree on waterside toe. (Spring 2013)

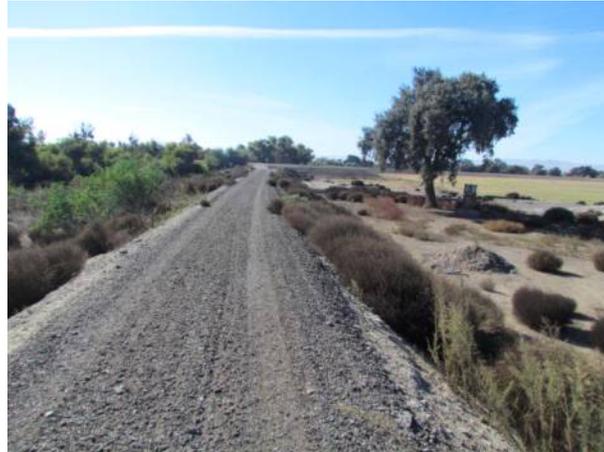
Levee Mile Report Line	2
Start Levee Mile	0.06
End Levee Mile	0.10
Location	Land Side
Category	Earthen Levee
Item	Vegetation
Looking east at typical view of tumble weeds on levee slopes.	
richard_f_20130930_040.JPG

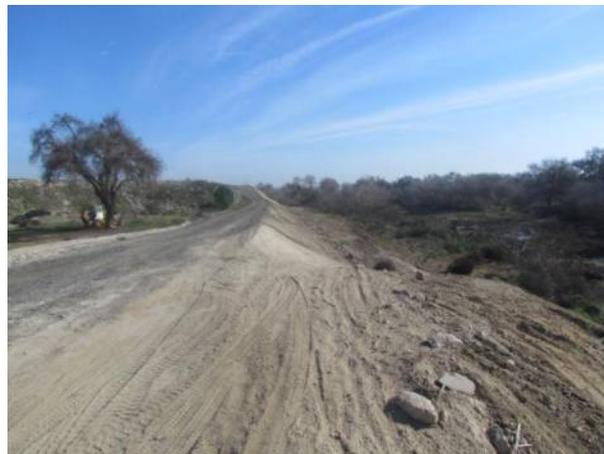
Levee Mile Report Line	2
Start Levee Mile	0.06
End Levee Mile	0.10
Location	Land Side
Category	Earthen Levee
Item	Vegetation
Looking east at typical view of levee.	
richard_f_20130930_041.JPG

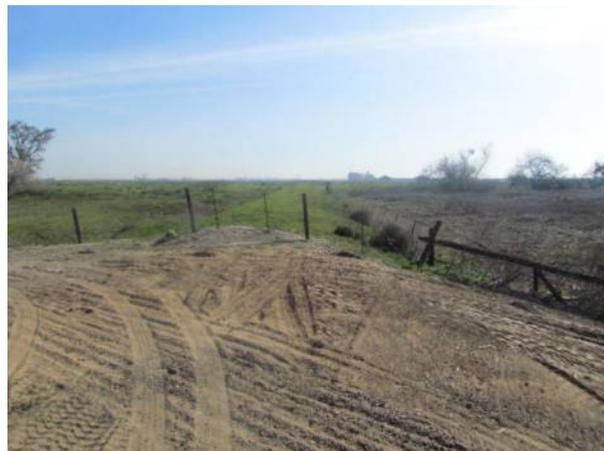
Levee Mile Report Line	3
Start Levee Mile	0.18
End Levee Mile	0.18
Location	Water Side
Category	Earthen Levee
Item	Trim / Thin Trees
Looking southeast at the end of the project levee.	
richard_f_20130930_042.JPG

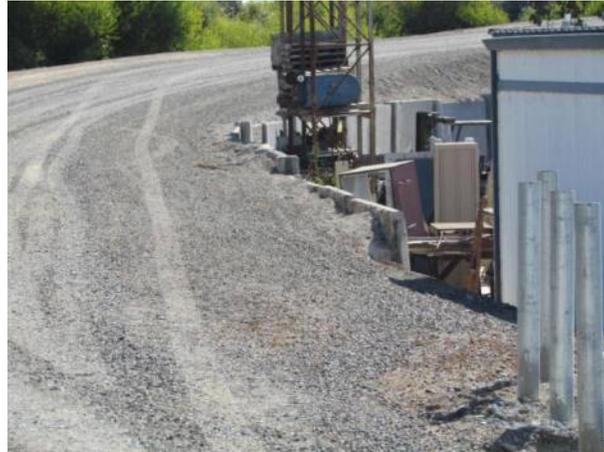
Levee Mile Report Line	4
Start Levee Mile	0.20
End Levee Mile	0.20
Location	Land Side
Category	Earthen Levee
Item	Encroachments
Looking east at retaining walls on landward toe.	
richard_f_20131106_151.JPG

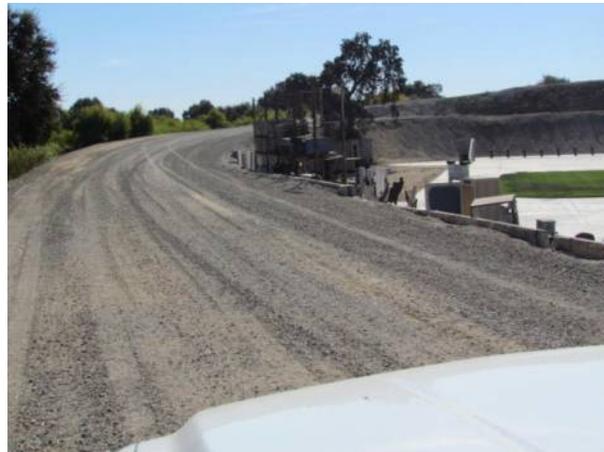
Levee Mile Report Line	4
Start Levee Mile	0.20
End Levee Mile	0.20
Location	Land Side
Category	Earthen Levee
Item	Encroachments
Looking northeast at retaining walls within the City of Modesto shooting range on landward slope and toe.	
richard_f_20131106_152.JPG

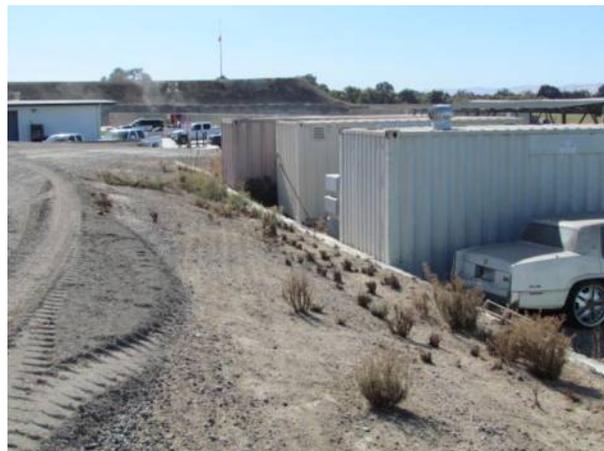
DWR ID: DWR_RD2091_02_f_2013_6									
5	0.22	0.22	Earthen Levee	Encroachments	LS M En	EQ : Equipment Inspector Comments: Several items stored at landward toe.	° °	° °	8 Y
DWR ID: DWR_RD2091_02_f_2013_8									
6	0.25	0.25	Earthen Levee	Encroachments	LS M En	TA : Tank Inspector Comments: Water tank has been in place for several years.	° °	° °	7 Y
DWR ID: DWR_RD2091_02_f_2013_7									
7	0.27	0.27	Earthen Levee	Trim / Thin Trees	WSA/W Ma	T1 : Trim trees to at least five feet above ground level.	37.485370 ° -121.050099 °	37.485370 ° -121.050099 °	5 Y
DWR ID: DWR_RD2091_02_f_2012_5									
8	0.29	0.29	Earthen Levee	Trim / Thin Trees	LS A/W Ma	T1 : Trim trees to at least five feet above ground level.	37.485447 ° -121.049750 °	37.485447 ° -121.049750 °	4 Y
DWR ID: DWR_RD2091_02_f_2012_4

Levee Mile Report Line	5
Start Levee Mile	0.22
End Levee Mile	0.22
Location	Land Side
Category	Earthen Levee
Item	Encroachments
Looking northeast at storage containers and abandoned vehicle at landward toe.	
richard_f_20131106_154.JPG

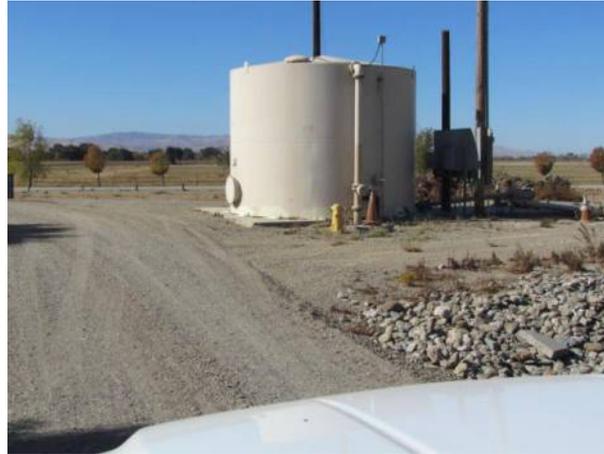
Levee Mile Report Line	6
Start Levee Mile	0.25
End Levee Mile	0.25
Location	Land Side
Category	Earthen Levee
Item	Encroachments

Looking west at water tank on landward shoulder.

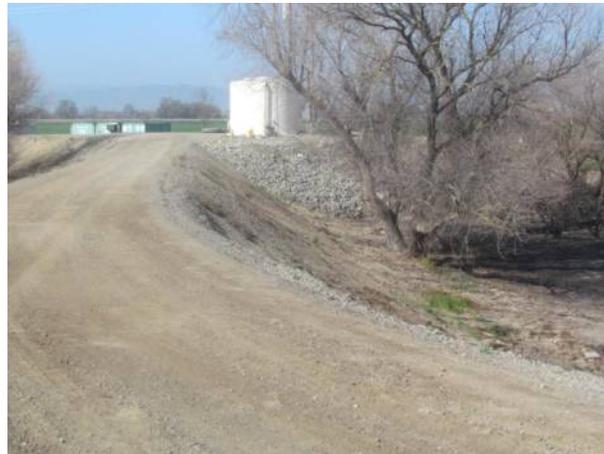
Levee Mile Report Line	7
Start Levee Mile	0.27
End Levee Mile	0.27
Location	Water Side
Category	Earthen Levee
Item	Trim / Thin Trees

Looking east at trimmed tree on waterside toe.

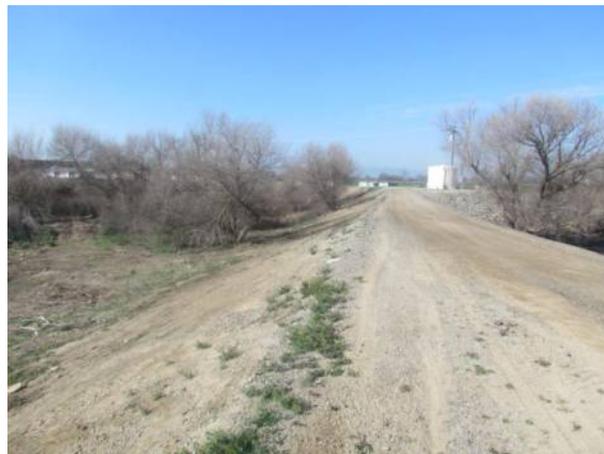
Levee Mile Report Line	8
Start Levee Mile	0.29
End Levee Mile	0.29
Location	Land Side
Category	Earthen Levee
Item	Trim / Thin Trees

Looking east at trimmed trees on landside slope and toe.
