**Flood Control Project Maintenance
Levee Inspections**

Fall 2012 Levee Maintenance Deficiency Summary Report

San Joaquin River Basin

**Flood Control Project Maintenance
Levee Inspections****LMA District Cover Sheet
Fall 2012 Levee Inspection Results****Reclamation District No. 2091 Chase**

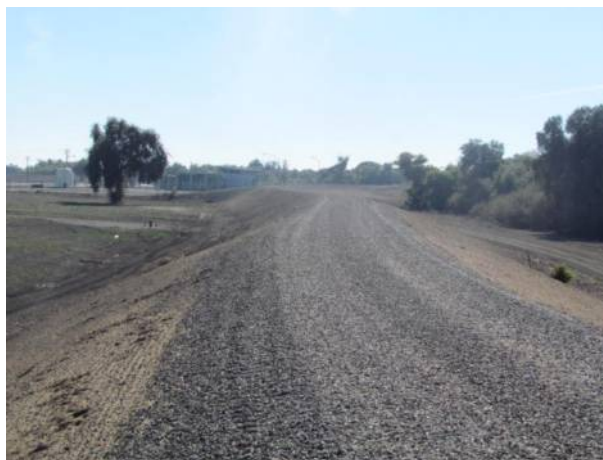
| Levee Mile Report Line | 4 |

| LMR No. | Levee Mile | | Category | Item | Location | Rating | Action/Comment | GPS Latitude/Longitude | | Issue No. |
|---|---|---|---|---|---|---|---|---|---|---|
| 4 | 0.00 | 7.59 | Earthen Levee | Vegetation | LS | A Ma | V7 : Trees / Woody Vegetation | ° | ° | 7 |

Looking south at typical view of levee slopes.

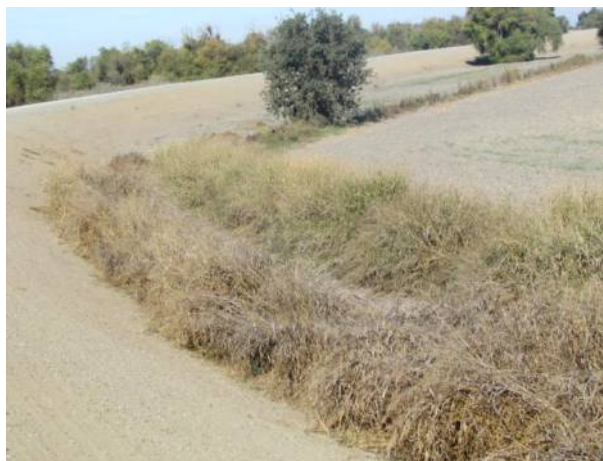
| Levee Mile Report Line | 7 |

| LMR No. | Levee Mile | | Category | Item | Location | Rating | Action/Comment | GPS Latitude/Longitude | | Issue No. |
|---|---|---|---|---|---|---|---|---|---|---|
| 7 | 4.46 | 4.51 | Earthen Levee | Encroachments | LS | M Ob | DT : Ditch | 37.500087 ° -121.081347 ° | 37.499579 ° -121.080847 ° | 6 Y |

Looking northeast at irrigation ditch on landside toe.

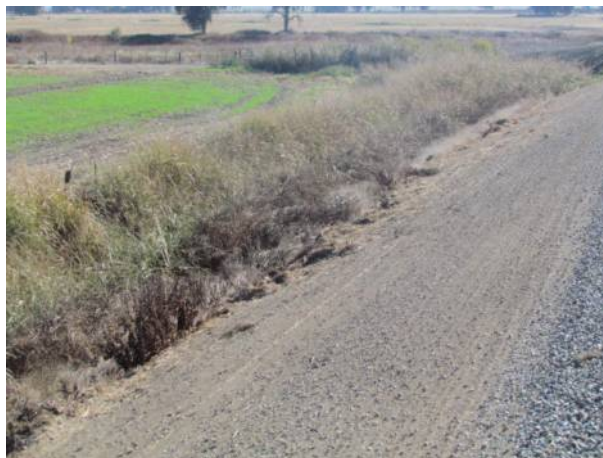
| Levee Mile Report Line | 7 |

Looking southeast at irrigation ditch on landside toe.

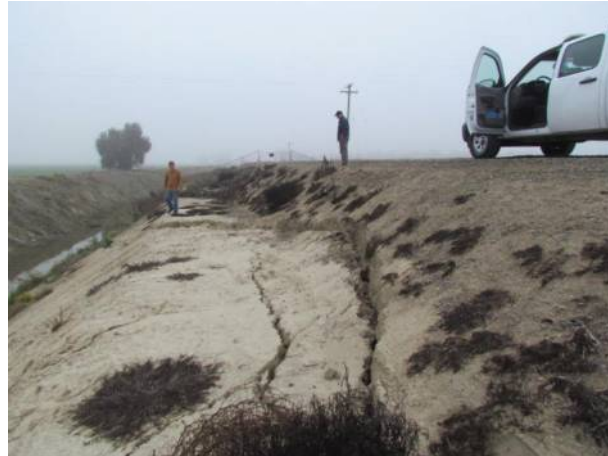
| Levee Mile Report Line | 8 |

| LMR No. | Levee Mile | | Category | Item | Location | Rating | Action/Comment | GPS Latitude/Longitude | | Issue No. |
|---|---|---|---|---|---|---|---|---|---|---|
| 8 | 7.55 | 7.55 | Earthen Levee | Slope Stability | LS | A/W Ma | S1 : Repair slope instability. Inspector Comments: Slide appears to be 100' + feet long on landside slope. Cracks are approx. 4-9" wide and 12-18" deep. Slide extends from the middle of the landside slope to landside toe. District indicated that the landowner repaired erosion/slip with no supervisor from LMA or State. No compaction results was provided. Site does appear to be stable at time of inspection, but should be monitored by LMA. | 37.479203 ° -121.044695 ° | 37.479203 ° -121.044695 ° | 3 Y |

| Looking south at slide on landside slope next to irrigation ditch. | |

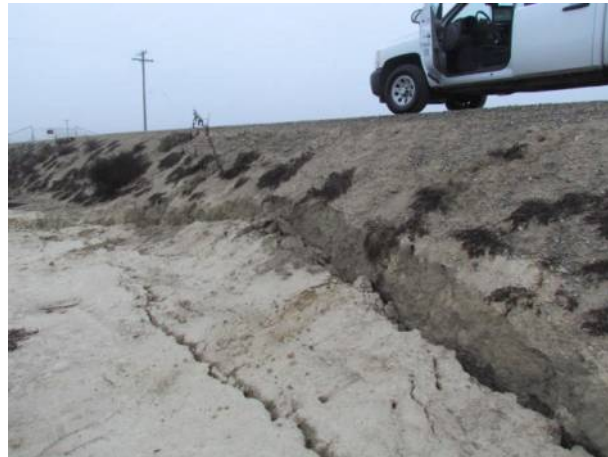
| Levee Mile Report Line | 8 |

| Looking southwest a slide on landside slope. | |

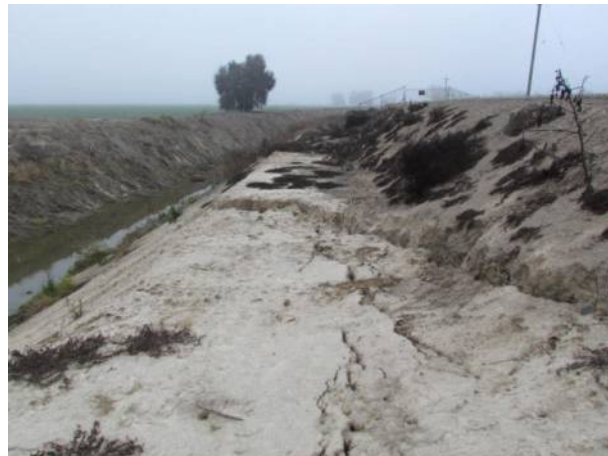
| Levee Mile Report Line | 8 |

| Looking at south end of slide. | |

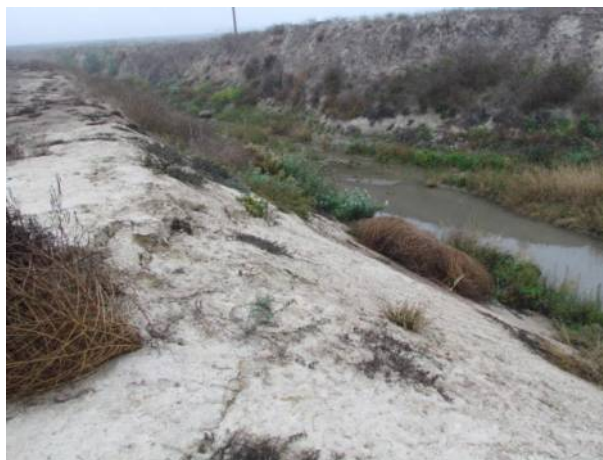
| Levee Mile Report Line | 8 |

Looking at north end of slide next to irrigation ditch.

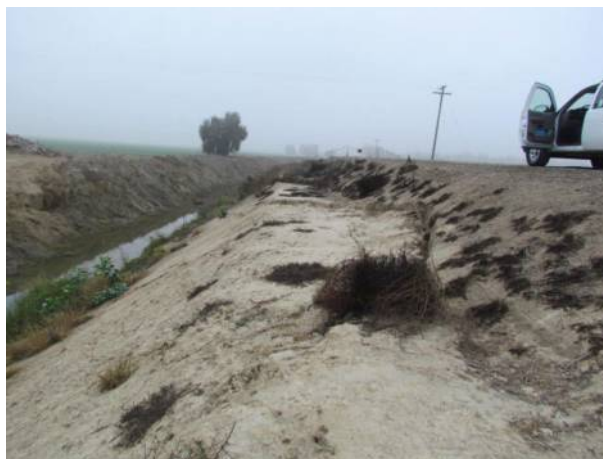
| Levee Mile Report Line | 8 |

Looking south at irrigation ditch at landside toe.

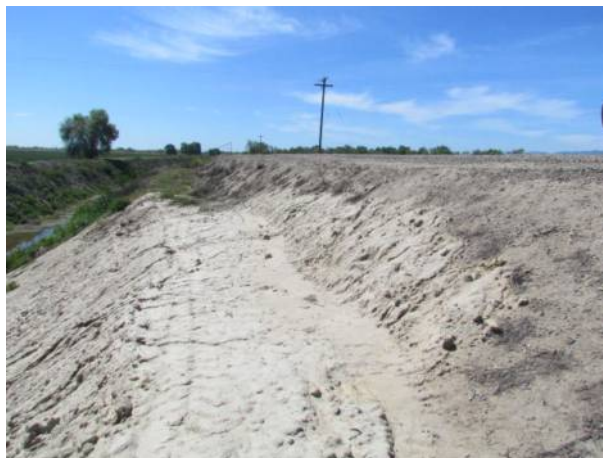
| Levee Mile Report Line | 8 |

Looking south at repaired erosion/slip on landside slope.

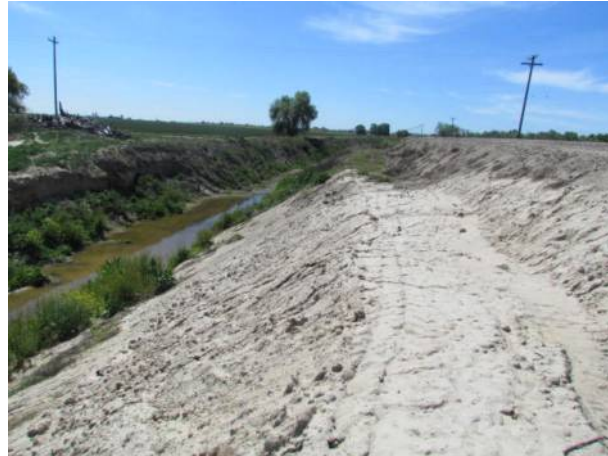
| Levee Mile Report Line | 8 |

Looking southeast at repaired erosion/slip on landside slope next to irrigation canal.

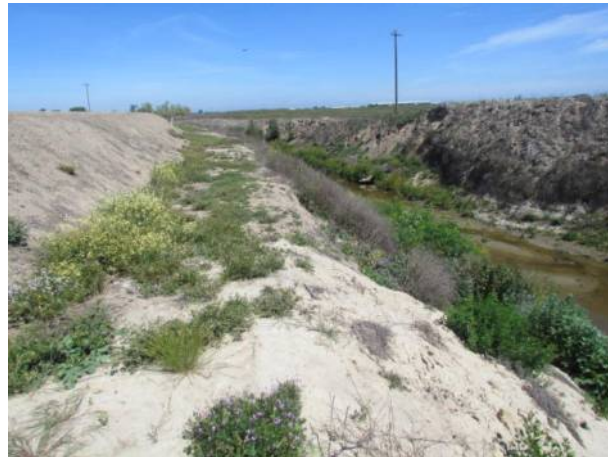
| Levee Mile Report Line | 8 |

Looking north at repaired erosion/slip on landside slope next to irrigation canal.

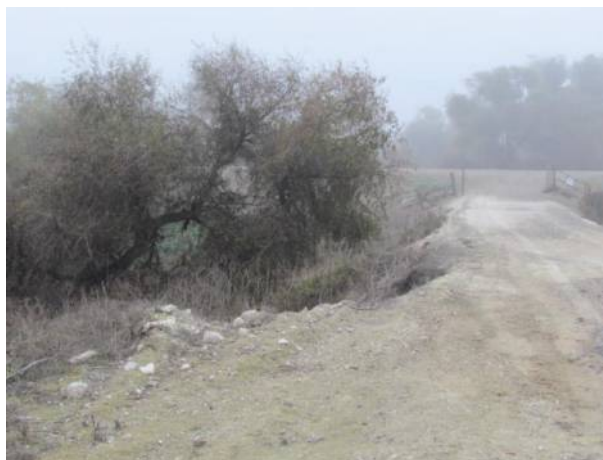
| Levee Mile Report Line | 1 |

| LMR No. | Levee Mile | | Category | Item | Location * | Rating ** | Action/Comment | GPS Latitude/Longitude | | Issue No. Photo |
|---|---|---|---|---|---|---|--|---|---|---|
| 1 | 0.03 | 0.03 | Earthen Levee | Trim / Thin Trees | WS | M Ma | T2 : Thin trees to allow visibility of the ground and room to flood fight. | 37.482523 ° -121.051103 ° | 37.482523 ° -121.051103 ° | 1 Y |

Looking west at tree on waterside toe and berm.

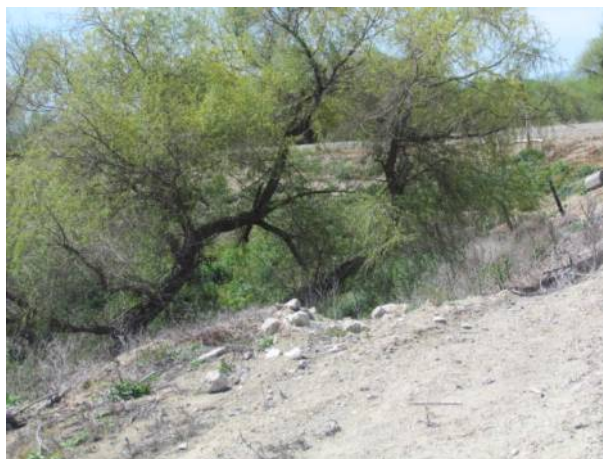
| Levee Mile Report Line | 1 |

Looking west at untrimmed tree on waterside slope.

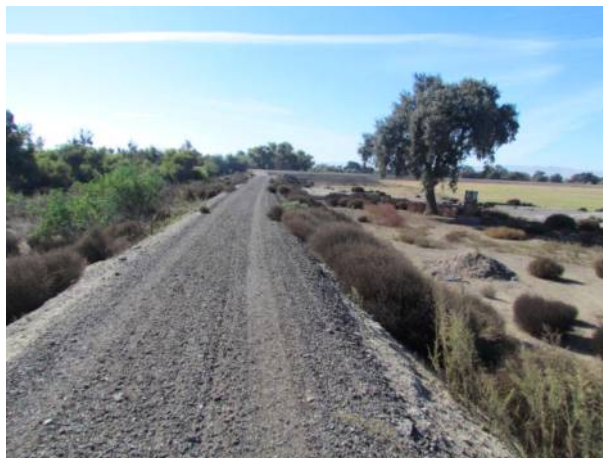
| Levee Mile Report Line | 2 |

| LMR No. | Levee Mile | | Category | Item | Location * | Rating ** | Action/Comment | GPS Latitude/Longitude | | Issue No. Photo |
|---|---|---|---|---|---|---|--|---|---|---|
| 2 | 0.06 | 0.10 | Earthen Levee | Vegetation | LS | M Ma | V2 : Remove the wild growth other than native grasses from the levee slopes. | 37.482815 ° -121.050849 ° | 37.483306 ° -121.050302 ° | 2 Y |

Looking east at typical view of tumble weeds on levee slopes.
