**Flood Control Project Maintenance
Levee Inspections**

**Fall 2014 Levee Maintenance Deficiency Summary Report
Overall LMA & Unit Ratings, including DWR Erosion Survey**

San Joaquin River Basin

Reclamation District No. 2091 Chase

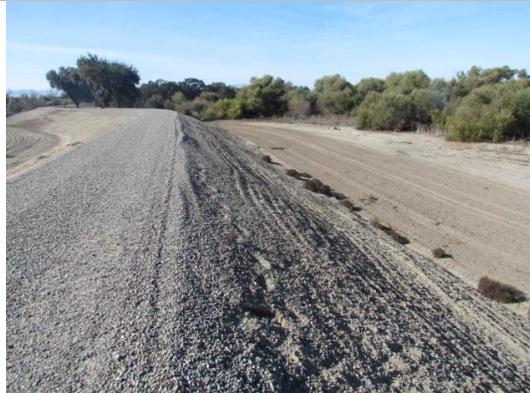
Photo 1 of 1 : FA_2014_RD2091_318_12_20141120_00018.jpg

LM Start	0.00	Rating **	A	Issue No.	12
LM End	7.59	Issue Type +	Ma	Location *	LS
Category	Earthen Levee		GPS Latitude/Longitude		
			Start	End	
Item	Vegetation			o	o
DWR ID	DWR_RD2091_01_f_2014_12				
Action/Comments					
Control annual grass and weeds on the levee slopes and easements. Inspector Comments: Landward slope has no visible maintenance issues.

Looking north at typical view of landward slope.

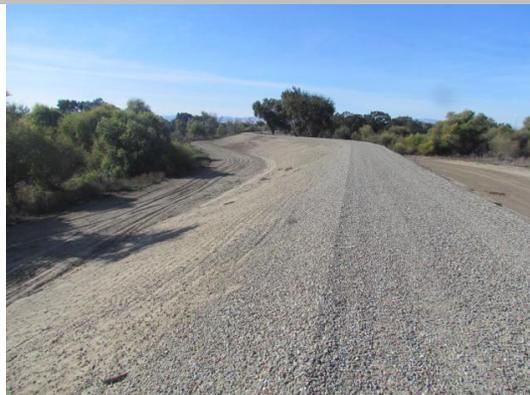
Photo 1 of 1 : FA_2014_RD2091_318_13_20141120_00017.jpg

LM Start	0.00	Rating **	A	Issue No.	13
LM End	7.59	Issue Type +	Ma	Location *	WS
Category	Earthen Levee		GPS Latitude/Longitude		
			Start	End	
Item	Vegetation			o	o
DWR ID	DWR_RD2091_01_f_2014_13				
Action/Comments					
Control annual grass and weeds on the levee slopes and easements. Inspector Comments: Waterward slope has no visible maintenance issues.

Looking north at typical view of waterward slope.

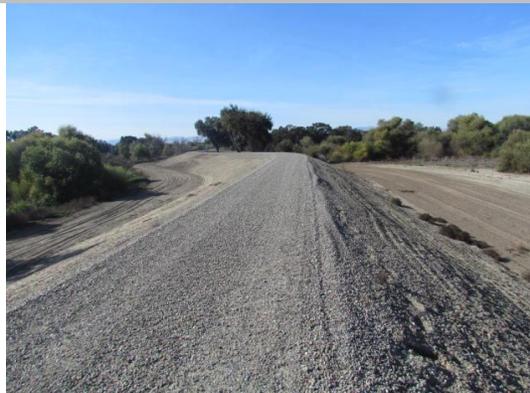
Photo 1 of 1 : FA_2014_RD2091_318_14_20141120_00016.jpg

LM Start	0.00	Rating **	A	Issue No.	14
LM End	7.59	Issue Type +	Ma	Location *	CR
Category	Earthen Levee		GPS Latitude/Longitude		
			Start	End	
Item	Vegetation			o	o
DWR ID	DWR_RD2091_01_f_2014_14				
Action/Comments					
Control annual grass and weeds on the levee slopes and easements. Inspector Comments: Levee crown has no visible maintenance issues.

Looking north at typical view of levee crown.

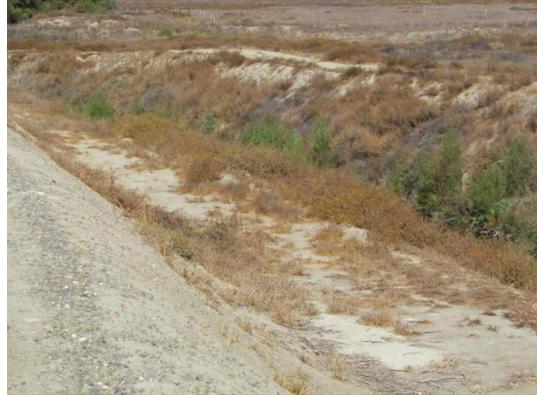
Photo 1 of 2 : FA_2014_RD2091_318_8_20141103_00009.jpg

LM Start	7.55	Rating **	U	Issue No.	8
LM End	7.55	Issue Type +	En	Location *	LS
Category	Earthen Levee		GPS Latitude/Longitude		
			Start	End	
Item	Encroachments			°	°
DWR ID	DWR_RD2091_01_f_2013_8				
Action/Comments					
Ditch Inspector Comments: Ditch has been in place for several years. Ditch is 10' to 15' from the landward toe and is 15" to 20' deep.

Looking east at drainage ditch at landward toe.

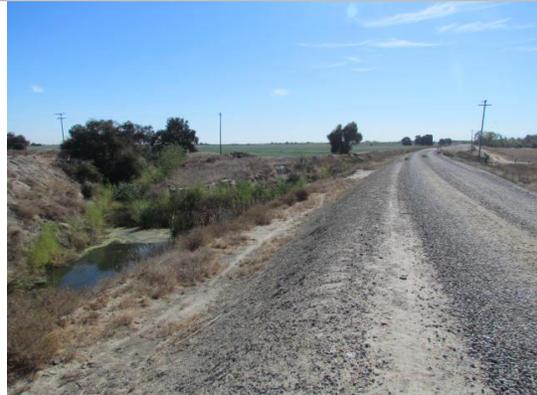
Photo 2 of 2 : FA_2014_RD2091_318_8_20141103_00010.jpg

Looking southeast at drainage ditch at landward toe.

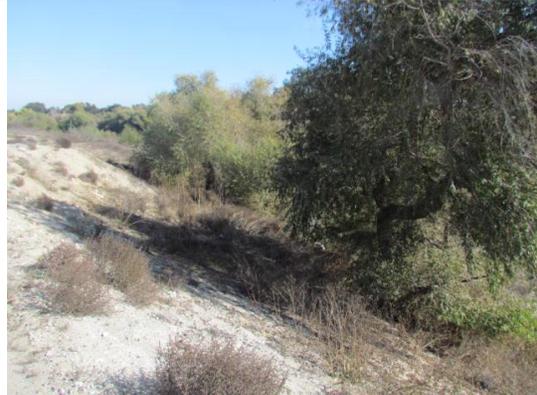
Photo 1 of 2 : FA_2014_RD2091_319_1_20141120_00011.jpg

Looking east at untrimmed trees on waterward slope. (Fall 2014)

LM Start	0.03	Rating **	M	Issue No.	1
LM End	0.03	Issue Type +	Ma	Location *	WS
Category	Earthen Levee		GPS Latitude/Longitude		
			Start	End	
Item	Trim / Thin Trees		37.482523 °	37.482523 °	
			-121.051103 °	-121.051103 °	
DWR ID	DWR_RD2091_02_s_2012_1				
Action/Comments					
Thin trees to allow visibility of the ground and room to flood fight.

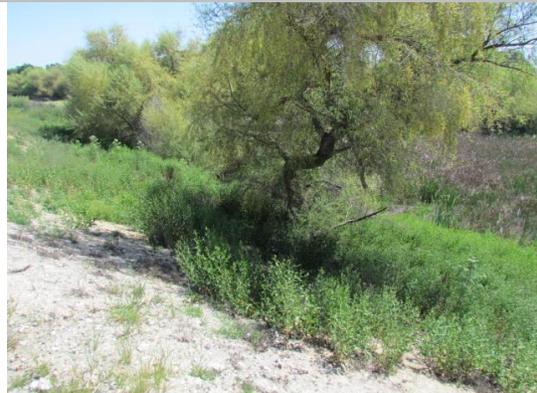
Photo 2 of 2 : FA_2014_RD2091_319_1_20141103_00001.jpg

Looking east at untrimmed tree on waterward slope. (Spring 2014)

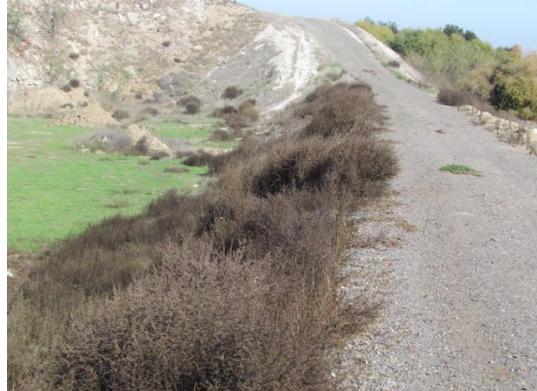
Photo 1 of 1 : FA_2014_RD2091_319_2_20141120_00012.jpg

LM Start	0.06	Rating **	M	Issue No.	2
LM End	0.10	Issue Type +	Ma	Location *	LS
Category	Earthen Levee		GPS Latitude/Longitude		
			Start	End	
Item	Vegetation		37.482815 °	37.483306 °	
			-121.050849 °	-121.050302 °	
DWR ID	DWR_RD2091_02_f_2012_2				
Action/Comments					
Remove the wild growth other than native grasses from the levee slopes. Inspector Comments: Control tumble weeds on landward slope.

Looking north at tumble weeds on landward slope.

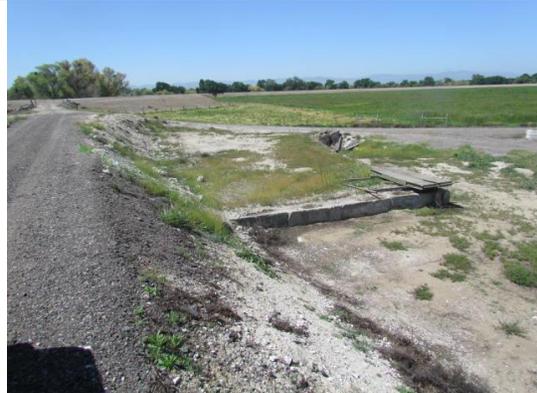
Photo 1 of 1 : FA_2014_RD2091_319_12_20141103_00009.jpg

LM Start	0.06	Rating **	M	Issue No.	12
LM End	0.06	Issue Type +	En	Location *	LS
Category	Earthen Levee		GPS Latitude/Longitude		
			Start	End	
Item	Encroachments		37.482844 °	37.482844 °	
			-121.050816 °	-121.050816 °	
DWR ID	DWR_RD2091_02_s_2014_12				
Action/Comments					
Retaining Wall Inspector Comments: Concrete foundation on landward toe.

Looking west at concrete foundation/retaining wall at landward toe.

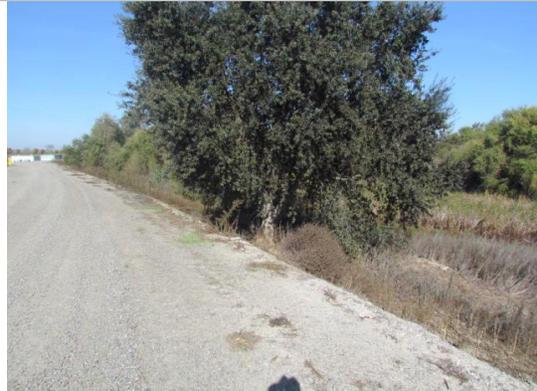
Photo 1 of 1 : FA_2014_RD2091_319_3_20141120_00013.jpg

Looking north at untrimmed tree on waterward slope.

LM Start	0.18	Rating **	M	Issue No.	3
LM End	0.18	Issue Type +	Ma	Location *	WS
Category	Earthen Levee		GPS Latitude/Longitude		
			Start	End	
Item	Trim / Thin Trees		37.484342 °	37.484342 °	
			-121.049848 °	-121.049848 °	
DWR ID	DWR_RD2091_02_f_2012_3				
Action/Comments					
Trim trees to at least five feet above ground level.

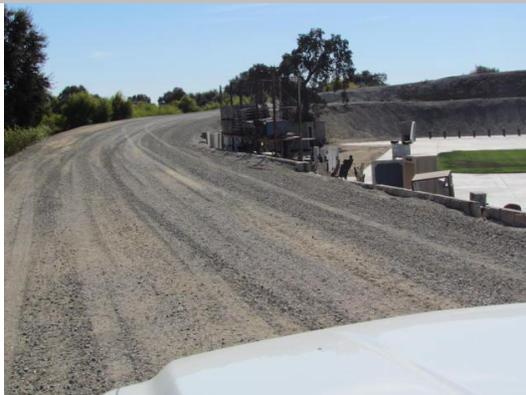
Photo 1 of 2 : FA_2014_RD2091_319_6_20141103_00005.jpg

LM Start	0.20	Rating **	M	Issue No.	6
LM End	0.20	Issue Type +	En	Location *	LS
Category	Earthen Levee		GPS Latitude/Longitude		
			Start	End	
Item	Encroachments			°	°
DWR ID	DWR_RD2091_02_f_2013_6				
Action/Comments					
Retaining Wall Inspector Comments: Retaining walls have been in place for several years.

Looking northeast at retaining walls within the City of Modesto shooting range on landward slope and toe.

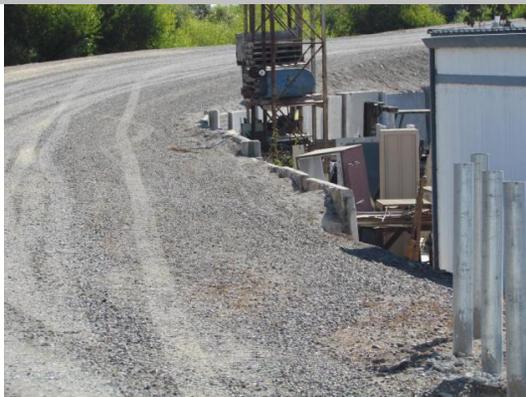
Photo 2 of 2 : FA_2014_RD2091_319_6_20141103_00006.jpg

Looking east at retaining walls on landward toe.

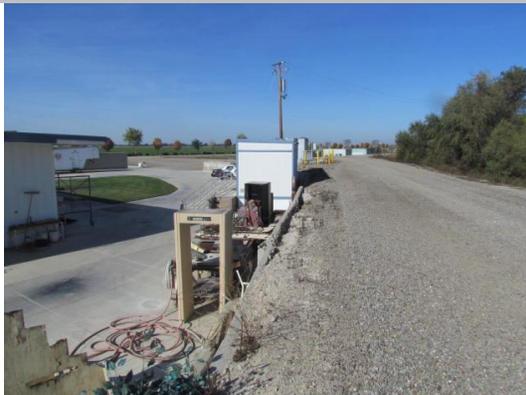
Photo 1 of 2 : FA_2014_RD2091_319_8_20141120_00014.jpg

LM Start	0.21	Rating **	M	Issue No.	8
LM End	0.25	Issue Type +	En	Location *	LS
Category	Earthen Levee		GPS Latitude/Longitude		
			Start	End	
Item	Encroachments		37.484565	°	37.485283
			-121.049980	°	-121.050252
DWR ID	DWR_RD2091_02_f_2013_8				
Action/Comments					
Equipment Inspector Comments: Several items stored at landward toe.

Looking north at several items at landward toe.

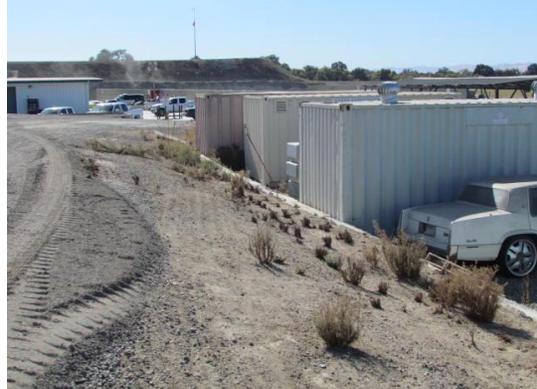
Photo 2 of 2 : FA_2014_RD2091_319_8_20141103_00008.jpg

LM Start	0.21	Rating **	M	Issue No.	8 (cont)
LM End	0.25	Issue Type +	En	Location *	LS
Category	Earthen Levee		GPS Latitude/Longitude		
			Start	End	
Item	Encroachments		37.484565 °	37.485283 °	
			-121.049980 °	-121.050252 °	
DWR ID	DWR_RD2091_02_f_2013_8				
Action/Comments					
Equipment Inspector Comments: Several items stored at landward toe.

Looking northeast at storage containers and abandoned vehicle at landward toe.

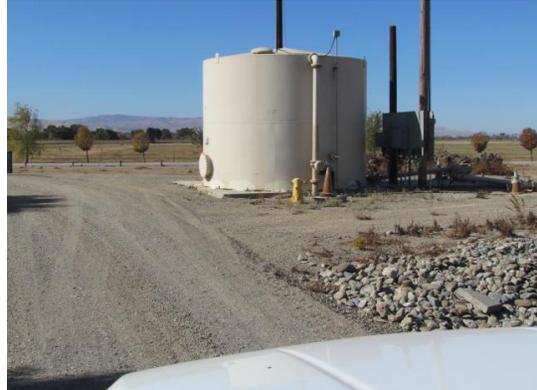
Photo 1 of 1 : FA_2014_RD2091_319_7_20141103_00007.jpg

LM Start	0.25	Rating **	M	Issue No.	7
LM End	0.25	Issue Type +	En	Location *	LS
Category	Earthen Levee		GPS Latitude/Longitude		
			Start	End	
Item	Encroachments				
DWR ID	DWR_RD2091_02_f_2013_7				
Action/Comments					
Tank Inspector Comments: Water tank has been in place for several years.

Looking west at water tank on landward shoulder.
