**Flood Control Project Maintenance
Levee Inspections**

Fall 2015 Levee Maintenance Deficiency Summary Report

Reclamation District No. 2091 Chase

Levee Inspection Report By Mile - Fall 2015

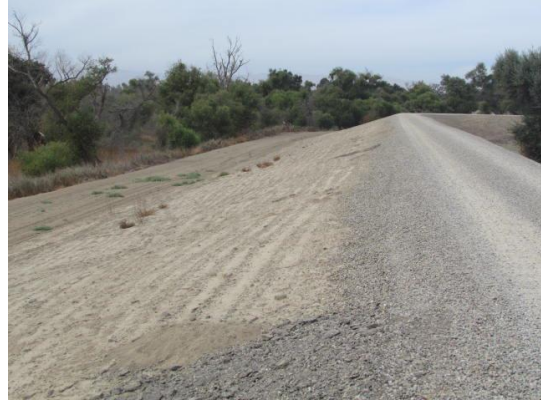
Photo 1 of 1 : FA_2015_RD2091_318_8_20151005_00010.jpg

LM Start	0.00	Rating **	A	Issue No.	8	
LM End	7.46	Issue Type +	Ma	Location *	LS	
Category	Earthen Levee			GPS Latitude/Longitude		
				Start		End
Item	Vegetation				o	
					o	
DWR ID	DWR_RD2091_01_f_2015_8					
Action/Comments						
Control annual grass and weeds on the levee slopes and easements. Inspector Comments: No visible problem noted.

Looking at typical view of levee landward slope.

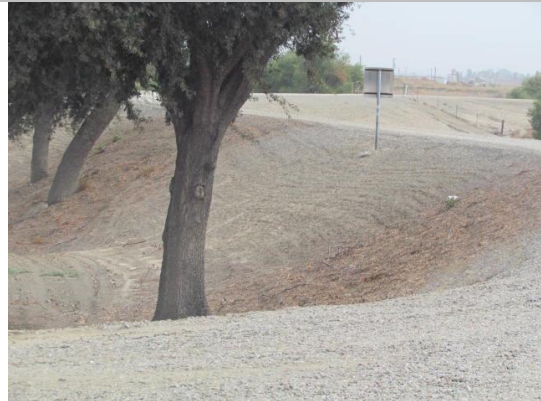
Photo 1 of 1 : FA_2015_RD2091_318_13_20151005_00009.jpg

LM Start	0.00	Rating **	A	Issue No.	13	
LM End	7.46	Issue Type +	Ma	Location *	WS	
Category	Earthen Levee			GPS Latitude/Longitude		
				Start		End
Item	Vegetation					o
						o
DWR ID	DWR_RD2091_01_f_2015_13					
Action/Comments						
Control annual grass and weeds on the levee slopes and easements. Inspector Comments: No visible problems noted.

Looking at typical view of levee slope.

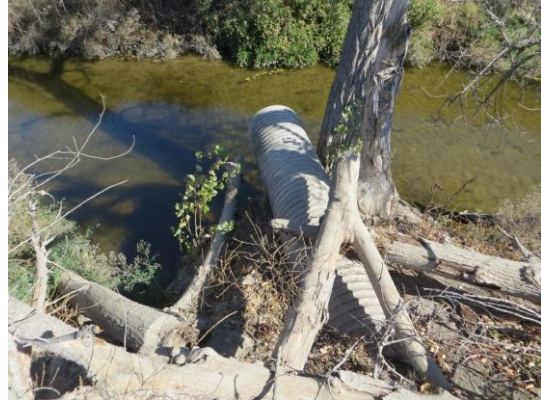
Photo 1 of 3 : UCIP_FA_2015_2557.jpg

Inspector Comments: FS_ID:43207
 DS_ID:23155
 EP_NO: N/A
 FS_HLM: 0.072
 Repair Type: Non-Urgent
 Crossing Status: Found
 UCIP Comments: Appears abandoned and if so should be done so properly.
 FIELD_STRUCT_DESC: 24-inch corrugated metal pipe through levee 7.2 feet below crown. Slide gate in 36-inch corrugated metal pipe riser on the waterward slope. Originally included in the 1961 O&M manual. As built drawings available, Drawing # 07-04-1555: 1555/17 & 1555/55, 906+85.
 FS Date: 01/29/2015

CMP stormdrain at outlet off WS toe.

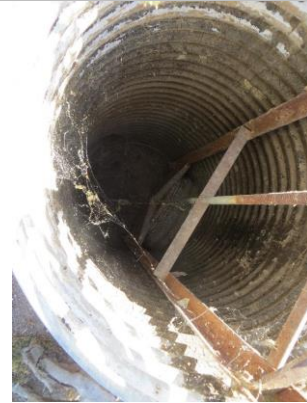
Photo 2 of 3 : UCIP_FA_2015_2558.jpg

Slide gate in 36-inch CMP riser on WS toe.

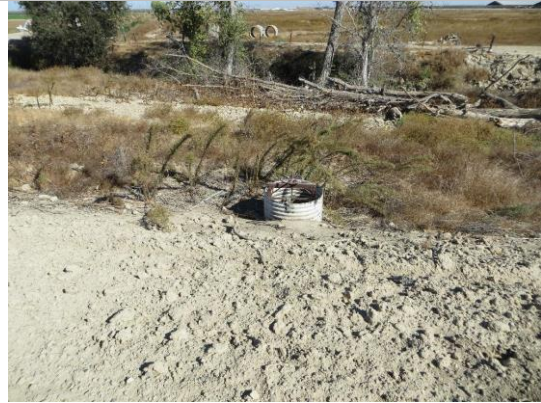
Photo 3 of 3 : UCIP_FA_2015_2559.jpg

Slide gate in 36-inch CMP riser on WS toe.

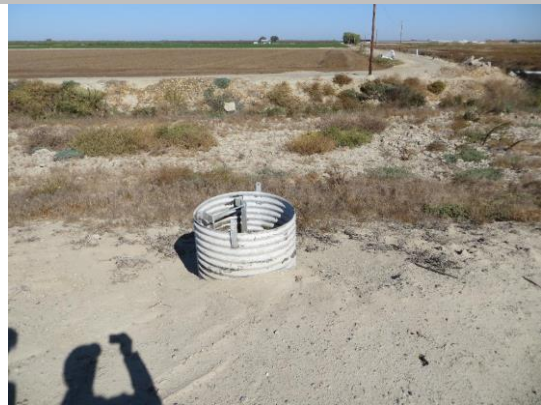
Photo 1 of 2 : UCIP_FA_2015_2459.jpg

LM Start	0.10	Rating **	U	Issue No.	56
LM End	0.10	Issue Type +	En	Location *	WS
Category	Supplemental			GPS Latitude/Longitude	
				Start	End
Item	DWR UCIP Field Study			37.542030 °	37.542030 °
				-121.094370 °	-121.094370 °
DWR ID					
Action/Comments					
Inspector Comments: FS_ID:43204					
DS_ID:23156					
EP_NO: N/A					
FS_HLM: 0.095					
Repair Type: Urgent					
Crossing Status: Found					
UCIP Comments: Pipe open on WS and slide gate has been removed.					
Appears abandoned and should be done so properly.					
FIELD_STRUCT_DESC: 24-inch corrugated metal pipe through levee					
9.0 feet below crown. Slide gate in corrugated metal pipe riser on the					
waterward slope. Originally included in the 1961 O&M manual. As built					
drawings available, Drawing # 07-04-1555: 1555/17 & 1555/55, 907+55.					
FS Date: 01/29/2015

36-inch CMP riser on WS slope.

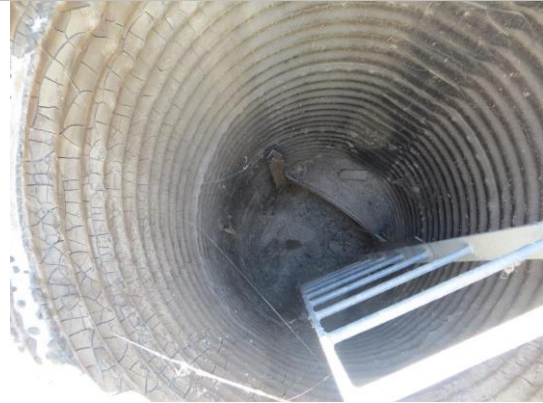
Photo 2 of 2 : UCIP_FA_2015_2560.jpg

Inspector Comments: FS_ID:43204
DS_ID:23156
EP_NO: N/A
FS_HLM: 0.095
Repair Type: Urgent
Crossing Status: Found
UCIP Comments: Pipe open on WS and slide gate has been removed. Appears abandoned and should be done so properly.
FIELD_STRUCT_DESC: 24-inch corrugated metal pipe through levee 9.0 feet below crown. Slide gate in corrugated metal pipe riser on the waterward slope. Originally included in the 1961 O&M manual. As built drawings available, Drawing # 07-04-1555: 1555/17 & 1555/55, 907+55.
FS Date: 01/29/2015

Slide gate missing from open end of pipe at WS slope.

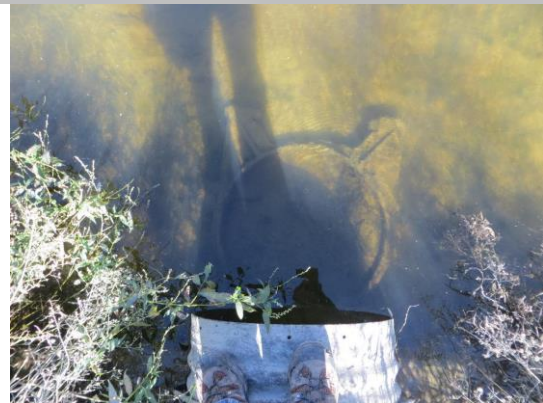
Photo 1 of 3 : UCIP_FA_2015_2324.jpg

Inspector Comments: FS_ID:43205
DS_ID:23158
EP_NO: N/A
FS_HLM: 0.234
Repair Type: Urgent
Crossing Status: Found
UCIP Comments: Flap gate has fallen off at WS toe. Appears abandoned and if so should be done so properly.
FIELD_STRUCT_DESC: 24-inch corrugated metal pipe through levee 10.0 feet below crown. Flap gate on the waterward end. Drain opening 15 feet off landward toe. Originally included in the 1961 O&M manual. As built drawings available, Drawing # 07-04-1555: 1555/17 & 1555/55, 915+00.
FS Date: 01/29/2015

Flapgate has fallen off at WS toe.

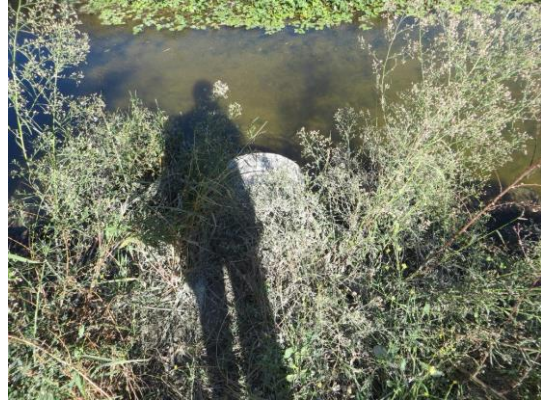
Photo 2 of 3 : UCIP_FA_2015_2325.jpg

Inspector Comments: FS_ID:43205
 DS_ID:23158
 EP_NO: N/A
 FS_HLM: 0.234
 Repair Type: Urgent
 Crossing Status: Found
 UCIP Comments: Flap gate has fallen off at WS toe. Appears abandoned and if so should be done so properly.
 FIELD_STRUCT_DESC: 24-inch corrugated metal pipe through levee 10.0 feet below crown. Flap gate on the waterward end. Drain opening 15 feet off landward toe. Originally included in the 1961 O&M manual. As built drawings available, Drawing # 07-04-1555: 1555/17 & 1555/55, 915+00.
 FS Date: 01/29/2015

Pipe visible in canal on WS toe.

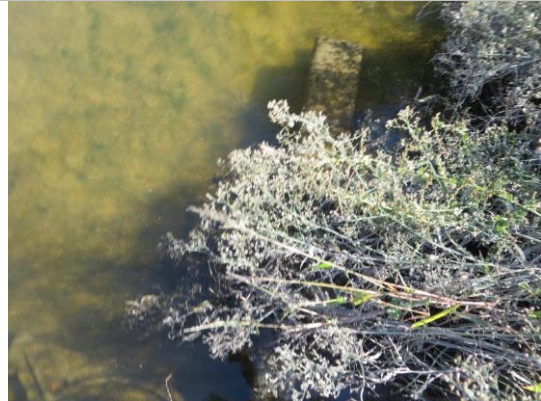
Photo 3 of 3 : UCIP_FA_2015_2460.jpg

Concrete headwall under pipe at WS toe.

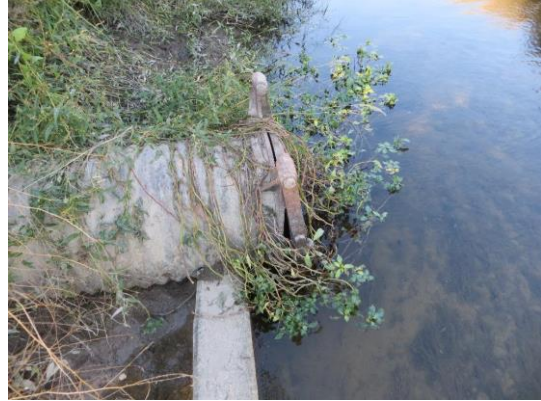
Photo 1 of 2 : UCIP_FA_2015_1953.jpg

LM Start	0.63	Rating **	U	Issue No.	58
LM End	0.63	Issue Type +	En	Location *	WS
Category	Supplemental			GPS Latitude/Longitude	
				Start	End
Item	DWR UCIP Field Study			37.541220 °	37.541220 °
				-121.103880 °	-121.103880 °
DWR ID					
Action/Comments					
Inspector Comments: FS_ID:43208 DS_ID:23161 EP_NO: N/A FS_HLM: 0.638 Repair Type: Urgent Crossing Status: Found

24-inch CMP on concrete headwall with flapgate on WS toe.

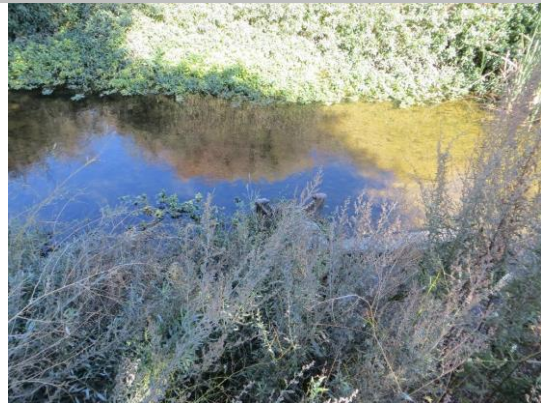
Photo 2 of 2 : UCIP_FA_2015_1954.jpg

24-inch CMP on concrete headwall with flapgate on WS toe.

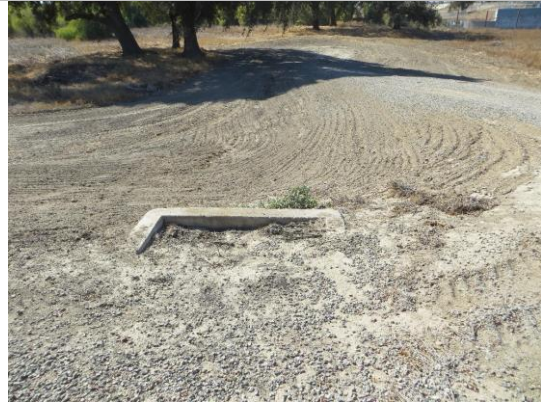
Photo 1 of 3 : UCIP_FA_2015_1955.jpg

Inspector Comments: FS_ID:43209
 DS_ID:23165
 EP_NO: N/A
 FS_HLM: 4.669
 Repair Type: Non-Urgent
 Crossing Status: Found
 UCIP Comments: Appears abandoned and if so should be done so properly.
 FIELD_STRUCT_DESC: 36-inch corrugated metal pipe through levee 15.0 feet below crown. Abandoned concrete inlet box on the waterward slope of levee. 6'X5' Concrete distribution box at the landward toe.
 Originally included in the 1961 O&M manual.
 FS Date: 01/29/2015

Abandoned concrete box on WS slope.

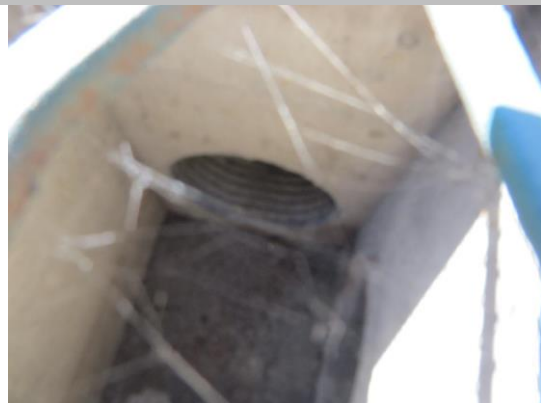
Photo 2 of 3 : UCIP_FA_2015_1956.jpg

Open CMP pipe through levee at distribution box on LS toe.

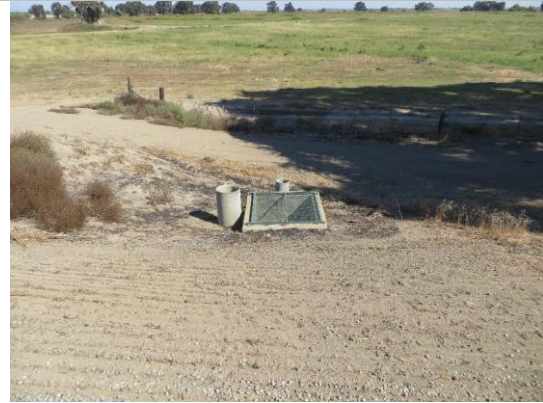
Photo 3 of 3 : UCIP_FA_2015_1957.jpg

Distribution box on LS toe.

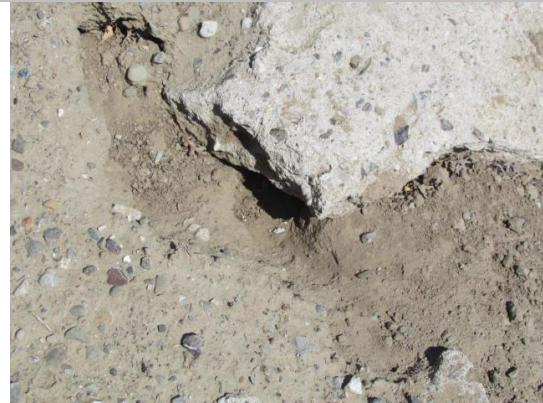
Photo 1 of 1 : FA_2015_RD2091_318_11_20150914_00003.jpg

LM Start	5.66	Rating **	A/W	Issue No.	11
LM End	5.68	Issue Type +	Ma	Location *	LS
Category	Earthen Levee			GPS Latitude/Longitude	
				Start	End
Item	Animal Control			37.486090 °	37.485839 °
				-121.067612 °	-121.067357 °
DWR ID	DWR_RD2091_01_s_2015_11				
Action/Comments					
No rodents visible, but rodent burrows visible; need to backfill and compact or grout burrows.					
Inspector Comments: The LMA has implemented a rodent program.					
No visible rodents and rodent holes.

Looking at typical view of rodent holes on the landward slope and toe.

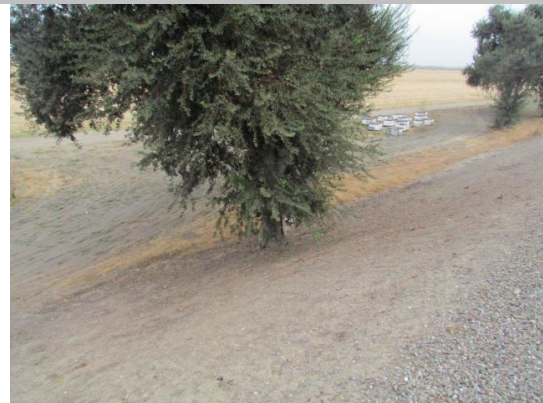
Photo 1 of 1 : FA_2015_RD2091_318_12_20151005_00011.jpg

LM Start	5.92	Rating **	M	Issue No.	12
LM End	5.92	Issue Type +	Ma	Location *	LS
Category	Earthen Levee			GPS Latitude/Longitude	
				Start	End
Item	Trim / Thin Trees			37.485998 °	37.485998 °
				-121.063323 °	-121.063323 °
DWR ID	DWR_RD2091_01_f_2015_12				
Action/Comments					
Trim trees to at least five feet above ground level.

Looking at untrimmed tree on landward toe.

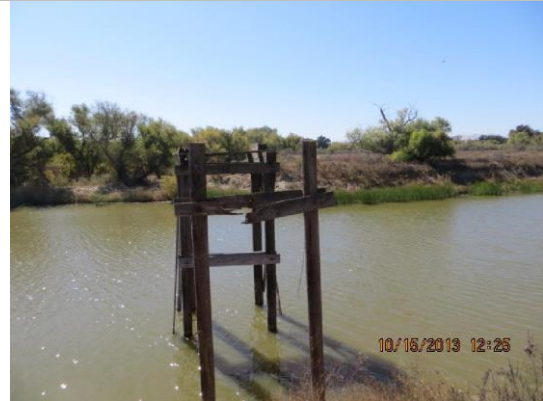
Photo 1 of 3 : UCIP_FA_2015_1958.jpg

FIELD_STRUCT_DESC: *Removed* 36-inch corrugated metal pipe through levee 15.0 feet below crown. Slide gate in corrugated metal pipe riser on the waterward slope. Concrete distribution box at the landward toe. Slide gate on the landward end. Concrete standpipe on the waterward berm. Pump on pile stream. Originally included in the 1961 O&M manual. Pipe removed under Permit No. 4421. Design drawings available in Permit No. 4421.

Abandoned pier off WS toe.

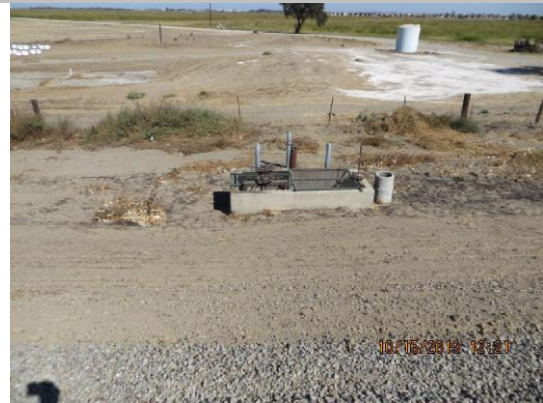
Photo 2 of 3 : UCIP_FA_2015_1959.jpg

Concrete distribution box on LS toe.

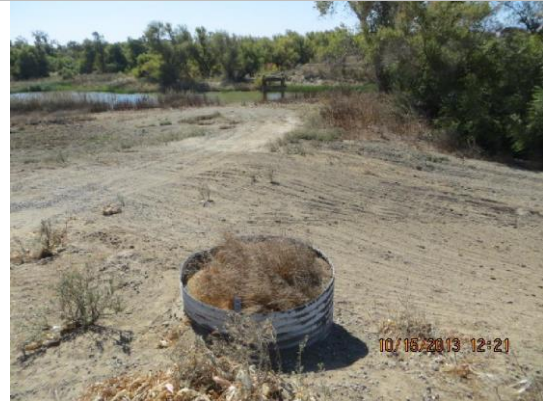
Photo 3 of 3 : UCIP_FA_2015_1960.jpg

Abandoned CMP riser on WS slope.

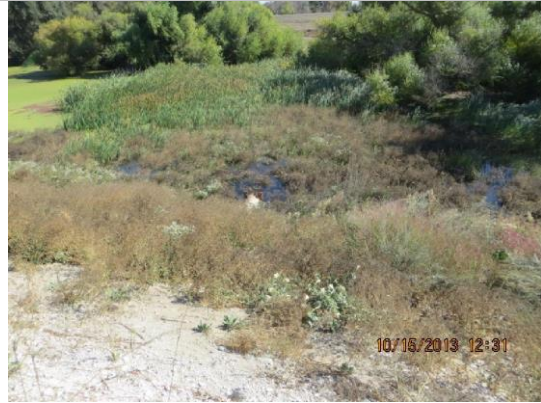
Photo 1 of 1 : UCIP_FA_2015_1961.jpg

LM Start	0.02	Rating **	U	Issue No.	15
LM End	0.02	Issue Type +	En	Location *	LS
Category	Supplemental			GPS Latitude/Longitude	
				Start	End
Item	DWR UCIP Field Study			37.482450 °	37.482450 °
				-121.051220 °	-121.051220 °
DWR ID					
Action/Comments					
Inspector Comments: FS_ID:43206 DS_ID:23175 EP_NO: N/A FS_HLM: 0.023 Repair Type: Urgent Crossing Status: Found UCIP Comments: Flap gate rusted in-place and does not function. In closed position. FIELD_STRUCT_DESC: 24-inch corrugated metal drain pipe through levee 16.4-feet below the crown. Flap gate on the waterward toe. FS Date: 01/29/2015

24-inch CMP with flapgate visible on WS toe.

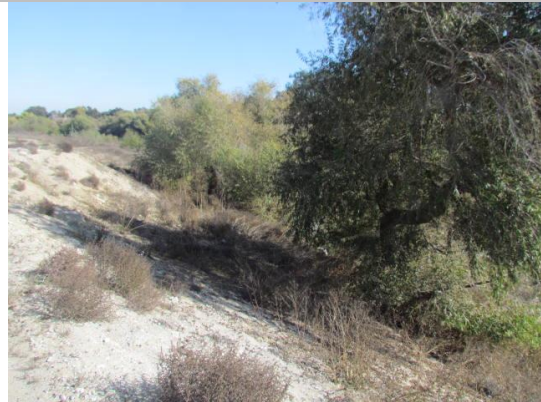
Photo 1 of 2 : FA_2015_RD2091_319_1_20150914_00001.jpg

LM Start	0.03	Rating **	M	Issue No.	1
LM End	0.03	Issue Type +	Ma	Location *	WS
Category	Earthen Levee			GPS Latitude/Longitude	
				Start	End
Item	Trim / Thin Trees			37.482523 °	37.482523 °
				-121.051103 °	-121.051103 °
DWR ID	DWR_RD2091_02_s_2012_1				
Action/Comments					
Thin trees to allow visibility of the ground and room to flood fight.

Looking east at untrimmed trees on waterward slope. (Fall 2014)

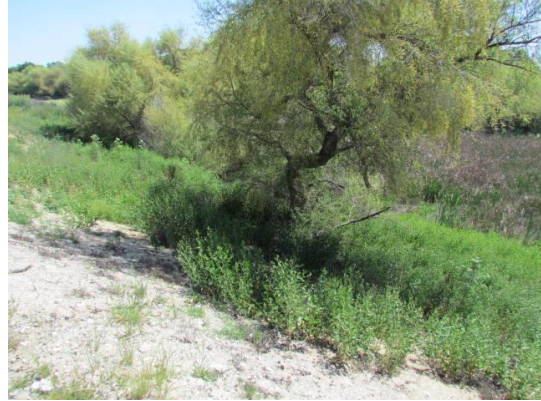
Photo 2 of 2 : FA_2015_RD2091_319_1_20150914_00002.jpg

Looking east at untrimmed tree on waterward slope. (Spring 2014)

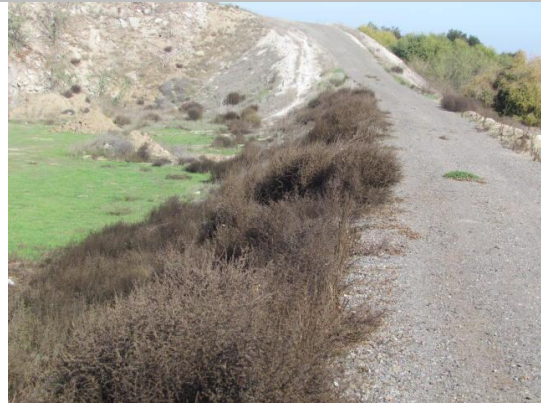
Photo 1 of 1 : FA_2015_RD2091_319_2_20150914_00003.jpg

LM Start	0.05	Rating **	A/W	Issue No.	2
LM End	0.05	Issue Type +	Ma	Location *	LS
Category	Earthen Levee			GPS Latitude/Longitude	
				Start	End
Item	Vegetation			37.482815 °	37.482815 °
				-121.050849 °	-121.050849 °
DWR ID	DWR_RD2091_02_f_2012_2				
Action/Comments					
Remove the wild growth other than native grasses from the levee slopes.					
Inspector Comments: Control tumble weeds on landward slope.

Looking north at tumble weeds on landward slope.
