**Flood Control Project Maintenance  
Levee Inspections**

**Fall 2016 Levee Maintenance Deficiency Summary Report**

**Reclamation District No. 2091 Chase**

**Levee Inspection Report By Mile - Fall 2016**

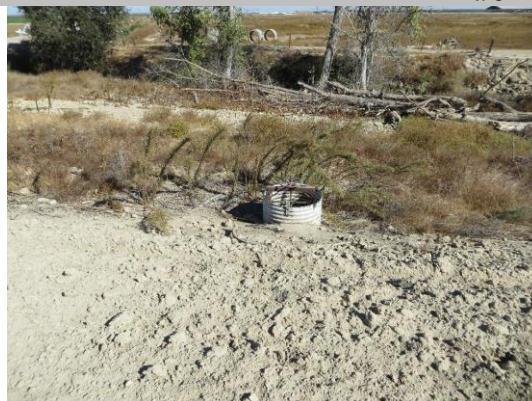
Photo 1 of 2 : UCIP\_FA\_2016\_43207\_38148.jpg

LM Start	0.08	Rating **	M	Issue No.	17
LM End	0.08	Issue Type +	En	Location *	LS
Category	Supplemental			GPS Latitude/Longitude	
				Start	End
Item	DWR UCIP Field Study			37.541970 °	37.541970 °
				-121.093980 °	-121.093980 °
DWR ID					
Comment Code					
Inspector Comment					
FS_ID:43207 DS_ID:23155 EP_NO: N/A Repair Type: Non-Urgent Crossing Status: Found UCIP Comments: Appears abandoned and if so should be done so properly. FIELD_STRUCT_DESC: *ABANDONED* 24-inch corrugated metal pipe through levee 7.2 feet below crown. Slide gate in 36-inch corrugated metal pipe riser on the waterward slope. Originally included in the 1961 O&M manual. As built drawings available, Drawing # 07-04-1555: 1555/17 & 1555/55, 906+85. FS Date: 1/29/2015 2:26:31 PM

Slide gate in 36-inch CMP riser on WS toe.

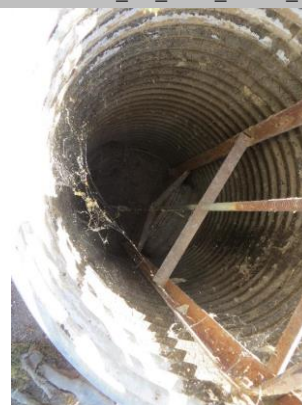
Photo 2 of 2 : UCIP\_FA\_2016\_43207\_38147.jpg

Slide gate in 36-inch CMP riser on WS toe.

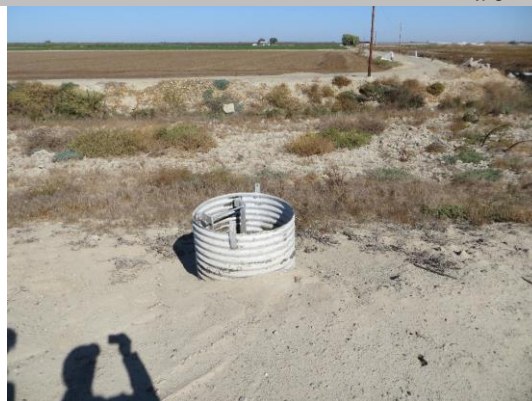
Photo 1 of 2 : UCIP\_FA\_2016\_50991\_38150.jpg

FS\_ID:50991  
DS\_ID:23156  
EP\_NO: N/A  
Repair Type: Urgent  
Crossing Status: Found  
UCIP Comments: 11/18/2016 Same as last inspection this is a non-functional crossing with no visible inlet on LS or outlet on WS. The only appurtenance found at this location is a CMP riser with a missing cover located on the WS. This crossing remains Urgent since the pipe on the WS may still be opened. According to Mike Alves, this crossing is abandoned and the City of Modesto is working with CVFPB to authorize proper abandonment/removal. The City is working at finding funds to pay for proper abandonment/removal of all the drainage structures through this levee. (O. Magana - DWR UCIP)01/29/2015 Pipe open on WS and slide gate has been removed. Appears abandoned and should be done so properly. (M. Alves - City of Modesto)  
FIELD\_STRUCT\_DESC: \*ABANDONED\* 24-inch corrugated metal drainage pipe through levee, 9 feet below crown. Slide gate in corrugated metal pipe (CMP) riser located on the waterside (WS) slope.

36-inch CMP riser on WS slope.

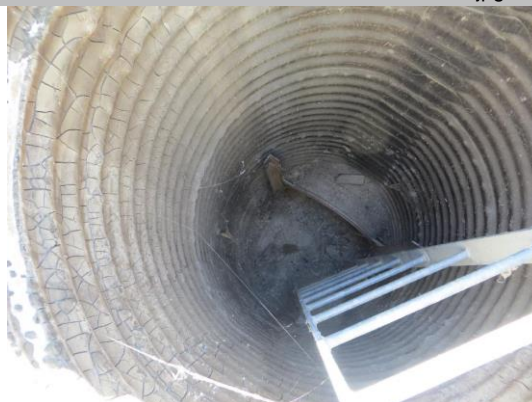
Photo 2 of 2 : UCIP\_FA\_2016\_50991\_38149.jpg

Slide gate missing from open end of pipe at WS slope.

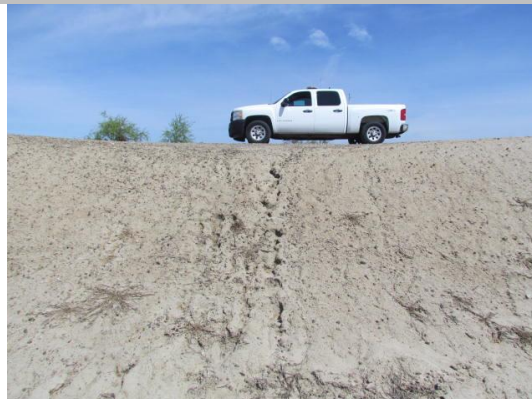
Photo 1 of 4 : FA\_2016\_RD2091\_318\_15\_20161007\_00002.jpg

LM Start	0.23	Rating **	U	Issue No.	15
LM End	0.23	Issue Type +	Ma	Location *	LS
Category	Earthen Levee			GPS Latitude/Longitude	
				Start	End
Item	Erosion / Bank Caving			37.541550 °	37.541550 °
				-121.096742 °	-121.096742 °
DWR ID	DWR_RD2091_01_s_2016_15				
Comment Code					
E1 : Note and monitor erosion site.					
Inspector Comment					
Caving on landward shoulder possible collapsed pipe. Caving is 34 feet long over one inch depth.

Looking west at dip on landward levee shoulder.

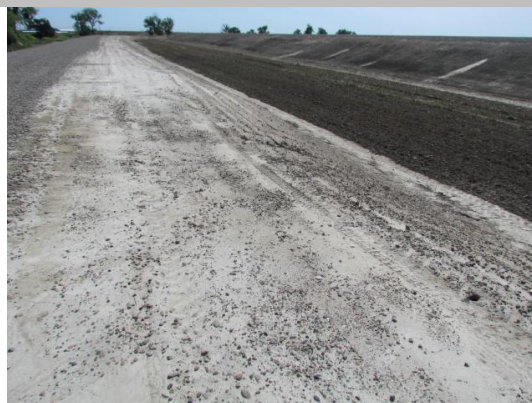
Photo 2 of 4 : FA\_2016\_RD2091\_318\_15\_20161007\_00003.jpg

Looking southeast at depression along landward shoulder.

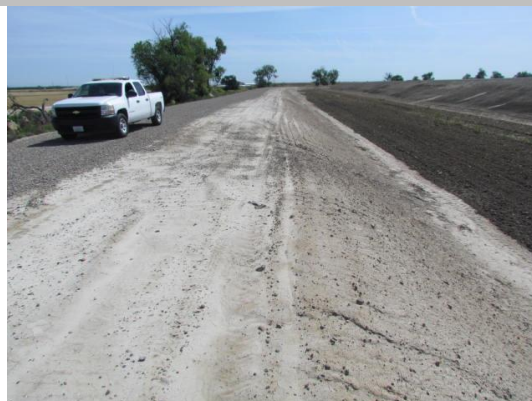
Photo 3 of 4 : FA\_2016\_RD2091\_318\_15\_20161007\_00004.jpg

Looking south at depression along landward shoulder.

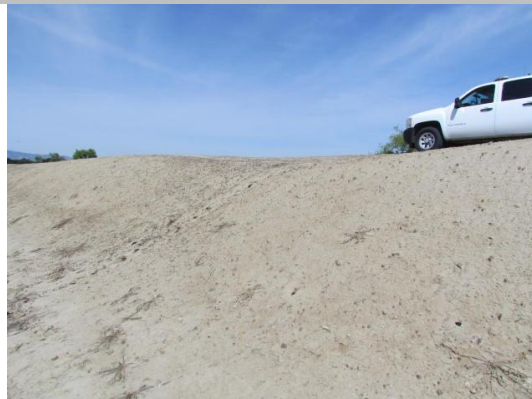
Photo 4 of 4 : FA\_2016\_RD2091\_318\_15\_20161007\_00005.jpg

LM Start	0.23	Rating **	U	Issue No.	15 (cont)	
LM End	0.23	Issue Type +	Ma	Location *	LS	
Category	Earthen Levee			GPS Latitude/Longitude		
				Start		End
Item	Erosion / Bank Caving			37.541550 °		37.541550 °
				-121.096742 °		-121.096742 °
DWR ID	DWR_RD2091_01_s_2016_15					
Comment Code						
E1 : Note and monitor erosion site.						
Inspector Comment						
Caving on landward shoulder possible collapsed pipe. Caving is 34 feet long over one inch depth.

Looking northwest at depression along landward shoulder.

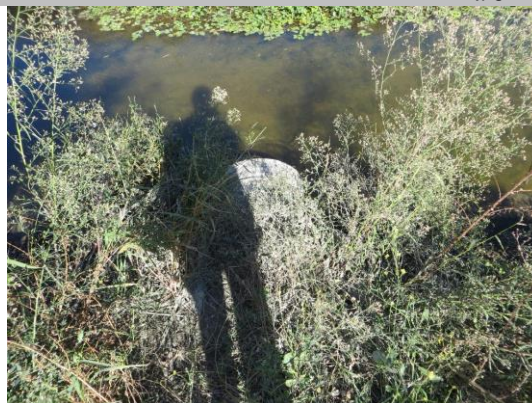
Photo 1 of 2 : UCIP\_FA\_2016\_50995\_38156.jpg

Comment Code					
Inspector Comment					
FS_ID:50995 DS_ID:23158 EP_NO: N/A Repair Type: Urgent Crossing Status: Found UCIP Comments: 11/18/2016 Same as last inspection this crossing remains Urgent the flap gate is still missing from the WS toe. According to Mike A. this crossing is abandoned and the City of Modesto is working with CVFPB to authorize proper abandonment/removal. The City is working at finding funds to pay for proper abandonment/removal of all the drainage structures through this levee. (O. Magana - DWR UCIP)01/29/2015 Flap gate has fallen off at WS toe. Appears abandoned and if so should be done so properly. (M. Alves - City of Modesto) FIELD_STRUCT_DESC: *ABANDONED* 24-inch corrugated metal drainage pipe through levee, 10 feet below crown. Flap gate located on the waterside (WS) end. Drain opening is located approximately 15 feet off the landside (LS) toe. [Additional Reference(s): DWR Levee Log, 1992. USACE San Joaquin River O&M Manual Unit 6, September 1961, (HLM 0.23), Drawing No. 07-04-1555, sheet(s) 1555/17 and 1555/55, reference station 915+00]. FS Date: 11/18/2016

Pipe visible in canal on WS toe.

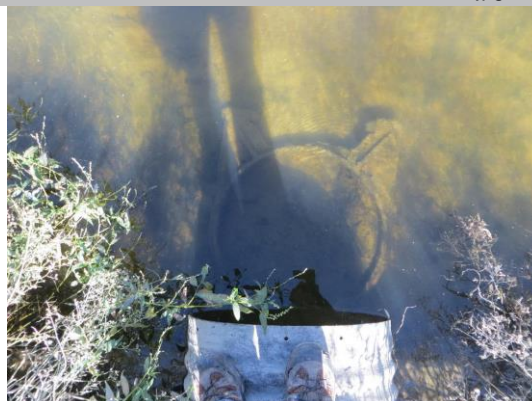
Photo 2 of 2 : UCIP\_FA\_2016\_50995\_38155.jpg

Comment Code						
Inspector Comment						
FS_ID:50995 DS_ID:23158 EP_NO: N/A Repair Type: Urgent Crossing Status: Found UCIP Comments: 11/18/2016 Same as last inspection this crossing remains Urgent the flap gate is still missing from the WS toe. According to Mike A. this crossing is abandoned and the City of Modesto is working with CVFPB to authorize proper abandonment/removal. The City is working at finding funds to pay for proper abandonment/removal of all the drainage structures through this levee. (O. Magana - DWR UCIP)01/29/2015 Flap gate has fallen off at WS toe. Appears abandoned and if so should be done so properly. (M. Alves - City of Modesto) FIELD_STRUCT_DESC: *ABANDONED* 24-inch corrugated metal drainage pipe through levee, 10 feet below crown. Flap gate located on the waterside (WS) end. Drain opening is located approximately 15 feet off the landside (LS) toe. [Additional Reference(s): DWR Levee Log, 1992. USACE San Joaquin River O&M Manual Unit 6, September 1961, (HLM 0.23), Drawing No. 07-04-1555, sheet(s) 1555/17 and 1555/55, reference station 915+00]. FS Date: 11/18/2016

Flapgate has fallen off at WS toe.

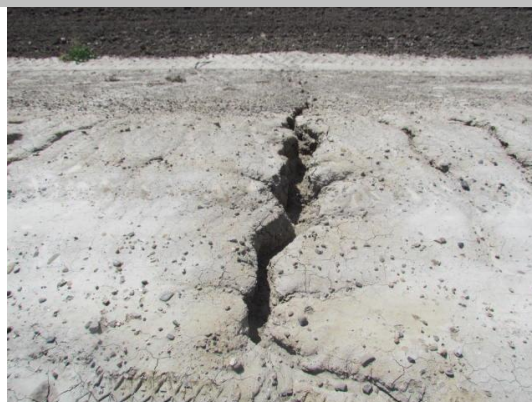
Photo 1 of 5 : FA\_2016\_RD2091\_318\_16\_20161007\_00006.jpg

LM Start	0.25	Rating **	M	Issue No.	16
LM End	0.28	Issue Type +	Ma	Location *	LS
Category	Earthen Levee			GPS Latitude/Longitude	
				Start	End
Item	Erosion / Bank Caving			37.541492 °	37.541408 °
				-121.097052 °	-121.097453 °
DWR ID	DWR_RD2091_01_s_2016_16				
Comment Code					
E1 : Note and monitor erosion site.					
Inspector Comment					
Several fringer erosions and possible rodent holes along landward shoulder and slope.

Looking east at fringer erosion on landward slope.

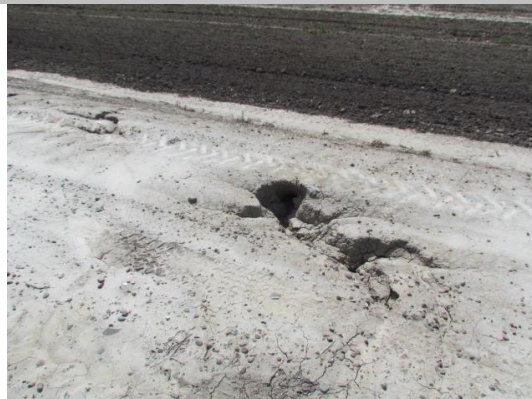
Photo 2 of 5 : FA\_2016\_RD2091\_318\_16\_20161007\_00007.jpg

LM Start	0.25	Rating **	M	Issue No.	16 (cont)	
LM End	0.28	Issue Type +	Ma	Location *	LS	
Category	Earthen Levee			GPS Latitude/Longitude		
				Start		End
Item	Erosion / Bank Caving			37.541492 °		37.541408 °
				-121.097052 °		-121.097453 °
DWR ID	DWR_RD2091_01_s_2016_16					
Comment Code						
E1 : Note and monitor erosion site.						
Inspector Comment						
Several fringer erosions and possible rodent holes along landward shoulder and slope.

Looking east at fringer erosion and possible rodent hole on landward slope.

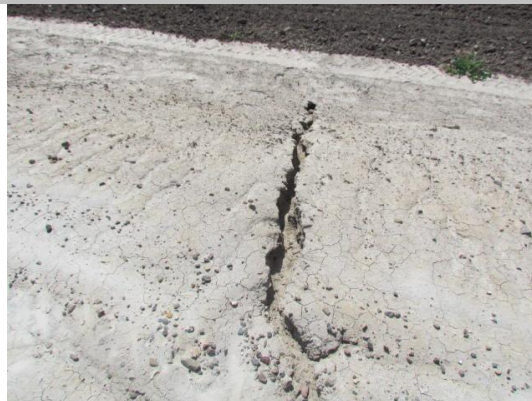
Photo 3 of 5 : FA\_2016\_RD2091\_318\_16\_20161007\_00008.jpg

Looking east at fringer erosion on landward slope.

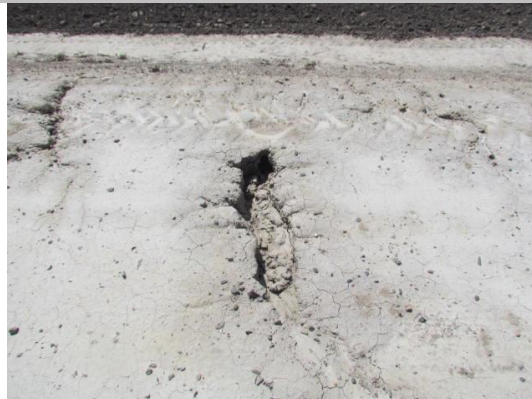
Photo 4 of 5 : FA\_2016\_RD2091\_318\_16\_20161007\_00009.jpg

Looking east at fringer erosion and possible rodent hole on landward slope.

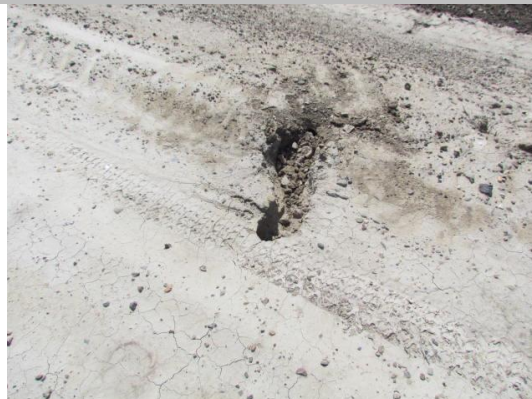
Photo 5 of 5 : FA\_2016\_RD2091\_318\_16\_20161007\_00010.jpg

LM Start	0.25	Rating **	M	Issue No.	16 (cont)	
LM End	0.28	Issue Type +	Ma	Location *	LS	
Category	Earthen Levee			GPS Latitude/Longitude		
				Start		End
Item	Erosion / Bank Caving			37.541492 °	37.541408 °	
				-121.097052 °	-121.097453 °	
DWR ID	DWR_RD2091_01_s_2016_16					
Comment Code						
E1 : Note and monitor erosion site.						
Inspector Comment						
Several fringer erosions and possible rodent holes along landward shoulder and slope.

Looking east at erosion and possible rodent hole on landward shoulder.

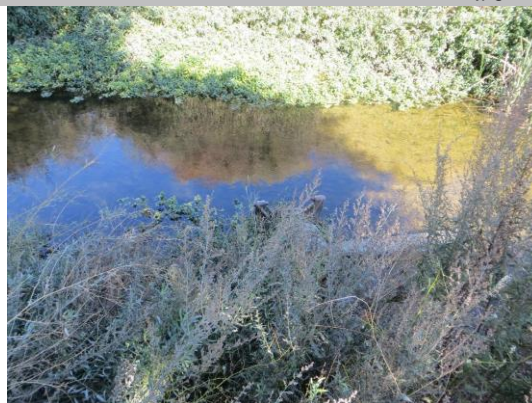
Photo 1 of 2 : UCIP\_FA\_2016\_50997\_38158.jpg

Comment Code					
Inspector Comment					
FS_ID:50997					
DS_ID:23161					
EP_NO: N/A					
Repair Type: Non-Urgent					
Crossing Status: Found					
UCIP Comments: 11/18/2016 Crossing has been downgraded from Urgent to Non-Urgent since the flap gate appears to fully close.					
According to Mike Alvez, this crossing is abandoned and the City of Modesto is working with CVFPB to authorize proper abandonment/removal. The City is working at finding funds to pay for proper abandonment/removal of all the drainage structures through this levee. (O. Magana - DWR UCIP)01/29/2015 Appears abandoned and if so should be done so properly. (M. Alvez - City of Modesto)					
FIELD_STRUCT_DESC: *ABANDONED* 24-inch corrugated metal drainage pipe through levee, 12 feet below crown. Flap gate and concrete headwall are located on the waterside (WS) end. [Additional Reference(s): DWR Levee Log, 1992. USACE San Joaquin River O&M Manual Unit 6, September 1961, (HLM 0.64)].

24-inch CMP on concrete headwall with flapgate on WS toe.

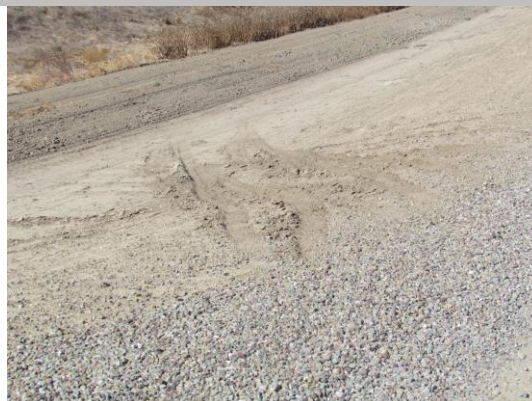
Photo 2 of 2 : FA\_2016\_RD2091\_318\_13\_20161027\_00031.jpg

LM Start	5.20	Rating **	M	Issue No.	13 (cont)	
LM End	5.20	Issue Type +	Ma	Location *	LS	
Category	Earthen Levee			GPS Latitude/Longitude		
				Start		End
Item	Slope Stability			37.490756 °		37.490756 °
				-121.073410 °		-121.073410 °
DWR ID	DWR_RD2091_01_f_2016_13					
Comment Code						
S3 : Repair the levee slope damaged by vehicle traffic and prevent access where possible.						
Inspector Comment						
Vehicle traffic damaging slope on waterward and landward slope.

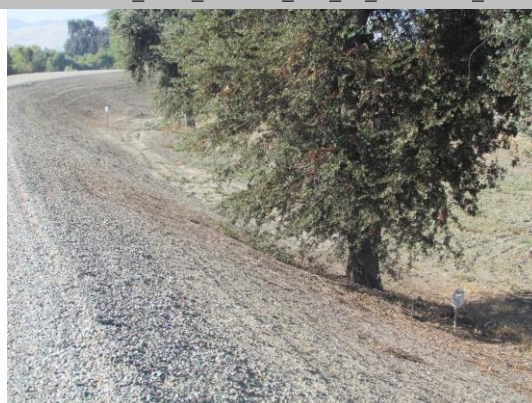
Photo 1 of 2 : FA\_2016\_RD2091\_318\_12\_20161027\_00033.jpg

LM Start	5.92	Rating **	M	Issue No.	12
LM End	5.92	Issue Type +	Ma	Location *	LS
Category	Earthen Levee			GPS Latitude/Longitude	
				Start	End
Item	Trim / Thin Trees			37.485998 °	37.485998 °
				-121.063323 °	-121.063323 °
DWR ID	DWR_RD2091_01_f_2015_12				
Comment Code					
T1 : Trim trees to at least five feet above ground level.					
Inspector Comment

Looking north at untrimmed tree at landward toe.

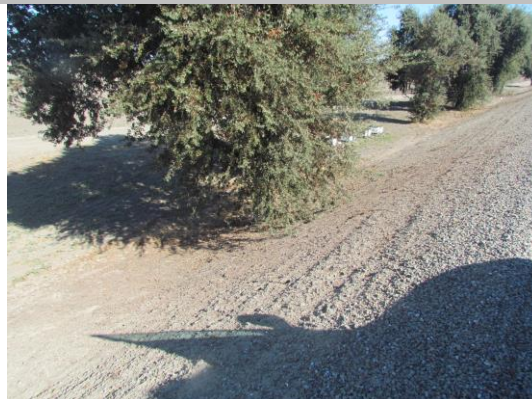
Photo 2 of 2 : FA\_2016\_RD2091\_318\_12\_20161027\_00032.jpg

LM Start	5.92	Rating **	M	Issue No.	12 (cont)	
LM End	5.92	Issue Type +	Ma	Location *	LS	
Category	Earthen Levee			GPS Latitude/Longitude		
				Start		End
Item	Trim / Thin Trees			37.485998 °		37.485998 °
				-121.063323 °		-121.063323 °
DWR ID	DWR_RD2091_01_f_2015_12					
Comment Code						
T1 : Trim trees to at least five feet above ground level.						
Inspector Comment

Look southeast at untrimmed tree at landward toe.

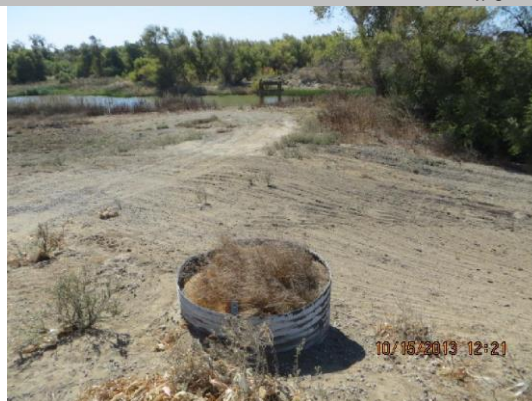
Photo 1 of 2 : UCIP\_FA\_2016\_43221\_38215.jpg

LM Start	6.20	Rating **	M	Issue No.	19
LM End	6.20	Issue Type +	En	Location *	LS
Category	Supplemental			GPS Latitude/Longitude	
				Start	End
Item	DWR UCIP Field Study			37.486060 °	37.486060 °
				-121.058790 °	-121.058790 °
DWR ID					
Comment Code					
Inspector Comment					
FS_ID:43221					
DS_ID:23166					
EP_NO: N/A					
Repair Type: Non-Urgent					
Crossing Status: Indicator Found					
UCIP Comments:					
FIELD_STRUCT_DESC: *Removed* 36-inch corrugated metal pipe through levee 15.0 feet below crown. Slide gate in corrugated metal pipe riser on the waterward slope. Concrete distribution box at the landward toe. Slide gate on the landward end. Concrete standpipe on the waterward berm. Pump on pile stream. Originally included in the 1961 O&M manual. Pipe removed under Permit No. 4421. Design drawings available in Permit No. 4421.					
FS Date: 1/29/2015 2:31:08 PM

Abandoned CMP riser on WS slope.

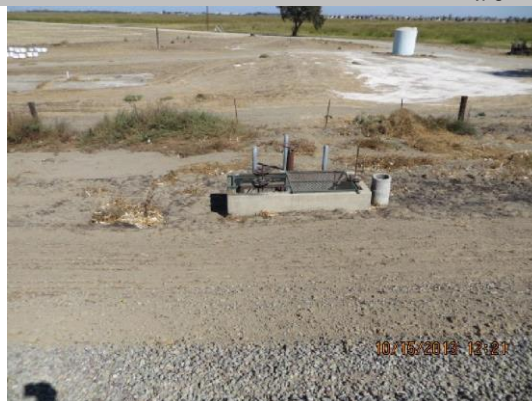
Photo 2 of 2 : UCIP\_FA\_2016\_43221\_38214.jpg

LM Start	6.20	Rating **	M	Issue No.	19 (cont)
LM End	6.20	Issue Type +	En	Location *	LS
Category	Supplemental			GPS Latitude/Longitude	
				Start	End
Item	DWR UCIP Field Study			37.486060 °	37.486060 °
				-121.058790 °	-121.058790 °
DWR ID					
Comment Code					
Inspector Comment					
FS_ID:43221 DS_ID:23166 EP_NO: N/A Repair Type: Non-Urgent Crossing Status: Indicator Found UCIP Comments: FIELD_STRUCT_DESC: *Removed* 36-inch corrugated metal pipe through levee 15.0 feet below crown. Slide gate in corrugated metal pipe riser on the waterward slope. Concrete distribution box at the landward toe. Slide gate on the landward end. Concrete standpipe on the waterward berm. Pump on pile stream. Originally included in the 1961 O&M manual. Pipe removed under Permit No. 4421. Design drawings available in Permit No. 4421. FS Date: 1/29/2015 2:31:08 PM

Concrete distribution box on LS toe.

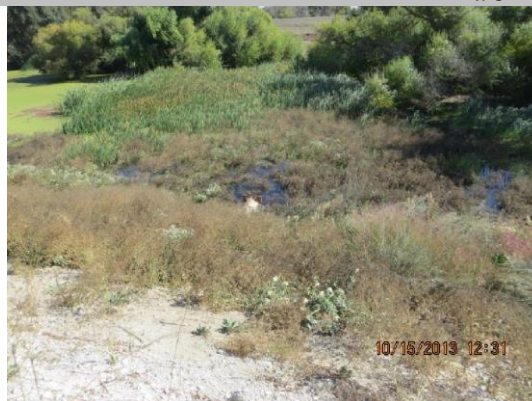
Photo 1 of 1 : UCIP\_FA\_2016\_50986\_38216.jpg

Comment Code					
Inspector Comment					
FS_ID:50986 DS_ID:23175 EP_NO: N/A Repair Type: Non-Urgent Crossing Status: Found UCIP Comments: 11/18/2016 Same as last inspection this is a non-functional crossing with flap gate in the closed position. This crossing has been downgraded from Urgent to Non-Urgent no integrity issues were observed on the levee crown or slopes. According to Mike A. this crossing is abandoned and the City of Modesto is working with CVFPB to authorize proper abandonment/removal. The City is working at finding funds to pay for proper abandonment/removal of all the drainage structures through this levee. (O. Magana - DWR UCIP)01/29/2015 Flap gate rusted in-place and does not function. In closed position. (M. Alves - City of Modesto) FIELD_STRUCT_DESC: 24-inch corrugated metal drainage pipe through levee, 16.4 feet below the crown. Flap gate is located on the waterside (WS) toe. [Additional Reference(s): DWR Levee Log, 1992]. FS Date: 11/18/2016

24-inch CMP with flapgate visible on WS toe.

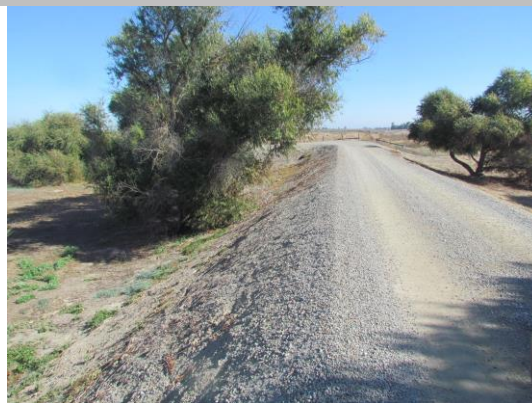
Photo 1 of 1 : FA\_2016\_RD2091\_319\_4\_20161027\_00002.jpg

LM Start	0.30	Rating **	M	Issue No.	4
LM End	0.30	Issue Type +	Ma	Location *	LS
Category	Earthen Levee			GPS Latitude/Longitude	
				Start	End
Item	Trim / Thin Trees			37.541327 °	37.541327 °
				-121.097895 °	-121.097895 °
DWR ID	DWR_RD2091_02_f_2016_4				
Comment Code					
T1 : Trim trees to at least five feet above ground level.					
Inspector Comment

Looking south at untrimmed tree at landward slope.
