**Flood Control Project Maintenance
Levee Inspections**

Fall 2017 Levee Maintenance Deficiency Summary Report

San Joaquin River Basin

Reclamation District No. 2091 Chase

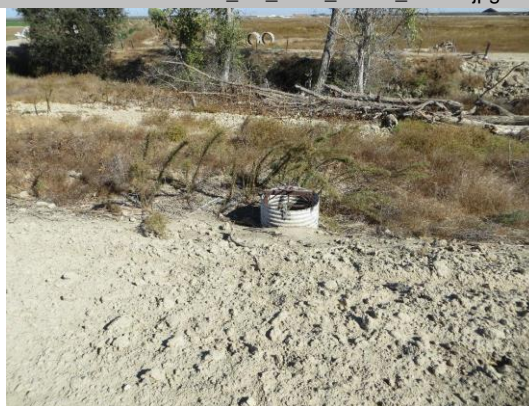
Photo 1 of 3 : UCIP_FA_2017_43207_38148.jpg

LM Start	0.08	Rating **	M	Issue No.	45
LM End	0.08	Issue Type +	Ma	Location *	
Category	Supplemental			GPS Latitude/Longitude	
				Start	End
Item	DWR UCIP LMA Responsibility			37.541970 °	37.541970 °
				-121.093980 °	-121.093980 °
DWR ID					
Comment Code					
Inspector Comment					
FS_ID:43207 DS_ID:23155 EP_NO: N/A Repair Type: Non-Urgent Crossing Status: Found UCIP Comments: Appears abandoned and if so should be done so properly. FIELD_STRUCT_DESC: *ABANDONED* 24-inch corrugated metal drainage pipe through the levee, 7.2 feet below the crown. Slide gate in a 36-inch corrugated metal pipe (CMP) riser on the waterside (WS) slope. [Additional Reference(s): DWR Levee Log, 1992. USACE San Joaquin O&M Manual 6, September 1961, (HLM 0.07), Drawing No. 07-04-1555, Sheets 1555/17 and 1555/55, (Station 906+85)]. FS Date: 1/29/2015 2:26:31 PM

Slide gate in 36-inch CMP riser on WS toe.

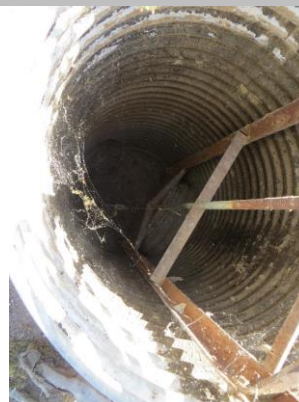
Photo 2 of 3 : UCIP_FA_2017_43207_38147.jpg

Slide gate in 36-inch CMP riser on WS toe.

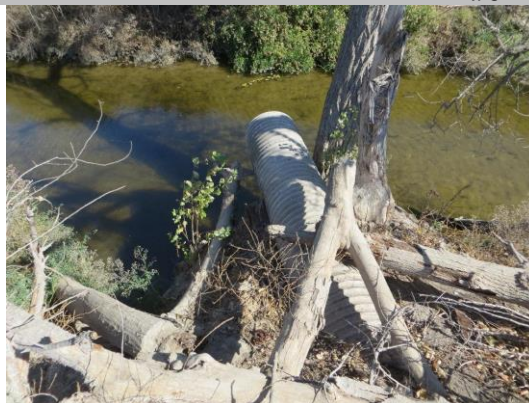
Photo 3 of 3 : UCIP_FA_2017_43207_38146.jpg

LM Start	0.08	Rating **	M	Issue No.	45 (cont)	
LM End	0.08	Issue Type +	Ma	Location *		
Category	Supplemental			GPS Latitude/Longitude		
				Start		End
Item	DWR UCIP LMA Responsibility			37.541970 °		37.541970 °
				-121.093980 °		-121.093980 °
DWR ID						
Comment Code						
Inspector Comment						
FS_ID:43207 DS_ID:23155 EP_NO: N/A Repair Type: Non-Urgent Crossing Status: Found UCIP Comments: Appears abandoned and if so should be done so properly. FIELD_STRUCT_DESC: *ABANDONED* 24-inch corrugated metal drainage pipe through the levee, 7.2 feet below the crown. Slide gate in a 36-inch corrugated metal pipe (CMP) riser on the waterside (WS) slope. [Additional Reference(s): DWR Levee Log, 1992. USACE San Joaquin O&M Manual 6, September 1961, (HLM 0.07), Drawing No. 07-04-1555, Sheets 1555/17 and 1555/55, (Station 906+85)]. FS Date: 1/29/2015 2:26:31 PM

CMP stormdrain at outlet off WS toe.

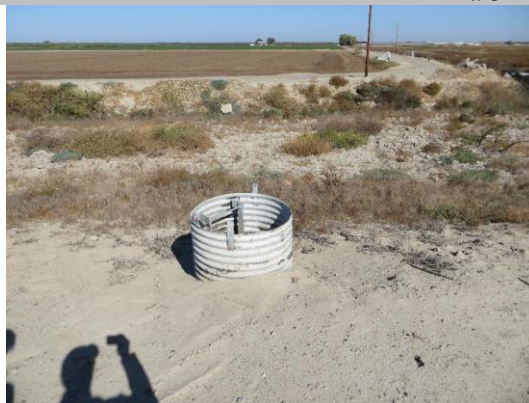
Photo 1 of 3 : UCIP_FA_2017_51387_38150.jpg

FS_ID:51387
DS_ID:23156
EP_NO: N/A
Repair Type: Urgent
Crossing Status: Found
UCIP Comments: 11/18/2016 Same as last inspection this is a non-functional crossing with no visible inlet on LS or outlet on WS. The only appurtenance found at this location is a CMP riser with a missing cover located on the WS. This crossing remains Urgent since the pipe on the WS may still be opened. According to Mike Alves, this crossing is abandoned and the City of Modesto is working with CVFPB to authorize proper abandonment/removal. The City is working at finding funds to pay for proper abandonment/removal of all the drainage structures through this levee. (O. Magana - DWR UCIP)01/29/2015 Pipe open on WS and slide gate has been removed. Appears abandoned and should be done so properly. (M. Alves - City of Modesto)
FIELD_STRUCT_DESC: *ABANDONED* 24-inch corrugated metal drainage pipe through the levee, 9 feet below the crown. Slide gate in a corrugated metal pipe (CMP) riser located on the waterside (WS) slope.

36-inch CMP riser on WS slope.

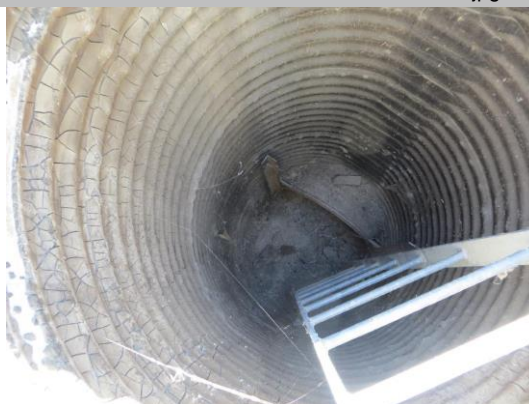
Photo 2 of 3 : UCIP_FA_2017_51387_38149.jpg

Slide gate missing from open end of pipe at WS slope.

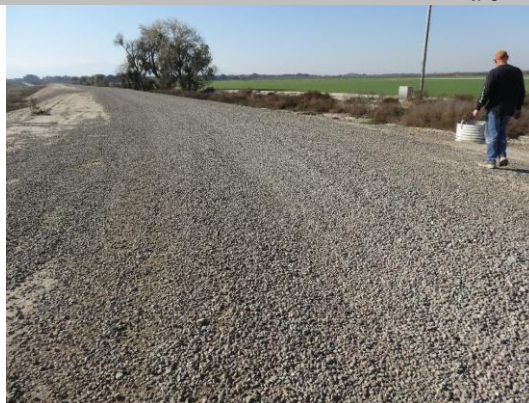
Photo 3 of 3 : UCIP_FA_2017_51387_76669.jpg

Comment Code						
Inspector Comment						
FS_ID:51387 DS_ID:23156 EP_NO: N/A Repair Type: Urgent Crossing Status: Found UCIP Comments: 11/18/2016 Same as last inspection this is a non-functional crossing with no visible inlet on LS or outlet on WS. The only appurtenance found at this location is a CMP riser with a missing cover located on the WS. This crossing remains Urgent since the pipe on the WS may still be opened. According to Mike Alves, this crossing is abandoned and the City of Modesto is working with CVFPB to authorize proper abandonment/removal. The City is working at finding funds to pay for proper abandonment/removal of all the drainage structures through this levee. (O. Magana - DWR UCIP)01/29/2015 Pipe open on WS and slide gate has been removed. Appears abandoned and should be done so properly. (M. Alves - City of Modesto) FIELD_STRUCT_DESC: *ABANDONED* 24-inch corrugated metal drainage pipe through the levee, 9 feet below the crown. Slide gate in a corrugated metal pipe (CMP) riser located on the waterside (WS) slope. [Additional Reference(s): DWR Levee Log, 1992. USACE San Joaquin O&M Manual 6, September 1961, (HLM 0.10), Drawing No. 07-04-1555, Sheets 1555/17 and 1555/55, (Station 907+55)]. FS Date: 11/18/2016

Overview of levee crown at pipe crossing.

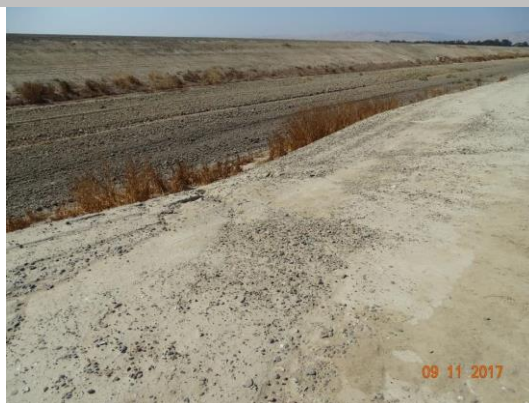
Photo 1 of 2 : FA_2017_RD2091_318_15_20170928_00046.jpg

LM Start	0.23	Rating **	U	Issue No.	15
LM End	0.23	Issue Type +	Ma	Location *	LS
Category	Earthen Levee			GPS Latitude/Longitude	
				Start	End
Item	Erosion / Bank Caving			37.541550 °	37.541550 °
				-121.096742 °	-121.096742 °
DWR ID	DWR_RD2091_01_s_2016_15				
Comment Code					
E1 : Note and monitor erosion site.					
Inspector Comment					
Caving on landward shoulder possible collapsed pipe. Caving is 34 feet long over one inch depth.

Looking southwest at the dip on the landside shoulder.

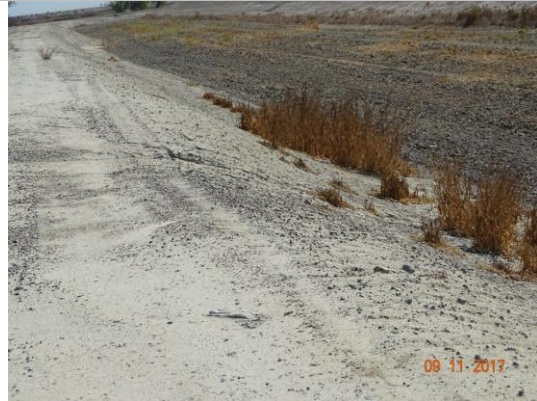
Photo 2 of 2 : FA_2017_RD2091_318_15_20170928_00047.jpg

Looking northeast at the dip in the landside shoulder.

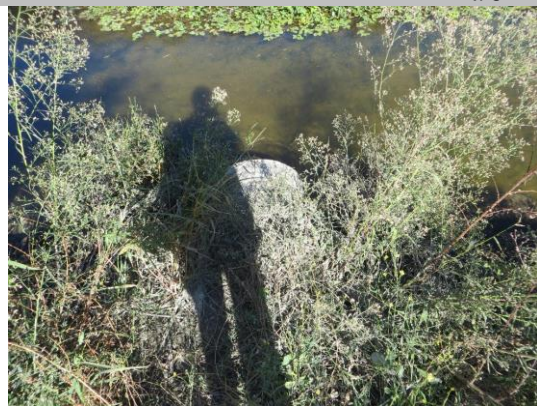
Photo 1 of 3 : UCIP_FA_2017_51388_38156.jpg

Comment Code						
Inspector Comment						
FS_ID:51388 DS_ID:23158 EP_NO: N/A Repair Type: Urgent Crossing Status: Found UCIP Comments: 11/18/2016 Same as last inspection. This crossing remains Urgent due to the flap gate still missing from the WS toe. According to Mike A. this crossing is an abandoned line and the City of Modesto is working with CVFPB to authorize proper abandonment/removal. The City is working at finding funds to pay for proper abandonment/removal of all the drainage structures through this levee. (O. Magana - DWR UCIP)01/29/2015 Flap gate has fallen off at WS toe. Appears abandoned and if so should be done so properly. (M. Alves - City of Modesto) FIELD_STRUCT_DESC: *ABANDONED* 24-inch corrugated metal drainage pipe through the levee, 10 feet below the crown. Flap gate on the waterside (WS) end. Drain opening is located approximately 15 feet off the landside (LS) toe. [Additional Reference(s): DWR Levee Log, 1992. USACE San Joaquin O&M Manual 6, September 1961, (HLM 0.23), Drawing No. 07-04-1555, Sheets 1555/17 and 1555/55, (Station 915+00)]. FS Date: 11/18/2016

Pipe visible in canal on WS toe.

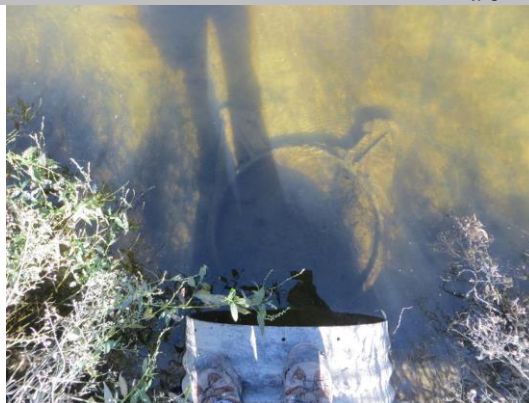
Photo 2 of 3 : UCIP_FA_2017_51388_38155.jpg

Comment Code						
Inspector Comment						
FS_ID:51388 DS_ID:23158 EP_NO: N/A Repair Type: Urgent Crossing Status: Found UCIP Comments: 11/18/2016 Same as last inspection. This crossing remains Urgent due to the flap gate still missing from the WS toe. According to Mike A. this crossing is an abandoned line and the City of Modesto is working with CVFPB to authorize proper abandonment/removal. The City is working at finding funds to pay for proper abandonment/removal of all the drainage structures through this levee. (O. Magana - DWR UCIP)01/29/2015 Flap gate has fallen off at WS toe. Appears abandoned and if so should be done so properly. (M. Alves - City of Modesto) FIELD_STRUCT_DESC: *ABANDONED* 24-inch corrugated metal drainage pipe through the levee, 10 feet below the crown. Flap gate on the waterside (WS) end. Drain opening is located approximately 15 feet off the landside (LS) toe. [Additional Reference(s): DWR Levee Log, 1992. USACE San Joaquin O&M Manual 6, September 1961, (HLM 0.23), Drawing No. 07-04-1555, Sheets 1555/17 and 1555/55, (Station 915+00)]. FS Date: 11/18/2016

Flapgate has fallen off at WS toe.

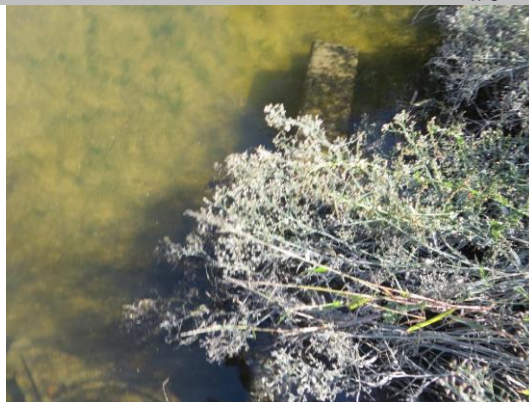
Photo 3 of 3 : UCIP_FA_2017_51388_38154.jpg

Concrete headwall under pipe at WS toe.

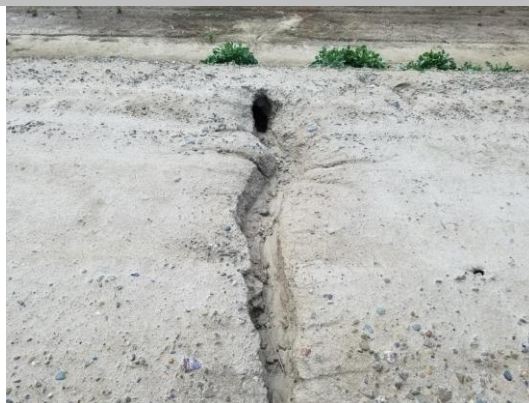
Photo 2 of 2 : FA_2017_RD2091_318_16_20170911_00014.jpg

Looking east at rill erosion above rodent hole on landward slope. (Spring 2017)

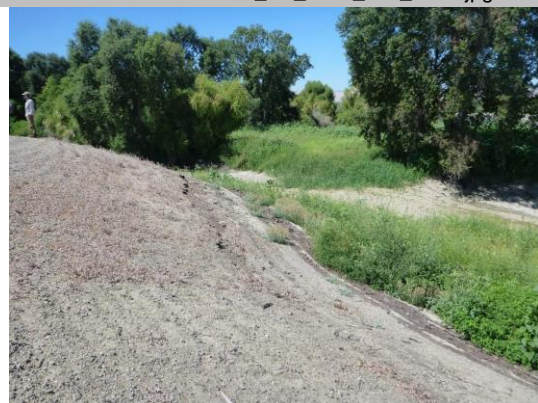
Photo 1 of 3 : LEVAL_FA_2017_471_2337.jpg

LM Start	0.94	Rating **	A/W	Issue No.	14
LM End	6.84	Issue Type +	Ma	Location *	
Category	Supplemental			GPS Latitude/Longitude	
				Start	End
Item	2017 Storm Damage			37.537775 °	37.482295 °
				-121.106730 °	-121.051592 °
DWR ID	DWR_RD2091_01_f _ 2017_14				
Comment Code					
Inspector Comment					
Levee Evaluation Comments					
Description:Wave wash damage/erosion of 2 miles ... see attached description and photos					
Site ID No:471					
Site Designation:LMA-298					
Repair Type: Erosion					
Rating:Area of Concern					
Field Date:7/20/2017					
Notes: Low priority because wavewash scarps are less than 1 ft and do not cut into prisim significantly and can be repaired by district through O&M. There is also a large berm here. Wavewash is present on both LS and WS

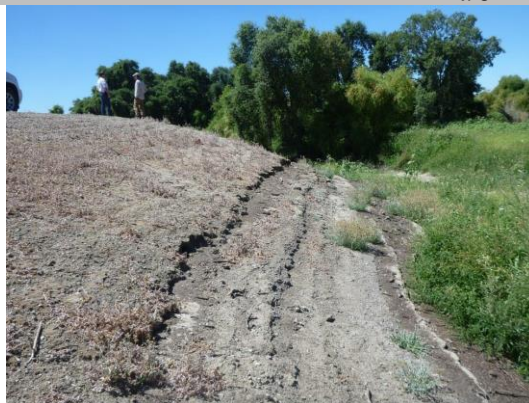
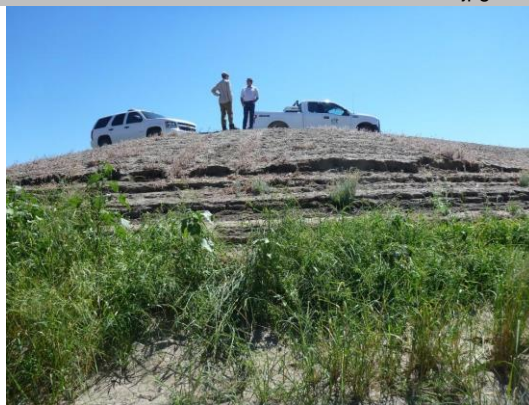
LM Start	0.94	Rating **	A/W	Issue No.	14 (cont)	
LM End	6.84	Issue Type +	Ma	Location *		
Category	Supplemental			GPS Latitude/Longitude		
				Start	End	
Item	2017 Storm Damage			37.537775 °	37.482295 °	
				-121.106730 °	-121.051592 °	
DWR ID	DWR_RD2091_01_f _ 2017_14					
Comment Code						
Inspector Comment						
Levee Evaluation Comments						
Description:Wave wash damage/erosion of 2 miles ... see attached description and photos						
Site ID No:471						
Site Designation:LMA-298						
Repair Type: Erosion						
Rating:Area of Concern						
Field Date:7/20/2017						
Notes: Low priority because wavewash scarps are less than 1 ft and do not cut into prisim significantly and can be repaired by district through O&M. There is also a large berm here. Wavewash is present on both LS and WS.

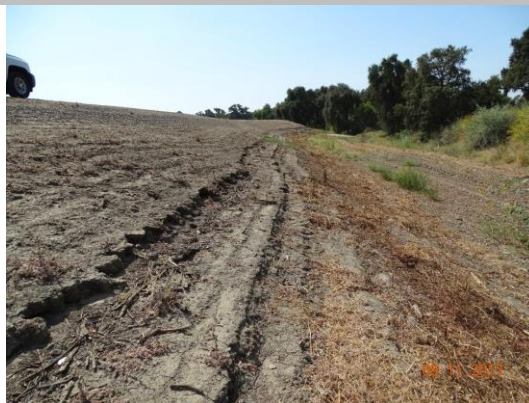
Photo 1 of 1 : FA_2017_RD2091_318_11_20170928_00049.jpg

LM Start	1.41	Rating **	A/W	Issue No.	11
LM End	1.43	Issue Type +	Ma	Location *	WS
Category	Earthen Levee			GPS Latitude/Longitude	
				Start	End
Item	Erosion / Bank Caving			37.531243 °	37.530896 °
				-121.106716 °	-121.106737 °
DWR ID	DWR_RD2091_01_f_2017_11				
Comment Code					
E2 : Schedule repair of erosion site prior to the next inspection.					
Inspector Comment					
Minor erosion on waterside toe.

Looking south at erosion on waterside slope.

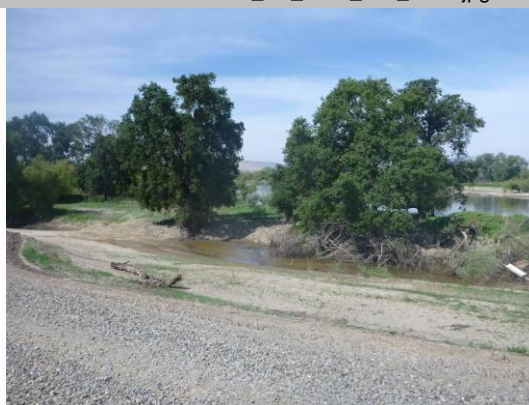
Photo 1 of 3 : LEVAL_FA_2017_132_1181.jpg

LM Start	1.41	Rating **	A/W	Issue No.	24	
LM End	1.44	Issue Type +	Ma	Location *		
Category	Supplemental			GPS Latitude/Longitude		
				Start	End	
Item	2017 Storm Damage			37.531170	°	37.530760
				-121.106750	°	-121.106710
DWR ID	DWR_RD2091_01_f_2017_24					
Comment Code						
Inspector Comment						
Levee Evaluation Comments						
Description:						
Site ID No:132						
Site Designation:DWR_RD2091_01_R_2012_01						
Repair Type: Erosion						
Rating:Area of Concern						
Field Date:6/7/2017						
Notes: Wavewash erosion up to 12" deep at high water mark.

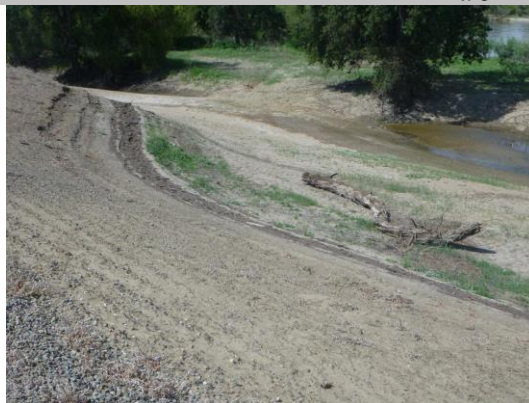
LM Start	1.41	Rating **	A/W	Issue No.	24 (cont)	
LM End	1.44	Issue Type +	Ma	Location *		
Category	Supplemental			GPS Latitude/Longitude		
				Start	End	
Item	2017 Storm Damage			37.531170 °	37.530760 °	
				-121.106750 °	-121.106710 °	
DWR ID	DWR_RD2091_01_f_2017_24					
Comment Code						
Inspector Comment						
Levee Evaluation Comments						
Description:						
Site ID No:132						
Site Designation:DWR_RD2091_01_R_2012_01						
Repair Type: Erosion						
Rating:Area of Concern						
Field Date:6/7/2017						
Notes: Wavewash erosion up to 12" deep at high water mark.

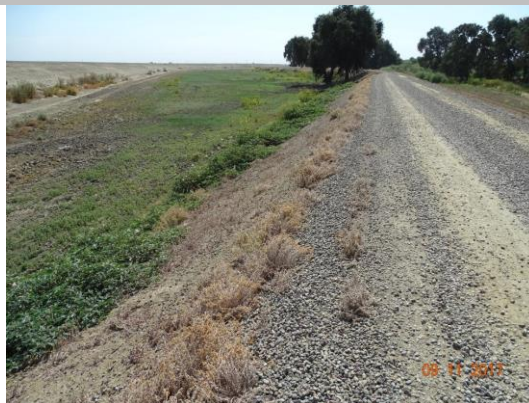
Photo 1 of 1 : FA_2017_RD2091_318_17_20170928_00051.jpg

Looking southeast at the landside slope.

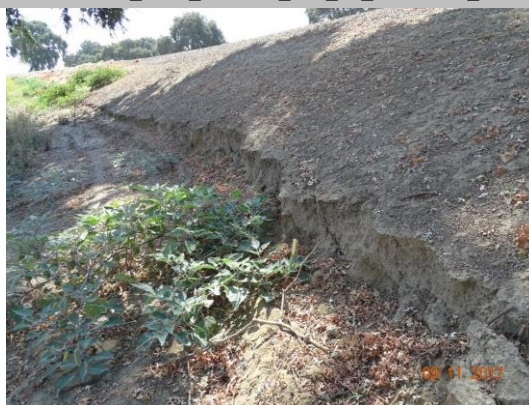
Photo 1 of 1 : FA_2017_RD2091_318_18_20170929_00052.jpg

LM Start	2.05	Rating **	M	Issue No.	18
LM End	2.06	Issue Type +	Ma	Location *	LS
Category	Earthen Levee			GPS Latitude/Longitude	
				Start	End
Item	Erosion / Bank Caving			37.526083 °	37.525897 °
				-121.099328 °	-121.099116 °
DWR ID	DWR_RD2091_01_f_2017_18				
Comment Code					
E2 : Schedule repair of erosion site prior to the next inspection.					
Inspector Comment					
Erosion at the landside toe.

Looking southeast at erosion on the toe of the landside slope.

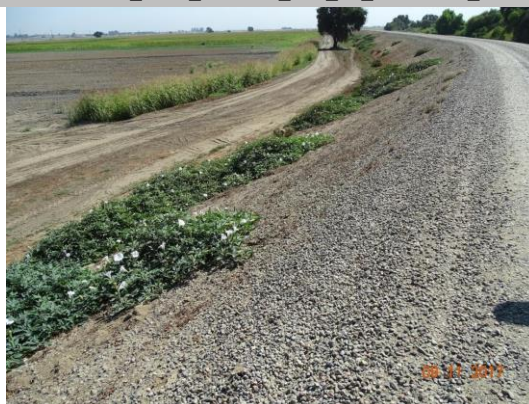
Photo 1 of 1 : FA_2017_RD2091_318_28_20170929_00053.jpg

Looking southeast at vegetation on the landside slope.

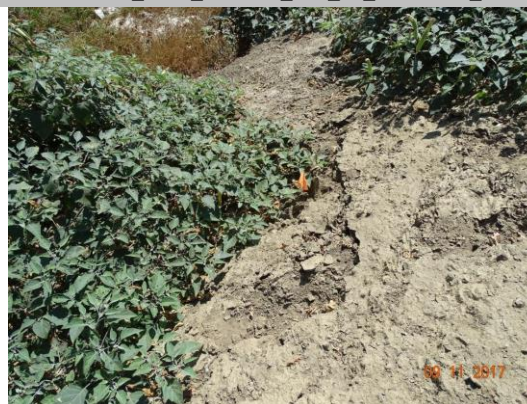
Photo 1 of 2 : FA_2017_RD2091_318_21_20170929_00054.jpg

LM Start	3.90	Rating **	M	Issue No.	21
LM End	3.90	Issue Type +	Ma	Location *	LS
Category	Earthen Levee			GPS Latitude/Longitude	
				Start	End
Item	Erosion / Bank Caving			37.506902 °	37.506902 °
				-121.082771 °	-121.082771 °
DWR ID	DWR_RD2091_01_s_2017_21				
Comment Code					
E2 : Schedule repair of erosion site prior to the next inspection.					
Inspector Comment					
Sinkhole at landward side toe

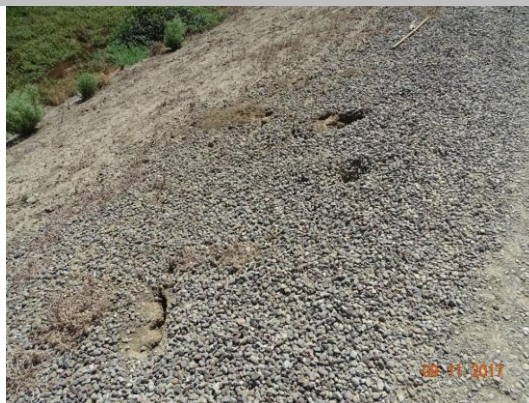
Photo 1 of 1 : FA_2017_RD2091_318_30_20170929_00055.jpg

LM Start	3.91	Rating **	M	Issue No.	30
LM End	3.95	Issue Type +	Ma	Location *	LS
Category	Earthen Levee			GPS Latitude/Longitude	
				Start	End
Item	Animal Control			37.506753 °	37.506251 °
				-121.082748 °	-121.082606 °
DWR ID	DWR_RD2091_01_f_2017_30				
Comment Code					
A3 : No rodents visible, but rodent burrows visible; need to backfill and compact or grout burrows.					
Inspector Comment

Looking south at landside slope.

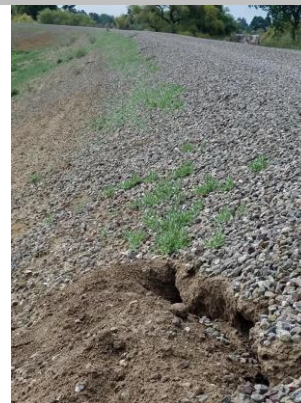
Photo 1 of 1 : FA_2017_RD2091_318_22_20170911_00018.jpg

LM Start	4.25	Rating **	M	Issue No.	22
LM End	4.25	Issue Type +	Ma	Location *	LS
Category	Earthen Levee			GPS Latitude/Longitude	
				Start	End
Item	Animal Control			37.501907 °	37.501907 °
				-121.082123 °	-121.082123 °
DWR ID	DWR_RD2091_01_s_2017_22				
Comment Code					
A3 : No rodents visible, but rodent burrows visible; need to backfill and compact or grout burrows.					
Inspector Comment

Looking south at rodent activity on landward shoulder and slope.

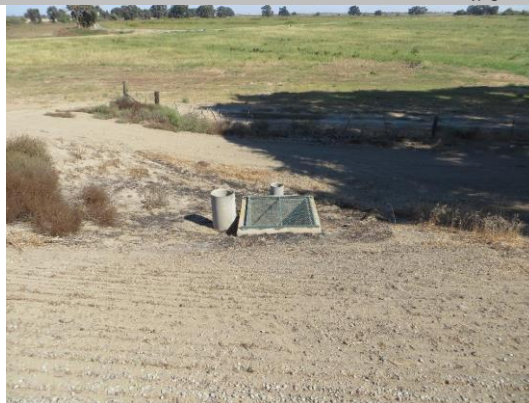
Photo 1 of 3 : UCIP_FA_2017_43209_38211.jpg

LM Start	4.59	Rating **	M	Issue No.	49
LM End	4.59	Issue Type +	En	Location *	
Category	Supplemental			GPS Latitude/Longitude	
				Start	End
Item	DWR UCIP Field Study			37.497390 °	37.497390 °
				-121.080370 °	-121.080370 °
DWR ID					
Comment Code					
Inspector Comment					
FS_ID:43209 DS_ID:23165 EP_NO: N/A Repair Type: Non-Urgent Crossing Status: Found UCIP Comments: Appears abandoned and if so should be done so properly. FIELD_STRUCT_DESC: 36-inch corrugated metal irrigation pipe through the levee, 15 feet below the crown. Abandoned concrete inlet box on the waterside (WS) slope of the levee. 6-foot by 5-foot concrete distribution box at the landside (LS) toe. [Additional Reference(s): DWR Levee Log, 1992. USACE San Joaquin O&M Manual 6, September 1961, (HLM 4.67), 30-inch pipe listed]. FS Date: 1/29/2015 2:27:42 PM

Distribution box on LS toe.

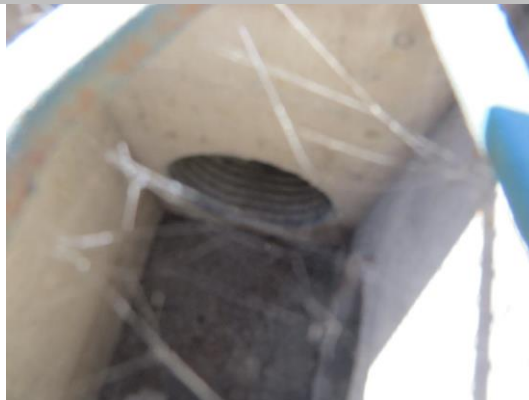
Photo 2 of 3 : UCIP_FA_2017_43209_38210.jpg

Open CMP pipe through levee at distribution box on LS toe.

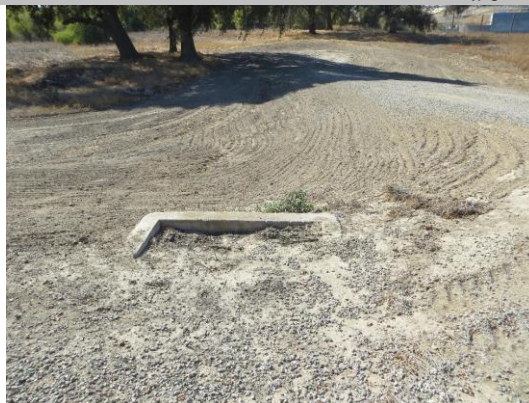
Photo 3 of 3 : UCIP_FA_2017_43209_38209.jpg

LM Start	4.59	Rating **	M	Issue No.	49 (cont)	
LM End	4.59	Issue Type +	En	Location *		
Category	Supplemental			GPS Latitude/Longitude		
				Start		End
Item	DWR UCIP Field Study			37.497390 °	37.497390 °	
				-121.080370 °	-121.080370 °	
DWR ID						
Comment Code						
Inspector Comment						
FS_ID:43209						
DS_ID:23165						
EP_NO: N/A						
Repair Type: Non-Urgent						
Crossing Status: Found						
UCIP Comments: Appears abandoned and if so should be done so properly.						
FIELD_STRUCT_DESC: 36-inch corrugated metal irrigation pipe through the levee, 15 feet below the crown. Abandoned concrete inlet box on the waterside (WS) slope of the levee. 6-foot by 5-foot concrete distribution box at the landside (LS) toe. [Additional Reference(s): DWR Levee Log, 1992. USACE San Joaquin O&M Manual 6, September 1961, (HLM 4.67), 30-inch pipe listed].						
FS Date: 1/29/2015 2:27:42 PM

Abandoned concrete box on WS slope.

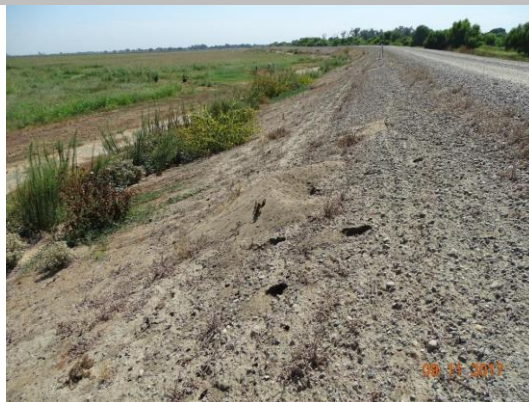
Photo 1 of 4 : FA_2017_RD2091_318_10_20170929_00056.jpg

LM Start	4.84	Rating **	U	Issue No.	10
LM End	4.85	Issue Type +	Ma	Location *	LS
Category	Earthen Levee			GPS Latitude/Longitude	
				Start	End
Item	Animal Control			37.494297 °	37.494115 °
				-121.078233 °	-121.078100 °
DWR ID	DWR_RD2091_01_f_2016_10				
Comment Code					
A3 : No rodents visible, but rodent burrows visible; need to backfill and compact or grout burrows.					
Inspector Comment					
Several large rodent holes on landward slope.

Looking southeast at landside slope.

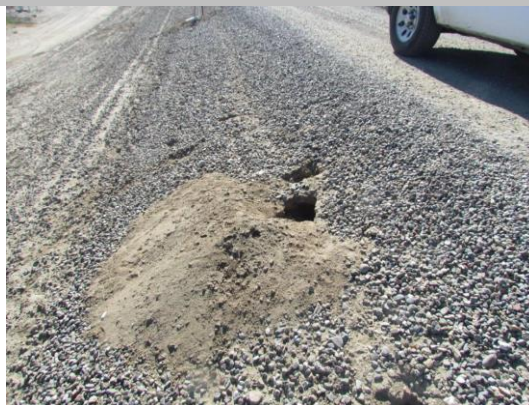
Photo 3 of 4 : FA_2017_RD2091_318_10_20170911_00004.jpg

Looking south at close-up view of rodent holes on landward slope.

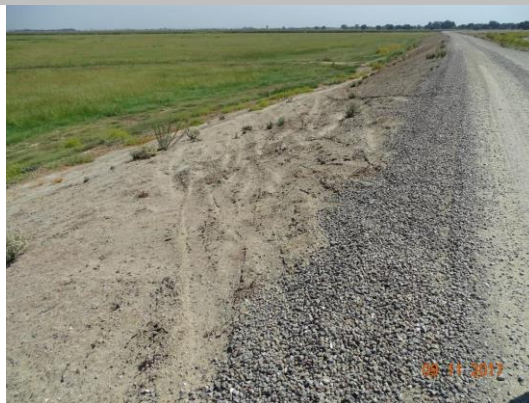
Photo 1 of 2 : FA_2017_RD2091_318_13_20170929_00057.jpg

Looking southeast at the landside slope.

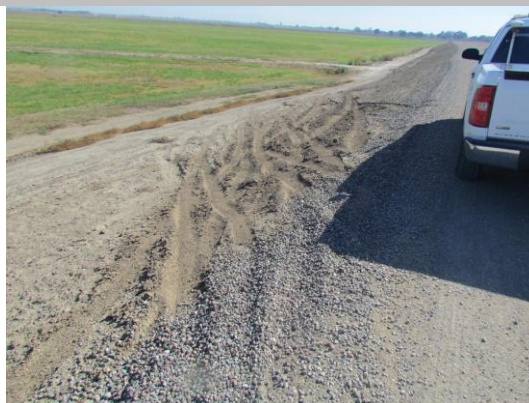
Photo 2 of 2 : FA_2017_RD2091_318_13_20170911_00008.jpg

Looking at damage on landside slope.

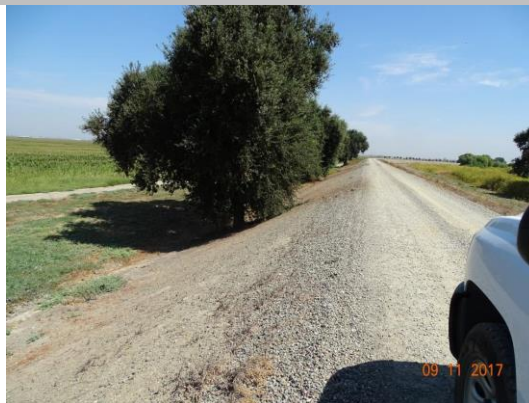
Photo 1 of 2 : FA_2017_RD2091_318_12_20170929_00058.jpg

Looking northeast at the landside slope.

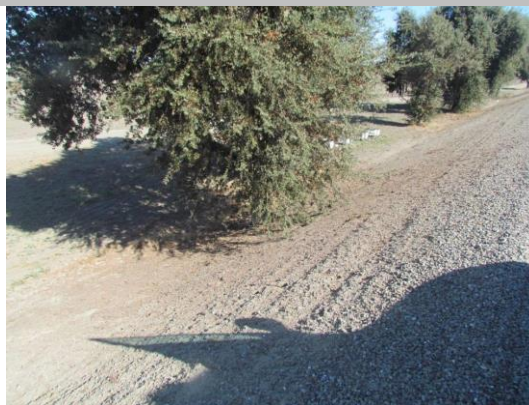
Photo 2 of 2 : FA_2017_RD2091_318_12_20170911_00007.jpg

Look northeast at untrimmed tree at landward toe.

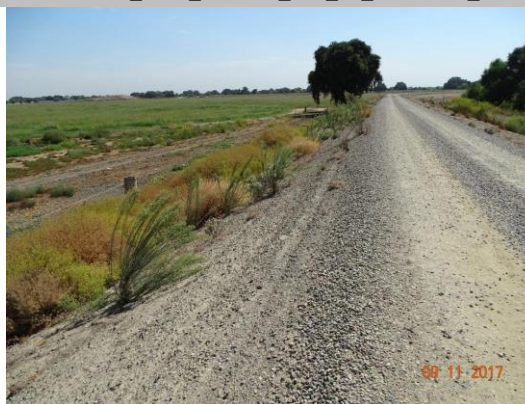
Photo 1 of 1 : FA_2017_RD2091_318_36_20170929_00059.jpg

Looking southeast at landside slope.

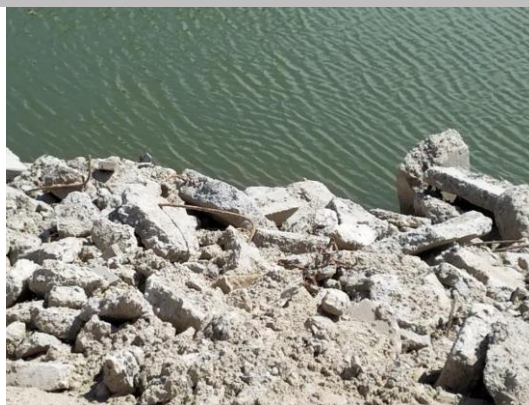
Photo 2 of 2 : FA_2017_RD2091_318_8_20170911_00002.jpg

Looking east at concrete rubble with rebar at landward toe next to canal.

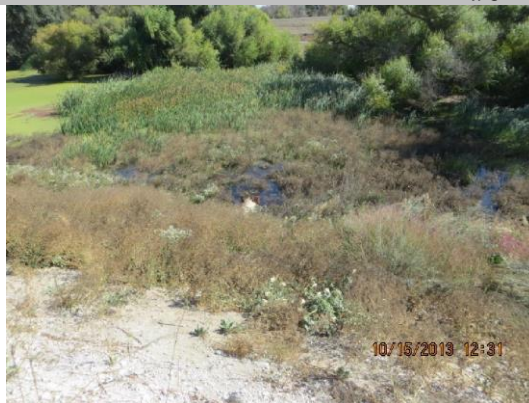
Photo 1 of 3 : UCIP_FA_2017_51390_38216.jpg

24-inch CMP with flapgate visible on WS toe.

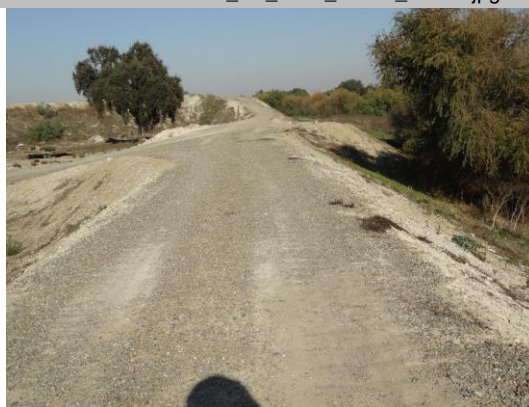
Photo 2 of 3 : UCIP_FA_2017_51390_76689.jpg

Overview photo of levee crown at crossing.

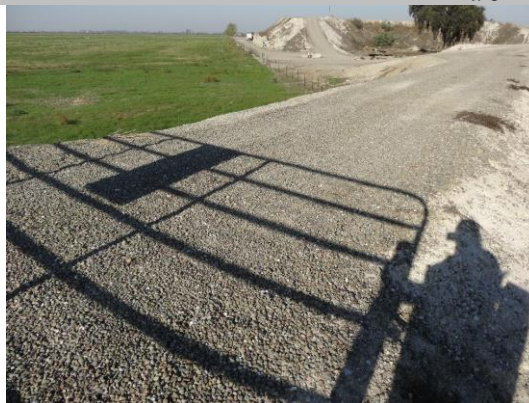
Photo 3 of 3 : UCIP_FA_2017_51390_76686.jpg

Overview of levee crown at crossing and at a distance there is a shooting range.
