**Flood Control Project Maintenance
Levee Inspections**

Fall 2018 Levee Maintenance Deficiency Summary Report

San Joaquin River Basin

Reclamation District No. 2091 Chase

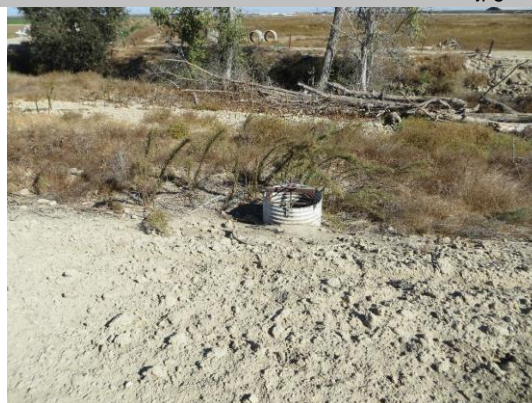
Photo 1 of 3 : UCIP_FA_2018_43207_38148.jpg

Comment Code						
Inspector Comment						
FS_ID:43207						
DS_ID:23155						
EP_NO: N/A						
Repair Type: Non-Urgent						
Crossing Status: Found						
UCIP Comments: 10/15/2013 Appears abandoned and if so should be done so properly. (W. Wylie - DWR UCIP)						
FIELD_STRUCT_DESC: *ABANDONED* 24-inch corrugated metal drainage pipe through the levee, 7.2 feet below the crown. Slide gate in a 36-inch corrugated metal pipe (CMP) riser on the waterside (WS) slope. [Additional Reference(s): DWR Levee Log, 1992. USACE San Joaquin O&M Manual 6, September 1961, (HLM 0.07), Drawing No. 07-04-1555, Sheets 1555/17 and 1555/55, (Station 906+85)].						
FS Date: 1/29/2015 2:26:31 PM

Slide gate in 36-inch CMP riser on WS toe.

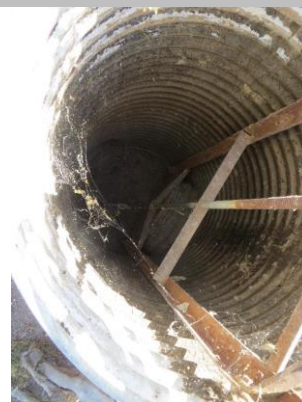
Photo 2 of 3 : UCIP_FA_2018_43207_38147.jpg

Slide gate in 36-inch CMP riser on WS toe.

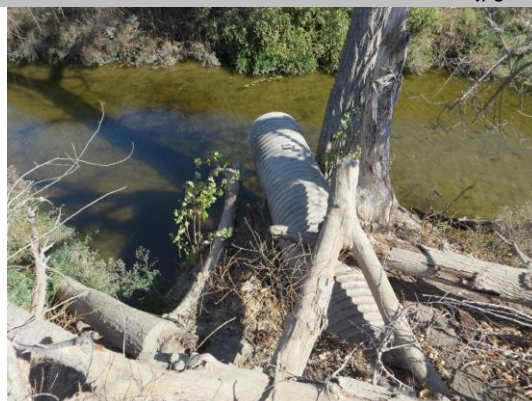
Photo 3 of 3 : UCIP_FA_2018_43207_38146.jpg

Comment Code						
Inspector Comment						
FS_ID:43207						
DS_ID:23155						
EP_NO: N/A						
Repair Type: Non-Urgent						
Crossing Status: Found						
UCIP Comments: 10/15/2013 Appears abandoned and if so should be done so properly. (W. Wylie - DWR UCIP)						
FIELD_STRUCT_DESC: *ABANDONED* 24-inch corrugated metal drainage pipe through the levee, 7.2 feet below the crown. Slide gate in a 36-inch corrugated metal pipe (CMP) riser on the waterside (WS) slope. [Additional Reference(s): DWR Levee Log, 1992. USACE San Joaquin O&M Manual 6, September 1961, (HLM 0.07), Drawing No. 07-04-1555, Sheets 1555/17 and 1555/55, (Station 906+85)].						
FS Date: 1/29/2015 2:26:31 PM

CMP stormdrain at outlet off WS toe.

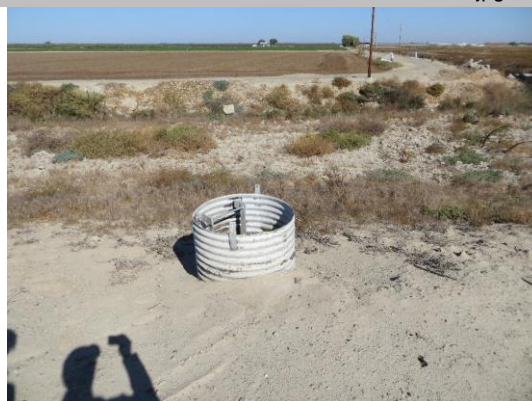
Photo 1 of 3 : UCIP_FA_2018_53094_38150.jpg

Comment Code						
Inspector Comment						
FS_ID:53094 DS_ID:23156 EP_NO: N/A Repair Type: Non-Urgent Crossing Status: Found UCIP Comments: 10/18/2018 Crossing remains abandoned. Unable to locate WS outlet due to dense vegetation. Crossing has been downgraded from Urgent to Non-Urgent. No integrity issues were observed along pipe alignment. LMA is still seeking proper abandonment or removal of this crossing. Crossing is part of the Deferred Maintenance Project (DMP) phase 1 inspection. No video inspection has been completed yet. (O. Magana - DWR UCIP) 11/18/2016 Same as last inspection this is a non-functional crossing with no visible inlet on LS or outlet on WS. The only appurtenance found at this location is a CMP riser with a missing cover located on the WS. This crossing remains Urgent since the pipe on the WS may still be opened. According to Mike Alves, this crossing is abandoned and the City of Modesto is working with CVFPB to authorize proper abandonment/removal. The City is working at finding funds to pay for proper abandonment/removal of all the drainage structures through this levee. (O. Magana - DWR UCIP)10/15/2013 Pipe open on WS and slide gate has been removed. Appears abandoned and should be done so properly. (W. Wylie - City of Modesto) FIELD_STRUCT_DESC: *ABANDONED* 24-inch corrugated metal drainage pipe through the levee, 9 feet below the crown. Slide gate in a corrugated metal pipe (CMP) riser located on the waterside (WS) slope. [Additional Reference(s): DWR Levee Log, 1992. USACE San Joaquin O&M Manual 6, September 1961, (HLM 0.10), Drawing No. 07-04-1555, Sheets 1555/17 and 1555/55, (Station 907+55)]. FS Date: 10/18/2018

36-inch CMP riser on WS slope.

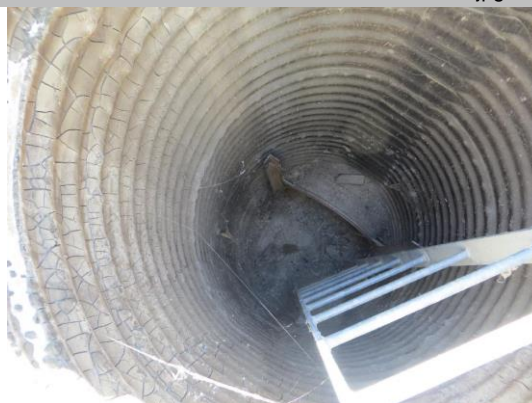
Photo 2 of 3 : UCIP_FA_2018_53094_38149.jpg

Comment Code						
Inspector Comment						
FS_ID:53094 DS_ID:23156 EP_NO: N/A Repair Type: Non-Urgent Crossing Status: Found UCIP Comments: 10/18/2018 Crossing remains abandoned. Unable to locate WS outlet due to dense vegetation. Crossing has been downgraded from Urgent to Non-Urgent. No integrity issues were observed along pipe alignment. LMA is still seeking proper abandonment or removal of this crossing. Crossing is part of the Deferred Maintenance Project (DMP) phase 1 inspection. No video inspection has been completed yet. (O. Magana - DWR UCIP) 11/18/2016 Same as last inspection this is a non-functional crossing with no visible inlet on LS or outlet on WS. The only appurtenance found at this location is a CMP riser with a missing cover located on the WS. This crossing remains Urgent since the pipe on the WS may still be opened. According to Mike Alves, this crossing is abandoned and the City of Modesto is working with CVFPB to authorize proper abandonment/removal. The City is working at finding funds to pay for proper abandonment/removal of all the drainage structures through this levee. (O. Magana - DWR UCIP)10/15/2013 Pipe open on WS and slide gate has been removed. Appears abandoned and should be done so properly. (W. Wylie - City of Modesto) FIELD_STRUCT_DESC: *ABANDONED* 24-inch corrugated metal drainage pipe through the levee, 9 feet below the crown. Slide gate in a corrugated metal pipe (CMP) riser located on the waterside (WS) slope. [Additional Reference(s): DWR Levee Log, 1992. USACE San Joaquin O&M Manual 6, September 1961, (HLM 0.10), Drawing No. 07-04-1555, Sheets 1555/17 and 1555/55, (Station 907+55)]. FS Date: 10/18/2018

Slide gate missing from open end of pipe at WS slope.

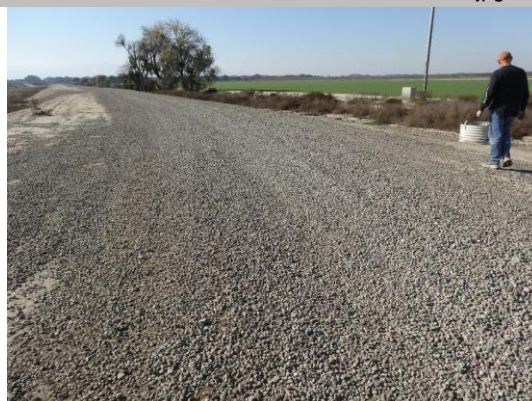
Photo 3 of 3 : UCIP_FA_2018_53094_76669.jpg

Comment Code						
Inspector Comment						
FS_ID:53094 DS_ID:23156 EP_NO: N/A Repair Type: Non-Urgent Crossing Status: Found UCIP Comments: 10/18/2018 Crossing remains abandoned. Unable to locate WS outlet due to dense vegetation. Crossing has been downgraded from Urgent to Non-Urgent. No integrity issues were observed along pipe alignment. LMA is still seeking proper abandonment or removal of this crossing. Crossing is part of the Deferred Maintenance Project (DMP) phase 1 inspection. No video inspection has been completed yet. (O. Magana - DWR UCIP) 11/18/2016 Same as last inspection this is a non-functional crossing with no visible inlet on LS or outlet on WS. The only appurtenance found at this location is a CMP riser with a missing cover located on the WS. This crossing remains Urgent since the pipe on the WS may still be opened. According to Mike Alves, this crossing is abandoned and the City of Modesto is working with CVFPB to authorize proper abandonment/removal. The City is working at finding funds to pay for proper abandonment/removal of all the drainage structures through this levee. (O. Magana - DWR UCIP)10/15/2013 Pipe open on WS and slide gate has been removed. Appears abandoned and should be done so properly. (W. Wylie - City of Modesto) FIELD_STRUCT_DESC: *ABANDONED* 24-inch corrugated metal drainage pipe through the levee, 9 feet below the crown. Slide gate in a corrugated metal pipe (CMP) riser located on the waterside (WS) slope. [Additional Reference(s): DWR Levee Log, 1992. USACE San Joaquin O&M Manual 6, September 1961, (HLM 0.10), Drawing No. 07-04-1555, Sheets 1555/17 and 1555/55, (Station 907+55)]. FS Date: 10/18/2018

Overview of levee crown at pipe crossing.

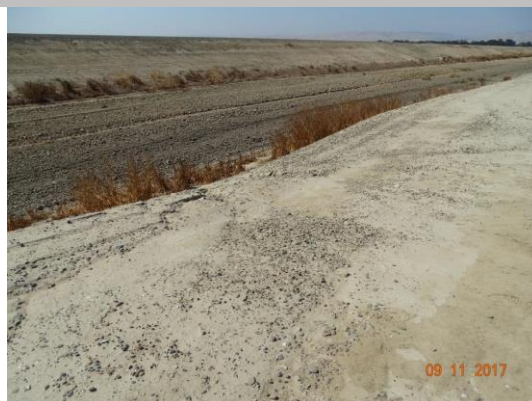
Photo 1 of 2 : FA_2018_RD2091_318_15_20180905_00015.jpg

LM Start	0.23	Rating **	A/W	Issue No.	15
LM End	0.23	Issue Type +	Ma	Location *	LS
Category	Earthen Levee			GPS Latitude/Longitude	
				Start	End
Item	Erosion / Bank Caving			37.541550 °	37.541550 °
				-121.096742 °	-121.096742 °
DWR ID	DWR_RD2091_01_s_2016_15				
Comment Code					
E1 : Note and monitor erosion site.					
Inspector Comment					
Caving on landward shoulder noted in 2017 possible collapsed pipe. Monitor for potential reoccurrence.

Looking southwest at the dip on the landside shoulder.

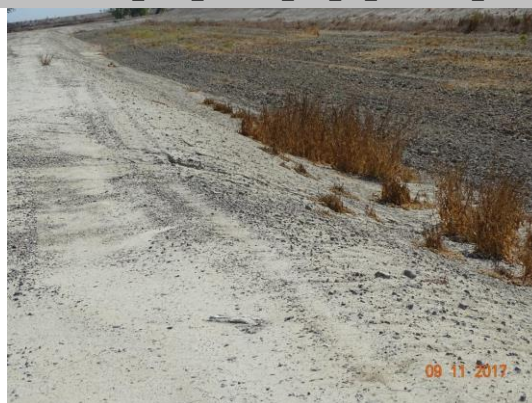
Photo 2 of 2 : FA_2018_RD2091_318_15_20180905_00016.jpg

Looking northeast at the dip in the landside shoulder.

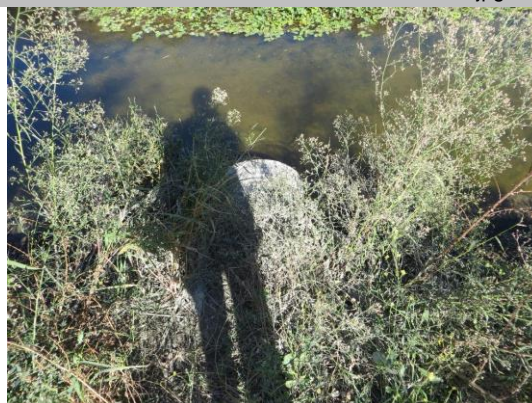
Photo 1 of 3 : UCIP_FA_2018_53431_38156.jpg

Comment Code					
Inspector Comment					
FS_ID:53431 DS_ID:23158 EP_NO: N/A Repair Type: Non-Urgent Crossing Status: Found UCIP Comments: 10/18/2018 Crossing remains abandoned. Unable to locate WS outlet due to dense vegetation. Crossing has been downgraded from Urgent to Non-Urgent, no integrity issues were observed along the pipe alignment. LMA is still seeking proper abandonment or removal of this crossing. This crossing is part of the Deferred Maintenance Project (DMP) phase 1 inspection. No video inspection has been completed yet. (O. Magana - DWR UCIP) 11/18/2016 Same as last inspection. This crossing remains Urgent due to the flap gate still missing from the WS toe. According to Mike Alves, this crossing is an abandoned line and the City of Modesto is working with CVFPB to authorize proper abandonment/removal. The City is working at finding funds to pay for proper abandonment/removal of all the drainage structures through this levee. (O. Magana - DWR UCIP)10/15/2013 Flap gate has fallen off at WS toe. Appears abandoned and if so should be done so properly. (W. Wylie - DWR UCIP) FIELD_STRUCT_DESC: *ABANDONED* 24-inch corrugated metal drainage pipe through the levee, 10 feet below the crown. Flap gate on the waterside (WS) end. Drain opening is located approximately 15 feet off the landside (LS) toe. [Additional Reference(s): DWR Levee Log, 1992. USACE San Joaquin O&M Manual 6, September 1961, (HLM 0.23), Drawing No. 07-04-1555, Sheets 1555/17 and 1555/55, (Station 915+00)]. FS Date: 10/18/2018

Pipe visible in canal on WS toe.

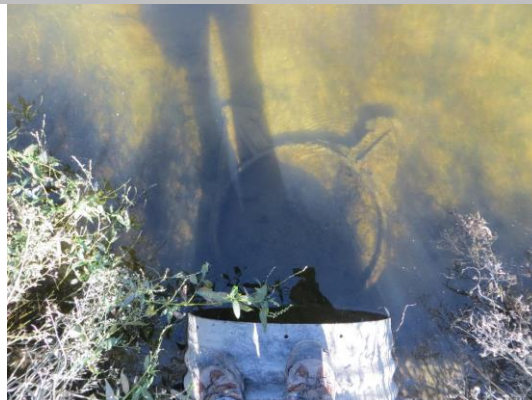
Photo 2 of 3 : UCIP_FA_2018_53431_38155.jpg

Comment Code						
Inspector Comment						
FS_ID:53431 DS_ID:23158 EP_NO: N/A Repair Type: Non-Urgent Crossing Status: Found UCIP Comments: 10/18/2018 Crossing remains abandoned. Unable to locate WS outlet due to dense vegetation. Crossing has been downgraded from Urgent to Non-Urgent, no integrity issues were observed along the pipe alignment. LMA is still seeking proper abandonment or removal of this crossing. This crossing is part of the Deferred Maintenance Project (DMP) phase 1 inspection. No video inspection has been completed yet. (O. Magana - DWR UCIP) 11/18/2016 Same as last inspection. This crossing remains Urgent due to the flap gate still missing from the WS toe. According to Mike Alves, this crossing is an abandoned line and the City of Modesto is working with CVFPB to authorize proper abandonment/removal. The City is working at finding funds to pay for proper abandonment/removal of all the drainage structures through this levee. (O. Magana - DWR UCIP)10/15/2013 Flap gate has fallen off at WS toe. Appears abandoned and if so should be done so properly. (W. Wylie - DWR UCIP) FIELD_STRUCT_DESC: *ABANDONED* 24-inch corrugated metal drainage pipe through the levee, 10 feet below the crown. Flap gate on the waterside (WS) end. Drain opening is located approximately 15 feet off the landside (LS) toe. [Additional Reference(s): DWR Levee Log, 1992. USACE San Joaquin O&M Manual 6, September 1961, (HLM 0.23), Drawing No. 07-04-1555, Sheets 1555/17 and 1555/55, (Station 915+00)]. FS Date: 10/18/2018

Flapgate has fallen off at WS toe.

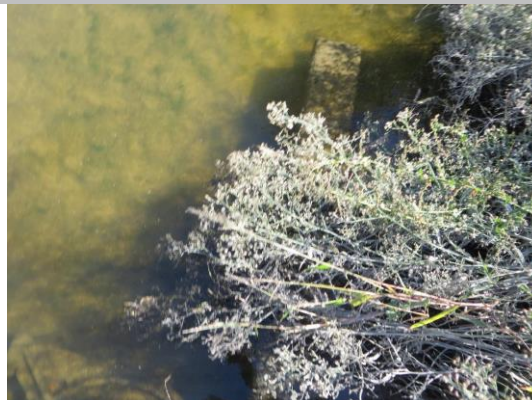
Photo 3 of 3 : UCIP_FA_2018_53431_38154.jpg

Comment Code						
Inspector Comment						
FS_ID:53431 DS_ID:23158 EP_NO: N/A Repair Type: Non-Urgent Crossing Status: Found UCIP Comments: 10/18/2018 Crossing remains abandoned. Unable to locate WS outlet due to dense vegetation. Crossing has been downgraded from Urgent to Non-Urgent, no integrity issues were observed along the pipe alignment. LMA is still seeking proper abandonment or removal of this crossing. This crossing is part of the Deferred Maintenance Project (DMP) phase 1 inspection. No video inspection has been completed yet. (O. Magana - DWR UCIP) 11/18/2016 Same as last inspection. This crossing remains Urgent due to the flap gate still missing from the WS toe. According to Mike Alves, this crossing is an abandoned line and the City of Modesto is working with CVFPB to authorize proper abandonment/removal. The City is working at finding funds to pay for proper abandonment/removal of all the drainage structures through this levee. (O. Magana - DWR UCIP)10/15/2013 Flap gate has fallen off at WS toe. Appears abandoned and if so should be done so properly. (W. Wylie - DWR UCIP) FIELD_STRUCT_DESC: *ABANDONED* 24-inch corrugated metal drainage pipe through the levee, 10 feet below the crown. Flap gate on the waterside (WS) end. Drain opening is located approximately 15 feet off the landside (LS) toe. [Additional Reference(s): DWR Levee Log, 1992. USACE San Joaquin O&M Manual 6, September 1961, (HLM 0.23), Drawing No. 07-04-1555, Sheets 1555/17 and 1555/55, (Station 915+00)]. FS Date: 10/18/2018

Concrete headwall under pipe at WS toe.

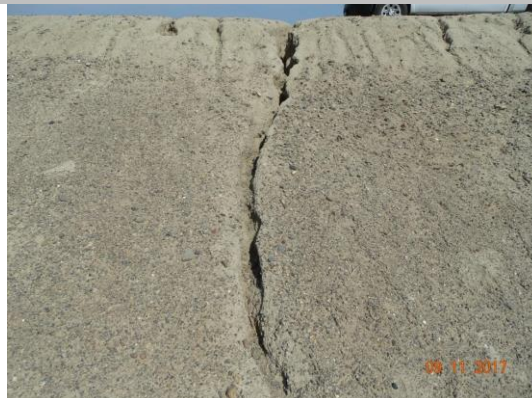
Photo 1 of 2 : FA_2018_RD2091_318_16_20180905_00017.jpg

Looking northwest at rill erosion on landside slope.

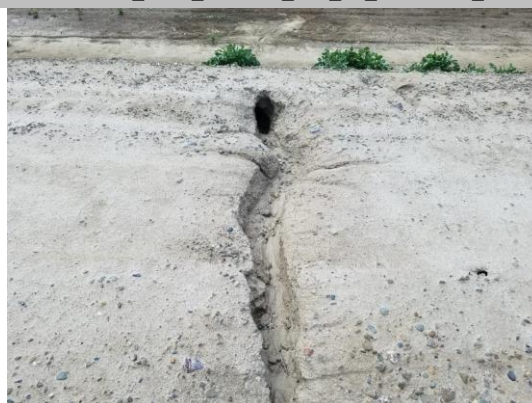
Photo 2 of 2 : FA_2018_RD2091_318_16_20180905_00018.jpg

Looking east at rill erosion above rodent hole on landward slope. (Spring 2017)

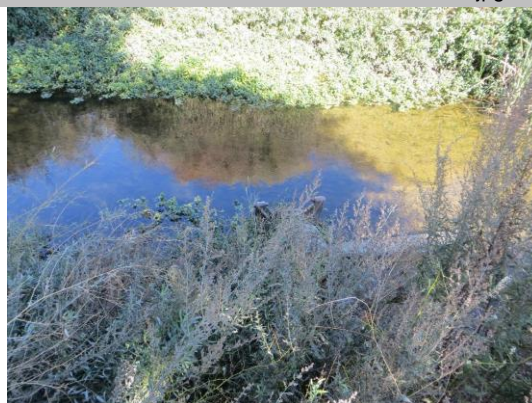
Photo 1 of 3 : UCIP_FA_2018_51639_38158.jpg

Comment Code						
Inspector Comment						
FS_ID:51639 DS_ID:23161 EP_NO: N/A Repair Type: Non-Urgent Crossing Status: Found UCIP Comments: 11/18/2016 Crossing has been downgraded from Urgent to Non-Urgent since the flap gate appears to fully close. According to Mike Alvez, this crossing is abandoned and the City of Modesto is working with CVFPB to authorize proper abandonment/removal. The City is working at finding funds to pay for proper abandonment/removal of all the drainage structures through this levee. (O. Magana - DWR UCIP)10/15/2013 Appears abandoned and if so should be done so properly. (W. Wylie - DWR UCIP) FIELD_STRUCT_DESC: *ABANDONED* 24-inch corrugated metal drainage pipe through the levee, 12 feet below the crown. Flap gate and concrete headwall on the waterside (WS) end. [Additional Reference(s): DWR Levee Log, 1992. USACE San Joaquin O&M Manual 6, September 1961, (HLM 0.64)]. FS Date: 11/18/2016

24-inch CMP on concrete headwall with flapgate on WS toe.

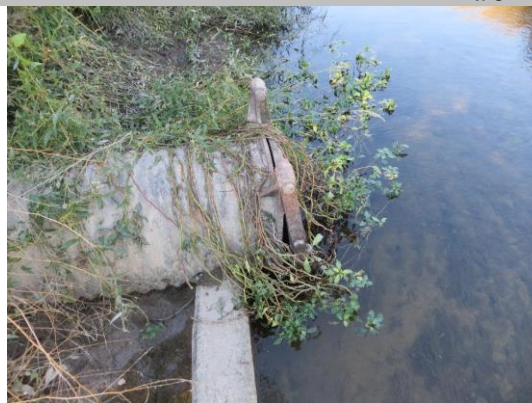
Photo 2 of 3 : UCIP_FA_2018_51639_38157.jpg

24-inch CMP on concrete headwall with flapgate on WS toe.

Comment Code						
Inspector Comment						
FS_ID:51639 DS_ID:23161 EP_NO: N/A Repair Type: Non-Urgent Crossing Status: Found UCIP Comments: 11/18/2016 Crossing has been downgraded from Urgent to Non-Urgent since the flap gate appears to fully close. According to Mike Alvez, this crossing is abandoned and the City of Modesto is working with CVFPB to authorize proper abandonment/removal. The City is working at finding funds to pay for proper abandonment/removal of all the drainage structures through this levee. (O. Magana - DWR UCIP)10/15/2013 Appears abandoned and if so should be done so properly. (W. Wylie - DWR UCIP) FIELD_STRUCT_DESC: *ABANDONED* 24-inch corrugated metal drainage pipe through the levee, 12 feet below the crown. Flap gate and concrete headwall on the waterside (WS) end. [Additional Reference(s): DWR Levee Log, 1992. USACE San Joaquin O&M Manual 6, September 1961, (HLM 0.64)]. FS Date: 11/18/2016

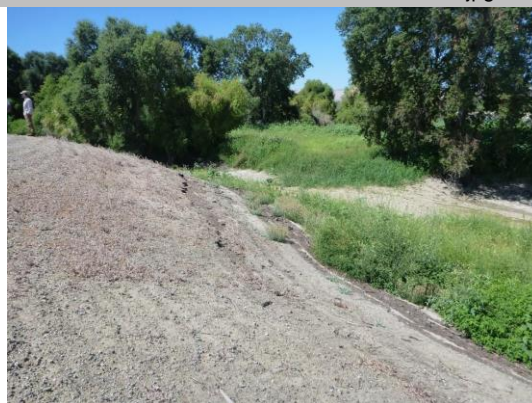
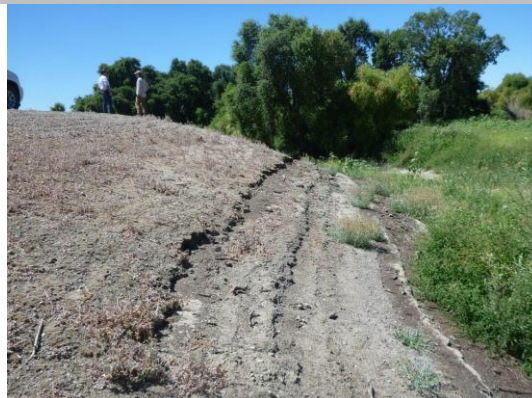
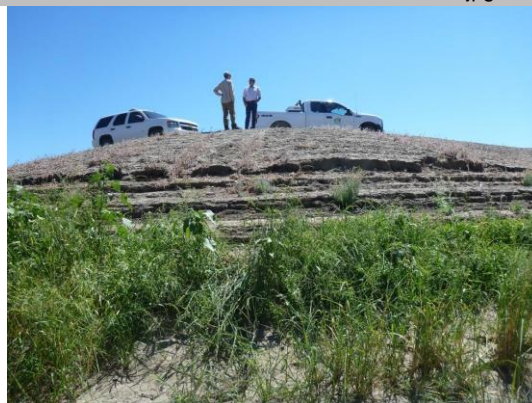
LM Start	0.94	Rating **	A/W	Issue No.	14
LM End	6.84	Issue Type +	Ma	Location *	
Category	Supplemental			GPS Latitude/Longitude	
				Start	End
Item	2017 Storm Damage			37.537775 °	37.482295 °
				-121.106730 °	-121.051592 °
DWR ID	DWR_RD2091_01_f _ 2017_14				
Comment Code					
Inspector Comment					
Levee Evaluation Comments					
Description:Wave wash damage/erosion of 2 miles ... see attached description and photos					
Site ID No:471					
Site Designation:LMA-298					
Repair Type: Erosion					
Rating:Area of Concern					
Field Date:7/20/2017					
Notes: Low priority because wavewash scarps are less than 1 ft and do not cut into prisim significantly and can be repaired by district through O&M. There is also a large berm here. Wavewash is present on both LS and WS.

LM Start	0.94	Rating **	A/W	Issue No.	14 (cont)
LM End	6.84	Issue Type +	Ma	Location *	
Category	Supplemental			GPS Latitude/Longitude	
				Start	End
Item	2017 Storm Damage			37.537775 °	37.482295 °
				-121.106730 °	-121.051592 °
DWR ID	DWR_RD2091_01_f_2017_14				
Comment Code					
Inspector Comment					
Levee Evaluation Comments					
Description:Wave wash damage/erosion of 2 miles ... see attached description and photos					
Site ID No:471					
Site Designation:LMA-298					
Repair Type: Erosion					
Rating:Area of Concern					
Field Date:7/20/2017					
Notes: Low priority because wavewash scarps are less than 1 ft and do not cut into prism significantly and can be repaired by district through O&M. There is also a large berm here. Wavewash is present on both LS and WS.					
LM Start	0.94	Rating **	A/W	Issue No.	14 (cont)
LM End	6.84	Issue Type +	Ma	Location *

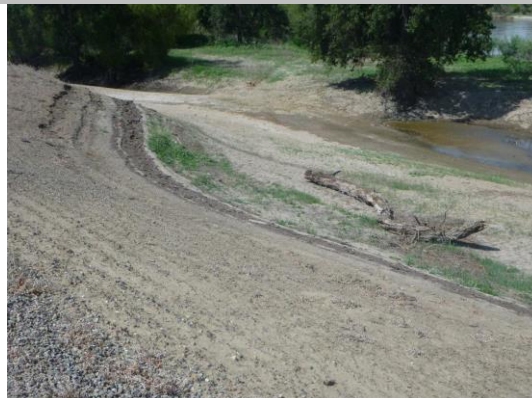
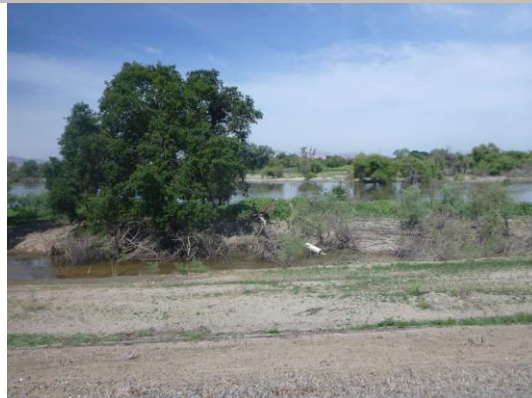
LM Start	1.41	Rating **	A/W	Issue No.	24 (cont)	
LM End	1.44	Issue Type +	Ma	Location *		
Category	Supplemental			GPS Latitude/Longitude		
				Start	End	
Item	2017 Storm Damage			37.531170 °	37.530760 °	
				-121.106750 °	-121.106710 °	
DWR ID	DWR_RD2091_01_f_2017_24					
Comment Code						
Inspector Comment						
Levee Evaluation Comments						
Description:						
Site ID No:132						
Site Designation:DWR_RD2091_01_R_2012_01						
Repair Type: Erosion						
Rating:Area of Concern						
Field Date:6/7/2017						
Notes: Wavewash erosion up to 12" deep at high water mark.

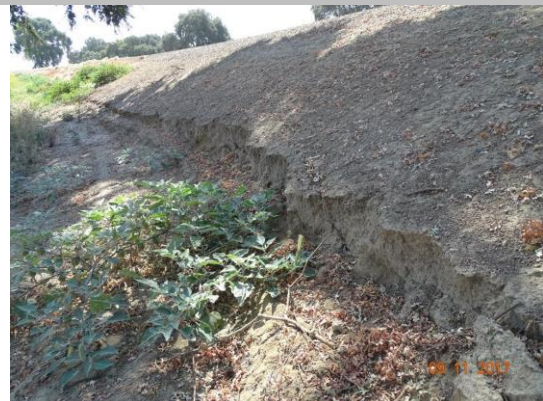
Photo 1 of 1 : FA_2018_RD2091_318_18_20180905_00020.jpg

LM Start	2.05	Rating **	M	Issue No.	18
LM End	2.06	Issue Type +	Ma	Location *	LS
Category	Earthen Levee			GPS Latitude/Longitude	
				Start	End
Item	Erosion / Bank Caving			37.526083 °	37.525897 °
				-121.099328 °	-121.099116 °
DWR ID	DWR_RD2091_01_f_2017_18				
Comment Code					
E2 : Schedule repair of erosion site prior to the next inspection.					
Inspector Comment					
Erosion at the landside toe.

Looking southeast at erosion on the toe of the landside slope.

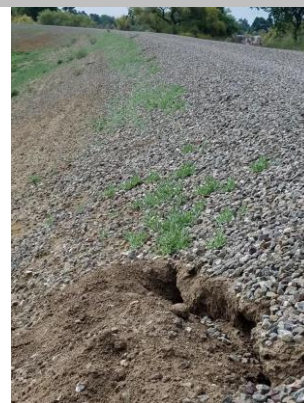
Photo 1 of 1 : FA_2018_RD2091_318_22_20180905_00021.jpg

LM Start	4.25	Rating **	A/W	Issue No.	22
LM End	4.25	Issue Type +	Ma	Location *	LS
Category	Earthen Levee			GPS Latitude/Longitude	
				Start	End
Item	Animal Control			37.501907 °	37.501907 °
				-121.082123 °	-121.082123 °
DWR ID	DWR_RD2091_01_s_2017_22				
Comment Code					
A3 : No rodents visible, but rodent burrows visible; need to backfill and compact or grout burrows.					
Inspector Comment					
Burrows no longer present. (2018)

Looking south at rodent activity on landward shoulder and slope.

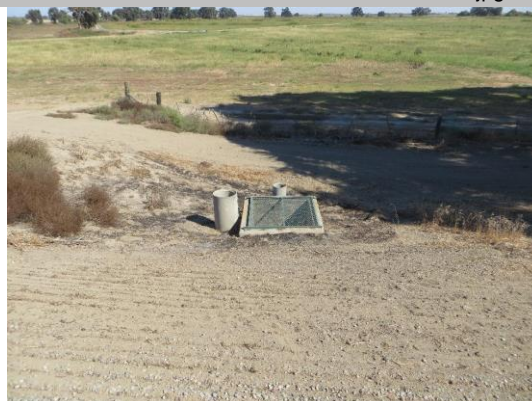
Photo 1 of 3 : UCIP_FA_2018_43209_38211.jpg

LM Start	4.59	Rating **	M	Issue No.	49
LM End	4.59	Issue Type +	En	Location *	
Category	Supplemental			GPS Latitude/Longitude	
				Start	End
Item	DWR UCIP Field Study			37.497390 °	37.497390 °
				-121.080370 °	-121.080370 °
DWR ID	23165				
Comment Code					
Inspector Comment					
FS_ID:43209 DS_ID:23165 EP_NO: N/A Repair Type: Non-Urgent Crossing Status: Found UCIP Comments: 10/15/2013 Appears abandoned and if so should be done so properly. (P. Amatya - DWR UCIP) FIELD_STRUCT_DESC: 36-inch corrugated metal irrigation pipe through the levee, 15 feet below the crown. Abandoned concrete inlet box on the waterside (WS) slope of the levee. 6-foot by 5-foot concrete distribution box at the landside (LS) toe. [Additional Reference(s): DWR Levee Log, 1992. USACE San Joaquin O&M Manual 6, September 1961, (HLM 4.67), 30-inch pipe listed]. FS Date: 1/29/2015 2:27:42 PM

Distribution box on LS toe.

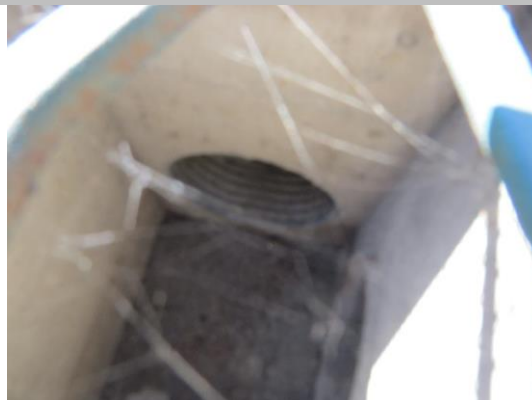
Photo 2 of 3 : UCIP_FA_2018_43209_38210.jpg

Open CMP pipe through levee at distribution box on LS toe.

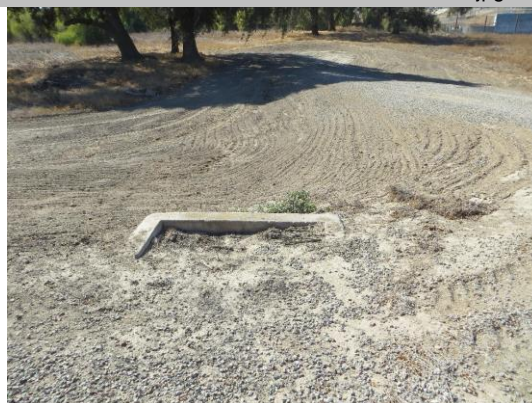
Photo 3 of 3 : UCIP_FA_2018_43209_38209.jpg

LM Start	4.59	Rating **	M	Issue No.	49 (cont)	
LM End	4.59	Issue Type +	En	Location *		
Category	Supplemental			GPS Latitude/Longitude		
				Start	End	
Item	DWR UCIP Field Study			37.497390 °	37.497390 °	
				-121.080370 °	-121.080370 °	
DWR ID	23165					
Comment Code						
Inspector Comment						
FS_ID:43209 DS_ID:23165 EP_NO: N/A Repair Type: Non-Urgent Crossing Status: Found UCIP Comments: 10/15/2013 Appears abandoned and if so should be done so properly. (P. Amatya - DWR UCIP) FIELD_STRUCT_DESC: 36-inch corrugated metal irrigation pipe through the levee, 15 feet below the crown. Abandoned concrete inlet box on the waterside (WS) slope of the levee. 6-foot by 5-foot concrete distribution box at the landside (LS) toe. [Additional Reference(s): DWR Levee Log, 1992. USACE San Joaquin O&M Manual 6, September 1961, (HLM 4.67), 30-inch pipe listed]. FS Date: 1/29/2015 2:27:42 PM

Abandoned concrete box on WS slope.

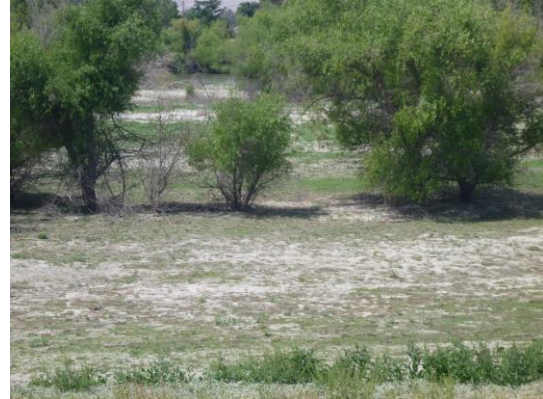
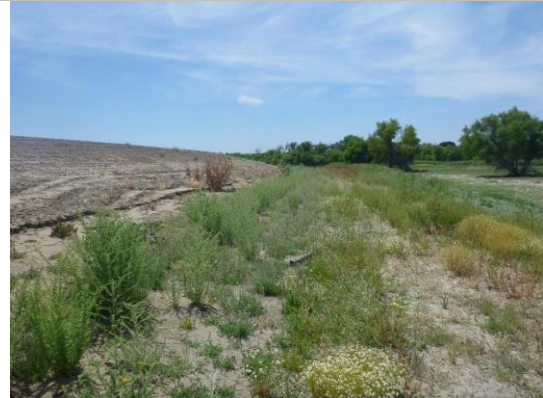
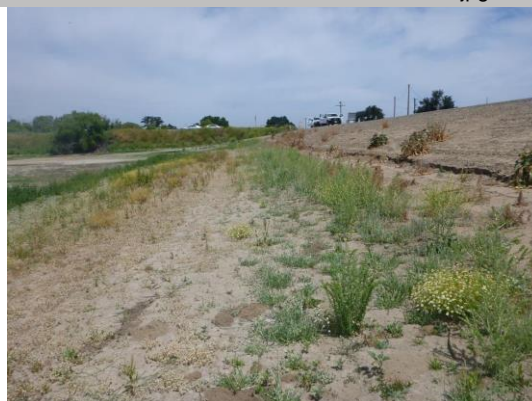
LM Start	4.83	Rating **	A/W	Issue No.	41
LM End	4.83	Issue Type +	Ma	Location *	
Category	Supplemental			GPS Latitude/Longitude	
				Start	End
Item	2017 Storm Damage			37.494300°	37.494300°
				-121.078300°	-121.078300°
DWR ID	DWR_RD2091_01_f_2017_41				
Comment Code					
Inspector Comment					
Levee Evaluation Comments					
Description:					
Site ID No:117					
Site Designation:LMA-37					
Repair Type: Erosion					
Rating:Area of Concern					
Field Date:6/7/2017					
Notes: Very minor erosion at toe of levee. Depth of erosion is 3" max.

LM Start	4.83	Rating **	A/W	Issue No.	41 (cont)	
LM End	4.83	Issue Type +	Ma	Location *		
Category	Supplemental			GPS Latitude/Longitude		
				Start		End
Item	2017 Storm Damage			37.494300	°	37.494300
				-121.078300	°	-121.078300
DWR ID	DWR_RD2091_01_f_2017_41					
Comment Code						
Inspector Comment						
Levee Evaluation Comments						
Description:						
Site ID No:117						
Site Designation:LMA-37						
Repair Type: Erosion						
Rating:Area of Concern						
Field Date:6/7/2017						
Notes: Very minor erosion at toe of levee. Depth of erosion is 3" max.

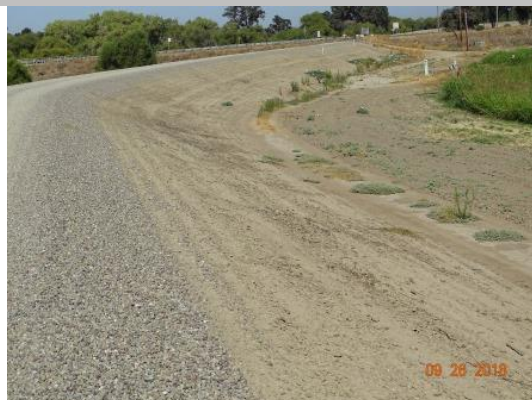
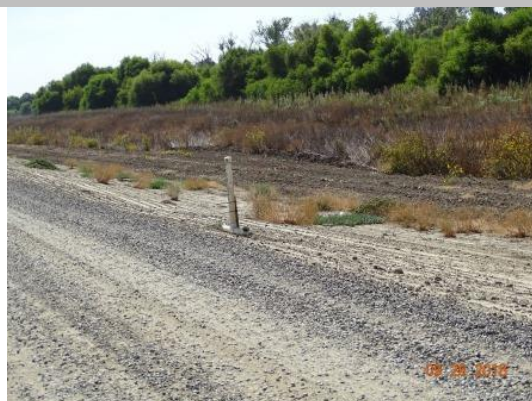
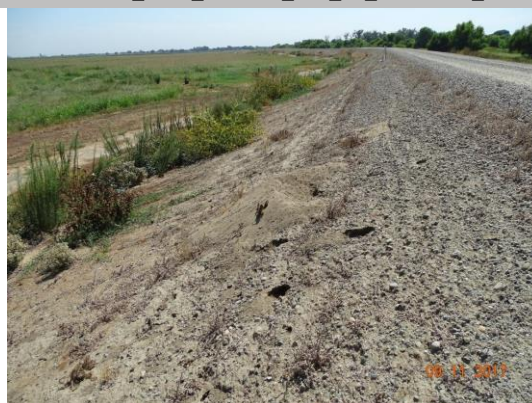
LM Start	4.84	Rating **	A/W	Issue No.	10
LM End	4.85	Issue Type +	Ma	Location *	LS
Category	Earthen Levee			GPS Latitude/Longitude	
				Start	End
Item	Animal Control			37.494297°	37.494115°
				-121.078233°	-121.078100°
DWR ID	DWR_RD2091_01_f_2018_10				
Comment Code					
A3 : No rodents visible, but rodent burrows visible; need to backfill and compact or grout burrows.					
Inspector Comment					
No visible burrows and rodent control program visible. (2018)

View of landside slope. (2018)

View of rodent control program in place. (2018)

Looking southeast at landside slope. (2017)

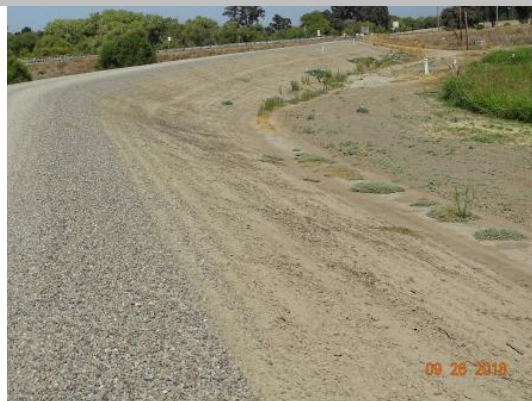
Photo 1 of 1 : FA_2018_RD2091_318_19_20180927_00048.jpg

LM Start	4.84	Rating **	A	Issue No.	19
LM End	4.84	Issue Type +	Ma	Location *	LS
Category	Earthen Levee			GPS Latitude/Longitude	
				Start	End
Item	Vegetation			37.494297°	37.494297°
				-121.078233°	-121.078233°
DWR ID	DWR_RD2091_01_f_2018_19				
Comment Code					
V1 : Control annual grass and weeds on the levee slopes and easements.					
Inspector Comment					
Vegetation was well maintained along levee

Representative view of landside slope looking downstream. (2018)

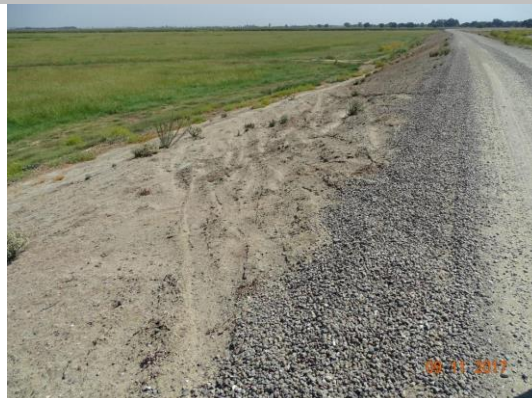
Photo 1 of 2 : FA_2018_RD2091_318_13_20180905_00010.jpg

LM Start	5.20	Rating **	A/W	Issue No.	13
LM End	5.20	Issue Type +	Ma	Location *	LS
Category	Earthen Levee			GPS Latitude/Longitude	
				Start	End
Item	Slope Stability			37.490756 °	37.490756 °
				-121.073410 °	-121.073410 °
DWR ID	DWR_RD2091_01_f_2016_13				
Comment Code					
S3 : Repair the levee slope damaged by vehicle traffic and prevent access where possible.					
Inspector Comment					
Vehicle traffic damaging slope on landward slope.

Looking southeast at the landside slope.

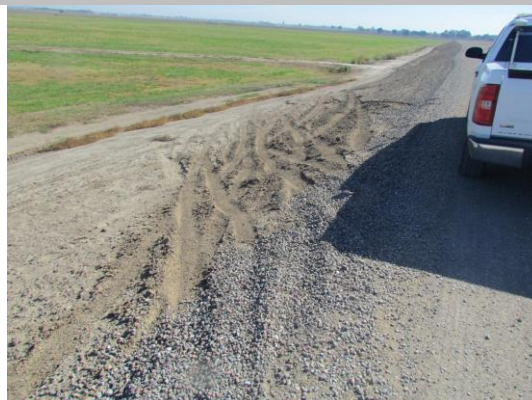
Photo 2 of 2 : FA_2018_RD2091_318_13_20180905_00011.jpg

Looking at damage on landside slope.

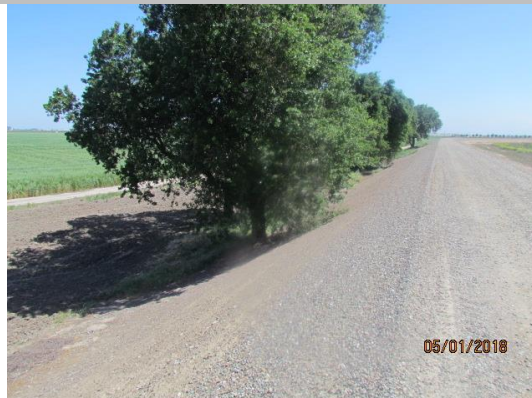
Photo 1 of 1 : FA_2018_RD2091_318_12_20180905_00009.jpg

Looking southeast at untrimmed tree at landward toe. (Spring 2018)

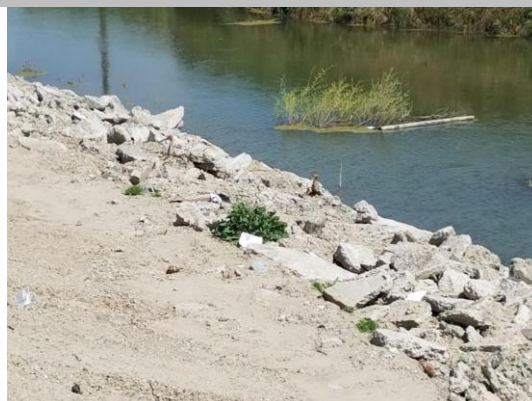
Photo 1 of 3 : FA_2018_RD2091_318_8_20180905_00001.jpg

Looking northeast at concrete rubble with rebar at landward toe next to canal.

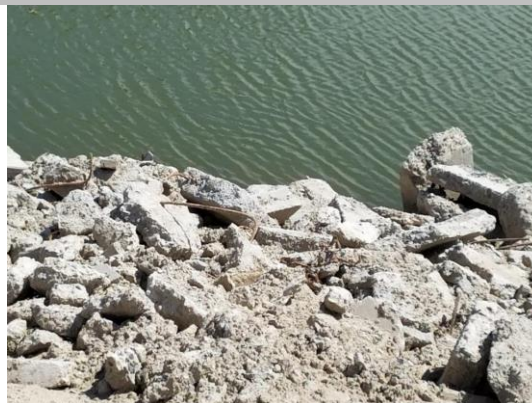
Photo 2 of 3 : FA_2018_RD2091_318_8_20180905_00002.jpg

Looking east at concrete rubble with rebar at landward toe next to canal.

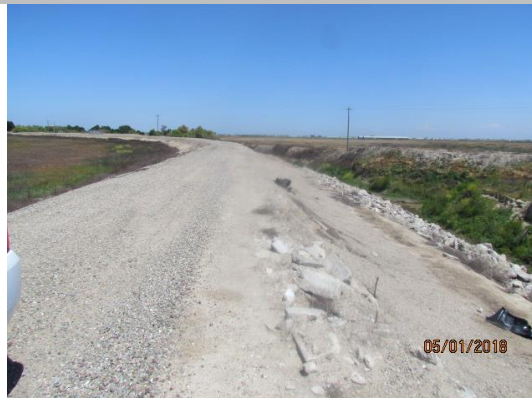
Photo 3 of 3 : FA_2018_RD2091_318_8_20180905_00003.jpg

Looking east at repaired site on waterward slope and toe. (Spring 2018)

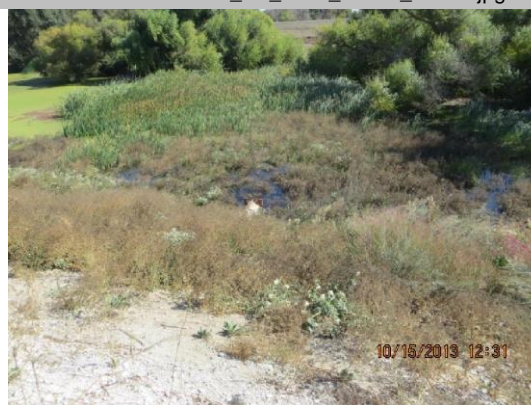
Photo 1 of 3 : UCIP_FA_2018_51390_38216.jpg

24-inch CMP with flapgate visible on WS toe.
