**Flood Control Project Maintenance
Levee Inspections**

Fall 2019 Levee Maintenance Deficiency Summary Report

San Joaquin River Basin

Reclamation District No. 2091 Chase

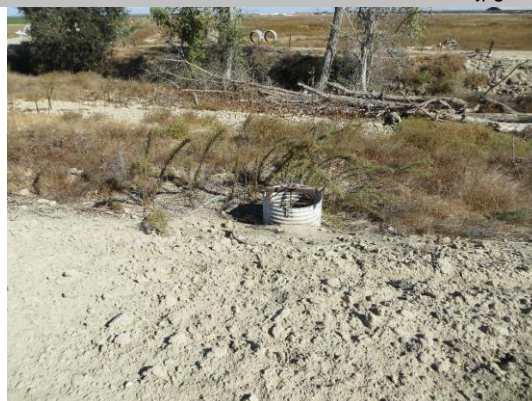
Photo 1 of 3 : UCIP_FA_2019_43207_38148.jpg

Comment Code						
Inspector Comment						
DS_ID:23155						
FS_ID:43207						
EP_NO: N/A						
Repair Type: Non-Urgent						
Crossing Status: Found						
UCIP Comments: 10/15/2013 Appears abandoned and if so should be done so properly. (W. Wylie - DWR UCIP)						
FIELD_STRUCT_DESC: *ABANDONED* 24-inch corrugated metal drainage pipe through the levee, 7.2 feet below the crown. Slide gate in a 36-inch corrugated metal pipe (CMP) riser on the waterside (WS) slope. [Additional Reference(s): DWR Levee Log, 1992. USACE San Joaquin O&M Manual 6, September 1961, (HLM 0.07), Drawing No. 07-04-1555, Sheets 1555/17 and 1555/55, (Station 906+85)].						
FS Date: 1/29/2015 2:26:31 PM

Slide gate in 36-inch CMP riser on WS toe.

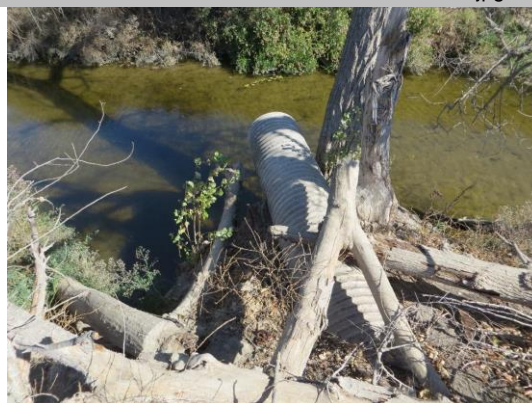
Photo 3 of 3 : UCIP_FA_2019_43207_38146.jpg

Comment Code						
Inspector Comment						
DS_ID:23155						
FS_ID:43207						
EP_NO: N/A						
Repair Type: Non-Urgent						
Crossing Status: Found						
UCIP Comments: 10/15/2013 Appears abandoned and if so should be done so properly. (W. Wylie - DWR UCIP)						
FIELD_STRUCT_DESC: *ABANDONED* 24-inch corrugated metal drainage pipe through the levee, 7.2 feet below the crown. Slide gate in a 36-inch corrugated metal pipe (CMP) riser on the waterside (WS) slope. [Additional Reference(s): DWR Levee Log, 1992. USACE San Joaquin O&M Manual 6, September 1961, (HLM 0.07), Drawing No. 07-04-1555, Sheets 1555/17 and 1555/55, (Station 906+85)].						
FS Date: 1/29/2015 2:26:31 PM

CMP stormdrain at outlet off WS toe.

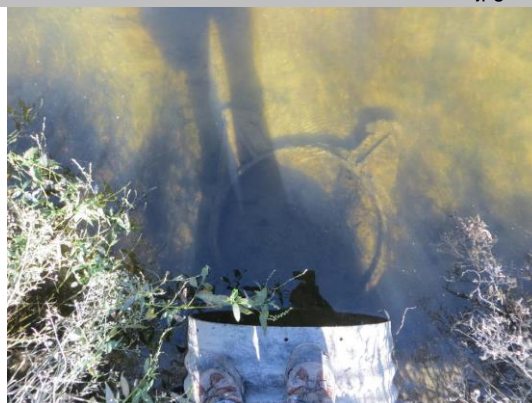
Photo 2 of 3 : UCIP_FA_2019_53431_38155.jpg

Flapgate has fallen off at WS toe.

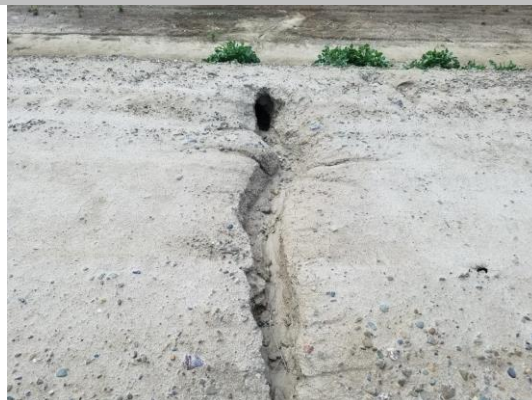
Photo 2 of 2 : FA_2019_RD2091_318_16_20190912_00016.jpg

Looking east at rill erosion above rodent hole on landward slope. (Spring 2017)

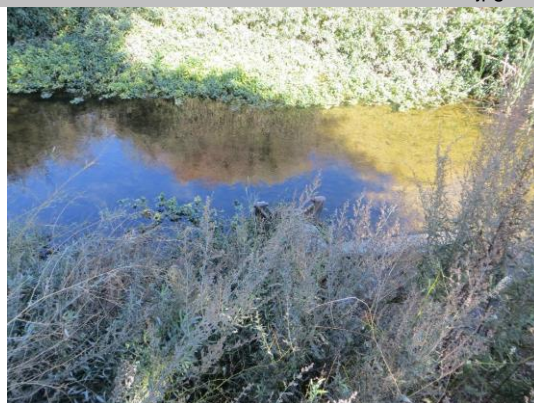
Photo 1 of 3 : UCIP_FA_2019_51639_38158.jpg

Comment Code						
Inspector Comment						
DS_ID:23161 FS_ID:51639 EP_NO: N/A Repair Type: Non-Urgent Crossing Status: Found UCIP Comments: 11/18/2016 Crossing has been downgraded from Urgent to Non-Urgent since the flap gate appears to fully close. According to Mike Alvez, this crossing is abandoned and the City of Modesto is working with CVFPB to authorize proper abandonment/removal. The City is working at finding funds to pay for proper abandonment/removal of all the drainage structures through this levee. (O. Magana - DWR UCIP)10/15/2013 Appears abandoned and if so should be done so properly. (W. Wylie - DWR UCIP) FIELD_STRUCT_DESC: *ABANDONED* 24-inch corrugated metal drainage pipe through the levee, 12 feet below the crown. Flap gate and concrete headwall on the waterside (WS) end. [Additional Reference(s): DWR Levee Log, 1992. USACE San Joaquin O&M Manual 6, September 1961, (HLM 0.64)]. FS Date: 11/18/2016

24-inch CMP on concrete headwall with flapgate on WS toe.

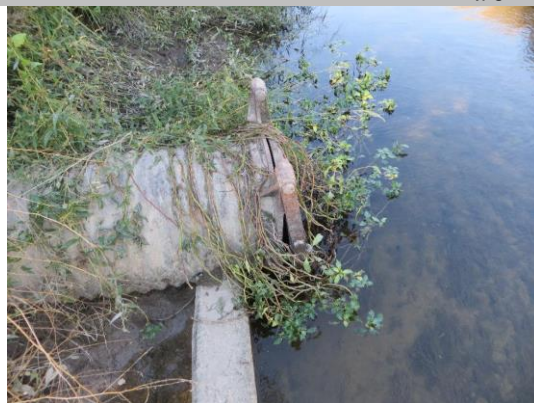
Photo 2 of 3 : UCIP_FA_2019_51639_38157.jpg

24-inch CMP on concrete headwall with flapgate on WS toe.

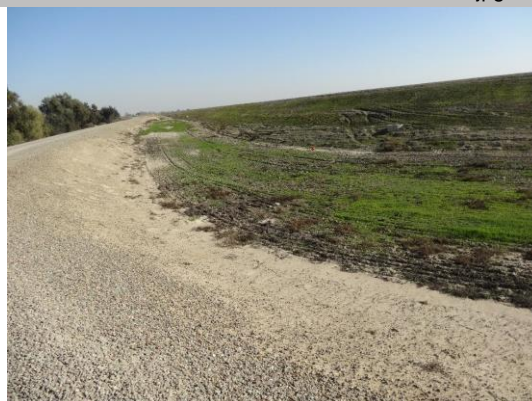
Photo 3 of 3 : UCIP_FA_2019_51639_76677.jpg

View of LS.

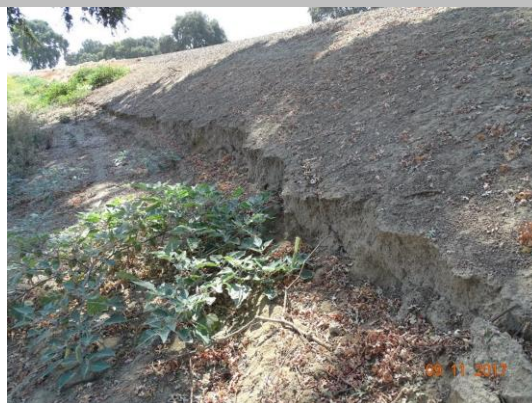
Photo 1 of 1 : FA_2019_RD2091_318_18_20190912_00017.jpg

LM Start	2.05	Rating **	M	Issue No.	18
LM End	2.06	Issue Type +	Ma	Location *	LS
Category	Earthen Levee			GPS Latitude/Longitude	
				Start	End
Item	Erosion / Bank Caving			37.526083 °	37.525897 °
				-121.099328 °	-121.099116 °
DWR ID	DWR_RD2091_01_f_2017_18				
Comment Code					
E2 : Schedule repair of erosion site prior to the next inspection.					
Inspector Comment					
Erosion at the landside toe.

Looking southeast at erosion on the toe of the landside slope.

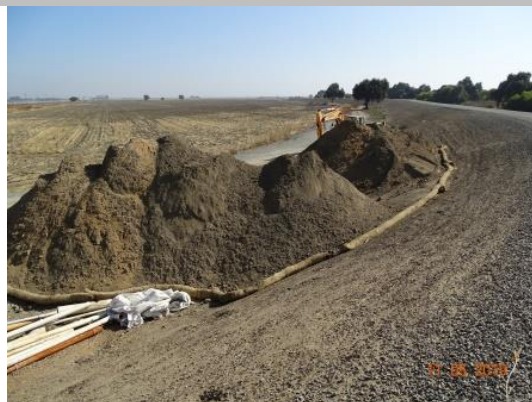
Photo 1 of 1 : FA_2019_RD2091_318_12_20191114_00044.jpg

View of material stored on the landside toe. (Fall 2019)

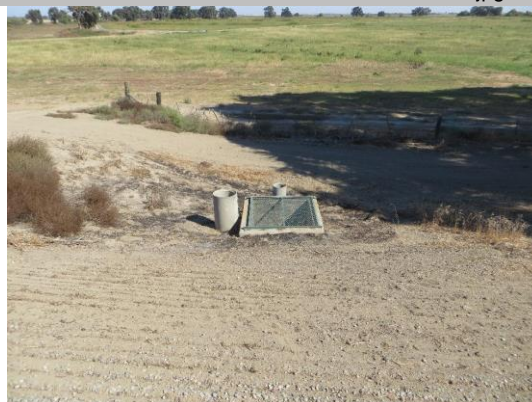
Photo 1 of 3 : UCIP_FA_2019_43209_38211.jpg

Comment Code					
Inspector Comment					
DS_ID:23165					
FS_ID:43209					
EP_NO: N/A					
Repair Type: Non-Urgent					
Crossing Status: Found					
UCIP Comments: 10/15/2013 Appears abandoned and if so should be done so properly. (P. Amatya - DWR UCIP)					
FIELD_STRUCT_DESC: 36-inch corrugated metal irrigation pipe through the levee, 15 feet below the crown. Abandoned concrete inlet box on the waterside (WS) slope of the levee. 6-foot by 5-foot concrete distribution box at the landside (LS) toe. [Additional Reference(s): DWR Levee Log, 1992. USACE San Joaquin O&M Manual 6, September 1961, (HLM 4.67), 30-inch pipe listed].					
FS Date: 1/29/2015 2:27:42 PM

Distribution box on LS toe.

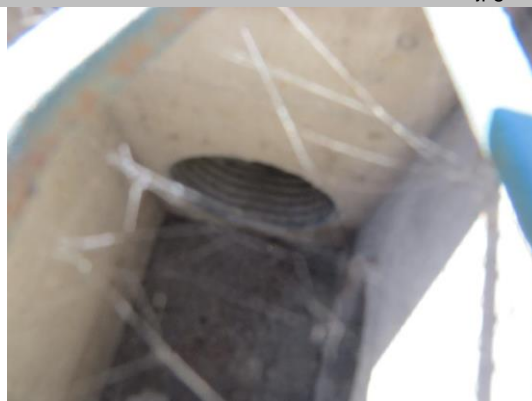
Photo 2 of 3 : UCIP_FA_2019_43209_38210.jpg

LM Start	4.59	Rating **	M	Issue No.	49 (cont)	
LM End	4.59	Issue Type +	En	Location *		
Category	Supplemental			GPS Latitude/Longitude		
				Start		End
Item	DRAFT DWR UCIP Field Study			37.497390 °		37.497390 °
				-121.080370 °		-121.080370 °
DWR ID	23165					
Comment Code						
Inspector Comment						
DS_ID:23165 FS_ID:43209 EP_NO: N/A Repair Type: Non-Urgent Crossing Status: Found UCIP Comments: 10/15/2013 Appears abandoned and if so should be done so properly. (P. Amatya - DWR UCIP) FIELD_STRUCT_DESC: 36-inch corrugated metal irrigation pipe through the levee, 15 feet below the crown. Abandoned concrete inlet box on the waterside (WS) slope of the levee. 6-foot by 5-foot concrete distribution box at the landside (LS) toe. [Additional Reference(s): DWR Levee Log, 1992. USACE San Joaquin O&M Manual 6, September 1961, (HLM 4.67), 30-inch pipe listed]. FS Date: 1/29/2015 2:27:42 PM

Open CMP pipe through levee at distribution box on LS toe.

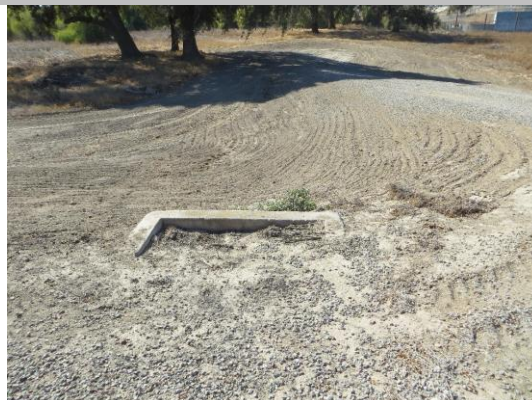
Photo 3 of 3 : UCIP_FA_2019_43209_38209.jpg

Abandoned concrete box on WS slope.

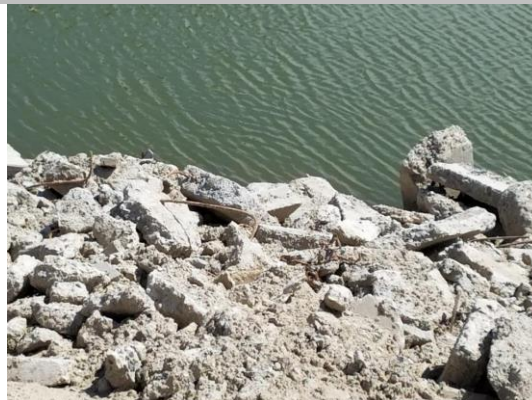
Photo 2 of 3 : FA_2019_RD2091_318_8_20190912_00002.jpg

LM Start	7.42	Rating **	U	Issue No.	8 (cont)	
LM End	7.45	Issue Type +	Ma	Location *	LS	
Category	Earthen Levee			GPS Latitude/Longitude		
				Start		End
Item	Erosion / Bank Caving			37.479308°	37.478998°	
				-121.044708°	-121.044660°	
DWR ID	DWR_RD2091_01_s_2017_8					
Comment Code						
E2 : Schedule repair of erosion site prior to the next inspection.						
Inspector Comment						
Repaired area with concrete containing rebar. Need to remove rebar.

Looking east at concrete rubble with rebar at landward toe next to canal.

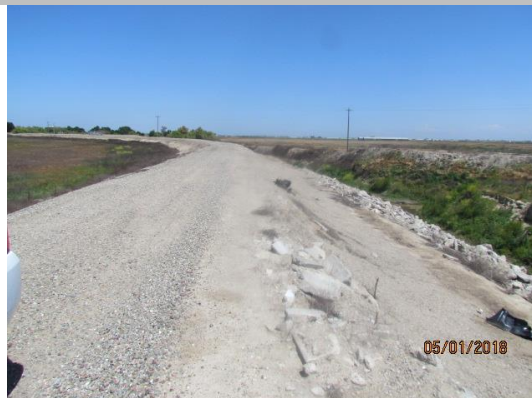
Photo 3 of 3 : FA_2019_RD2091_318_8_20190912_00003.jpg

Looking east at repaired site on waterward slope and toe. (Spring 2018)

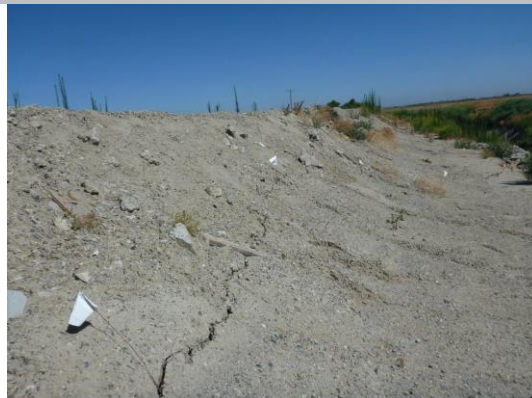
Photo 3 of 3 : LEVAL_FA_2019_473_2331.jpg

LM Start	7.45	Rating **	A/W	Issue No.	23 (cont)	
LM End	7.45	Issue Type +	Ma	Location *		
Category	Supplemental			GPS Latitude/Longitude		
				Start	End	
Item	2017 Storm Damage			37.479000 °	37.479000 °	
				-121.044000 °	-121.040000 °	
DWR ID	LMA-300					
Comment Code						
Inspector Comment						
Levee Evaluation Comments						
Description:Sloughing at Mile 7.59 of the San Joaquin River						
Site ID No:473						
Site Designation:LMA-300						
Repair Type: Erosion						
Rating:Area of Concern						
Field Date:7/20/2017						
Notes: Concrete rubble was installed here during the storms after noticing cracks and sloughing. It has rebar sticking out and needs to be replaced with clean rip rap. Responsibility is grey here because TID maintains channel and placed concrete during storm.

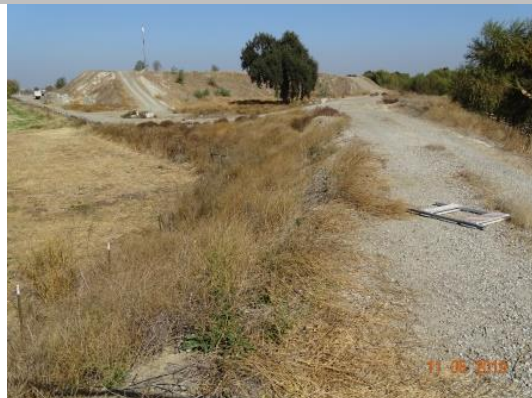
Photo 1 of 1 : FA_2019_RD2091_319_2_20191114_00004.jpg

View of the landside slope. (Fall 2019)

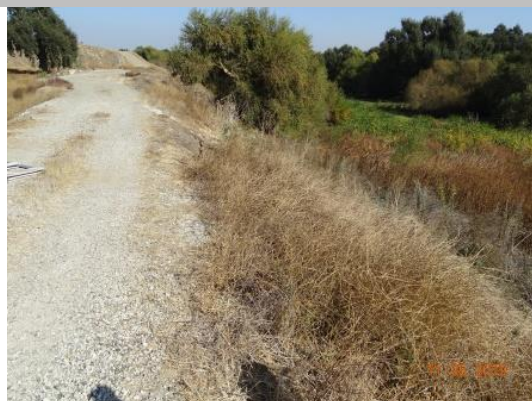
Photo 1 of 1 : FA_2019_RD2091_319_3_20191114_00005.jpg

LM Start	0.02	Rating **	U	Issue No.	3
LM End	0.04	Issue Type +	Ma	Location *	WS
Category	Earthen Levee			GPS Latitude/Longitude	
				Start	End
Item	Vegetation			37.482384 °	37.482685 °
				-121.051279 °	-121.050975 °
DWR ID	DWR_RD2091_02_f_2019_3				
Comment Code					
V1 : Control annual grass and weeds on the levee slopes and easements.					
Inspector Comment

View of the waterside slope. (Fall 2019)

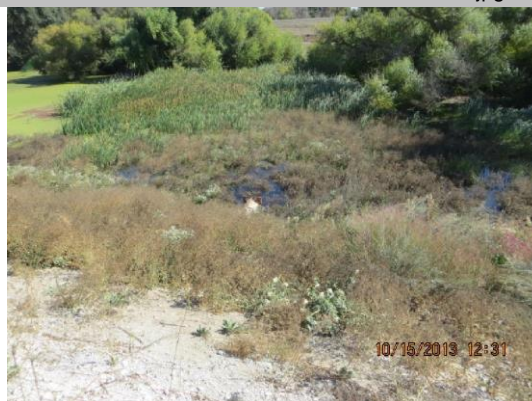
Photo 1 of 3 : UCIP_FA_2019_51390_38216.jpg

24-inch CMP with flapgate visible on WS toe.

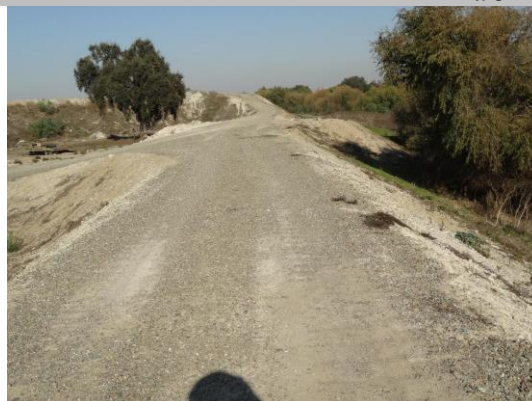
Photo 2 of 3 : UCIP_FA_2019_51390_76689.jpg

Overview photo of levee crown at crossing.

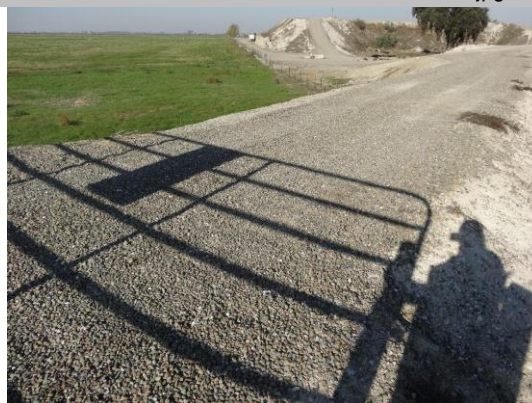
Photo 3 of 3 : UCIP_FA_2019_51390_76686.jpg

Overview of levee crown at crossing and at a distance there is a shooting range.
