Flood Control Project Maintenance Levee Inspections

Fall 2020 Levee Maintenance Deficiency Summary Report

San Joaquin River Basin

Reclamation District No. 2091 Chase

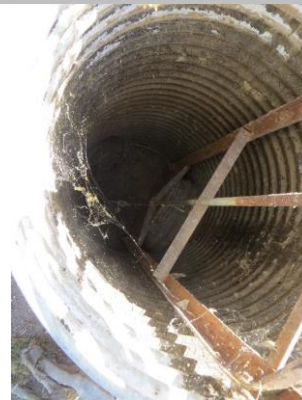
Photo 2 of 3 : UCIP_FA_2020_43207_38147.jpg

Slide gate in 36-inch CMP riser on WS toe.

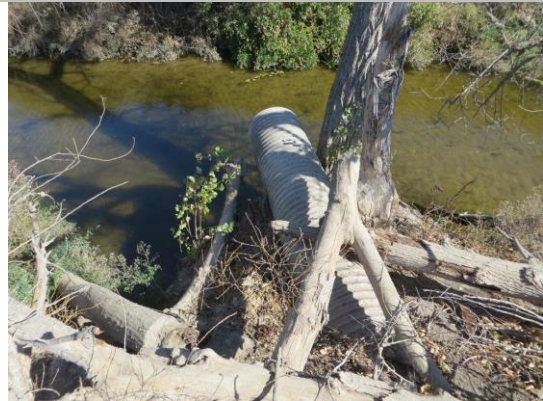
Photo 3 of 3 : UCIP_FA_2020_43207_38146.jpg

CMP stormdrain at outlet off WS toe.

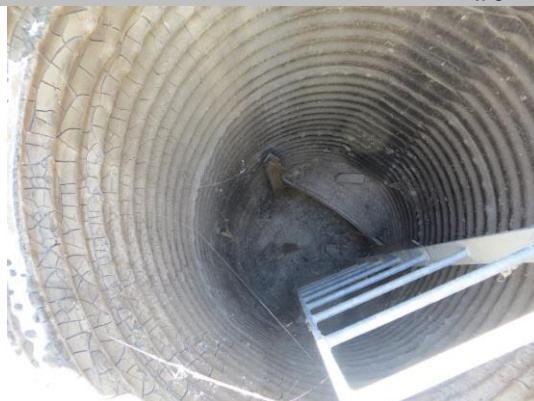
Photo 2 of 3 : UCIP_FA_2020_53094_38149.jpg

Slide gate missing from open end of pipe at WS slope.

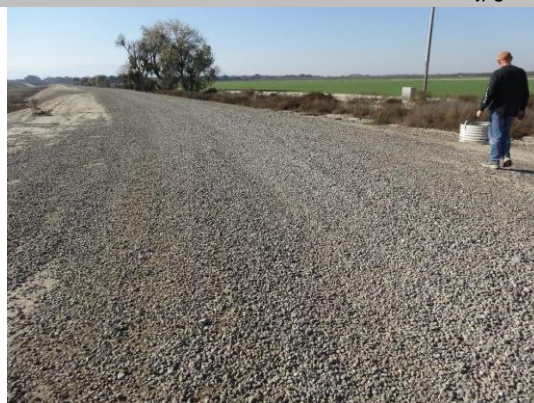
Photo 3 of 3 : UCIP_FA_2020_53094_76669.jpg

Overview of levee crown at pipe crossing.

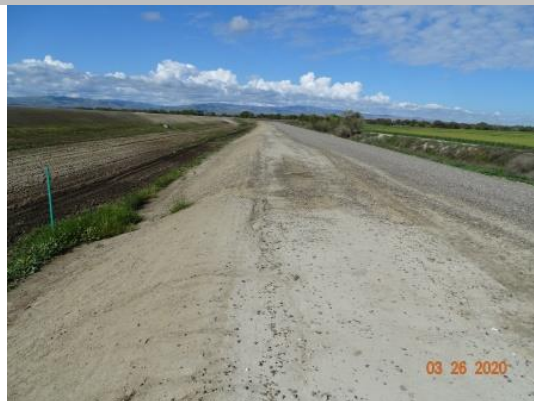
Photo 1 of 1 : FA_2020_RD2091_318_15_20200901_00006.jpg

LM Start	0.23	Rating **	A/W	Issue No.	15
LM End	0.23	Issue Type +	Ma	Location *	LS
Category	Earthen Levee			GPS Latitude/Longitude	
				Start	End
Item	Erosion / Bank Caving			37.541550 °	37.541550 °
				-121.096742 °	-121.096742 °
DWR ID	DWR_RD2091_01_s_2016_15				
Comment Code					
E1 : Note and monitor erosion site.					
Inspector Comment					
Caving on landward shoulder noted in 2017 possible collapsed pipe. Monitor for potential reoccurrence.

Looking west along the landside shoulder. (Spring 2020)

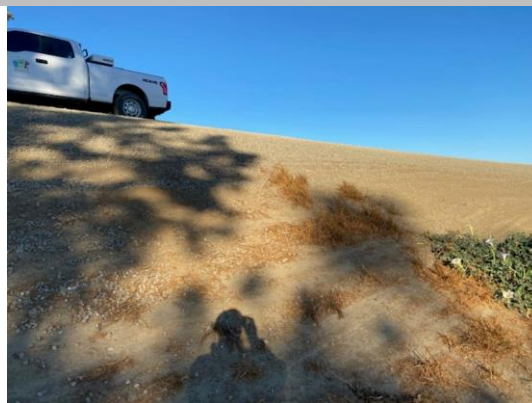
Photo 1 of 1 : FA_2020_RD2091_318_11_20201028_00026.jpg

LM Start	3.97	Rating **	A/W	Issue No.	11
LM End	3.97	Issue Type +	Ma	Location *	LS
Category	Earthen Levee			GPS Latitude/Longitude	
				Start	End
Item	Trim / Thin Trees			37.505925 °	37.505925 °
				-121.082469 °	-121.082469 °
DWR ID	DWR_RD2091_01_f _ 2020_11				
Comment Code					
T1 : Trim trees to at least five feet above ground level.					
Inspector Comment					
LMA removed tree sapling on the landside slope.

View of removed sapling growing in landside slope. (Fall 2020)

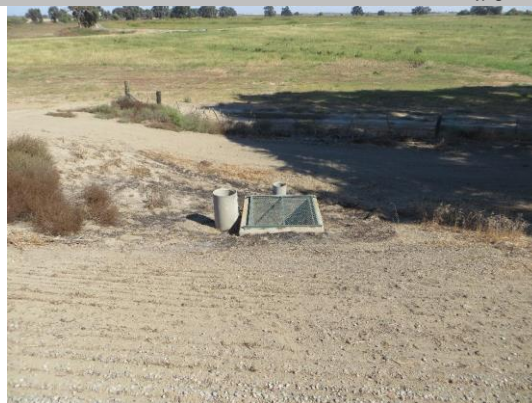
Photo 1 of 3 : UCIP_FA_2020_43209_38211.jpg

LM Start	4.59	Rating **	M	Issue No.	49	
LM End	4.59	Issue Type +	En	Location *		
Category	Supplemental			GPS Latitude/Longitude		
				Start		End
Item	DWR UCIP Field Study			37.497390 °	37.497390 °	
				-121.080370 °	-121.080370 °	
DWR ID	23165					
Comment Code						
Inspector Comment						
DS_ID:23165 FS_ID:43209 EP_NO: N/A Repair Type: Non-Urgent EVAL Issue: Crossing Status: Found UCIP Comments: 10/15/2013 Appears abandoned and if so should be done so properly. (P. Amatya - DWR UCIP) FIELD_STRUCT_DESC: 36-inch corrugated metal irrigation pipe through the levee, 15 feet below the crown. Abandoned concrete inlet box on the waterside (WS) slope of the levee. 6-foot by 5-foot concrete distribution box at the landside (LS) toe. [Additional Reference(s): DWR Levee Log, 1992. USACE San Joaquin O&M Manual 6, September 1961, (HLM 4.67), 30-inch pipe listed]. FS Date: 1/29/2015 2:27:42 PM

Distribution box on LS toe.

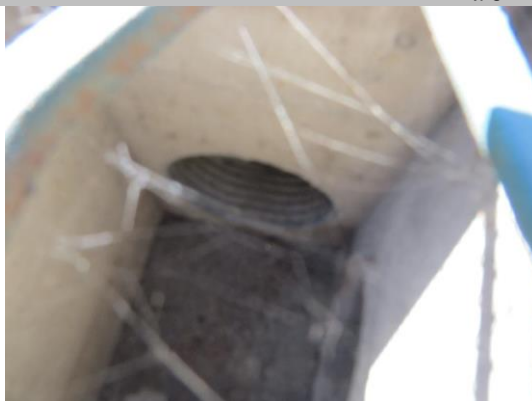
Photo 2 of 3 : UCIP_FA_2020_43209_38210.jpg

Open CMP pipe through levee at distribution box on LS toe.

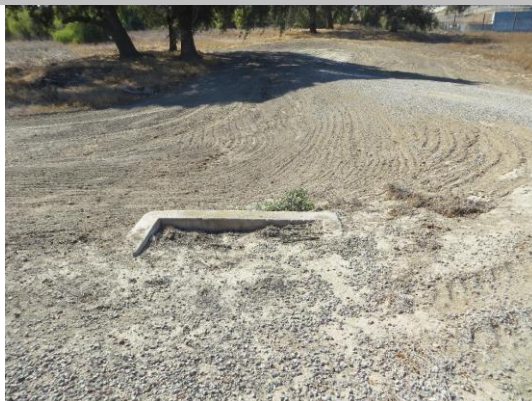
Photo 3 of 3 : UCIP_FA_2020_43209_38209.jpg

Abandoned concrete box on WS slope.

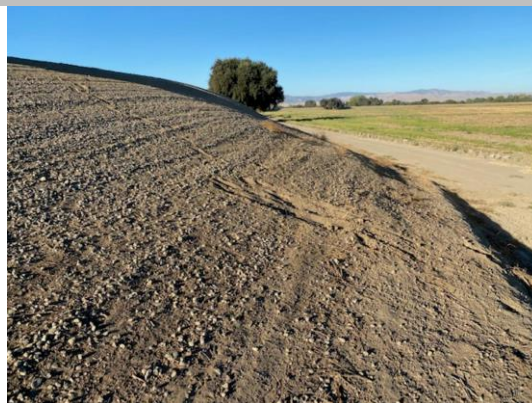
Photo 1 of 1 : FA_2020_RD2091_318_14_20201028_00027.jpg

LM Start	6.07	Rating **	A/W	Issue No.	14
LM End	6.07	Issue Type +	Ma	Location *	LS
Category	Earthen Levee			GPS Latitude/Longitude	
				Start	End
Item	Animal Control			37.486852 °	37.486852 °
				-121.060915 °	-121.060915 °
DWR ID	DWR_RD2091_01_s_2020_14				
Comment Code					
A3 : No rodents visible, but rodent burrows visible; need to backfill and compact or grout burrows.					
Inspector Comment					
LMA repaired slope with animal burrow.

View of repaired animal burrow on landside slope. (Fall 2020)

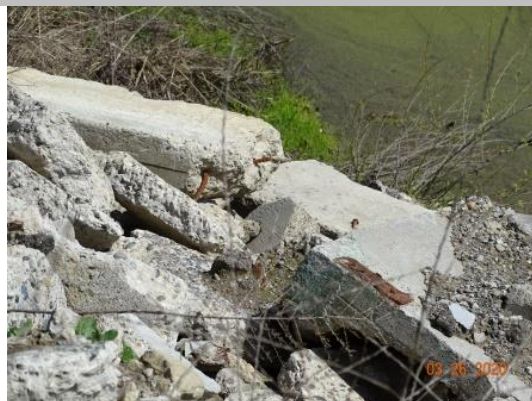
Photo 1 of 1 : FA_2020_RD2091_318_8_20200901_00002.jpg

LM Start	7.42	Rating **	U	Issue No.	8
LM End	7.45	Issue Type +	Ma	Location *	LS
Category	Earthen Levee			GPS Latitude/Longitude	
				Start	End
Item	Erosion / Bank Caving			37.479308 °	37.478998 °
				-121.044708 °	-121.044660 °
DWR ID	DWR_RD2091_01_s_2017_8				
Comment Code					
E2 : Schedule repair of erosion site prior to the next inspection.					
Inspector Comment					
Repaired area with concrete containing rebar. Need to remove rebar.

View of rebar and other steel in the concrete rubble along the landside toe. (Spring 2020)

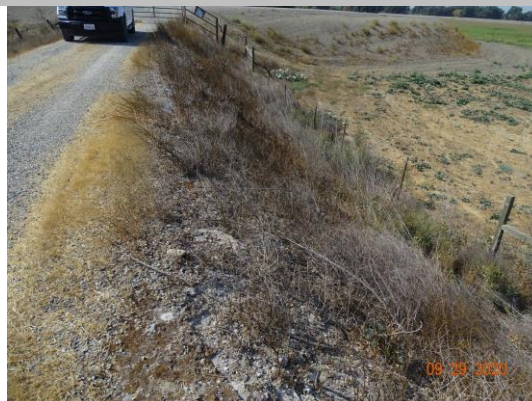
Photo 1 of 1 : FA_2020_RD2091_319_2_20201008_00004.jpg

LM Start	0.01	Rating **	M	Issue No.	2
LM End	0.03	Issue Type +	Ma	Location *	LS
Category	Earthen Levee			GPS Latitude/Longitude	
				Start	End
Item	Vegetation			37.482294 °	37.482513 °
				-121.051383 °	-121.051149 °
DWR ID	DWR_RD2091_02_f _ 2020_2				
Comment Code					
V1 : Control annual grass and weeds on the levee slopes and easements.					
Inspector Comment

View of vegetation on the landside slope. (Fall 2020)

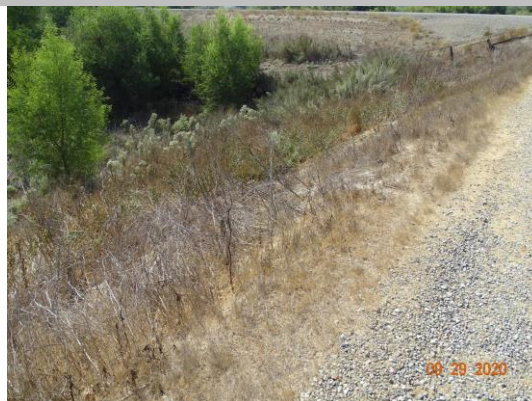
Photo 1 of 1 : FA_2020_RD2091_319_3_20201008_00005.jpg

LM Start	0.01	Rating **	M	Issue No.	3
LM End	0.03	Issue Type +	Ma	Location *	WS
Category	Earthen Levee			GPS Latitude/Longitude	
				Start	End
Item	Vegetation			37.482333 °	37.482513 °
				-121.051338 °	-121.051149 °
DWR ID	DWR_RD2091_02_f _ 2020_3				
Comment Code					
V1 : Control annual grass and weeds on the levee slopes and easements.					
Inspector Comment

Vegetation on the waterside slope. (Fall 2020)

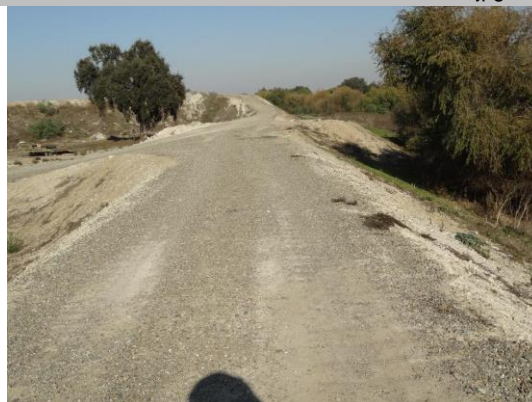
Photo 2 of 3 : UCIP_FA_2020_51390_76689.jpg

Overview photo of levee crown at crossing.

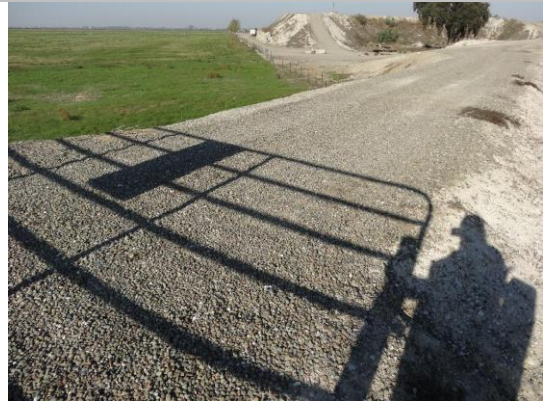
Photo 3 of 3 : UCIP_FA_2020_51390_76686.jpg

Overview of levee crown at crossing and at a distance there is a shooting range.
