Flood Control Project Maintenance Levee Inspections

Fall 2021 Levee Maintenance Deficiency Summary Report

San Joaquin River Basin

Reclamation District No. 2091 Chase

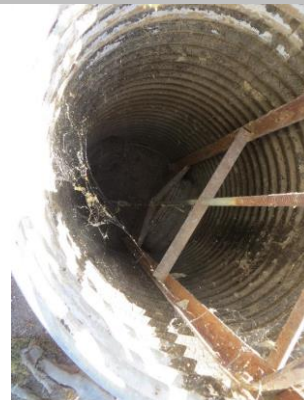
Photo 2 of 3 : UCIP_FA_2021_43207_38147.jpg

Comment Code						
Inspector Comment						
DS_ID:23155 FS_ID:43207 EP_NO: N/A Repair Type: Non-Urgent EVAL Issue: Crossing Status: Found UCIP Comments: 10/15/2013 Appears abandoned and if so should be done so properly. (W. Wylie - DWR UCIP) FIELD_STRUCT_DESC: *ABANDONED* 24-inch corrugated metal drainage pipe through the levee, 7.2 feet below the crown. Slide gate in a 36-inch corrugated metal pipe (CMP) riser on the waterside (WS) slope. [Additional Reference(s): DWR Levee Log, 1992. USACE San Joaquin O&M Manual 6, September 1961, (HLM 0.07), Drawing No. 07-04-1555, Sheets 1555/17 and 1555/55, (Station 906+85)]. FS Date: 1/29/2015 2:26:31 PM

Slide gate in 36-inch CMP riser on WS toe.

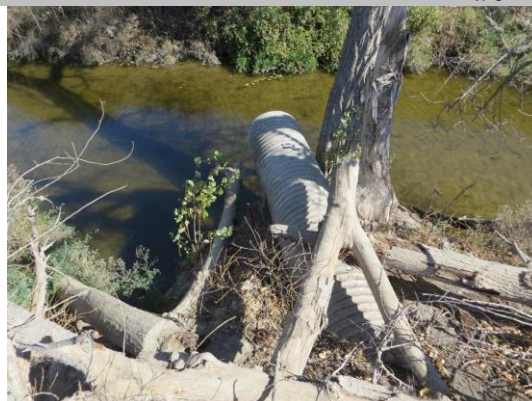
Photo 3 of 3 : UCIP_FA_2021_43207_38146.jpg

CMP stormdrain at outlet off WS toe.

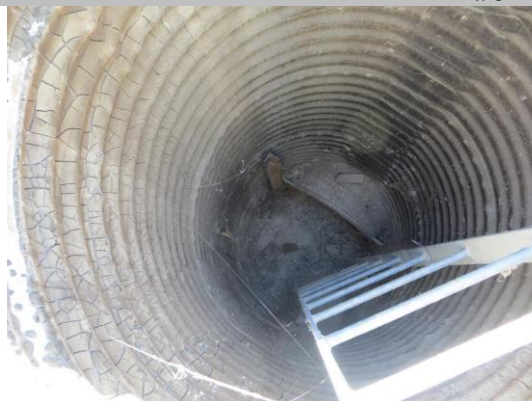
Photo 2 of 3 : UCIP_FA_2021_53094_38149.jpg

Comment Code						
Inspector Comment						
DS_ID:23156 FS_ID:53094 EP_NO: N/A Repair Type: Non-Urgent EVAL Issue: Crossing Status: Found UCIP Comments: 10/18/2018 Crossing remains abandoned. Unable to locate WS outlet due to dense vegetation. Crossing has been downgraded from Urgent to Non-Urgent. No integrity issues were observed along pipe alignment. LMA is still seeking proper abandonment or removal of this crossing. Crossing is part of the Deferred Maintenance Project (DMP) phase 1 inspection. No video inspection has been completed yet. (O. Magana - DWR UCIP) 11/18/2016 Same as last inspection this is a non-functional crossing with no visible inlet on LS or outlet on WS. The only appurtenance found at this location is a CMP riser with a missing cover located on the WS. This crossing remains Urgent since the pipe on the WS may still be opened. According to Mike Alves, this crossing is abandoned and the City of Modesto is working with CVFPB to authorize proper abandonment/removal. The City is working at finding funds to pay for proper abandonment/removal of all the drainage structures through this levee. (O. Magana - DWR UCIP)10/15/2013 Pipe open on WS and slide gate has been removed. Appears abandoned and should be done so properly. (W. Wylie - City of Modesto) FIELD_STRUCT_DESC: *ABANDONED* 24-inch corrugated metal drainage pipe through the levee, 9 feet below the crown. Slide gate in a corrugated metal pipe (CMP) riser located on the waterside (WS) slope. [Additional Reference(s): DWR Levee Log, 1992. USACE San Joaquin O&M Manual 6, September 1961, (HLM 0.10), Drawing No. 07-04-1555, Sheets 1555/17 and 1555/55, (Station 907+55)]. FS Date: 10/18/2018

Slide gate missing from open end of pipe at WS slope.

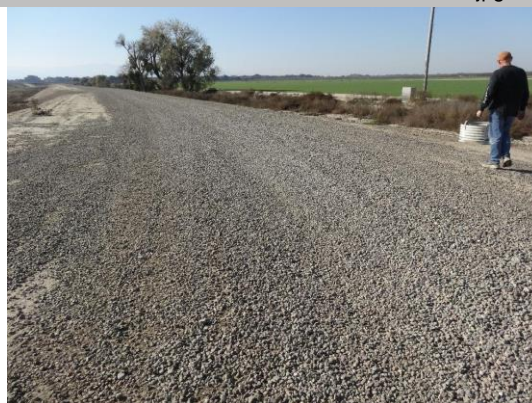
Photo 3 of 3 : UCIP_FA_2021_53094_76669.jpg

Overview of levee crown at pipe crossing.

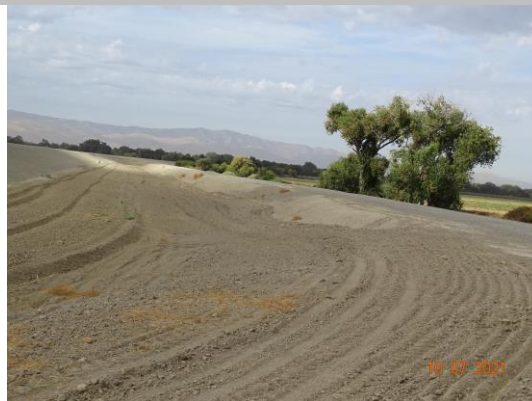
Photo 1 of 1 : FA_2021_RD2091_318_10_20211012_00018.jpg

LM Start	0.12	Rating **	A	Issue No.	10
LM End	0.12	Issue Type +	Ma	Location *	LS
Category	Earthen Levee			GPS Latitude/Longitude	
				Start	End
Item	Vegetation			37.541999 °	37.541999 °
				-121.094724 °	-121.094724 °
DWR ID	DWR_RD2091_01_f _ 2021_10				
Comment Code					
V1 : Control annual grass and weeds on the levee slopes and easements.					
Inspector Comment					
The annual vegetation is well maintained.

Looking upstream along the landside slope. (Fall 2021)

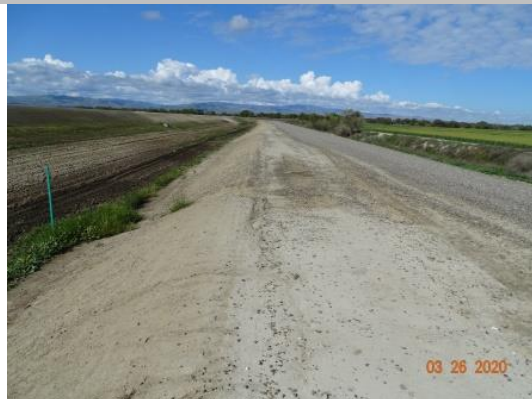
Photo 1 of 1 : FA_2021_RD2091_318_15_20210830_00002.jpg

LM Start	0.23	Rating **	A/W	Issue No.	15
LM End	0.23	Issue Type +	Ma	Location *	LS
Category	Earthen Levee			GPS Latitude/Longitude	
				Start	End
Item	Erosion / Bank Caving			37.541550 °	37.541550 °
				-121.096742 °	-121.096742 °
DWR ID	DWR_RD2091_01_s_2016_15				
Comment Code					
E1 : Note and monitor erosion site.					
Inspector Comment					
Caving on landward shoulder noted in 2017 possible collapsed pipe. Monitor for potential reoccurrence.

Looking west along the landside shoulder. (Spring 2020)

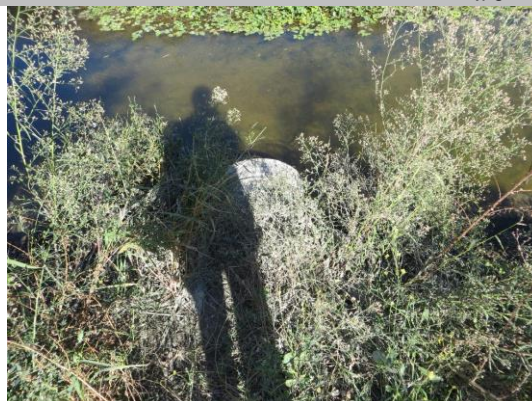
Photo 1 of 3 : UCIP_FA_2021_53431_38156.jpg

Comment Code					
Inspector Comment					
DS_ID:23158 FS_ID:53431 EP_NO: N/A Repair Type: Non-Urgent EVAL Issue: Crossing Status: Found UCIP Comments: 10/18/2018 Crossing remains abandoned. Unable to locate WS outlet due to dense vegetation. Crossing has been downgraded from Urgent to Non-Urgent, no integrity issues were observed along the pipe alignment. LMA is still seeking proper abandonment or removal of this crossing. This crossing is part of the Deferred Maintenance Project (DMP) phase 1 inspection. No video inspection has been completed yet. (O. Magana - DWR UCIP) 11/18/2016 Same as last inspection. This crossing remains Urgent due to the flap gate still missing from the WS toe. According to Mike Alves, this crossing is an abandoned line and the City of Modesto is working with CVFPB to authorize proper abandonment/removal. The City is working at finding funds to pay for proper abandonment/removal of all the drainage structures through this levee. (O. Magana - DWR UCIP)10/15/2013 Flap gate has fallen off at WS toe. Appears abandoned and if so should be done so properly. (W. Wylie - DWR UCIP) FIELD_STRUCT_DESC: *ABANDONED* 24-inch corrugated metal drainage pipe through the levee, 10 feet below the crown. Flap gate on the waterside (WS) end. Drain opening is located approximately 15 feet off the landside (LS) toe. [Additional Reference(s): DWR Levee Log, 1992. USACE San Joaquin O&M Manual 6, September 1961, (HLM 0.23), Drawing No. 07-04-1555, Sheets 1555/17 and 1555/55, (Station 915+00)]. FS Date: 10/18/2018

Pipe visible in canal on WS toe.

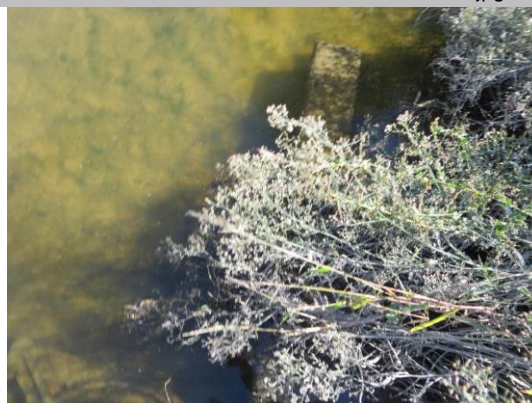
Photo 3 of 3 : UCIP_FA_2021_53431_38154.jpg

Concrete headwall under pipe at WS toe.

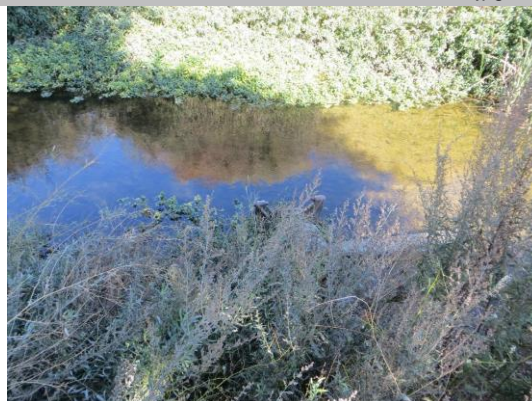
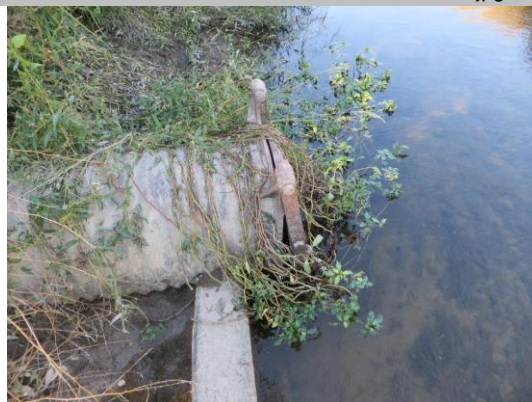
Photo 1 of 3 : UCIP_FA_2021_51639_38158.jpg

Comment Code					
Inspector Comment					
DS_ID:23161 FS_ID:51639 EP_NO: N/A Repair Type: Non-Urgent EVAL Issue: Crossing Status: Found UCIP Comments: 11/18/2016 Crossing has been downgraded from Urgent to Non-Urgent since the flap gate appears to fully close. According to Mike Alvez, this crossing is abandoned and the City of Modesto is working with CVFPB to authorize proper abandonment/removal. The City is working at finding funds to pay for proper abandonment/removal of all the drainage structures through this levee. (O. Magana - DWR UCIP)10/15/2013 Appears abandoned and if so should be done so properly. (W. Wylie - DWR UCIP) FIELD_STRUCT_DESC: *ABANDONED* 24-inch corrugated metal drainage pipe through the levee, 12 feet below the crown. Flap gate and concrete headwall on the waterside (WS) end. [Additional Reference(s): DWR Levee Log, 1992. USACE San Joaquin O&M Manual 6, September 1961, (HLM 0.64)]. FS Date: 11/18/2016

24-inch CMP on concrete headwall with flapgate on WS toe.

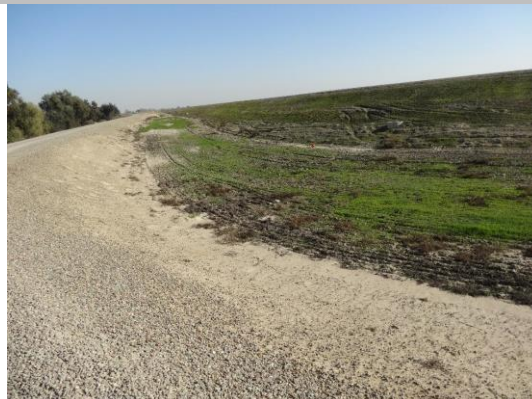
Photo 3 of 3 : UCIP_FA_2021_51639_76677.jpg

View of LS.

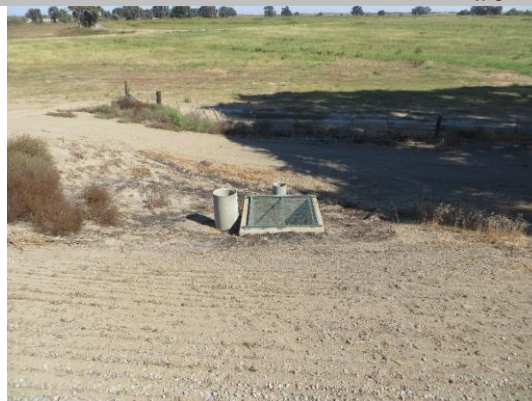
Photo 1 of 3 : UCIP_FA_2021_43209_38211.jpg

LM Start	4.59	Rating **	M	Issue No.	49	
LM End	4.59	Issue Type +	En	Location *		
Category	Supplemental			GPS Latitude/Longitude		
				Start		End
Item	DWR UCIP Field Study			37.497390 °		37.497390 °
				-121.080370 °		-121.080370 °
DWR ID	23165					
Comment Code						
Inspector Comment						
DS_ID:23165 FS_ID:43209 EP_NO: N/A Repair Type: Non-Urgent EVAL Issue: Crossing Status: Found UCIP Comments: 10/15/2013 Appears abandoned and if so should be done so properly. (P. Amatya - DWR UCIP) FIELD_STRUCT_DESC: 36-inch corrugated metal irrigation pipe through the levee, 15 feet below the crown. Abandoned concrete inlet box on the waterside (WS) slope of the levee. 6-foot by 5-foot concrete distribution box at the landside (LS) toe. [Additional Reference(s): DWR Levee Log, 1992. USACE San Joaquin O&M Manual 6, September 1961, (HLM 4.67), 30-inch pipe listed]. FS Date: 1/29/2015 2:27:42 PM

Distribution box on LS toe.

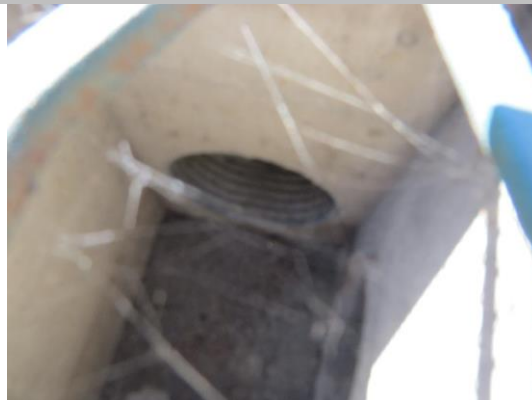
Photo 2 of 3 : UCIP_FA_2021_43209_38210.jpg

Open CMP pipe through levee at distribution box on LS toe.

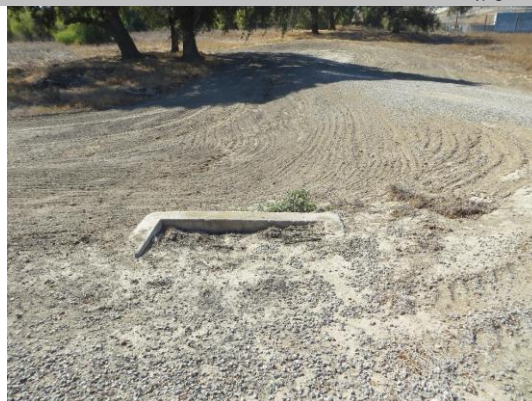
Photo 3 of 3 : UCIP_FA_2021_43209_38209.jpg

Abandoned concrete box on WS slope.

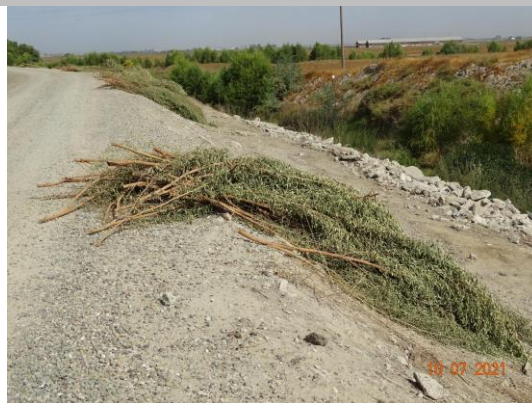
Photo 1 of 1 : FA_2021_RD2091_318_11_20211012_00019.jpg

LM Start	7.36	Rating **	M	Issue No.	11
LM End	7.45	Issue Type +	En	Location *	LS
Category	Earthen Levee			GPS Latitude/Longitude	
				Start	End
Item	Encroachments			37.480164 °	37.478954 °
				-121.045021 °	-121.044651 °
DWR ID	DWR_RD2091_01_f_2021_11				
Comment Code					
PR : Prunings					
Inspector Comment					
Pruning piles left intermittently along the landside shoulder.

Pruning piles left on the landside slope. (Fall 2021)

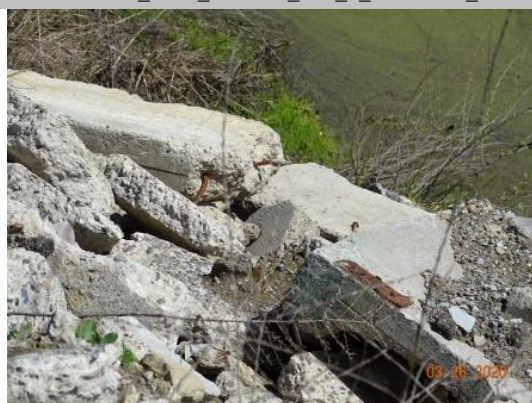
Photo 1 of 1 : FA_2021_RD2091_318_8_20210830_00001.jpg

LM Start	7.42	Rating **	A/W	Issue No.	8
LM End	7.45	Issue Type +	Ma	Location *	LS
Category	Earthen Levee			GPS Latitude/Longitude	
				Start	End
Item	Erosion / Bank Caving			37.479308 °	37.478998 °
				-121.044708 °	-121.044660 °
DWR ID	DWR_RD2091_01_s_2017_8				
Comment Code					
E1 : Note and monitor erosion site.					
Inspector Comment					
Concrete with rebar has been removed from landside slope. Some concrete with rebar remains in the drainage ditch off the landside toe.

View of rebar and other steel in the concrete rubble along the landside toe. (Spring 2020)

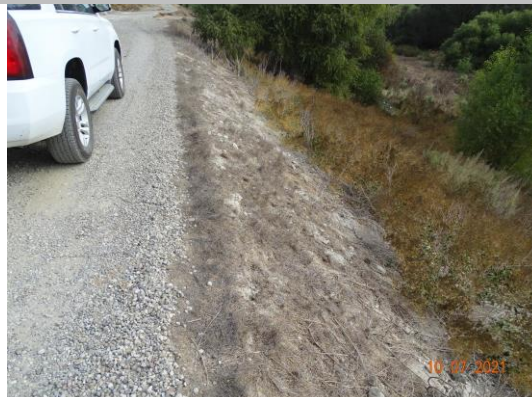
Photo 1 of 1 : FA_2021_RD2091_319_2_20211012_00004.jpg

LM Start	0.02	Rating **	A	Issue No.	2
LM End	0.02	Issue Type +	Ma	Location *	WS
Category	Earthen Levee			GPS Latitude/Longitude	
				Start	End
Item	Vegetation			37.482433 °	37.482433 °
				-121.051248 °	-121.051248 °
DWR ID	DWR_RD2091_02_f _ 2021_2				
Comment Code					
V1 : Control annual grass and weeds on the levee slopes and easements.					
Inspector Comment					
The annual vegetation is well maintained.

View of vegetation control on the waterside slope. (Fall 2021)

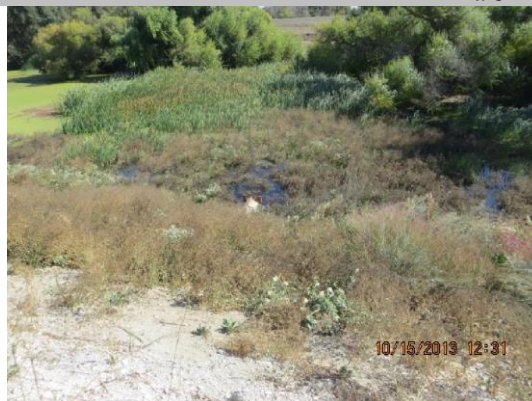
Photo 1 of 3 : UCIP_FA_2021_51390_38216.jpg

Comment Code					
Inspector Comment					
DS_ID:23175 FS_ID:51390 EP_NO: N/A Repair Type: Non-Urgent EVAL Issue: Crossing Status: Found UCIP Comments: 11/18/2016 Same as last inspection. This is a non-functional crossing with flap gate in the closed position. This crossing has been downgraded from Urgent to Non-Urgent -- no integrity issues were observed on the levee crown or slopes. According to Mike A. this crossing is abandoned and the City of Modesto is working with CVFPB to authorize proper abandonment/removal. The City is working at finding funds to pay for proper abandonment/removal of all the drainage structures through this levee. (O. Magana - DWR UCIP)10/15/2013 Flap gate rusted in-place and does not function. In closed position. (W. Wylie - DWR UCIP) FIELD_STRUCT_DESC: 24-inch corrugated metal drainage pipe through the levee, 16.4 feet below the crown. Flap gate on the waterside (WS) toe. [Additional Reference(s): DWR Levee Log, 1992]. FS Date: 11/18/2016

24-inch CMP with flapgate visible on WS toe.

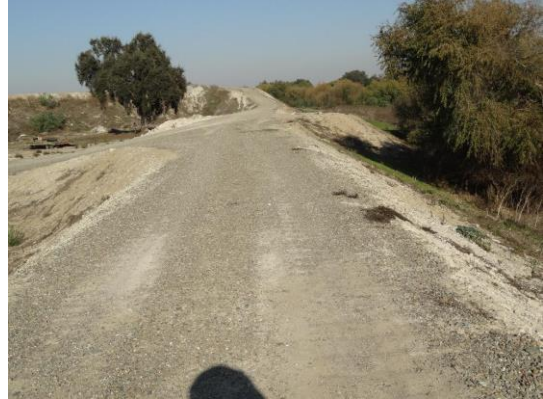
Photo 2 of 3 : UCIP_FA_2021_51390_76689.jpg

Overview photo of levee crown at crossing.

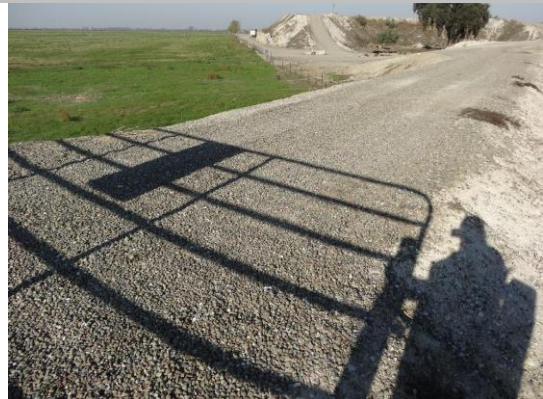
Photo 3 of 3 : UCIP_FA_2021_51390_76686.jpg

Overview of levee crown at crossing and at a distance there is a shooting range.
