**Flood Control Project Maintenance  
Levee Inspections**

**Fall 2022 Levee Maintenance Deficiency Summary Report**

**San Joaquin River Basin**

**Reclamation District No. 2091 Chase**

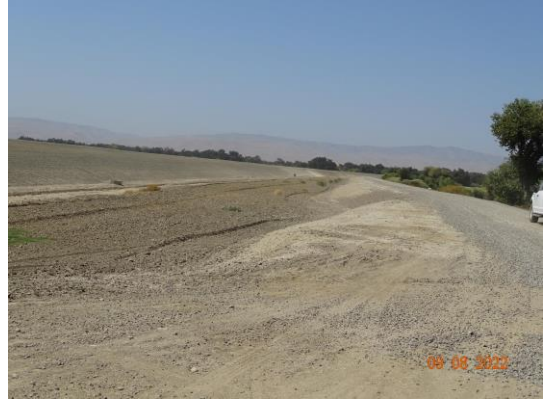
Photo 1 of 1 : FA\_2022\_RD2091\_318\_17\_20220915\_00002.jpg

LM Start	0.13	Rating **	A	Issue No.	17
LM End	0.13	Issue Type +	Ma	Location *	LS
Category	Earthen Levee			GPS Latitude/Longitude	
				Start	End
Item	Vegetation			37.541963 °	37.541963 °
				-121.094869 °	-121.094869 °
DWR ID	DWR_RD2091_01_f _ 2022_17				
Comment Code					
V1 : Control annual grass and weeds on the levee slopes and easements.					
Inspector Comment					
The annual vegetation is well maintained.

View of the landside slope looking upstream. (Fall 2022)

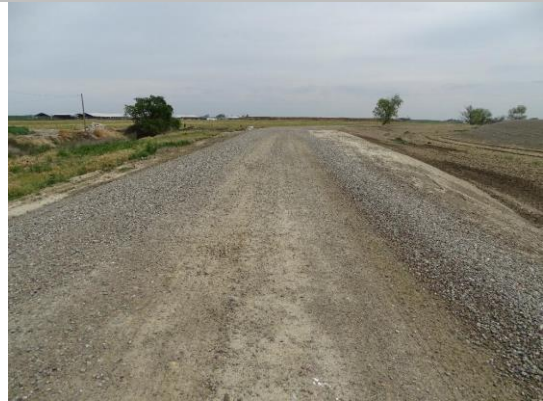
Photo 1 of 3 : UCIP\_FA\_2022\_74084\_110660.jpg

Comment Code						
Inspector Comment						
DS_ID:23157 FS_ID:74084 EP_NO: N/A Repair Type: Non-Urgent EVAL Issue: Crossing Status: Not Found UCIP Comments: 03/30/2022 Record updated from No Action Needed to Non-Urgent. Crossing not found. Geophysical study indicates possible presence of pipe through levee. Owner needs to coordinate with the CVFPB to remove or abandon crossing according to Title 23 requirements. (M.Thao - DWR UCIP)  FIELD_STRUCT_DESC: 24-inch corrugated metal drainage pipe through the levee, 7 feet below the crown. Drain off the landside (LS) toe. Flap gate on the waterside (WS). Flashboards on the LS. [Additional Reference(s): DWR Levee Log, 1992. USACE San Joaquin O&M Manual 6, September 1961, (HLM 0.13), Drawing No. 07-04-1555, Sheets 1555/17 and 1555/55, (Station 909+60)]. FS Date: 3/30/2022

Levee crown looking upstream.

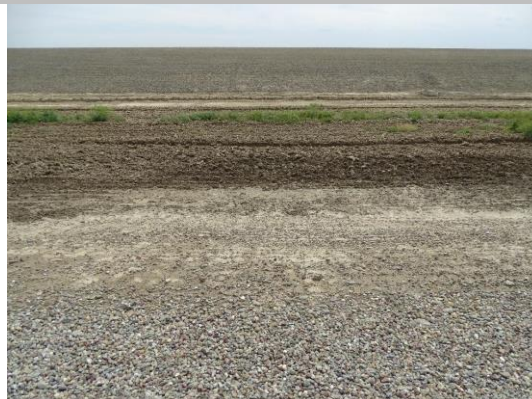
Photo 2 of 3 : UCIP\_FA\_2022\_74084\_110661.jpg

LS view: Looking from crown; general overview looking at slope of wastewater settling ponds embankment.

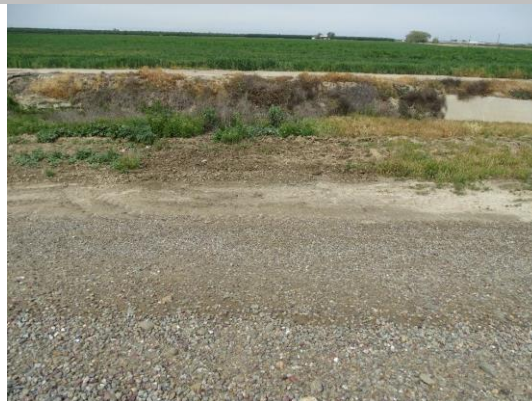
Photo 3 of 3 : UCIP\_FA\_2022\_74084\_110662.jpg

WS view: Looking from crown; general overview.

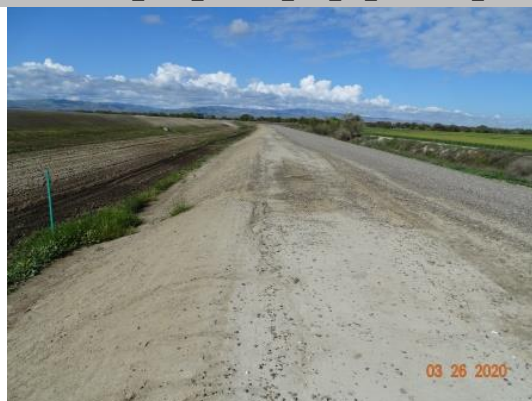
Photo 1 of 1 : FA\_2022\_RD2091\_318\_15\_20220822\_00001.jpg

LM Start	0.23	Rating **	A/W	Issue No.	15
LM End	0.23	Issue Type +	Ma	Location *	LS
Category	Earthen Levee			GPS Latitude/Longitude	
				Start	End
Item	Erosion / Bank Caving			37.541550 °	37.541550 °
				-121.096742 °	-121.096742 °
DWR ID	DWR_RD2091_01_s_2016_15				
Comment Code					
E1 : Note and monitor erosion site.					
Inspector Comment					
Caving on landward shoulder noted in 2017 possible collapsed pipe. Monitor for potential reoccurrence.

Looking west along the landside shoulder. (Spring 2020)

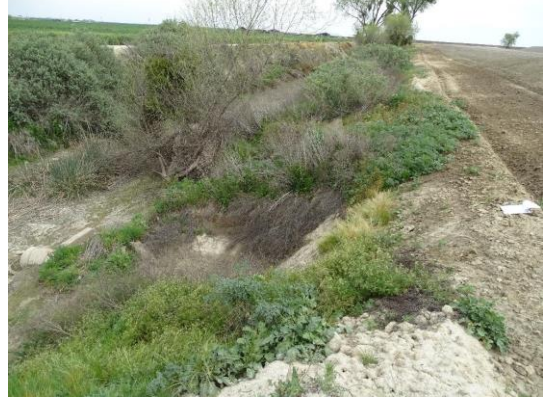
Photo 1 of 2 : UCIP\_FA\_2022\_74087\_110679.jpg

Comment Code						
Inspector Comment						
DS_ID:23158 FS_ID:74087 EP_NO: N/A Repair Type: Urgent EVAL Issue: 3a, Flood Risk Crossing Status: Found UCIP Comments: 03/30/2022 Record updated from Non-Urgent to Urgent. Flap gate has fallen off at pipe outlet on WS. More than 1/2-foot subsidence was observed on the bank slope above the pipe alignment, but appears to be outside the levee prism. Crossing appears abandoned. Recommend owner to contact CVFPB to abandon or remove pipe from levee. (M.Thao - DWR UCIP) 10/18/2018 Crossing remains abandoned. Unable to locate WS outlet due to dense vegetation. Crossing has been downgraded from Urgent to Non-Urgent, no integrity issues were observed along the pipe alignment. LMA is still seeking proper abandonment or removal of this crossing. This crossing is part of the Deferred Maintenance Project (DMP) phase 1 inspection. No video inspection has been completed yet. (O. Magana - DWR UCIP)11/18/2016 Same as last inspection. This crossing remains Urgent due to the flap gate still missing from the WS toe. According to Mike Alves, this crossing is an abandoned line and the City of Modesto is working with CVFPB to authorize proper abandonment/removal. The City is working at finding funds to pay for proper abandonment/removal of all the drainage structures through this levee. (O. Magana - DWR UCIP)10/15/2013 Flap gate has fallen off at WS toe. Appears abandoned and if so should be done so properly. (W. Wylie - DWR UCIP) FIELD_STRUCT_DESC: *ABANDONED* 24-inch corrugated metal drainage pipe through the levee, 10 feet below the crown. Flap gate on the waterside (WS) end. Drain opening is located approximately 15 feet off the landside (LS) toe. [Additional Reference(s): DWR Levee Log, 1992. USACE San Joaquin O&M Manual 6, September 1961, (HLM 0.23), Drawing No. 07-04-1555, Sheets 1555/17 and 1555/55, (Station 915+00)]. FS Date: 3/30/2022

WS view: Depression on berm above pipe alignment; headwall and outlet visible on left.

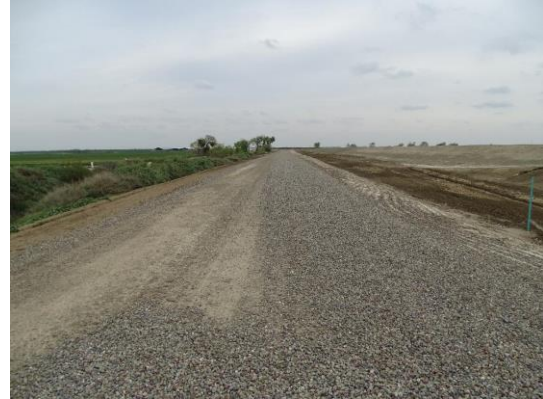
Photo 1 of 3 : UCIP\_FA\_2022\_74367\_110745.jpg

Comment Code						
Inspector Comment						
DS_ID:23160 FS_ID:74367 EP_NO: N/A Repair Type: Non-Urgent EVAL Issue: Crossing Status: Found UCIP Comments: 03/30/2022 Record updated from No Action Needed to Non-Urgent. Crossing appears abandoned. Geophysical study indicates possible presence of pipe through levee. Coordinates have been updated from 37.540948, -121.099691 to 37.540936, -121.099600. Owner needs to coordinate with the CVFPB to remove or abandon crossing according to Title 23 requirements. Recommend owner to contact CVFPB to abandon or remove pipe from levee. There was a sinkhole present on LS approximately 20 feet off levee toe located at base of the wastewater settle ponds embankment; an approximate 30-inch diameter CMP riser was observed within the sinkhole. Subsidence and erosion was observed, outside the levee prism, on WS berm slope above the pipe alignment. (M.Thao - DWR UCIP) FIELD_STRUCT_DESC: 24-inch corrugated metal drainage pipe through the levee, 10 feet below the crown. Flap gate on the waterside (WS) end. Concrete headwalls on both ends. Landside (LS) end covered with dirt. [Additional Reference(s): DWR Levee Log, 1992. USACE San Joaquin O&M Manual 6, September 1961, (HLM 0.40), Drawing No. 07-04-1555, Sheets 1555/17 and 1555/55, (Station 923+70)]. FS Date: 3/30/2022

Levee crown looking upstream.

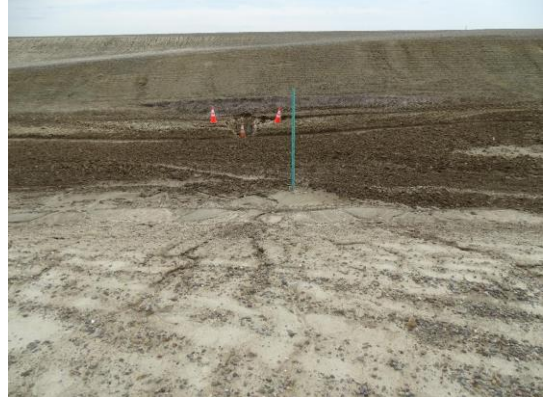
Photo 2 of 3 : UCIP\_FA\_2022\_74367\_110746.jpg

LS view: Looking from crown; sinkhole at toe of wastewater settling pond embankment.

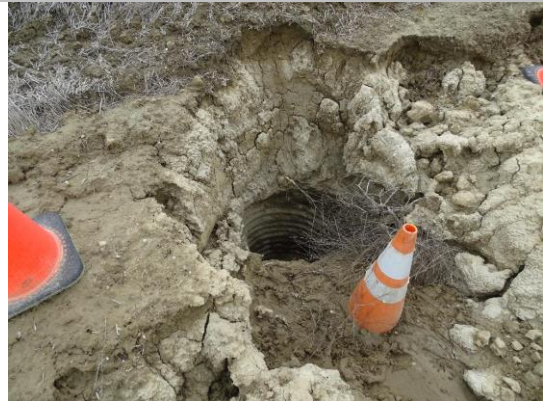
Photo 3 of 3 : UCIP\_FA\_2022\_74367\_110747.jpg

LS view: Close-up view of sink hole and CMP riser at toe of wastewater settling pond embankment.

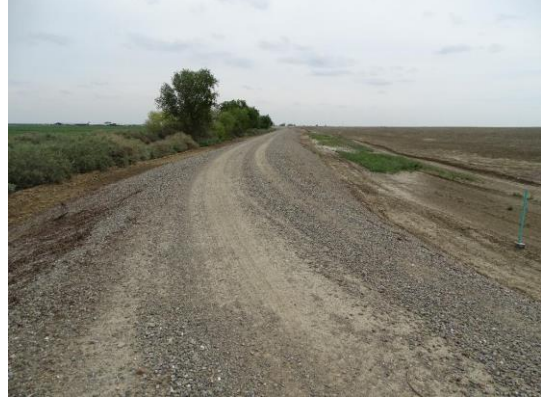
Photo 1 of 3 : UCIP\_FA\_2022\_74260\_110906.jpg

Comment Code						
Inspector Comment						
DS_ID:23161 FS_ID:74260 EP_NO: N/A Repair Type: Urgent EVAL Issue: 3a, Flood Risk Crossing Status: Found UCIP Comments: 03/30/2022 Record updated from Non-Urgent to Urgent. Flap gate is slightly opened and appears to be due to the outlet angling downward. Crossing appears abandoned. Recommend owner to contact CVFPB to abandon or remove pipe from levee. (M.Thao - DWR UCIP) 11/18/2016 Crossing has been downgraded from Urgent to Non-Urgent since the flap gate appears to fully close. According to Mike Alvez, this crossing is abandoned and the City of Modesto is working with CVFPB to authorize proper abandonment/removal. The City is working at finding funds to pay for proper abandonment/removal of all the drainage structures through this levee. (O. Magana - DWR UCIP)10/15/2013 Appears abandoned and if so should be done so properly. (W. Wylie - DWR UCIP) FIELD_STRUCT_DESC: *ABANDONED* 24-inch corrugated metal drainage pipe through the levee, 12 feet below the crown. Flap gate and concrete headwall on the waterside (WS) end. [Additional Reference(s): DWR Levee Log, 1992. USACE San Joaquin O&M Manual 6, September 1961, (HLM 0.64)]. FS Date: 3/30/2022

Levee crown looking upstream.

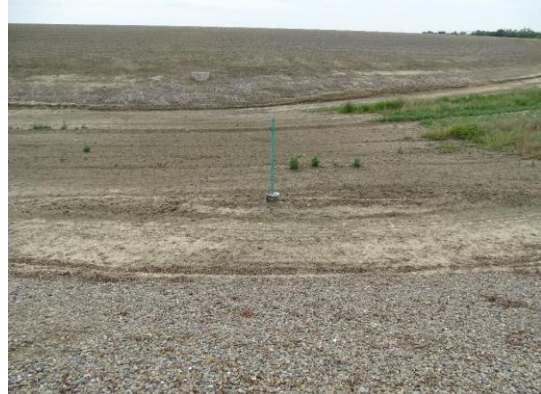
Photo 2 of 3 : UCIP\_FA\_2022\_74260\_110903.jpg

LS view: Looking from crown; general overview looking at slope of wastewater settling pond embankment.

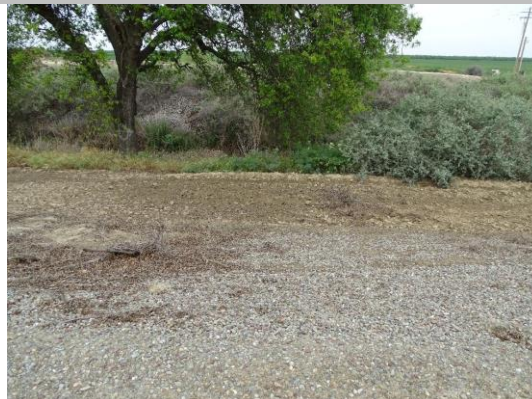
Photo 3 of 3 : UCIP\_FA\_2022\_74260\_110904.jpg

WS view: Looking from crown; general overview.

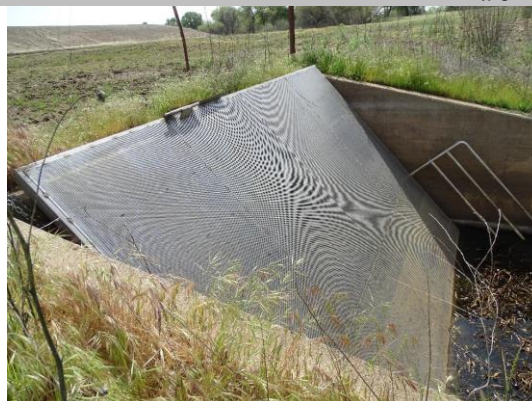
Photo 1 of 1 : UCIP\_FA\_2022\_74297\_110967.jpg

Comment Code						
Inspector Comment						
DS_ID:23162 FS_ID:74297 EP_NO: 5560 Repair Type: Non-Urgent EVAL Issue: 10, Unauthorized Modification or Non-Compliant Permit Crossing Status: Found UCIP Comments: 03/30/2022 Record updated from No Action Needed to Non-Urgent. A fish screen has been added to the concrete headwall at the WS toe; unable to find a permit for modification. (M.Thao - DWR UCIP)  FIELD_STRUCT_DESC: 1 of 3: 48-inch by 48-inch concrete treated effluent culvert through the levee, 28.5 feet below the crown. Slide gate on the waterside (WS) shoulder. Flap gate on the WS toe. (Permit No. 5560, 1967 - City of Modesto. Design drawings available in permit). [Additional Reference(s): DWR Levee Log, 1992]. FS Date: 3/30/2022

WS view: Headwall off toe; fish screen added since last inspection.

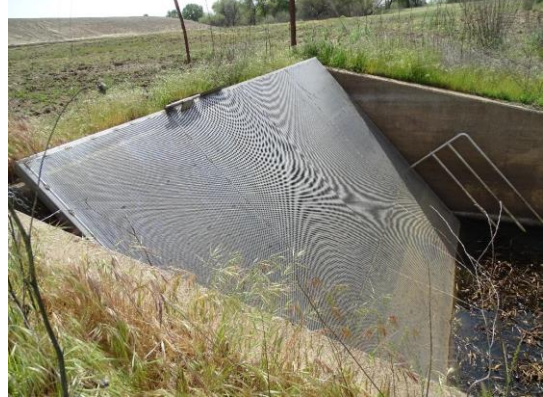
Photo 1 of 1 : UCIP\_FA\_2022\_74295\_110982.jpg

Comment Code						
Inspector Comment						
DS_ID:23171 FS_ID:74295 EP_NO: 5560 Repair Type: Non-Urgent EVAL Issue: 10, Unauthorized Modification or Non-Compliant Permit Crossing Status: Found UCIP Comments: 03/30/2022 Record updated from No Action Needed to Non-Urgent. A fish screen has been added to the concrete headwall at the WS toe; unable to find a permit for modification. All siphon breaker components appear to be present and in working order within the CMP riser. (M.Thao - DWR UCIP) 10/15/2013 Siphon breaker missing components at CMP riser on WS shoulder. (W. Wylie - DWR UCIP) FIELD_STRUCT_DESC: 3 of 3: 36-inch steel sewer pipe through the levee, 3 feet below the crown. Siphon breaker in a 24-inch corrugated metal pipe (CMP) riser on the waterside (WS) shoulder. Pump and butterfly valve off the landside (LS) toe. Concrete U-shaped headwall on the WS slope. (Permit No. 5560, 1967 - City of Modesto. Design drawings available in permit). [Additional Reference(s): DWR Levee Log, 1992]. FS Date: 3/30/2022

WS view: Concrete headwall off toe; fish screen added since last inspection.

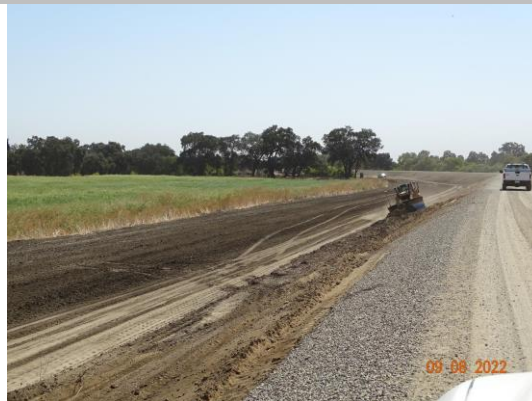
Photo 1 of 1 : FA\_2022\_RD2091\_318\_18\_20220915\_00003.jpg

LM Start	2.87	Rating **	A/W	Issue No.	18
LM End	4.43	Issue Type +	En	Location *	LS
Category	Earthen Levee			GPS Latitude/Longitude	
				Start	End
Item	Encroachments			37.518644 °	37.499551 °
				-121.089180 °	-121.080847 °
DWR ID	DWR_RD2091_01_f_2022_18				
Comment Code					
LC : Authorized Levee Construction					
Inspector Comment					
Seepage and stability berms being constructed under permit 19330 at LM 2.87-3.94, 4.5-5.01, 5.7-5.75, 6.08, and 6.38-6.88

View of construction being performed on landside of levee section. (Fall 2022)

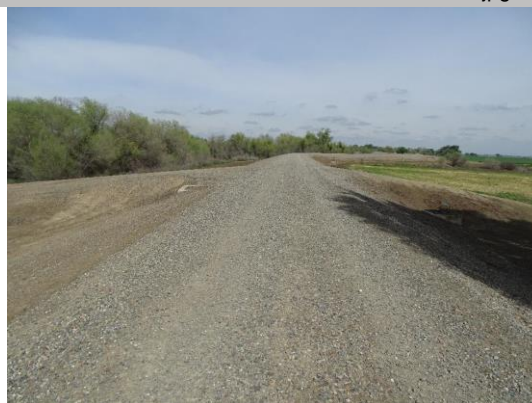
Photo 1 of 3 : UCIP\_FA\_2022\_74445\_111011.jpg

Comment Code					
Inspector Comment					
DS_ID:23165 FS_ID:74445 EP_NO: N/A Repair Type: Urgent EVAL Issue: 3a, Flood Risk Crossing Status: Found UCIP Comments: 03/30/2022 Record updated from Non-Urgent to Urgent. Crossing appears abandoned. Three pipe inlets were located on the river edge and appears to have been previously grouted and capped. Unsure if all inlets connect to the same pipe. Two capped inlets appear to be missing and opened on the WS. Unable to locate a permit and confirm proper pipe abandonment. Recommend owner to contact CVFPB to abandon or remove pipe from levee. A standpipe on the LS toe has been dismantled causing a safety hazard. (M.Thao - DWR UCIP) 10/15/2013 Appears abandoned and if so should be done so properly. (P. Amatya - DWR UCIP) FIELD_STRUCT_DESC: 36-inch corrugated metal irrigation pipe through the levee, 15 feet below the crown. Abandoned concrete inlet box on the waterside (WS) slope of the levee. 6-foot by 5-foot concrete distribution box at the landside (LS) toe. [Additional Reference(s): DWR Levee Log, 1992. USACE San Joaquin O&M Manual 6, September 1961, (HLM 4.67), 30-inch pipe listed]. FS Date: 3/30/2022

Levee crown looking downstream.

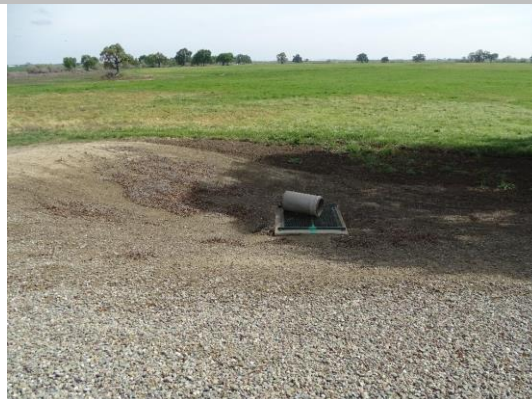
Photo 2 of 3 : UCIP\_FA\_2022\_74445\_111012.jpg

LS view: Looking from crown; distribution box on toe.

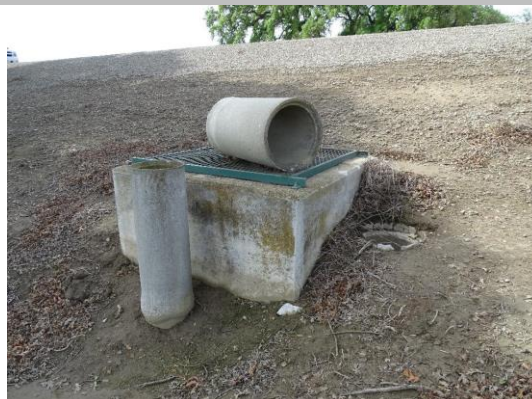
Photo 3 of 3 : UCIP\_FA\_2022\_74445\_111009.jpg

LS view: Distribution box on toe; adjacent standpipe (right) dismantled causing safety hazard.

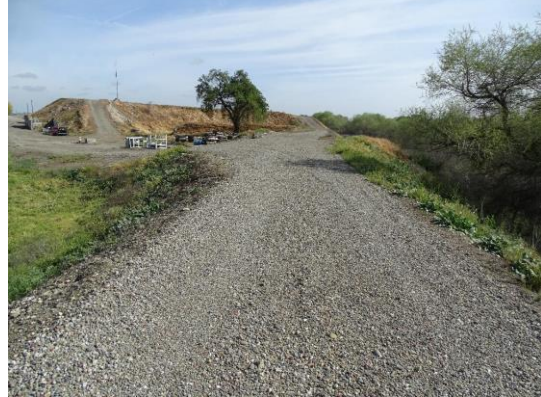
Photo 1 of 3 : UCIP\_FA\_2022\_75664\_111084.jpg

Comment Code					
Inspector Comment					
DS_ID:23175 FS_ID:75664 EP_NO: N/A Repair Type: Non-Urgent EVAL Issue: 11, Maintenance Compliance Issue Crossing Status: Found UCIP Comments: 03/30/2022 Record remains Non-Urgent. Dense vegetation prevented location of the flap gate on the WS and proper inspection of levee along pipe alignment on WS; recommend clearing vegetation. Unable to locate a permit and confirm proper pipe abandonment. Recommend owner to contact CVFPB to abandon or remove pipe from levee. (M.Thao - DWR UCIP) 11/18/2016 Same as last inspection. This is a non-functional crossing with flap gate in the closed position. This crossing has been downgraded from Urgent to Non-Urgent -- no integrity issues were observed on the levee crown or slopes. According to Mike A. this crossing is abandoned and the City of Modesto is working with CVFPB to authorize proper abandonment/removal. The City is working at finding funds to pay for proper abandonment/removal of all the drainage structures through this levee. (O. Magana - DWR UCIP)10/15/2013 Flap gate rusted in-place and does not function. In closed position. (W. Wylie - DWR UCIP) FIELD_STRUCT_DESC: 24-inch corrugated metal drainage pipe through the levee, 16.4 feet below the crown. Flap gate on the waterside (WS) toe. [Additional Reference(s): DWR Levee Log, 1992]. FS Date: 3/30/2022

Overview of levee crown.

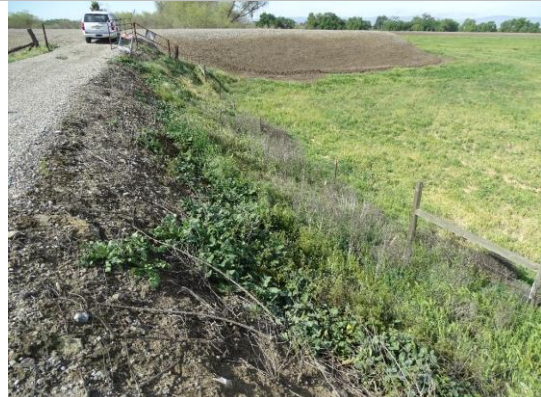
Photo 2 of 3 : UCIP\_FA\_2022\_75664\_111086.jpg

LS view: Looking from crown; general overview.
