Flood Control Project Maintenance Levee Inspections

Fall 2023 Levee Maintenance Deficiency Summary Report

San Joaquin River Basin

Reclamation District No. 2091 Chase

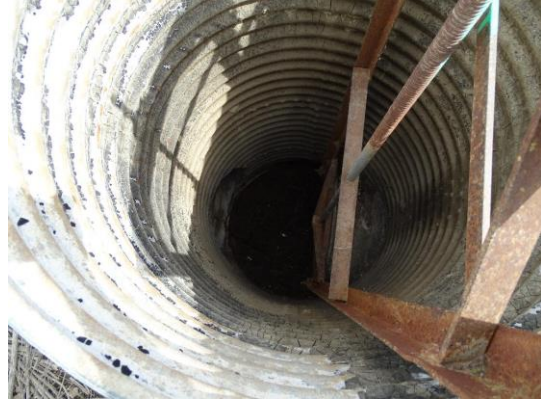
Photo 1 of 1 : UCIP_FA_2023_78558_110619.jpg

Comment Code					
Inspector Comment					
DS_ID:23155 FS_ID:78558 EP_NO: N/A Repair Type: Non-Urgent EVAL Issue: 4b, Safety Issue Crossing Status: Found UCIP Comments: 03/30/2022 Record remains Non-Urgent. No cover present on CMP riser causing a safety hazard. Crossing appears abandoned. Recommend owner to contact CVFPB to abandon or remove pipe from levee. (M.Thao - DWR UCIP) 10/15/2013 Appears abandoned and if so should be done so properly. (W. Wylie - DWR UCIP) FIELD_STRUCT_DESC: 24-inch corrugated metal drainage pipe through the levee, 7.2 feet below the crown. Slide gate in a 36-inch corrugated metal pipe (CMP) riser on the waterside (WS) slope. [Additional Reference(s): DWR Levee Log, 1992 (HLM 0.07). USACE San Joaquin O&M Manual Unit 6, September 1961, Revised 29 December 2016, (HLM 0.07), listed as 24-inch pipe. USACE As-Built Drawing No. 07-04-1555, Sheets 1555/17 and 1555/55, (Station 906+85), July 1959]. FS Date: 3/30/2022

WS view: Looking into CMP riser; no cover.

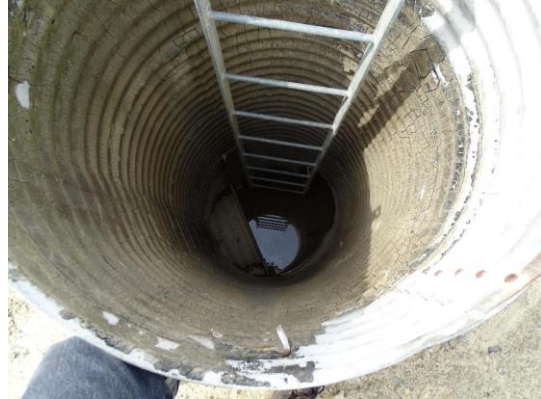
Photo 1 of 1 : UCIP_FA_2023_78559_110641.jpg

DS_ID:23156
FS_ID:78559
EP_NO: N/A
Repair Type: Non-Urgent
EVAL Issue: 4b, Safety Issue
Crossing Status: Found
UCIP Comments: 03/30/2022 Record remains Non-Urgent.
Recommend owner to contact CVFPB to abandon or remove pipe from levee. No cover was present on CMP riser causing a safety hazard.
(M.Thao - DWR UCIP)
10/18/2018 Crossing remains abandoned. Unable to locate WS outlet due to dense vegetation. Crossing has been downgraded from Urgent to Non-Urgent. No integrity issues were observed along pipe alignment. LMA is still seeking proper abandonment or removal of this crossing. Crossing is part of the Deferred Maintenance Project (DMP) phase 1 inspection. No video inspection has been completed yet. (O. Magana - DWR UCIP)11/18/2016 Same as last inspection this is a non-functional crossing with no visible inlet on LS or outlet on WS. The only appurtenance found at this location is a CMP riser with a missing cover located on the WS. This crossing remains Urgent since the pipe on the WS may still be opened. According to Mike Alves, this crossing is abandoned and the City of Modesto is working with CVFPB to authorize proper abandonment/removal. The City is working at finding funds to pay for proper abandonment/removal of all the drainage structures through this levee. (O. Magana - DWR UCIP)10/15/2013 Pipe open on WS and slide gate has been removed. Appears abandoned and should be done so properly. (W. Wylie - City of Modesto)

FIELD_STRUCT_DESC: 24-inch corrugated metal drainage pipe through the levee, 9 feet below the crown. Slide gate in a corrugated metal pipe (CMP) riser located on the waterside (WS) slope. [Additional Reference(s): DWR Levee Log, 1992 (HLM 0.10). USACE San Joaquin O&M Manual Unit 6, September 1961, Revised 29 December 2016, (HLM 0.10), listed as 24-inch pipe. USACE As-Built Drawing No. 07-04-1555, Sheets 1555/17 and 1555/55, (Station 907+55), October 1960].
FS Date: 3/30/2022

WS view: Looking into CMP riser; no cover.

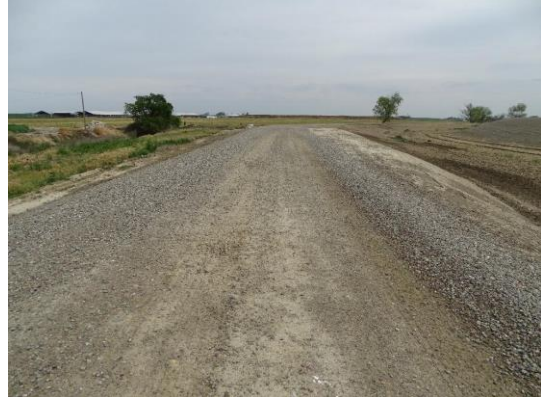
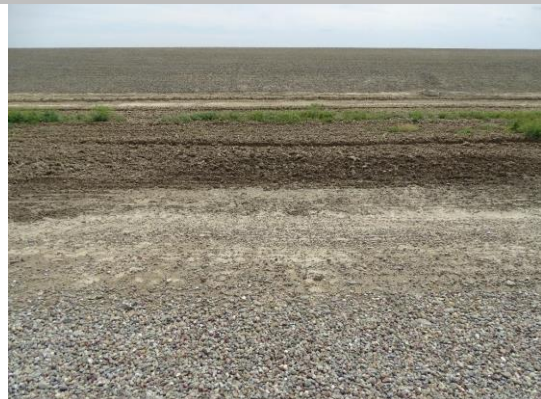
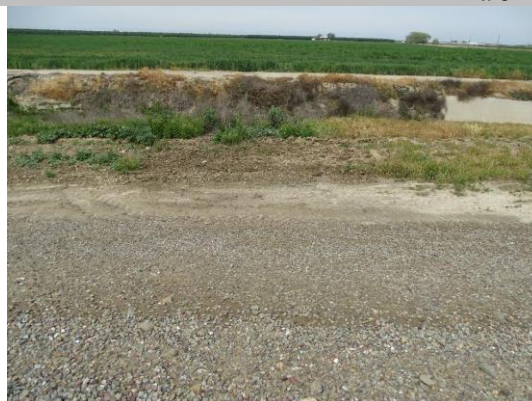
Comment Code						
Inspector Comment						
DS_ID:23157 FS_ID:80598 EP_NO: N/A Repair Type: Non-Urgent EVAL Issue: Crossing Status: Not Found UCIP Comments: 03/30/2022 Record updated from No Action Needed to Non-Urgent. Crossing not found. Geophysical study indicates possible presence of pipe through levee. Owner needs to coordinate with the CVFPB to remove or abandon crossing according to Title 23 requirements. (M.Thao - DWR UCIP) FIELD_STRUCT_DESC: 24-inch corrugated metal drainage pipe through the levee, 7 feet below the crown. Flap gate on the waterside (WS). Flashboards on the LS. [Additional Reference(s): DWR Levee Log, 1992 (HLM 0.13). USACE San Joaquin O&M Manual Unit 6, September 1961, Revised 29 December 2016, (HLM 0.13), listed as 24-inch pipe. USACE As-Built Drawing No. 07-04-1555, Sheets 1555/17 and 1555/55, (Station 909+60), April 1960]. FS Date: 3/30/2022

Levee crown looking upstream.

LS view: Looking from crown; general overview looking at slope of wastewater settling ponds embankment.

WS view: Looking from crown; general overview.

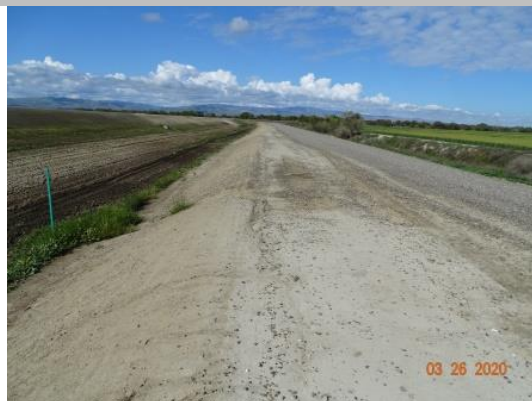
Photo 1 of 1 : FA_2023_RD2091_318_15_20231003_00001.jpg

LM Start	0.23	Rating **	A/W	Issue No.	15
LM End	0.23	Issue Type +	Ma	Location *	LS
Category	Earthen Levee			GPS Latitude/Longitude	
				Start	End
Item	Erosion / Bank Caving			37.541550°	37.541550°
				-121.096742°	-121.096742°
DWR ID	DWR_RD2091_01_s_2016_15				
Comment Code					
E1 : Note and monitor erosion site.					
Inspector Comment					
Caving on landward shoulder noted in 2017 as a possible collapsed pipe. Monitor for potential reoccurrence.

Looking west along the landside shoulder. (Spring 2020)

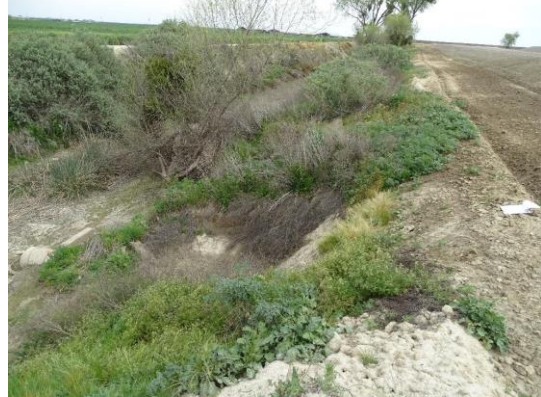
Photo 1 of 2 : UCIP_FA_2023_80647_110679.jpg

Comment Code					
Inspector Comment					
DS_ID:23158 FS_ID:80647 EP_NO: N/A Repair Type: Urgent EVAL Issue: 3a, Flood Risk Crossing Status: Found UCIP Comments: 03/30/2022 Record updated from Non-Urgent to Urgent. Flap gate has fallen off at pipe outlet on WS. More than 1/2-foot subsidence was observed on the bank slope above the pipe alignment, but appears to be outside the levee prism. Crossing appears abandoned. Recommend owner to contact CVFPB to abandon or remove pipe from levee. (M.Thao - DWR UCIP) 10/18/2018 Crossing remains abandoned. Unable to locate WS outlet due to dense vegetation. Crossing has been downgraded from Urgent to Non-Urgent, no integrity issues were observed along the pipe alignment. LMA is still seeking proper abandonment or removal of this crossing. This crossing is part of the Deferred Maintenance Project (DMP) phase 1 inspection. No video inspection has been completed yet. (O. Magana - DWR UCIP)11/18/2016 Same as last inspection. This crossing remains Urgent due to the flap gate still missing from the WS toe. According to Mike Alves, this crossing is an abandoned line and the City of Modesto is working with CVFPB to authorize proper abandonment/removal. The City is working at finding funds to pay for proper abandonment/removal of all the drainage structures through this levee. (O. Magana - DWR UCIP)10/15/2013 Flap gate has fallen off at WS toe. Appears abandoned and if so should be done so properly. (W. Wylie - DWR UCIP) FIELD_STRUCT_DESC: 24-inch corrugated metal drainage pipe through the levee, 10 feet below the crown. Flap gate on the waterside (WS) end. Pipe inlet is located approximately 15 feet off the landside (LS) toe. [Additional Reference(s): DWR Levee Log, 1992 (HLM 0.23). USACE San Joaquin O&M Manual Unit 6, September 1961, Revised 29 December 2016, (HLM 0.23), listed as 24-inch pipe. USACE As-Built Drawing No. 07-04-1555, Sheets 1555/17 and 1555/55, (Station 915+00), April 1960]. FS Date: 3/30/2022

WS view: Depression on berm above pipe alignment; headwall and outlet visible on left.

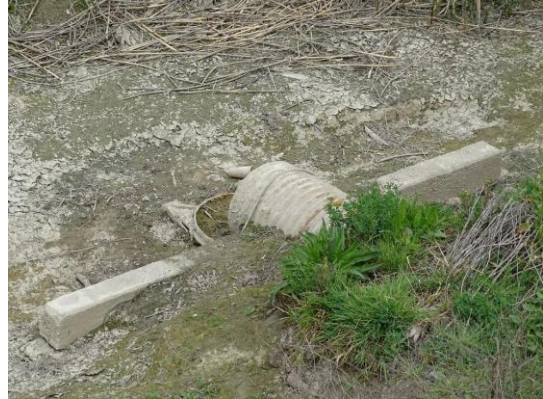
Photo 2 of 2 : UCIP_FA_2023_80647_110680.jpg

WS view: Close-up view of headwall and pipe outlet; flap gate has fallen off.

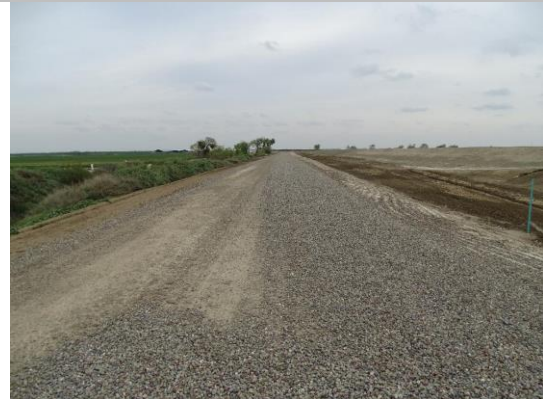
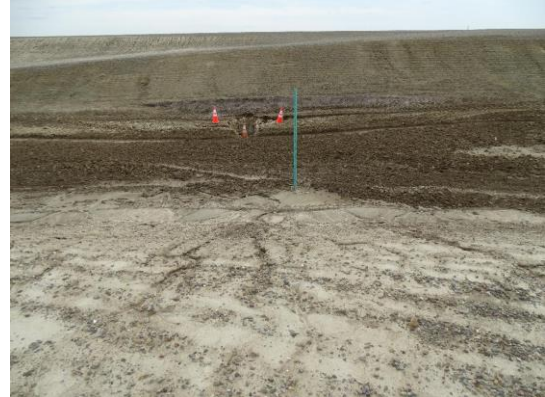
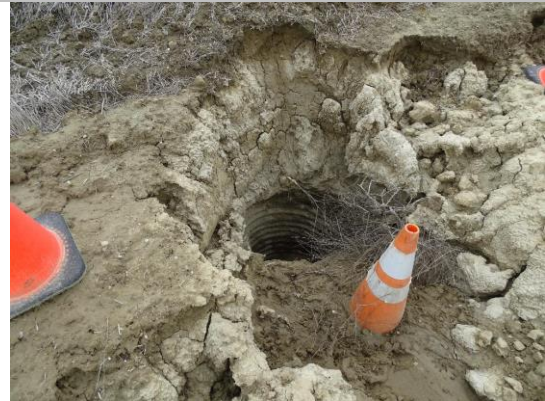
Comment Code						
Inspector Comment						
DS_ID:23160 FS_ID:80629 EP_NO: N/A Repair Type: Non-Urgent EVAL Issue: Crossing Status: Found UCIP Comments: 03/30/2022 Record updated from No Action Needed to Non-Urgent. Crossing appears abandoned. Geophysical study indicates possible presence of pipe through levee. Coordinates have been updated from 37.540948, -121.099691 to 37.540936, -121.099600. Owner needs to coordinate with the CVFPB to remove or abandon crossing according to Title 23 requirements. Recommend owner to contact CVFPB to abandon or remove pipe from levee. Material appears to have sunk into a 30-inch CMP standpipe located at the base of a wastewater settling pond embankment, which is approximately 20 feet landward of the levee toe. In addition, subsidence and erosion was observed outside the levee prism on WS berm slope above the pipe alignment. (M.Thao - DWR UCIP) FIELD_STRUCT_DESC: 24-inch corrugated metal drainage pipe through the levee, 10 feet below the crown. Flap gate on the waterside (WS) end. Concrete headwalls on both ends. Landside (LS) end covered with dirt. [Additional Reference(s): DWR Levee Log, 1992. USACE San Joaquin O&M Manual Unit 6, September 1961, Revised 29 December 2016, (HLM 0.40), listed as 24-inch pipe. USACE As-Built Drawing No. 07-04-1555, Sheets 1555/17 and 1555/55, (Station 923+70), April 1960]. FS Date: 3/30/2022

LS view: Looking from crown; sunken material at CMP standpipe located at toe of wastewater settling pond embankment.

LS view: Close-up view of sunken material at CMP standpipe located at toe of wastewater settling pond embankment.

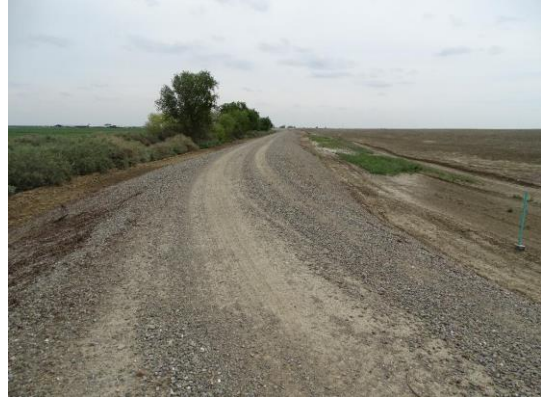
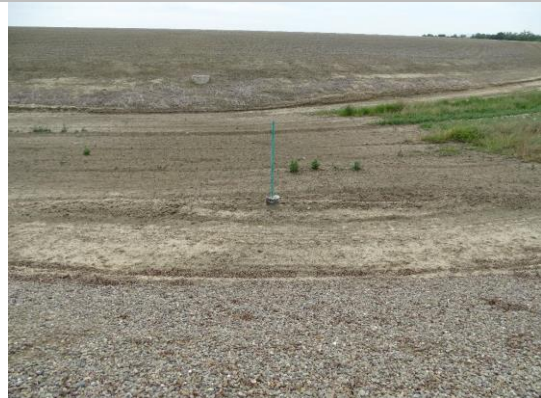
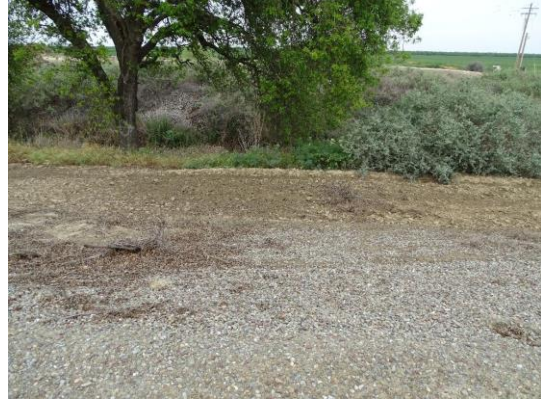
DS_ID:23161
FS_ID:78563
EP_NO: N/A
Repair Type: Urgent
EVAL Issue: 3a, Flood Risk
Crossing Status: Found
UCIP Comments: 03/30/2022 Record updated from Non-Urgent to Urgent. Flap gate is slightly opened and appears to be due to the outlet angling downward. Crossing appears abandoned. Recommend owner to contact CVFPB to abandon or remove pipe from levee. (M.Thao - DWR UCIP)
11/18/2016 Crossing has been downgraded from Urgent to Non-Urgent since the flap gate appears to fully close. According to Mike Alvez, this crossing is abandoned and the City of Modesto is working with CVFPB to authorize proper abandonment/removal. The City is working at finding funds to pay for proper abandonment/removal of all the drainage structures through this levee. (O. Magana - DWR UCIP)10/15/2013 Appears abandoned and if so should be done so properly. (W. Wylie - DWR UCIP)
FIELD_STRUCT_DESC: 24-inch corrugated metal drainage pipe through the levee, 12 feet below the crown. Flap gate and concrete headwall on the waterside (WS) end. [Additional Reference(s): DWR Levee Log, 1992 (HLM 0.64). USACE San Joaquin O&M Manual Unit 6, September 1961, Revised 29 December 2016, (HLM 0.64), listed as 24-inch pipe].

Levee crown looking upstream.

LS view: Looking from crown; general overview looking at slope of wastewater settling pond embankment.

WS view: Looking from crown; general overview.

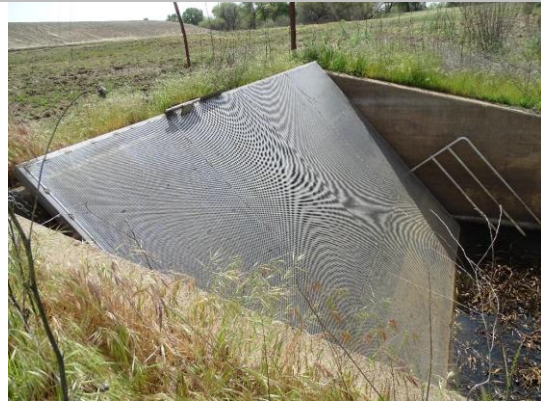
Photo 1 of 1 : UCIP_FA_2023_78541_110967.jpg

Comment Code					
Inspector Comment					
DS_ID:23162 FS_ID:78541 EP_NO: 5560 Repair Type: Non-Urgent EVAL Issue: 10, Unauthorized Modification or Non-Compliant Permit Crossing Status: Found UCIP Comments: 03/30/2022 Record updated from No Action Needed to Non-Urgent. A fish screen has been added to the concrete headwall at the WS toe; unable to find a permit for modification. (M.Thao - DWR UCIP) FIELD_STRUCT_DESC: 1 of 3: 48-inch by 48-inch concrete treated effluent culvert through the levee, 28.5 feet below the crown. Slide gate on the waterside (WS) shoulder. Flap gate on the WS toe. (Permit No. 5560, 1967 - City of Modesto. Design drawings available in permit). [Additional Reference(s): DWR Levee Log, 1992 (HLM 2.44)]. FS Date: 3/30/2022

WS view: Headwall off toe; fish screen added since last inspection.

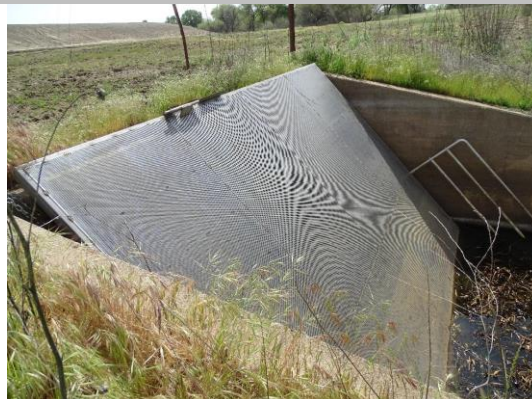
Photo 1 of 1 : UCIP_FA_2023_78542_110974.jpg

Comment Code					
Inspector Comment					
DS_ID:23163 FS_ID:78542 EP_NO: 5560 Repair Type: Non-Urgent EVAL Issue: 10, Unauthorized Modification or Non-Compliant Permit Crossing Status: Found UCIP Comments: 03/30/2022 Record updated from No Action Needed to Non-Urgent. A fish screen has been added to the concrete headwall at the WS toe; unable to find a permit for modification. (M.Thao - DWR UCIP) FIELD_STRUCT_DESC: 2 of 3: 36-inch steel sewer pipe through the levee, 3 feet below the crown. Siphon breaker in a 24-inch corrugated metal pipe (CMP) riser on the waterside (WS) shoulder. Butterfly valve next to pump off the landside (LS) toe. Concrete U-shaped headwall off the WS toe. (Permit No. 5560, 1967 - City of Modesto. Design drawings available in permit). [Additional Reference(s): DWR Levee Log, 1992 (HLM 2.44)]. FS Date: 3/30/2022

WS view: Concrete headwall off toe; fish screen added since last inspection.

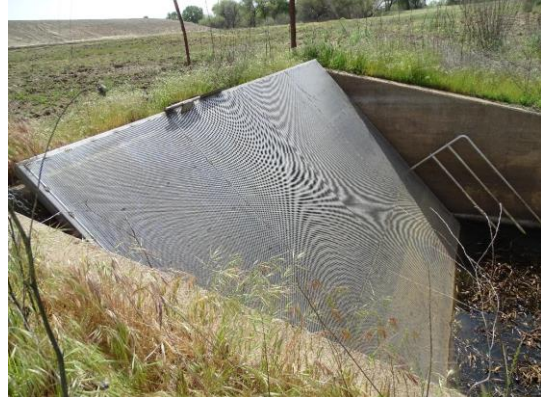
Photo 1 of 1 : UCIP_FA_2023_78543_110982.jpg

Comment Code						
Inspector Comment						
DS_ID:23171 FS_ID:78543 EP_NO: 5560 Repair Type: Non-Urgent EVAL Issue: 10, Unauthorized Modification or Non-Compliant Permit Crossing Status: Found UCIP Comments: 03/30/2022 Record updated from No Action Needed to Non-Urgent. A fish screen has been added to the concrete headwall at the WS toe; unable to find a permit for modification. All siphon breaker components appear to be present and in working order within the CMP riser. (M.Thao - DWR UCIP) 10/15/2013 Siphon breaker missing components at CMP riser on WS shoulder. (W. Wylie - DWR UCIP) FIELD_STRUCT_DESC: 3 of 3: 36-inch steel sewer pipe through the levee, 3 feet below the crown. Siphon breaker in a 24-inch corrugated metal pipe (CMP) riser on the waterside (WS) shoulder. Pump and butterfly valve off the landside (LS) toe. Concrete U-shaped headwall on the WS slope. (Permit No. 5560, 1967 - City of Modesto. Design drawings available in permit). [Additional Reference(s): DWR Levee Log, 1992 (HLM 2.44)]. FS Date: 3/30/2022

WS view: Concrete headwall off toe; fish screen added since last inspection.

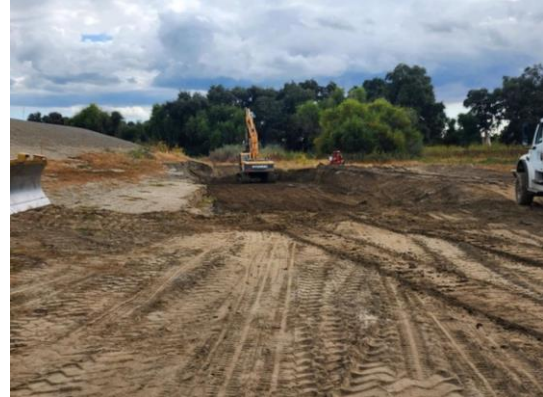
Photo 1 of 1 : FA_2023_RD2091_318_17_20231016_00023.jpg

View of erosion on the waterside toe that is currently being filled in (Fall 2023).

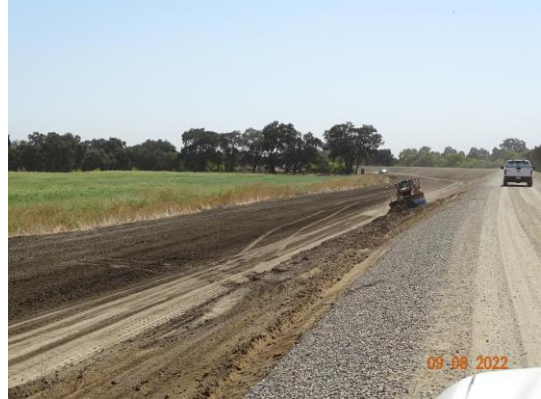
Photo 1 of 1 : FA_2023_RD2091_318_18_20231003_00002.jpg

View of construction being performed on landside of levee section. (Fall 2022)

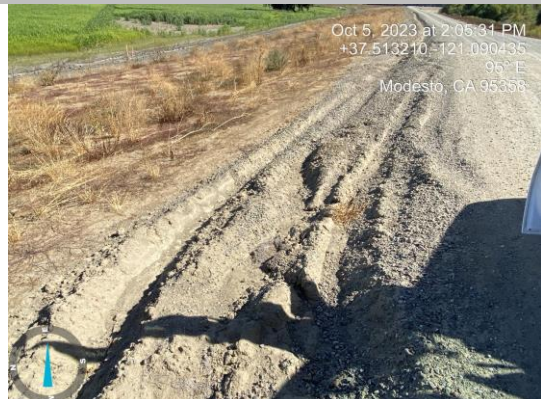
Photo 1 of 1 : FA_2023_RD2091_318_19_20231016_00022.jpg

LM Start	3.27	Rating **	M	Issue No.	19
LM End	3.27	Issue Type +	Ma	Location *	LS
Category	Earthen Levee			GPS Latitude/Longitude	
				Start	End
Item	Erosion / Vehicle Traffic			37.513133°	37.513133°
				-121.090438°	-121.090440°
DWR ID	DWR_RD2091_01_f_2023_19				
Comment Code					
E6 : Repair the levee slope damaged by vehicle traffic and prevent access where possible.					
Inspector Comment					
Vehicle ruts are located on the landside slope near the crown.

View of vehicle ruts along the landside shoulder (Fall 2023).

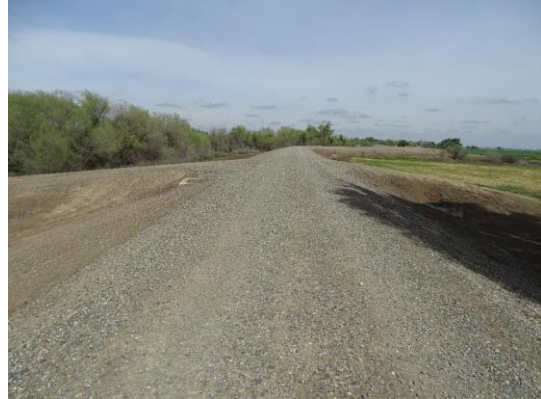
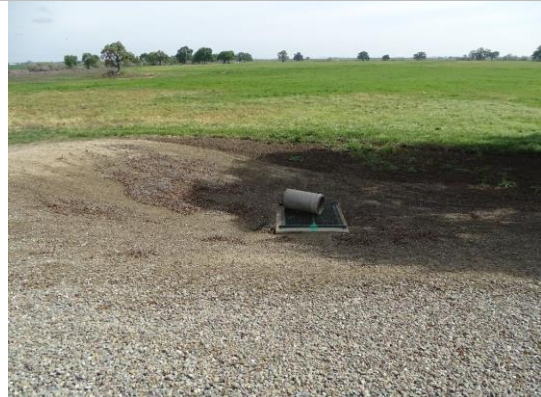
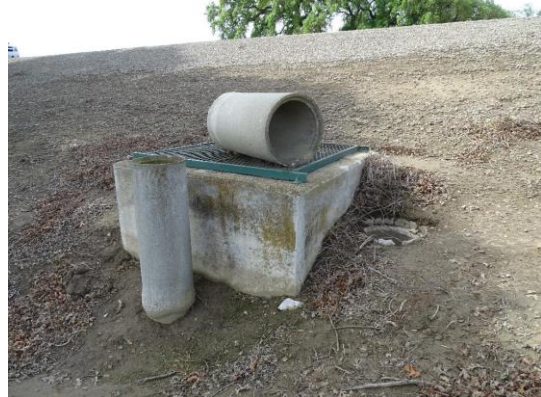
Comment Code						
Inspector Comment						
DS_ID:23165 FS_ID:78568 EP_NO: N/A Repair Type: Urgent EVAL Issue: 3a, Flood Risk Crossing Status: Found UCIP Comments: 03/30/2022 Record updated from Non-Urgent to Urgent. Crossing appears abandoned. Three pipe inlets were located on the river edge and appears to have been previously grouted and capped. Unsure if all inlets connect to the same pipe. Two capped inlets appear to be missing and opened on the WS. Unable to locate a permit and confirm proper pipe abandonment. Recommend owner to contact CVFPB to abandon or remove pipe from levee. A standpipe on the LS toe has been dismantled causing a safety hazard. (M.Thao - DWR UCIP) 10/15/2013 Appears abandoned and if so should be done so properly. (P. Amatya - DWR UCIP) FIELD_STRUCT_DESC: 36-inch corrugated metal irrigation pipe through the levee, 15 feet below the crown. Abandoned concrete inlet box on the waterside (WS) slope of the levee. 6-foot by 5-foot concrete distribution box at the landside (LS) toe. [Additional Reference(s): DWR Levee Log, 1992 (HLM 4.67). USACE San Joaquin O&M Manual Unit 6, September 1961, Revised 29 December 2016, (HLM 4.67), listed as 30-inch pipe]. FS Date: 3/30/2022

LS view: Looking from crown; distribution box on toe.

LS view: Distribution box on toe; adjacent standpipe (right) dismantled causing safety hazard.

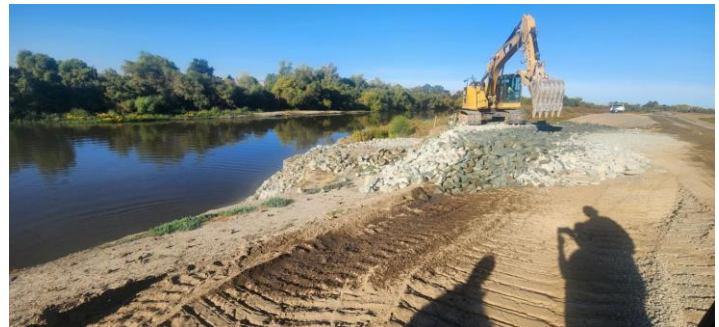
Photo 1 of 1 : FA_2023_RD2091_318_22_20231016_00024.jpg

LM Start	5.27	Rating **	A/W	Issue No.	22
LM End	5.27	Issue Type +	Ma	Location *	WS
Category	Earthen Levee			GPS Latitude/Longitude	
				Start	End
Item	Erosion / Bank Caving			37.490180°	37.490180°
				-121.072422°	-121.072422°
DWR ID	DWR_RD2091_01_f_2023_22				
Comment Code					
E1 : Note and monitor erosion site.					
Inspector Comment					
Erosion on waterside bank that has eroded into the theoretical levee prism. Owner is currently repairing the site.

View of waterside erosion being repaired (Fall 2023).

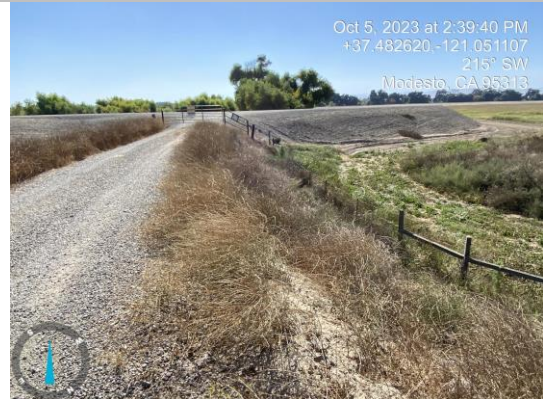
Photo 1 of 1 : FA_2023_RD2091_319_2_20231016_00004.jpg

View of landside vegetation (Fall 2023).

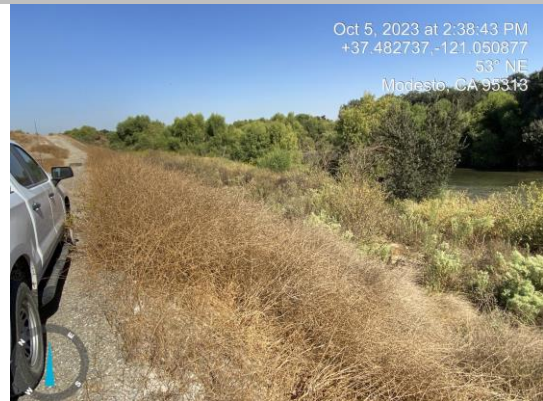
Photo 1 of 1 : FA_2023_RD2091_319_3_20231016_00005.jpg

LM Start	0.00	Rating **	U	Issue No.	3
LM End	0.05	Issue Type +	Ma	Location *	WS
Category	Earthen Levee			GPS Latitude/Longitude	
				Start	End
Item	Vegetation			37.482217°	-121.050872°
				-121.051473°	37.482760°
DWR ID	DWR_RD2091_02_f_2023_3				
Comment Code					
V1 : Control annual grass and weeds on the levee slopes and easements.					
Inspector Comment

View of waterside vegetation (Fall 2023).

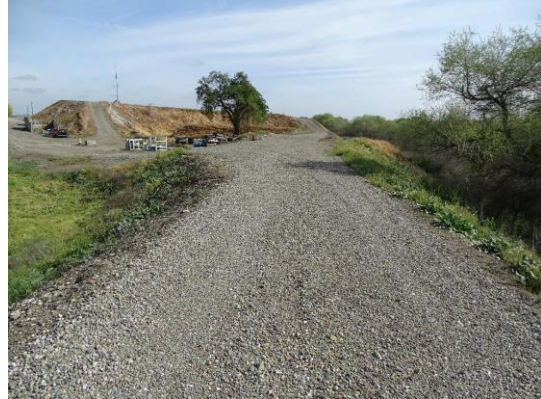
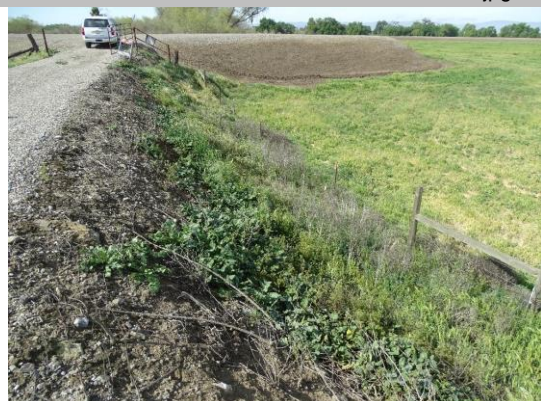
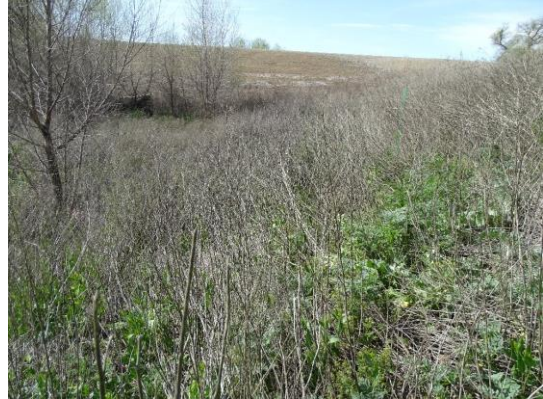
Comment Code						
Inspector Comment						
DS_ID:23175 FS_ID:78524 EP_NO: N/A Repair Type: Non-Urgent EVAL Issue: 11, Maintenance Compliance Issue Crossing Status: Found UCIP Comments: 03/30/2022 Record remains Non-Urgent. Dense vegetation prevented location of the flap gate on the WS and proper inspection of levee along pipe alignment on WS; recommend clearing vegetation. Unable to locate a permit and confirm proper pipe abandonment. Recommend owner to contact CVFPB to abandon or remove pipe from levee. (M.Thao - DWR UCIP) 11/18/2016 Same as last inspection. This is a non-functional crossing with flap gate in the closed position. This crossing has been downgraded from Urgent to Non-Urgent -- no integrity issues were observed on the levee crown or slopes. According to Mike A. this crossing is abandoned and the City of Modesto is working with CVFPB to authorize proper abandonment/removal. The City is working at finding funds to pay for proper abandonment/removal of all the drainage structures through this levee. (O. Magana - DWR UCIP)10/15/2013 Flap gate rusted in-place and does not function. In closed position. (W. Wylie - DWR UCIP) FIELD_STRUCT_DESC: 24-inch corrugated metal drainage pipe through the levee, 16.4 feet below the crown. Flap gate on the waterside (WS) toe. [Additional Reference(s): DWR Levee Log, 1992 (HLM 0.01)]. FS Date: 3/30/2022

WS view: Dense vegetation on WS; flap gate not found due to vegetation.
