Flood Control Project Maintenance Levee Inspections

Fall 2024 Levee Maintenance Deficiency Summary Report

San Joaquin River Basin

Reclamation District No. 2091 Chase

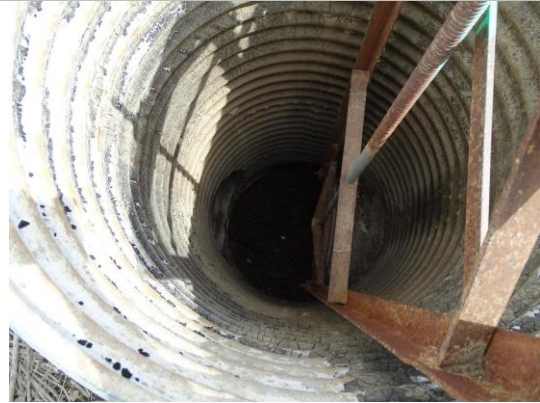
Photo 1 of 1 : UCIP_FA_2024_78558_110619.jpg

LM Start	0.08	Rating **	M	Issue No.	31	
LM End	0.08	Issue Type +	Ma	Location *		
Category	Supplemental			GPS Latitude/Longitude		
				Start	End	
Item	DWR UCIP LMA Responsibility			37.541970°	37.541970°	
				-121.093980°	-121.093980°	
DWR ID	23155

Comment Code						
Inspector Comment						
DS_ID:23155 FS_ID:78558 EP_NO: N/A Repair Type: Non-Urgent EVAL Issue: 4b, Safety Issue Crossing Status: Found UCIP Comments: 03/30/2022 Record remains Non-Urgent. No cover present on CMP riser causing a safety hazard. Crossing appears abandoned. Recommend owner to contact CVFPB to abandon or remove pipe from levee. (M.Thao - DWR UCIP) 10/15/2013 Appears abandoned and if so should be done so properly. (W. Wylie - DWR UCIP) FIELD_STRUCT_DESC: 24-inch corrugated metal drainage pipe through the levee, 7.2 feet below the crown. Slide gate in a 36-inch corrugated metal pipe (CMP) riser on the waterside (WS) slope. [Additional Reference(s): DWR Levee Log, 1992 (HLM 0.07). USACE San Joaquin O&M Manual Unit 6, September 1961, Revised 29 December 2016, (HLM 0.07), listed as 24-inch pipe. USACE As-Built Drawing No. 07-04-1555, Sheets 1555/17 and 1555/55, (Station 906+85), July 1959]. FS Date: 3/30/2022

WS view: Looking into CMP riser; no cover.

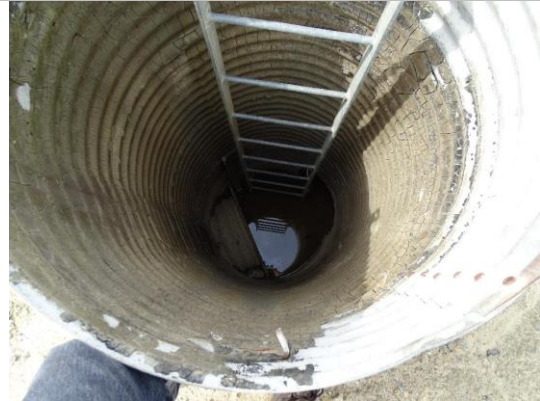
Photo 1 of 1 : UCIP_FA_2024_78559_110641.jpg

LM Start	0.10	Rating **	M	Issue No.	32
LM End	0.10	Issue Type +	Ma	Location *	
Category	Supplemental			GPS Latitude/Longitude	
				Start	End
Item	DWR UCIP LMA Responsibility			37.542030°	37.542030°
				-121.094370°	-121.094370°
DWR ID	23156

DS_ID:23156
FS_ID:78559
EP_NO: N/A
Repair Type: Non-Urgent
EVAL Issue: 4b, Safety Issue
Crossing Status: Found
UCIP Comments: 03/30/2022 Record remains Non-Urgent.
Recommend owner to contact CVFPB to abandon or remove pipe from levee. No cover was present on CMP riser causing a safety hazard.
(M.Thao - DWR UCIP)
10/18/2018 Crossing remains abandoned. Unable to locate WS outlet due to dense vegetation. Crossing has been downgraded from Urgent to Non-Urgent. No integrity issues were observed along pipe alignment. LMA is still seeking proper abandonment or removal of this crossing. Crossing is part of the Deferred Maintenance Project (DMP) phase 1 inspection. No video inspection has been completed yet. (O. Magana - DWR UCIP)11/18/2016 Same as last inspection this is a non-functional crossing with no visible inlet on LS or outlet on WS. The only appurtenance found at this location is a CMP riser with a missing cover located on the WS. This crossing remains Urgent since the pipe on the WS may still be opened. According to Mike Alves, this crossing is abandoned and the City of Modesto is working with CVFPB to authorize proper abandonment/removal. The City is working at finding funds to pay for proper abandonment/removal of all the drainage structures through this levee. (O. Magana - DWR UCIP)10/15/2013 Pipe open on WS and slide gate has been removed. Appears abandoned and should be done so properly. (W. Wylie - City of Modesto)

FIELD_STRUCT_DESC: 24-inch corrugated metal drainage pipe through the levee, 9 feet below the crown. Slide gate in a corrugated metal pipe (CMP) riser located on the waterside (WS) slope. [Additional Reference(s): DWR Levee Log, 1992 (HLM 0.10). USACE San Joaquin O&M Manual Unit 6, September 1961, Revised 29 December 2016, (HLM 0.10), listed as 24-inch pipe. USACE As-Built Drawing No. 07-04-1555, Sheets 1555/17 and 1555/55, (Station 907+55), October 1960].
FS Date: 3/30/2022

WS view: Looking into CMP riser; no cover.

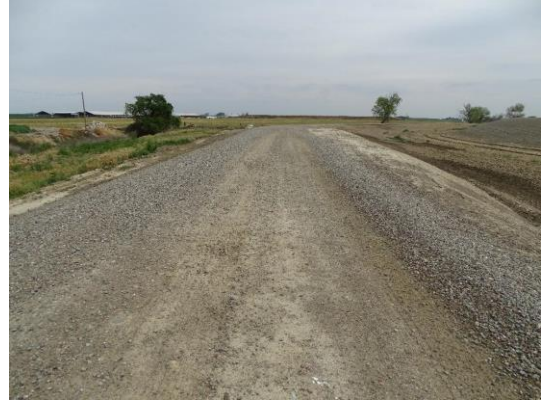
Photo 1 of 3 : UCIP_FA_2024_80598_110660.jpg

Comment Code					
Inspector Comment					
DS_ID:23157 FS_ID:80598 EP_NO: N/A Repair Type: Non-Urgent EVAL Issue: Crossing Status: Not Found UCIP Comments: 03/30/2022 Record updated from No Action Needed to Non-Urgent. Crossing not found. Geophysical study indicates possible presence of pipe through levee. Owner needs to coordinate with the CVFPB to remove or abandon crossing according to Title 23 requirements. (M.Thao - DWR UCIP) FIELD_STRUCT_DESC: 24-inch corrugated metal drainage pipe through the levee, 7 feet below the crown. Flap gate on the waterside (WS). Flashboards on the LS. [Additional Reference(s): DWR Levee Log, 1992 (HLM 0.13). USACE San Joaquin O&M Manual Unit 6, September 1961, Revised 29 December 2016, (HLM 0.13), listed as 24-inch pipe. USACE As-Built Drawing No. 07-04-1555, Sheets 1555/17 and 1555/55, (Station 909+60), April 1960]. FS Date: 3/30/2022

Levee crown looking upstream.

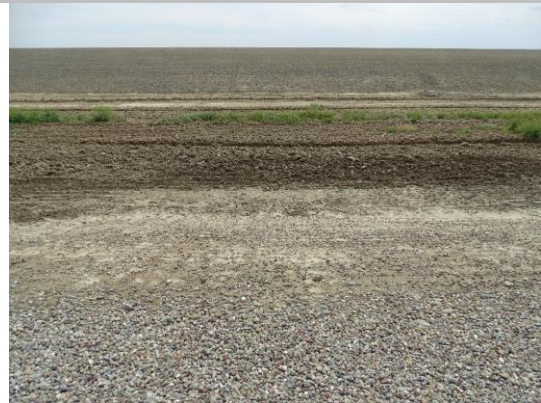
Photo 2 of 3 : UCIP_FA_2024_80598_110661.jpg

LS view: Looking from crown; general overview looking at slope of wastewater settling ponds embankment.

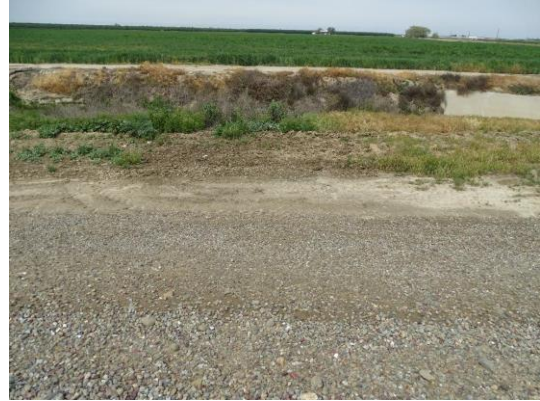
Photo 3 of 3 : UCIP_FA_2024_80598_110662.jpg

WS view: Looking from crown; general overview.

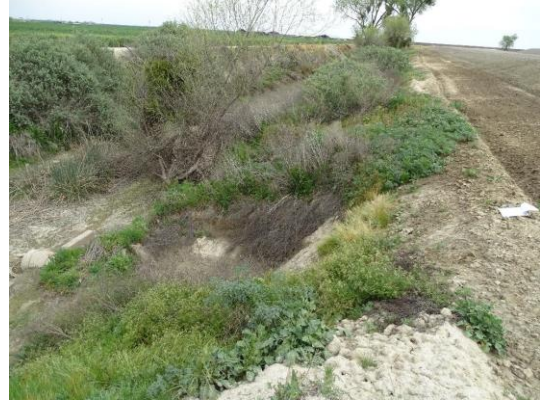
Photo 1 of 2 : UCIP_FA_2024_80647_110679.jpg

LM Start	0.24	Rating **	U	Issue No.	34	
LM End	0.24	Issue Type +	Ma	Location *		
Category	Supplemental			GPS Latitude/Longitude		
				Start	End	
Item	DWR UCIP LMA Responsibility			37.541564°	37.541564°	
				-121.096792°	-121.096792°	
DWR ID	23158

Comment Code						
Inspector Comment						
DS_ID:23158 FS_ID:80647 EP_NO: N/A Repair Type: Urgent EVAL Issue: 3a, Flood Risk Crossing Status: Found UCIP Comments: 03/30/2022 Record updated from Non-Urgent to Urgent. Flap gate has fallen off at pipe outlet on WS. More than 1/2-foot subsidence was observed on the bank slope above the pipe alignment, but appears to be outside the levee prism. Crossing appears abandoned. Recommend owner to contact CVFPB to abandon or remove pipe from levee. (M.Thao - DWR UCIP) 10/18/2018 Crossing remains abandoned. Unable to locate WS outlet due to dense vegetation. Crossing has been downgraded from Urgent to Non-Urgent, no integrity issues were observed along the pipe alignment. LMA is still seeking proper abandonment or removal of this crossing. This crossing is part of the Deferred Maintenance Project (DMP) phase 1 inspection. No video inspection has been completed yet. (O. Magana - DWR UCIP)11/18/2016 Same as last inspection. This crossing remains Urgent due to the flap gate still missing from the WS toe. According to Mike Alves, this crossing is an abandoned line and the City of Modesto is working with CVFPB to authorize proper abandonment/removal. The City is working at finding funds to pay for proper abandonment/removal of all the drainage structures through this levee. (O. Magana - DWR UCIP)10/15/2013 Flap gate has fallen off at WS toe. Appears abandoned and if so should be done so properly. (W. Wylie - DWR UCIP) FIELD_STRUCT_DESC: 24-inch corrugated metal drainage pipe through the levee, 10 feet below the crown. Flap gate on the waterside (WS) end. Pipe inlet is located approximately 15 feet off the landside (LS) toe. [Additional Reference(s): DWR Levee Log, 1992 (HLM 0.23). USACE San Joaquin O&M Manual Unit 6, September 1961, Revised 29 December 2016, (HLM 0.23), listed as 24-inch pipe. USACE As-Built Drawing No. 07-04-1555, Sheets 1555/17 and 1555/55, (Station 915+00), April 1960]. FS Date: 3/30/2022

WS view: Depression on berm above pipe alignment; headwall and outlet visible on left.

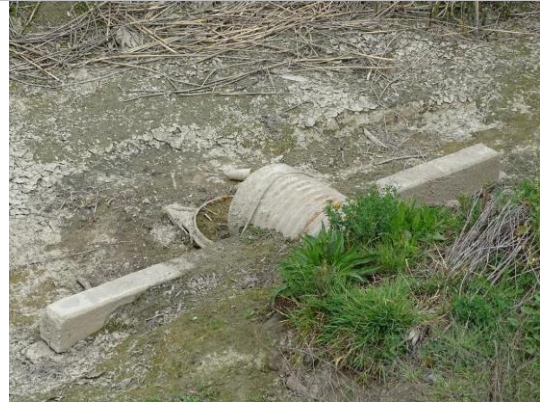
Photo 2 of 2 : UCIP_FA_2024_80647_110680.jpg

WS view: Close-up view of headwall and pipe outlet; flap gate has fallen off.

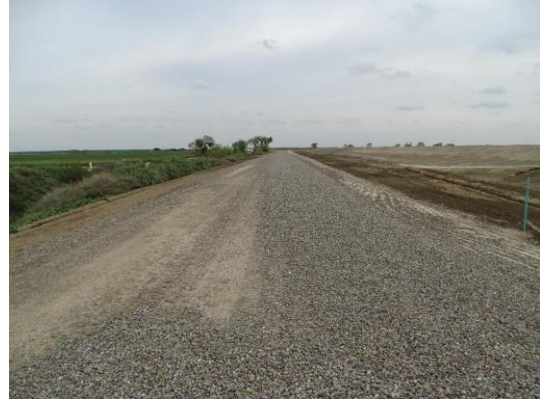
Photo 1 of 3 : UCIP_FA_2024_80629_110745.jpg

Comment Code						
Inspector Comment						
DS_ID:23160 FS_ID:80629 EP_NO: N/A Repair Type: Non-Urgent EVAL Issue: Crossing Status: Found UCIP Comments: 03/30/2022 Record updated from No Action Needed to Non-Urgent. Crossing appears abandoned. Geophysical study indicates possible presence of pipe through levee. Coordinates have been updated from 37.540948, -121.099691 to 37.540936, -121.099600. Owner needs to coordinate with the CVFPB to remove or abandon crossing according to Title 23 requirements. Recommend owner to contact CVFPB to abandon or remove pipe from levee. Material appears to have sunk into a 30-inch CMP standpipe located at the base of a wastewater settling pond embankment, which is approximately 20 feet landward of the levee toe. In addition, subsidence and erosion was observed outside the levee prism on WS berm slope above the pipe alignment. (M.Thao - DWR UCIP) FIELD_STRUCT_DESC: 24-inch corrugated metal drainage pipe through the levee, 10 feet below the crown. Flap gate on the waterside (WS) end. Concrete headwalls on both ends. Landside (LS) end covered with dirt. [Additional Reference(s): DWR Levee Log, 1992. USACE San Joaquin O&M Manual Unit 6, September 1961, Revised 29 December 2016, (HLM 0.40), listed as 24-inch pipe. USACE As-Built Drawing No. 07-04-1555, Sheets 1555/17 and 1555/55, (Station 923+70), April 1960]. FS Date: 3/30/2022

Levee crown looking upstream.

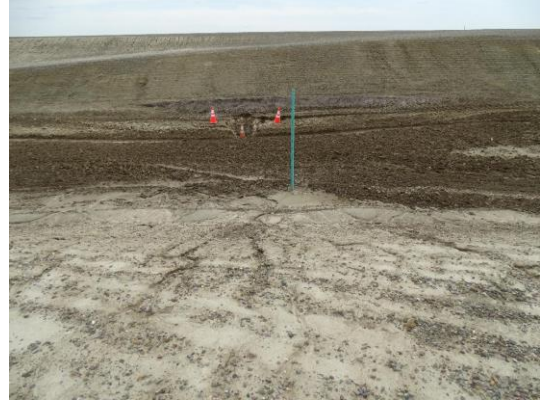
Photo 2 of 3 : UCIP_FA_2024_80629_110746.jpg

LS view: Looking from crown; sunken material at CMP standpipe located at toe of wastewater settling pond embankment.

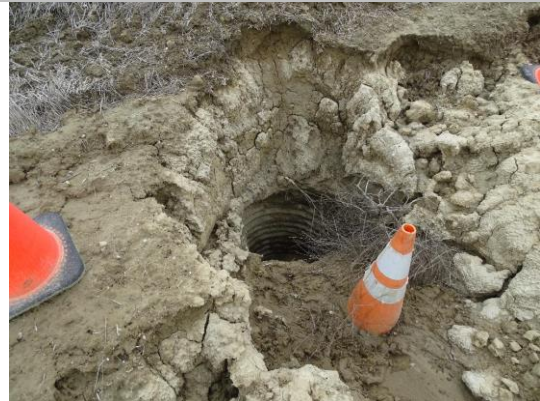
Photo 3 of 3 : UCIP_FA_2024_80629_110747.jpg

LS view: Close-up view of sunken material at CMP standpipe located at toe of wastewater settling pond embankment.

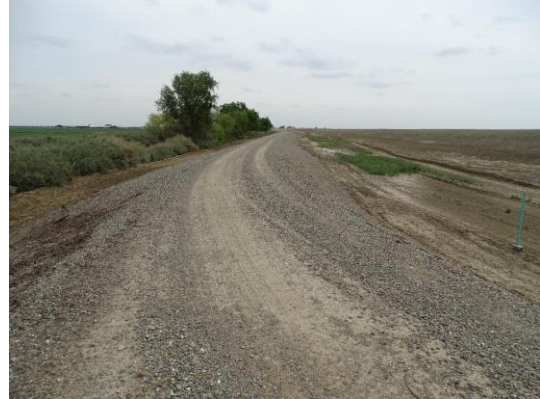
Photo 1 of 3 : UCIP_FA_2024_78563_110906.jpg

Comment Code						
Inspector Comment						
DS_ID:23161 FS_ID:78563 EP_NO: N/A Repair Type: Urgent EVAL Issue: 3a, Flood Risk Crossing Status: Found UCIP Comments: 03/30/2022 Record updated from Non-Urgent to Urgent. Flap gate is slightly opened and appears to be due to the outlet angling downward. Crossing appears abandoned. Recommend owner to contact CVFPB to abandon or remove pipe from levee. (M.Thao - DWR UCIP) 11/18/2016 Crossing has been downgraded from Urgent to Non-Urgent since the flap gate appears to fully close. According to Mike Alvez, this crossing is abandoned and the City of Modesto is working with CVFPB to authorize proper abandonment/removal. The City is working at finding funds to pay for proper abandonment/removal of all the drainage structures through this levee. (O. Magana - DWR UCIP)10/15/2013 Appears abandoned and if so should be done so properly. (W. Wylie - DWR UCIP) FIELD_STRUCT_DESC: 24-inch corrugated metal drainage pipe through the levee, 12 feet below the crown. Flap gate and concrete headwall on the waterside (WS) end. [Additional Reference(s): DWR Levee Log, 1992 (HLM 0.64). USACE San Joaquin O&M Manual Unit 6, September 1961, Revised 29 December 2016, (HLM 0.64), listed as 24-inch pipe]. FS Date: 3/30/2022

Levee crown looking upstream.

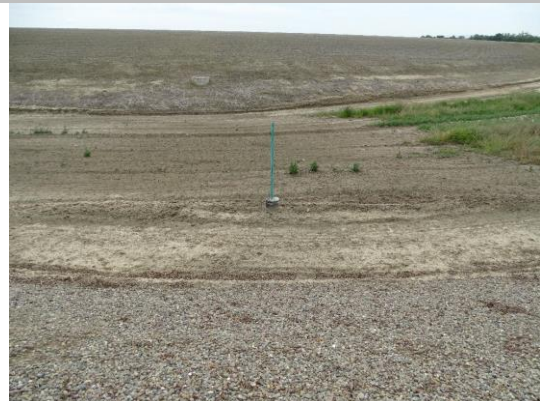
Photo 2 of 3 : UCIP_FA_2024_78563_110903.jpg

LS view: Looking from crown; general overview looking at slope of wastewater settling pond embankment.

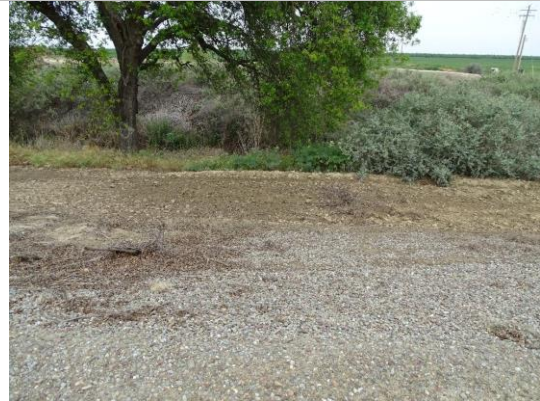
Photo 3 of 3 : UCIP_FA_2024_78563_110904.jpg

WS view: Looking from crown; general overview.

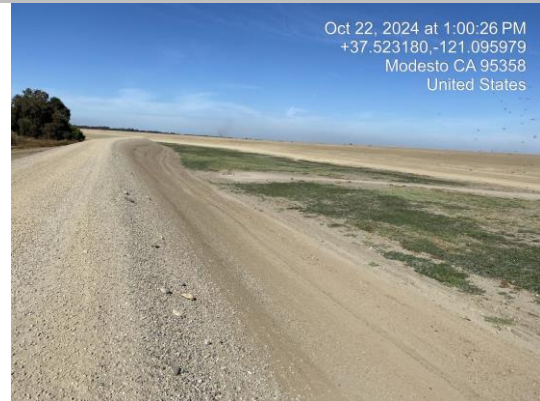
Photo 1 of 1 : FA_2024_RD2091_318_17_20241101_00026.jpg

LM Start	2.33	Rating **	A	Issue No.	17
LM End	2.33	Issue Type +	Ma	Location *	LS
Category	Earthen Levee			GPS Latitude/Longitude	
				Start	End
Item	Vegetation			37.523176°	37.523176°
				-121.095903°	-121.095903°
DWR ID	DWR_RD2091_01_f_2024_17				
Comment Code					
V1 : Control annual grass and weeds on the levee slopes and easements.					
Inspector Comment

View of good vegetation on the landside slope (Fall 2024).

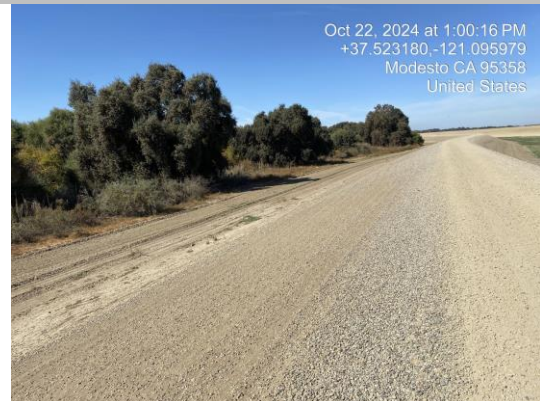
Photo 1 of 1 : FA_2024_RD2091_318_15_20241101_00027.jpg

LM Start	2.33	Rating **	A	Issue No.	15
LM End	2.33	Issue Type +	Ma	Location *	WS
Category	Earthen Levee			GPS Latitude/Longitude	
				Start	End
Item	Vegetation			37.523177°	37.523177°
				-121.095890°	-121.095890°
DWR ID	DWR_RD2091_01_f_2024_15				
Comment Code					
V1 : Control annual grass and weeds on the levee slopes and easements.					
Inspector Comment

View of good vegetation on the waterside slope (Fall 2024).

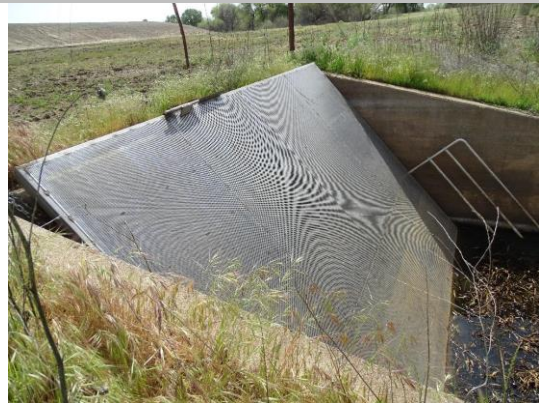
Photo 1 of 1 : UCIP_FA_2024_78541_110967.jpg

Comment Code						
Inspector Comment						
DS_ID:23162						
FS_ID:78541						
EP_NO: 5560						
Repair Type: Non-Urgent						
EVAL Issue: 10, Unauthorized Modification or Non-Compliant Permit						
Crossing Status: Found						
UCIP Comments: 03/30/2022 Record updated from No Action Needed to Non-Urgent. A fish screen has been added to the concrete headwall at the WS toe; unable to find a permit for modification. (M.Thao - DWR UCIP)						
FIELD_STRUCT_DESC: 1 of 3: 48-inch by 48-inch concrete treated effluent culvert through the levee, 28.5 feet below the crown. Slide gate on the waterside (WS) shoulder. Flap gate on the WS toe. (Permit No. 5560, 1967 - City of Modesto. Design drawings available in permit). [Additional Reference(s): DWR Levee Log, 1992 (HLM 2.44)].						
FS Date: 3/30/2022

WS view: Headwall off toe; fish screen added since last inspection.

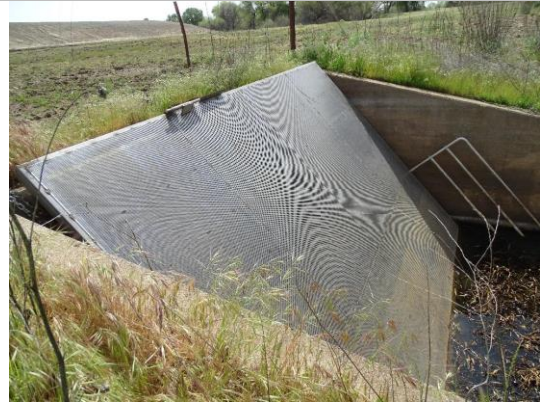
Photo 1 of 1 : UCIP_FA_2024_78542_110974.jpg

Comment Code					
Inspector Comment					
DS_ID:23163 FS_ID:78542 EP_NO: 5560 Repair Type: Non-Urgent EVAL Issue: 10, Unauthorized Modification or Non-Compliant Permit Crossing Status: Found UCIP Comments: 03/30/2022 Record updated from No Action Needed to Non-Urgent. A fish screen has been added to the concrete headwall at the WS toe; unable to find a permit for modification. (M.Thao - DWR UCIP) FIELD_STRUCT_DESC: 2 of 3: 36-inch steel sewer pipe through the levee, 3 feet below the crown. Siphon breaker in a 24-inch corrugated metal pipe (CMP) riser on the waterside (WS) shoulder. Butterfly valve next to pump off the landside (LS) toe. Concrete U-shaped headwall off the WS toe. (Permit No. 5560, 1967 - City of Modesto. Design drawings available in permit). [Additional Reference(s): DWR Levee Log, 1992 (HLM 2.44)]. FS Date: 3/30/2022

WS view: Concrete headwall off toe; fish screen added since last inspection.

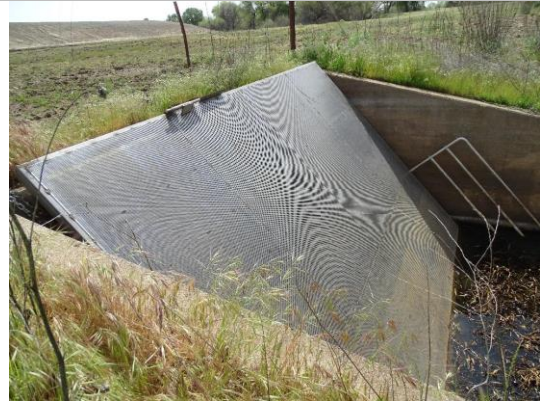
Photo 1 of 1 : UCIP_FA_2024_78543_110982.jpg

Comment Code						
Inspector Comment						
DS_ID:23171 FS_ID:78543 EP_NO: 5560 Repair Type: Non-Urgent EVAL Issue: 10, Unauthorized Modification or Non-Compliant Permit Crossing Status: Found UCIP Comments: 03/30/2022 Record updated from No Action Needed to Non-Urgent. A fish screen has been added to the concrete headwall at the WS toe; unable to find a permit for modification. All siphon breaker components appear to be present and in working order within the CMP riser. (M.Thao - DWR UCIP) 10/15/2013 Siphon breaker missing components at CMP riser on WS shoulder. (W. Wylie - DWR UCIP) FIELD_STRUCT_DESC: 3 of 3: 36-inch steel sewer pipe through the levee, 3 feet below the crown. Siphon breaker in a 24-inch corrugated metal pipe (CMP) riser on the waterside (WS) shoulder. Pump and butterfly valve off the landside (LS) toe. Concrete U-shaped headwall on the WS slope. (Permit No. 5560, 1967 - City of Modesto. Design drawings available in permit). [Additional Reference(s): DWR Levee Log, 1992 (HLM 2.44)]. FS Date: 3/30/2022

WS view: Concrete headwall off toe; fish screen added since last inspection.

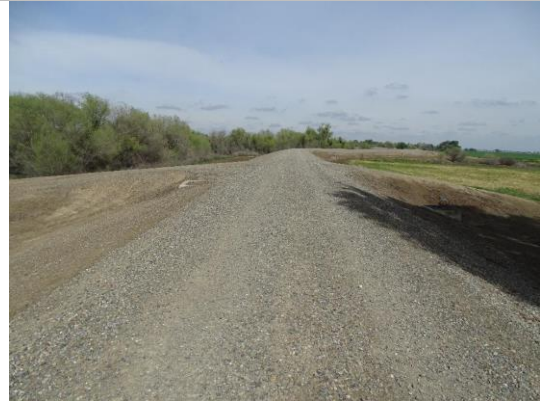
Photo 1 of 3 : UCIP_FA_2024_78568_111011.jpg

Comment Code						
Inspector Comment						
DS_ID:23165 FS_ID:78568 EP_NO: N/A Repair Type: Urgent EVAL Issue: 3a, Flood Risk Crossing Status: Found UCIP Comments: 03/30/2022 Record updated from Non-Urgent to Urgent. Crossing appears abandoned. Three pipe inlets were located on the river edge and appears to have been previously grouted and capped. Unsure if all inlets connect to the same pipe. Two capped inlets appear to be missing and opened on the WS. Unable to locate a permit and confirm proper pipe abandonment. Recommend owner to contact CVFPB to abandon or remove pipe from levee. A standpipe on the LS toe has been dismantled causing a safety hazard. (M.Thao - DWR UCIP) 10/15/2013 Appears abandoned and if so should be done so properly. (P. Amatya - DWR UCIP) FIELD_STRUCT_DESC: 36-inch corrugated metal irrigation pipe through the levee, 15 feet below the crown. Abandoned concrete inlet box on the waterside (WS) slope of the levee. 6-foot by 5-foot concrete distribution box at the landside (LS) toe. [Additional Reference(s): DWR Levee Log, 1992 (HLM 4.67). USACE San Joaquin O&M Manual Unit 6, September 1961, Revised 29 December 2016, (HLM 4.67), listed as 30-inch pipe]. FS Date: 3/30/2022

Levee crown looking downstream.

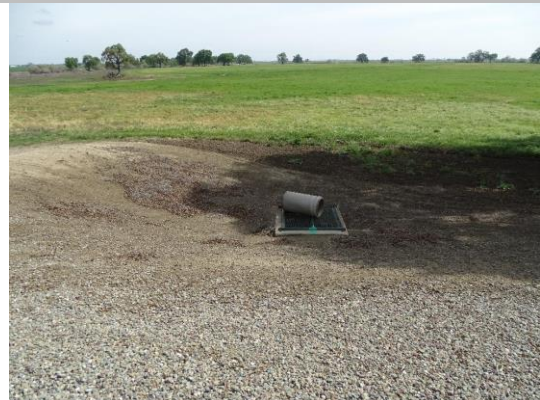
Photo 2 of 3 : UCIP_FA_2024_78568_111012.jpg

LS view: Looking from crown; distribution box on toe.

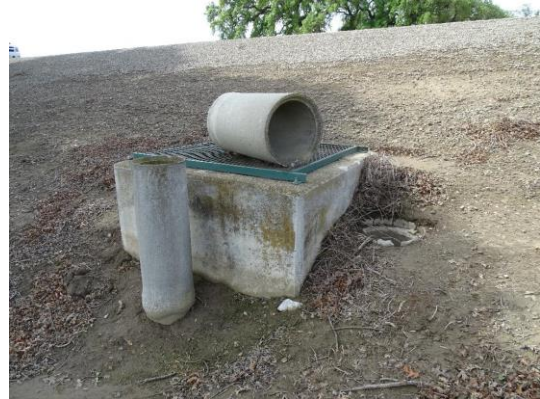
Photo 3 of 3 : UCIP_FA_2024_78568_111009.jpg

LS view: Distribution box on toe; adjacent standpipe (right) dismantled causing safety hazard.

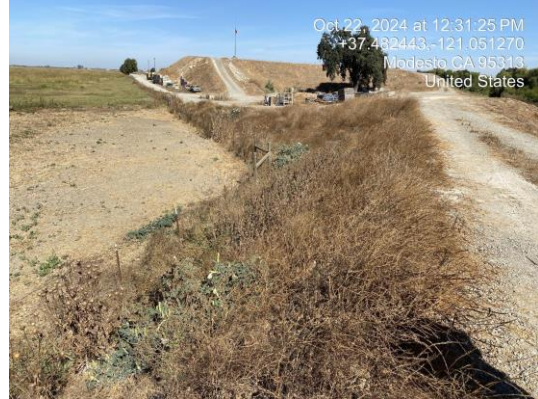
Photo 1 of 1 : FA_2024_RD2091_319_2_20241101_00004.jpg

LM Start	0.00	Rating **	U	Issue No.	2
LM End	0.05	Issue Type +	Ma	Location *	LS
Category	Earthen Levee			GPS Latitude/Longitude	
				Start	End
Item	Vegetation			37.482217°	37.482760°
				-121.051473°	-121.050872°
DWR ID	DWR_RD2091_02_f _ 2024_2				
Comment Code					
V1 : Control annual grass and weeds on the levee slopes and easements.					
Inspector Comment

View of vegetation on the landside slope and easement (Fall 2024).

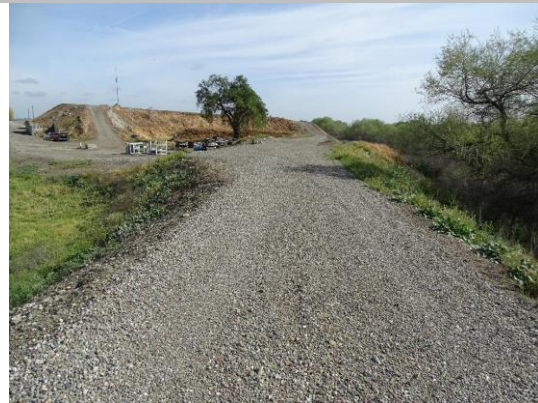
Photo 1 of 3 : UCIP_FA_2024_78524_111084.jpg

Comment Code						
Inspector Comment						
DS_ID:23175 FS_ID:78524 EP_NO: N/A Repair Type: Non-Urgent EVAL Issue: 11, Maintenance Compliance Issue Crossing Status: Found UCIP Comments: 03/30/2022 Record remains Non-Urgent. Dense vegetation prevented location of the flap gate on the WS and proper inspection of levee along pipe alignment on WS; recommend clearing vegetation. Unable to locate a permit and confirm proper pipe abandonment. Recommend owner to contact CVFPB to abandon or remove pipe from levee. (M.Thao - DWR UCIP) 11/18/2016 Same as last inspection. This is a non-functional crossing with flap gate in the closed position. This crossing has been downgraded from Urgent to Non-Urgent -- no integrity issues were observed on the levee crown or slopes. According to Mike A. this crossing is abandoned and the City of Modesto is working with CVFPB to authorize proper abandonment/removal. The City is working at finding funds to pay for proper abandonment/removal of all the drainage structures through this levee. (O. Magana - DWR UCIP)10/15/2013 Flap gate rusted in-place and does not function. In closed position. (W. Wylie - DWR UCIP) FIELD_STRUCT_DESC: 24-inch corrugated metal drainage pipe through the levee, 16.4 feet below the crown. Flap gate on the waterside (WS) toe. [Additional Reference(s): DWR Levee Log, 1992 (HLM 0.01)]. FS Date: 3/30/2022

Overview of levee crown.

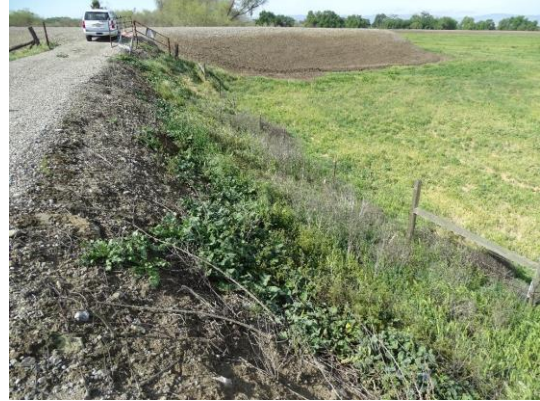
Photo 2 of 3 : UCIP_FA_2024_78524_111086.jpg

LS view: Looking from crown; general overview.

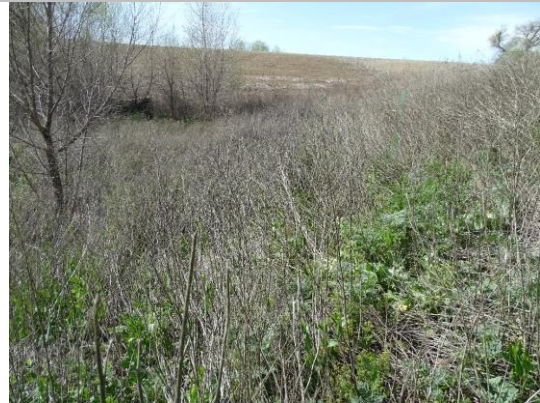
Photo 3 of 3 : UCIP_FA_2024_78524_113444.jpg

WS view: Dense vegetation on WS; flap gate not found due to vegetation.
