**Flood Control Project Maintenance  
Levee Inspections  
LMA District Cover Sheet  
Spring 2012 Levee Inspection Results**

**Reclamation District No. 2091 Chase**

**Levee Inspection Report By Mile - Spring 2012**

Waterway		Bank	Unit Miles	Inspection Start/End	Inspector
Unit No. 01 San Joaquin River		Right	7.59	04/17/2012 04/17/2012	Richard Willoughby

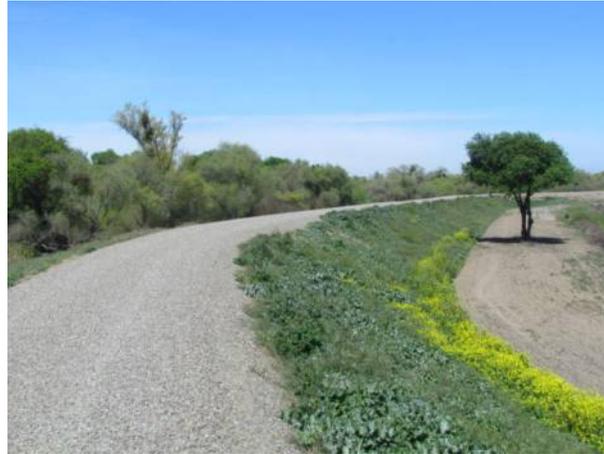
Levee Mile Report Line	4
Start Levee Mile	0.00
End Levee Mile	7.59
Location	Land Side
Category	Earthen Levee
Item	Vegetation

Looking north at typical view of levee slope.

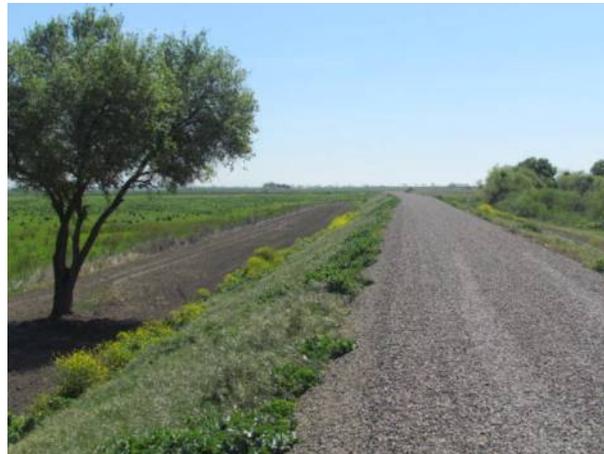
Levee Mile Report Line	5
Start Levee Mile	0.00
End Levee Mile	7.59
Location	Water Side
Category	Earthen Levee
Item	Vegetation

Looking south at typical view of levee landside slope.

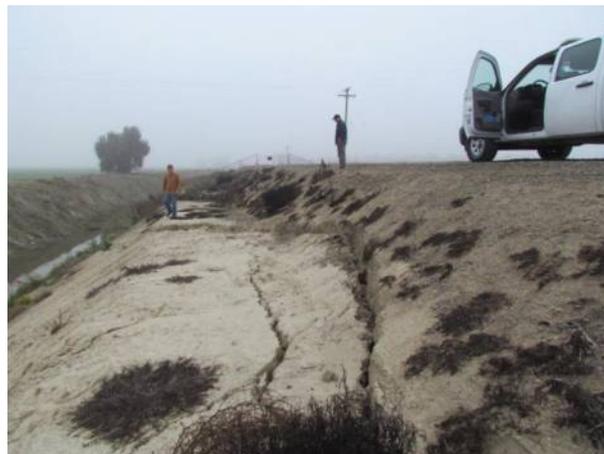
Levee Mile Report Line	8
Start Levee Mile	7.55
End Levee Mile	7.55
Location	Land Side
Category	Earthen Levee
Item	Slope Stability

Looking south at slide on landside slope next to irrigation ditch.

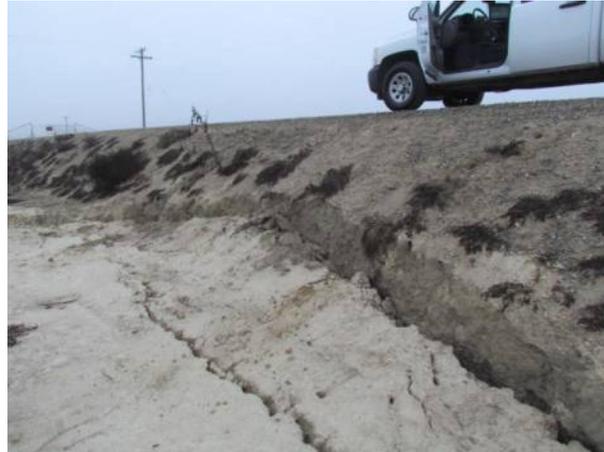
Levee Mile Report Line	8
Start Levee Mile	7.55
End Levee Mile	7.55
Location	Land Side
Category	Earthen Levee
Item	Slope Stability
Looking southwest a slide on landside slope.	
richard_s_20120313_143.jpg

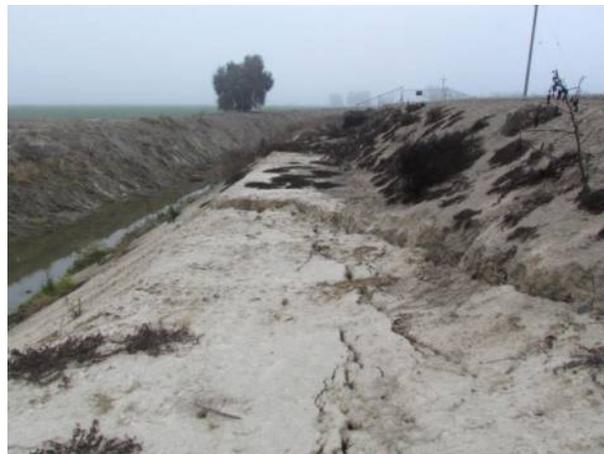
Levee Mile Report Line	8
Start Levee Mile	7.55
End Levee Mile	7.55
Location	Land Side
Category	Earthen Levee
Item	Slope Stability
Looking at south end of slide.	
richard_s_20120313_144.jpg

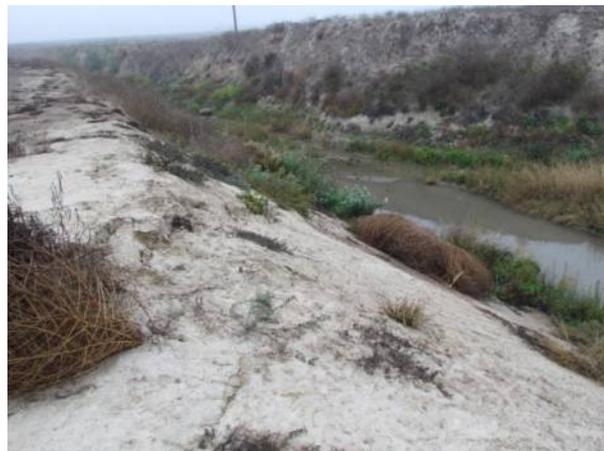
Levee Mile Report Line	8
Start Levee Mile	7.55
End Levee Mile	7.55
Location	Land Side
Category	Earthen Levee
Item	Slope Stability
Looking at north end of slide next to irrigation ditch.	
richard_s_20120313_145.jpg

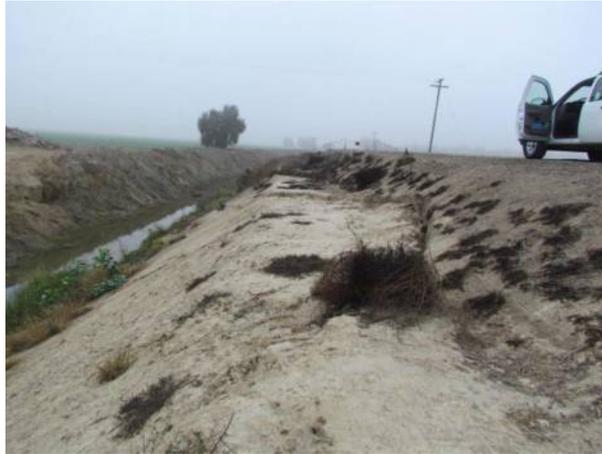
Levee Mile Report Line	8
Start Levee Mile	7.55
End Levee Mile	7.55
Location	Land Side
Category	Earthen Levee
Item	Slope Stability

Looking south at irrigation ditch at landside toe.

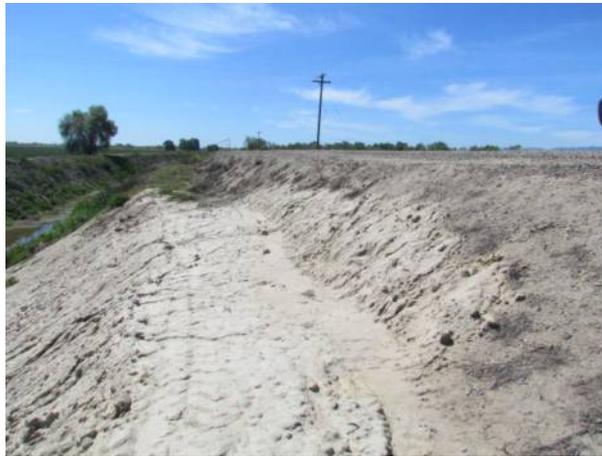
Levee Mile Report Line	8
Start Levee Mile	7.55
End Levee Mile	7.55
Location	Land Side
Category	Earthen Levee
Item	Slope Stability

Looking south at repaired erosion/slip on landside slope.

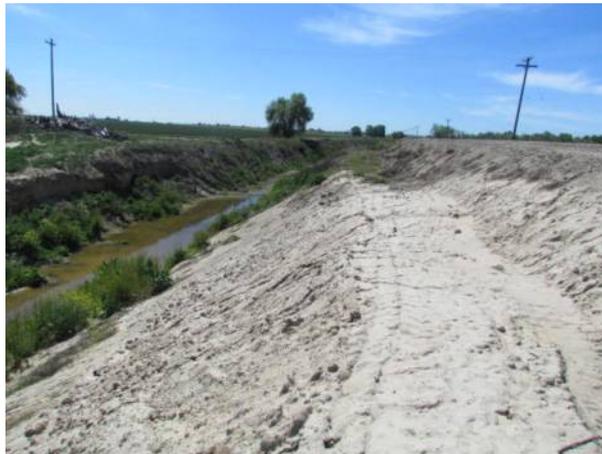
Levee Mile Report Line	8
Start Levee Mile	7.55
End Levee Mile	7.55
Location	Land Side
Category	Earthen Levee
Item	Slope Stability

Looking southeast at repaired erosion/slip on landside slope next to irrigation canal.

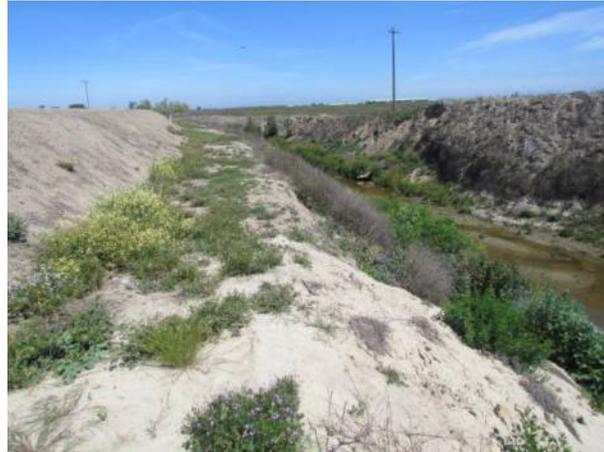
Levee Mile Report Line	8
Start Levee Mile	7.55
End Levee Mile	7.55
Location	Land Side
Category	Earthen Levee
Item	Slope Stability
Looking north at repaired erosion/slip on landside slope next to irrigation canal.	
richard_s_20120419_275.jpg

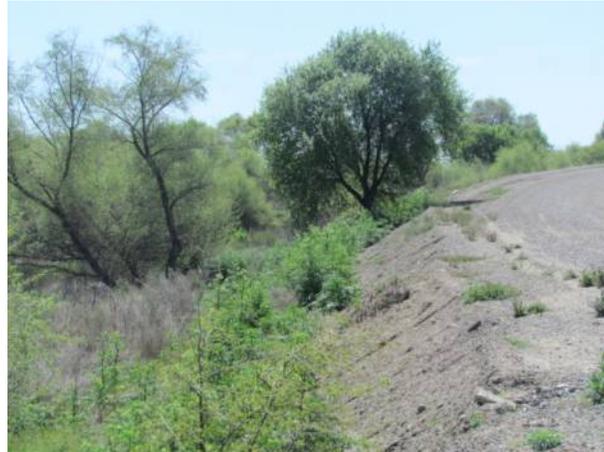
Levee Mile Report Line	2
Start Levee Mile	0.00
End Levee Mile	0.33
Location	Water Side
Category	Earthen Levee
Item	Vegetation

Looking west at typical view of levee slope.

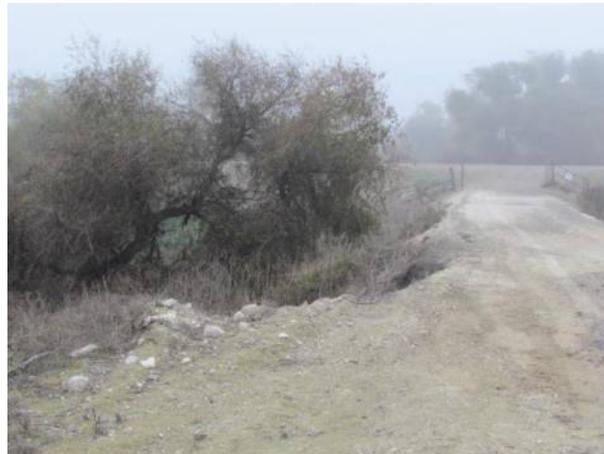
Levee Mile Report Line	3
Start Levee Mile	0.03
End Levee Mile	0.03
Location	Water Side
Category	Earthen Levee
Item	Trim / Thin Trees

Looking west at tree on waterside toe and berm.

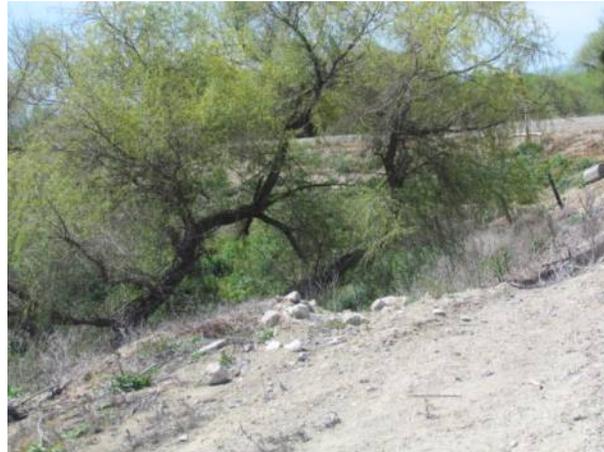
Levee Mile Report Line	3
Start Levee Mile	0.03
End Levee Mile	0.03
Location	Water Side
Category	Earthen Levee
Item	Trim / Thin Trees

Looking west at untrimmed tree on waterside slope.
