**Flood Control Project Maintenance
Levee Inspections**
LMA District Cover Sheet
Spring 2016 Levee Inspection Results

Reclamation District No. 2091 Chase

Levee Inspection Report By Mile - Spring 2016

Waterway	Bank	Unit Miles	Inspection Start/End	Inspector
Unit No. 01 San Joaquin River	Right	7.46	04/26/2016 04/26/2016	Richard Willoughby

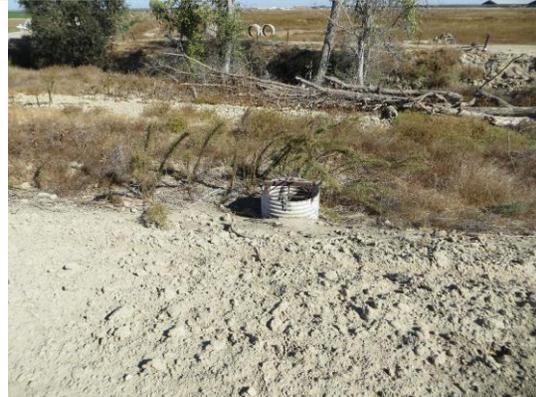
Photo 1 of 2 : UCIP_SP_2016_43207_38148.jpg

LM Start	0.08	Rating **	M	Issue No.	19
LM End	0.08	Issue Type +	En	Location *	WS
Category	Supplemental			GPS Latitude/Longitude	
				Start	End
Item	DWR UCIP Field Study			37.541970 °	37.541970 °
				-121.093980 °	-121.093980 °
DWR ID					
Comment Code					
Inspector Comment					
FS_ID:43207 DS_ID:23155 EP_NO: N/A Repair Type: Non-Urgent Crossing Status: Found UCIP Comments: Appears abandoned and if so should be done so properly. FIELD_STRUCT_DESC: 24-inch corrugated metal pipe through levee 7.2 feet below crown. Slide gate in 36-inch corrugated metal pipe riser on the waterward slope. Originally included in the 1961 O&M manual. As built drawings available, Drawing # 07-04-1555: 1555/17 & 1555/55, 906+85. FS Date: 1/29/2015 2:26:31 PM

Slide gate in 36-inch CMP riser on WS toe.

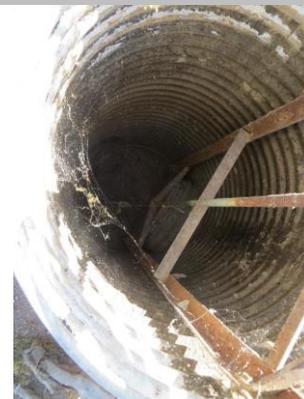
Photo 2 of 2 : UCIP_SP_2016_43207_38147.jpg

Slide gate in 36-inch CMP riser on WS toe.

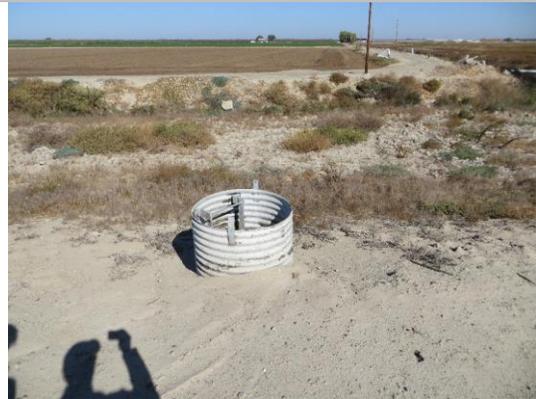
Photo 1 of 2 : UCIP_SP_2016_43204_38150.jpg

LM Start	0.10	Rating **	U	Issue No.	17
LM End	0.10	Issue Type +	En	Location *	WS
Category	Supplemental			GPS Latitude/Longitude	
				Start	End
Item	DWR UCIP Field Study			37.542030 °	37.542030 °
				-121.094370 °	-121.094370 °
DWR ID					
Comment Code					
Inspector Comment					
FS_ID:43204 DS_ID:23156 EP_NO: N/A Repair Type: Urgent Crossing Status: Found UCIP Comments: Pipe open on WS and slide gate has been removed. Appears abandoned and should be done so properly. FIELD_STRUCT_DESC: 24-inch corrugated metal pipe through levee 9.0 feet below crown. Slide gate in corrugated metal pipe riser on the waterward slope. Originally included in the 1961 O&M manual. As built drawings available, Drawing # 07-04-1555: 1555/17 & 1555/55, 907+55. FS Date: 1/29/2015 2:25:12 PM

36-inch CMP riser on WS slope.

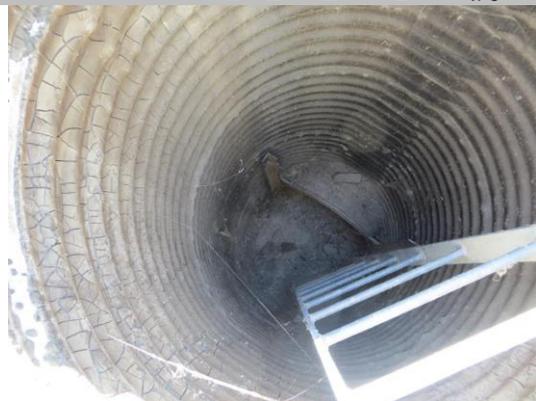
Photo 2 of 2 : UCIP_SP_2016_43204_38149.jpg

Slide gate missing from open end of pipe at WS slope.

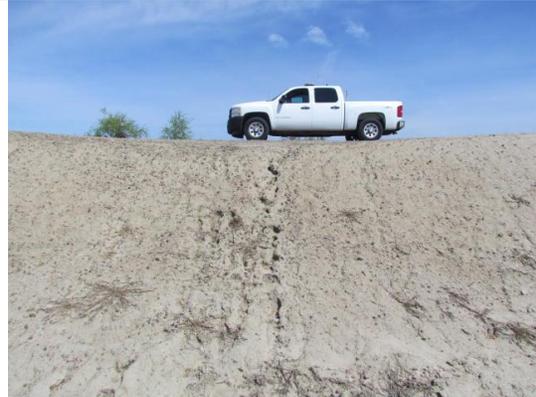
Photo 1 of 4 : SP_2016_RD2091_318_15_20160427_00022.jpg

LM Start	0.23	Rating **	U	Issue No.	15
LM End	0.23	Issue Type +	Ma	Location *	LS
Category	Earthen Levee			GPS Latitude/Longitude	
				Start	End
Item	Erosion / Bank Caving			37.541550 °	37.541550 °
				-121.096742 °	-121.096742 °
DWR ID	DWR_RD2091_01_s_2016_15				
Comment Code					
E1 : Note and monitor erosion site.					
Inspector Comment					
Caving on landward shoulder possible collapsed pipe. Caving is 34 feet long over one inch depth.

Looking west at dip on landward levee shoulder.

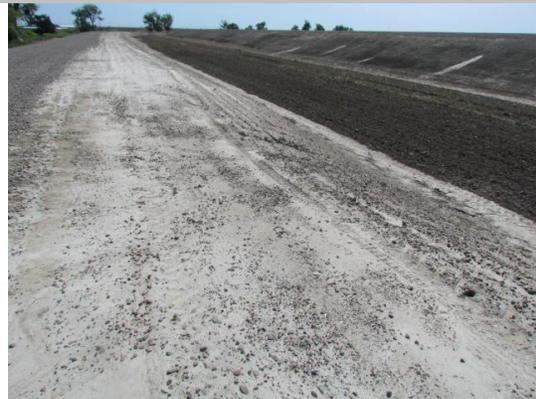
Photo 2 of 4 : SP_2016_RD2091_318_15_20160427_00020.jpg

Looking southeast at depression along landward shoulder.

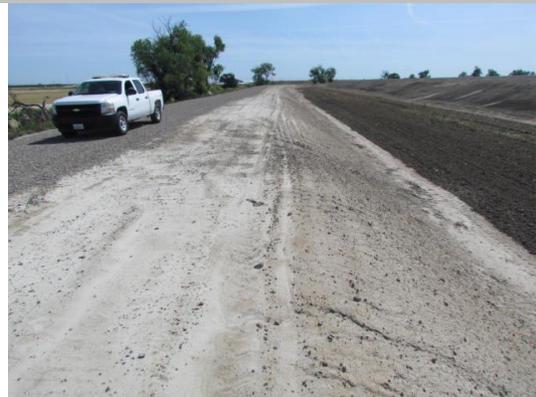
Photo 3 of 4 : SP_2016_RD2091_318_15_20160427_00021.jpg

Looking south at depression along landward shoulder.

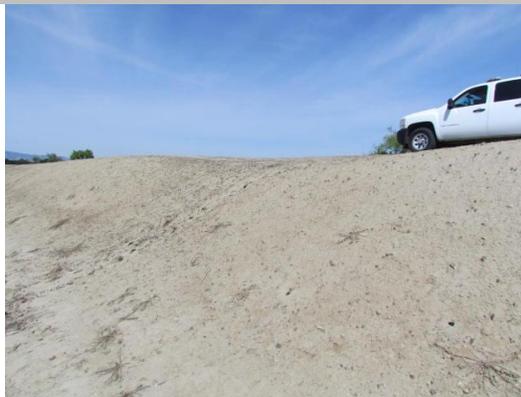
Photo 4 of 4 : SP_2016_RD2091_318_15_20160427_00023.jpg

Looking northwest at depression along landward shoulder.

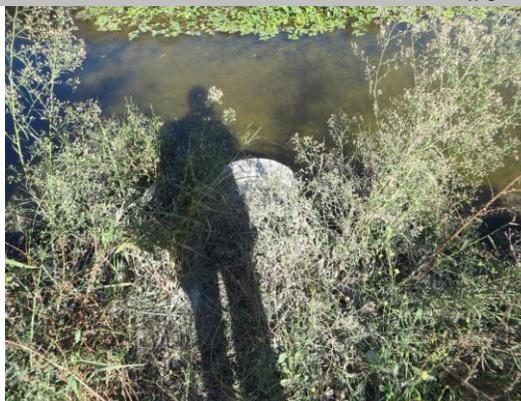
Photo 1 of 2 : UCIP_SP_2016_43205_38156.jpg

LM Start	0.24	Rating **	U	Issue No.	18
LM End	0.24	Issue Type +	En	Location *	LS
Category	Supplemental			GPS Latitude/Longitude	
				Start	End
Item	DWR UCIP Field Study			37.541564 °	37.541564 °
				-121.096792 °	-121.096792 °
DWR ID					
Comment Code					
Inspector Comment					
FS_ID:43205 DS_ID:23158 EP_NO: N/A Repair Type: Urgent Crossing Status: Found UCIP Comments: Flap gate has fallen off at WS toe. Appears abandoned and if so should be done so properly. FIELD_STRUCT_DESC: 24-inch corrugated metal pipe through levee 10.0 feet below crown. Flap gate on the waterward end. Drain opening 15 feet off landward toe. Originally included in the 1961 O&M manual. As built drawings available, Drawing # 07-04-1555: 1555/17 & 1555/55, 915+00. FS Date: 1/29/2015 2:25:43 PM

Pipe visible in canal on WS toe.

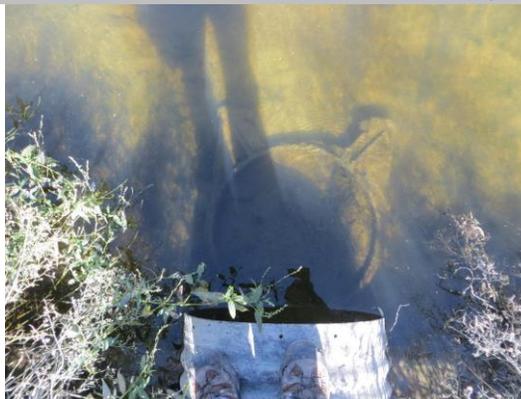
Photo 2 of 2 : UCIP_SP_2016_43205_38155.jpg

Flapgate has fallen off at WS toe.

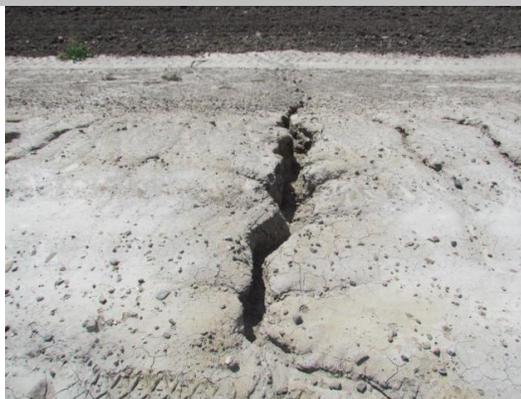
Photo 1 of 5 : SP_2016_RD2091_318_16_20160427_00026.jpg

LM Start	0.25	Rating **	M	Issue No.	16
LM End	0.28	Issue Type +	Ma	Location *	LS
Category	Earthen Levee			GPS Latitude/Longitude	
				Start	End
Item	Erosion / Bank Caving			37.541492 °	37.541408 °
				-121.097052 °	-121.097453 °
DWR ID	DWR_RD2091_01_s_2016_16				
Comment Code					
E1 : Note and monitor erosion site.					
Inspector Comment					
Several fringer erosions and possible rodent holes along landward shoulder and slope.

Looking east at fringer erosion on landward slope.

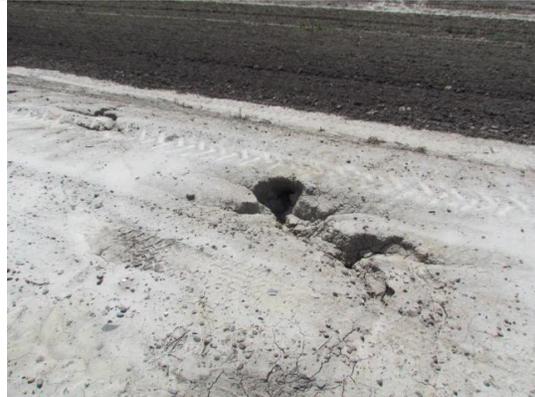
Photo 2 of 5 : SP_2016_RD2091_318_16_20160427_00024.jpg

Looking east at fringer erosion and possible rodent hole on landward slope.

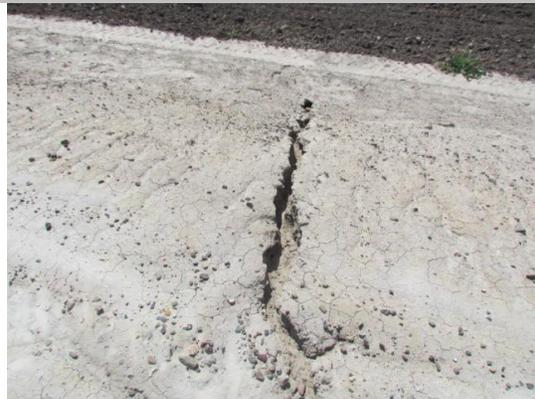
Photo 3 of 5 : SP_2016_RD2091_318_16_20160427_00027.jpg

Looking east at fringer erosion on landward slope.

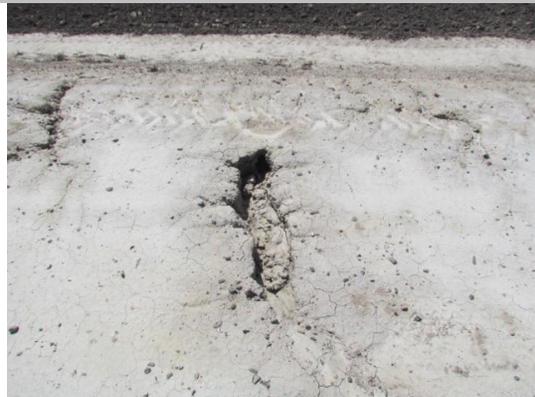
Photo 4 of 5 : SP_2016_RD2091_318_16_20160427_00025.jpg

Looking east at fringer erosion and possible rodent hole on landward slope.

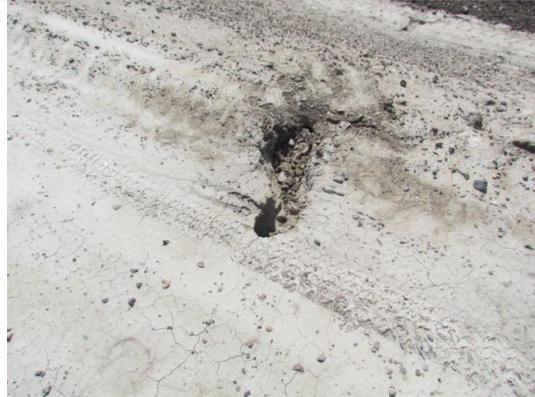
Photo 5 of 5 : SP_2016_RD2091_318_16_20160427_00028.jpg

Looking east at erosion and possible rodent hole on landward shoulder.

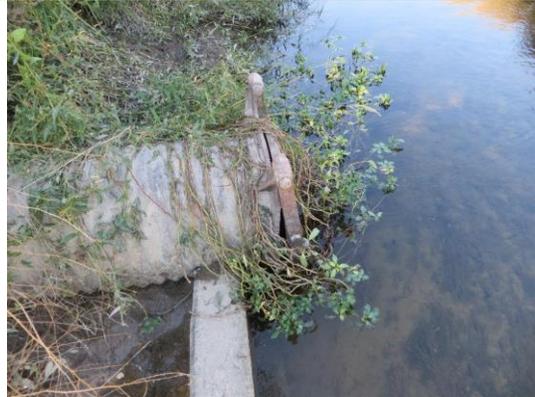
Photo 2 of 2 : UCIP_SP_2016_43208_38157.jpg

24-inch CMP on concrete headwall with flapgate on WS toe.

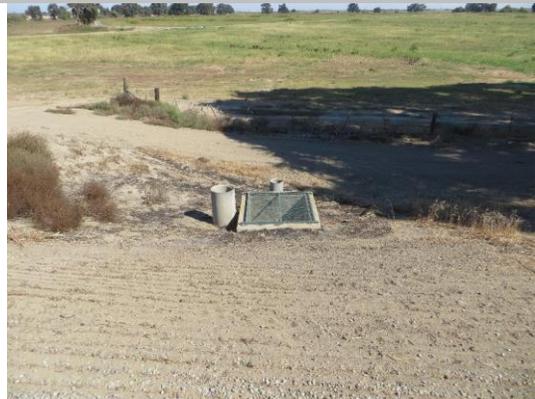
Photo 1 of 2 : UCIP_SP_2016_43209_38211.jpg

LM Start	4.59	Rating **	M	Issue No.	21
LM End	4.59	Issue Type +	En	Location *	LS
Category	Supplemental			GPS Latitude/Longitude	
				Start	End
Item	DWR UCIP Field Study			37.497390 °	37.497390 °
				-121.080370 °	-121.080370 °
DWR ID					
Comment Code					
Inspector Comment					
FS_ID:43209 DS_ID:23165 EP_NO: N/A Repair Type: Non-Urgent Crossing Status: Found UCIP Comments: Appears abandoned and if so should be done so properly. FIELD_STRUCT_DESC: 36-inch corrugated metal pipe through levee 15.0 feet below crown. Abandoned concrete inlet box on the waterward slope of levee. 6'X5' Concrete distribution box at the landward toe. Originally included in the 1961 O&M manual. FS Date: 1/29/2015 2:27:42 PM

Distribution box on LS toe.

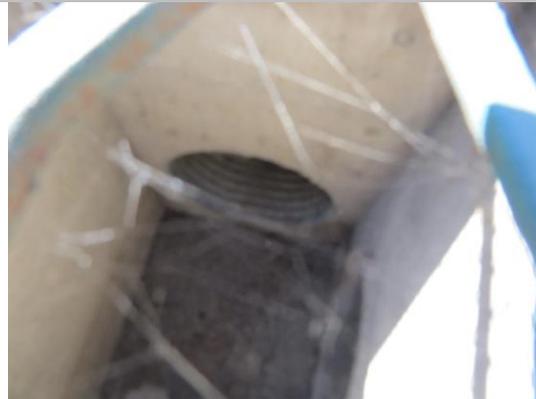
Photo 2 of 2 : UCIP_SP_2016_43209_38210.jpg

Open CMP pipe through levee at distribution box on LS toe.

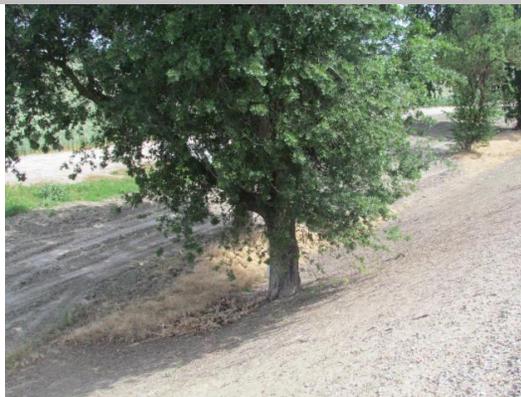
Photo 1 of 1 : SP_2016_RD2091_318_12_20160427_00029.jpg

LM Start	5.92	Rating **	M	Issue No.	12
LM End	5.92	Issue Type +	Ma	Location *	LS
Category	Earthen Levee		GPS Latitude/Longitude		
			Start	End	
Item	Trim / Thin Trees		37.485998 °	37.485998 °	
			-121.063323 °	-121.063323 °	
DWR ID	DWR_RD2091_01_f_2015_12				
Comment Code					
T1 : Trim trees to at least five feet above ground level.					
Inspector Comment

Looking southeast at untrimmed tree on landward slope.

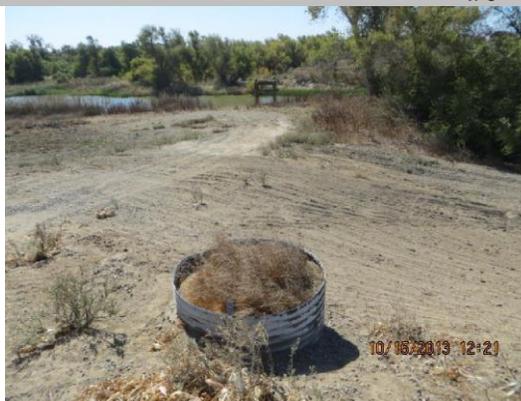
Photo 1 of 2 : UCIP_SP_2016_43221_38215.jpg

LM Start	6.20	Rating **	M	Issue No.	22
LM End	6.20	Issue Type +	En	Location *	LS
Category	Supplemental		GPS Latitude/Longitude		
			Start	End	
Item	DWR UCIP Field Study		37.486060 °	37.486060 °	
			-121.058790 °	-121.058790 °	
DWR ID					
Comment Code					
Inspector Comment					
FS_ID:43221 DS_ID:23166 EP_NO: N/A Repair Type: Non-Urgent Crossing Status: Indicator Found UCIP Comments: FIELD_STRUCT_DESC: *Removed* 36-inch corrugated metal pipe through levee 15.0 feet below crown. Slide gate in corrugated metal pipe riser on the waterward slope. Concrete distribution box at the landward toe. Slide gate on the landward end. Concrete standpipe on the waterward berm. Pump on pile stream. Originally included in the 1961 O&M manual. Pipe removed under Permit No. 4421. Design drawings available in Permit No. 4421. FS Date: 1/29/2015 2:31:08 PM

Abandoned CMP riser on WS slope.

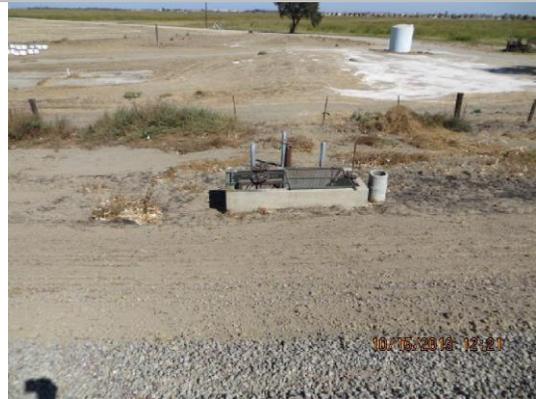
Photo 2 of 2 : UCIP_SP_2016_43221_38214.jpg

Concrete distribution box on LS toe.

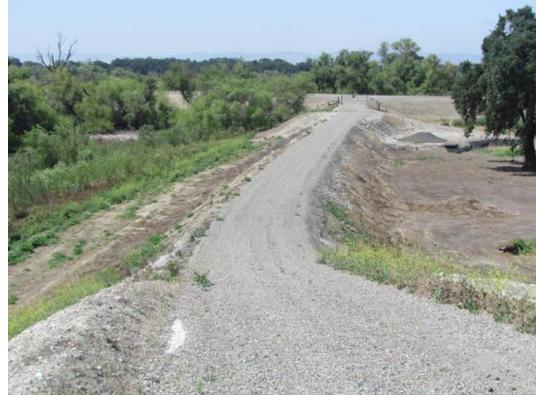
Photo 1 of 1 : SP_2016_RD2091_319_4_20160523_00005.jpg

LM Start	0.00	Rating **	M	Issue No.	4
LM End		Issue Type +	Ma	Location *	LS
Category	Earthen Levee		GPS Latitude/Longitude		
			Start	End	
Item	Vegetation		37.482230 °		°
			-121.051485 °		°
DWR ID	DWR_RD2091_02_s_2016_4				
Comment Code					
V1 : Control annual grass and weeds on the levee slopes and easements.					
Inspector Comment

Looking west at landside and waterside slopes.

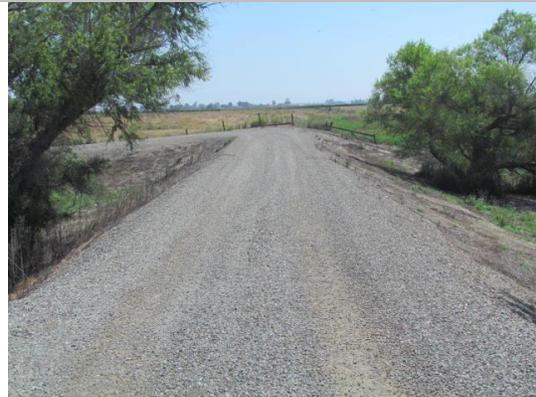
Photo 1 of 1 : SP_2016_RD2091_319_5_20160523_00006.jpg

LM Start	0.00	Rating **	M	Issue No.	5
LM End		Issue Type +	Ma	Location *	WS
Category	Earthen Levee		GPS Latitude/Longitude		
			Start	End	
Item	Vegetation		37.482230 °		°
			-121.051485 °		°
DWR ID	DWR_RD2091_02_s_2016_5				
Comment Code					
V1 : Control annual grass and weeds on the levee slopes and easements.					
Inspector Comment

Looking south at LM 0.30 landside and waterside slopes.

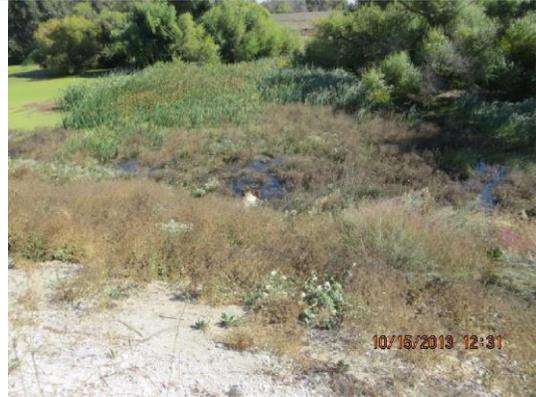
Photo 1 of 1 : UCIP_SP_2016_43206_38216.jpg

LM Start	0.02	Rating **	U	Issue No.	6
LM End	0.02	Issue Type +	En	Location *	WS
Category	Supplemental			GPS Latitude/Longitude	
				Start	End
Item	DWR UCIP Field Study			37.482450 °	37.482450 °
				-121.051220 °	-121.051220 °
DWR ID					
Comment Code					
Inspector Comment					
FS_ID:43206 DS_ID:23175 EP_NO: N/A Repair Type: Urgent Crossing Status: Found UCIP Comments: Flap gate rusted in-place and does not function. In closed position. FIELD_STRUCT_DESC: 24-inch corrugated metal drain pipe through levee 16.4-feet below the crown. Flap gate on the waterward toe. FS Date: 1/29/2015 2:25:56 PM

24-inch CMP with flapgate visible on WS toe.
