**Flood Control Project Maintenance
Levee Inspections**

Maintenance Issue Types Only, Levee Inspection Report By Mile - Spring 2016

Reclamation District No. 2091 Chase

Waterway	Bank	Unit Miles	Inspection Start/End	Inspector
Unit No. 01 San Joaquin River	Right	7.46	04/26/2016 04/26/2016	Richard Willoughby

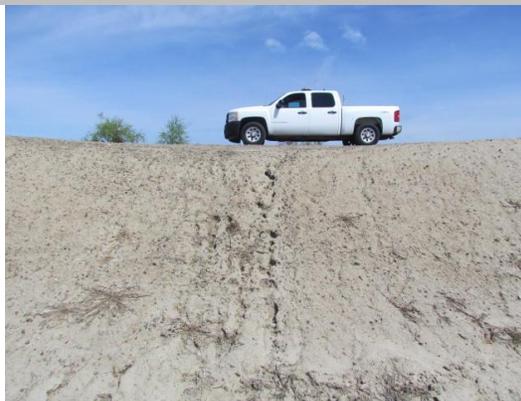
Photo 1 of 4 : SP_2016_RD2091_318_15_20160427_00022.jpg

LM Start	0.23	Rating **	U	Issue No.	15
LM End	0.23	Issue Type +	Ma	Location *	LS
Category	Earthen Levee		GPS Latitude/Longitude		
			Start	End	
Item	Erosion / Bank Caving		37.541550 °	37.541550 °	
			-121.096742 °	-121.096742 °	
DWR ID	DWR_RD2091_01_s_2016_15				
Comment Code					
E1 : Note and monitor erosion site.					
Inspector Comment					
Caving on landward shoulder possible collapsed pipe. Caving is 34 feet long over one inch depth.

Looking west at dip on landward levee shoulder.

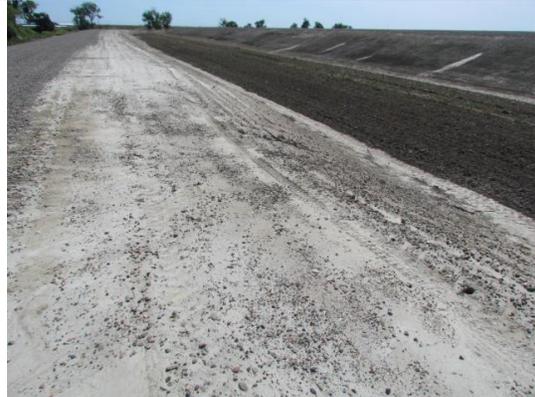
Photo 2 of 4 : SP_2016_RD2091_318_15_20160427_00020.jpg

LM Start	0.23	Rating **	U	Issue No.	15 (cont)
LM End	0.23	Issue Type +	Ma	Location *	LS
Category	Earthen Levee			GPS Latitude/Longitude	
				Start	End
Item	Erosion / Bank Caving			37.541550 °	37.541550 °
				-121.096742 °	-121.096742 °
DWR ID	DWR_RD2091_01_s_2016_15				
Comment Code					
E1 : Note and monitor erosion site.					
Inspector Comment					
Caving on landward shoulder possible collapsed pipe. Caving is 34 feet long over one inch depth.

Looking southeast at depression along landward shoulder.

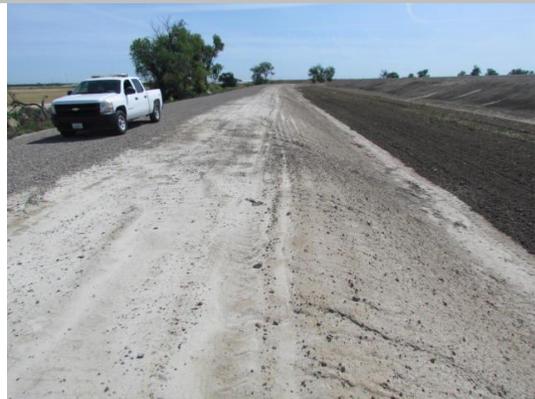
Photo 3 of 4 : SP_2016_RD2091_318_15_20160427_00021.jpg

Looking south at depression along landward shoulder.

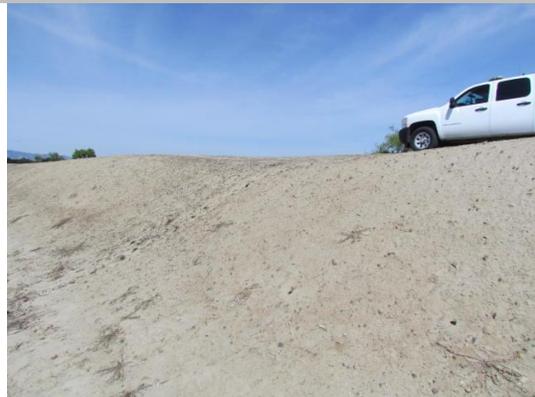
Photo 4 of 4 : SP_2016_RD2091_318_15_20160427_00023.jpg

Looking northwest at depression along landward shoulder.

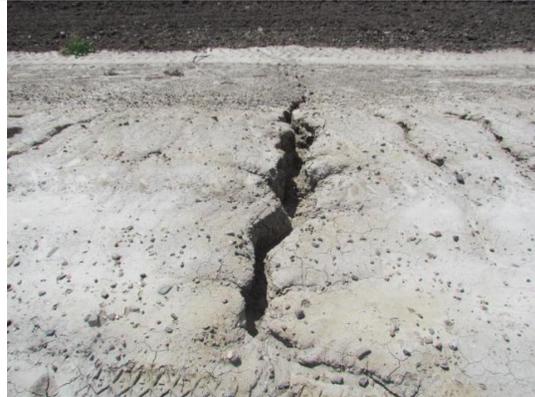
Photo 1 of 5 : SP_2016_RD2091_318_16_20160427_00026.jpg

LM Start	0.25	Rating **	M	Issue No.	16
LM End	0.28	Issue Type +	Ma	Location *	LS
Category	Earthen Levee			GPS Latitude/Longitude	
				Start	End
Item	Erosion / Bank Caving			37.541492 °	37.541408 °
				-121.097052 °	-121.097453 °
DWR ID	DWR_RD2091_01_s_2016_16				
Comment Code					
E1 : Note and monitor erosion site.					
Inspector Comment					
Several fringer erosions and possible rodent holes along landward shoulder and slope.

Looking east at fringer erosion on landward slope.

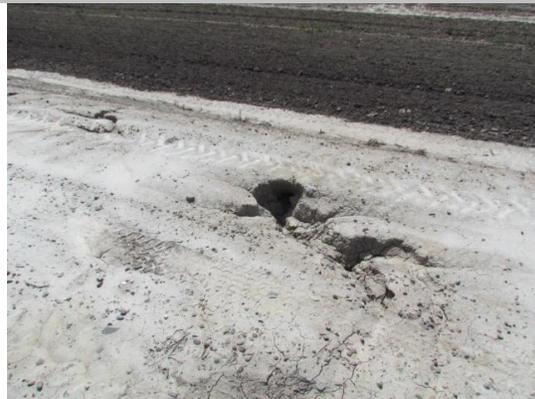
Photo 2 of 5 : SP_2016_RD2091_318_16_20160427_00024.jpg

Looking east at fringer erosion and possible rodent hole on landward slope.

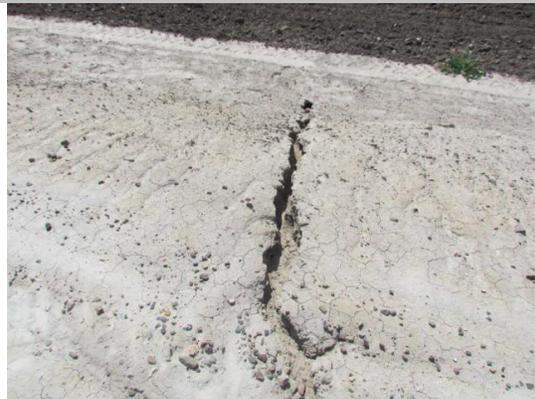
Photo 3 of 5 : SP_2016_RD2091_318_16_20160427_00027.jpg

Looking east at fringer erosion on landward slope.

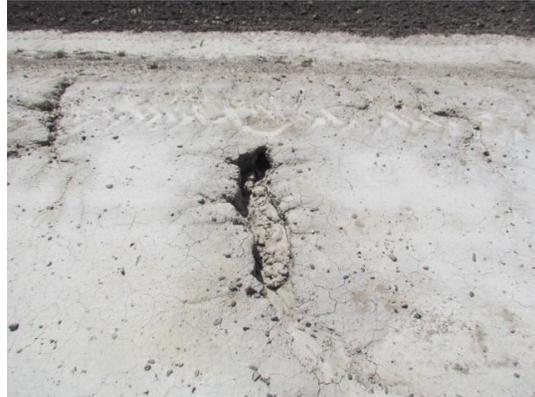
Photo 4 of 5 : SP_2016_RD2091_318_16_20160427_00025.jpg

LM Start	0.25	Rating **	M	Issue No.	16 (cont)
LM End	0.28	Issue Type +	Ma	Location *	LS
Category	Earthen Levee			GPS Latitude/Longitude	
				Start	End
Item	Erosion / Bank Caving			37.541492 °	37.541408 °
				-121.097052 °	-121.097453 °
DWR ID	DWR_RD2091_01_s_2016_16				
Comment Code					
E1 : Note and monitor erosion site.					
Inspector Comment					
Several fringer erosions and possible rodent holes along landward shoulder and slope.

Looking east at fringer erosion and possible rodent hole on landward slope.

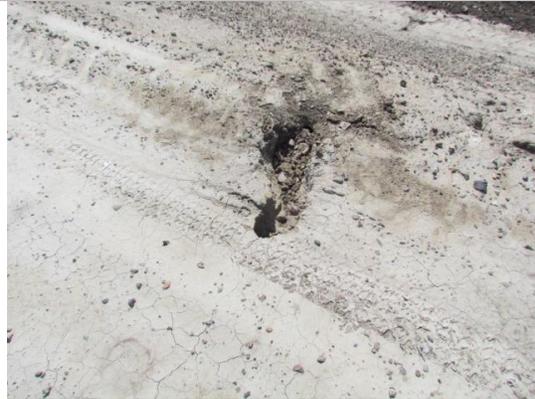
Photo 5 of 5 : SP_2016_RD2091_318_16_20160427_00028.jpg

Looking east at erosion and possible rodent hole on landward shoulder.

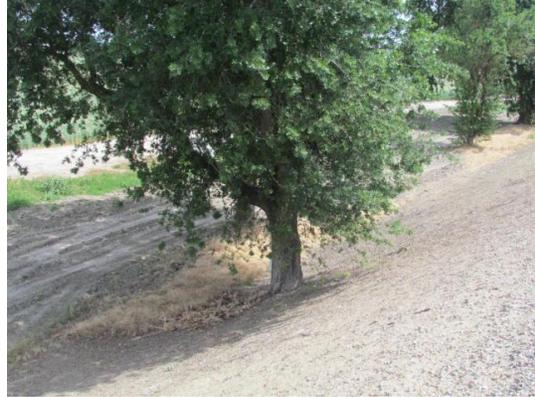
Photo 1 of 1 : SP_2016_RD2091_318_12_20160427_00029.jpg

LM Start	5.92	Rating **	M	Issue No.	12
LM End	5.92	Issue Type +	Ma	Location *	LS
Category	Earthen Levee		GPS Latitude/Longitude		
			Start	End	
Item	Trim / Thin Trees		37.485998 °	37.485998 °	
			-121.063323 °	-121.063323 °	
DWR ID	DWR_RD2091_01_f_2015_12				
Comment Code					
T1 : Trim trees to at least five feet above ground level.					
Inspector Comment

Looking southeast at untrimmed tree on landward slope.

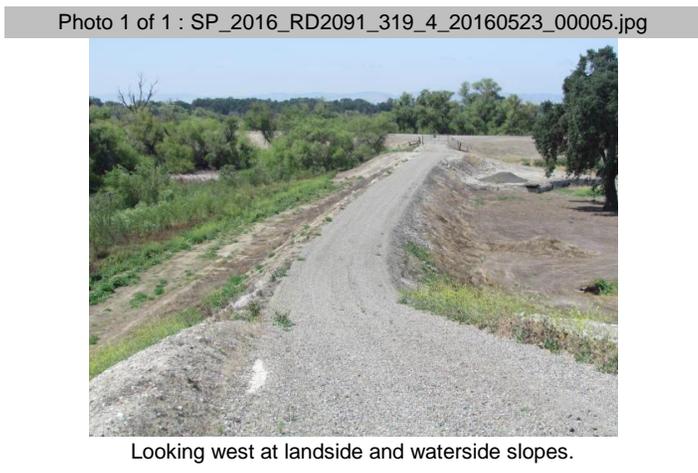
LM Start	0.00	Rating **	M	Issue No.	4
LM End		Issue Type +	Ma	Location *	LS
Category	Earthen Levee		GPS Latitude/Longitude		
			Start	End	
Item	Vegetation		37.482230 °		
			-121.051485 °		
DWR ID	DWR_RD2091_02_s_2016_4				
Comment Code					
V1 : Control annual grass and weeds on the levee slopes and easements.					
Inspector Comment

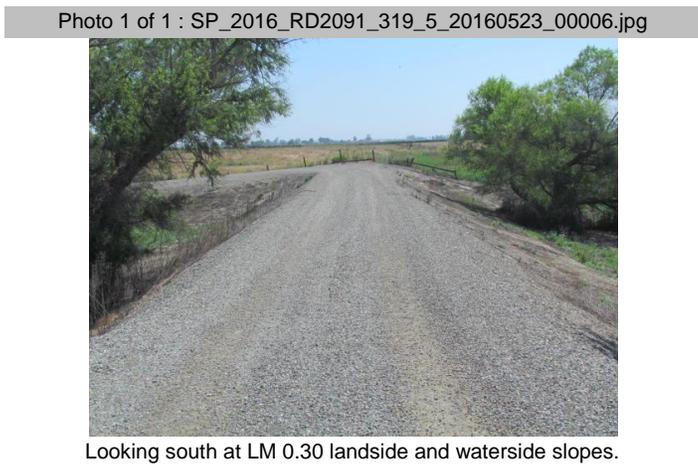
LM Start	0.00	Rating **	M	Issue No.	5
LM End		Issue Type +	Ma	Location *	WS
Category	Earthen Levee		GPS Latitude/Longitude		
			Start	End	
Item	Vegetation		37.482230 °		
			-121.051485 °		
DWR ID	DWR_RD2091_02_s_2016_5				
Comment Code					
V1 : Control annual grass and weeds on the levee slopes and easements.					
Inspector Comment
