**Flood Control Project Maintenance
Levee Inspections
LMA District Cover Sheet
Spring 2010 Levee Inspection Results**

Reclamation District No. 2091 Chase

Levee Inspection Report By Mile - Spring 2010

Waterway	Bank	Unit Miles	Inspection Start/End	Inspector
Unit No. 01 San Joaquin River	Right	7.59	04/21/2010 04/21/2010	Richard Willoughby

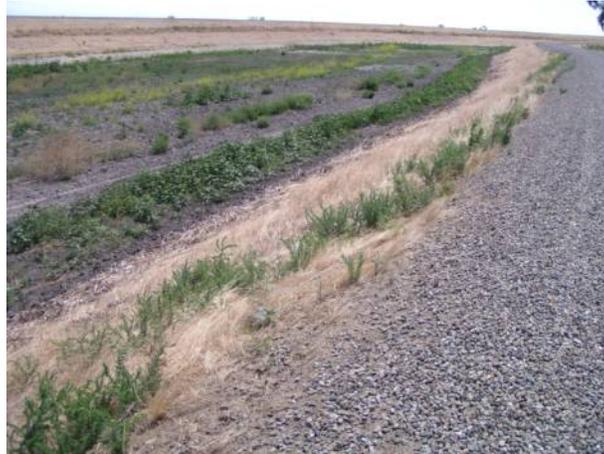
Levee Mile Report Line	1
Start Levee Mile	0.00
End Levee Mile	7.59
Location	Land Side
Category	Earthen Levee
Item	Vegetation
Looking at typical view of levee landside.	
jhirabay_s_20100610_001.JPG

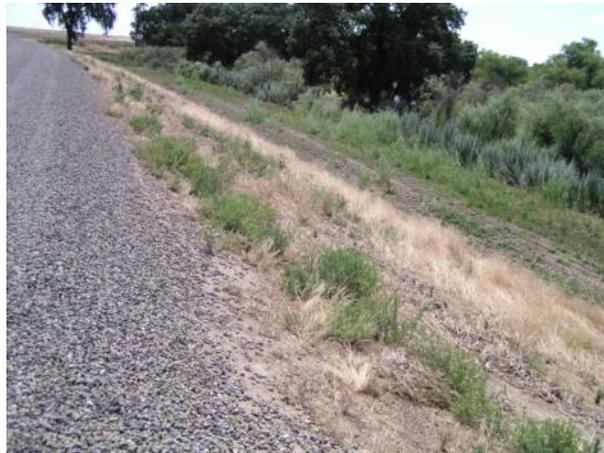
Levee Mile Report Line	2
Start Levee Mile	0.00
End Levee Mile	7.59
Location	Water Side
Category	Earthen Levee
Item	Vegetation
Looking at typical waterside view of levee	
jhirabay_s_20100617_004.JPG

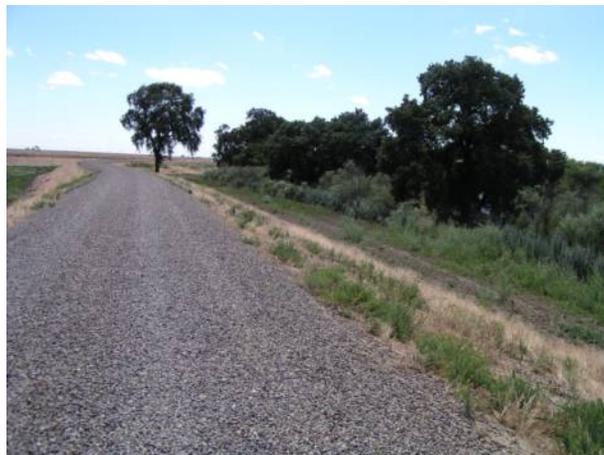
Levee Mile Report Line	3
Start Levee Mile	0.00
End Levee Mile	7.59
Location	Crown
Category	Earthen Levee
Item	Crown Surface / Depressions / Rutting
Looking at typical view of levee crown	
jhirabay_s_20100617_005.JPG

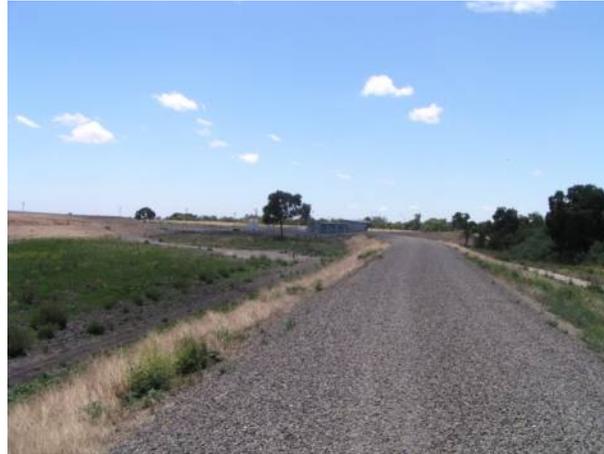
Levee Mile Report Line	1
Start Levee Mile	0.00
End Levee Mile	0.33
Location	Land Side
Category	Earthen Levee
Item	Vegetation
Looking at typical view of levee	
jhirabay_s_20100617_001.JPG
