**Flood Control Project Maintenance  
Levee Inspections**

**Fall 2008 Levee Maintenance Deficiency Summary Report**

**Reclamation District No. 2092**

Waterway	Bank	Unit Miles
Unit No. 01 San Joaquin River	Right	3.80

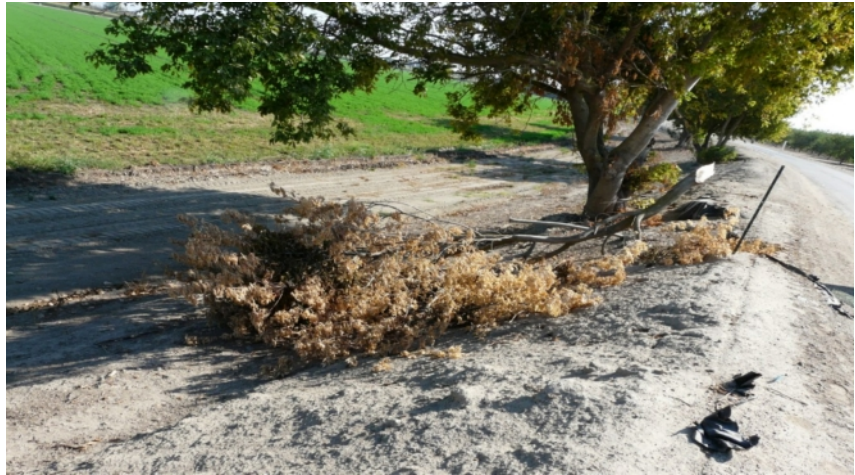
Levee Mile Report Line	1
Start Levee Mile	0.06
End Levee Mile	0.06
Location	
Category	Earthen Levee
Item	Encroachments
Remove debris on waterside of levee at crown.

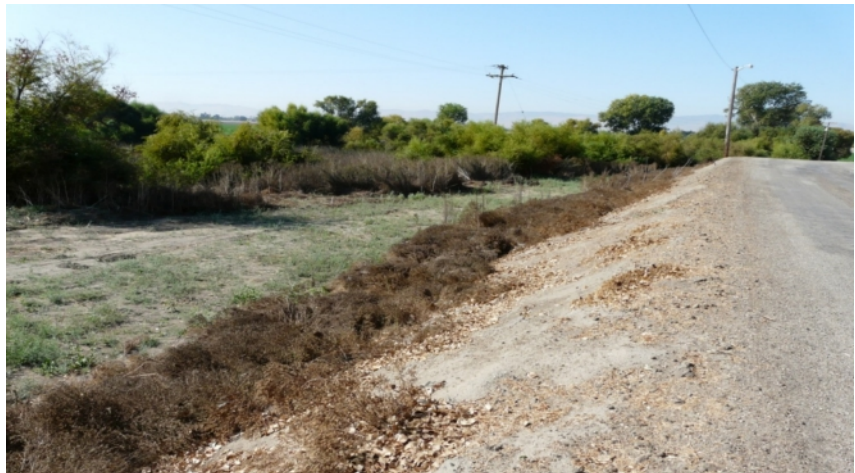
Levee Mile Report Line	2
Start Levee Mile	0.21
End Levee Mile	0.26
Location	
Category	Earthen Levee
Item	Vegetation
Remove/trim brush at landside toe

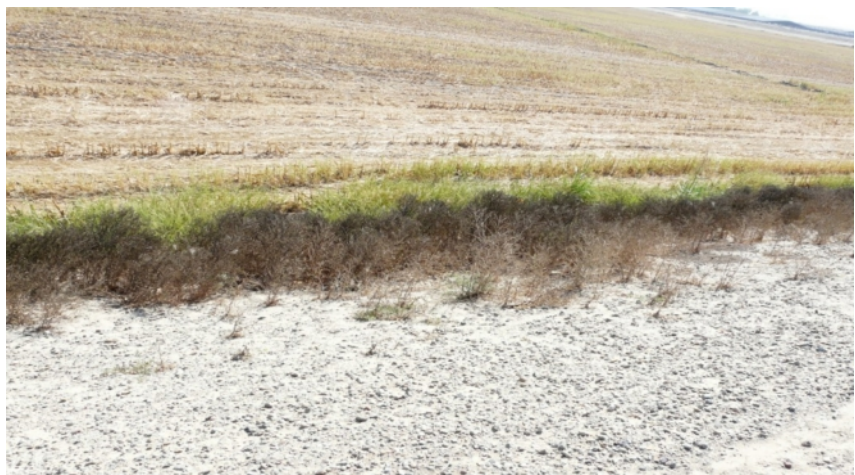
Levee Mile Report Line	4
Start Levee Mile	2.54
End Levee Mile	2.56
Location	
Category	Earthen Levee
Item	Vegetation
Remove/trim brush/weeds at toe of landside slope
