**Flood Control Project Maintenance  
Levee Inspections**

**Fall 2009 Levee Maintenance Deficiency Summary Report**

**Reclamation District No. 2092 Dos Rios**

**Levee Inspection Report By Mile - Fall 2009**

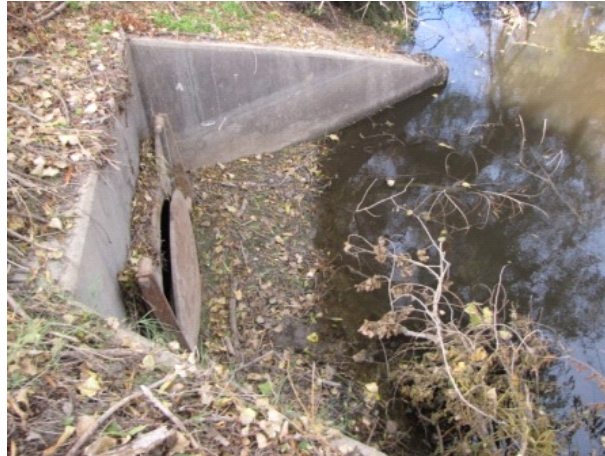
Levee Mile Report Line	1
Start Levee Mile	0.19
End Levee Mile	0.19
Location	Water Side
Category	Interior Drainage & Piping Systems
Item	Flap Gates

LMR No	Levee Mile		Category	Item	Location *	Rating **	Action/Comment	GPS Latitude/Longitude		Issue No.
	Start	End						Start	End	Photo
1	0.19	0.19	Interior Drainage & Piping Systems	Flap Gates	WS	M	Inspector Comments: Flap gate propped open, screw gate appears operational.	37.601999 ° -121.161290 °	37.601999 ° -121.161290 °	966 Y
2	0.77	1.35	Earthen Levee	Encroachments	LS	PO	Agricultural Ditch	37.597291 ° -121.168496 °	° °	968 Y
3	0.77	0.77	Earthen Levee	Vegetation	LS	C	Remove the wild growth other than native grasses from the levee slopes.	37.597290 ° -121.168494 °	37.597290 ° -121.168494 °	969
4	1.55	1.69	Supplemental	DWR Erosion Survey	WS	M	Inspector Comments: 2009: maintenance issue; minor sloughing extending to mid-slope; damage looks to be wave wash erosion; site recommended as local maintenance issue, per CLRO CES Evaluation 2008 Report; previously rated "M" [2009 SiteID:RD2092U1RM84.6]	37.587130 ° -121.162830 °	37.587130 ° -121.162830 °	1

View of flap gate stuck open with sedimentation.

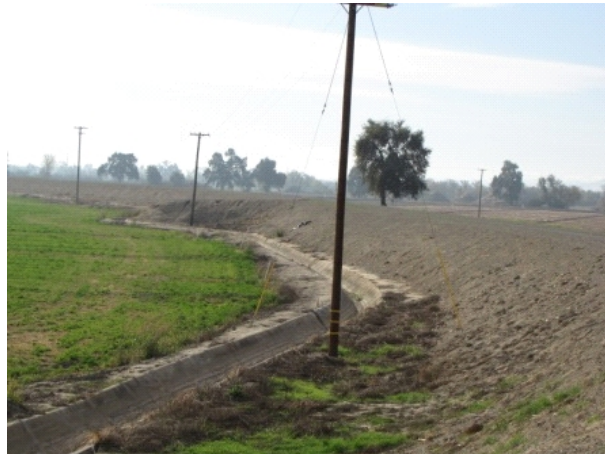
Levee Mile Report Line	2
Start Levee Mile	0.77
End Levee Mile	1.35
Location	Land Side
Category	Earthen Levee
Item	Encroachments

View of agricultural ditch at the landward toe looking upstream.

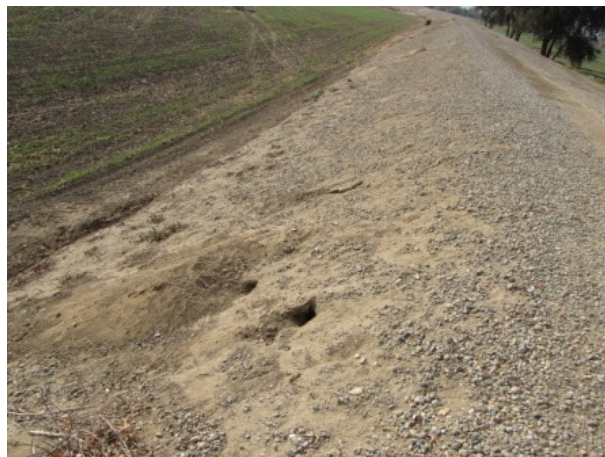
Levee Mile Report Line	5
Start Levee Mile	1.59
End Levee Mile	1.62
Location	Land Side
Category	Earthen Levee
Item	Animal Control

View of rodent holes in landward slope looking upstream.

5	1.59	1.62	Earthen Levee	Animal Control	LS	M	Exterminate rodents and backfill and compact or grout burrows.	37.587564 ° -121.162459 °	37.587117 ° -121.162732 °	970 Y
6	2.07	2.07	Earthen Levee	Animal Control	LS	M	No rodents visible, but rodent burrows visible; need to backfill and compact or grout borrows.	37.584295 ° -121.158809 °	37.584295 ° -121.158809 °	971 Y
7	2.84	3.09	Earthen Levee	Encroachments	LS	PO	Fences Inspector Comments: Barbed wire fence on landward slope.	37.574973 ° -121.156647 °	37.574001 ° -121.152183 °	972 Y

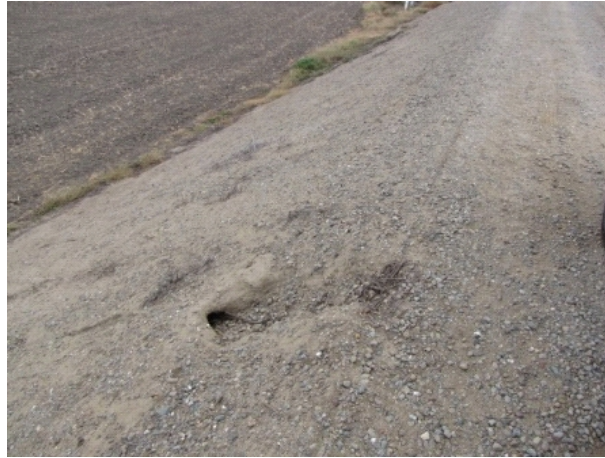
Levee Mile Report Line	6
Start Levee Mile	2.07
End Levee Mile	2.07
Location	Land Side
Category	Earthen Levee
Item	Animal Control

View of rodent holes in the landward shoulder looking upstream.

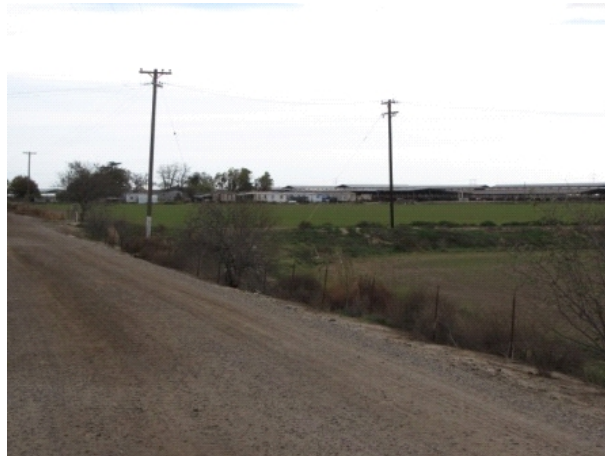
Levee Mile Report Line	7
Start Levee Mile	2.84
End Levee Mile	3.09
Location	Land Side
Category	Earthen Levee
Item	Encroachments

View of barbed wire fence along the waterward slope looking upstream.
