**Flood Control Project Maintenance  
Levee Inspections**

**Fall 2011 Levee Maintenance Deficiency Summary Report**

**Reclamation District No. 2092 Dos Rios**

**Levee Inspection Report By Mile - Fall 2011**

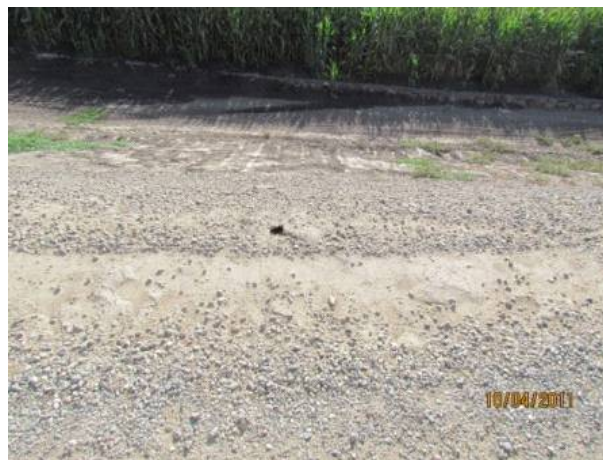
| Levee Mile Report Line | 4 |

| LMR No. | Levee Mile | | Category | Item | Location * | Rating ** | Action/Comment | GPS Latitude/Longitude | | Issue No.<br>Photo |
|---|---|---|---|---|---|---|--|---|---|---|
| 4 | 0.51 | 0.51 | Earthen Levee | Animal Control | LS | M | No rodents visible, but rodent burrows visible; need to backfill and compact or grout burrows. | 37.600651 °<br>-121.166749 ° | 37.600651 °<br>-121.166749 ° | 2<br>Y |

A rodent hole was found on the landside of the levee. The picture was taken from the crown looking towards the toe.

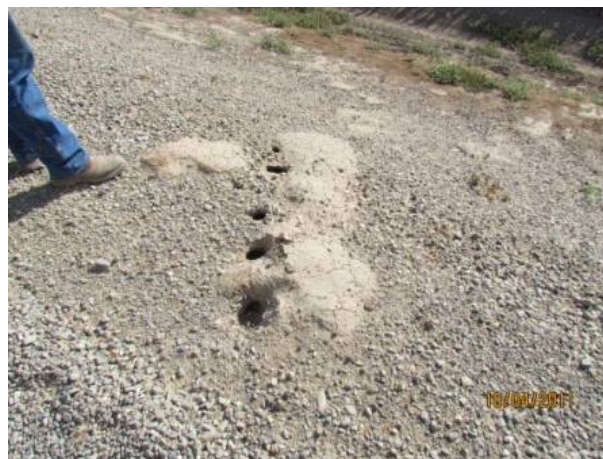
| Levee Mile Report Line | 5 |

| LMR No. | Levee Mile | | Category | Item | Location * | Rating ** | Action/Comment | GPS Latitude/Longitude | | Issue No.<br>Photo |
|---|---|---|---|---|---|---|--|---|---|---|
| 5 | 0.55 | 0.55 | Earthen Levee | Animal Control | LS | M | No rodents visible, but rodent burrows visible; need to backfill and compact or grout burrows. | 37.600095 °<br>-121.166909 ° | 37.600095 °<br>-121.166909 ° | 3<br>Y |

Rodent holes were found on the landside of the levee. The picture was taken from the crown looking towards the toe of the levee.

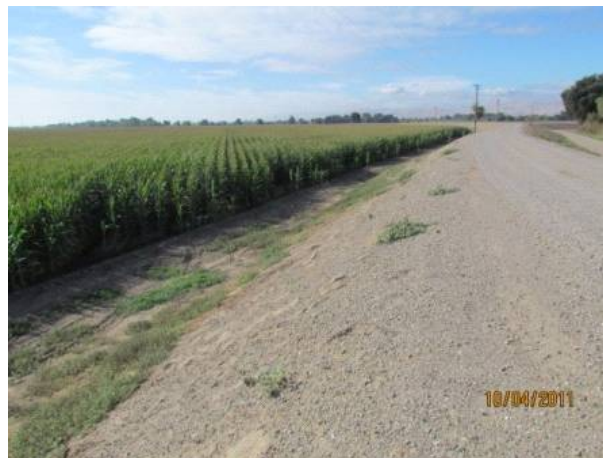
| Levee Mile Report Line | 7 |

| LMR No. | Levee Mile | | Category | Item | Location * | Rating ** | Action/Comment | GPS Latitude/Longitude | | Issue No.<br>Photo |
|---|---|---|---|---|---|---|--|---|---|---|
| 7 | 0.63 | 0.63 | Earthen Levee | Animal Control | LS | A | No rodents visible, but rodent burrows visible; need to backfill and compact or grout burrows. | 37.598848 °<br>-121.167379 ° | 37.598848 °<br>-121.167379 ° | 20<br>Y |

Rodent holes are repaired on the landside slope of the levee looking upstream.

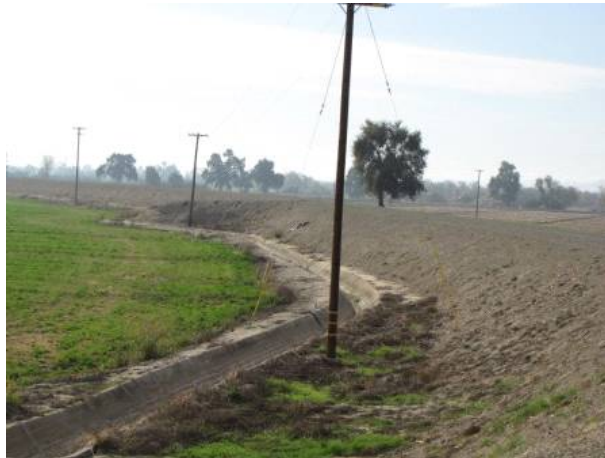
| Levee Mile Report Line | 9 |

| LMR No. | Levee Mile | | Category | Item | Location * | Rating ** | Action/Comment | GPS Latitude/Longitude | | Issue No.<br>Photo |
|---|---|---|---|---|---|---|--|---|---|---|
| 9 | 0.77 | 1.33 | Earthen Levee | Encroachments | LS | PO | Agricultural Ditch | 37.597291 °<br>-121.168496 ° | 37.590568 °<br>-121.164028 ° | 968<br>Y |

| View of agricultural ditch at the landward toe looking upstream. | |

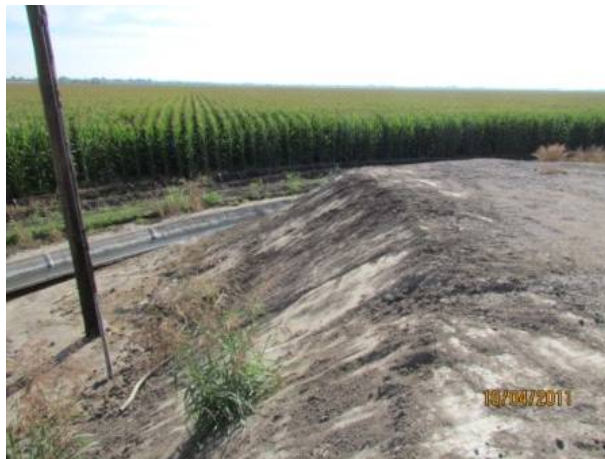
| Levee Mile Report Line | 11 |

| LMR No. | Levee Mile | | Category | Item | Location * | Rating ** | Action/Comment | GPS Latitude/Longitude | | Issue No.<br>Photo |
|---|---|---|---|---|---|---|--|---|---|---|
| 11 | 0.86 | 0.86 | Earthen Levee | Slope Stability | LS | A | Repair slope instability. | 37.595979 °<br>-121.168254 ° | 37.595979 °<br>-121.168254 ° | 5<br>Y |

| Slope stability was repaired by the LMA on the landside of the levee. | |

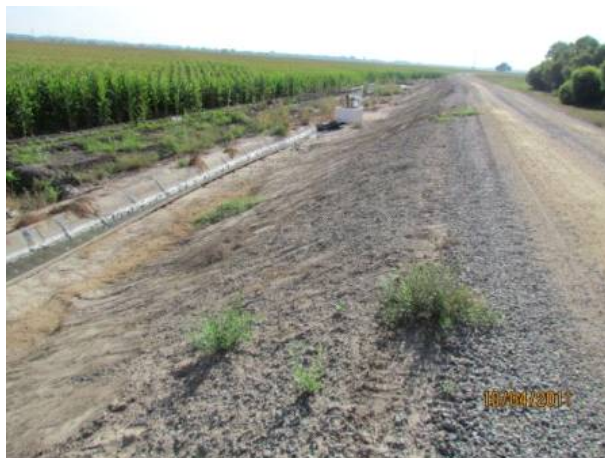
| Levee Mile Report Line | 12 |

| LMR No. | Levee Mile | | Category | Item | Location * | Rating ** | Action/Comment | GPS Latitude/Longitude | | Issue No.<br>Photo |
|---|---|---|---|---|---|---|--|---|---|---|
| 12 | 1.29 | 1.29 | Earthen Levee | Slope Stability | LS | A | Repair slope instability. | 37.590791 °<br>-121.164481 ° | 37.590791 °<br>-121.164481 ° | 9<br>Y |

| Slope stability was repaired on the landside of the levee looking upstream. | |

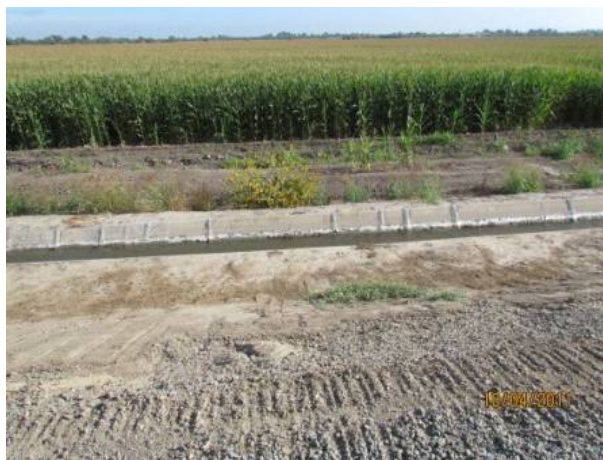
| Levee Mile Report Line | 14 |

| LMR No. | Levee Mile | | Category | Item | Location * | Rating ** | Action/Comment | GPS Latitude/Longitude | | Issue No.<br>Photo |
|---|---|---|---|---|---|---|--|---|---|---|
| 14 | 1.34 | 1.57 | Earthen Levee | Encroachments | LS | PO | Agricultural Ditch | 37.590479 °<br>-121.163844 ° | 37.587758 °<br>-121.162349 ° | 7<br>Y |

An agricultural ditch was found on the toe of the landside of the levee looking upstream.

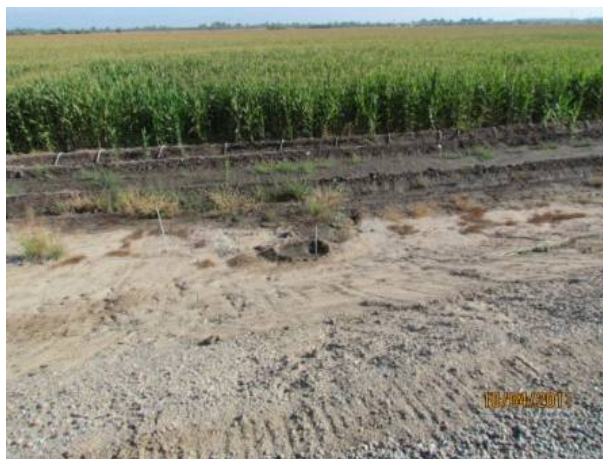
| Levee Mile Report Line | 15 |

| LMR No. | Levee Mile | | Category | Item | Location * | Rating ** | Action/Comment | GPS Latitude/Longitude | | Issue No.<br>Photo |
|---|---|---|---|---|---|---|--|---|---|---|
| 15 | 1.34 | 1.34 | Earthen Levee | Seepage / Sandboils | LS | U | Inspector Comments: It happened because of the underground pipe leakage. | 37.590467 °<br>-121.163822 ° | 37.590467 °<br>-121.163822 ° | 10<br>Y |

A sand boil was found on the landside of the levee. It was caused by a pipe leak couple of feet below the boil location. LMA was notified to repair it as soon as possible. The picture was taken from the crown looking upstream.

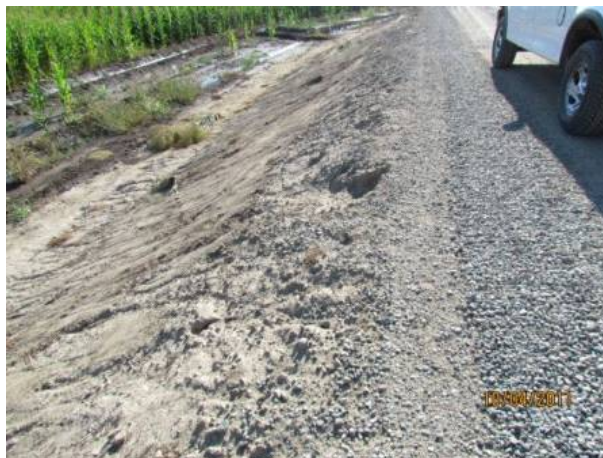
| Levee Mile Report Line | 16 |

| LMR No. | Levee Mile | | Category | Item | Location * | Rating ** | Action/Comment | GPS Latitude/Longitude | | Issue No.<br>Photo |
|---|---|---|---|---|---|---|--|---|---|---|
| 16 | 1.36 | 1.36 | Earthen Levee | Slope Stability | LS | M | Repair slope instability. | 37.590341 °<br>-121.163549 ° | 37.590341 °<br>-121.163549 ° | 11<br>Y |

Slope instability was found on the landside slope of the levee looking upstream.

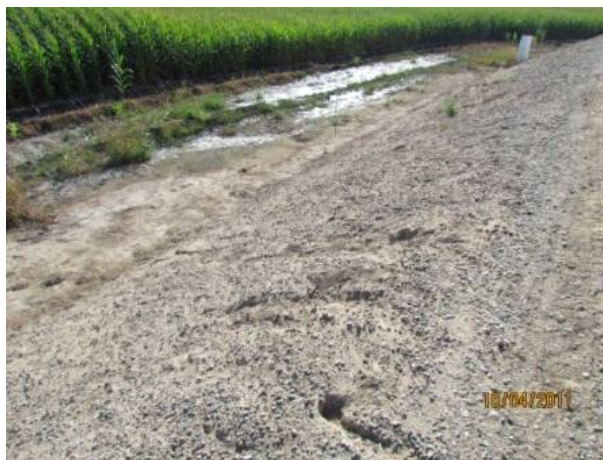
| LMR No. | Levee Mile | | Category | Item | Location * | Rating ** | Action/Comment | GPS Latitude/Longitude | | Issue No. |
|---|---|---|---|---|---|---|---|---|---|---|
| 18 | 1.47 | 1.47 | Earthen Levee | Slope Stability | LS | M | Repair slope instability. | 37.589061 °<br>-121.162168 ° | 37.589061 °<br>-121.162168 ° | 25<br>Y |

Slope instability was found on the landside of the levee looking upstream.

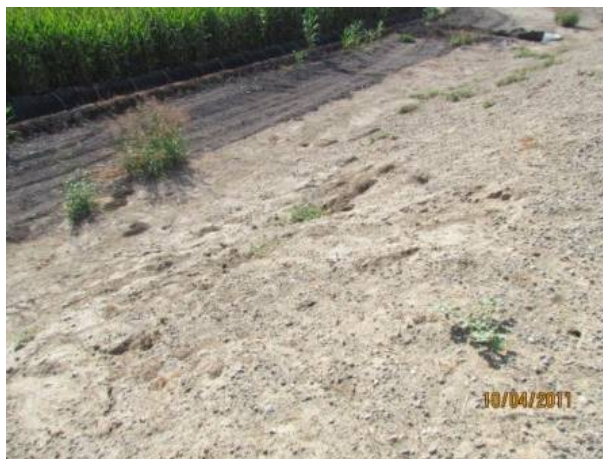
| Levee Mile Report Line | 19 |

| LMR No. | Levee Mile | | Category | Item | Location * | Rating ** | Action/Comment | GPS Latitude/Longitude | | Issue No. |
|---|---|---|---|---|---|---|---|---|---|---|
| 19 | 1.53 | 1.53 | Earthen Levee | Animal Control | LS | M | No rodents visible, but rodent burrows visible; need to backfill and compact or grout burrows. | 37.588375 °<br>-121.162084 ° | 37.588375 °<br>-121.162084 ° | 12<br>Y |

Rodent holes were found on the landside of the levee looking upstream.

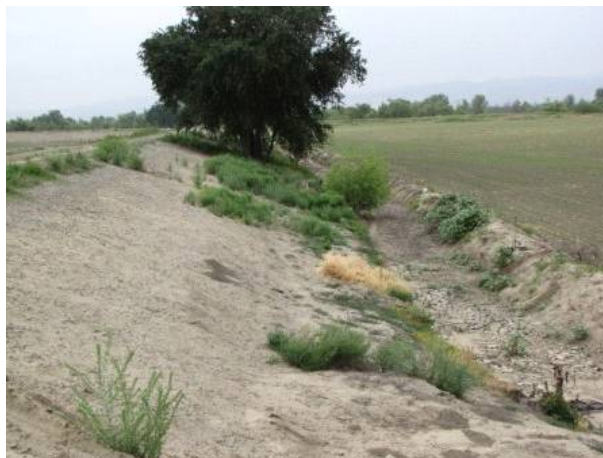
| Levee Mile Report Line | 21 |

| LMR No. | Levee Mile | | Category | Item | Location * | Rating ** | Action/Comment | GPS Latitude/Longitude | | Issue No. |
|---|---|---|---|---|---|---|---|---|---|---|
| 21 | 1.59 | 1.87 | Earthen Levee | Encroachments | WS | PO | Agricultural Ditch | 37.587575 °<br>-121.162454 ° | 37.584057 °<br>-121.162387 ° | 8<br>Y |

View of an agricultural ditch at the waterward toe of the slope.

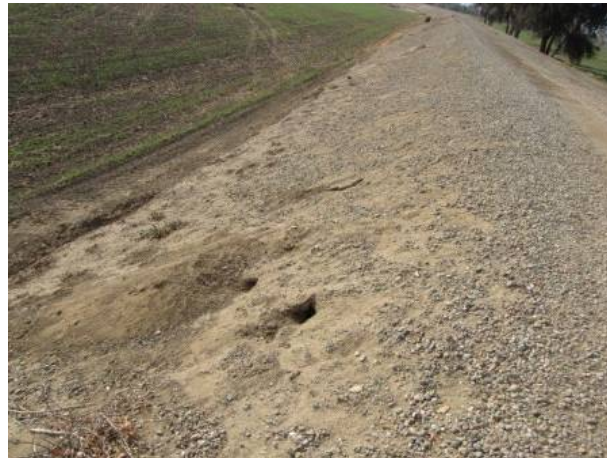
View of rodent holes in landward slope looking upstream.

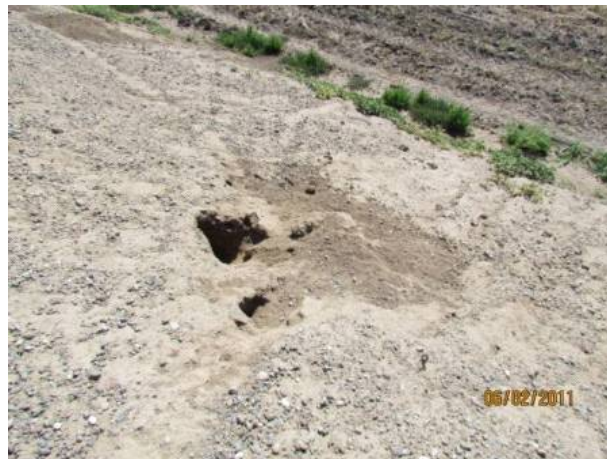
| Levee Mile Report Line | 22 |

| LMR No. | Levee Mile | | Category | Item | Location * | Rating ** | Action/Comment | GPS Latitude/Longitude | | Issue No. |
|---|---|---|---|---|---|---|---|---|---|---|
| 22 | 1.59 | 1.62 | Earthen Levee | Animal Control | LS | M | Repair the levee slope damaged by livestock and prevent large animal access.<br>Inspector Comments: New land owner at this levee mile. | 37.587564 °<br>-121.162459 ° | 37.587117 °<br>-121.162732 ° | 970<br>Y |

Rodent hole on the landside of the slope seems to be bigger since the last inspection. The picture was taken from the crown looking upstream.

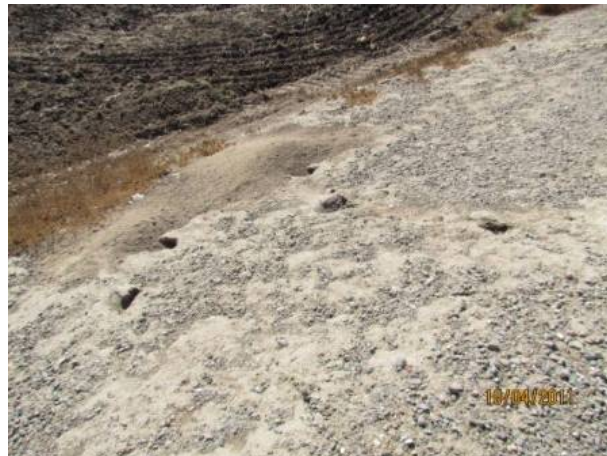
| Levee Mile Report Line | 22 |

Updated picture of the rodent holes on the landside of the levee during fall 2011 inspection.

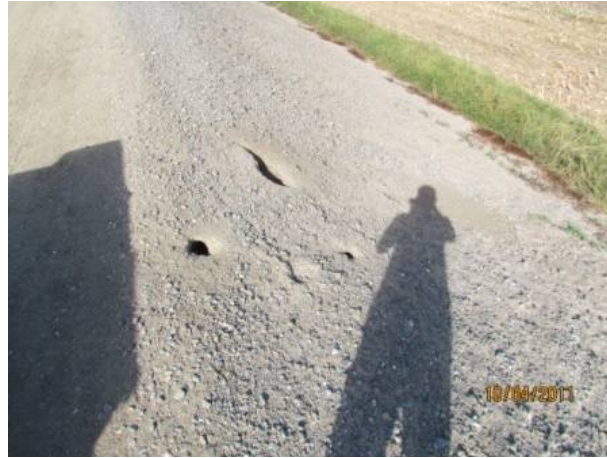
| Rodent holes were found on the landside of the levee looking downstream. | |

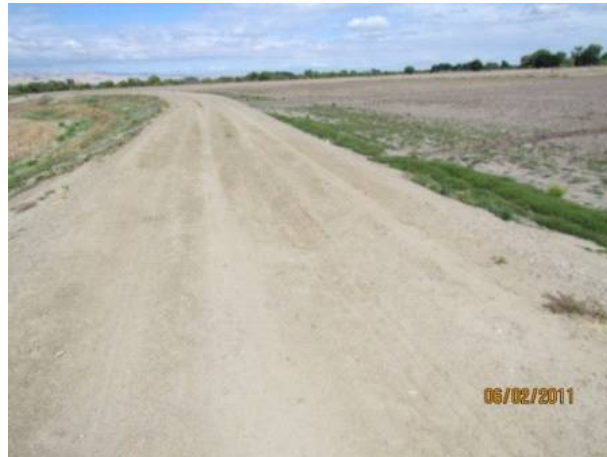
| Levee Mile Report Line | 25 |

| LMR No. | Levee Mile | | Category | Item | Location * | Rating ** | Action/Comment | GPS Latitude/Longitude | | Issue No. |
|---|---|---|---|---|---|---|---|---|---|---|
| 25 | 2.02 | 2.02 | Earthen Levee | Crown Surface / Depressions / Rutting | CR | M | Regrade the crown roadway for proper drainage. | 37.584355 °<br>-121.159676 ° | 37.584355 °<br>-121.159676 ° | 27<br>Y |

| Crown depression was found due to vehicular traffic. The picture was taken from crown looking downstream. | |

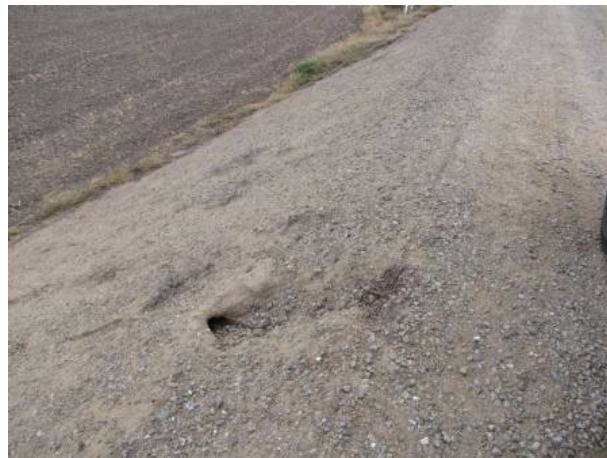
| Levee Mile Report Line | 26 |

| LMR No. | Levee Mile | | Category | Item | Location * | Rating ** | Action/Comment | GPS Latitude/Longitude | | Issue No. |
|---|---|---|---|---|---|---|---|---|---|---|
| 26 | 2.07 | 2.07 | Earthen Levee | Animal Control | LS | M | No rodents visible, but rodent burrows visible; need to backfill and compact or grout burrows. | 37.584295 °<br>-121.158809 ° | 37.584295 °<br>-121.158809 ° | 971<br>Y |

| View of rodent holes in the landward shoulder looking upstream. | |

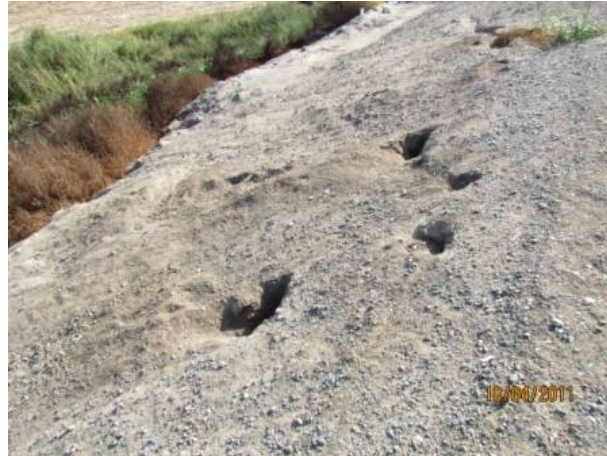
| Rodent holes were found on the landside of the levee looking upstream. | |

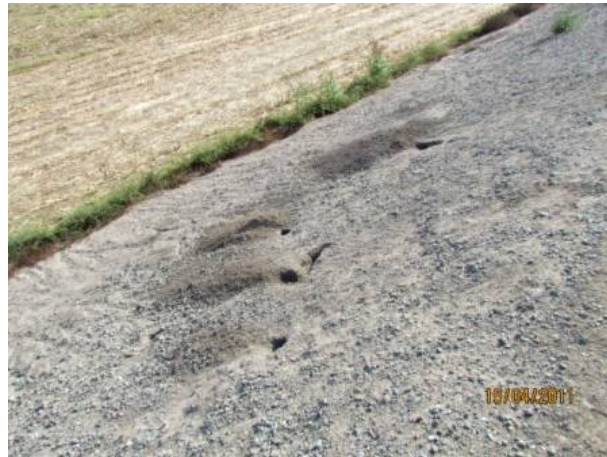
| Levee Mile Report Line | 28 |

| LMR No. | Levee Mile | | Category | Item | Location * | Rating ** | Action/Comment | GPS Latitude/Longitude | | Issue No. |
|---|---|---|---|---|---|---|---|---|---|---|
| 28 | 2.13 | 2.13 | Earthen Levee | Animal Control | LS | M | No rodents visible, but rodent burrows visible; need to backfill and compact or grout burrows. | 37.584004 °<br>-121.157831 ° | 37.584004 °<br>-121.157831 ° | 17<br>Y |

| Rodent holes were found on the landside of the levee looking upstream. | |

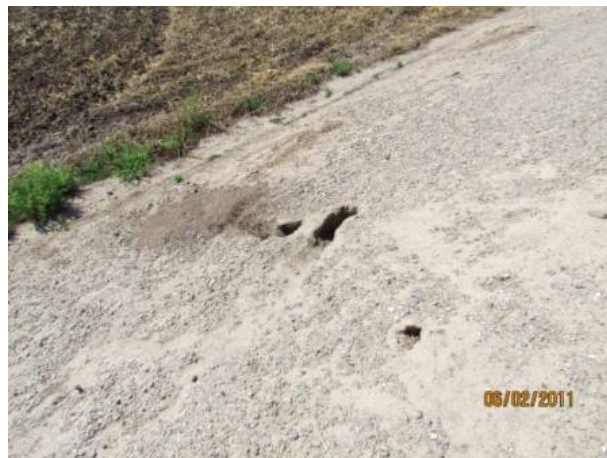
| Levee Mile Report Line | 30 |

| LMR No. | Levee Mile | | Category | Item | Location * | Rating ** | Action/Comment | GPS Latitude/Longitude | | Issue No. |
|---|---|---|---|---|---|---|---|---|---|---|
| 30 | 2.41 | 2.41 | Earthen Levee | Animal Control | LS | M | No rodents visible, but rodent burrows visible; need to backfill and compact or grout burrows. | 37.580851 °<br>-121.156438 ° | 37.580851 °<br>-121.156438 ° | 28<br>Y |

| Rodent holes were found on the landside slope of the levee. The picture was taken from the crown looking upstream. | |

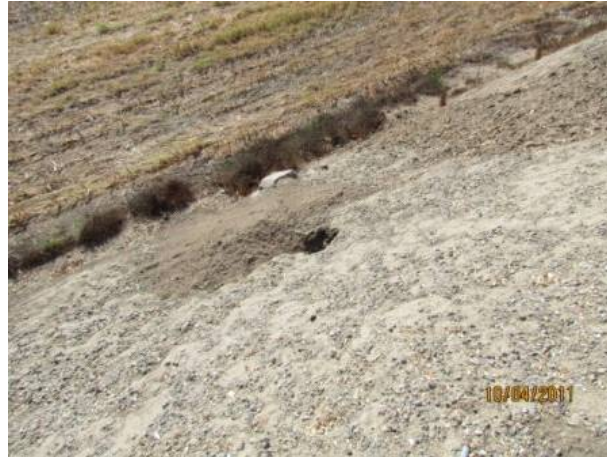
Updated picture of rodent hole on the landside of the levee looking upstream during fall 2011 inspection.

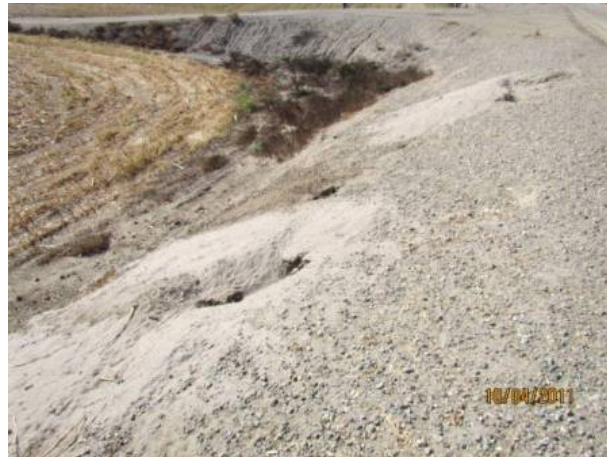
| Levee Mile Report Line | 31 |

| LMR No. | Levee Mile | | Category | Item | Location * | Rating ** | Action/Comment | GPS Latitude/Longitude | | Issue No. |
|---|---|---|---|---|---|---|--|---|---|---|
| 31 | 2.42 | 2.42 | Earthen Levee | Animal Control | LS | M | No rodents visible, but rodent burrows visible; need to backfill and compact or grout burrows. | 37.580441 °<br>-121.156758 ° | 37.580441 °<br>-121.156758 ° | 14<br>Y |

Rodent holes were found on the landside slope of the levee looking upstream.

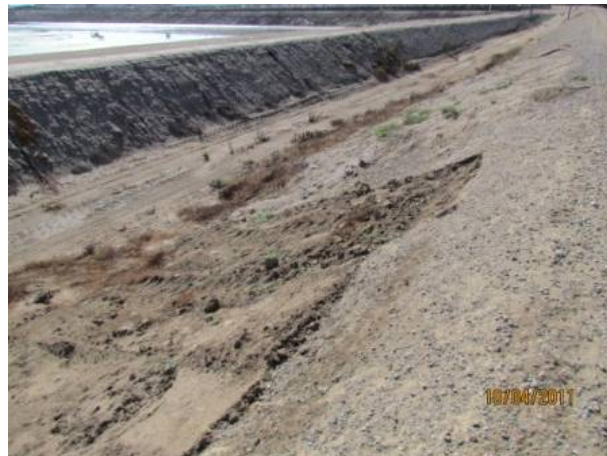
| Levee Mile Report Line | 33 |

| LMR No. | Levee Mile | | Category | Item | Location * | Rating ** | Action/Comment | GPS Latitude/Longitude | | Issue No. |
|---|---|---|---|---|---|---|--|---|---|---|
| 33 | 2.67 | 2.67 | Earthen Levee | Slope Stability | LS | M | Repair slope instability. | 37.577214 °<br>-121.157151 ° | 37.577214 °<br>-121.157151 ° | 19<br>Y |

Slope instability was found on the landside slope of the levee. The slope was also damaged by a vehicle. The picture was taken from the crown looking upstream.

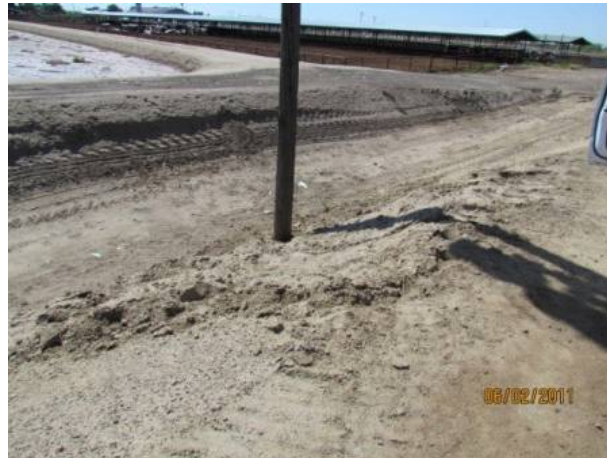
Slope instability was found on the landside of the levee looking upstream.

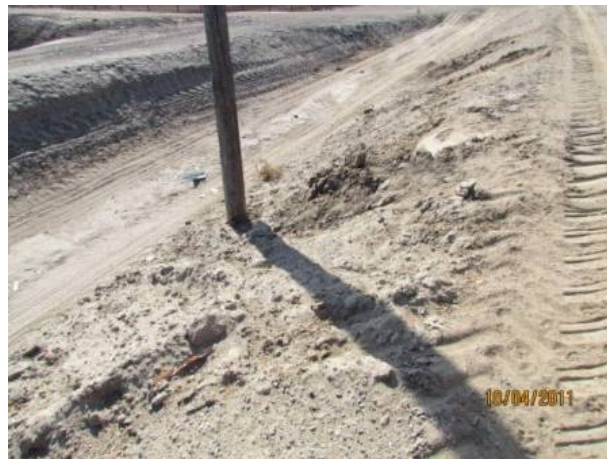
| Levee Mile Report Line | 34 |

| LMR No. | Levee Mile | | Category | Item | Location * | Rating ** | Action/Comment | GPS Latitude/Longitude | | Issue No. |
|---|---|---|---|---|---|---|--|---|---|---|
| 34 | 2.73 | 2.73 | Earthen Levee | Slope Stability | LS | M | Repair the levee slope damaged by vehicle traffic and prevent access where possible. | 37.576336 °<br>-121.157217 ° | 37.576336 °<br>-121.157217 ° | 30<br>Y |

Updates picture of the slope instability on the landside of the levee looking upstream.

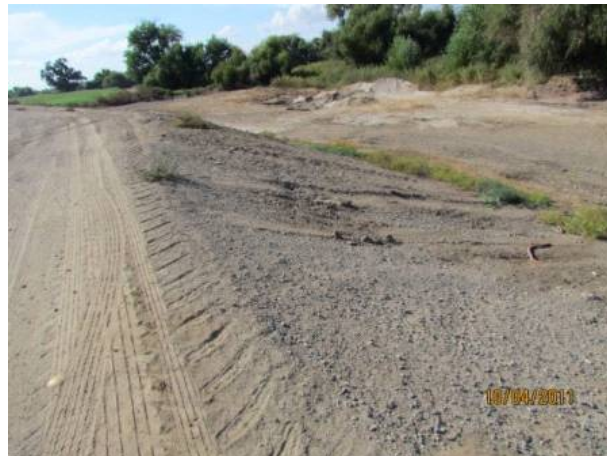
| Levee Mile Report Line | 35 |

| LMR No. | Levee Mile | | Category | Item | Location * | Rating ** | Action/Comment | GPS Latitude/Longitude | | Issue No. |
|---|---|---|---|---|---|---|--|---|---|---|
| 35 | 2.76 | 2.76 | Earthen Levee | Slope Stability | WS | M | Repair slope instability. | 37.575946 °<br>-121.157230 ° | 37.575946 °<br>-121.157230 ° | 33<br>Y |

Slope instability was found on the waterside of the levee looking upstream.

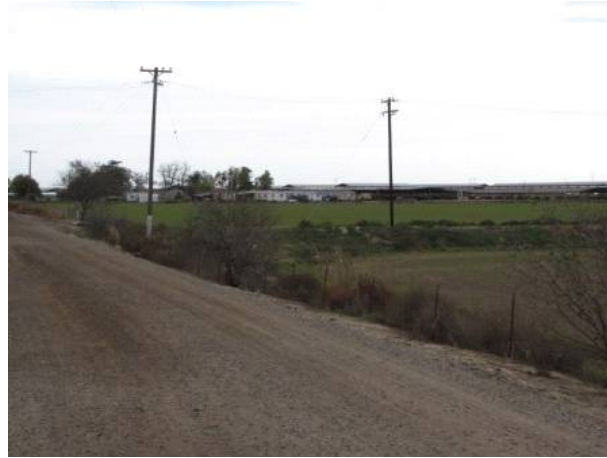
| LMR No. | Levee Mile | | Category | Item | Location * | Rating ** | Action/Comment | GPS Latitude/Longitude | | Issue No. |
|---|---|---|---|---|---|---|--|---|---|---|
| 37 | 2.84 | 3.09 | Earthen Levee | Encroachments | LS | PO | Fences<br>Inspector Comments: Barbed wire fence on landward slope. | 37.574973 °<br>-121.156647 ° | 37.574001 °<br>-121.152183 ° | 972<br>Y |

| View of barbed wire fence along the waterward slope looking upstream. | |
