**Flood Control Project Maintenance
Levee Inspections**

Fall 2012 Levee Maintenance Deficiency Summary Report

San Joaquin River Basin

Reclamation District No. 2092 Dos Rios

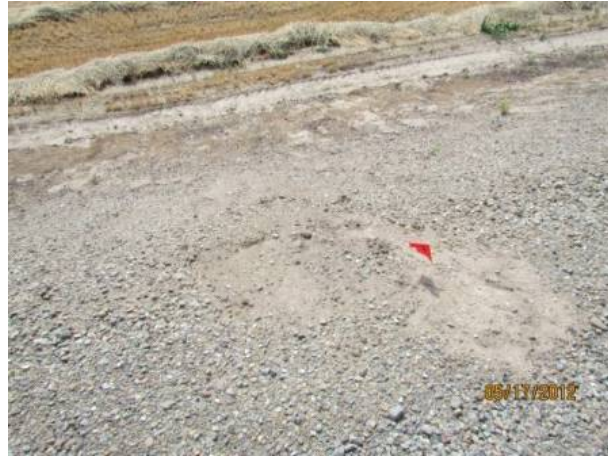
Levee Mile Report Line	5
Start Levee Mile	0.55
End Levee Mile	0.55
Location	Land Side
Category	Earthen Levee
Item	Animal Control

The rodent holes were repaired by the LMA on the landside of the levee looking upstream.

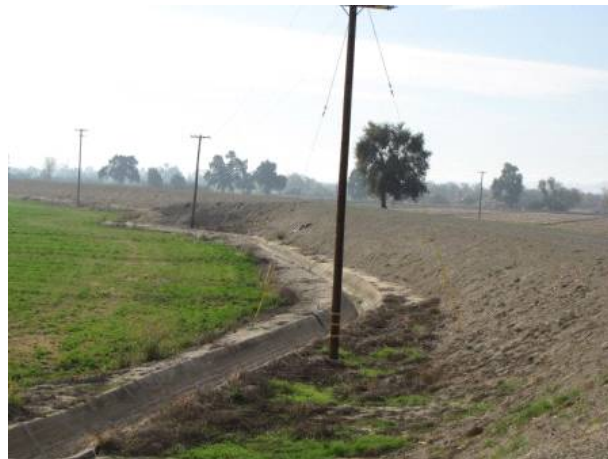
Levee Mile Report Line	6
Start Levee Mile	0.77
End Levee Mile	1.33
Location	Land Side
Category	Earthen Levee
Item	Encroachments

View of agricultural ditch at the landward toe looking upstream.

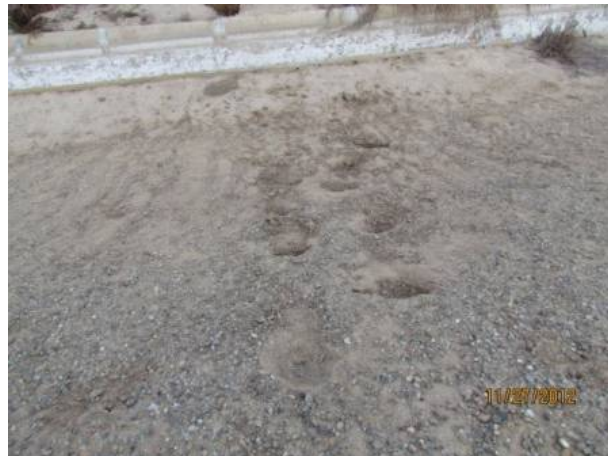
Levee Mile Report Line	8
Start Levee Mile	1.04
End Levee Mile	1.04
Location	Land Side
Category	Earthen Levee
Item	Encroachments

Stairs were dug into the landside slope of the levee looking upstream.

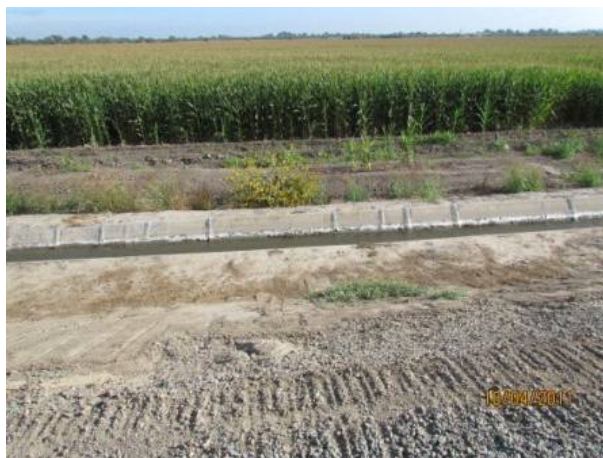
Levee Mile Report Line	9
Start Levee Mile	1.34
End Levee Mile	1.57
Location	Land Side
Category	Earthen Levee
Item	Encroachments

An agricultural ditch was found on the toe of the landside of the levee looking upstream.

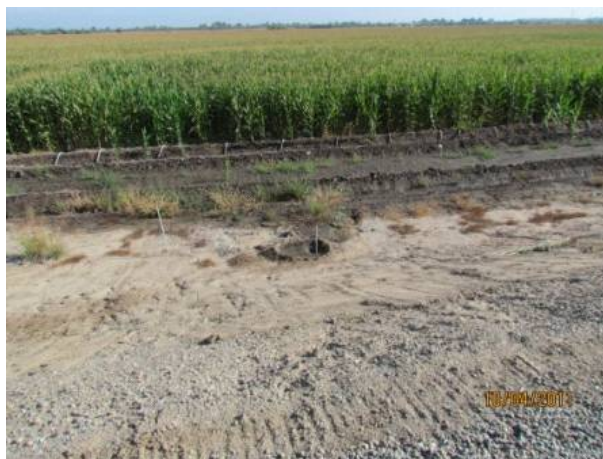
Levee Mile Report Line	10
Start Levee Mile	1.34
End Levee Mile	1.34
Location	Land Side
Category	Earthen Levee
Item	Encroachments

A sand boil was found on the landside of the levee. It was caused by a pipe leak couple of feet below the boil location. LMA was notified to repair it as soon as possible. The picture was taken from the crown looking upstream.

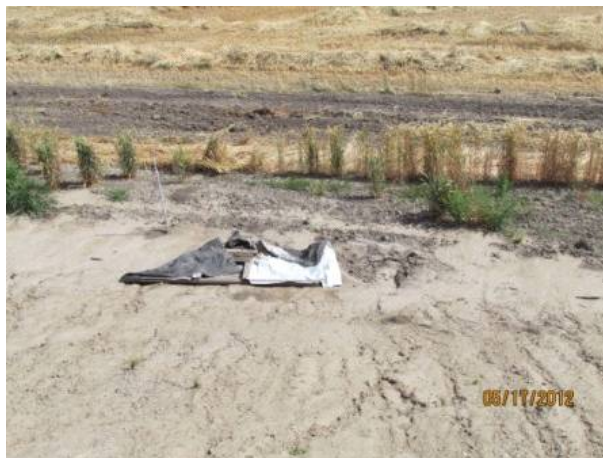
Levee Mile Report Line	10
Start Levee Mile	1.34
End Levee Mile	1.34
Location	Land Side
Category	Earthen Levee
Item	Encroachments

During spring inspection 2012, the sand boil was not active but materials were present on the landside toe of the levee. The sand boil occurred due to an underground irrigation pipe leakage. The picture was taken from the crown looking toward the toe of the levee. The area was repaired but should be monitored.

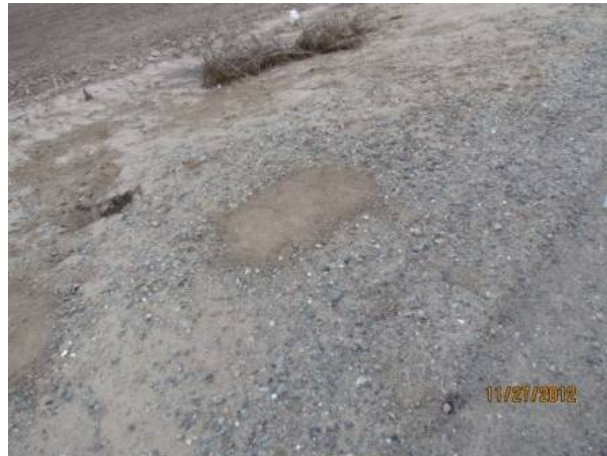
Levee Mile Report Line	12
Start Levee Mile	1.35
End Levee Mile	1.35
Location	Land Side
Category	Earthen Levee
Item	Animal Control

Animal holes were repaired by the LMA on the landside of the levee looking upstream.

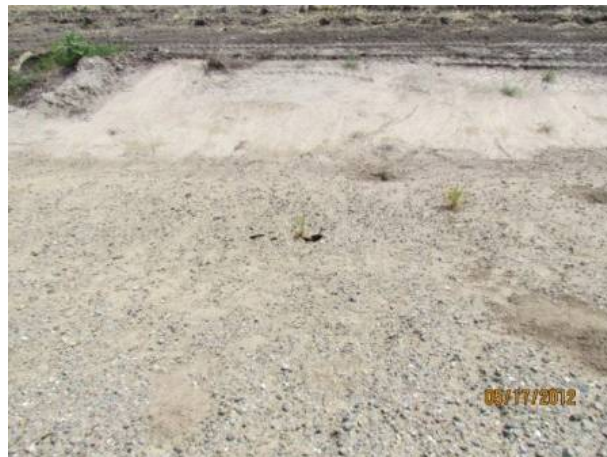
Levee Mile Report Line	14
Start Levee Mile	1.47
End Levee Mile	1.47
Location	Land Side
Category	Earthen Levee
Item	Animal Control

Animal holes were found on the landside of the levee looking upstream.

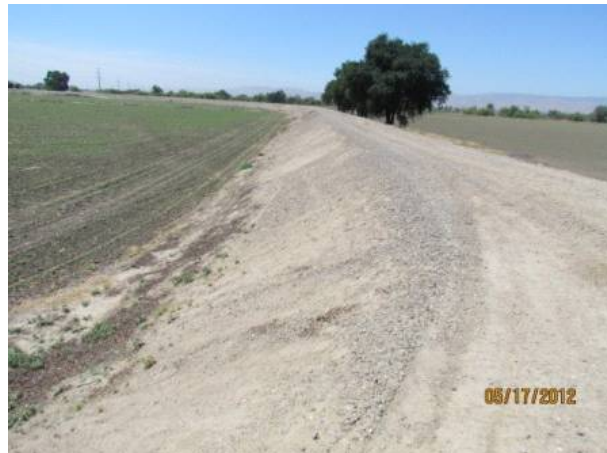
Levee Mile Report Line	18
Start Levee Mile	1.58
End Levee Mile	1.58
Location	Land Side
Category	Earthen Levee
Item	Animal Control

Rodent holes were repaired by the LMA on the landside slope of the levee looking upstream.

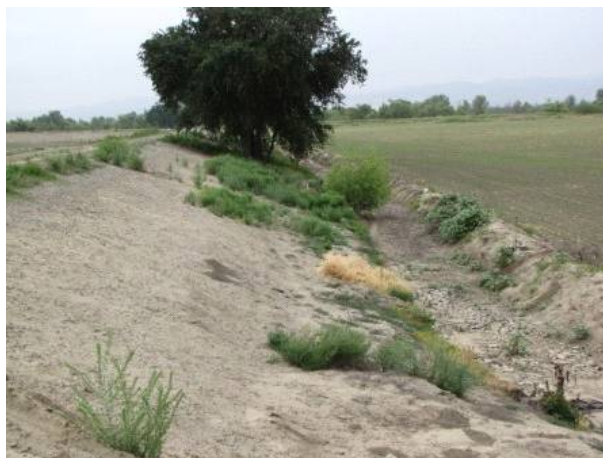
Levee Mile Report Line	19
Start Levee Mile	1.59
End Levee Mile	1.87
Location	Water Side
Category	Earthen Levee
Item	Encroachments

View of an agricultural ditch at the waterward toe of the slope.

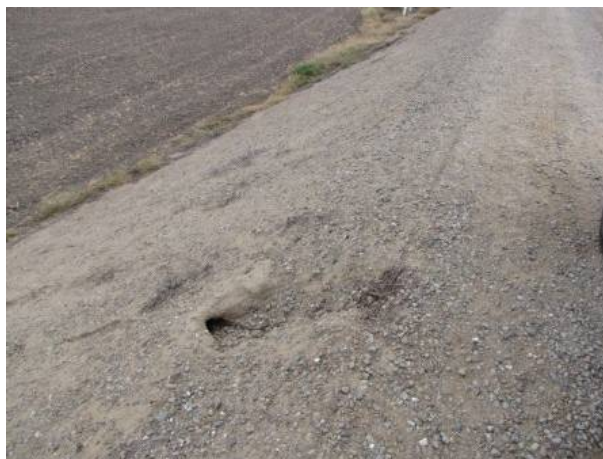
Levee Mile Report Line	21
Start Levee Mile	2.07
End Levee Mile	2.07
Location	Land Side
Category	Earthen Levee
Item	Animal Control

View of rodent holes in the landward shoulder looking upstream.

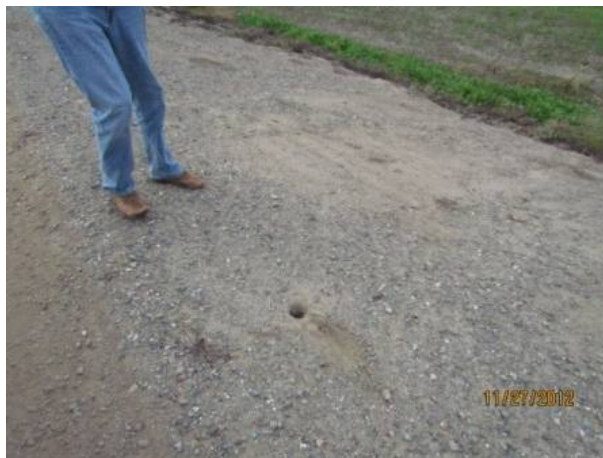
Levee Mile Report Line	21
Start Levee Mile	2.07
End Levee Mile	2.07
Location	Land Side
Category	Earthen Levee
Item	Animal Control

View of a rodent hole on the landside shoulder of the levee looking downstream.

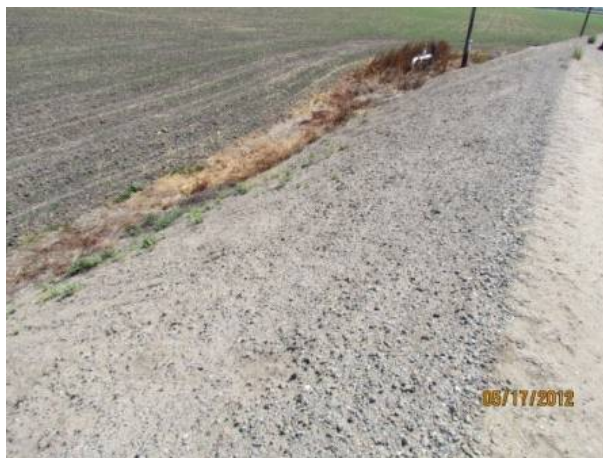
Levee Mile Report Line	22
Start Levee Mile	2.09
End Levee Mile	2.09
Location	Land Side
Category	Earthen Levee
Item	Animal Control

Rodent holes were repaired by the LMA on the landside slope of the levee looking upstream.

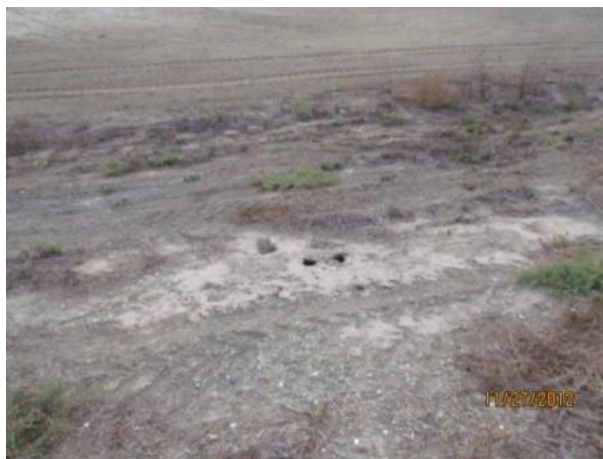
Levee Mile Report Line	23
Start Levee Mile	2.13
End Levee Mile	2.13
Location	Water Side
Category	Earthen Levee
Item	Animal Control

Rodent holes were found on the waterside toe of the levee looking upstream.

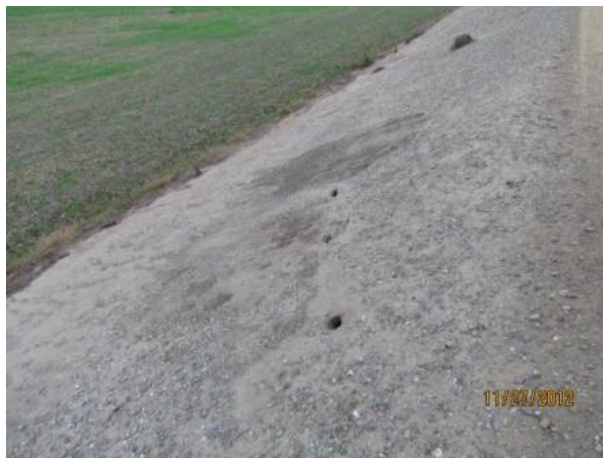
Levee Mile Report Line	24
Start Levee Mile	2.13
End Levee Mile	2.13
Location	Land Side
Category	Earthen Levee
Item	Animal Control

Rodent holes were found on the landside slope of the levee looking upstream.

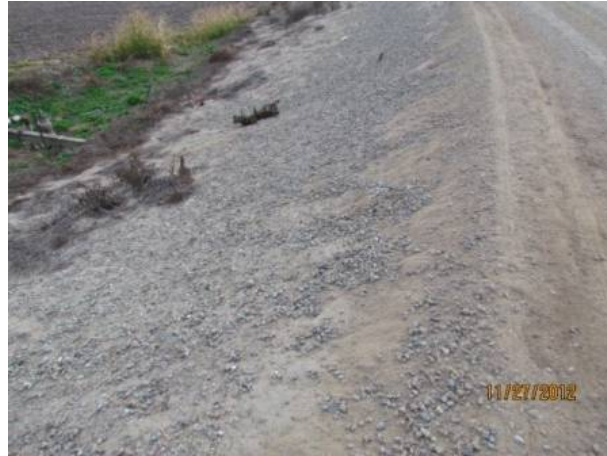
Levee Mile Report Line	28
Start Levee Mile	2.44
End Levee Mile	2.44
Location	Land Side
Category	Earthen Levee
Item	Animal Control

Rodent holes were repaired by the LMA on the landside slope of the levee looking upstream.

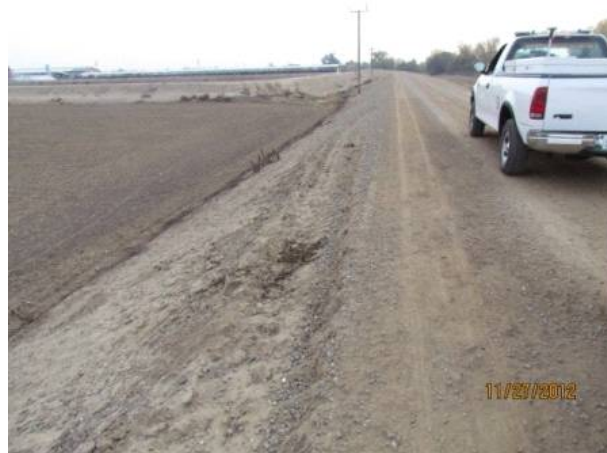
Levee Mile Report Line	29
Start Levee Mile	2.62
End Levee Mile	2.62
Location	Land Side
Category	Earthen Levee
Item	Slope Stability

Slope instability was found due to vehicular traffic on the landside shoulder of levee looking upstream.

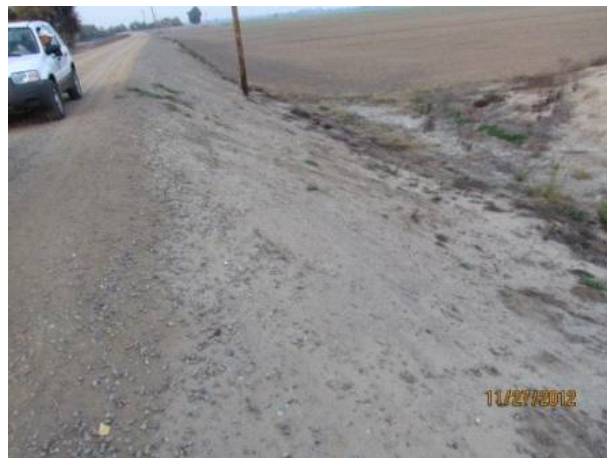
Levee Mile Report Line	30
Start Levee Mile	2.67
End Levee Mile	2.67
Location	Land Side
Category	Earthen Levee
Item	Slope Stability

Slope instability was repaired by the LMA on the landside slope of the levee looking downstream.

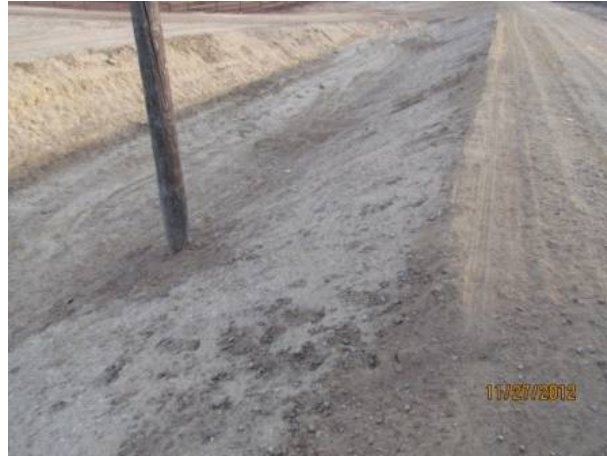
Levee Mile Report Line	32
Start Levee Mile	2.73
End Levee Mile	2.73
Location	Land Side
Category	Earthen Levee
Item	Slope Stability

Slope instability was repaired by the LMA on the landside slope of the levee looking upstream.

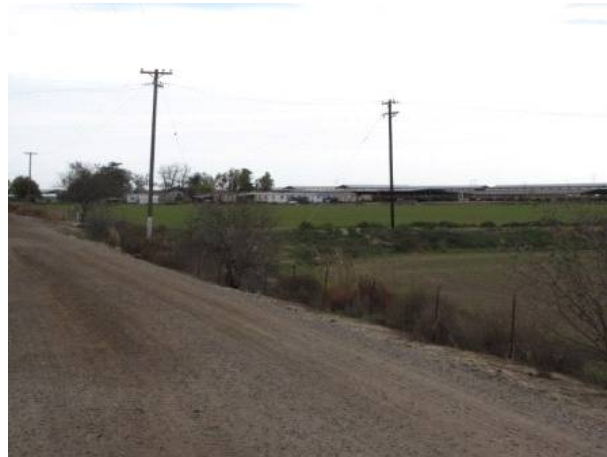
Levee Mile Report Line	35
Start Levee Mile	2.84
End Levee Mile	3.09
Location	Land Side
Category	Earthen Levee
Item	Encroachments

View of barbed wire fence along the waterward slope looking upstream.
